AN ARCHAEOLOGICAL WATCHING BRIEF
ON LAND TO THE REAR OF
23-27, HIGH STREET,
PEWSEY, WILTSHIRE.

National Grid Reference: SU 1652 6014
Planning Reference: E/2012/1110/FUL

PREPARED FOR MR. ANDY TEAL OF BOURNE VALLEY HOMES LTD.

October 2015

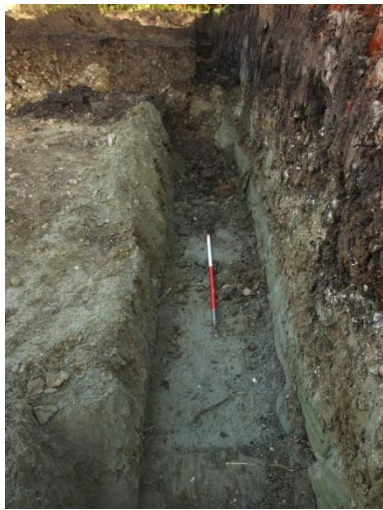
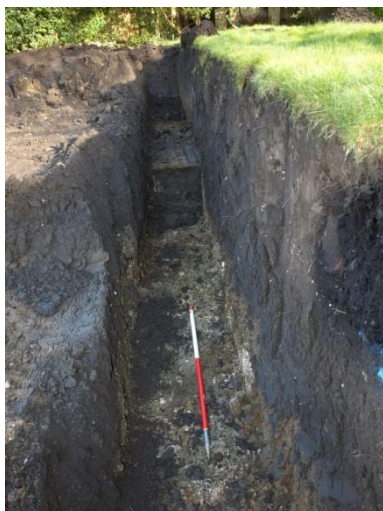
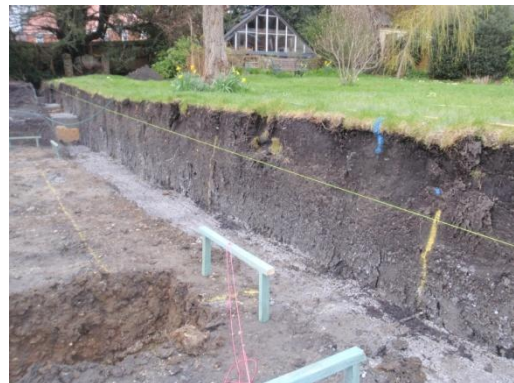
Plate 26: Northern end of the boundary wall foundation trench, from the south

Plate 27: The boundary wall foundation trench, from the south

Plate 29: The boundary wall foundation trench, from the south-west

7.3.1 This was followed by the monitored mechanical excavation of the foundations for the new eastern site boundary wall. This foundation trench was excavated under archaeological supervision to a length of 31.70m, to a width of 0.75m and to depths of between 0.85m-2.05m below ground levels. The depth of the excavations increased to the south which reflected the lower site ground levels to the south. The foundation trench excavations were also stepped at various points [**Plates 26-27 and 29**].

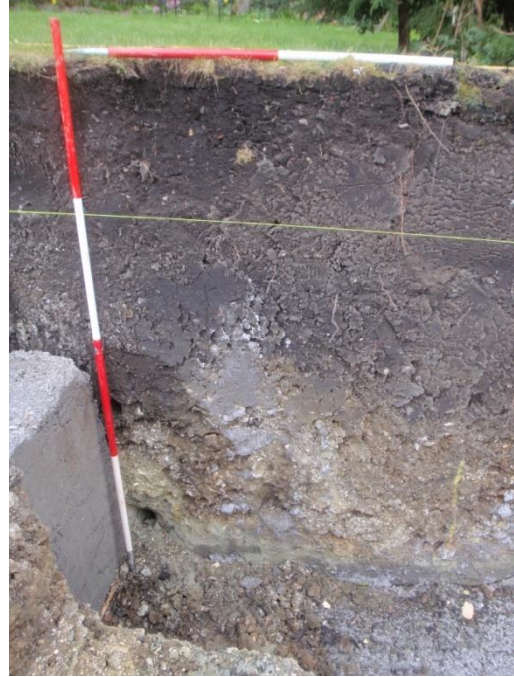
Plate 28: Representative Section 3, from the west

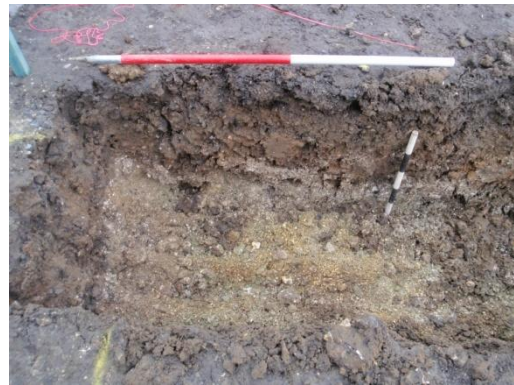
Plate 35: Representative Section 4, from the north

7.4.2 The mechanical excavation of the foundation trenches for **House Plot 1** were carried out under archaeological supervision to varying lengths, to a width of 0.60m and to depths of between 0.60m-1.0m below the already reduced ground levels [**Plates 34, 36, 38, 40-44 and 46-54**]. These mechanical excavations extended through the topsoil horizon (001), the deposit (003) and into the natural horizon (004), which extended to the base of these excavations. This deposit sequence was recorded within **Representative Sections 4 and 7 [Plates 35 and 45]**.

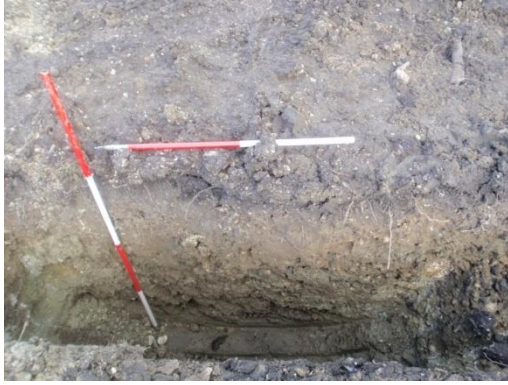
Plate 37: Section 5 of pit/ditch cut [005] with fills (006) and (007), from the north

7.4.4 At the western end of the first foundation trench which was excavated, the cut of an undated large pit or ditch [005] with fills (006) and (007) were identified. There were no finds from either fills (006) or (007). The profile of this feature was recorded within the north facing **Section 5 [Plate 37]**. It was possible to trace the line of this feature within a second foundation trench to the immediate north and somewhat tenuously within the cuts of two further foundation trenches further to the north. So it was possible to conclude that it was more likely that this feature may have been a ditch. This ditch was sealed by the ploughsoil/buried soil horizon (003) and was cut into the underlying natural horizon (004). A slight deviation in the line of this ditch to the north-west was also noted.

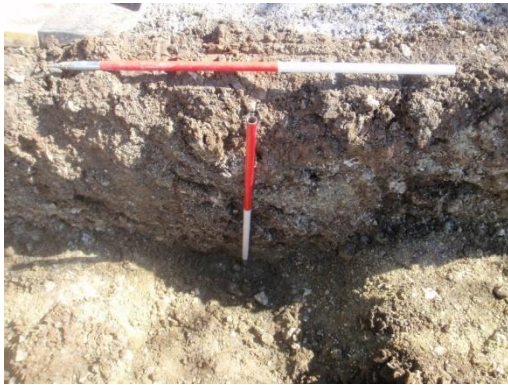
Plate 39: Section 6 of the gully cut [008] with fill (009), from the west

7.4.5 A second archaeological feature was identified during the mechanical excavation of the outside foundation trench which was parallel to the eastern site boundary. This comprised the cut of an east-west orientated undated linear gully [008] with fill (009). The profile of this gully was recorded within the west facing **Section 6 [Plate 39]**. The fill (009) did not yield any finds. This gully was sealed by the undated buried soil/ploughsoil horizon (003) and was cut into the natural horizon (004).

- 008** Cut of an undated east-west orientated linear gully that was identified during the mechanical excavation of the foundations for **House Plot 1**. Sharp break of slope at top, steeply sloping convex sides with rounded break of slope at base & flattish base. Cut into **(004)**. Recorded within **Section 6**. Length >0.70m, width - 0.84m, depth - 0.35m.

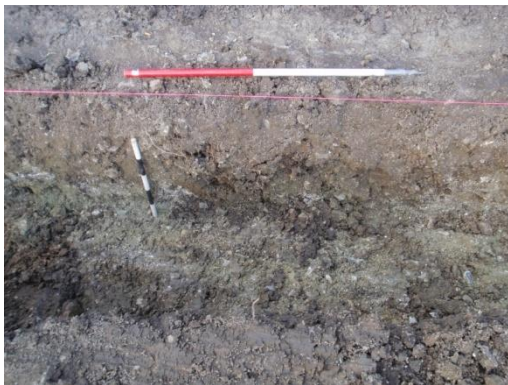
Plate 45: Representative Section 7, from the south

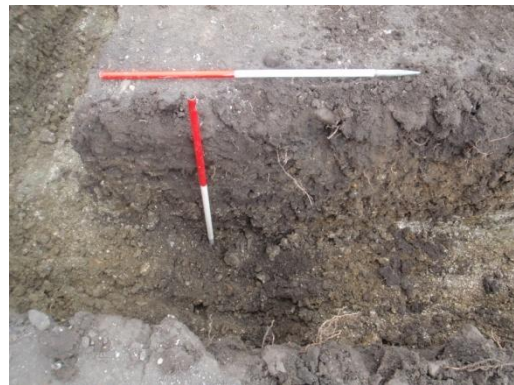
Plate 72: Section 9, from the west

7.6.3 At the north-western corner of **House Plot 2**, the mechanical excavation of the foundation trench here identified the cut of a second archaeological feature. This comprised an undated pit [012] with fills (013) and (014). The profile of this ditch was recorded within **Section 9 [Plate 72]**. Neither fill (013) nor (014) produced any finds. This feature was sealed by the topsoil horizon (001) and as such was also cut from a relatively high level, giving this feature a possible post-medieval origin. This feature was also cut into the buried soil/ploughsoil horizon (003) and the natural horizon (004).

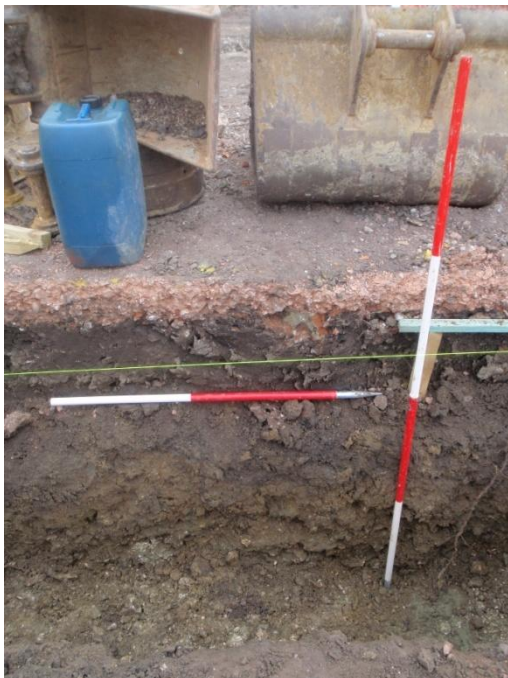
Plate 75: Representative Section 10, from the west

7.6.1 The foundations for **House Plots 2 and 3** had been laid out prior to arrival. These foundation trenches were excavated to varying lengths, to a width of 0.70m and to depths of between 0.80m-1.0m below the already reduced levels [**Plates, 69, 71, 73-74, 76-78, 80, 82-83 and 85-87**]. These monitored mechanical excavations identified a simple deposit sequence which comprised the topsoil horizon (001), the undated ploughsoil/buried soil horizon (003) and the underlying natural horizon (004), which was found to extend to the base of these excavations. This deposit sequence was recorded within **Representative Section 10 [Plate 75]**.

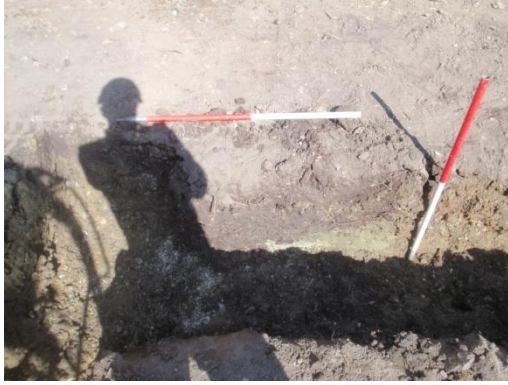
Plate 79: Section 11 of pit cut [015] with fill (016), from the south

- 7.6.4 Within the central area of **House Plot 2**, a third archaeological feature was identified during the mechanical excavation of a foundation trench here. This comprised the cut of a further pit [015] with fill (016). The profile of this pit was recorded within **Section 11 [Plate 79]**. The fill (016) did not produce any finds. The pit cut [015] was sealed by the topsoil horizon (001) and as such was also cut from a relatively high level, giving a possible post-medieval date to this feature, which was in turn cut into the ploughsoil/buried soil horizon (003) and the natural horizon (004).

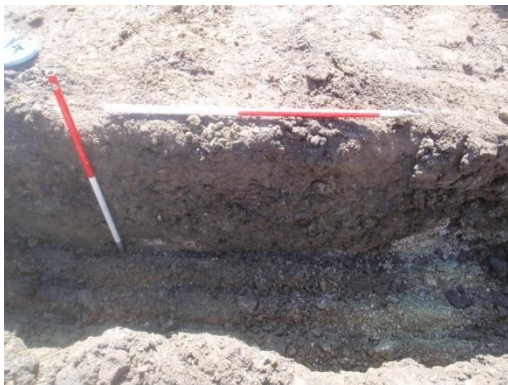
Plate 81: Section 12 of the pit cut [017] with fill (018), from the north

- 7.6.5 The cut of a fourth archaeological feature was encountered during the mechanical excavation of a further foundation trench along the southern fringes of **House Plot 2**. This comprised the cut of a further undated pit [017] with fill (018). The profile of this pit was recorded within **Section 12 [Plate 81]**. The fill (018) did not yield any finds. The pit cut [017] was sealed by the topsoil horizon (001) and as such was also cut from a relatively high level, giving a possible post-medieval date to this feature, which was in turn cut into the ploughsoil/buried soil horizon (003) and the natural horizon (004).
