**NEVILLE HALL MIFA
FREELANCE ARCHAEOLOGIST & CONSULTANT**

ARCHAEOLOGICAL MONITORING & RECORDING
AT CHURCH FARM, CHURCH LANE,
RAND, LINCOLNSHIRE.

National Grid Reference: TF 1073 7892
Site Code: CLRA15
Accession No: LCNCC: 2015.142
Planning Reference: 132429

September 2015

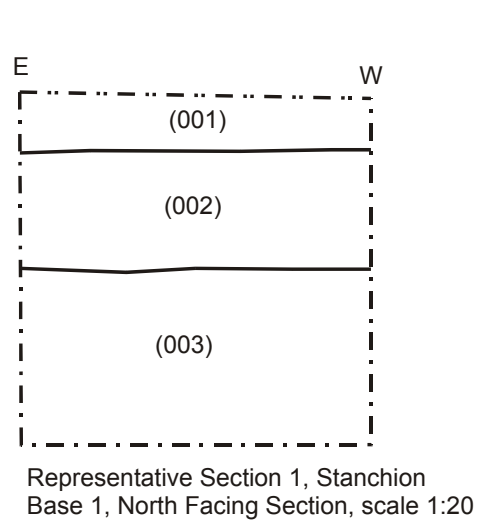
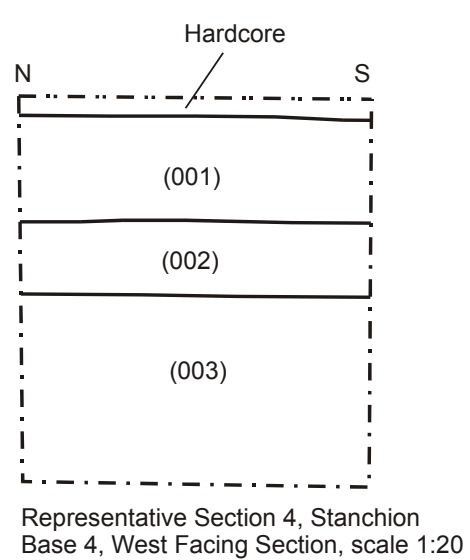
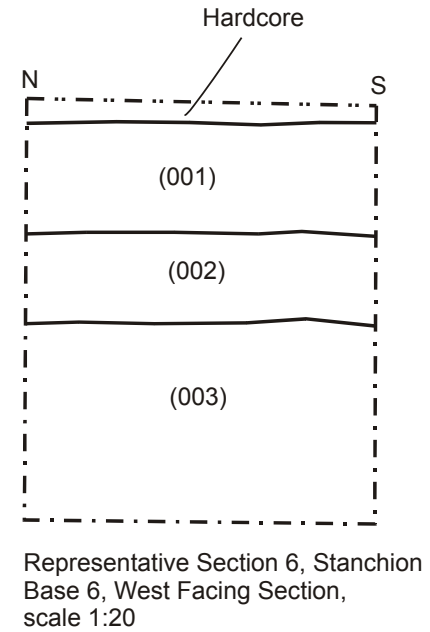
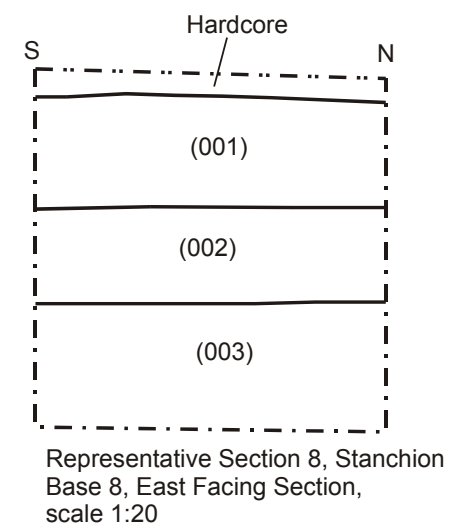
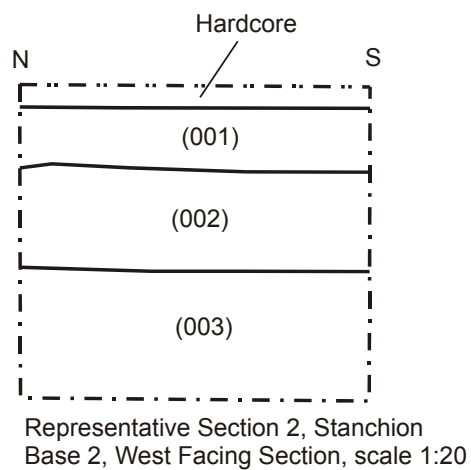
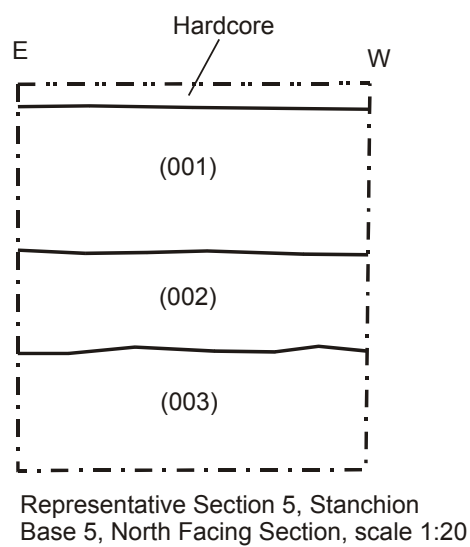
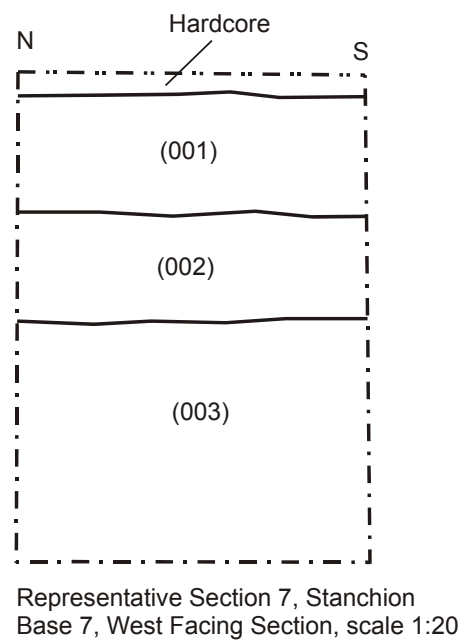
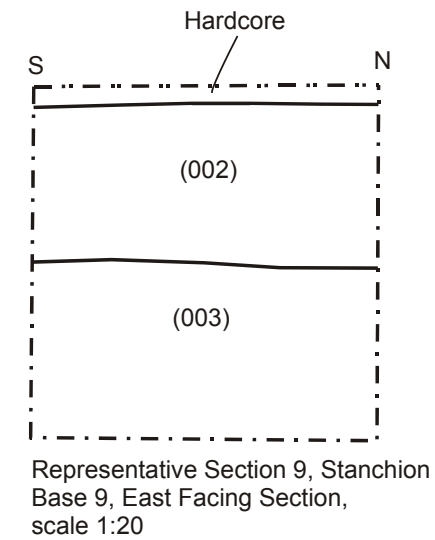
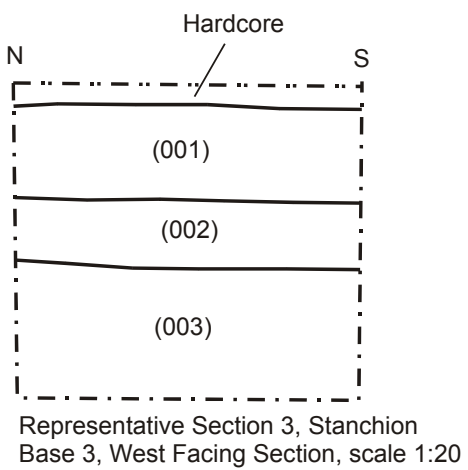
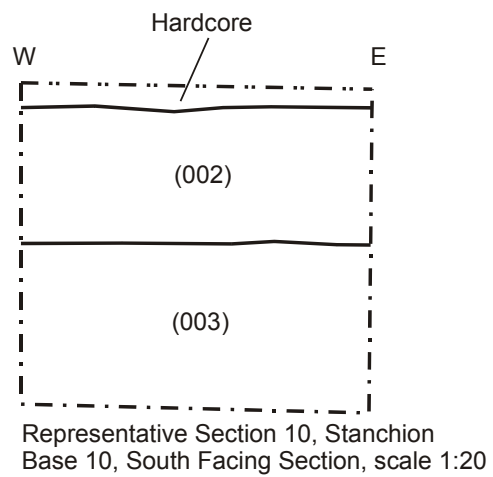
Figure 5: Representative Sections 1-10 at a scale of 1:20

- 8.2 Overall, the groundworks programme identified a simple deposit sequence which consisted of a topsoil horizon, a buried soil or ploughsoil horizon and an underlying natural horizon of boulder clays. This deposit sequence was recorded within a total of ten representative sections during the excavation of the corresponding ten foundation stanchion bases. An assemblage of post-medieval pottery dating from the late 17th to the mid 19th centuries was recovered from the buried soil or ploughsoil horizon during the initial mechanical ground reduction.

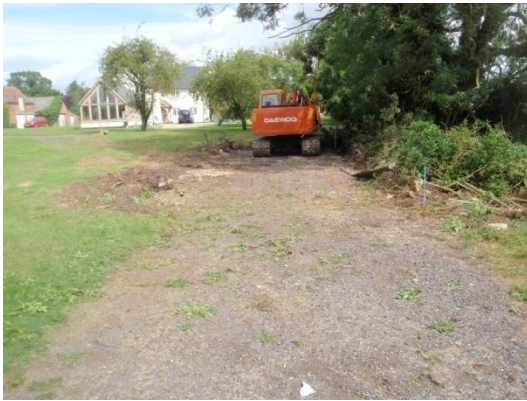
- 7.1.1 The eastern portion of the new build area had already been disturbed to a certain extent by the site of a former Nissen hut which had been removed. The basal foundation of this structure comprising breeze blocks had been left *in situ* [**Plates 1 and 12**]. The remainder of the development site comprised a grassed area [**Plates 2-4**].

Plate 1: View of the site of a former Nissen hut, from the south

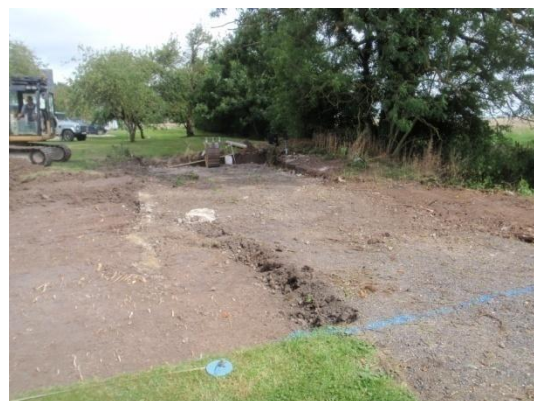
Plate 12: View of the site of a former Nissen hut showing line of foundations, from the south

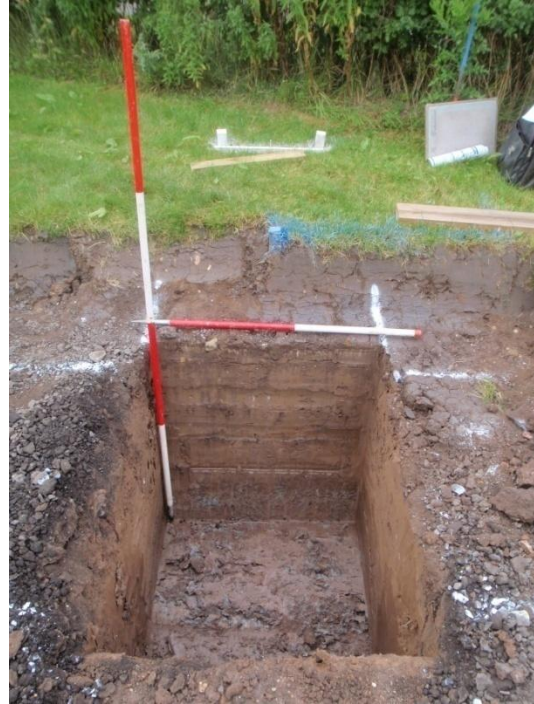
Plate 21: Section 1, **Stanchion Base 1**, from the north

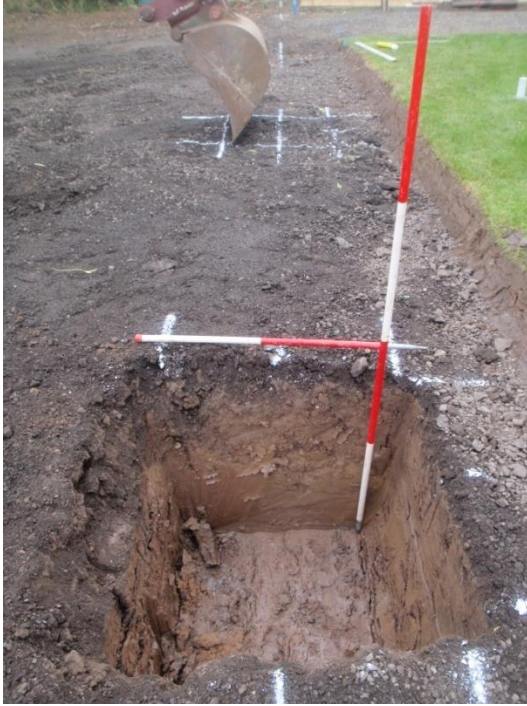
Stanchion Base 2 was situated to the east of **Stanchion Base 1** and was excavated to a length of 1.15m (from north-south), to a width of 1.0m (from east-west) and to a depth of 0.90m below the reduced levels. The same deposit sequence noted earlier was also identified within this excavation and was recorded within **Representative Section 2** [Plate 23].

Plate 23: Section 2, Stanchion Base 2, from the west

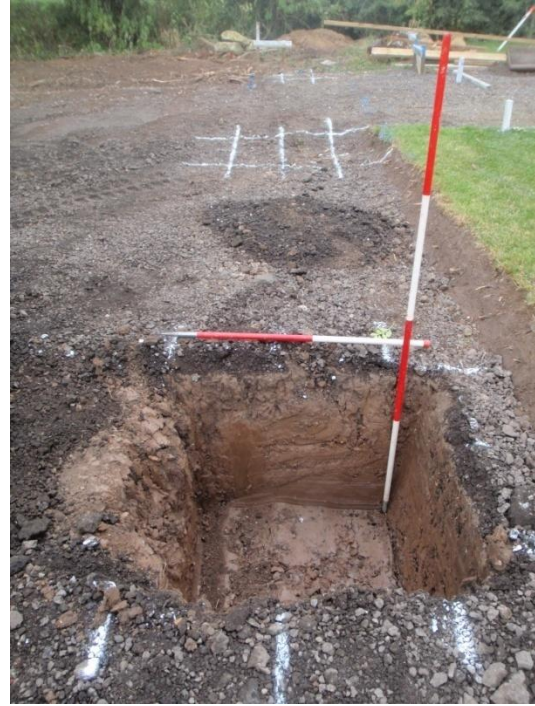
Stanchion Base 3 was located to the east of **Stanchion Base 2** and was excavated to a length of 1.20m (from north-south), to a width of 1.10m (from east-west) and to a depth of 0.90m below the reduced levels. The same deposit sequence noted earlier was also

Plate 25: Section 3, Stanchion Base 3, from the west

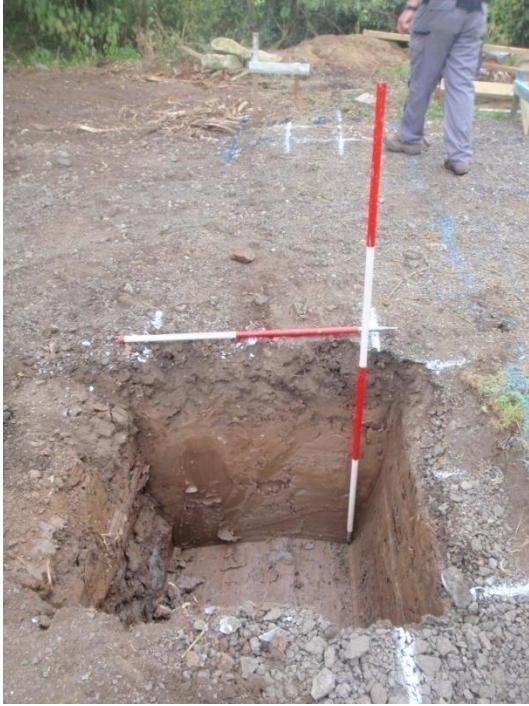
Stanchion Base 4 was positioned to the east of **Stanchion Base 3** and was excavated to a length of 1.20m (from north-south), to a width of 1.0m (from east-west) and to a depth of 1.10m below the reduced levels. The same deposit sequence noted earlier was also identified within this excavation and was recorded within **Representative Section 4 [Plate 27]**. This stanchion base was excavated within the area of the site of the former Nissen hut.

Plate 27: Section 4, Stanchion Base 4, from the west

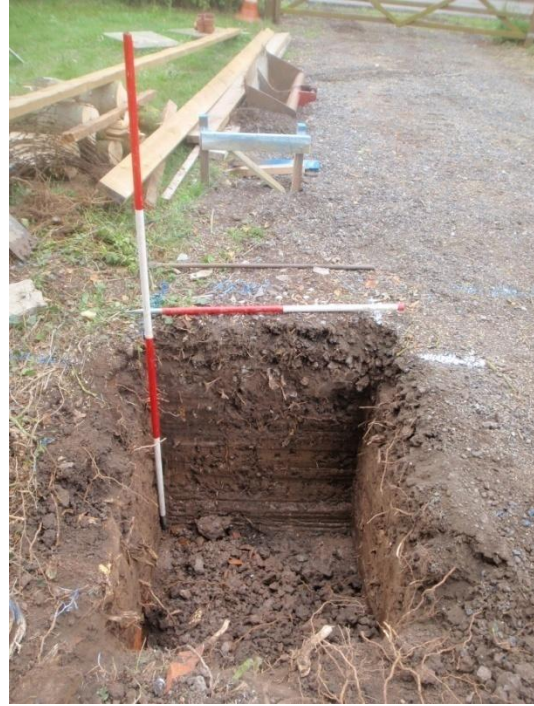
Stanchion Base 5 was located at the south-eastern corner of the new build area and to the east of **Stanchion Base 4**. **Stanchion Base 5** was excavated to a length of 1.25m in length (from north-south), to a width of 1.10m (from east-west) and to a depth of 1.10m below the reduced levels. The same deposit sequence noted earlier was also identified within this excavation and was recorded within **Representative Section 5 [Plate 29]**. The line of a 19th century red ceramic drain was identified traversing this excavation. **Stanchion Base 5** was also excavated through the site of the former Nissen hut which had stood here. This stanchion base was excavated within the area of the site of the former Nissen hut.

Plate 29: Section 5, Stanchion Base 5, from the north

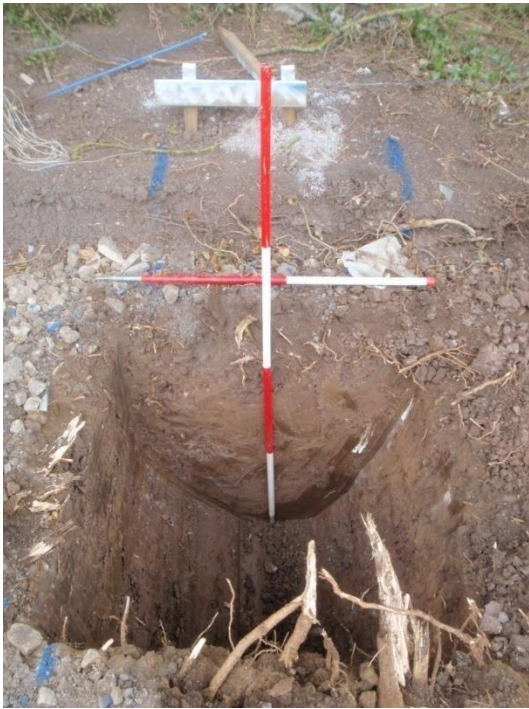
Stanchion Base 6 was positioned at the north-eastern corner of the new build area and to the north of **Stanchion Base 5**. **Stanchion Base 6** was excavated to a length of 1.10m (from north-south), to a width of 1.0m (from east-west) and to a depth of 1.20m below the reduced levels **[Plate 31]**. The same deposit sequence noted earlier was also identified within this excavation and was recorded within **Representative Section 6 [Plate 32]**. **Stanchion Base 6** was also excavated through the site of the former Nissen hut which had stood here.

Plate 32: Section 6, **Stanchion Base 6**, from the west

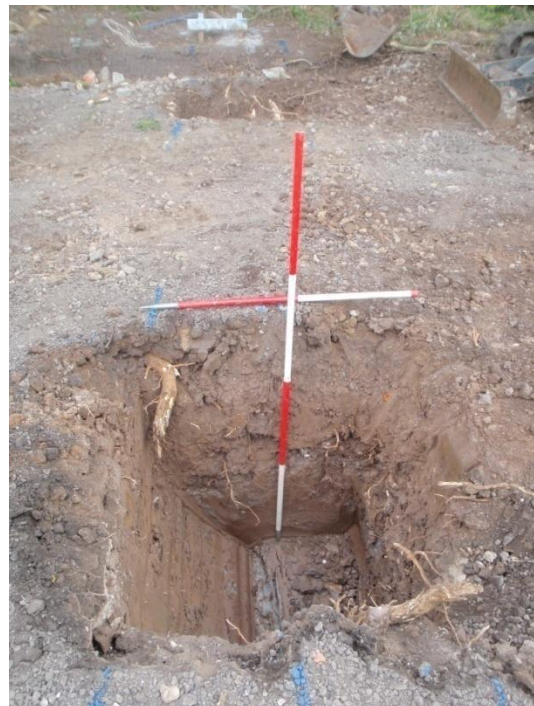
Stanchion Base 7 was located to the west of **Stanchion Base 6** and was excavated to a length of 1.30m (from north-south), to a width of 1.20m (from east-west) and to a depth of 1.40m below the reduced levels. The same deposit sequence noted earlier was also identified within this excavation and was recorded within **Representative Section 7 [Plate 34]**. This excavation also extended through part of the modern breeze block foundations of the former Nissen hut which had stood here.

Plate 34: Section 7, **Stanchion Base 7**, from the west

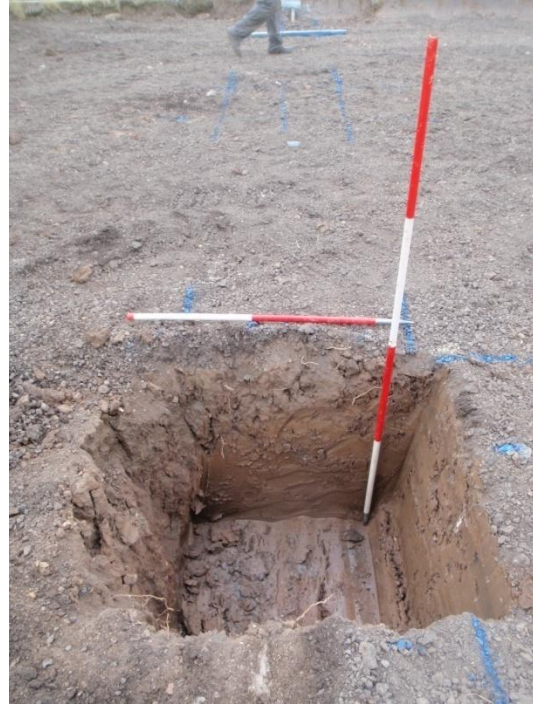
Stanchion Base 8 was situated to the west of **Stanchion Base 7** and was excavated to a length of 1.30m (from north-south), to a width of 1.10m (from east-west) and to a depth of 1.0m below the reduced levels. The same deposit sequence noted earlier was also identified within this excavation and was recorded within **Representative Section 8 [Plate 37]**.

Plate 37: Section 8, Stanchion Base 8, from the east

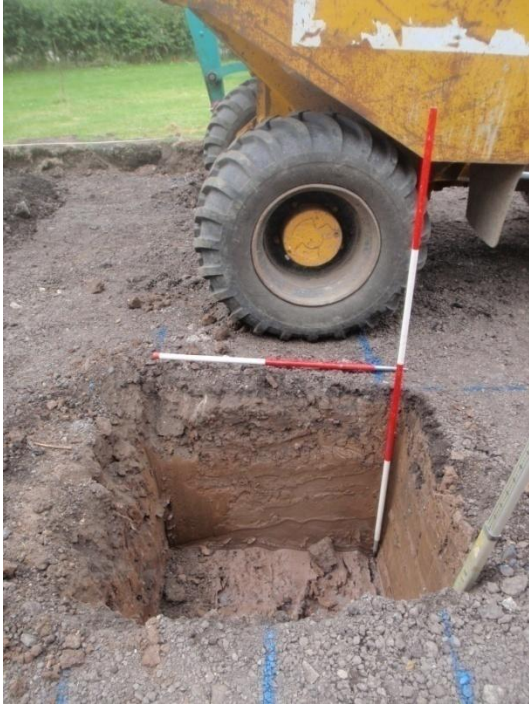
Plate 39: Section 9, Stanchion Base 9,
from the east

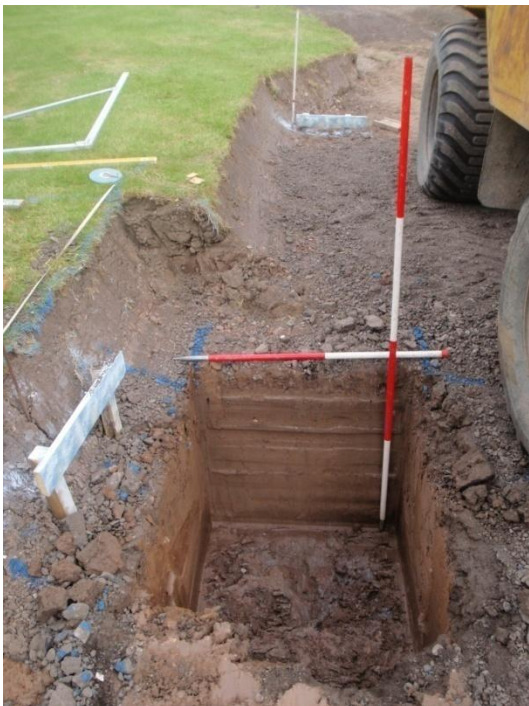
Plate 40: Section 10, Stanchion Base
10, from the south
