**NEVILLE HALL MIFA
FREELANCE ARCHAEOLOGIST & CONSULTANT**

PHASES 1 & 2 OF THE
LEVEL II HISTORIC BUILDING RECORDING
AT 9, APIARY GATE,
CASTLE DONINGTON,
LEICESTERSHIRE.

October 2015

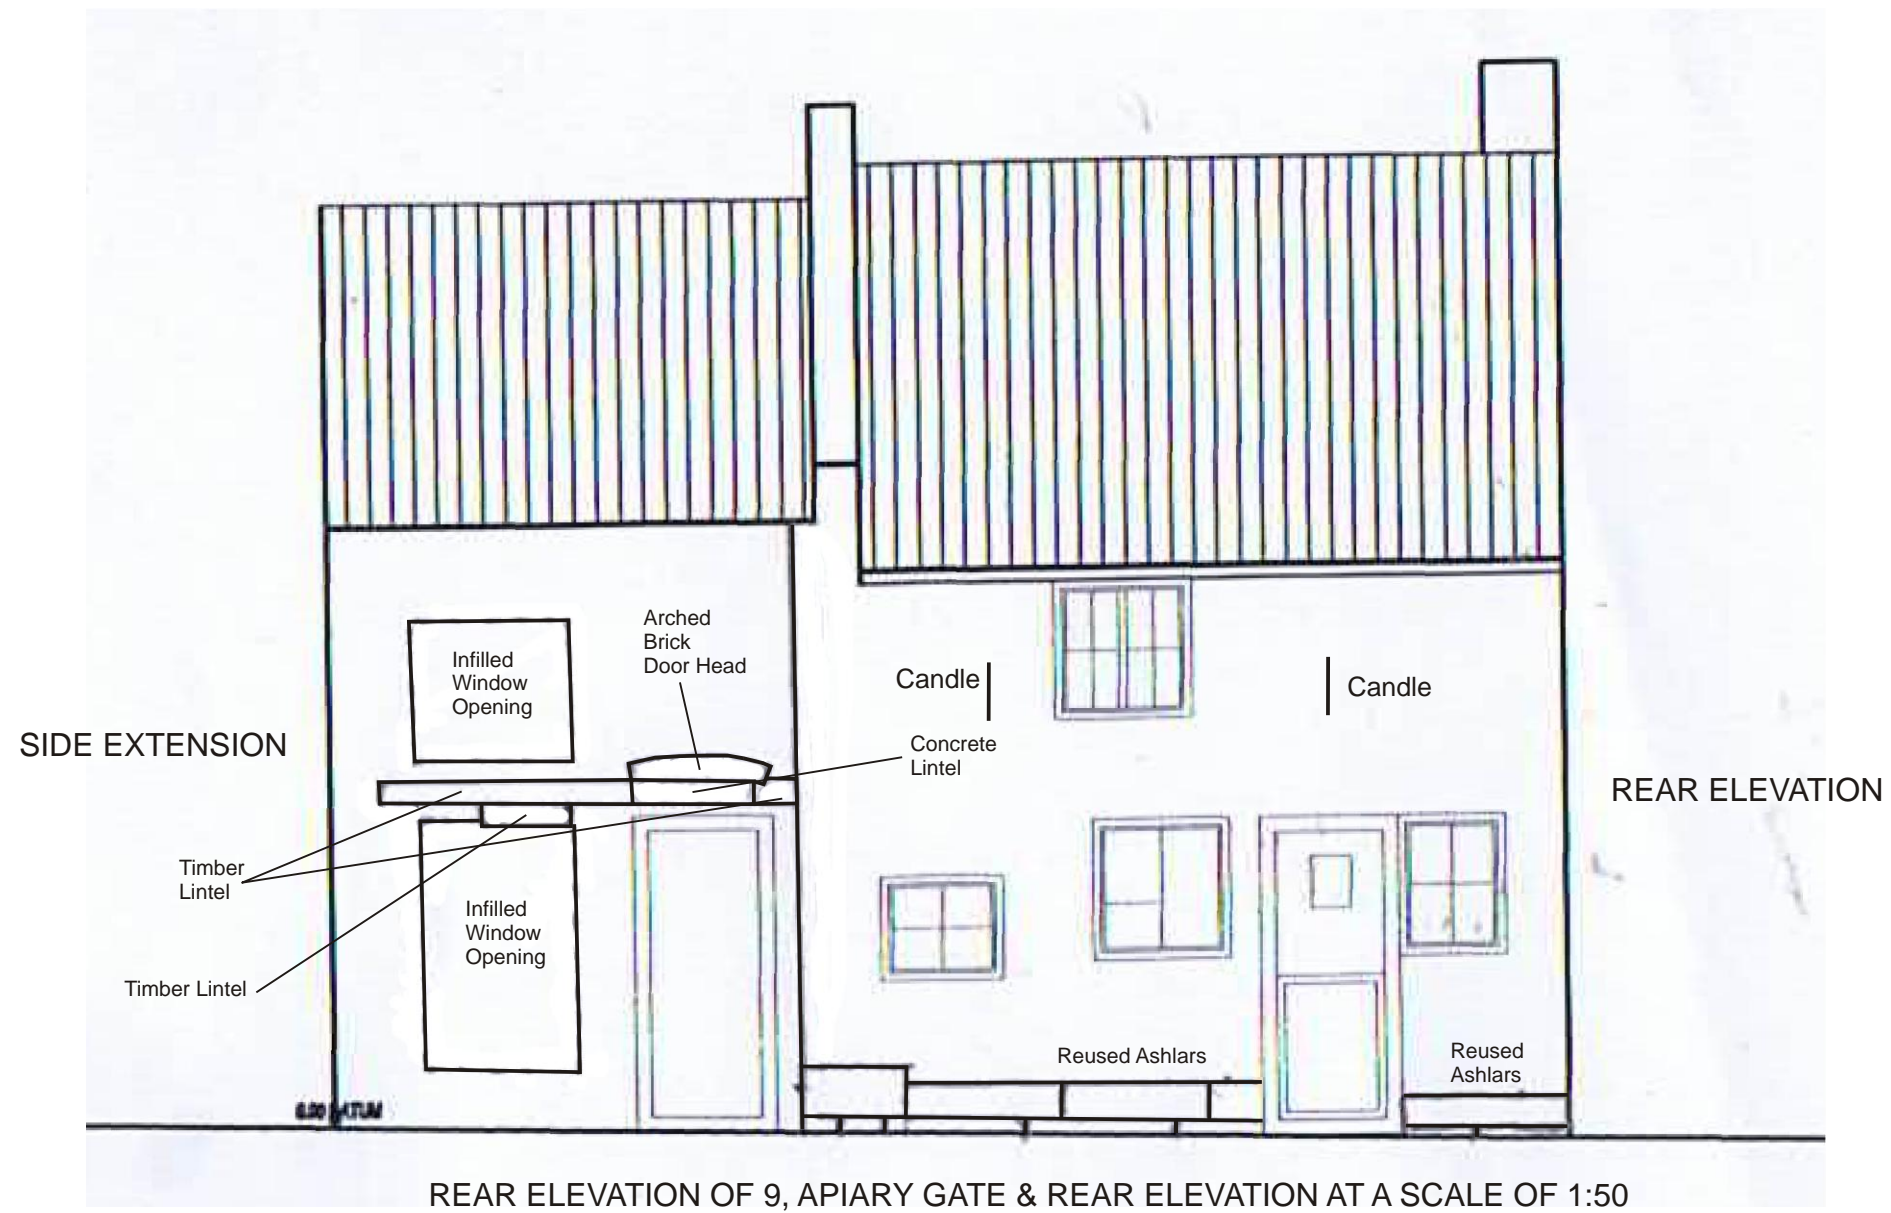
Figure 9: Rear Elevation of 9, Apiary Gate & Side Elevation at a scale of 1:50

7.1.2.2 At the base or ground level of the Rear Elevation is a foundation of two courses of sandstone ashlar, which are interrupted by the rear entrance to the building and its threshold. The sandstone blocks are cut into various rectangular shaped sizes with no bonding material visible. Above these sandstone ashlars is an area of modern concrete rendering, which obscures the underlying brickwork.

7.1.2.5 There is further evidence of the decorative brickwork, which was first noted in the whole Front Elevation of this building. Of particular note and at first floor level only are two small decorative areas of brickwork, which appear to be original features. These are 'candles' in brick composed of four vertically arranged brick headers topped by a diamond shaped header, denoting the 'flame'.

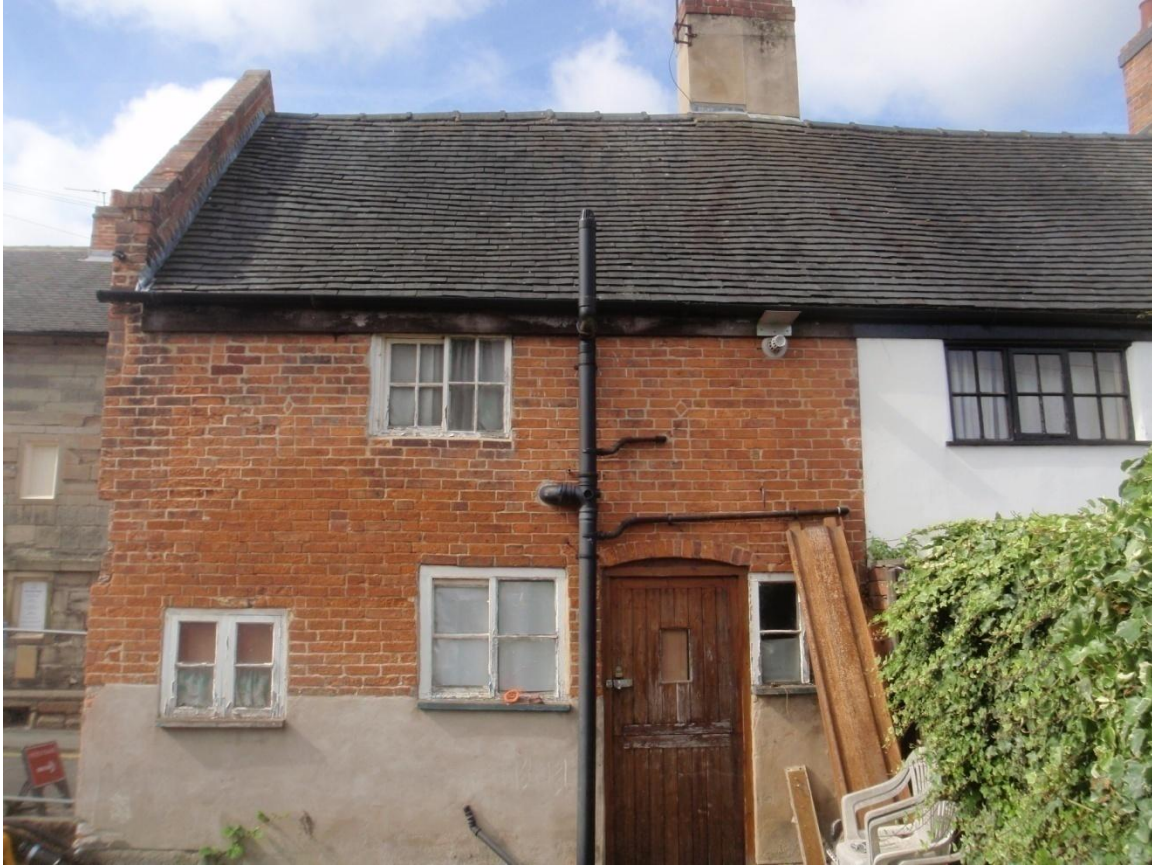
7.2.1.1 **Plate 26** shows the rear (north) elevation of 9, Apiary Gate, following the demolition of the former adjoining side extension. This image shows that no change has taken place to the external fabric of this Elevation.

Plate 26: View of the Rear (North) Elevation of 9, Apiary Gate following the demolition of the Side Extension, from the north

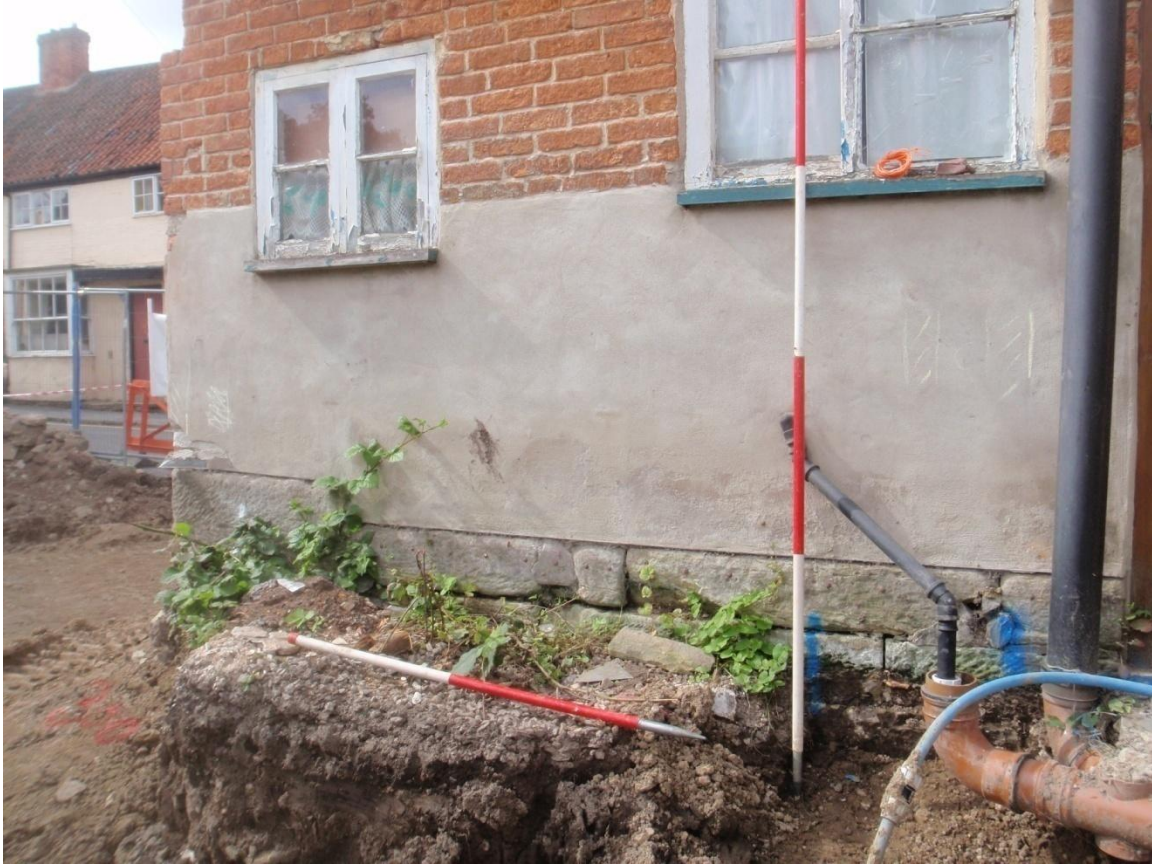
Plate 27: View of the lower levels of the Rear (North) Elevation of 9, Apiary Gate showing the sandstone ashlar foundations exposed by site groundworks, from the north

7.2.1.2 The Phase 1 building recording had noted that at the base or ground floor level of this Elevation, two courses of foundation sandstone ashlar were visible. Various site groundworks associated with the construction of the new residential dwellings on the site comprising limited ground reduction had exposed a further and third course of sandstone ashlar below the first two [**Plates 27-28**].

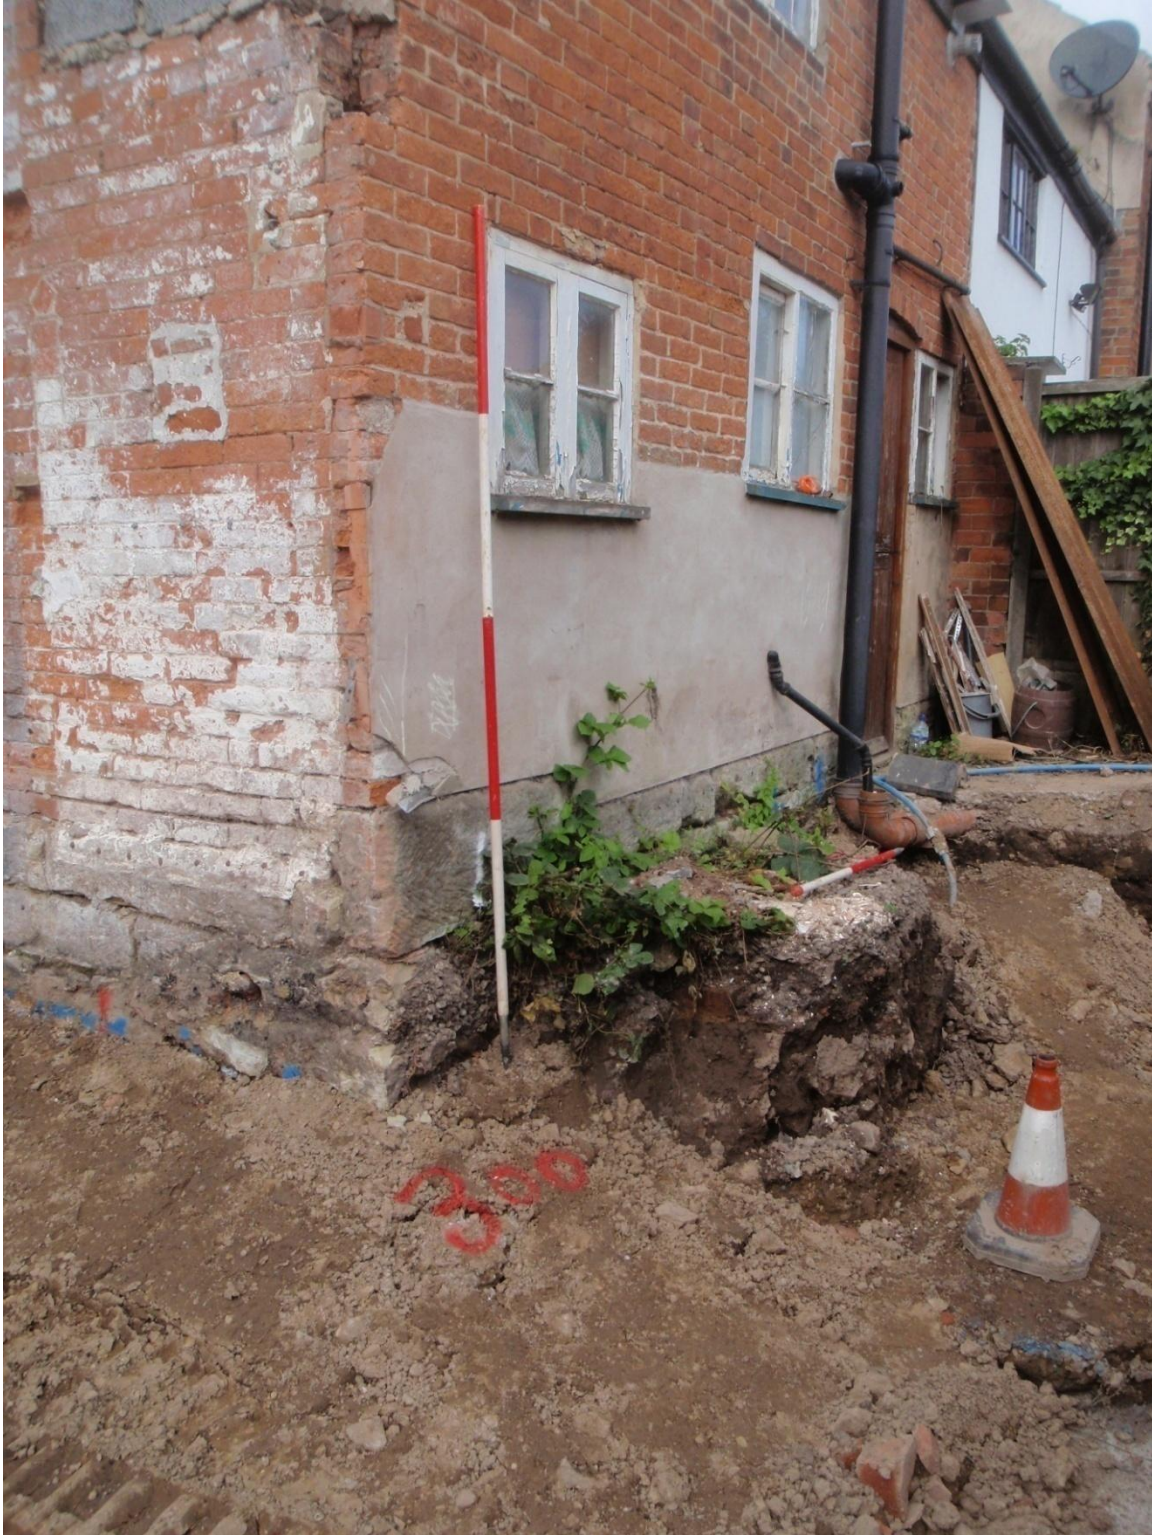
Plate 28: View of the lower levels of the Rear (North) Elevation and of the newly exposed Side (East) Elevation of 9, Apiary Gate, from the east

- 7.2.2.2 The Phase 1 building recording had noted that at ground floor level is a foundation of two courses of rectangular shaped sandstone ashlar of various sizes with no apparent bonding material visible. The groundworks associated with the construction of the new residential dwellings on the site had entailed some ground reduction which had exposed a third and underlying course of sandstone ashlar to the foundation of this Side Elevation. This foundation of three courses of stone ashlar was found to extend across the whole width of this Side Elevation [**Plates 28-30**].

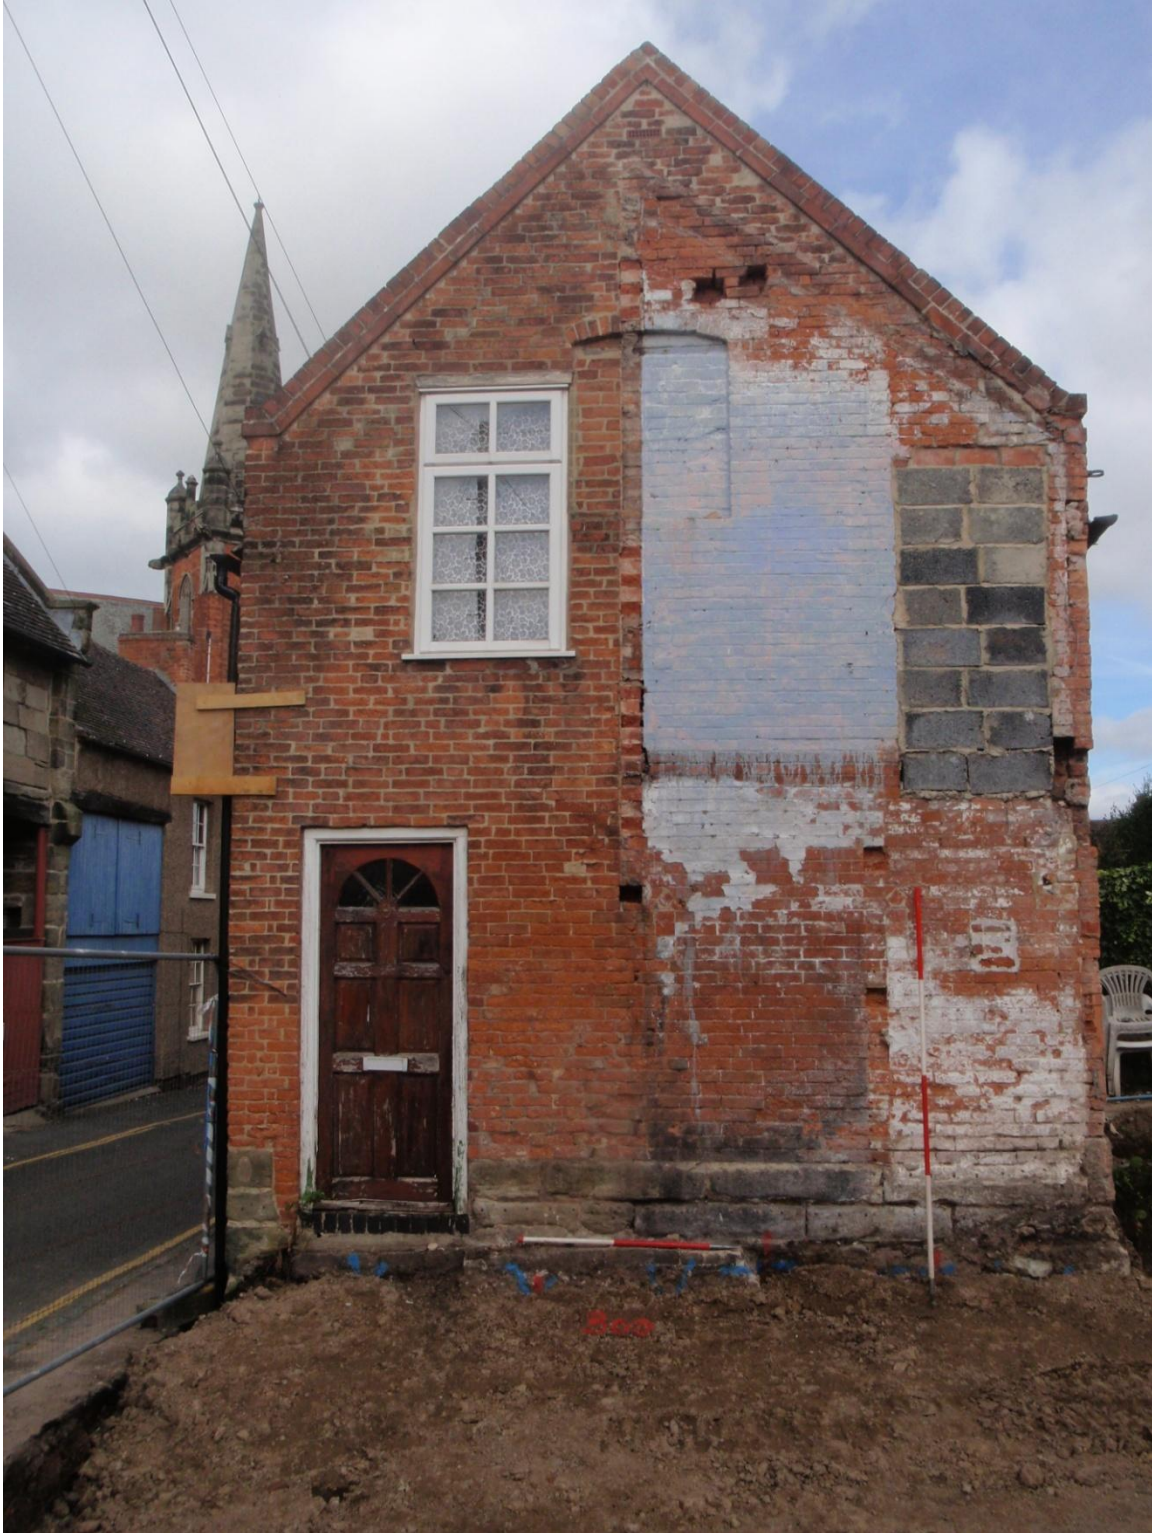
Plate 29: View of the newly and fully exposed Side (East) Elevation of 9, Apiary Gate, from the east

- 7.2.2.3 Above these foundations, the brickwork of this Side (East) Elevation was also fully exposed and appeared to be consistent with that recorded during the Phase 1 building recording. The brickwork at the lower levels of this Elevation is composed of three courses of stretchers which alternate with a course of alternate headers and stretchers with the same bonding materials as was recorded in the Rear (North) Elevation during the Phase 1 recording. Similarly, at the first floor levels of this Side (East) Elevation the nature of this brickwork bonding changes and is composed mostly of courses of stretchers [**Plates 29-30**].

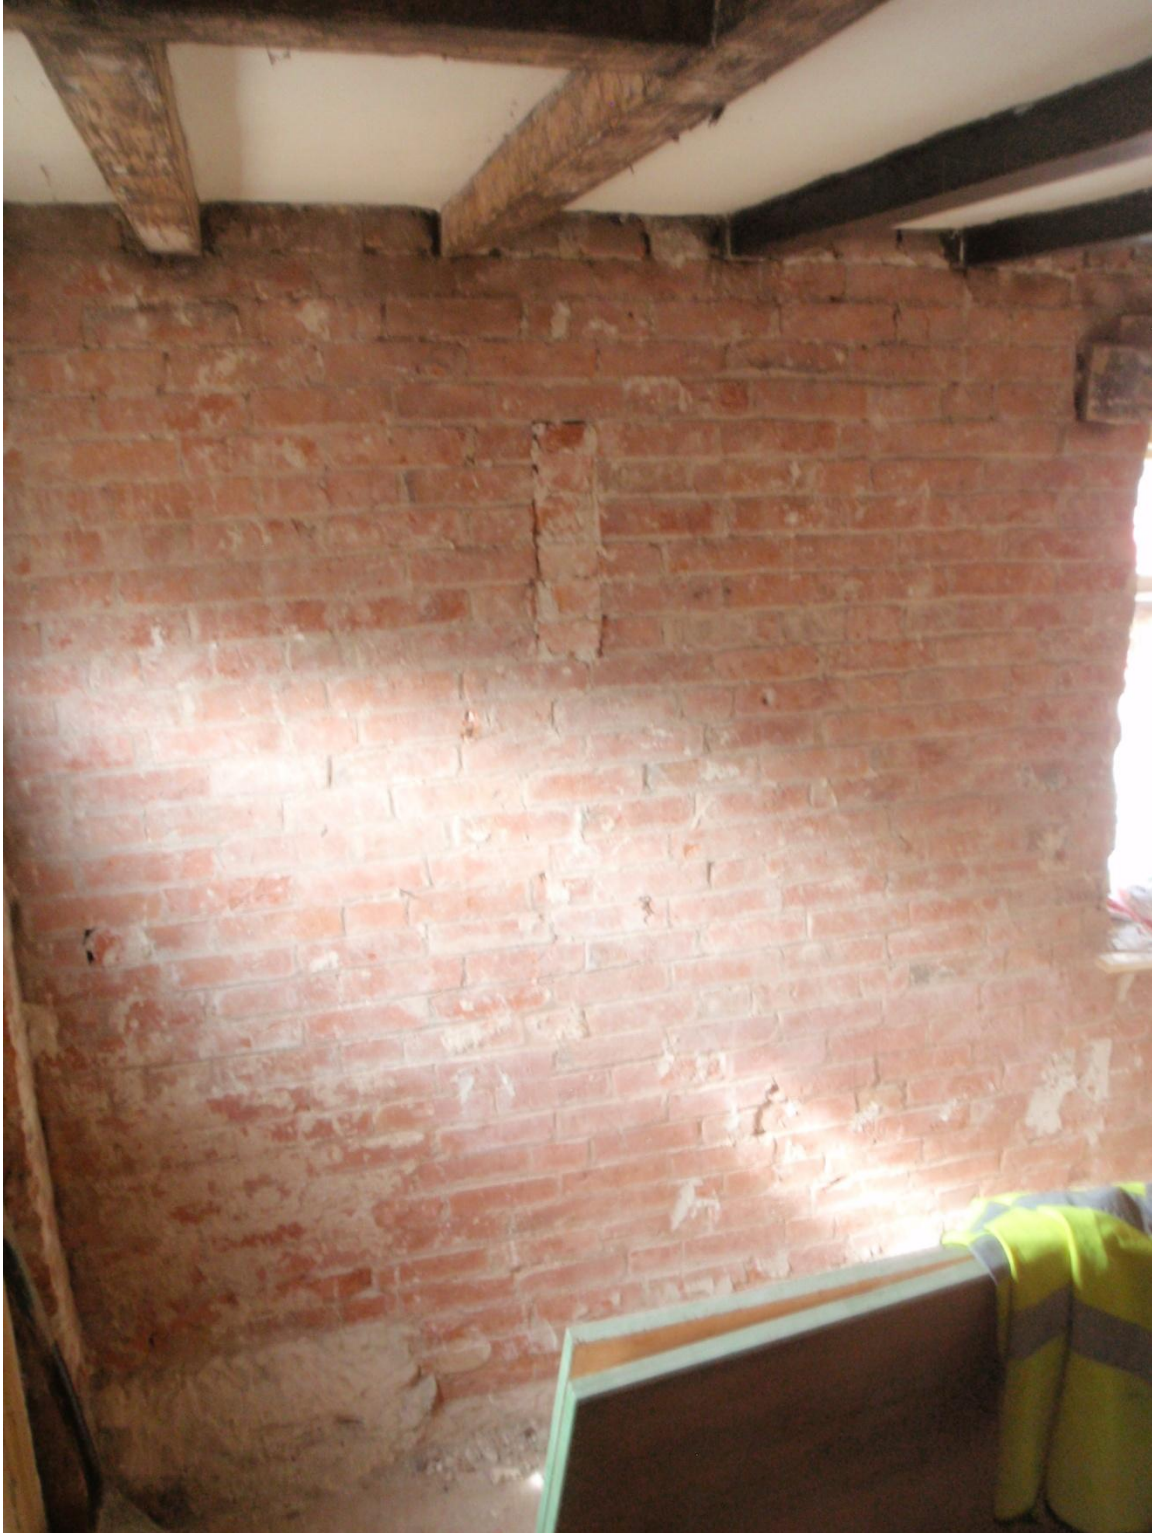
- brickwork bonding in these two walls was identical to that previously recorded externally during the Phase 1 programme. The removal of this plasterwork had also revealed the internal face of one of the ground floor decorative 'candle' brick features along with one course of the sandstone ashlar foundations along the base of the internal south wall.

Plate 37: View of the exposed south wall of the ground floor lounge, showing the decorative 'candle' brickwork feature, from the north

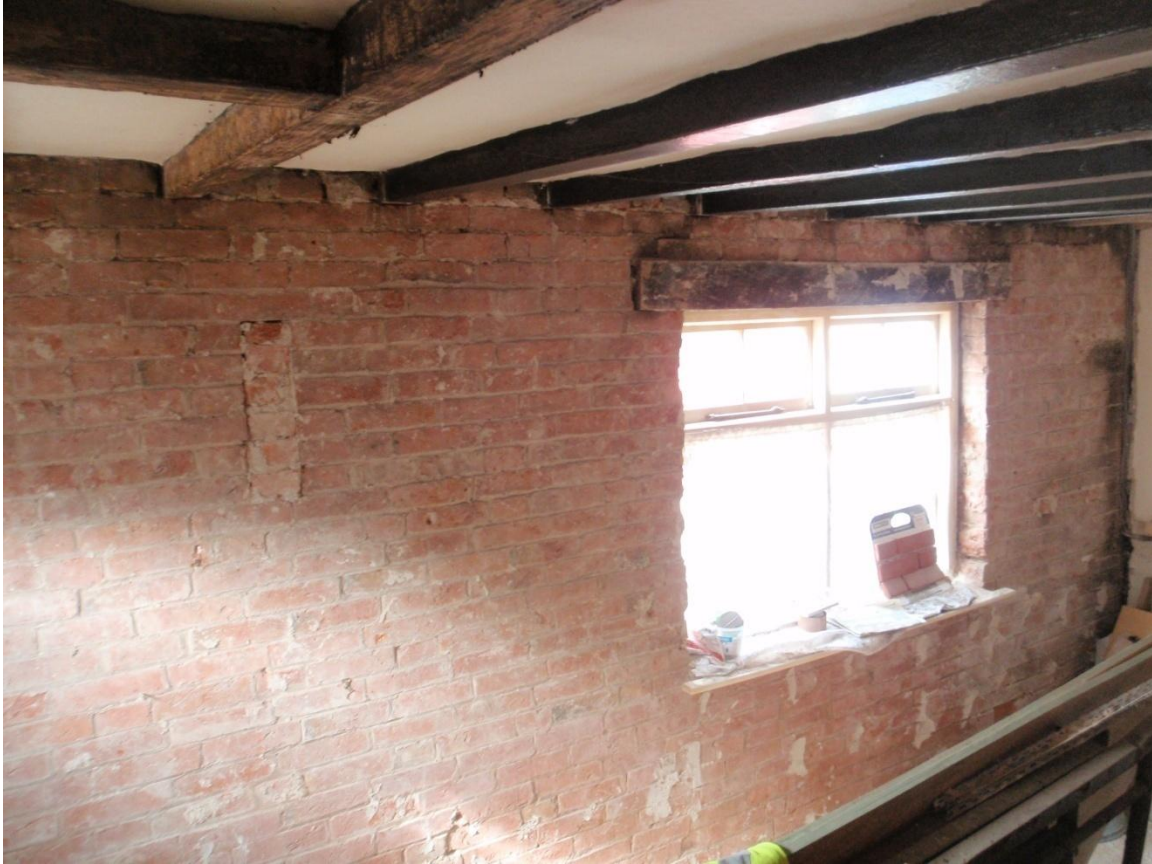
Plate 38: View of the exposed south wall of the ground floor lounge, showing the decorative 'candle' brickwork feature, from the north

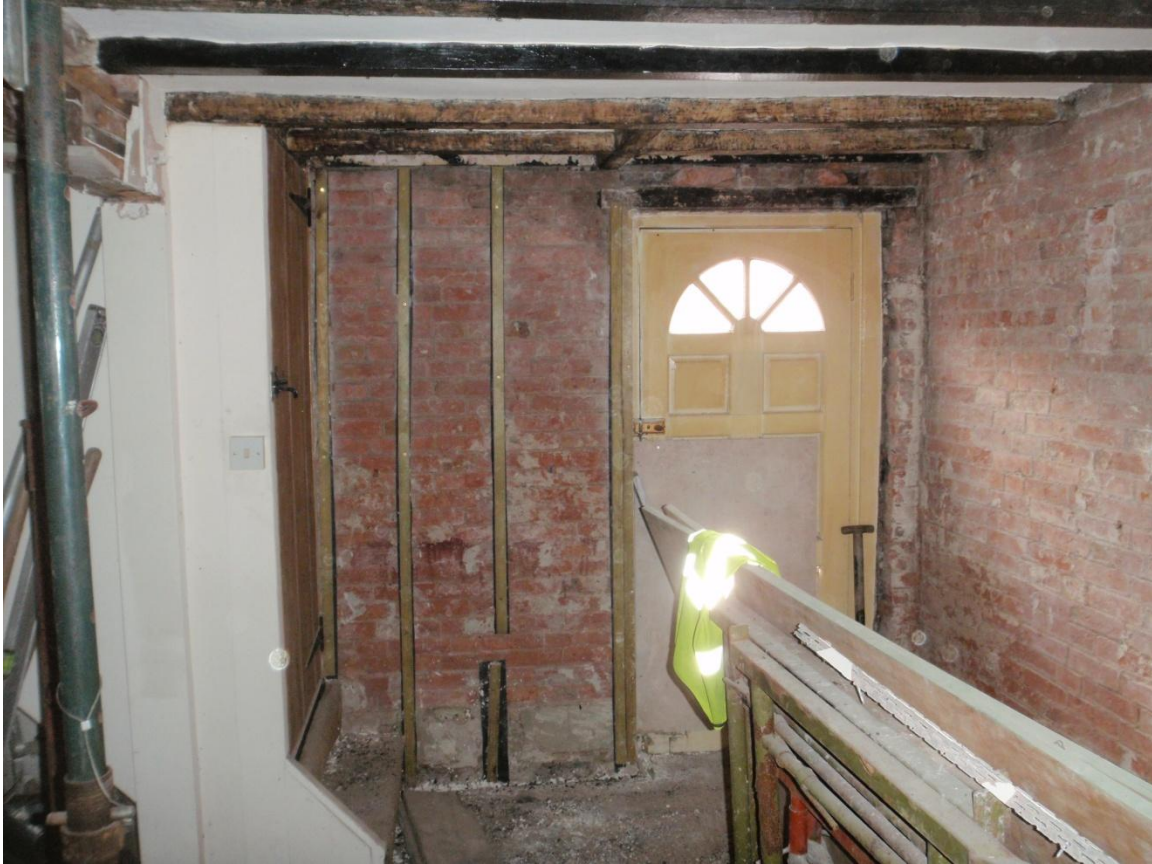
- 7.2.4.5 **Plate 39** shows the exposed brickwork in the east wall of the ground floor lounge. This exposure revealed that the brickwork fabric is composed of three courses of stretchers which alternate with one course of alternate headers and stretchers. The brickwork is bonded by a light buff lime mortar. This brickwork bonding and the nature of the bonding material was identical to that recorded on the corresponding exterior ground floor of the Side (East) Elevation of the building during the Phase 1 building recording.

Plate 39: View of the exposed east wall of the ground floor lounge, from the west

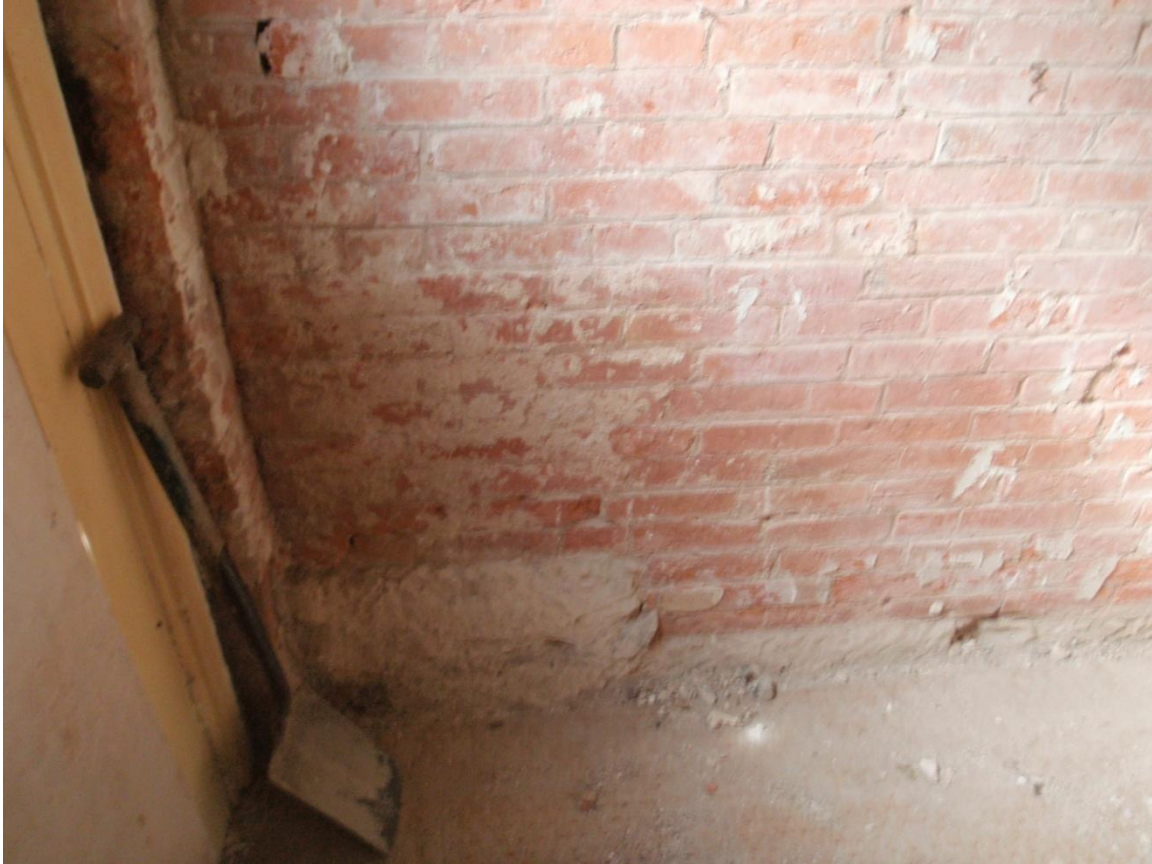
Plate 40: View of the exposed sandstone ashlar foundation in the south wall of the ground floor lounge, from the north

- 7.2.4.4 **Plates 40 and 41** provide images of the foundations of sandstone ashlar which were exposed both by the removal of the plasterwork from the south wall of the ground floor lounge along with the lowering of the floor here. Only one course of this foundation was revealed here, but this is significant and it corresponds to the identical foundations which were also recorded on the corresponding ground floor exterior of the South Elevation of the building during the Phase 1 building recording.

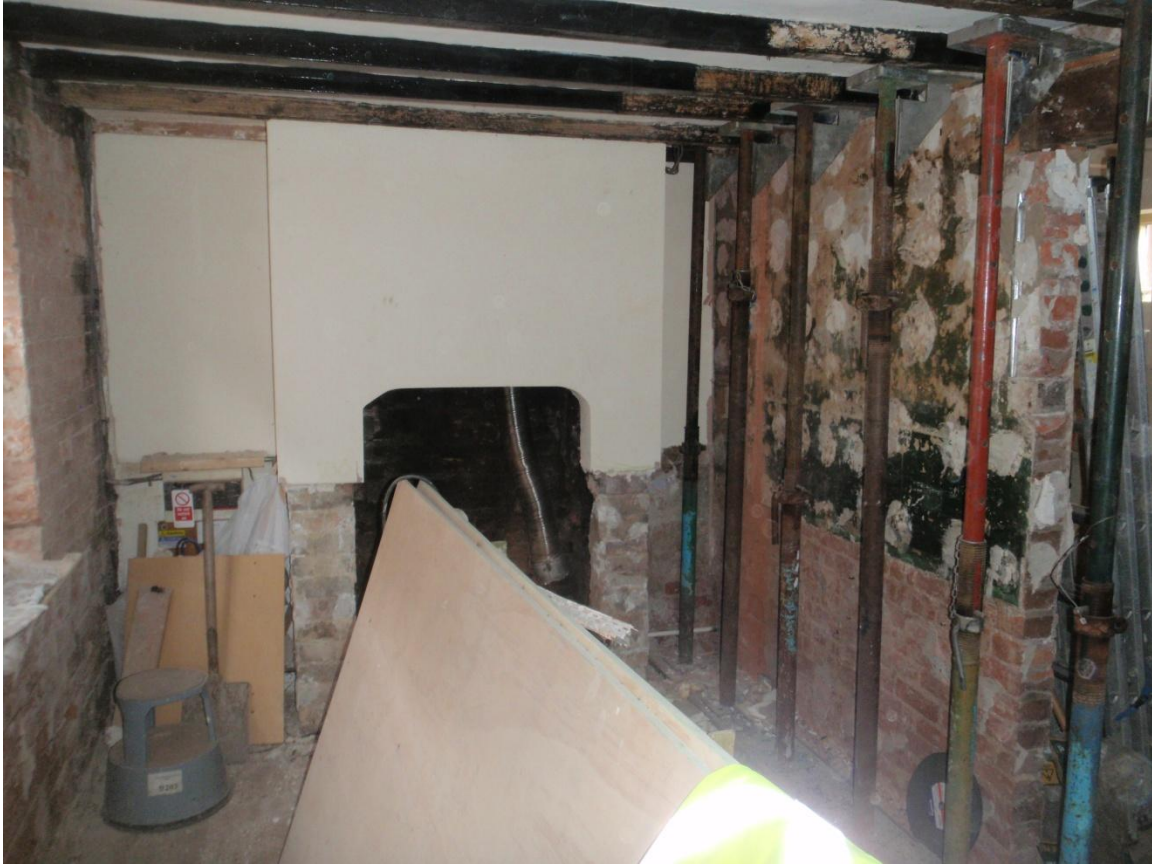
- 7.2.4.6 **Plate 42** shows the corresponding west wall of the ground floor lounge. Of note was the exposed brickwork at the lower levels of the chimney breast and of the lower levels of the west wall, which is modern in origin composed of a mixture of brick headers and stretchers.

Plate 42: View of the ground floor lounge, from the east

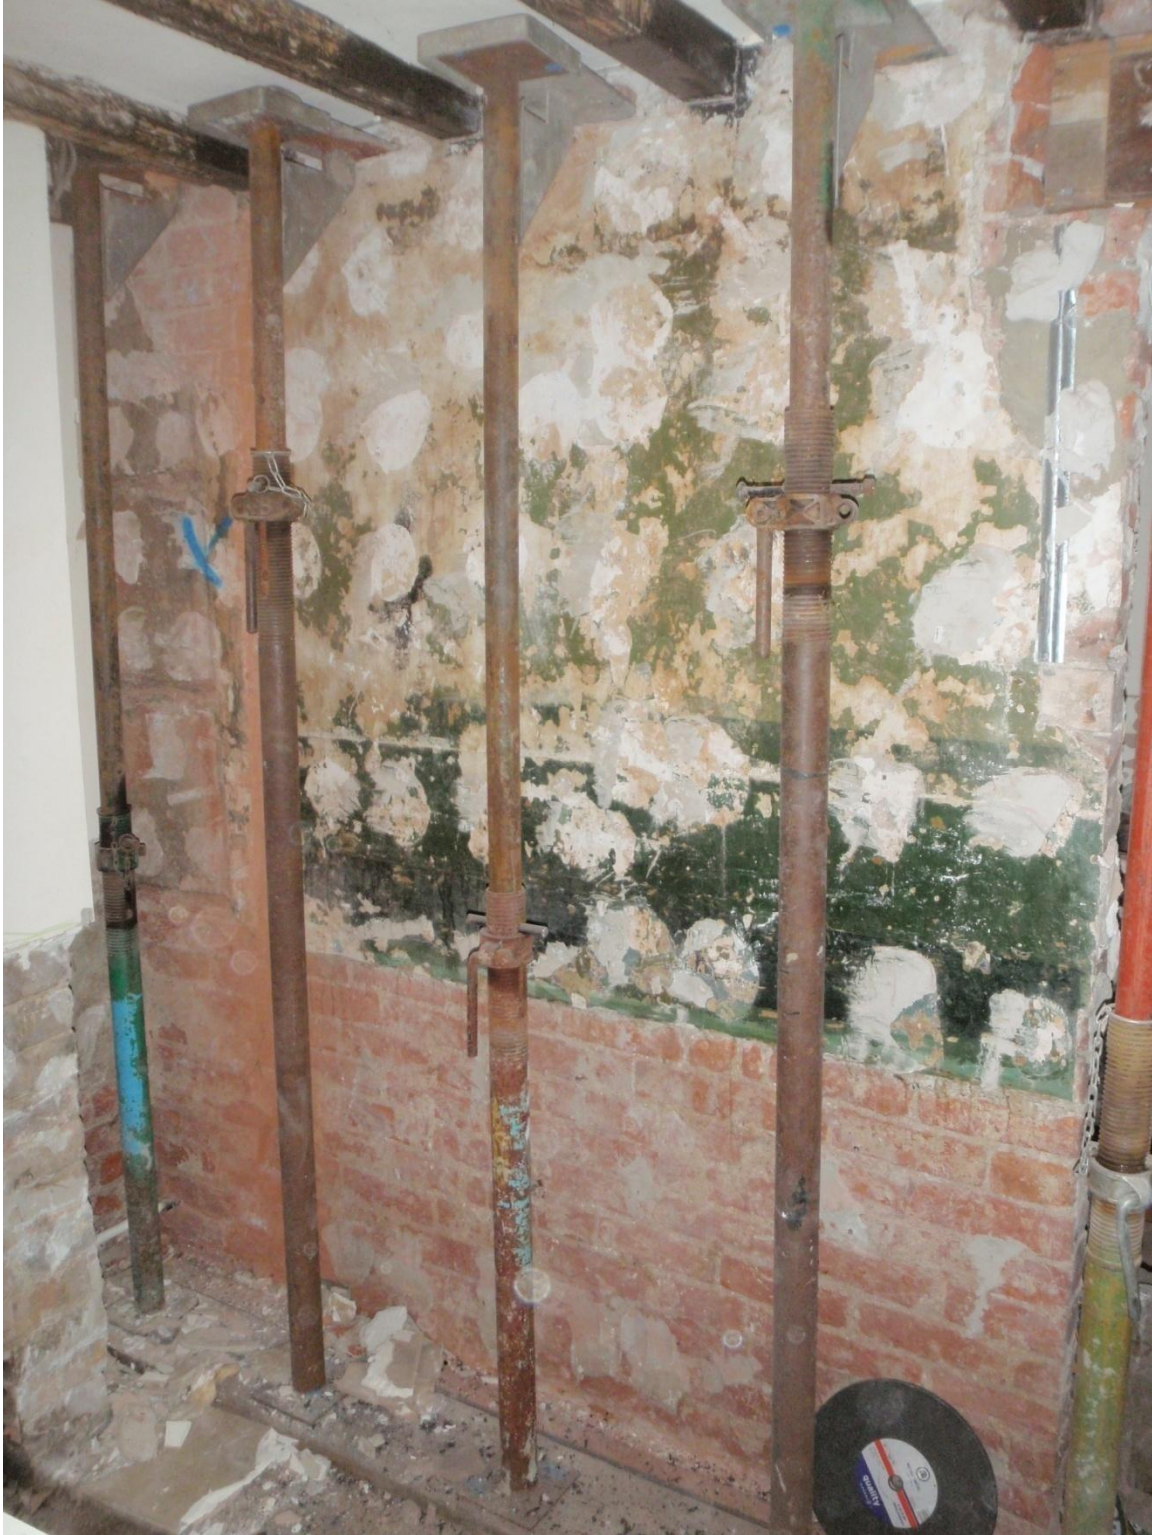
- 7.2.4.7 **Plate 43** depicts the internal partition wall between the ground floor kitchen and lounge. This is clearly a modern addition to the ground floor of this building as the exposed brickwork is modern in origin composed of brick stretchers.

Plate 43: View of the internal partition wall between the ground floor kitchen and lounge, from the south

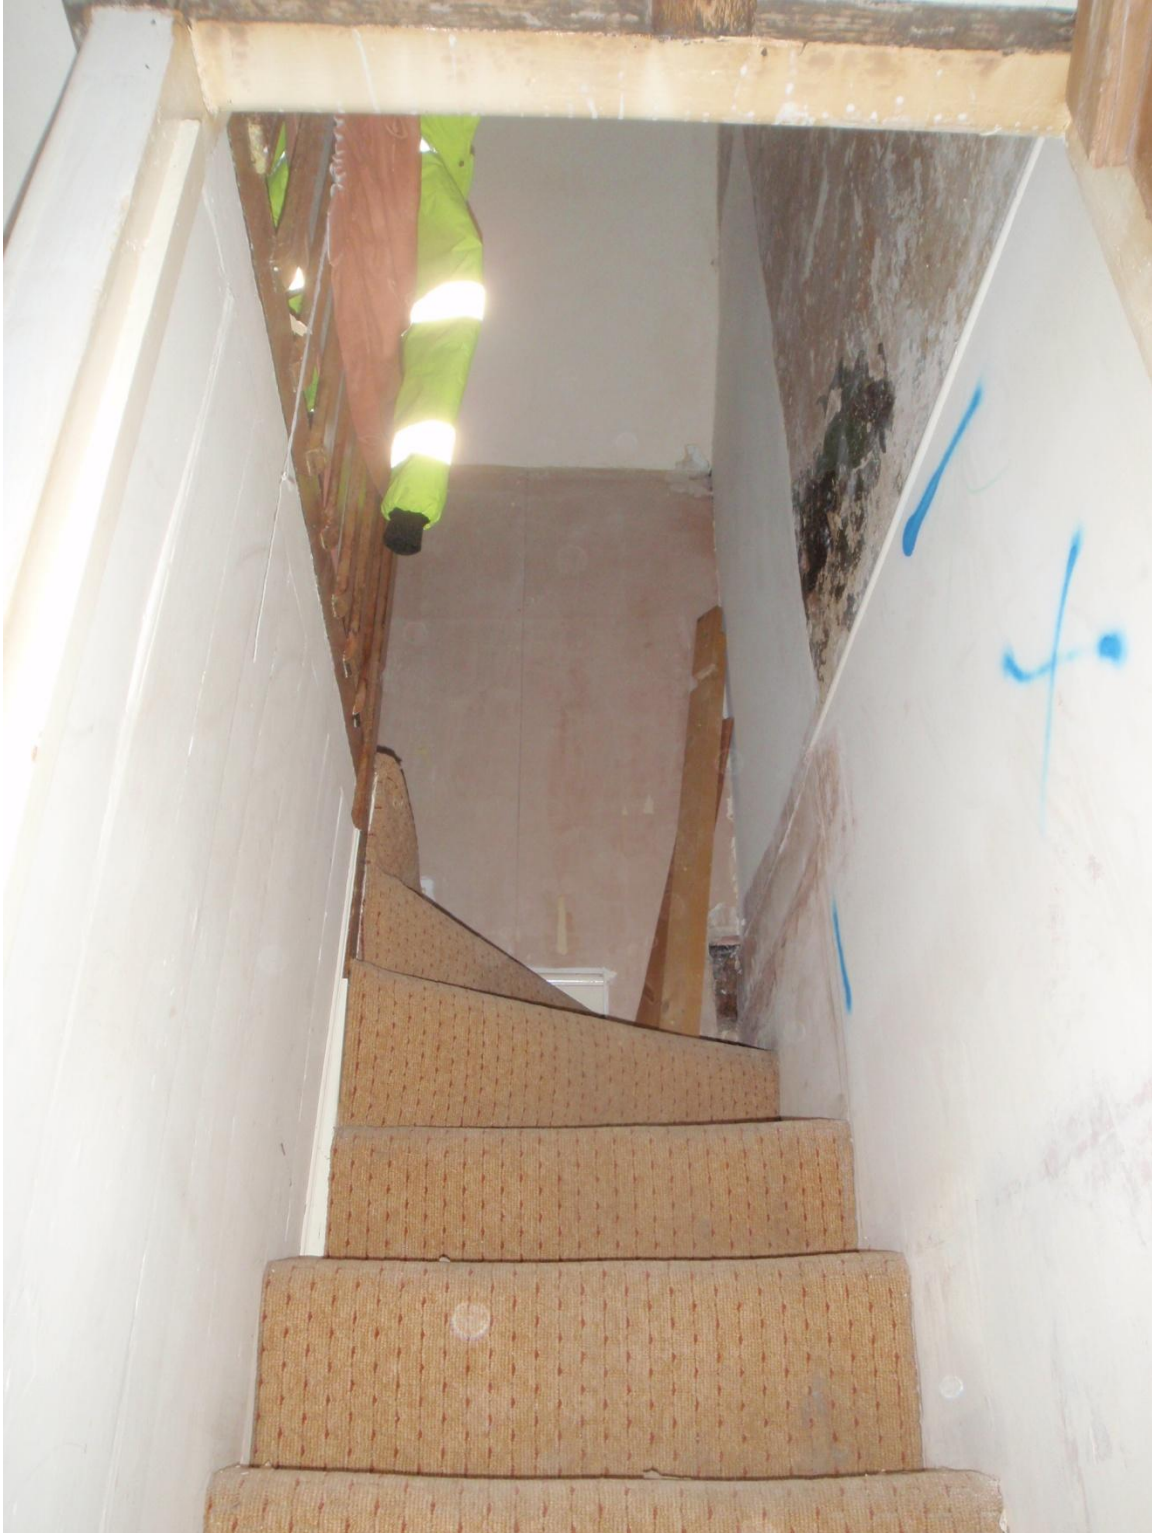
- 7.2.4.8 **Plate 44** shows the ground floor stairwell leading to the first floor. No alterations have taken place to this and no original fabric of the building has been exposed here.

Plate 44: View of the stairwell to the first floor, from the south

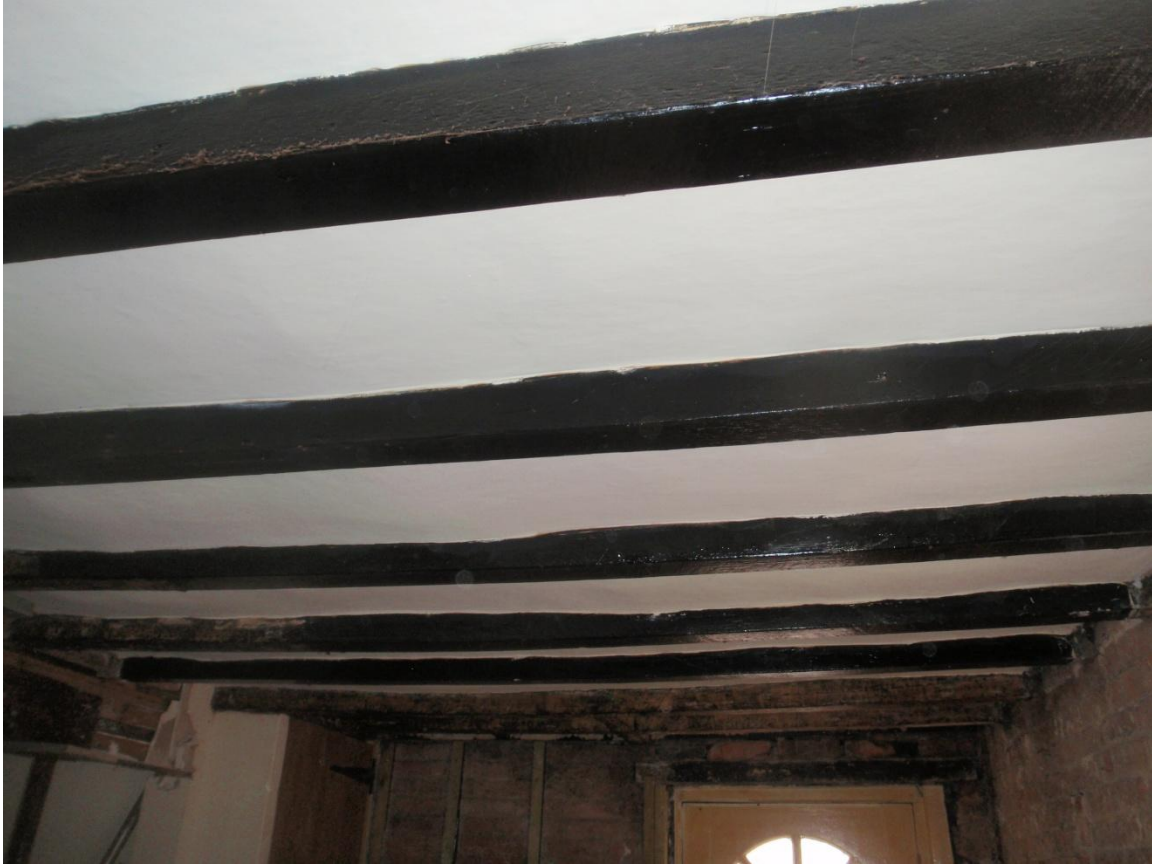
- 7.2.4.9 **Plate 45** shows the ground floor ceiling to the lounge, which remains the same, no alterations having taken place.

Plate 45: View of the ground floor lounge ceiling, from the west

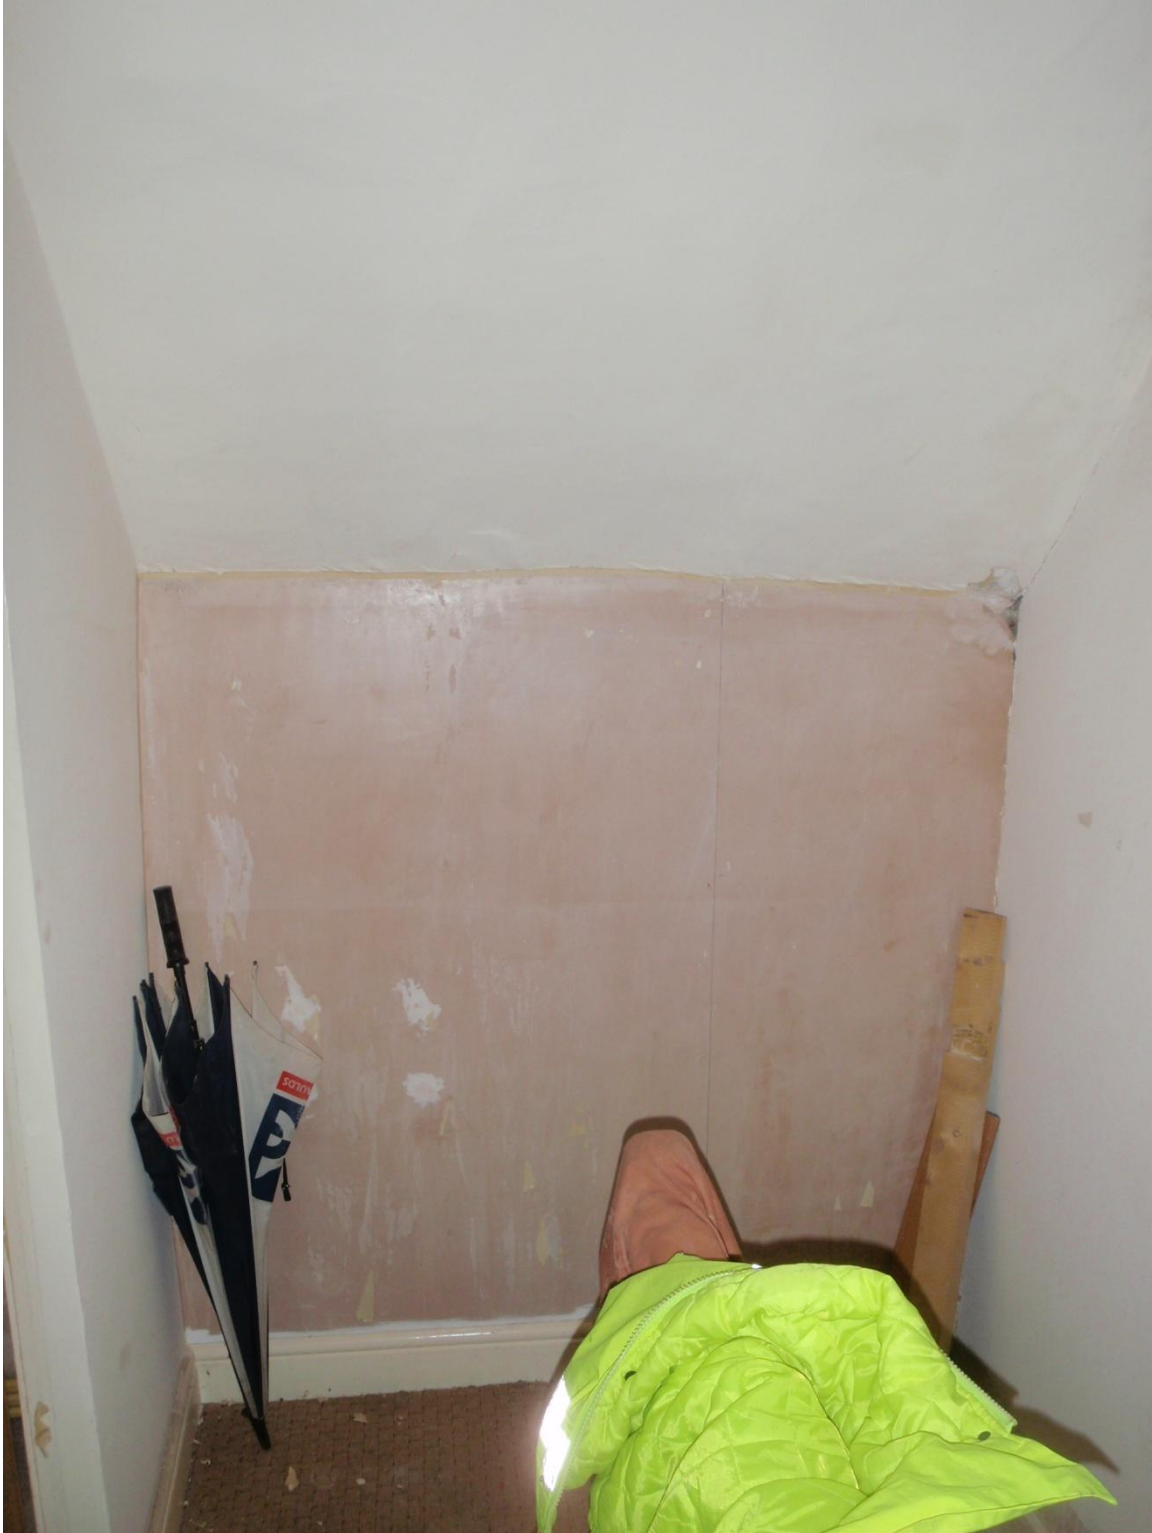
- 7.2.5.1 **Plate 46** shows the first floor landing and that no internal alteration works have taken place here. So no original build fabric has been exposed in this area of the building.
- 7.2.5.2 **Plates 47-51** show various views of the first floor bathroom and that no internal alteration works have taken place here. So no original build fabric has been exposed in this area of the building.
- 7.2.5.3 **Plates 52-56** show various views of the first floor bedroom including walls and ceiling and that no internal alteration works have taken place here. So no original build fabric has been exposed in this area of the building.

Plate 46: View of the first floor landing, from the south

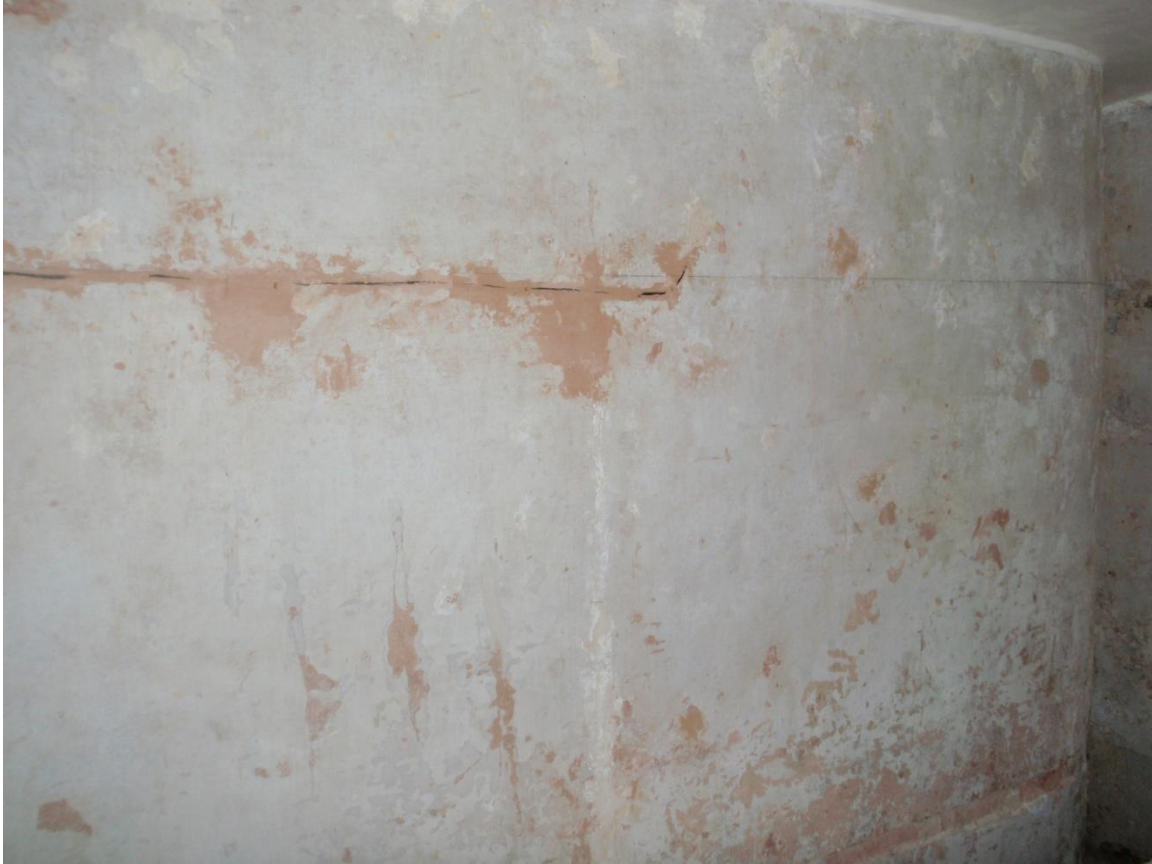
Plate 47: View of the south wall of the first floor bathroom, from the north-east
