**NEVILLE HALL MIFA
FREELANCE ARCHAEOLOGIST & CONSULTANT**

PHASES 1 & 2 OF THE
LEVEL II HISTORIC BUILDING RECORDING
AT 9, APIARY GATE,
CASTLE DONINGTON,
LEICESTERSHIRE.

October 2015

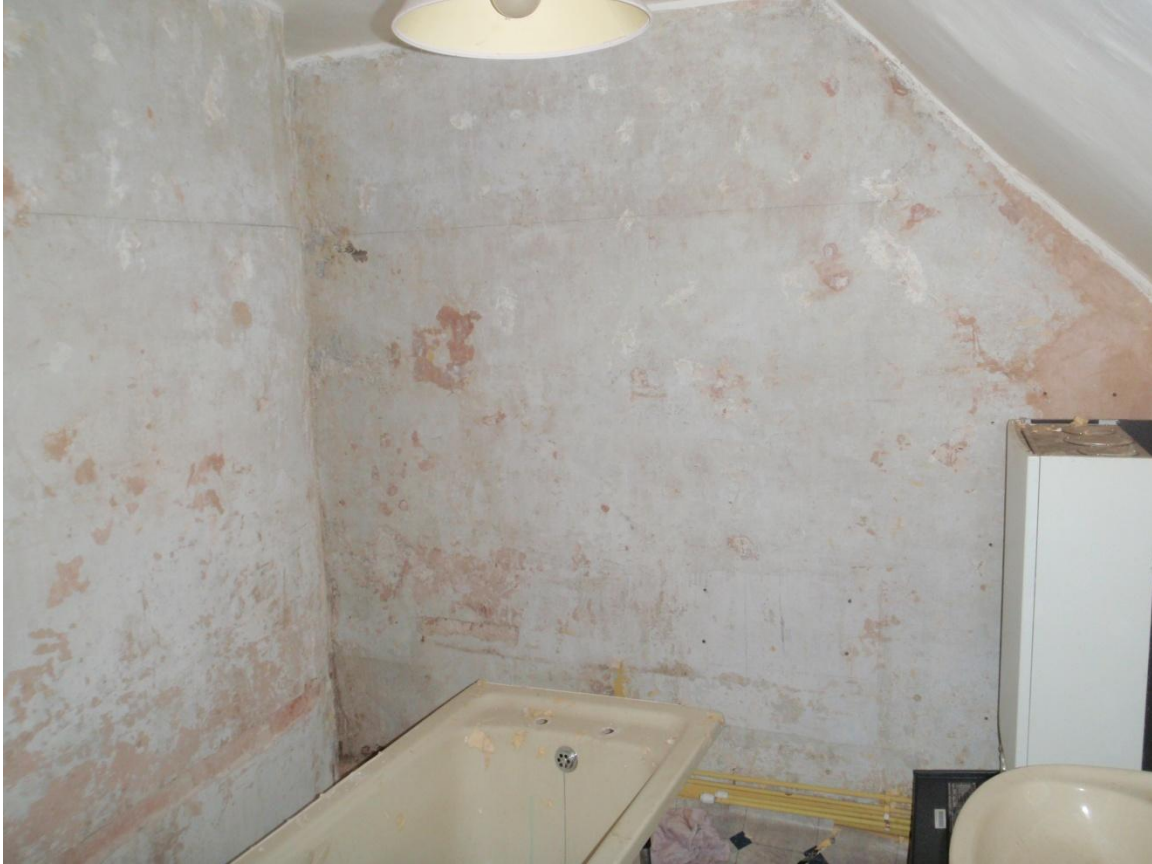
- 7.2.5.1 **Plate 46** shows the first floor landing and that no internal alteration works have taken place here. So no original build fabric has been exposed in this area of the building.
- 7.2.5.2 **Plates 47-51** show various views of the first floor bathroom and that no internal alteration works have taken place here. So no original build fabric has been exposed in this area of the building.
- 7.2.5.3 **Plates 52-56** show various views of the first floor bedroom including walls and ceiling and that no internal alteration works have taken place here. So no original build fabric has been exposed in this area of the building.

Plate 48: View of the first floor bathroom, from the east

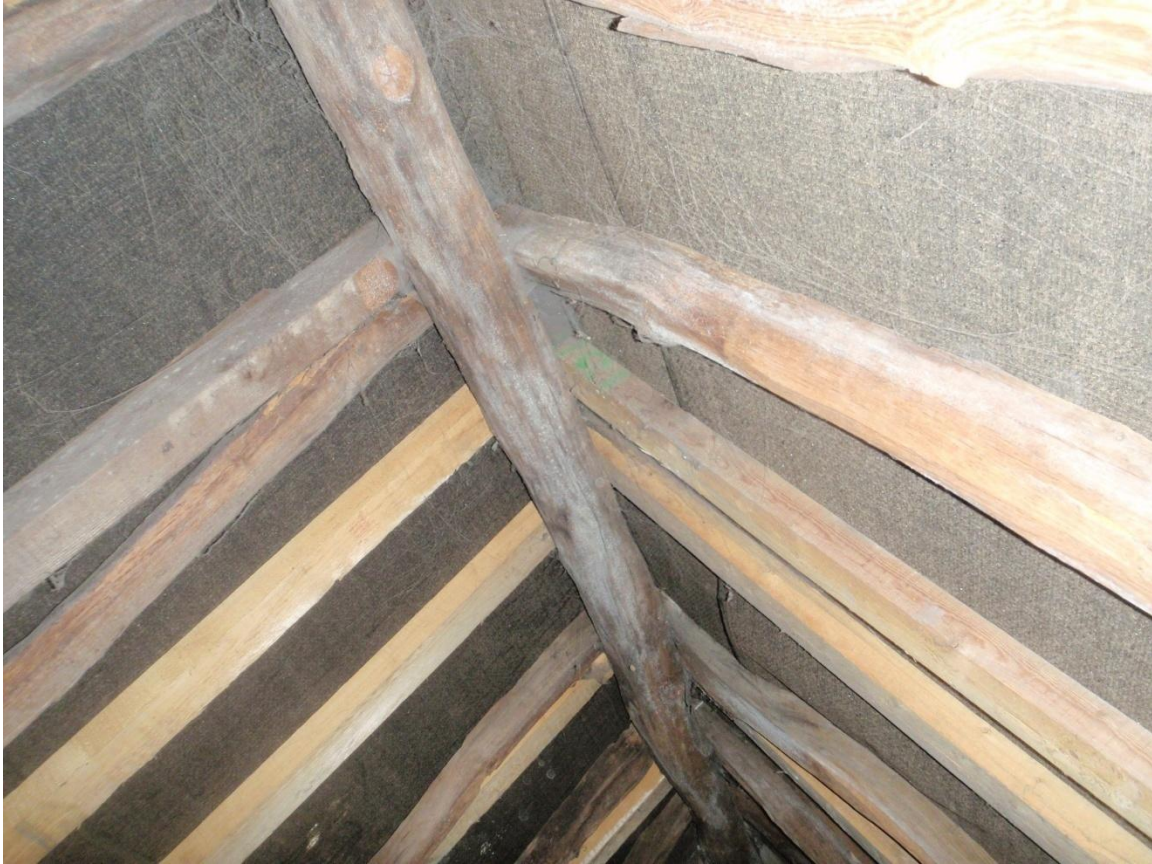
Plate 58: View of the internal roof space, from the east

- 7.2.6.3 **Plate 58** shows the roof structure of rafters and roof apex timber in more detail. Some of the modern rafter replacements show up in sharp contrast to the older roof rafters. **Plate 59** features in detail the structure of the first floor ceiling composed of a series of north-south orientated horizontal joists with one east-west orientated horizontal joist which extends along the length of this roof space. Also featured are a series of lathe panels making up the inner structure of the ceiling itself.

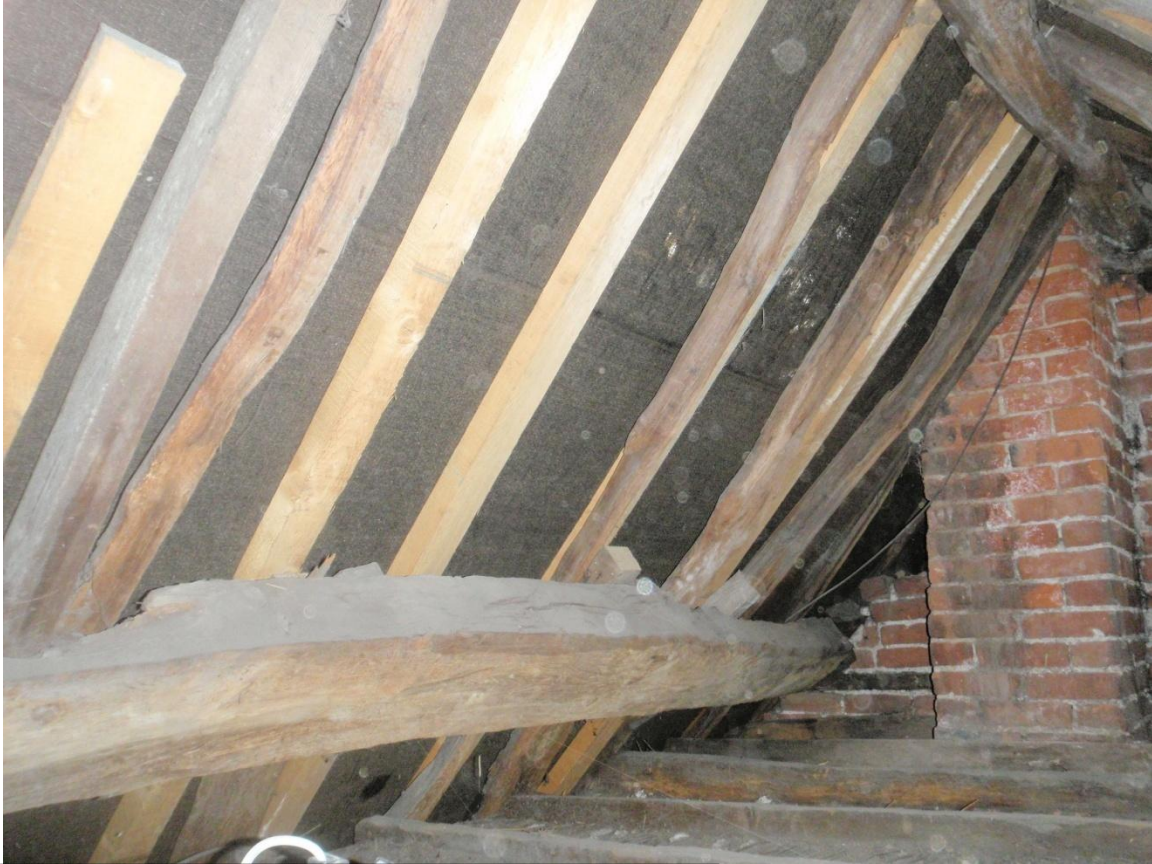
Plate 60: View of the internal roof space, from the east

- 7.2.6.4 **Plate 60** depicts in detail the southern side of the roof structure of the principal purlin and the modern replacement and earlier roof rafters.

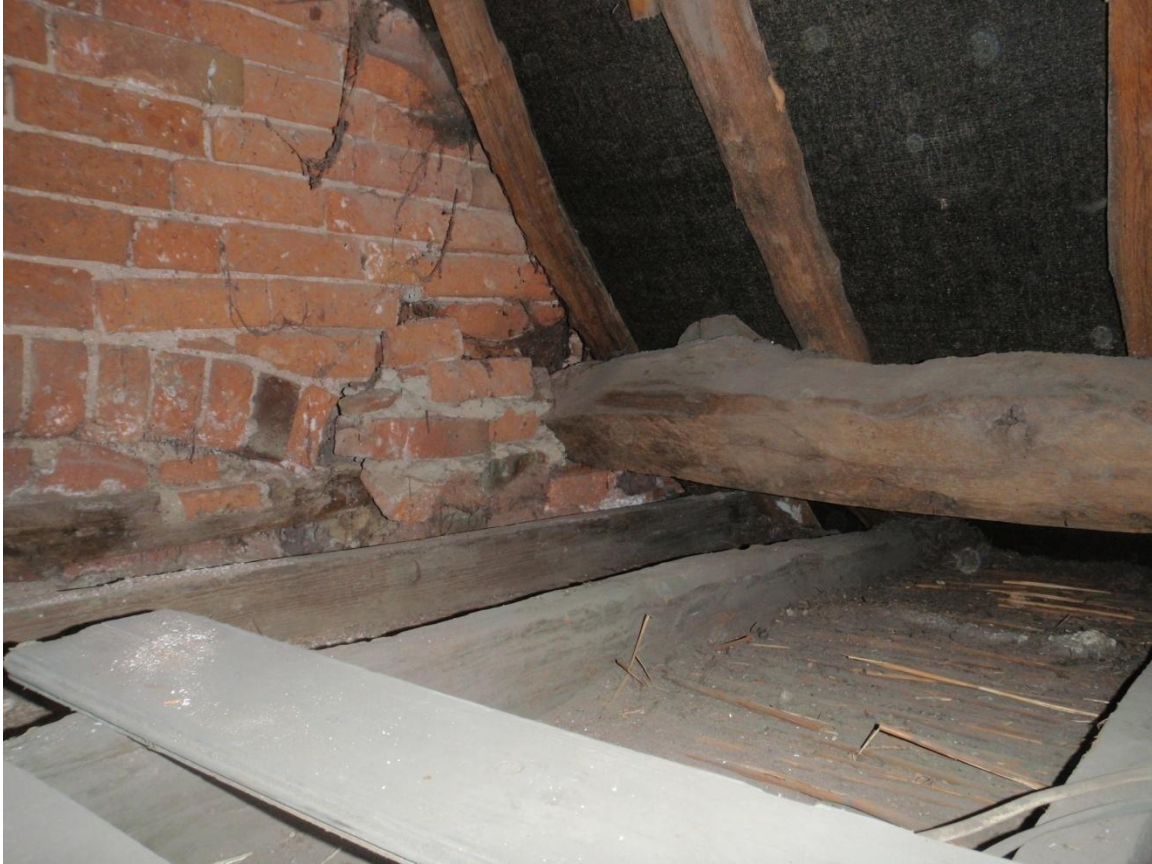
Plate 61: View of the internal roof space, from the east

- 7.2.6.5 **Plate 61** shows in detail the structure of the first floor ceiling of joists and lathe work along with the lower levels of the northern side of the roof structure of the principal purlin and modern replacement and earlier rafters.

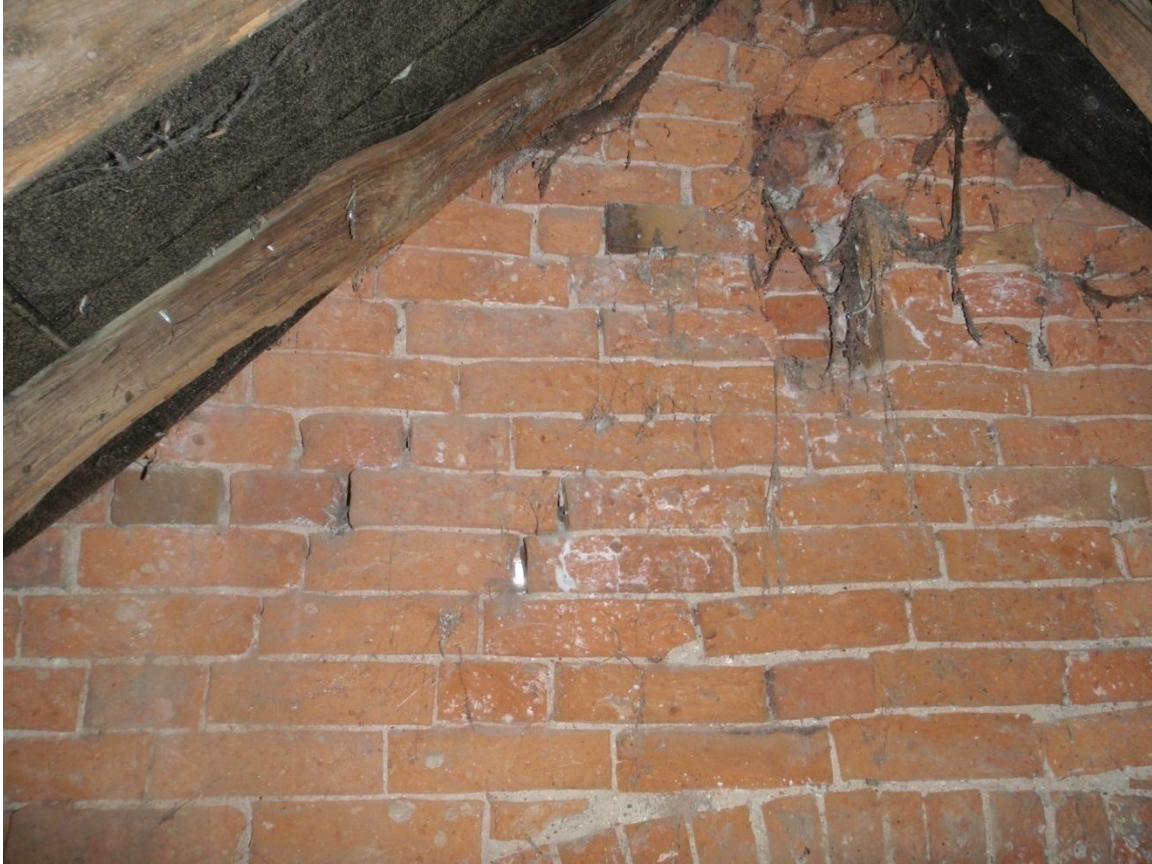
Plate 62: View of the internal roof space, from the west

- 7.2.6.6 **Plate 62** features the lower levels of the eastern end of the roof space showing the brickwork and the arched head of the infilled window opening which was recorded at the upper levels of the exterior of the Side (East) Elevation of the building. The lower levels of the south side of the roof space of the principal purlin and earlier rafters are also shown.

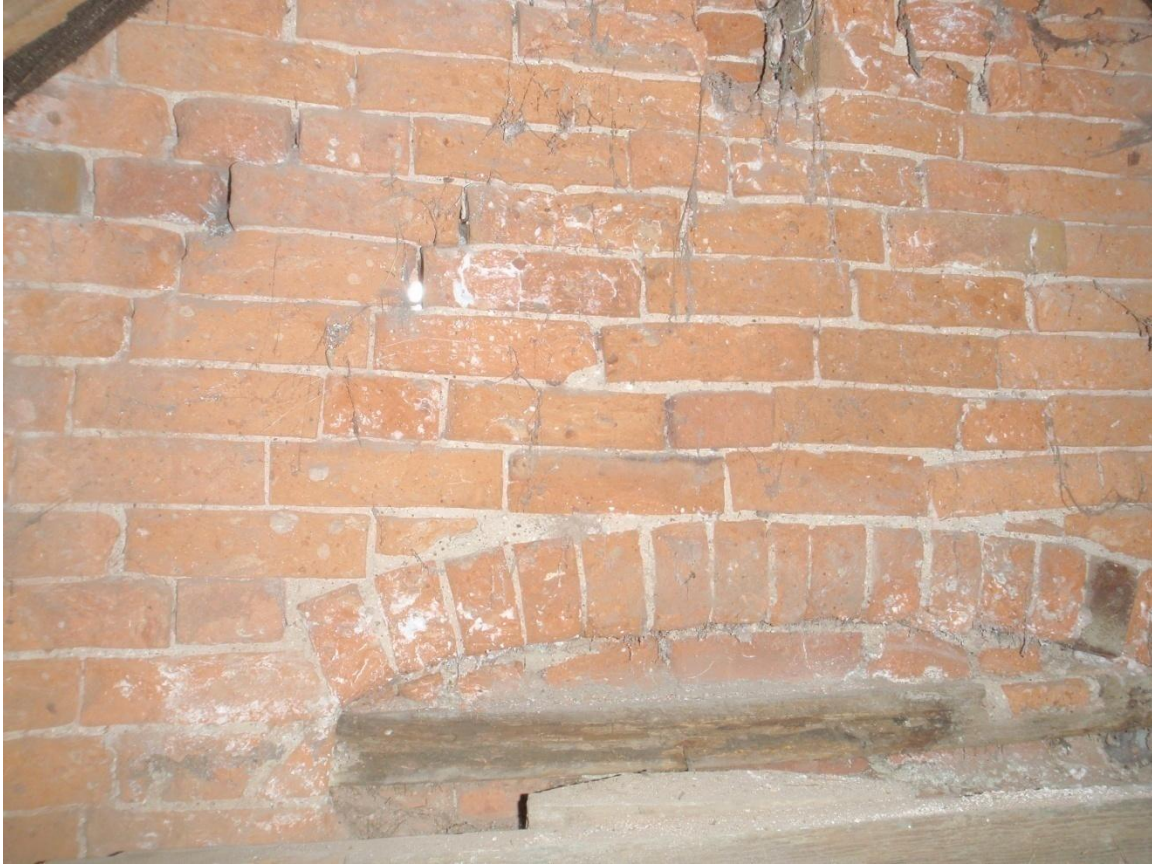
Plate 63: View of the internal roof space, from the west

- 7.2.6.7 **Plate 63** depicts the upper levels of the eastern end of the roof space and in detail of the brickwork here. These are the very upper levels of the internal face of the Side (East) Elevation of the original building, which was fully exposed by the demolition of the former side extension. A small vertical niche in the brickwork is featured at the apex. The brickwork itself is composed of three courses of brick stretches which alternate with one course of alternate brick headers and stretchers. This is identical to the brickwork bonding which was recorded on the external face of the Side (East) Elevation of the building during the Phase 1 recording.

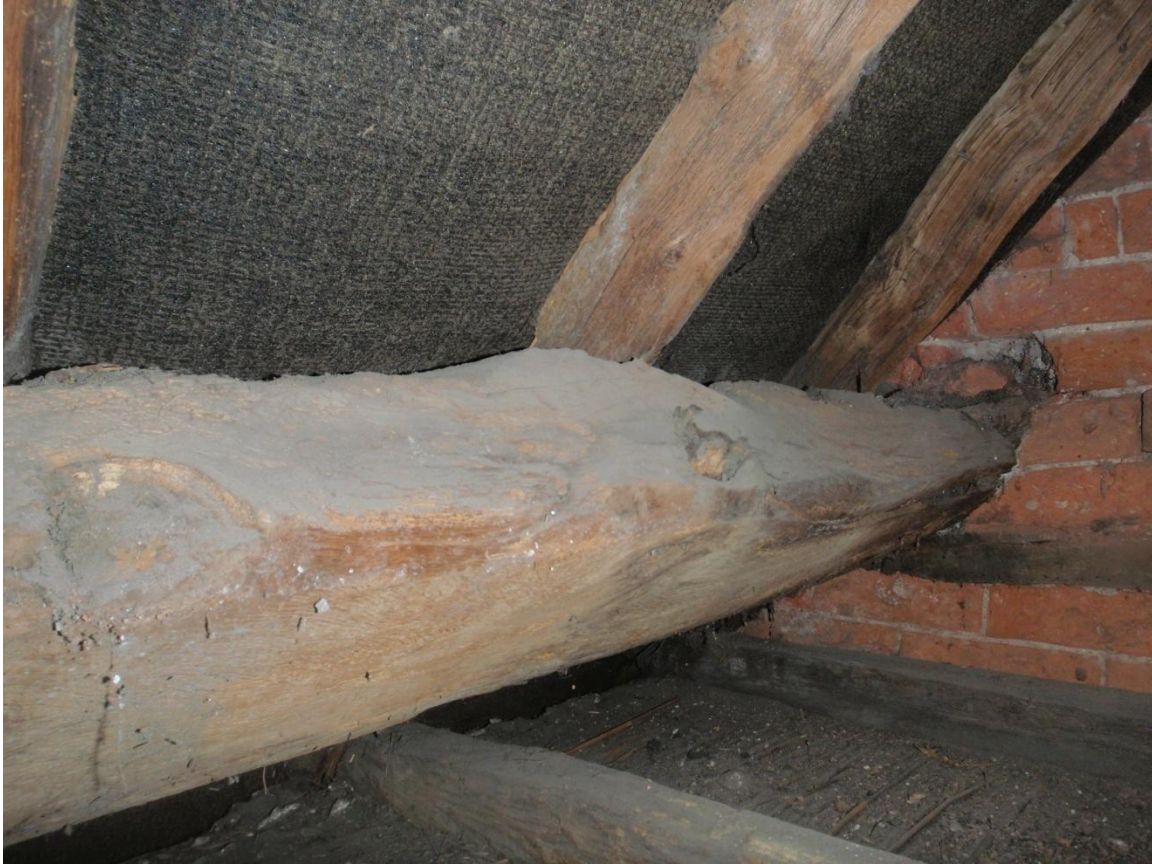
Plate 64: View of the internal roof space, from the west

- 7.2.6.8 **Plate 64** shows the lower levels of the brickwork at the eastern end of the roof space and in detail of the infilled arched window opening head of brick headers. Of particular interest is the short section of horizontal timber within the window opening infilling of brick of a supporting timber.
