LEVEL II HISTORIC BUILDING RECORDING  
AT FRITH FARM,  
RYHALL ROAD,  
LITTLE CASTERTON, RUTLAND.

**National Grid Reference: TF 0200 1120**

*An historic building survey equivalent to English Heritage Level 2 of Units 2 and 3 at Frith Farm, Ryhall Road, Little Casterton, Rutland was undertaken by Neville Hall MIFA on the 23rd of January 2016.*

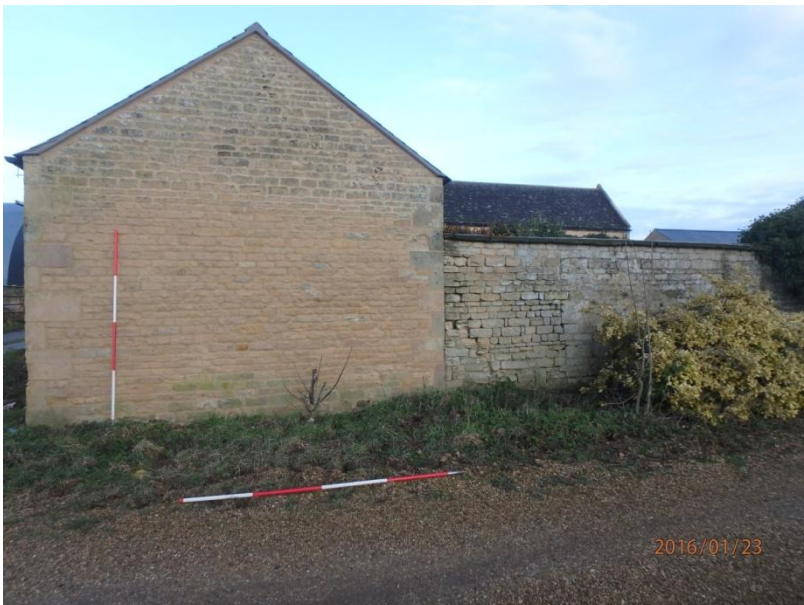
**Plate 5: View of the South Elevation of the West Range (Outbuilding 1) and the Southern Boundary Wall, from the south**

**Plate 5** features both the South Elevation of the West Range (Outbuilding 1) and the southern face of the adjacent Southern Boundary Wall. Outbuilding 1 is a single storey farm building with

a modern gabled roof in slate with ridge tiles also of modern slate. The South Elevation of Outbuilding 1 is constructed of courses of roughly shaped and worked limestone blocks along with worked, shaped and faced limestone quoins at the south-western and south-eastern corners of this Elevation respectively. The original bonding material where apparent is composed of a light buff sandy mortar. The coursed stonework shows evidence of modern repointing. The adjacent south boundary wall, which is not bonded to this South Elevation, is similarly composed of courses of roughly shaped and worked limestone blocks. There is no evidence of any modern repointing in the south face of this wall, though the original bonding material to the stonework is apparent composed of a light buff lime mortar. The boundary wall is topped with stone capping slabs.

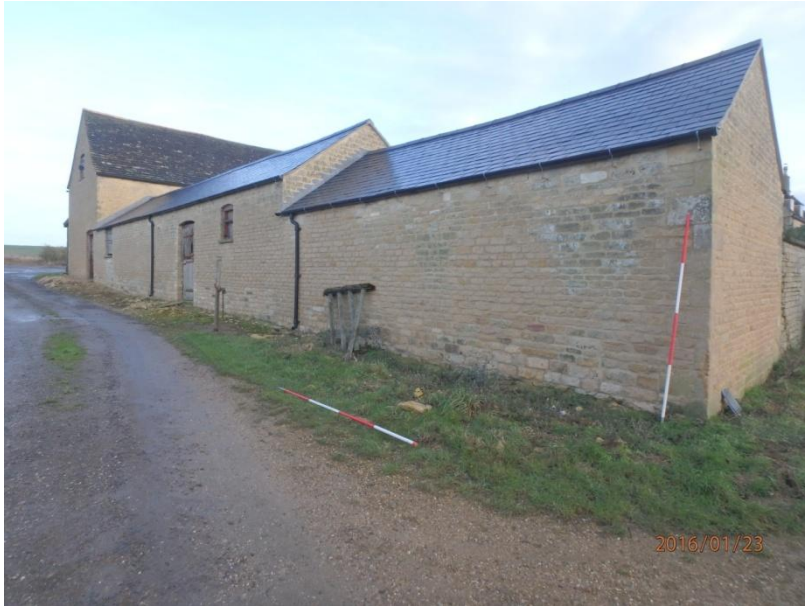
**Plate 6: View of the West Elevation of the West Range, (Outbuildings 1 and 2), from the south-west**

**Plate 6** features the West Elevation of the southern portion of the West Range, designated as Outbuilding 1. This West Elevation is similarly constructed of coursed roughly shaped and worked limestone blocks with much evidence of modern repointing. There is modern Upvc guttering at roof level which extends to a modern vertical Upvc downpipe at the northern end of this Elevation.

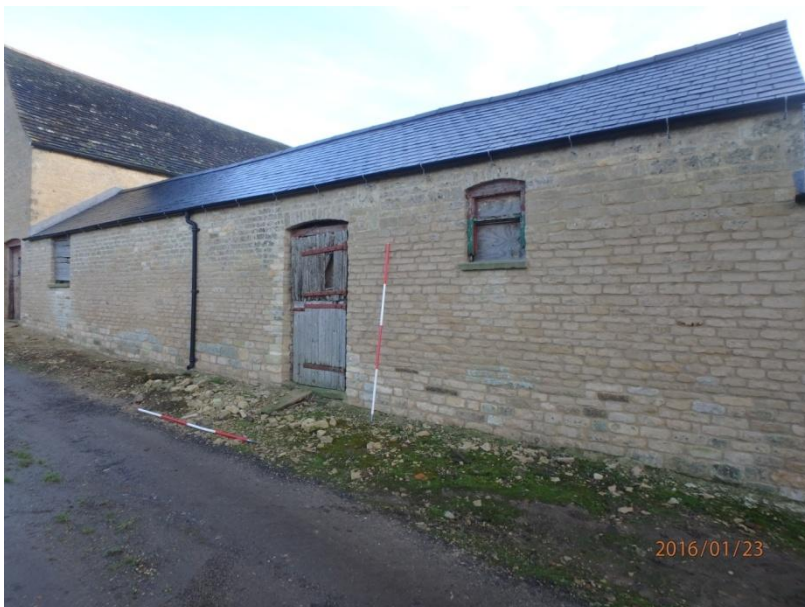
**Plate 7: View of the West Elevation of the West Range, (Outbuilding 2) from the south-west**

**Plate 7** provides a view of the northern portion of this West Range, which is designated as Outbuilding 2. This second outbuilding is slightly higher of one and a half storeys in height. This building similarly has a gabled roof in modern slate with modern slate ridge tiles. There is modern Upvc horizontal guttering at roof level which extends to a modern vertical Upvc downpipe. This second outbuilding is similarly constructed of coursed roughly shaped and worked limestone blocks with occasional reused worked, shaped and faced limestone ashlar incorporated into this wall fabric with much evidence of modern repointing.

To the left (south) is a small unglazed two light timber casement window with a curved timber head and surrounds and a stone cill. Above the window opening is a curved upper head also in one course of roughly shaped and worked limestone blocks. To the north (left) is a door opening with two timber half doors composed of a series of vertical tongued and grooved timber planks occupying this opening. There are four cast metal strap hinges to the left. There is also a simple door frame composed of a horizontal timber door head and surrounds. The external timber planks are attached to an internal timber framework of angled and horizontal timbers. The curved upper door opening head is composed of one course of roughly shaped and worked limestone blocks. The threshold is of stone. To the north (left) is a second window opening with a stone cill. This window opening has been boarded over externally with a series of horizontal timber planks, which obscures any underlying detail.

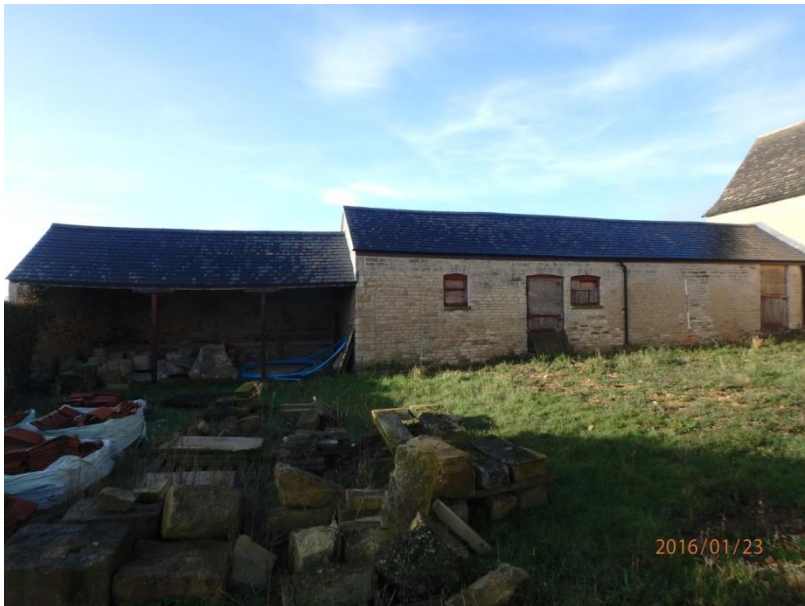
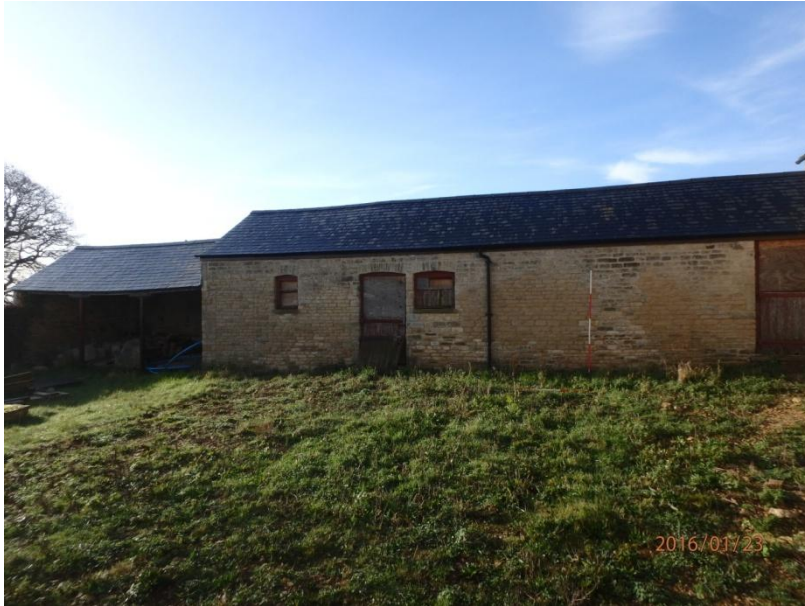
**Plate 8: View of the East Elevation of the West Range (Outbuildings 1 and 2), from the east**

**Plates 8 and 9** provide general views of the East Elevation of the West Range comprising Outbuilding 1 to the south and the adjoining Outbuilding 2 to the north.

**Plate 9: View of the East Elevation of the West Range (Outbuildings 1 and 2), from the east**

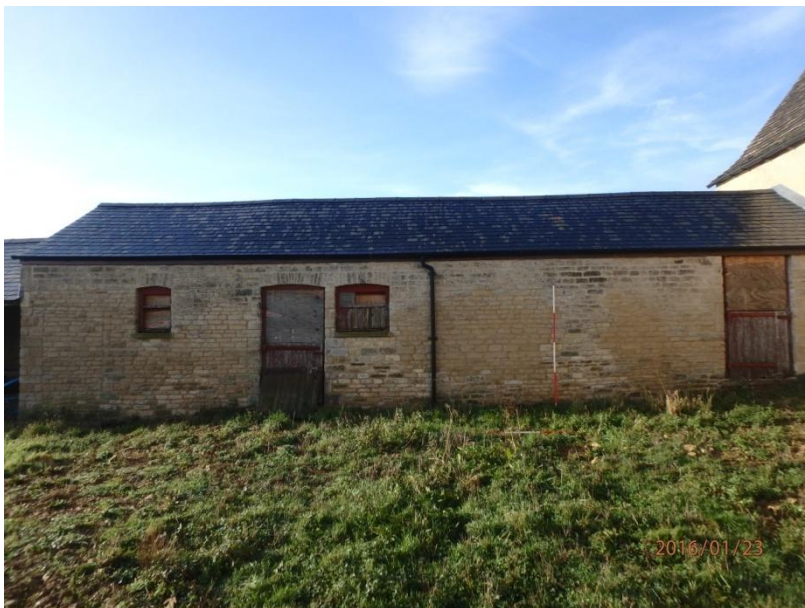
**Plate 10: View of the East Elevation of the West Range (Outbuilding 2), from the east**

**Plate 10** features the northern portion of the East Elevation of the West Range comprising Outbuilding 2. This East Elevation is constructed of coursed, roughly worked and shaped limestone blocks with much evidence of modern repointing. There is modern Upvc guttering at roof levels which extends to a central vertical modern Upvc downpipe. At the southern end of this northern portion of the East Elevation, the south-eastern corner of this outbuilding is marked by a vertical column of worked, shaped and faced limestone quoins.

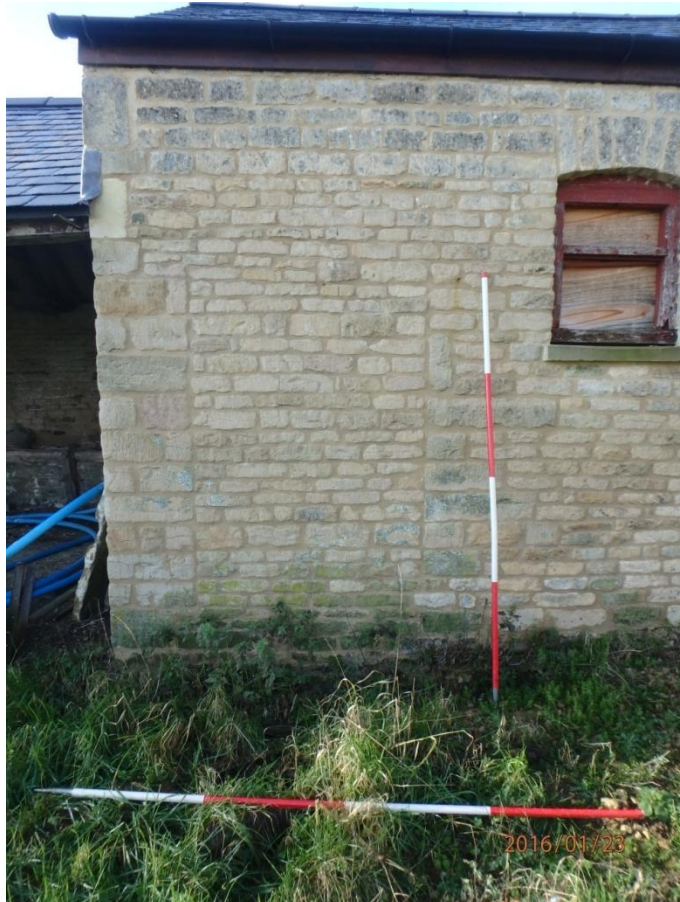
**Plate 11: Detail: View of a blocked in door opening within the East Elevation of Outbuilding 2, from the east**

Also at the southern end of this northern portion of the East Elevation of the West Range comprising Outbuilding 2 is an infilled former east facing door opening, which is featured on **Plate 11**. The extent of this opening and the position of its former lintel are clearly visible in the wall fabric as two vertical lines in this fabric to either side and a widening in the infilling at the upper levels. The infilling is of later courses shaped and worked limestone blocks.

**Plates 11 and 12** feature to the left (north) of the infilled door opening, a small two light unglazed timber casement window. The opening is occupied by a simple timber frame of transom, head

and surrounds with a modern stone cill. The upper curved window head is composed of one course of shaped and worked limestone blocks. The window is blocked in internally by a wooden board.

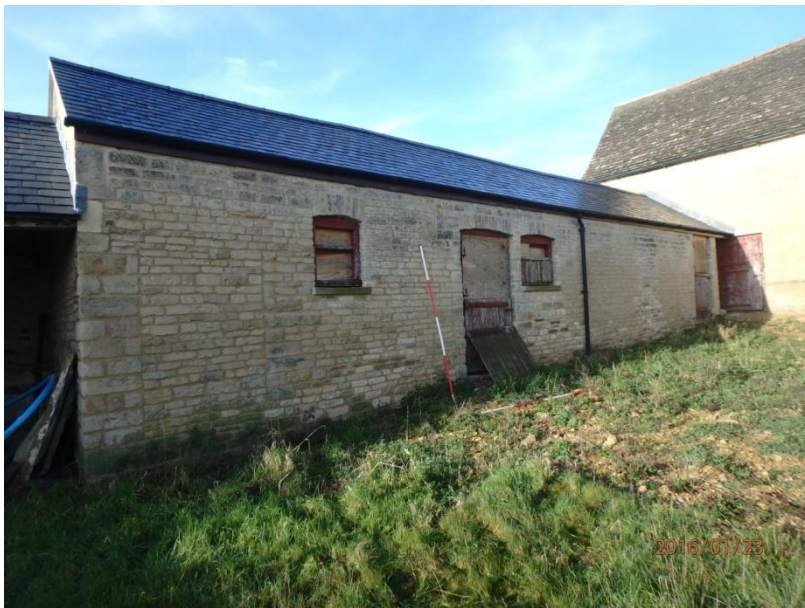
**Plate 12: View of the East Elevation of Outbuilding 2 of the West Range, from the east**

To the left (north) of this is a second east facing door opening, which is shown on **Plates 12 and 13**. The doorway itself is composed of two timber half doors of a series of vertical tongued and grooved timber planks. The upper half door has become detached with the lower half door remaining *in situ*. Consequently there are only two cast metal strap hinges in place to the left. The door is contained within a simple timber frame of head and surrounds. The upper curved door head is of a series of shaped and worked limestone blocks. The upper half of the door opening has been boarded over.

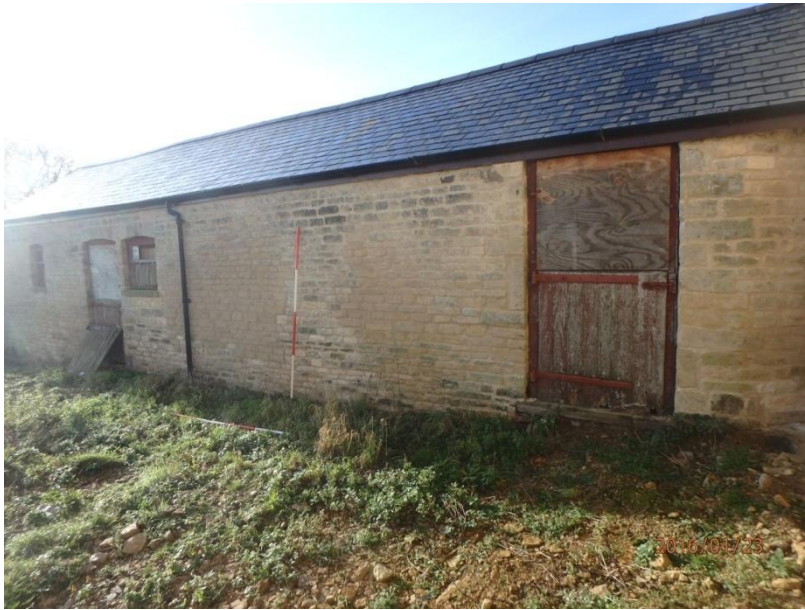
**Plate 13: View of the East Elevation of Outbuilding 2 of the West Range, from the east**

At the northern end of this East Elevation of Outbuilding 2 is a third east facing door opening, which is also featured on **Plate 13**. This was composed of two timber half doors, the upper one of which is absent and has been boarded over. The remaining lower half door is composed of a series of vertical tongued and grooved timber planks. To the left are two remaining cast metal

strap hinges. The opening is also occupied by simple timber surrounds to either side with a stone threshold. **Plate 13** also shows the northern end of this Elevation tapering off to the left.

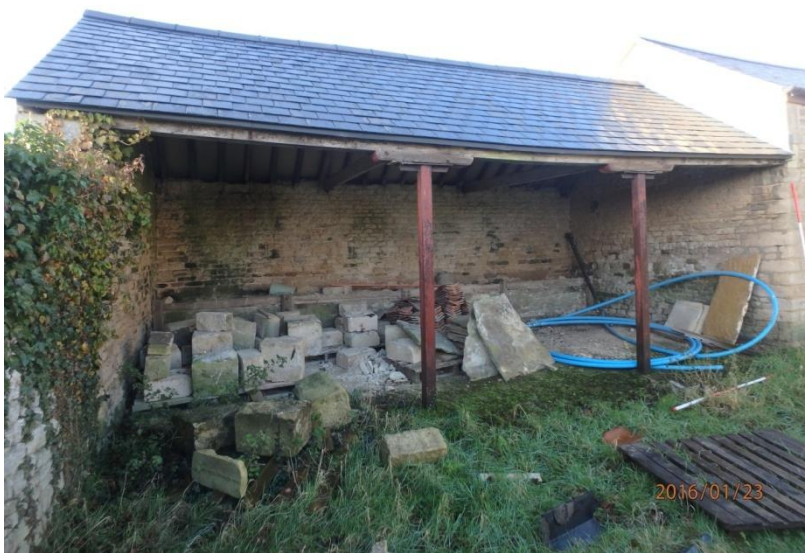
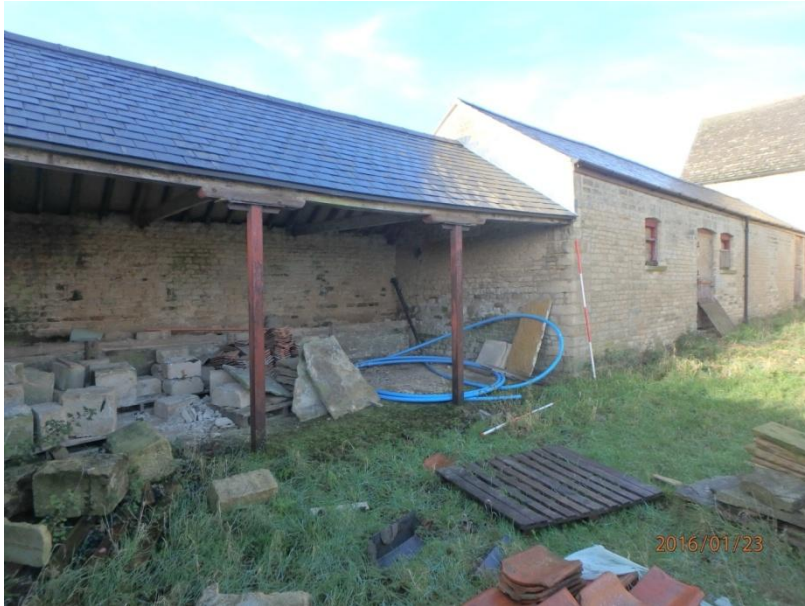
**Plate 14: View of the East Elevation of Outbuilding 1 of the West Range, from the east**

**Plate 15: View of the East Elevation of the West Range (Outbuildings 1 and 2), from the east**

**Plates 14 and 15** provide views of the southern portion of the East Elevation of this West Range which comprises the designated Outbuilding 1. This portion of the East Elevation is open to the east. There is an horizontal timber wallplate at roof level which supports the roof structure. This wallplate is in turn supported by two modern vertical steel columns. These columns are fixed to two carved and shaped timber heads which are in turn affixed to the wallplate. It would appear that the original supporting columns are absent and have been replaced by modern replacements.

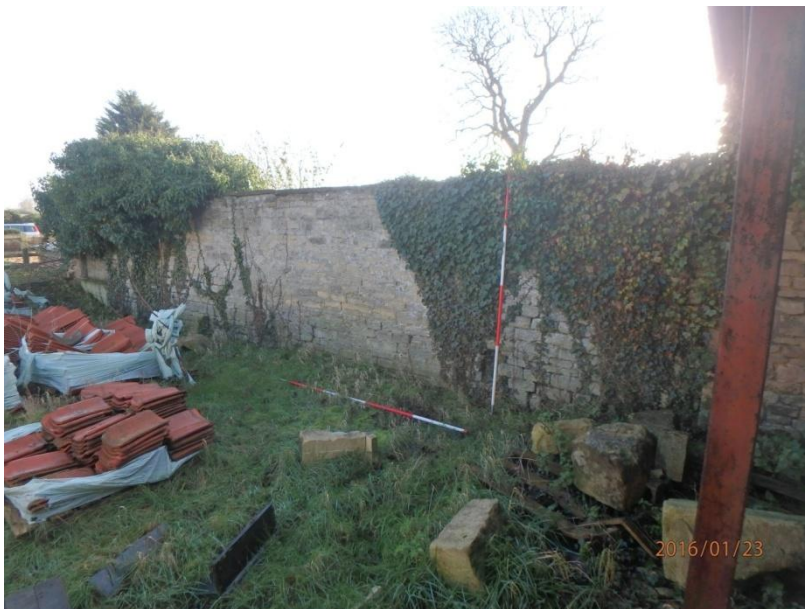
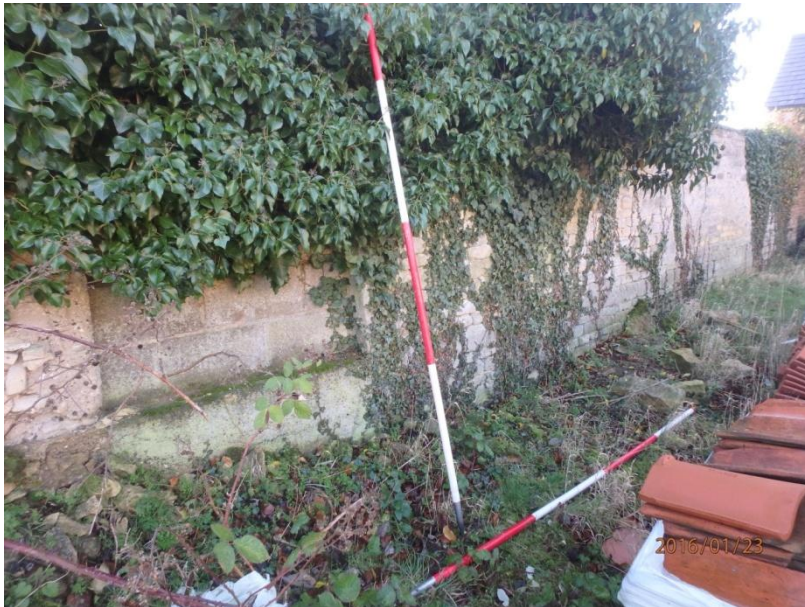
**Plate 16: View of the north face of the Southern Boundary Wall, from the north**

**Plate 18: View of the north face of the Southern Boundary Wall, from the north-east**

**Plates 16 and 18** provide views of the north face of the Southern Boundary Wall, which is similarly composed of coursed roughly shaped and worked limestone blocks. There is no evidence of any modern repointing in the north face of this wall, though the original bonding material to the stonework is apparent composed of a light buff lime mortar. The wall is topped with stone capping slabs. Of particular note and featured on both **Plates 17 and 18** are the lower levels of a blocked in gateway with a stone threshold. The infill is clearly of later courses of shaped and worked stonework. The upper levels of this opening are obscured by dense vegetation growth.

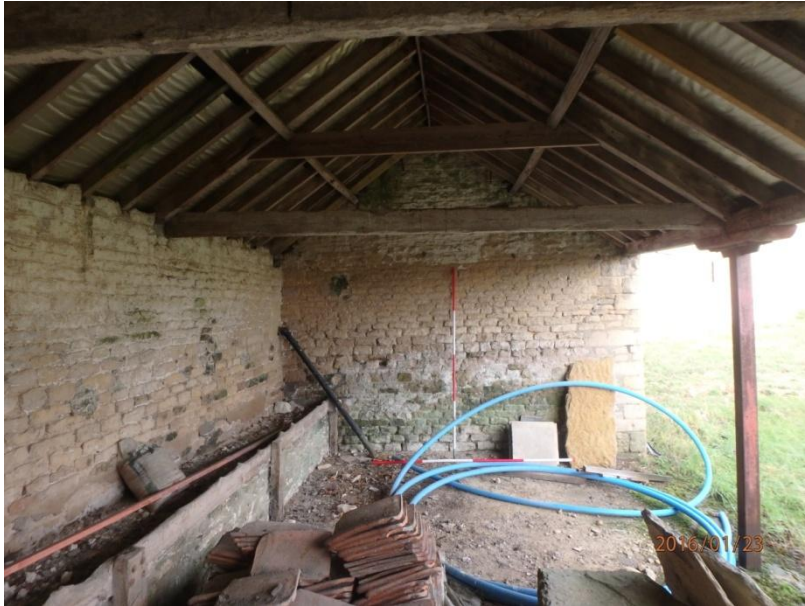
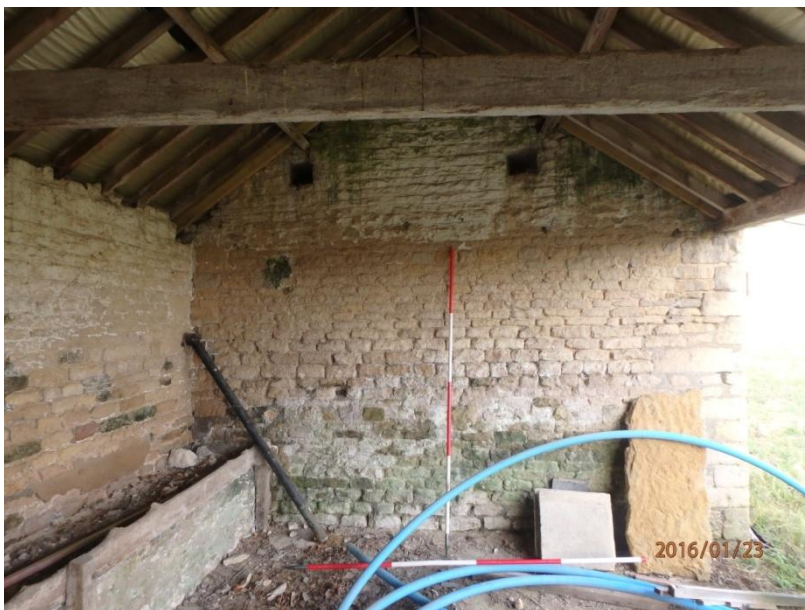
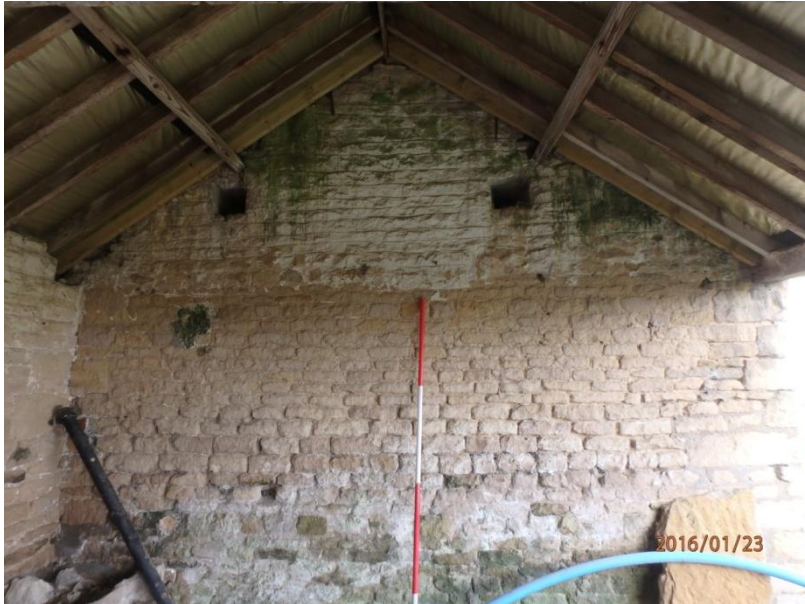
**Plate 19: View of the interior of Outbuilding 1, from the south**

**Plate 20: View of the north wall of Outbuilding 1, from the south**

**Plates 19-21** feature the north wall of Outbuilding 1, which also corresponds to the south facing former South Elevation of Outbuilding 2. This north wall is composed of courses of shaped and worked limestone blocks. The bonding material is a light buff lime mortar. There are two small square shaped ventilation apertures situated at just below roof level. The wallplate at the East Elevation and the roof supporting timber purlins have been inserted into this wall fabric. The floor of this outbuilding is of modern concrete.

**Plate 21: View of the upper levels of the north wall of Outbuilding 1, from the south**

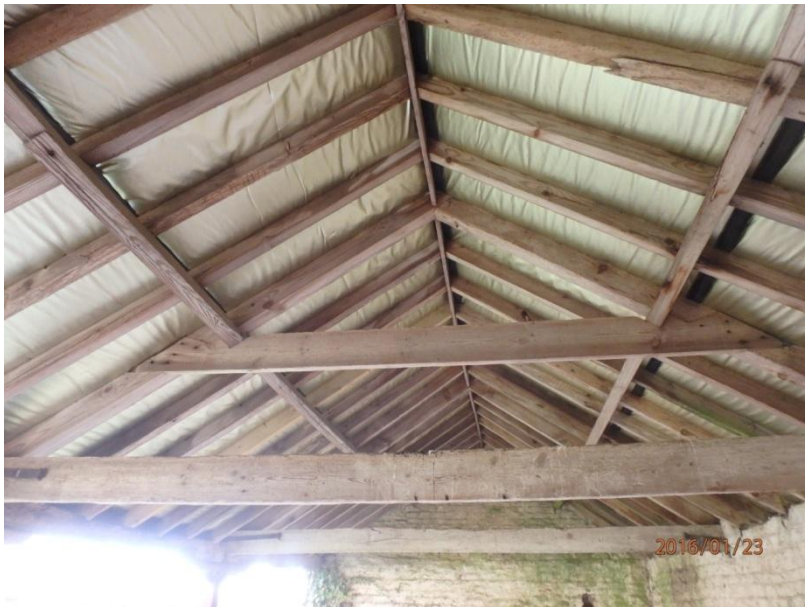
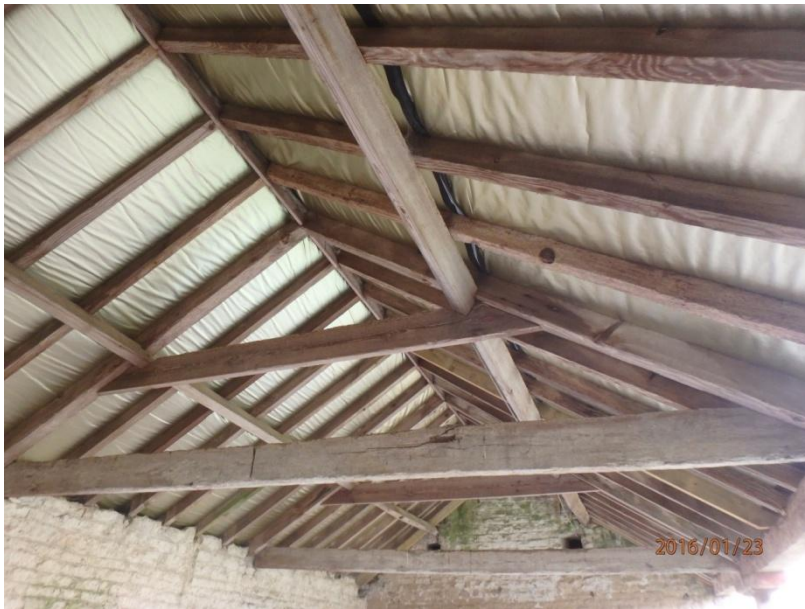
**Plate 22: View of the roof supporting structure of Outbuilding 1, from the north**

**Plates 22 and 27** provide views of the simple roof supporting structure of Outbuilding 1. At the lower levels are a series of pairs of horizontal timber collars which are attached to the aforementioned wallplate at the East Elevation and are inserted into the fabric of the west wall. To these are attached a series of horizontal timber purlins and common rafters, the latter of which extend to horizontal roof apex timbers.

**Plate 27: View of the roof supporting structure of Outbuilding 1, from the south**

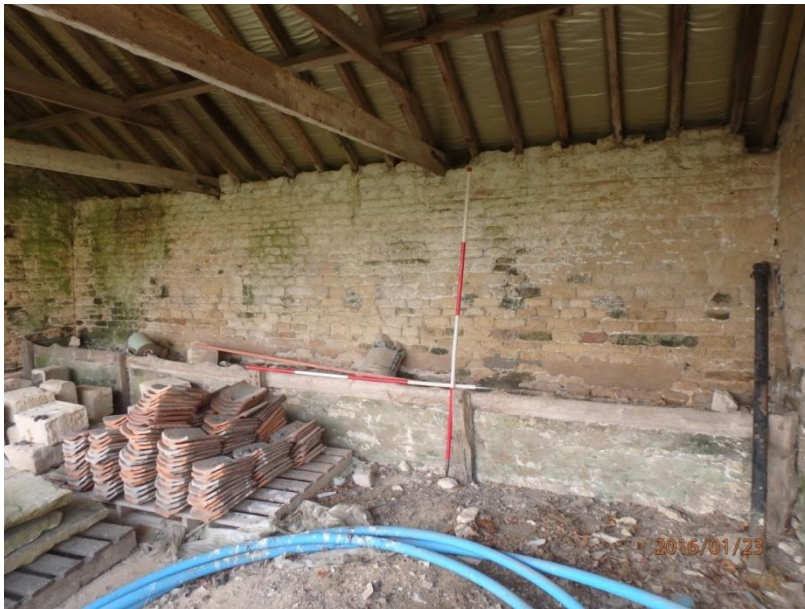
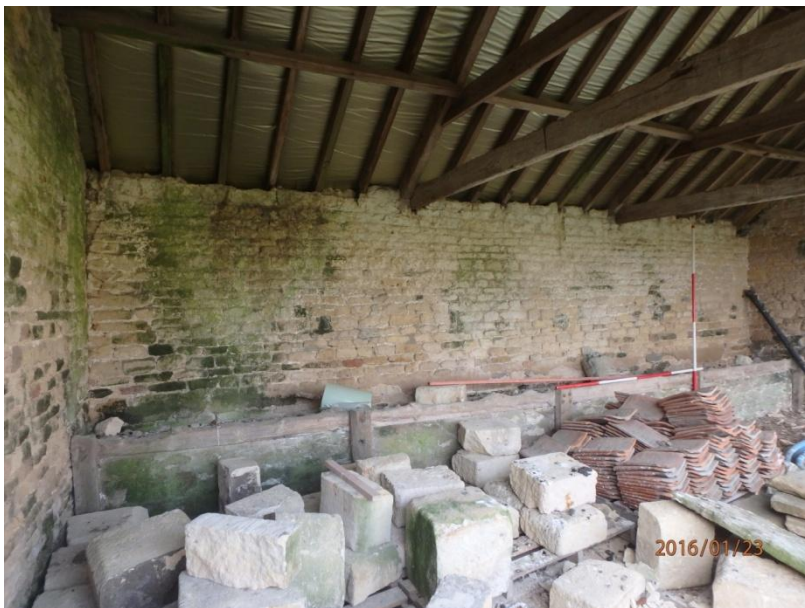
**Plate 23: View of the west wall of Outbuilding 1, from the east**

**Plate 24: View of the west wall of Outbuilding 1, from the east**

**Plates 23 and 24** feature the west wall of Outbuilding 1. The fabric of this wall is composed of courses of shaped and worked limestone blocks. The bonding material is a light buff lime mortar. At the lower levels is a former animal trough, the interior of which is lined with concrete. This trough is bonded to the west wall and is constructed of courses of shaped and worked limestone blocks, which have been rendered over with modern concrete. Inserted into this fabric are several vertical and horizontal timbers which extend along the top of the trough.

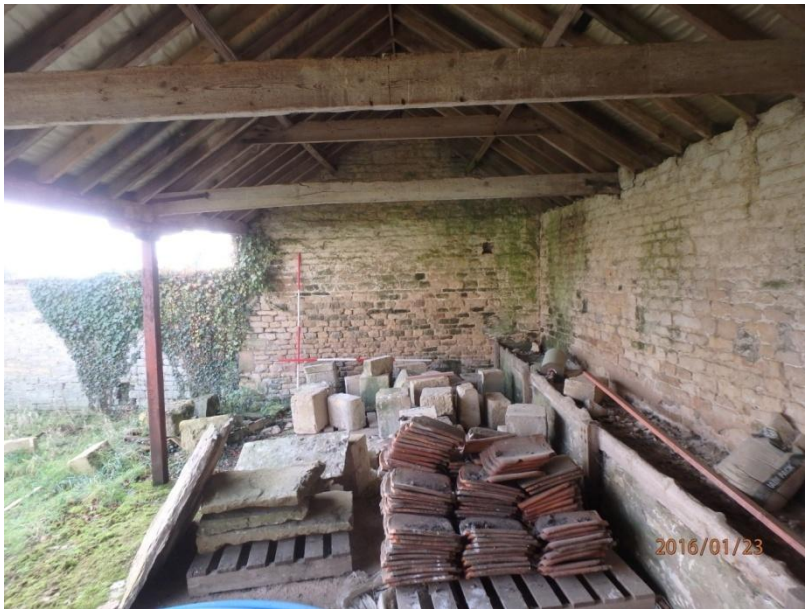
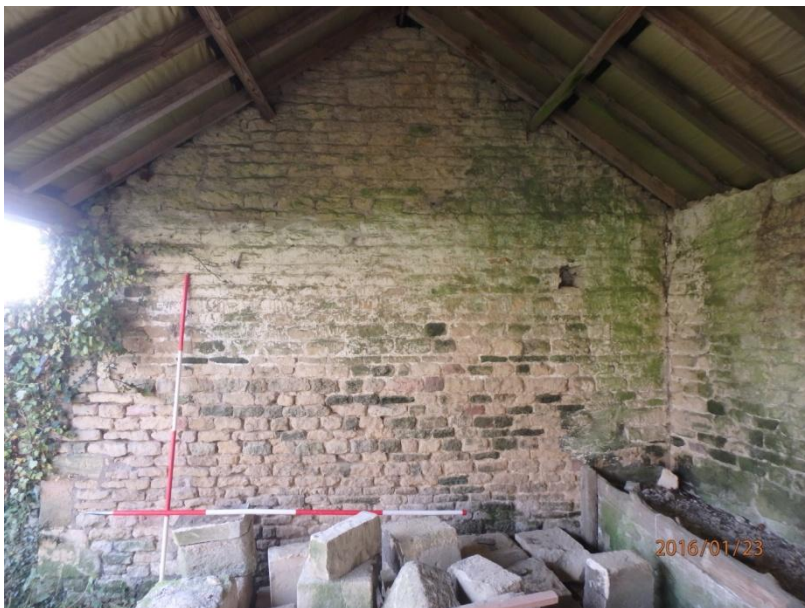
**Plate 25: View of the interior of Outbuilding 1, from the north**

**Plate 26: View of the south wall of Outbuilding 1, from the north**

**Plates 25 and 26** feature the south wall of Outbuilding 1. The fabric of this south wall is composed of courses of shaped and worked limestone blocks. The bonding material is a light buff lime mortar. There is a small square shaped ventilation aperture on the right and within the upper levels of the wall. This aperture was not featured on the opposing external South Elevation wall.

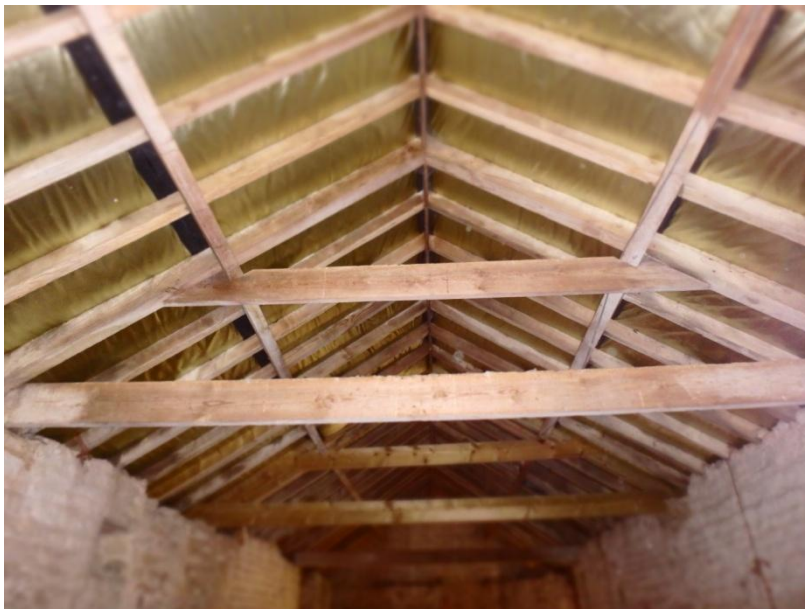
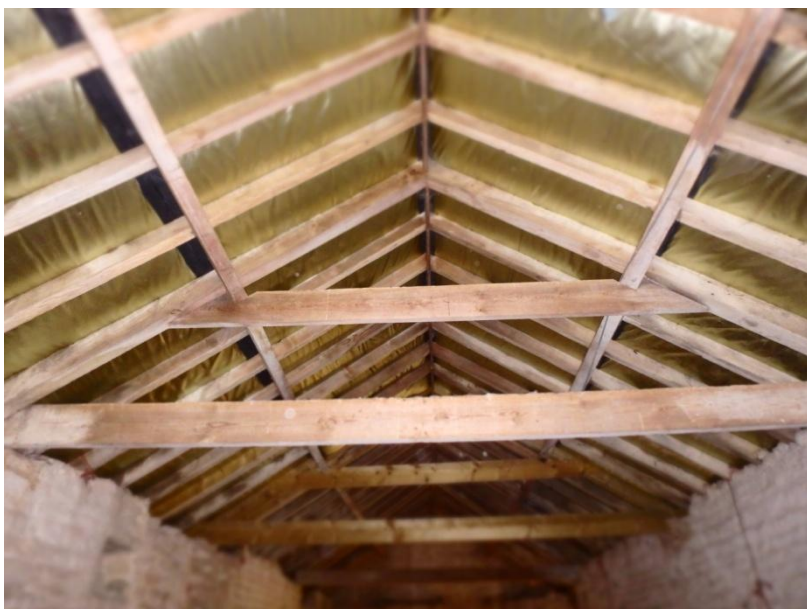
**Plate 28: View of the roof supporting structure of Cell 1, from the north**

**Plates 28 and 29** provide detailed views of the roof supporting structure of Cell 1. This is identical in nature to that which was previously recorded within the adjacent Outbuilding 1 to the south. At the lower levels are a series of pairs of horizontal timber collars which are attached to tops of the east and west walls. To these are attached in turn a series of horizontal timber purlins and common rafters, the latter of which extends to horizontal roof apex timbers.

**Plate 29: View of the roof supporting structure of Cell 1, from the north**

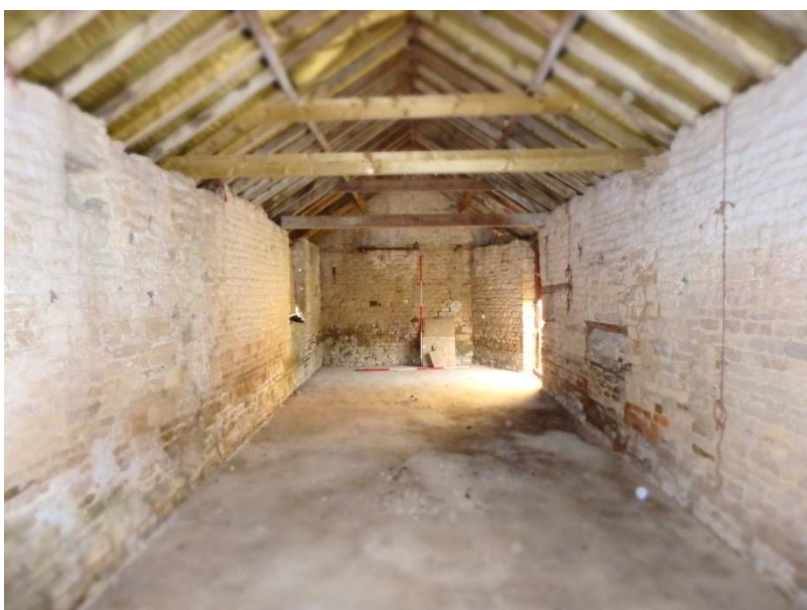
**Plate 30: View of the roof supporting structure and interior of Cell 1, from the south**

**Plate 30** provides an additional view of the supporting roof structure of Cell 1 along with a general view of the north and much of the east and west walls. The floor of Cell 1 is of modern concrete.

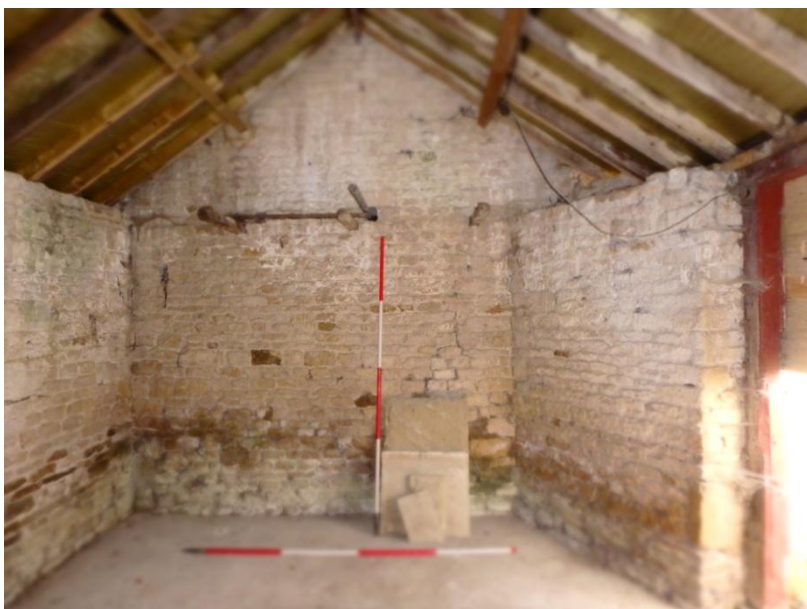
**Plate 31: View of the north wall of Cell 1, from the south**

**Plate 31** provides a detailed view of the north wall of Cell 1 including the tapering of the northern portion of the east wall. This north wall including the tapered northern section of the east wall is constructed of courses of shaped and worked limestone blocks, much of which has been whitewashed over. The bonding material is a light buff lime mortar. There are in addition, four small and square shaped ventilation apertures at ground floor ceiling level.

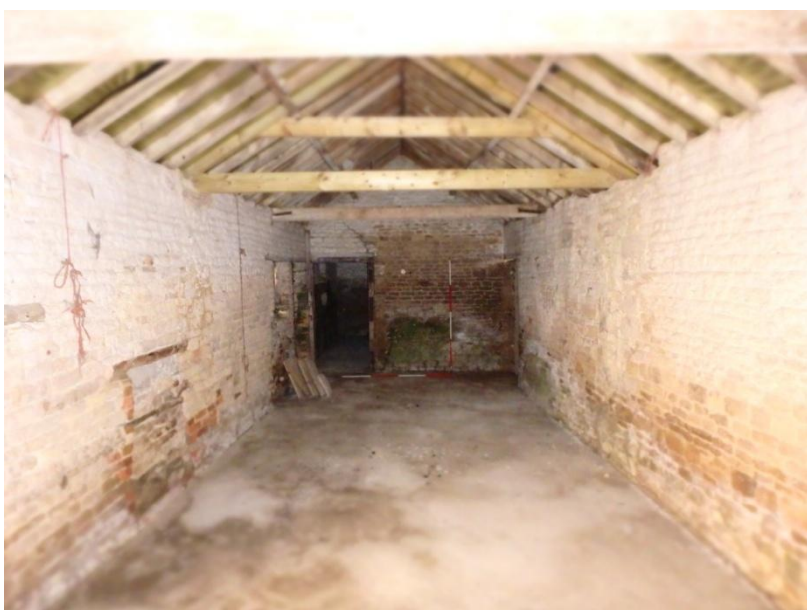
**Plate 32: View of the roof supporting structure and interior of Cell 1, from the north**

**Plate 32** provides a further general view of the interior of Cell 1 taken from the vantage point of the northern end of this room and features the roof supporting structure, the south wall and much of the east and west walls.

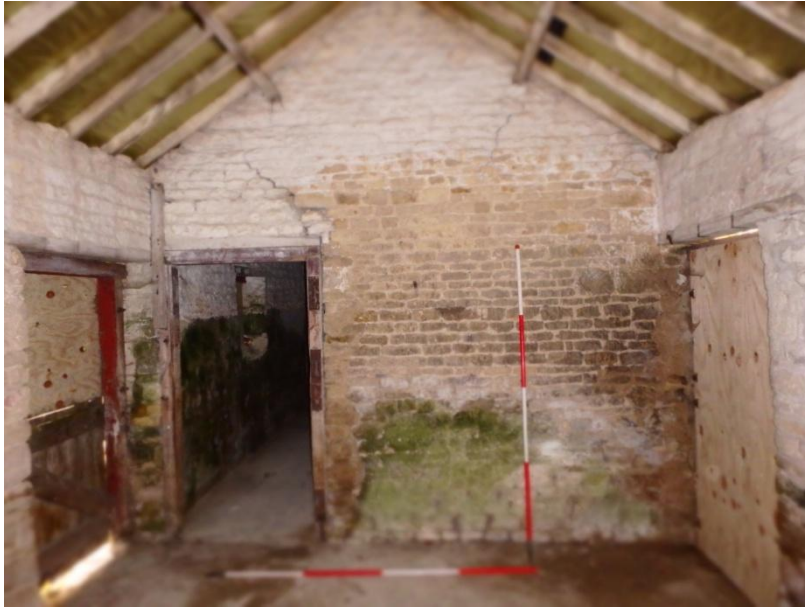
**Plate 33: View of the south wall of Cell 1, from the north**

**Plate 33** provides a detailed view of the south wall of Cell 1. The fabric of this south wall is composed of courses of shaped and worked limestone blocks, some of which has been whitewashed over. The bonding material is a light buff lime mortar. To the left (east) is a door opening which leads onto the adjoining Cell 2 to the south. The door itself is absent with the door opening being only occupied by a simple timber frame of head and surrounds. Above the head is a short length of horizontal timber lintel.

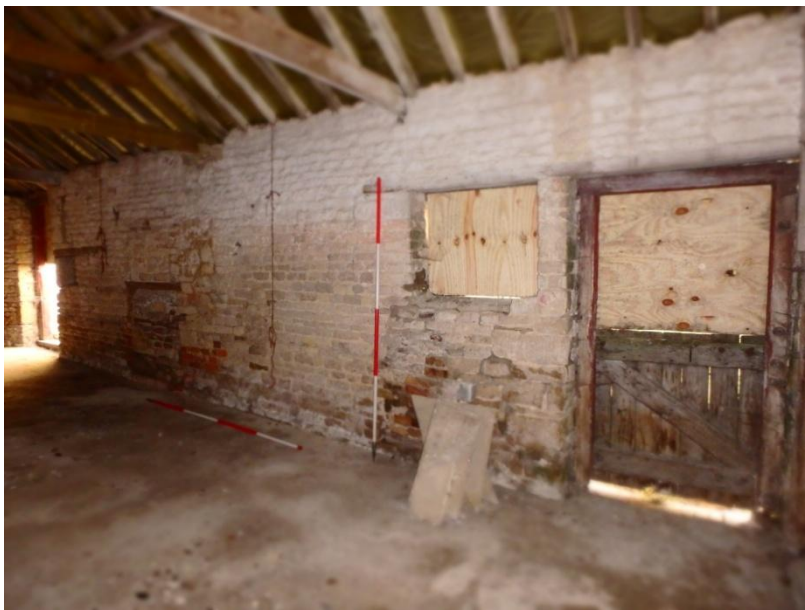
**Plate 34: View of the east wall of Cell 1, from the west**

**Plates 34 and 35** provide detailed views of the east wall of Cell 1. At the southern end of this wall is the inner face of a door opening which was previously recorded in detail on the external East Elevation of this outbuilding. The surviving lower half door is attached to a framework of angled and horizontal timbers. Above the door opening is an horizontal timber lintel. To the immediate north (left) of this is a window opening which was also previously recorded in detail on the external East Elevation of this outbuilding. There is a further horizontal timber lintel above this opening. Towards the northern end of this wall is an infilled fireplace with an horizontal timber lintel above it [**Plate 36**]. The infill is a mixture of uncoursed and roughly shaped and worked limestone blocks, some brick headers and stretchers and cement rendering at the upper levels.

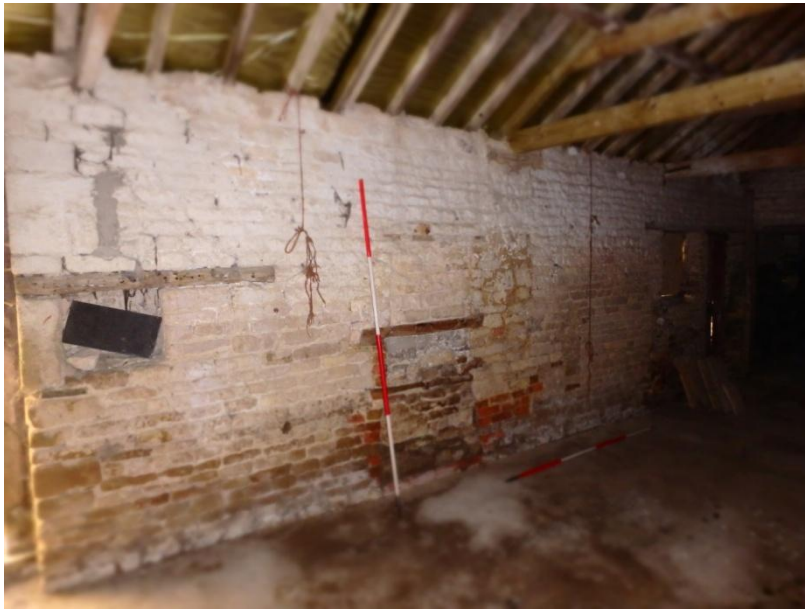
**Plate 35: View of the east wall of Cell 1, from the west**

The wall fabric of this east wall is composed of courses of shaped and worked limestone blocks, much of which has been whitewashed over. The bonding material is a light buff lime mortar. At

the door opening at the northern end of the east wall is a column of worked, shaped and faced limestone ashlar at the internal door opening surrounds. The inner face of this door opening is of a simple timber frame of head and surrounds.

A small alcove with a short section of horizontal timber incorporated into the wall fabric is also situated at the northern end of the east wall [Plate 35]. There is also some more recent repair to the fabric of the east wall with brick stretchers around the infilled fireplace [Plate 36].

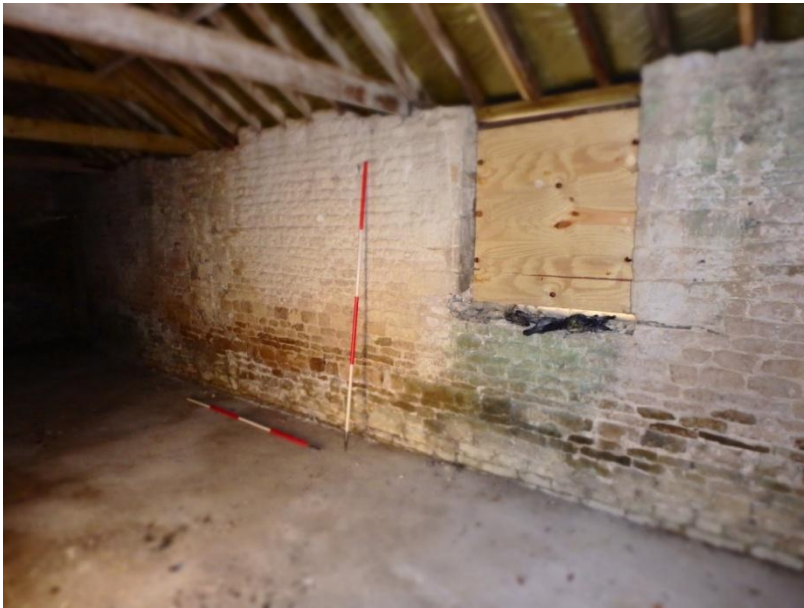
**Plate 37: View of the west wall of Cell 1, from the north-east**

**Plates 37-39** feature in detail the west wall of Cell 1. The fabric of this west wall is composed of courses of shaped and worked limestone blocks, much of which has been whitewashed over. The bonding material is a light buff lime mortar. At the northern end of this east wall is a window opening which was previously recorded in detail on the exterior West Elevation of this outbuilding. The window opening surrounds are constructed of columns of worked shaped and faced limestone ashlar to either side. At the southern end of this east wall is a door opening which was also previously recorded in detail on the exterior West Elevation of this outbuilding. There is an internal horizontal timber lintel above this door opening.

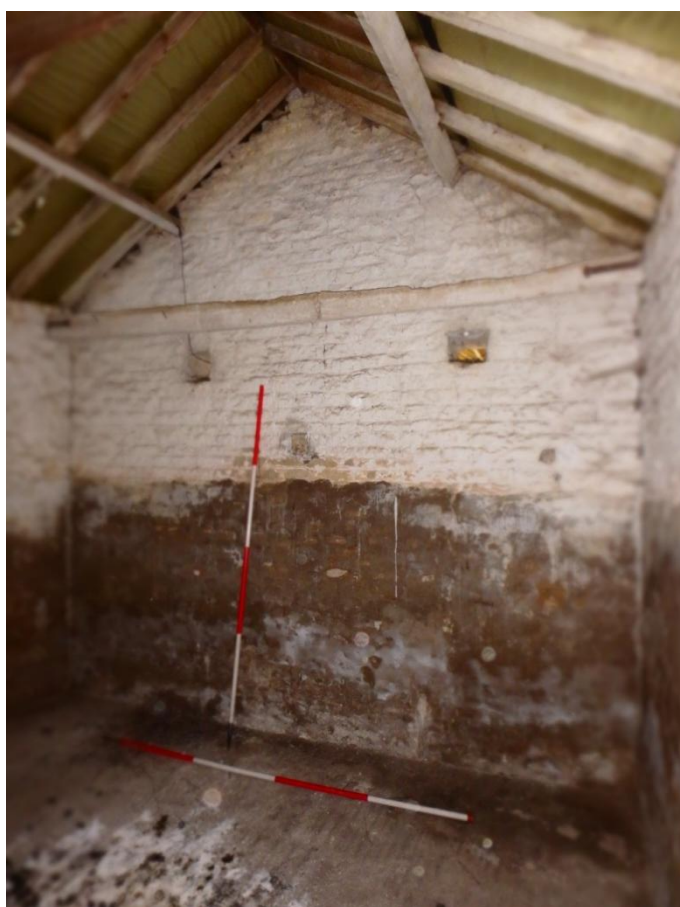
**Plate 40: View of the south wall of Cell 2, from the north**

**Plates 40 and 41** provide views of the south wall of Cell 2. The lower levels of the wall fabric have been rendered over with modern cement which obscures the nature of the underlying wall fabric. However, the upper levels are composed of courses of shaped and worked limestone

blocks, which has been whitewashed over. There is an horizontal timber wallplate incorporated into this wall fabric at ground floor ceiling level along with two small rectangular ventilation apertures just below this.

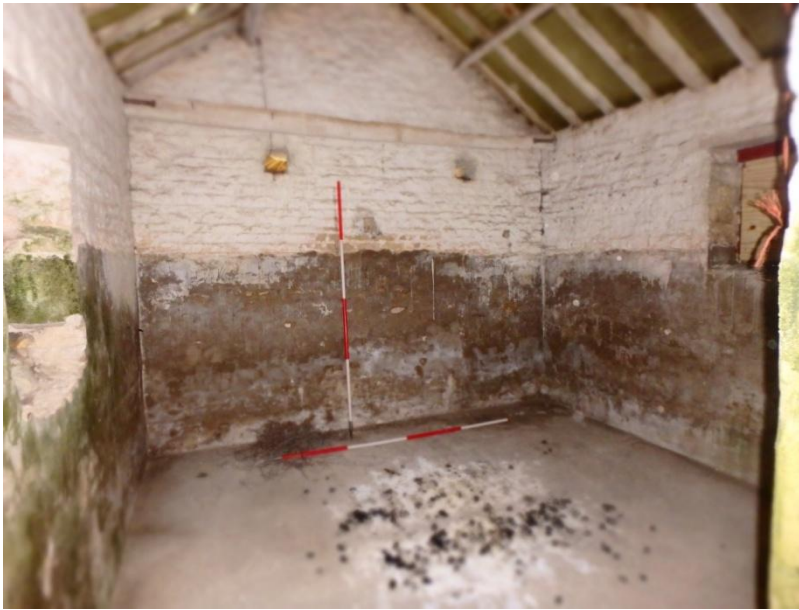
**Plate 41: View of the interior of Cell 2, from the north**

**Plate 41** also features the modern concrete floor of Cell 2.

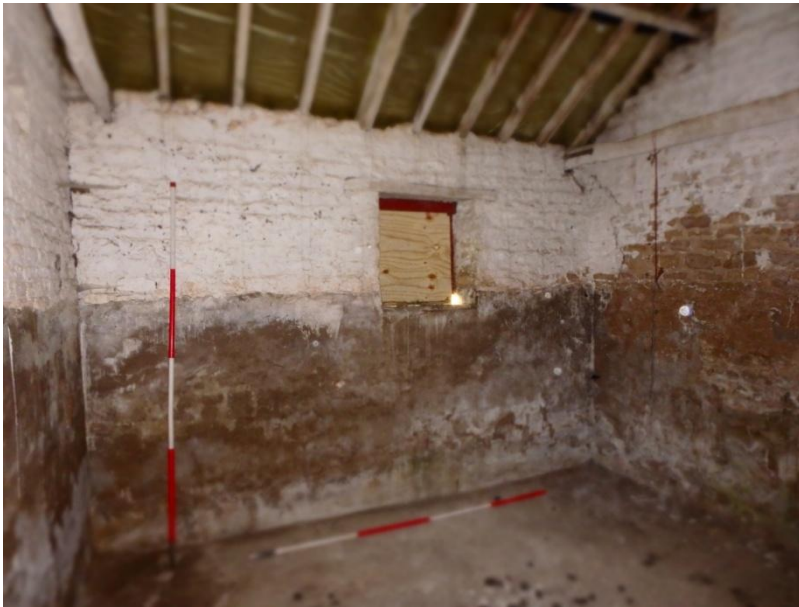
**Plate 42: View of the west wall of Cell 2, from the east**

**Plate 42** shows the west wall of Cell 2. The lower levels of this wall have similarly been rendered over with modern cement thus obscuring any underlying detail of the wall fabric. The upper levels of the wall fabric by contrast are readily apparent composed of courses of shaped and worked limestone blocks, which has been whitewashed over. The inner face of a small window opening which was previously recorded in detail on the opposing exterior West Elevation of this outbuilding is also revealed with an internal horizontal lintel above it.

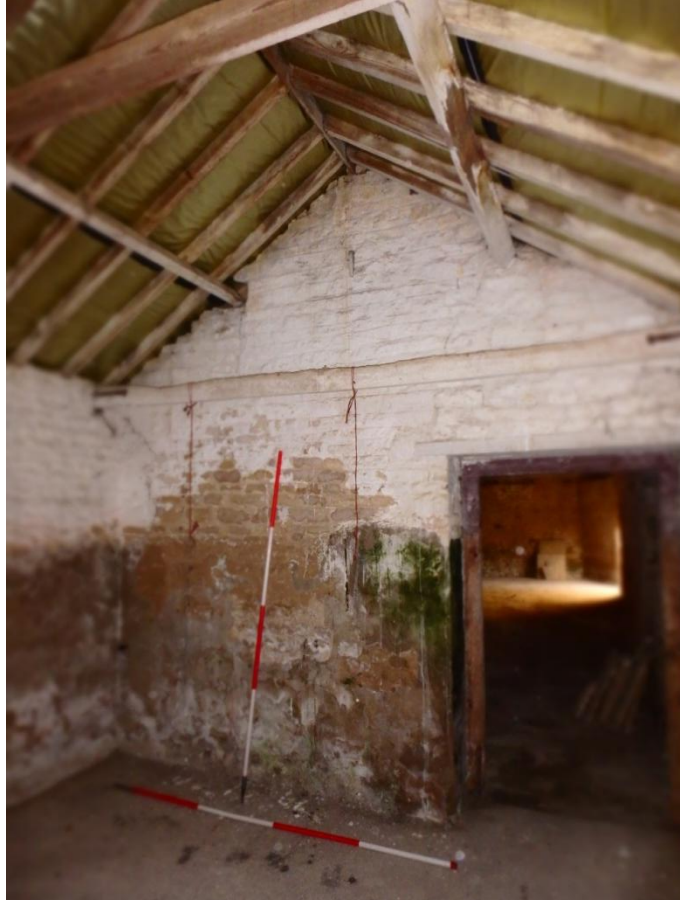
**Plate 43: View of the north wall of Cell 2, from the south**

**Plate 43** features the north wall of Cell 2. The lower levels of this wall have similarly been rendered over with modern cement thus obscuring any underlying detail of the wall fabric. The upper levels of the wall fabric by contrast are readily apparent composed of courses of shaped

and worked limestone blocks, which has been whitewashed over. There is an horizontal timber wallplate incorporated into this wall fabric at ground floor ceiling level. The inner face of the door opening which extends onto the adjoining Cell 1 to the north is also revealed with an horizontal timber lintel above the doorway.
