LEVEL II HISTORIC BUILDING RECORDING  
AT FRITH FARM,  
RYHALL ROAD,  
LITTLE CASTERTON, RUTLAND.

**National Grid Reference: TF 0200 1120**

*An historic building survey equivalent to English Heritage Level 2 of Units 2 and 3 at Frith Farm, Ryhall Road, Little Casterton, Rutland was undertaken by Neville Hall MIFA on the 23rd of January 2016.*

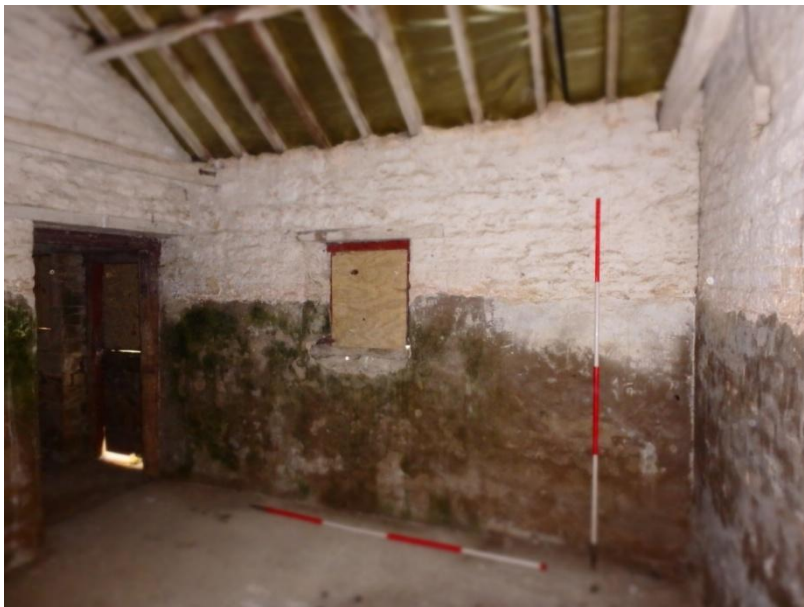
**Plate 44: View of the east wall of Cell 2, from the west**

**Plate 44** features the east wall of Cell 2. The lower levels of this wall have similarly been rendered over with modern cement thus obscuring any underlying detail of the wall fabric. The upper levels of the wall fabric by contrast are readily apparent composed of courses of shaped and worked limestone blocks, which has been whitewashed over. The inner face of a small window opening which was previously recorded in detail on the opposing exterior East Elevation of this outbuilding is also revealed with an internal horizontal timber lintel above the opening.

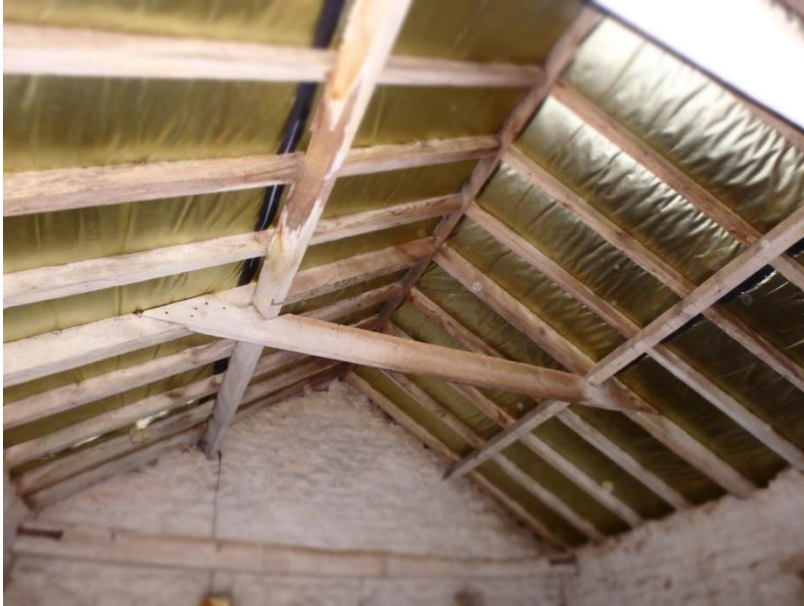
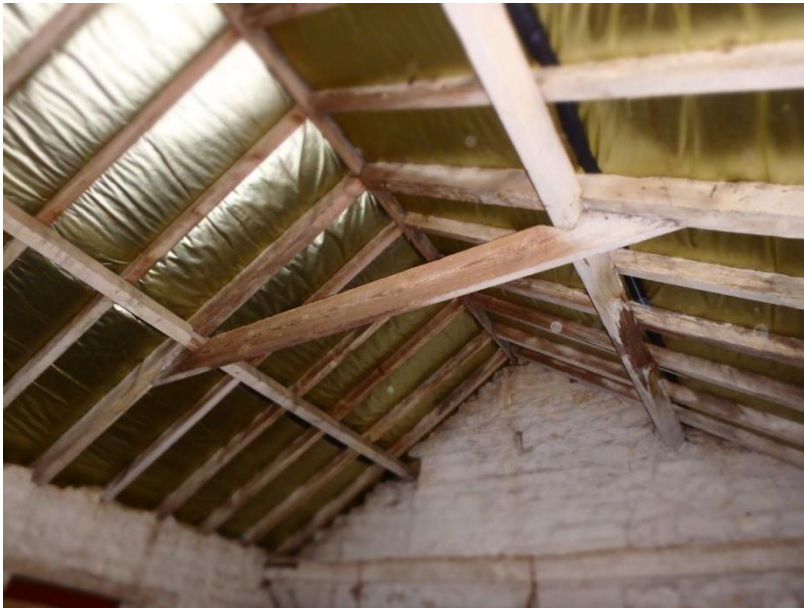
**Plate 45: View of the roof supporting structure of Cell 2, from the north**

**Plate 46: View of the roof supporting structure of Cell 2, from the south**

**Plates 45 and 46** provide detailed views of the supporting roof structure of Cell 2. The supporting roof structure of Cell 2 is relatively simple in nature composed of two horizontal timber collars to which are attached two horizontal timber purlins along with a series of common rafters, which extend to an horizontal timber at the roof apex. The purlins and rafters are inserted into the walls. There is a notable absence of wallplates on the east and west walls.

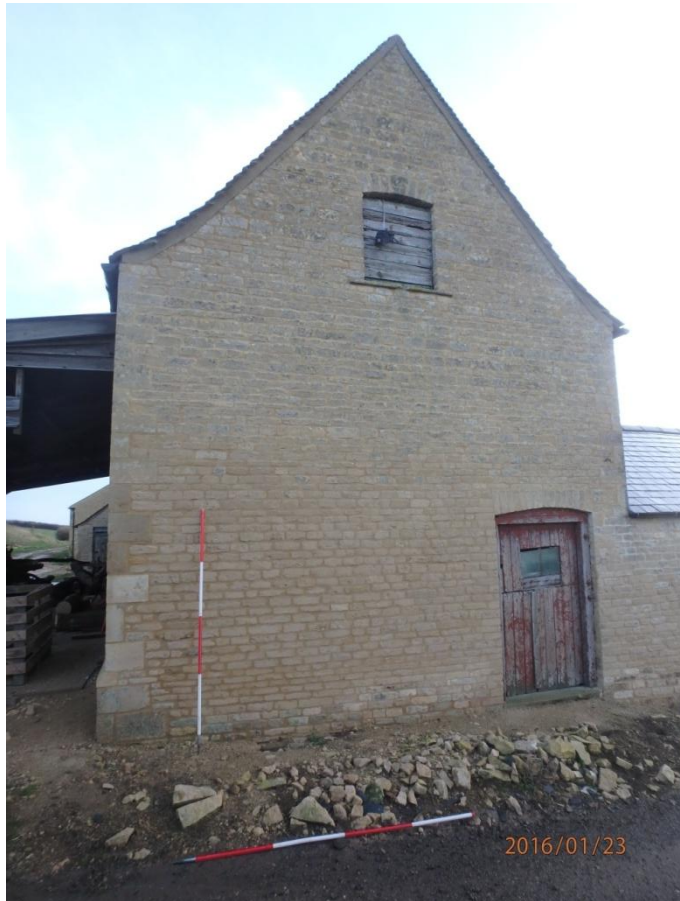
**Plate 47: View of the West Elevation, from the west**

**Plate 47** provides a view of the West Elevation of the Grade II listed Barn or North Range. This building is of two storeys in height with a gabled roof in slate and slate ridge tiles. The wall fabric of this West Elevation is composed of coursed worked and shaped limestone blocks with modern repointing evident. A vertical series of worked shaped and faced limestone quoins occupy the north-western corner of this building.

At the ground floor level and to the right (south) is a west facing door opening. The doorway is of two half doors, which are composed of a series of vertical tongued and grooved timber planks. A simple timber frame of head and surrounds also occupies this door opening. A small partially glazed and partially boarded over window opening is within the upper half door. The curved upper door head is composed of one course of roughly shaped and worked limestone blocks.

At first floor level is an original window opening which has been boarded over with a series of horizontal timber planks. There is a stone cill at the base of the opening and a curved window head above this of one course of roughly shaped and worked limestone blocks.

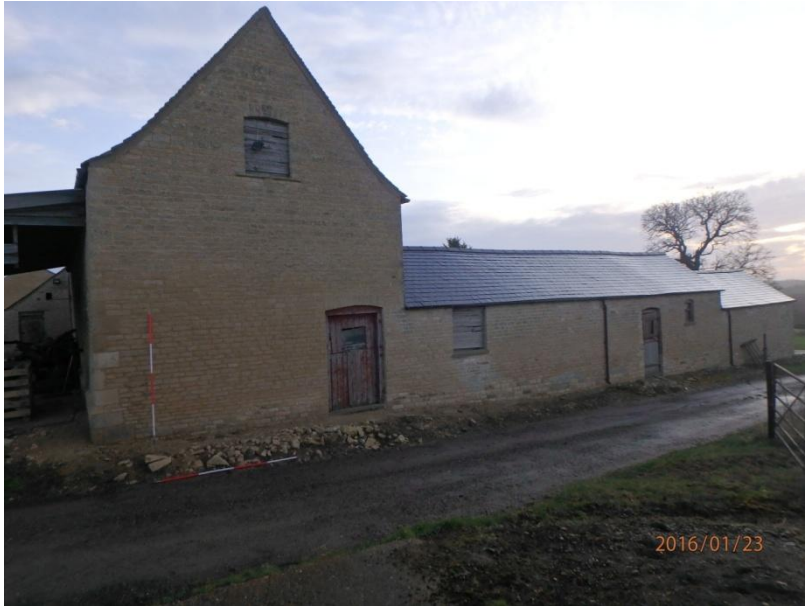
**Plate 48: General view of the West Elevation of the North Range and the West Elevation of the West Range, from the west**

**Plate 48** provides a general view of this West Elevation and also of the West Elevation of the West Range composed of Outbuildings 1 and 2.

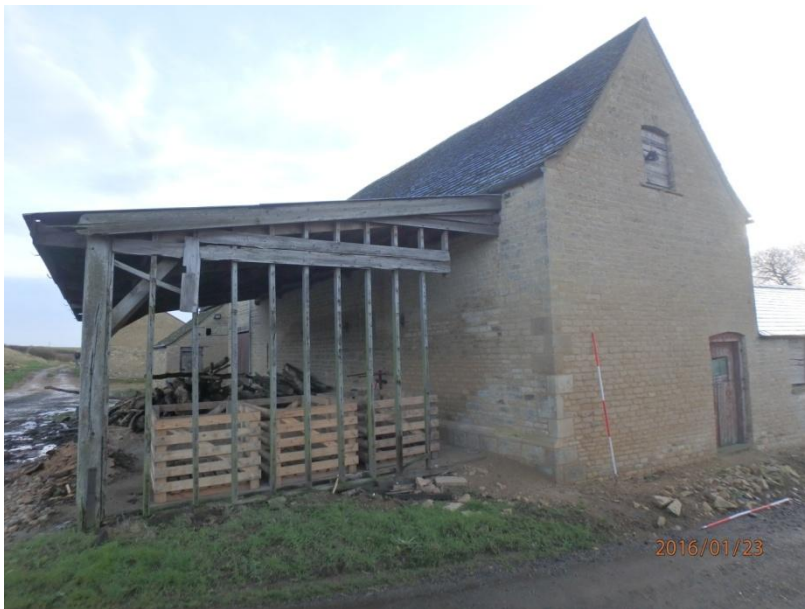
**Plate 49: View of the West Elevation and the western side of the lean-to of the North Range, from the west**

**Plate 49** provides a further view of the West Elevation of this North Range along with the western side of a lean-to, which is attached to the North Elevation of this building. This lean-to first appears on the Second Edition O.S. map of 1904. This lean-to is of one storey in height and has a flattish though slightly angled roof or half-gabled roof with a roof covering of modern sheets of corrugated metal. The western facing side of this lean-to comprises a timber frame which is made up of one substantial vertical timber post at the northern end along with a second substantial angled timber which is part of the supporting roof structure and which is inserted into the wall

fabric of the North Elevation. Attached to this angled timber is a framework composed of a series of secondary vertical timbers and a single horizontal timber at the base at ground level. To this in turn are attached the remnants of timber weatherboarding, of which only the upper levels survive composed of a series of horizontal timber planks.

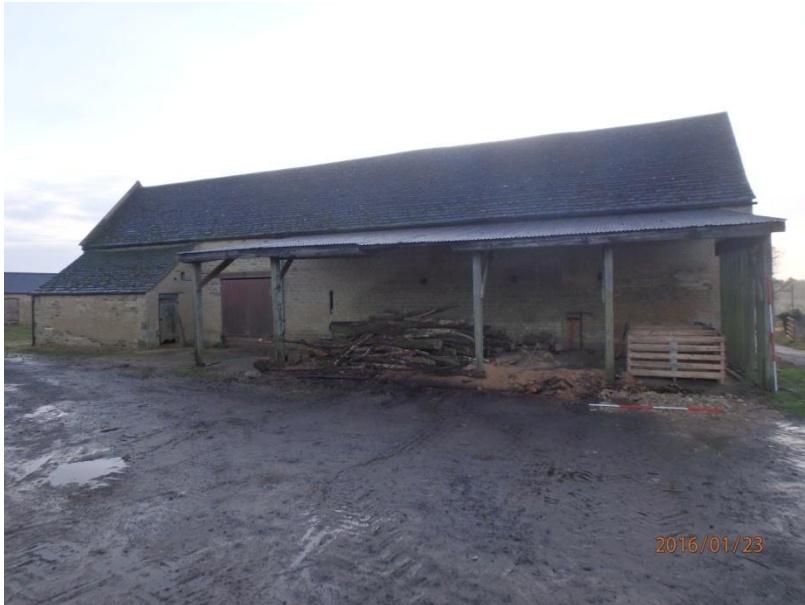
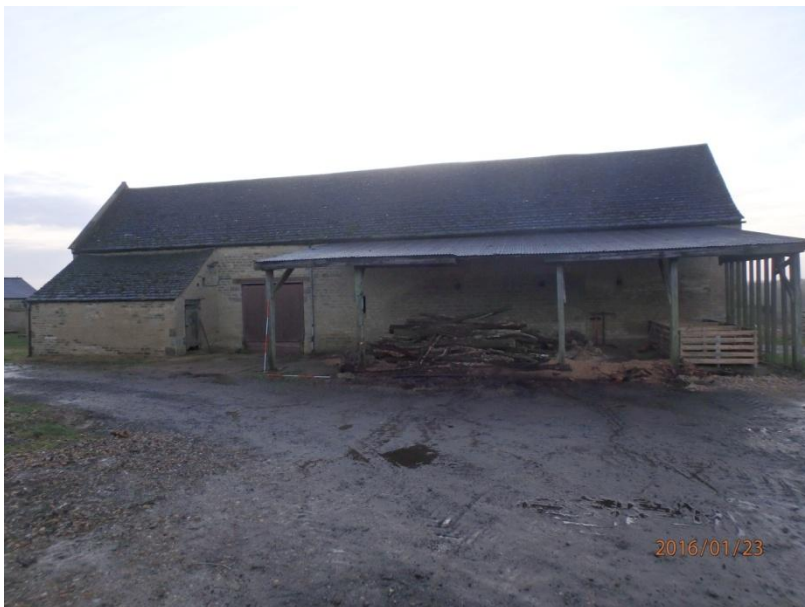
**Plate 50: View of the North Elevation of the North Range including the northern side of the lean-to, from the north**

**Plate 51: View of the North Elevation of the North Range including the northern side of the lean-to, from the north**

**Plates 50 and 51** provide general views of the North Elevation of this North Range showing the lean-to to the right (west), the double-doored north facing entrance to the east of this and a single storey side extension at the eastern end of this North Elevation. The lean-to is open to the north. The northern face of this structure is composed of a series of five substantial vertical timber posts which support the roof structure.

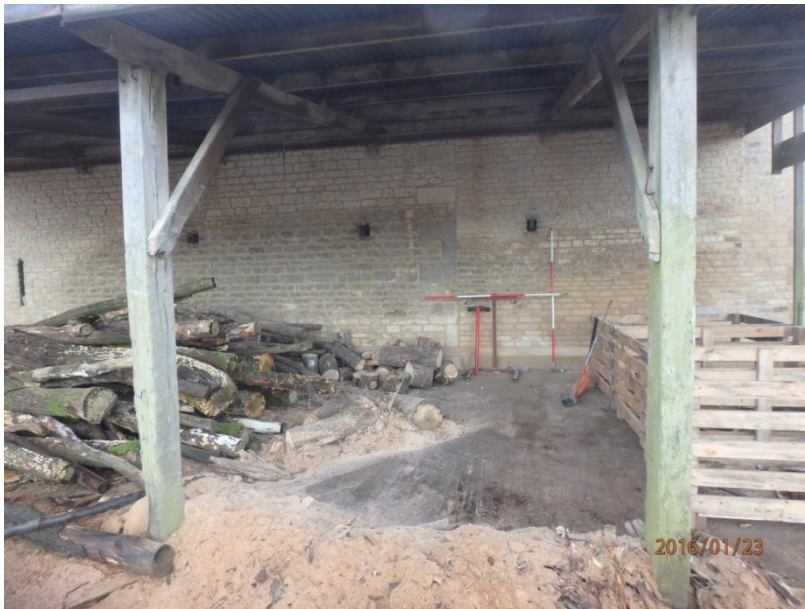
**Plate 52: Detail: View of the lower levels of the North Elevation of the North Range, from the north**

**Plates 52 and 53** feature in detail two of the substantial vertical timber posts at the north face of the lean-to. Behind and in the foreground of this is the wall fabric of the North Elevation. The wall fabric of this North Elevation is composed of coursed shaped and worked limestone blocks with modern repointing. There are in addition, three rectangular shaped ventilation apertures at ground floor ceiling levels cut into this wall fabric. At ground level is a foundation offset composed of a string course of chamfered shaped and faced limestone blocks below which are further coursed shaped and worked limestone blocks which make up the remainder of the foundation.

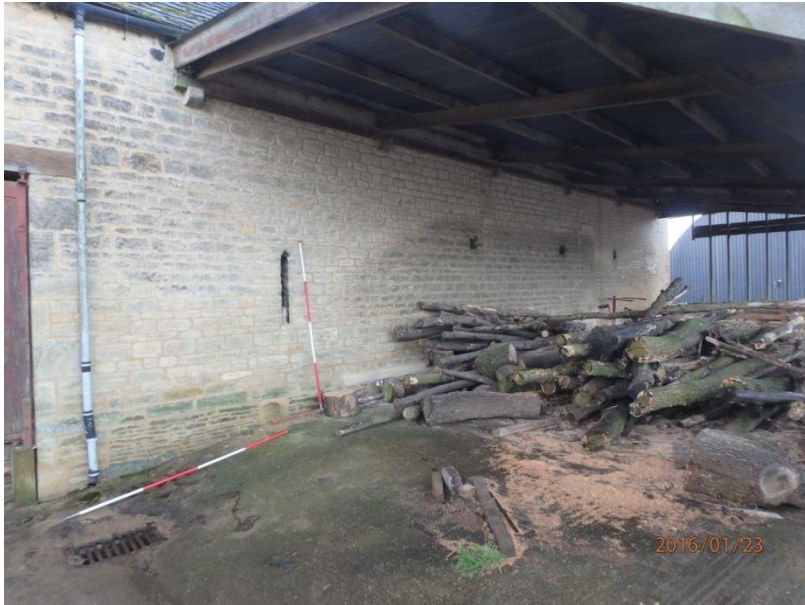
**Plate 54: Detail: View of the lower levels of the North Elevation of the North Range, from the north-east**

**Plate 54** features further parts of the wall fabric of this North Elevation showing a fourth vertical ventilation aperture. Below this fourth ventilation aperture and the foundation offset, the

foundation is composed of courses and thin shaped and faced limestone slabs. Behind the roof of the lean-to is modern Upvc guttering at roof level which extends to a vertical VPVC downpipe to the east (left) of the fourth ventilation aperture. The floor of the lean-to is composed of modern concrete providing an external yard surface.

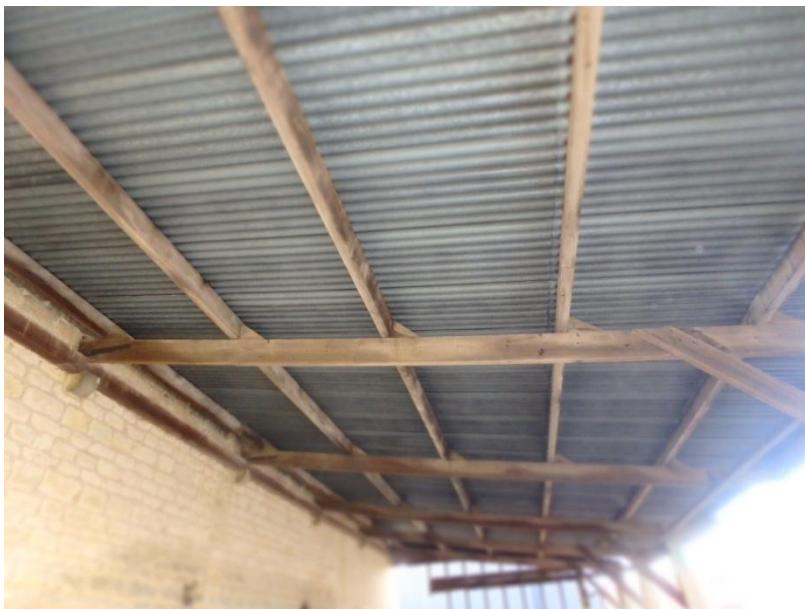
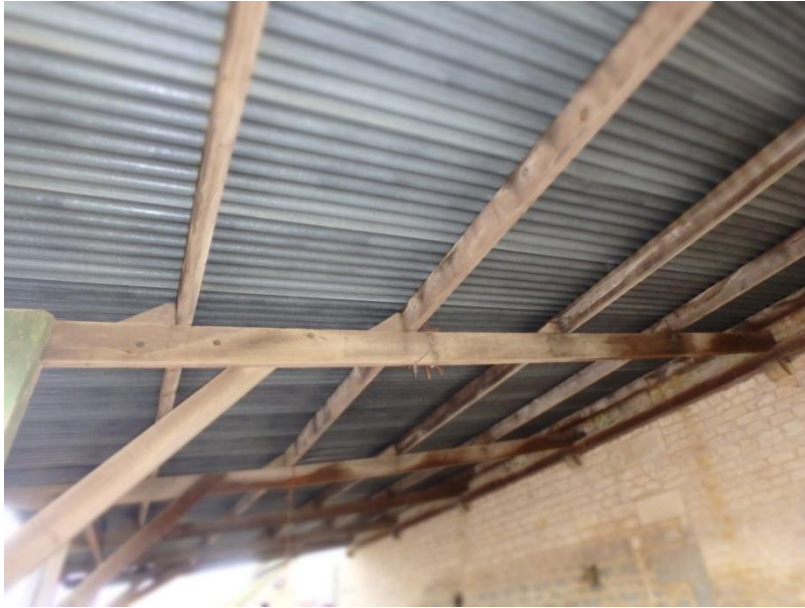
**Plate 55: View of the roof supporting structure of the lean-to, from the east**

**Plates 55 and 56** both feature in detail the nature of the roof supporting structure of the lean-to. This is a relatively simple structure consisting of a timber framework of horizontal principal purlins and principal rafters. The southern ends of the rafters are attached to a substantial horizontal timber wallplate at roof level, which is inserted into the wall fabric of the North Elevation. This wallplate in turns rests upon a series of six carved and shaped limestone plinths which are part of the wall fabric of this North Elevation.

**Plate 56: View of the roof supporting structure of the lean-to, from the west**

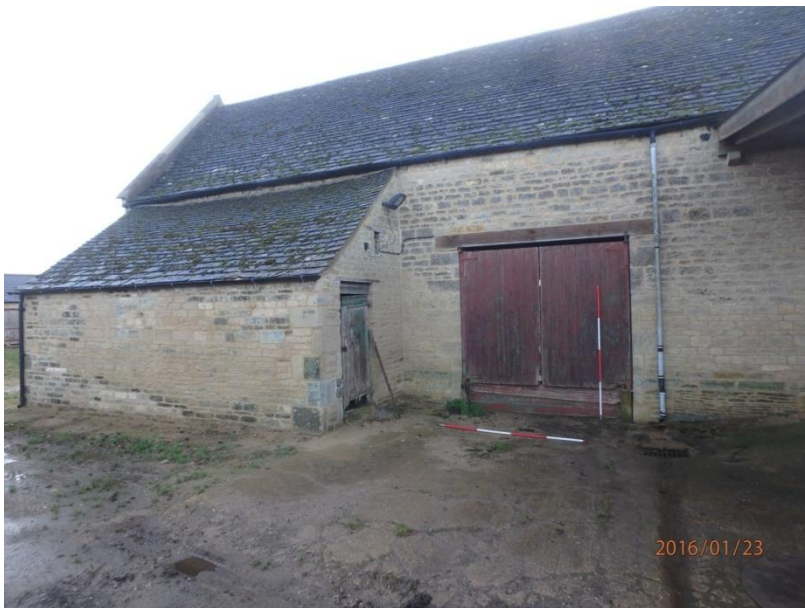
**Plate 57: View of the northern portion of the North Elevation of the North Range including side extension, from the north**

**Plate 57** shows a double-doored north facing entrance to the North Range. The door head consists of a substantial horizontal timber lintel, which is inserted into the wall fabric of this North Elevation. The double doors are composed of a series of vertical tongued and grooved timber planks. To either side are four modern cast metal hinges. The lower levels of the door opening are occupied by a series of horizontal timber planks, which board up these lower levels. At ground floor level and to either side of the opening are two short stubs of vertical timbers, which may mark the basal remnants of an earlier door frame. Any door frame is not visible externally. There are two vertical counns of worked, shaped and faced limestone quoins to either side of this door opening, which marks it as an original feature.

**Plate 57** also features the single storey side extension at the eastern end of this North Range. This structure has a half-gabled roof in slate. There is modern Upvc guttering at roof level which leads to a vertical modern Upvc downpipe to the left (east). The North Elevation of this side extension is also featured on **Plate 57**. The wall fabric here is composed of coursed worked and shaped limestone blocks with modern repointing. There are also some reused worked, shaped, and faced limestone ashlar incorporated within this wall fabric. There are the vertical columns of worked, shaped and faced limestone quoins at the north-western and north-eastern corners of this extension. There is no foundation offset here.

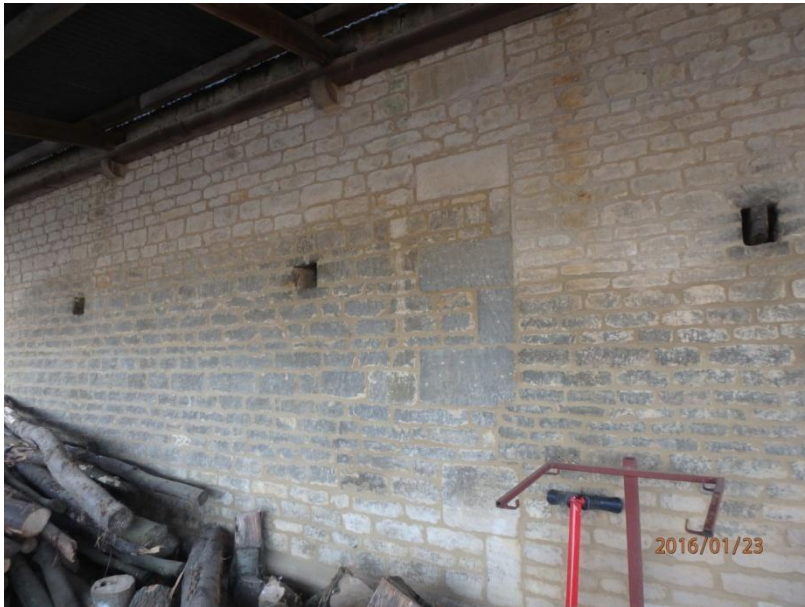
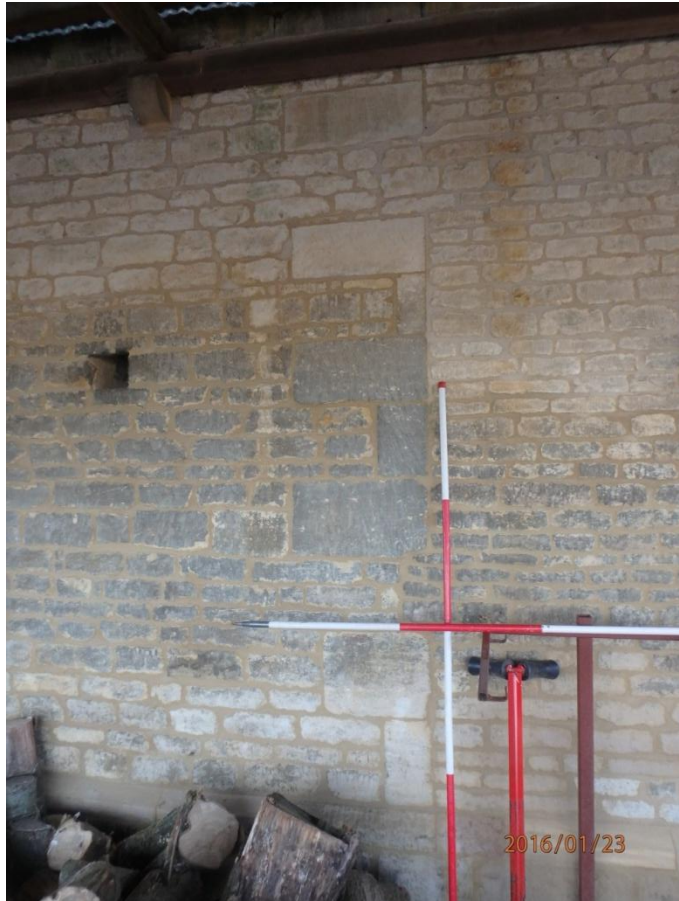
**Plate 59: Detail: View of the original western end of the Grade II listed Barn, from the north**

**Plates 59 and 60** feature in detail a vertical dividing line in the wall fabric of the North Elevation. This vertical division is further marked by a vertical column of worked, shaped and faced

limestone quoins. The wall fabric to the west of this vertical dividing line is composed of similar coursed shaped and faced limestone blocks as the wall fabric to the east of this vertical division. It is thus clear that a later western two storied extension to the North Range has been constructed.

**Plate 60: Detail: View of the original western end of the Grade II listed Barn, from the north**

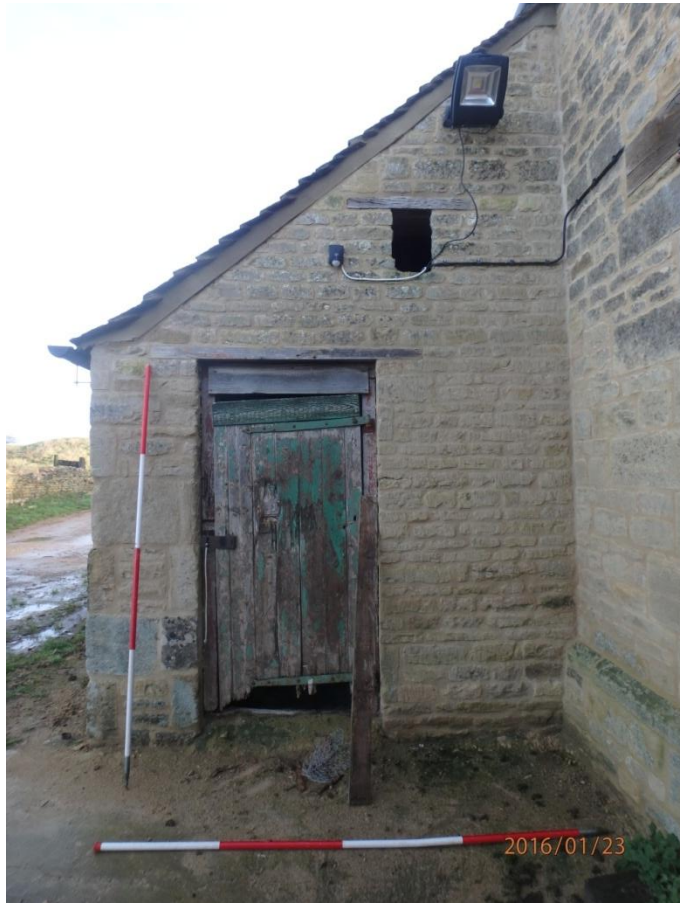
**Plate 61: Detail: View of the West Elevation of the Side Extension, from the west**

**Plate 61** features the west facing West Elevation of this Side Extension. The wall fabric here is identical to that of the adjoining North Elevation composed of coursed worked and shaped limestone blocks with modern repointing. The foundation offset is absent here also. At ground floor level is a west facing door opening. The door is composed of a series of vertical tongued and grooved timber planks with two cast metal strap hinges to the right. The door opening also contains a simple timber frame of head and surrounds. There are the remains of a stone threshold. The upper levels of the door opening are boarded over with two horizontal timber planks. These may cover over an unglazed fanlight. Above the door opening is a modern horizontal timber lintel. Above this and built into the wall fabric is a rectangular shaped ventilation aperture with a modern horizontal timber lintel above it. There are in addition a vertical line of worked, shaped and faced limestone quoins at the north-western corner of this building.

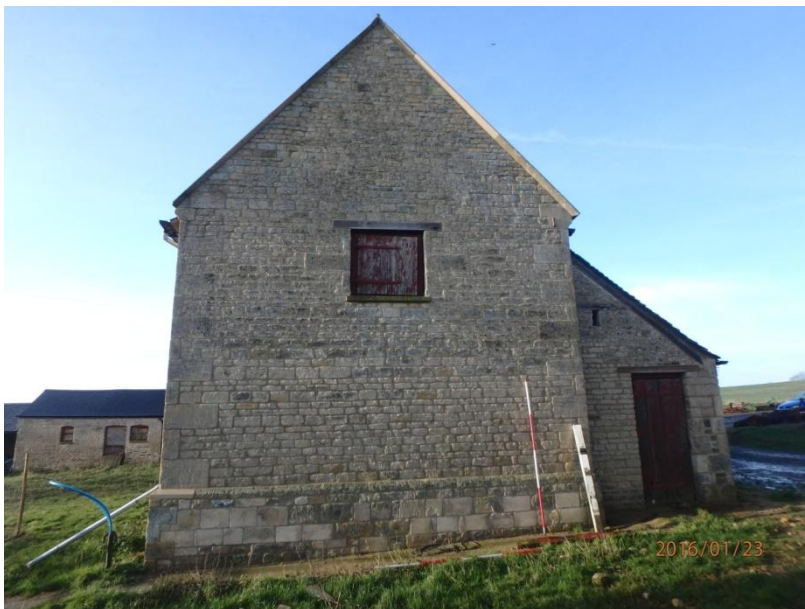
**Plate 62: View of the East Elevations of the North Range and Side Extension, from the east**

**Plate 62** provides a view of both the East Elevation of the North Range and also of the East Elevation of the single storey Side Extension and **Plate 63** - a detailed view of the East Elevation of the Side Extension. The layout of this East Elevation is identical to that of the opposing West Elevation of this building. To the right (north) is an east facing door opening with the door constructed of a series of vertical tongued and grooved timber planks. To the left are two cast metal strap hinges. Also within the doorway is a simple timber frame of head and surrounds with a stone threshold. Above this is a modern horizontal timber lintel. Above the door opening is a second rectangular shaped ventilation aperture within the wall fabric which is topped with a

further modern horizontal timber lintel. The wall fabric is composed of coursed worked and shaped limestone blocks with modern repointing. The foundation offset is absent here also.

The wall fabric of the East Elevation of the North Range is composed of coursed worked and shaped limestone blocks with modern repointing. At ground level is a foundation offset composed of a string course of chamfered shaped and faced limestone blocks below which are further

coursed shaped and faced limestone blocks and reused ashlar which make up the remainder of the foundation. There are in addition the vertical lines of two columns of worked, shaped and faced limestone quoins at the north-eastern and south-eastern corners of this building respectively. At first floor level is an east facing window opening. The window opening is occupied by a wooden shutter composed of a series of vertical tongued and grooved timber planks with two cast metal strap hinges to the left. The window opening also contains a simple timber frame of head and surrounds with a stone cill. Above this is a modern horizontal timber lintel.

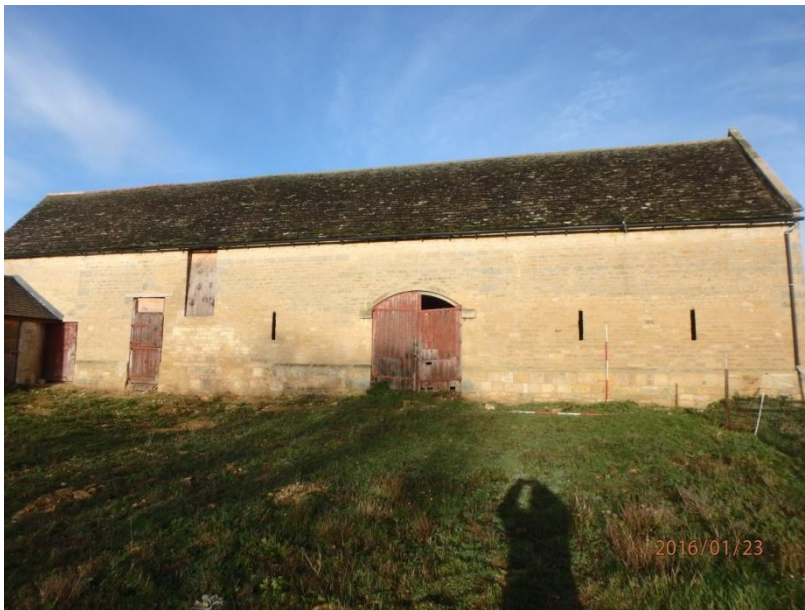
**Plate 64: View of the South Elevation of the North Range, from the south**

**Plate 64** provides a general view of the whole South Elevation of the North Range.

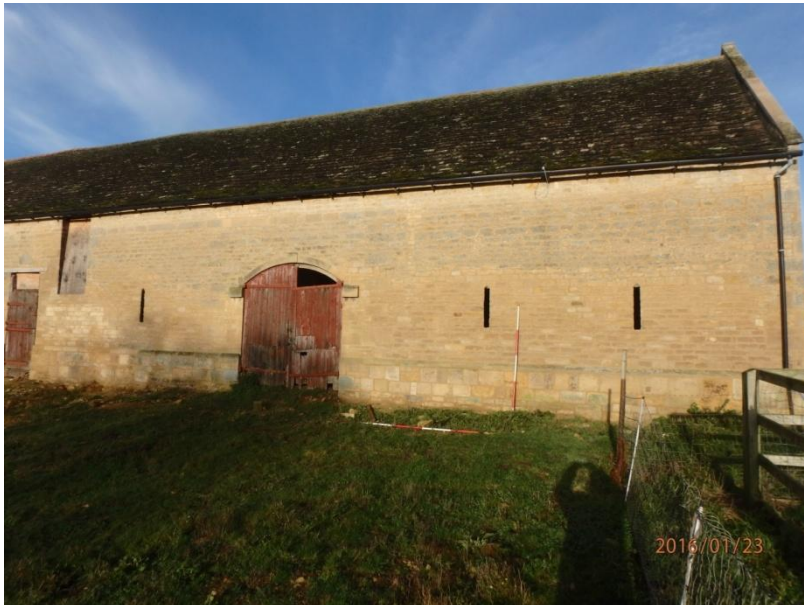
**Plate 65:** View of the eastern portion of the South Elevation of the North Range, from the south

**Plate 65** features in detail the eastern portion of the South Elevation of the North Range. The wall fabric of this South Elevation is composed of coursed worked and shaped limestone blocks along with distinctive courses of reused, worked, shaped and faced limestone ashlar with modern repointing. There is modern Upvc guttering at roof level leading to a vertical modern UPVC downpipe at the eastern end of the Elevation. At ground level is a foundation offset composed of a string course of chamfered shaped and faced limestone blocks below which are further coursed shaped and faced limestone blocks and coursed and reused worked, shaped and faced limestone ashlar which make up the remainder of the foundation. To the right (east) are two vertical ventilation apertures or slits at ground floor level.

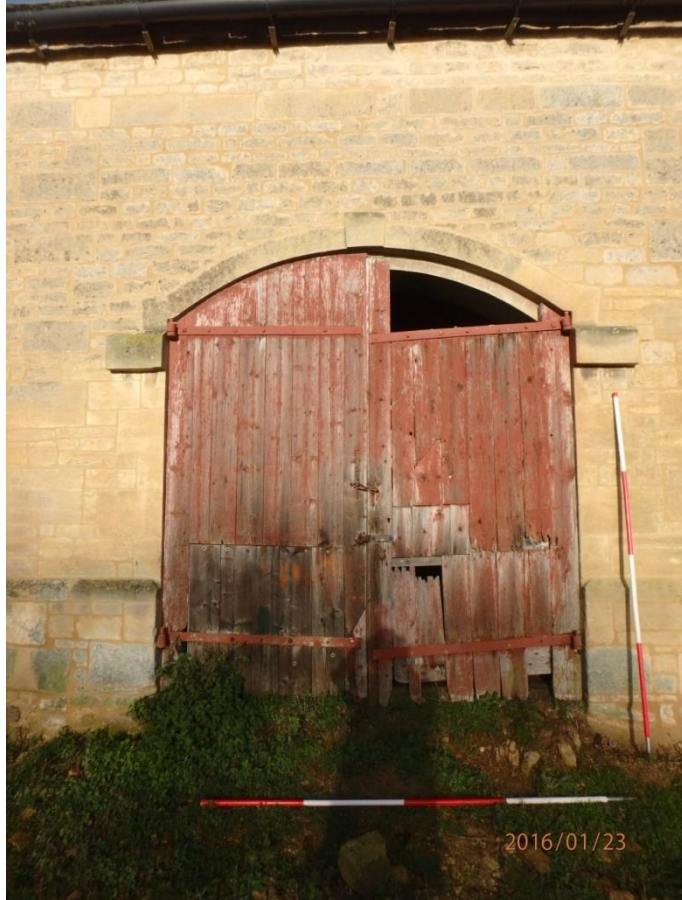
**Plate 66: Detail: View of the south facing entrance to the South Elevation, from the south**

**Plate 66** provides a detailed view of the central south facing door opening. This is a double doored entrance with two vertical columns of worked, shaped and faced limestone quoins to either side. The curved decorative external door head is of carved worked, shaped and faced limestone ashlar with a decorative carved keystone at the midst of the head. To either side and at the base of the head are two rectangular shaped and slightly protruding worked, shaped and faced decorative limestone ashlar. The door itself is composed of a series of vertical tongued and grooved vertical timber planks with four cast metal strap hinges to either side.

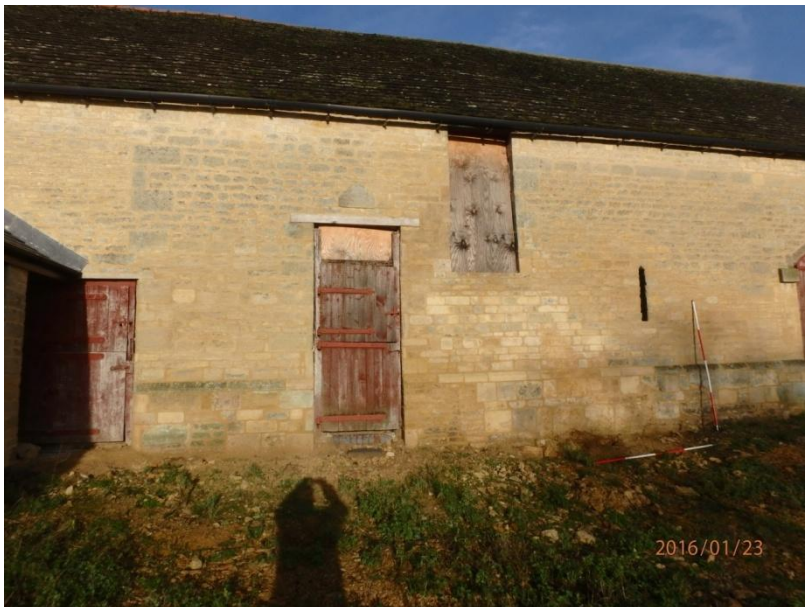
**Plate 67: View of the western portion of the South Elevation of the North Range from the south**

**Plate 67** features the western portion of the East Elevation of the North Range. To the left (west) and at ground floor level is a third vertical ventilation aperture or slit.

**Plates 67 and 69** also feature a second door opening at first floor level. This opening originally had an east facing stone stairwell leading onto it from the ground levels. It is understood that this was recently demolished though the outline of this can still be observed on the external wall fabric leading up to this opening. The opening itself is boarded over with a wooden board. To either side are two vertical columns of worked, shaped and faced limestone quoins indicating that this is an original feature of the building. To the immediate west (left) of this and at ground floor level is a third south facing door opening. This door opening is occupied by two timber half doors composed of a series of vertical tongued and grooved timber planks with four cast metal strap hinges to the left. The door frame is not visible externally. There is an unglazed fanlight above the upper timber half door, which is boarded over. Above this is a modern horizontal timber lintel.

**Plates 67 and 69** also show a decorative carved datestone above this door opening, which is attached to the wall fabric. This datestone is featured in detail on **Plate 70**, with which the date '1763' can be clearly discerned along with initials below it.

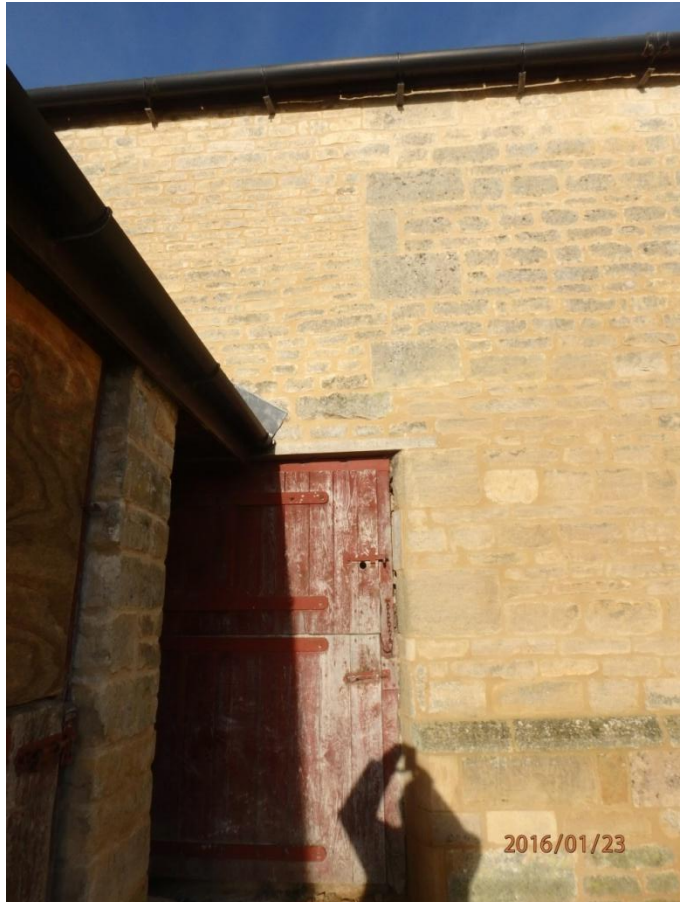
**Plate 68:** Detail: View of the division between the Original Barn and the western extension, from the south

**Plate 68** also features a vertical dividing line in the wall fabric, which is marked by a vertical column of worked, shaped and faced limestone quoins. This line marked the original western end to this building and clearly indicated that the western portion of this North Range was a later extension. There is an identical dividing line in the wall fabric on the opposing North Elevation of this building.

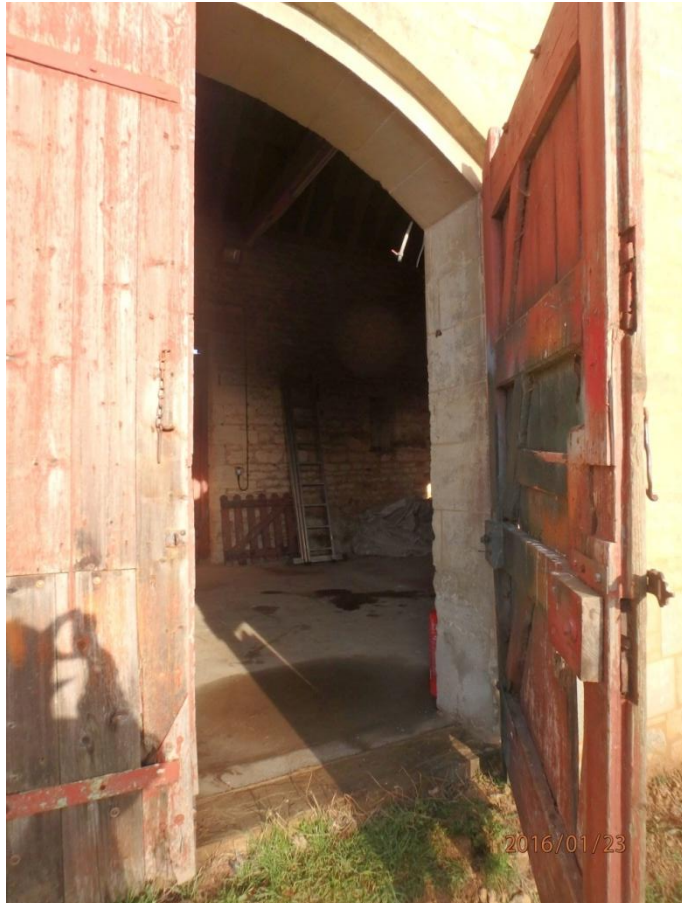
**Plate 71: View of the interior of the south facing entrance in the South Elevation, from the south**

**Plate 71** provides a detailed view of part of the interior of this entrance with a slightly recessed carved and curved inner door head composed of worked, shaped and faced limestone ashlar. **Plate 71** also shows that the two doors are attached to an internal framework of angled and horizontal timbers.

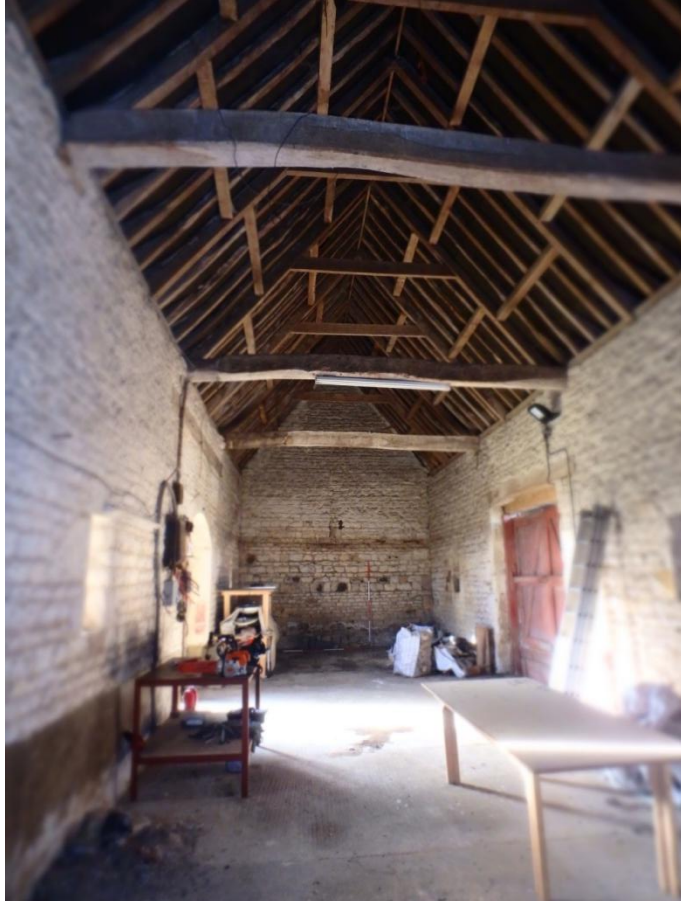
**Plate 73: General view of the interior of Cell 3, from the east**

**Plate 73** provides a general view of the interior of Cell 3, which has a modern concrete floor.

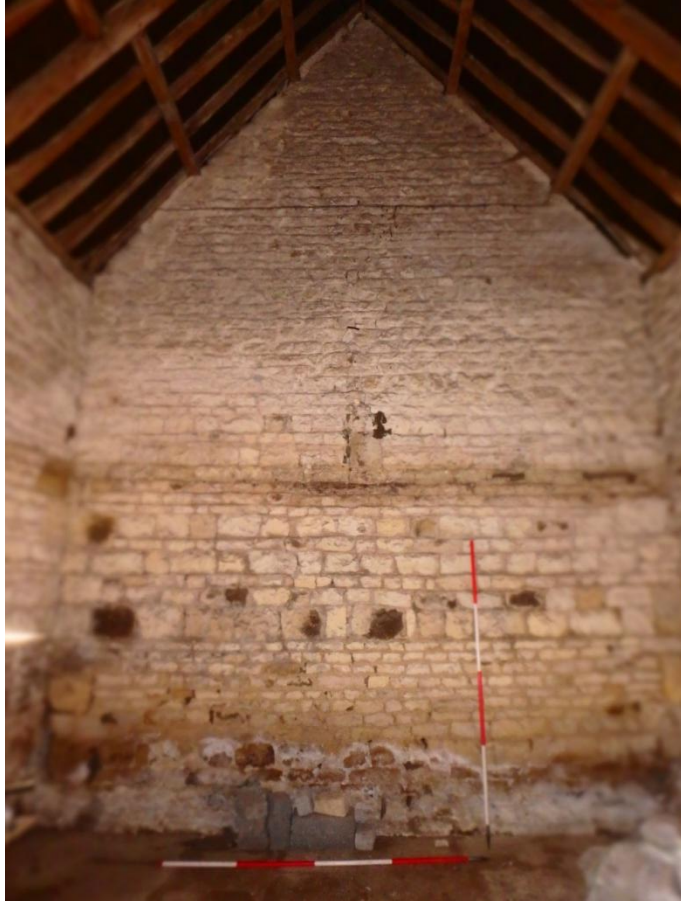
**Plate 74: View of the west wall of Cell 3, from the east**

**Plate 74** provides a detailed view of the west wall of Cell 3. The wall fabric of this west wall is composed of coursed worked and shaped limestone blocks along with distinctive courses of reused worked, shaped and faced limestone ashlar. There is also much evidence of modern repointing along with evidence of earlier bonding material in places comprising a light buff sandy mortar.

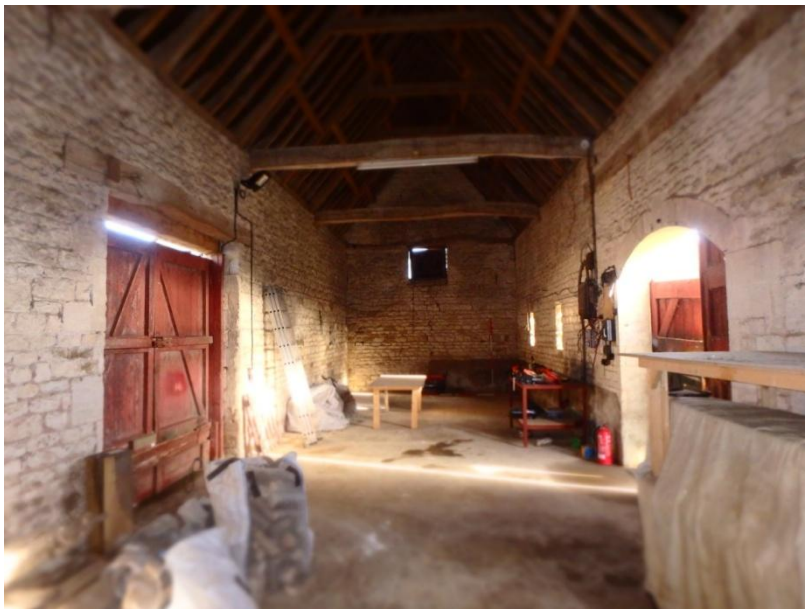
**Plate 75: General view of the interior of Cell 3, from the west**

**Plate 75** provides a further general view of the interior of Cell 3.

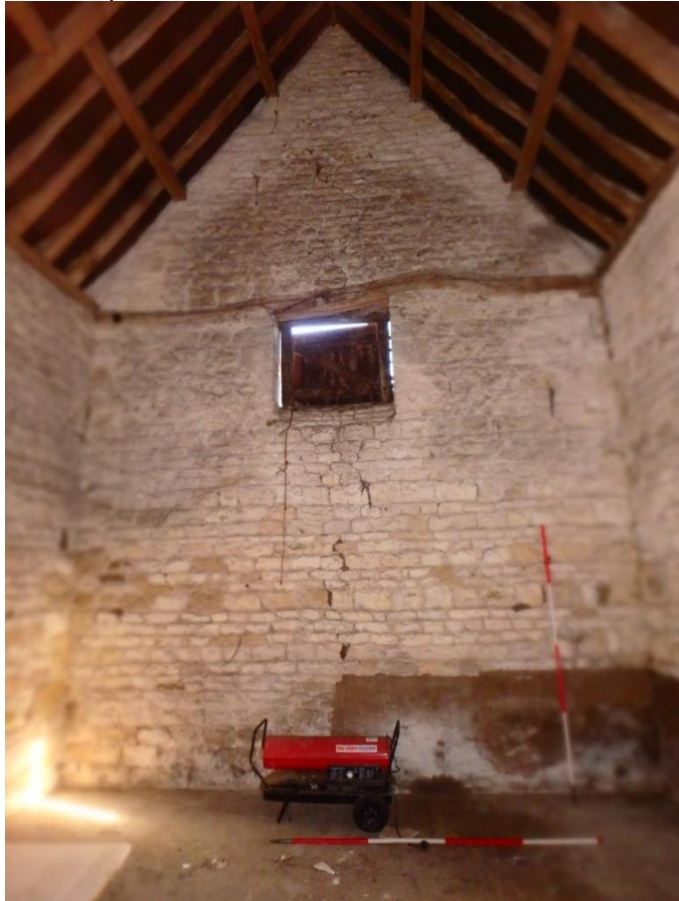
**Plate 76: View of the east wall of Cell 3, from the west**

**Plate 76** provides a detailed view of the east wall of Cell 3. The wall fabric of this east wall is composed of coursed worked and shaped limestone blocks along with distinctive courses of reused worked, shaped and faced limestone ashlar. There is also much evidence of modern

repointing along with evidence of earlier bonding material in places comprising a light buff sandy mortar. There is an horizontal timber wallplate at first floor ceiling level. Just below this is the inner face of the window opening previously recorded on the opposing exterior East Elevation. This reveals a simple timber frame of head and surrounds and an internal horizontal timber lintel.

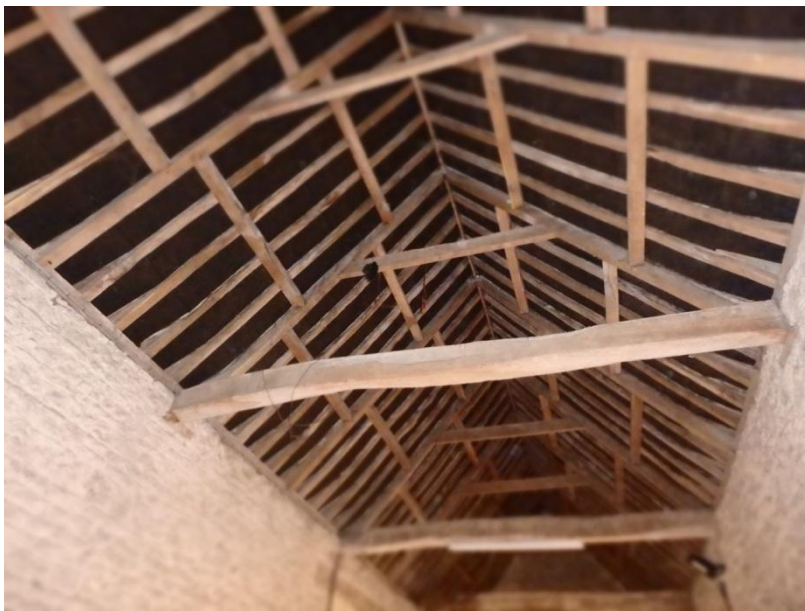
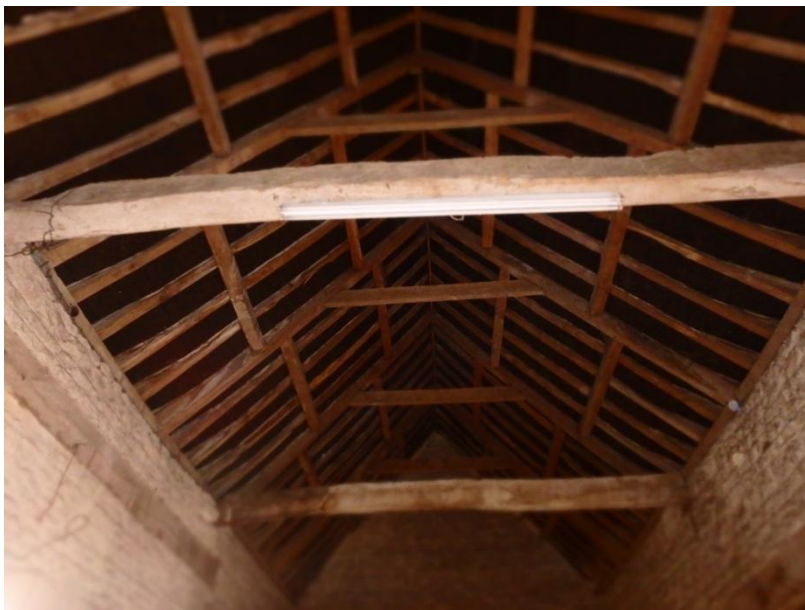
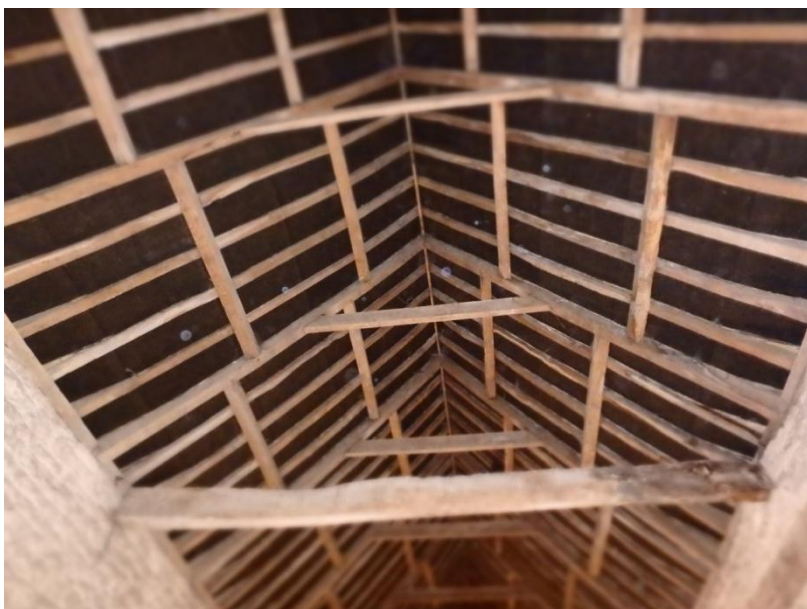
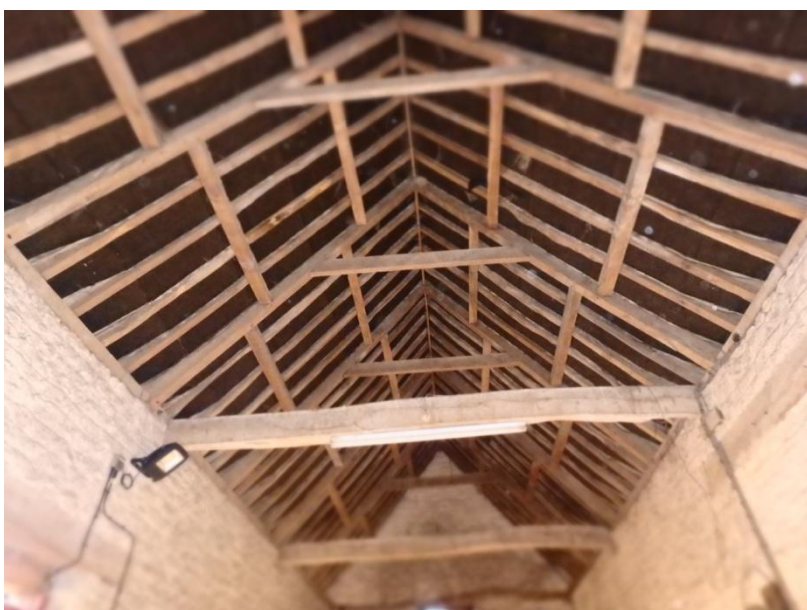
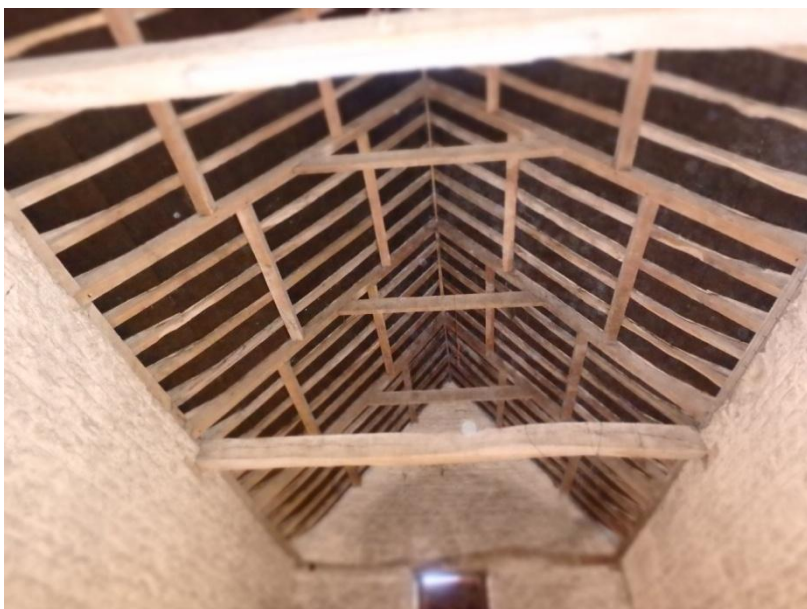
**Plates 77-82** provide various detailed views of the roof supporting structure of Cell 3. Along the tops of both the north and south walls are a series of horizontal timber wallplates. A series of substantial horizontal tie beams are inserted in the wall fabric of both the north and south walls. The main component parts of this roof supporting structure comprises a series of simple roof trusses which consist of principal rafters to either side with connecting horizontal timber collars. The remainder of this roof supporting structure is composed of a framework of common rafters and horizontal purlins.

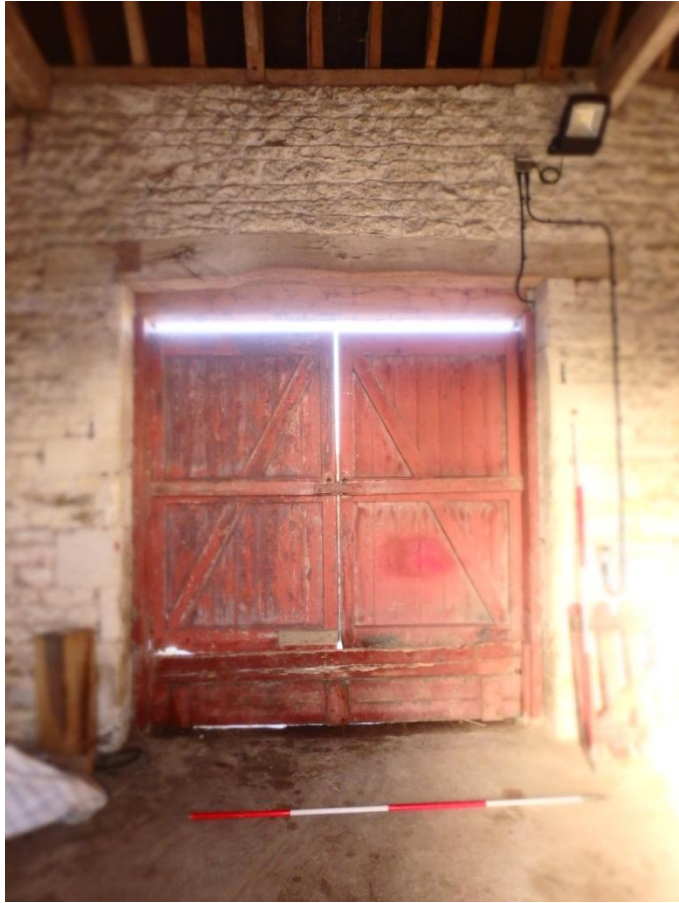
**Plate 84: View of the north facing entrance of Cell 3, from the south**

**Plate 84** shows in detail the north facing entrance to Cell 3, which was previously recorded on the opposing external North Elevation. This image features the inner face of this entrance with a substantial internal horizontal timber lintel above. To either side of the entrance are two vertical columns of worked, shaped and faced limestone quoins. The door frame is composed of timber

head with surrounds to either side. The double doors themselves are attached to an internal framework of angled, vertical and horizontal timbers.
