LEVEL II HISTORIC BUILDING RECORDING  
AT FRITH FARM,  
RYHALL ROAD,  
LITTLE CASTERTON, RUTLAND.

**National Grid Reference: TF 0200 1120**

*An historic building survey equivalent to English Heritage Level 2 of Units 2 and 3 at Frith Farm, Ryhall Road, Little Casterton, Rutland was undertaken by Neville Hall MIFA on the 23rd of January 2016.*

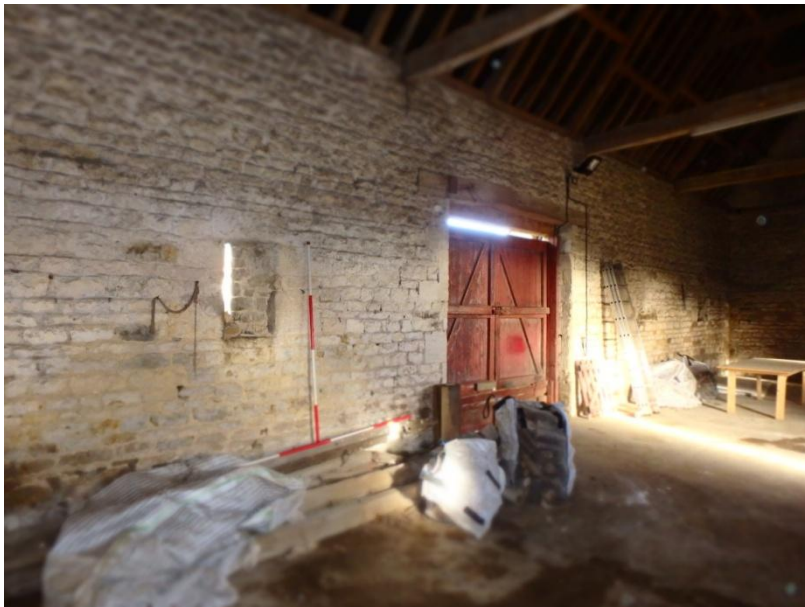
**Plate 85: View of the north wall of Cell 3, from the south-west**

**Plate 85** provides a view of the western portion of the north wall of Cell 3. The wall fabric here is as previously described for the eastern portion. There is a third vertical ventilation aperture or slit to the left (west) of the north facing entrance. This similarly, has a chamfered recess.

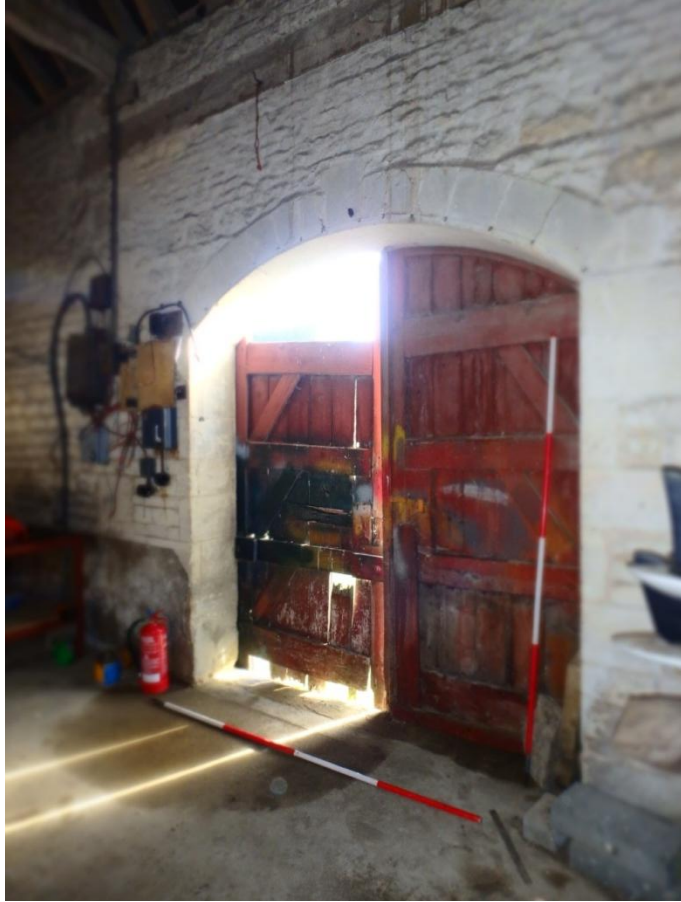
**Plate 86: View of the south facing entrance of Cell 3, from the north-west**

**Plate 86** features in detail the inner face of the south facing entrance of Cell 3. The inner face of the curved door head with central keystone matches that of the outer faced previously recorded on the opposing external South Elevation. To either side of the entrance are two vertical columns of worked, shaped and faced limestone quoins. There is no door frame with the hinges inserted directly into the stonework. The double doors are attached to an internal framework of angled and horizontal timbers.

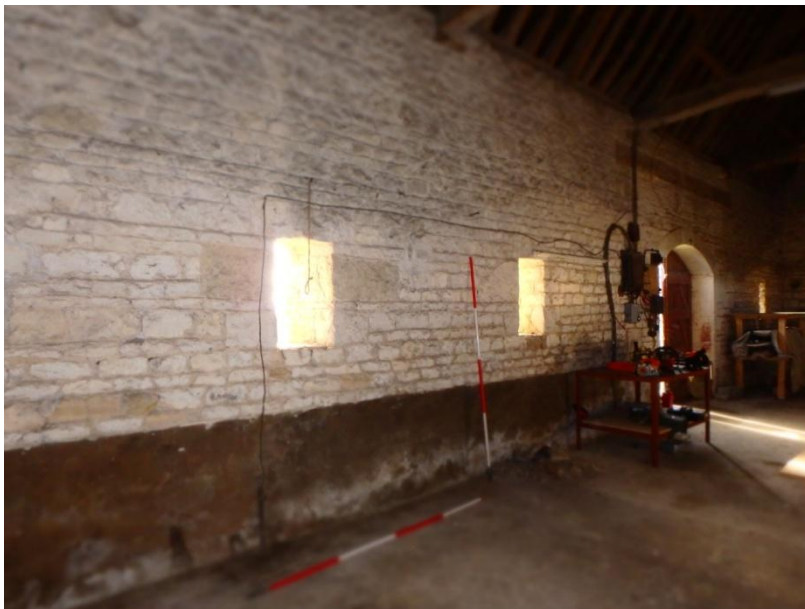
**Plate 87: View of the south wall of Cell 3, from the north-east**

**Plate 87** provides a view of the eastern portion of the south wall of Cell 3. The lower levels of this wall have been rendered over with modern cement thus obscuring any underlying detail of the wall fabric. Above this the wall fabric is composed of courses of shaped and worked limestone blocks along with courses of worked, shaped and faced limestone ashlar, particularly towards the base of the wall with much evidence of modern repointing. In addition and to the left (east) of the south facing entrance are the inner faces of two vertical ventilation apertures or slits, which were previously recorded on the opposing external South Elevation are shown with internal chamfered recesses.

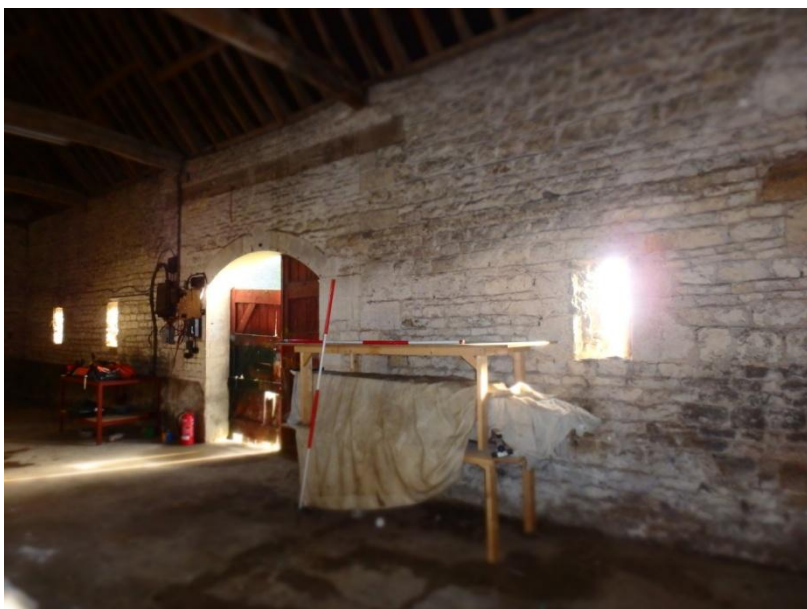
**Plate 89: View of the western portion of the south wall of Cell 3, from the north**

**Plate 89** features the western portion of the south wall of Cell 3. The wall fabric here is as previously described for the eastern portion though with the cement rendering being absent here. There is a third vertical ventilation aperture or slit to the right (west) of the south facing entrance. This similarly, has a chamfered recess.

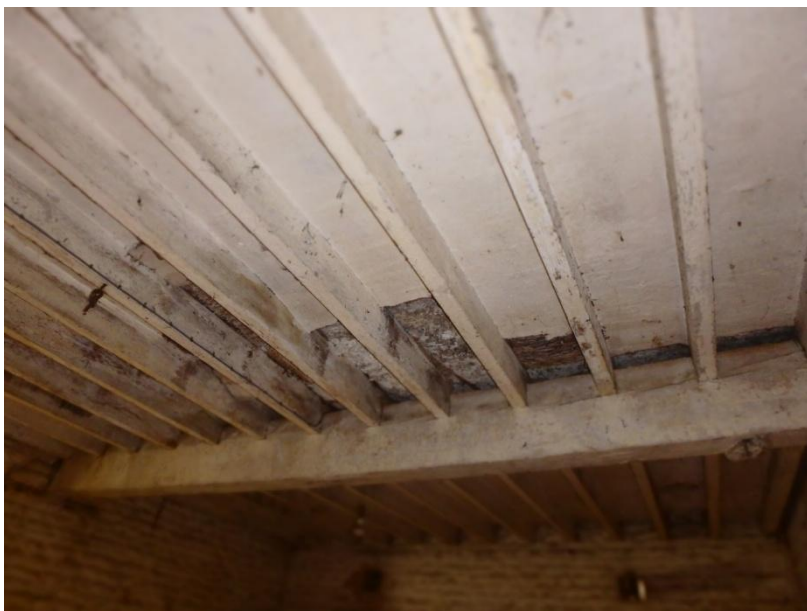
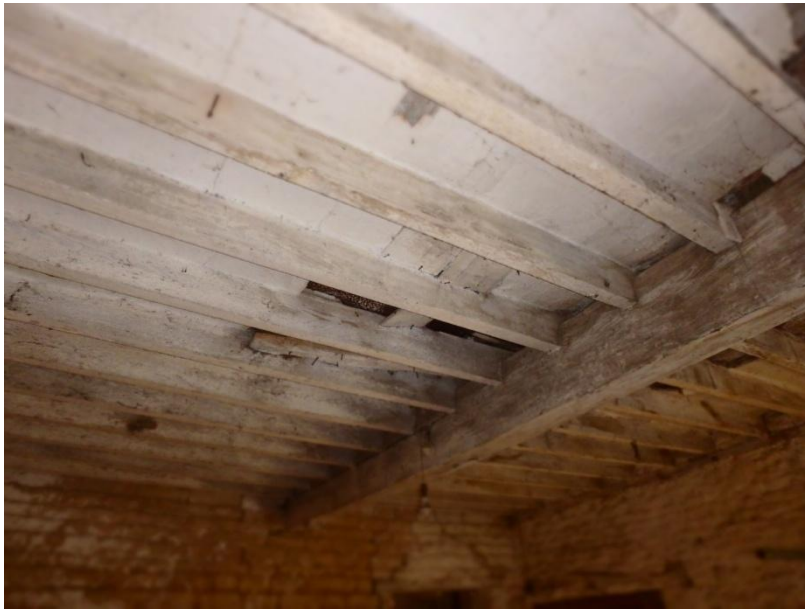
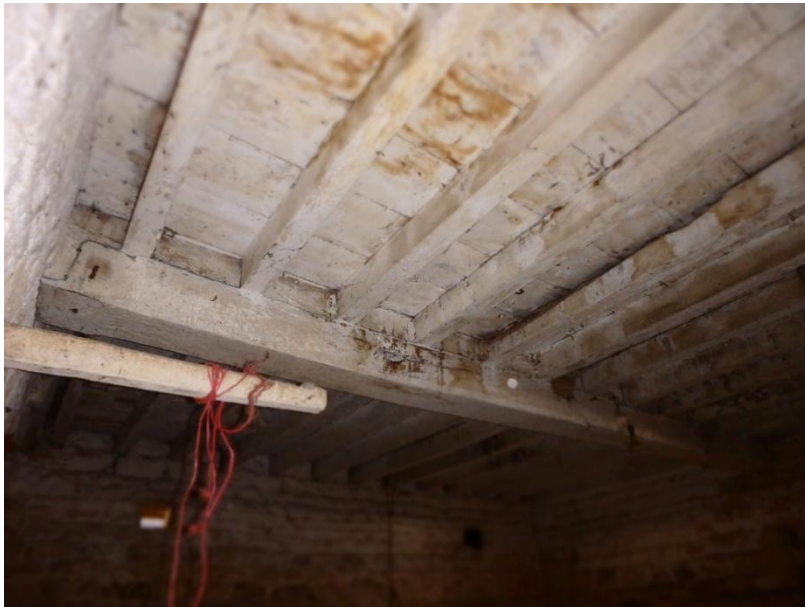
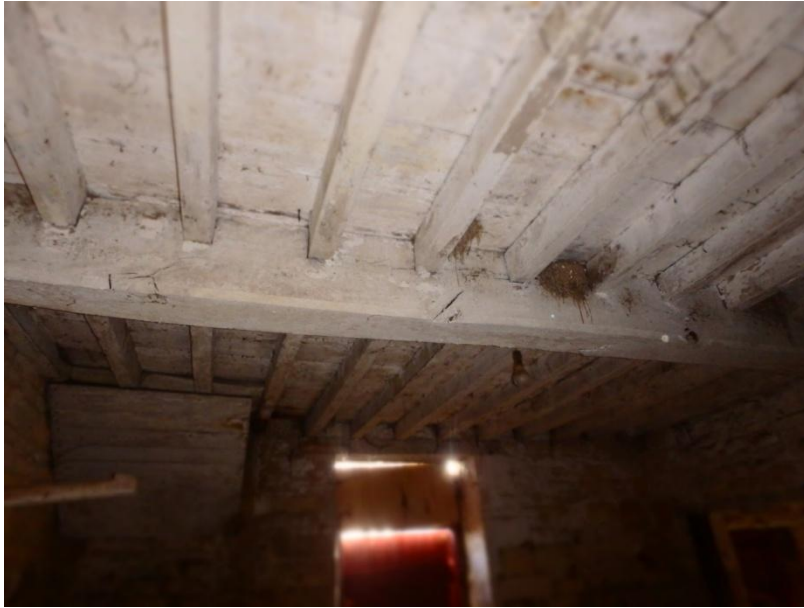
**Plates 90-93** provide detailed views of the ground floor ceiling of this room. The main component part of this is a north-south orientated substantial principal horizontal timber floor joist which is inserted in the wall fabric of the east and west walls. Attached in turn to this are a series of

horizontal secondary timber joists, the ends of which are affixed to two horizontal timber wallplates which extend along the tops of the north and south walls. To the secondary joists is attached the floor of timber planks. All parts of this ceiling have been painted white.

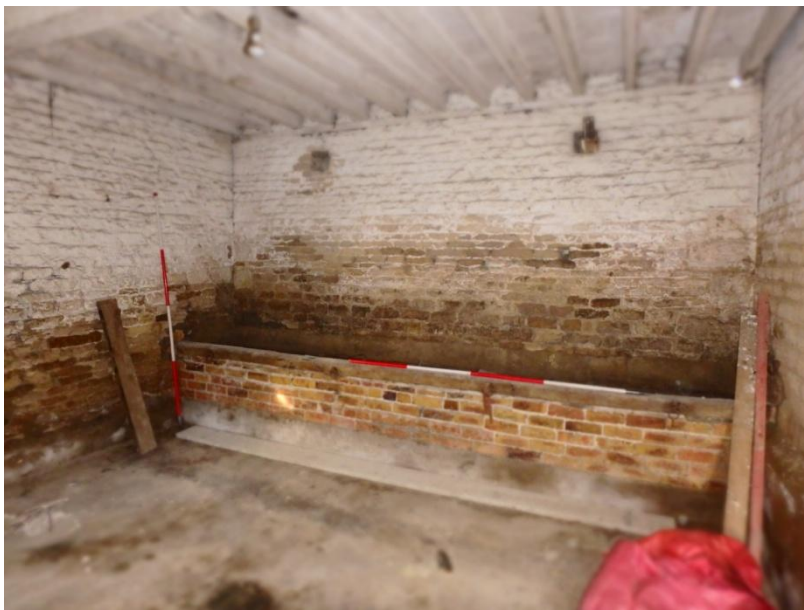
**Plate 94: View of the north wall of Room A, from the south**

**Plate 94** provides a view of the north wall of Room A. The wall fabric of this north wall is composed of courses of worked and shaped limestone blocks with the light buff sandy mortar bonding. The upper levels of this wall have been whitewashed over. At just below ground floor ceiling level are the inner faces of two rectangular shaped ventilation apertures which were previously recorded on the opposing external North Elevation. At the lower levels is a ceramic lined trough, which is constructed of courses of modern brick stretchers with occasional headers with cement rendering at the lower levels. Along the top of the trough is an horizontal timber. The floor of Room A is of modern concrete.

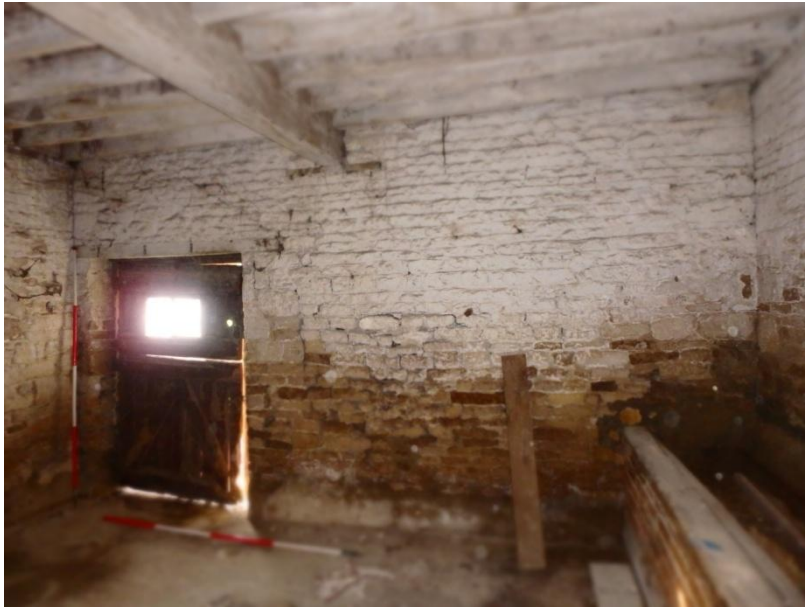
**Plate 95: View of the west wall of Room A, from the east**

**Plate 95** features the adjoining west wall of Room A which is an internal dividing wall of the ground floor of Cell 4. The wall fabric of this north wall is composed of courses of worked and shaped limestone blocks with the light buff sandy mortar bonding along with occasional shaped,

worked and faced limestone ashlar incorporated into this fabric. Much of this wall fabric has been whitewashed over. To the left (south) is the inner face of a door opening, which was previously recorded on the opposing external West Elevation of the North Range. There is an horizontal internal timber lintel above the opening. The two timber half doors are attached to an internal timber frame of angled and horizontal timbers.

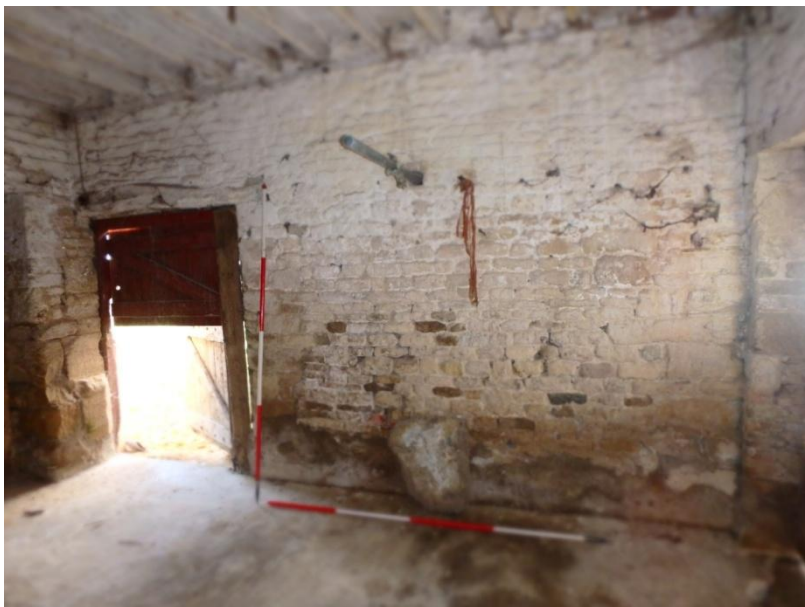
**Plate 96: View of the south wall of Room A, from the north**

**Plate 96** provides a view of the south wall of Room A. Much of this wall fabric has been whitewashed over. Where visible, the wall fabric of this south wall is composed of courses of worked and shaped limestone blocks with the light buff sandy mortar bonding along with occasional shaped, worked and faced limestone ashlar incorporated into this fabric. The very lowest levels of the wall have been rendered over with modern cement. The inner face of the south facing door opening, which was previously recorded on the opposing external South

Elevation of the North Range has an horizontal internal timber lintel above the opening. The two timber half doors are attached to an internal timber frame of angled and horizontal timbers.

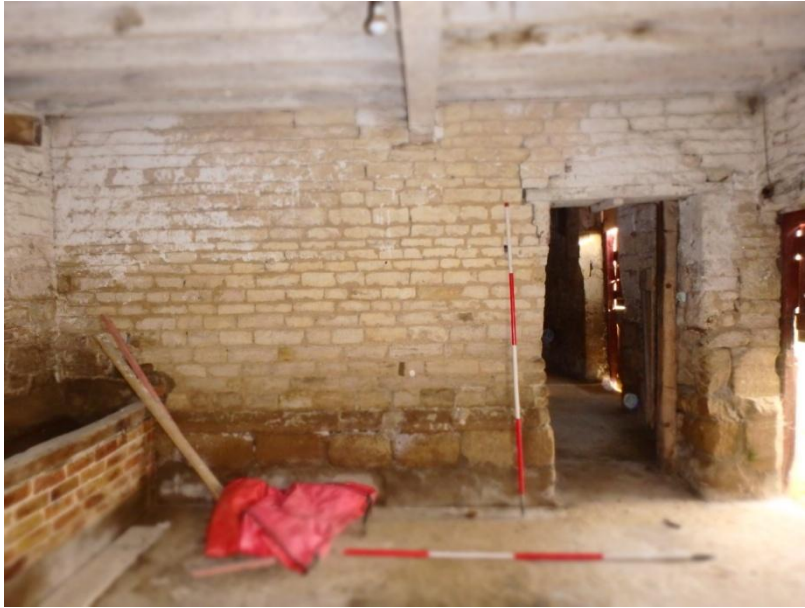
**Plate 97: View of the east wall of Room A, from the west**

**Plate 97** features the east wall of Room A. The wall fabric is composed of coursed worked and shaped limestone blocks with much evidence of modern repointing. This image is significant in that it features the lower levels of the original West Elevation of the North Range prior to the construction of the later Western Extension. This is attested to by the presence of the string course of the chamfered limestone foundation offset at the lower levels; below which are courses of worked, shaped and faced limestone ashlar to either side of the west facing internal door opening, which leads eastwards onto the adjoining Room B. This matches the corresponding foundation offsets on the North, East and South Elevation of the original building. This door opening appears to be a later insertion into this wall fabric contemporary with the construction of the later Western Extension. This is attested to by the crude insertion of several reused limestone ashlar to the right (south) of the door opening.

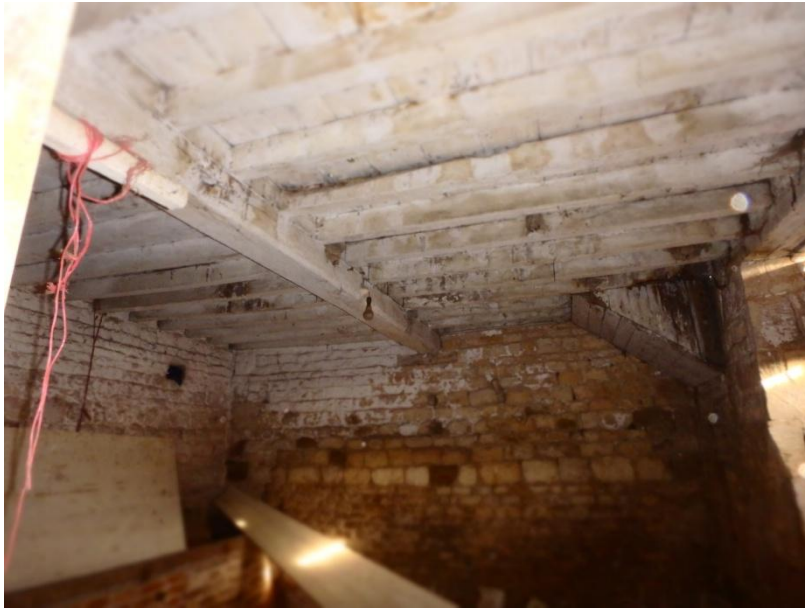
**Plate 98: View of the ground floor ceiling of Room B, from the west**

**Plate 98** features the ground floor ceiling of Room B. The structure of this ceiling is identical to that which was previously recorded within the adjoining ground floor Room A. The main component part of this is a north-south orientated substantial principal horizontal timber floor joist which is inserted in the wall fabric of the east and west walls. Attached in turn to this are a series of horizontal secondary timber joists, the ends of which are affixed to two horizontal timber wallplates which extend along the tops of the north and south walls. To the secondary joists is attached the floor of timber planks. All parts of this ceiling have been painted white.

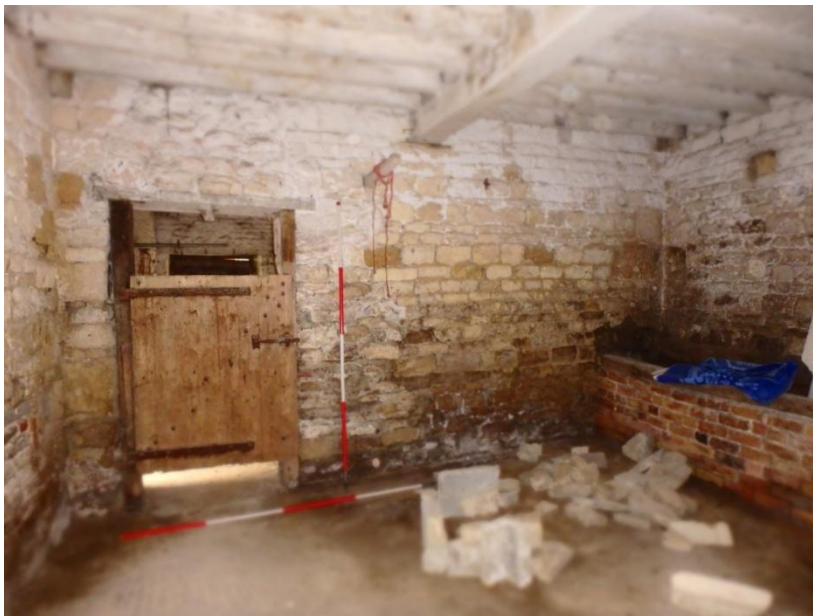
**Plate 99: View of the west wall of Room B, from the east**

**Plate 99** provides a view of the west wall of Room B which is an internal ground floor dividing wall between this room and Room A. This west wall is the inner face of the lower levels of the original West Elevation of the North Range discussed earlier. The wall fabric is of coursed worked and shaped limestone blocks along with courses of reused worked, shaped and faced limestone ashlar with the light buff sandy mortar. The upper levels of the wall have been whitewashed over. To the left (south) is a door opening, which appears to be a later insertion into this wall fabric contemporary with the construction of the later Western Extension. This is attested to by the crude insertion of several reused limestone ashlar to the left (south) of the door opening. The

door itself is composed of a series of vertical tongued and grooved timber planks which are in turn attached to an internal timber frame of angled and horizontal timbers. There are also two cast metal strap hinges to the left. The simple door frame consists of a head and surrounds and above the head is an horizontal timber lintel.

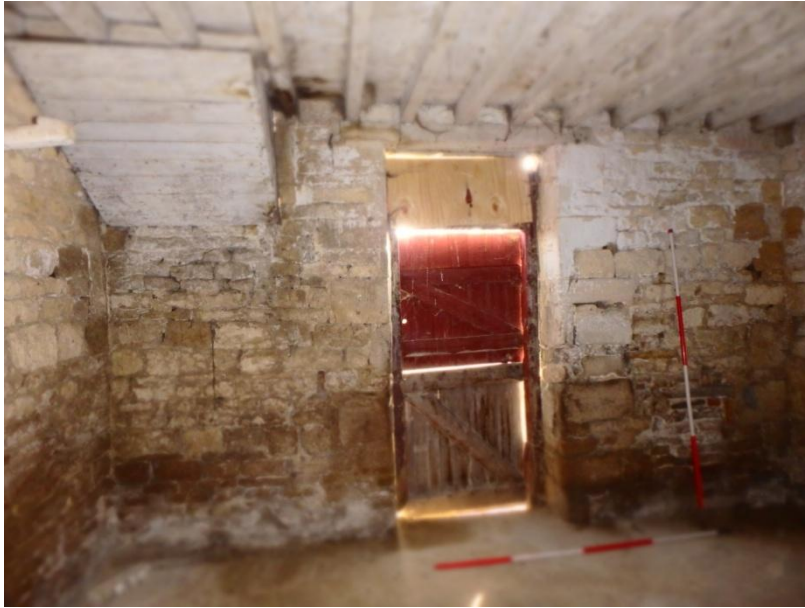
**Plate 100:** View of the south wall of Room B, from the north

**Plate 100** features the south wall of Room B. In the upper left of this image are the remains of the inner face of a stairwell which led from the outside to the first floor (Room D). This is composed of a series of horizontal timber planks which are attached to an internal timber frame. The wall fabric is composed of coursed worked and shaped limestone blocks along with courses of reused worked, shaped and faced limestone ashlar with the light buff sandy mortar. The upper levels of the wall have been whitewashed over. The inner face of the south facing door entrance previously recorded in the opposing external South Elevation is also featured. Above the door

opening is an internal horizontal timber lintel. The two timber half doors are attached to an internal frame of angled and horizontal timbers.

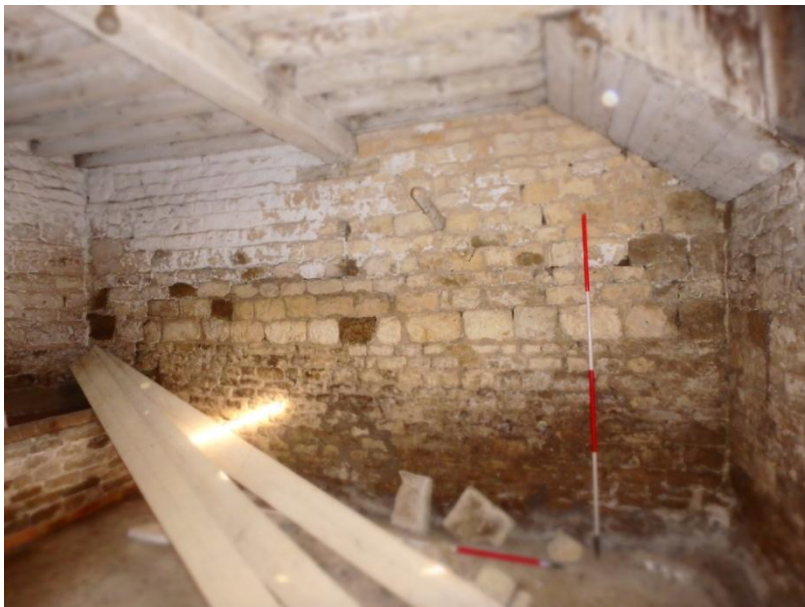
**Plate 101:** View of the east wall of Room B, from the west

**Plate 101** provides a view of the east wall of Room B, which represents the lower levels of the internal dividing wall between Cells 3 and 4. Part of the upper levels of this wall have been whitewashed over. The wall fabric is composed of coursed worked and shaped limestone blocks along with courses of reused worked, shaped and faced limestone ashlar with the light buff sandy mortar.

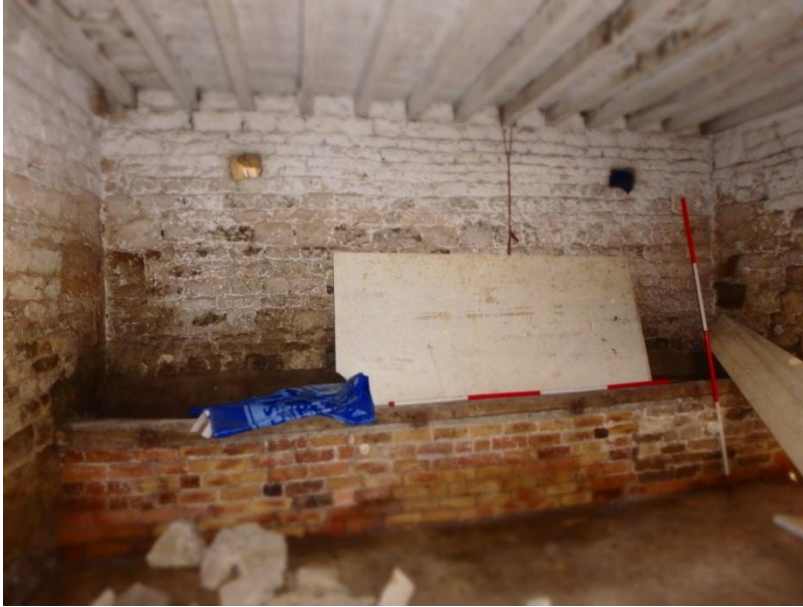
**Plate 102: View of the north wall of Room B, from the south**

**Plate 102** features the north wall of Room B. At the upper levels and just below the ground floor ceiling are two rectangular shaped ventilation apertures, which were previously recorded on the opposing external North Elevation. Much of the wall fabric has been whitewashed over. Where

visible, the wall fabric of this north wall is composed of courses of worked and shaped limestone blocks with the light buff sandy mortar bonding material. At the lower levels is a ceramic lined trough, which is constructed of courses of modern brick stretchers with occasional headers with cement rendering at the lower levels. Along the top of the trough is an horizontal timber. The floor of Room B is of modern concrete.

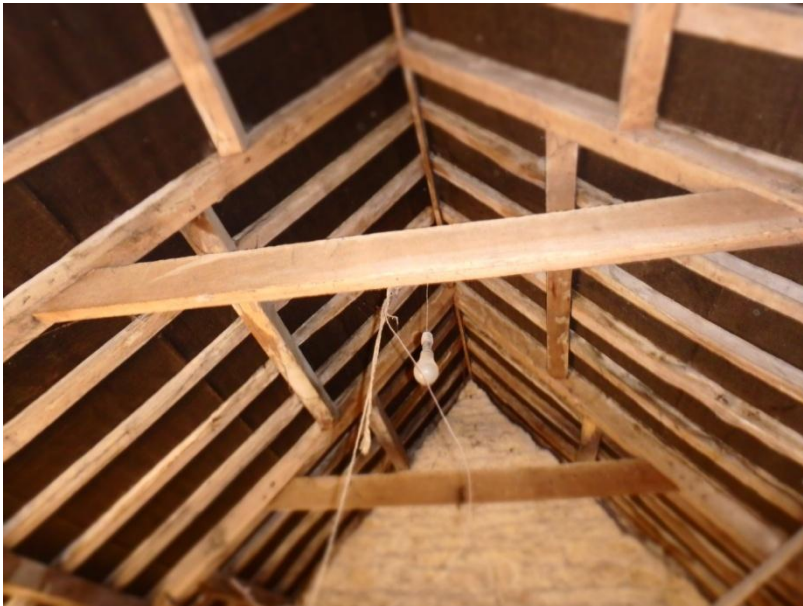
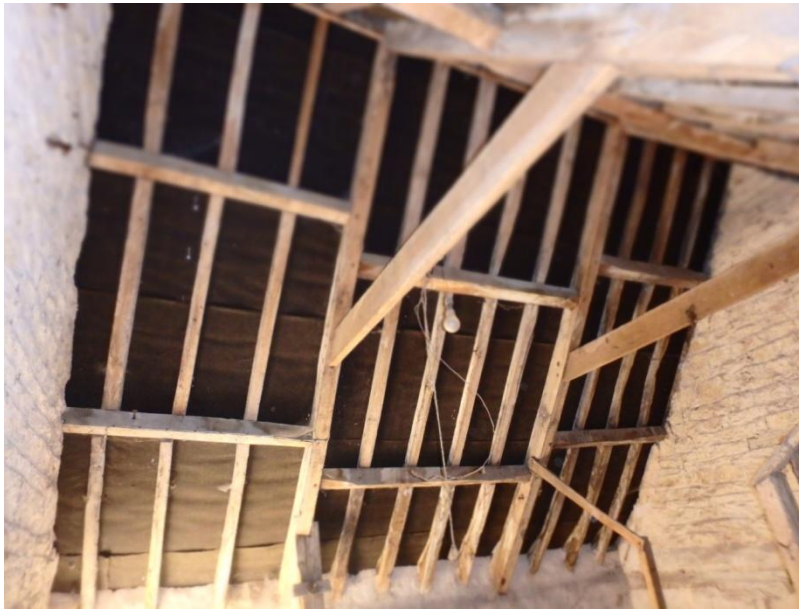
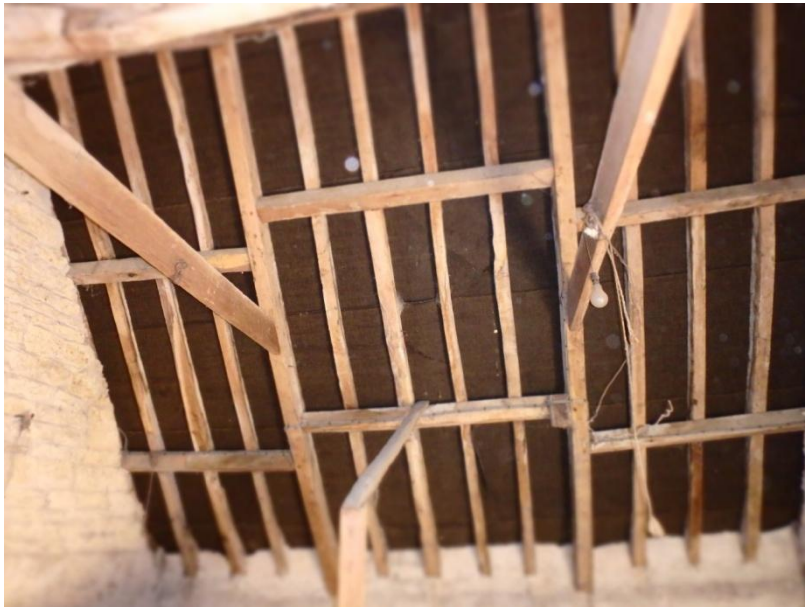
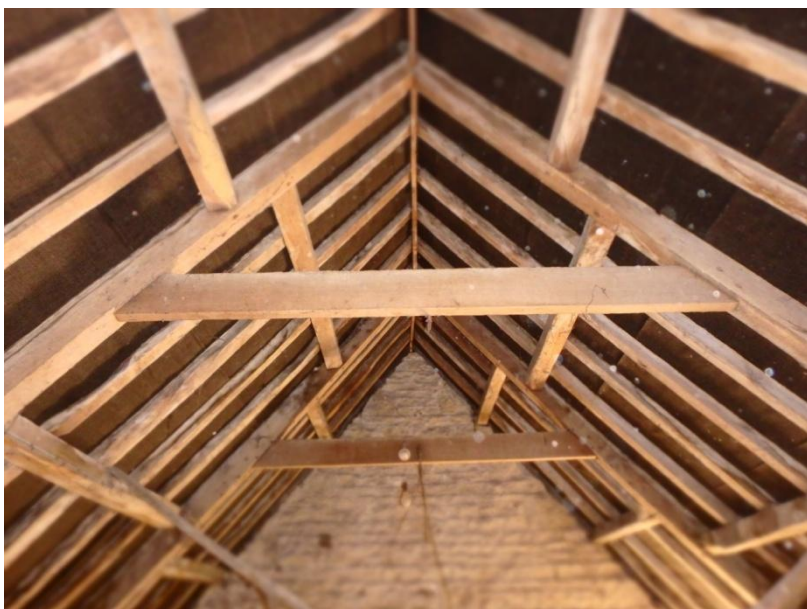
**Plates 103-106** provide detailed views of the roof supporting structure within Room D of Cell 4. This is similar in nature to that of the roof supporting structure within the adjoining Cell 1 of the North Range, though with the absence of the aforementioned substantial horizontal tie beams.

The main component parts of this roof supporting structure comprise two simple roof trusses which consist of principal rafters to either side with connecting horizontal timber collars. The remainder of this roof supporting structure is composed of a framework of common rafters and horizontal purlins. The purlins are also inserted into the wall fabric of the east and west walls. The rafters and principal rafters are inserted into the wall fabric of the north and south walls given the absence of wall plates here.

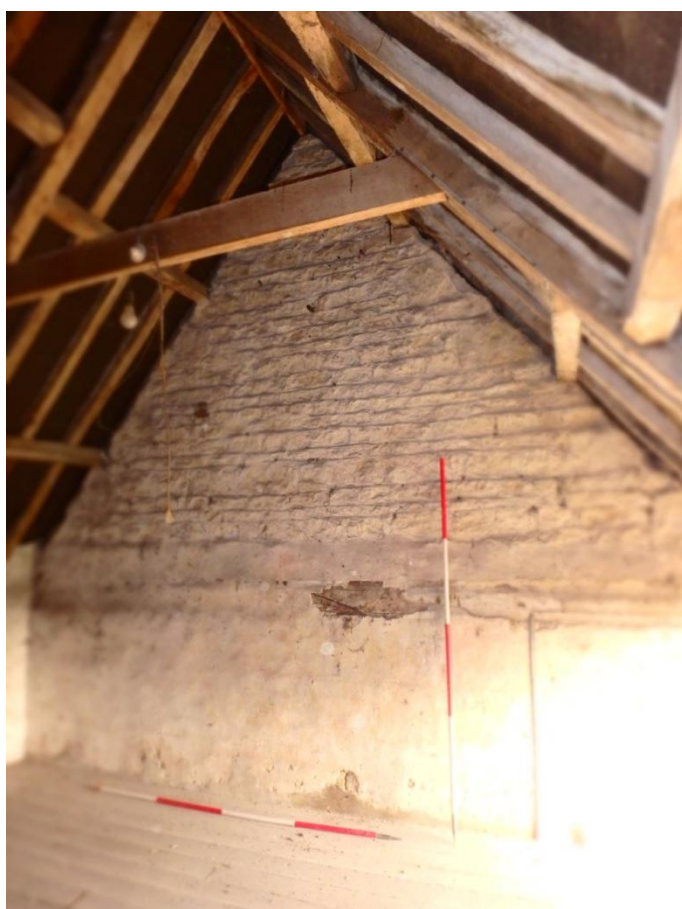
**Plate 107:** View of the east wall of Room D, from the west

**Plate 107** provides a detailed view of the east wall of Room D which comprises the upper levels of the internal dividing wall between Cell 4 and Cell 3 of the North Range. This wall fabric is composed of courses of worked and shaped limestone blocks and courses of worked, shaped

and faced reused limestone ashlar. The wall fabric has been covered over with whitewash whilst the lower levels have been rendered over with modern cement, obscuring underlying detail. The floor of Room D is of timber planks.

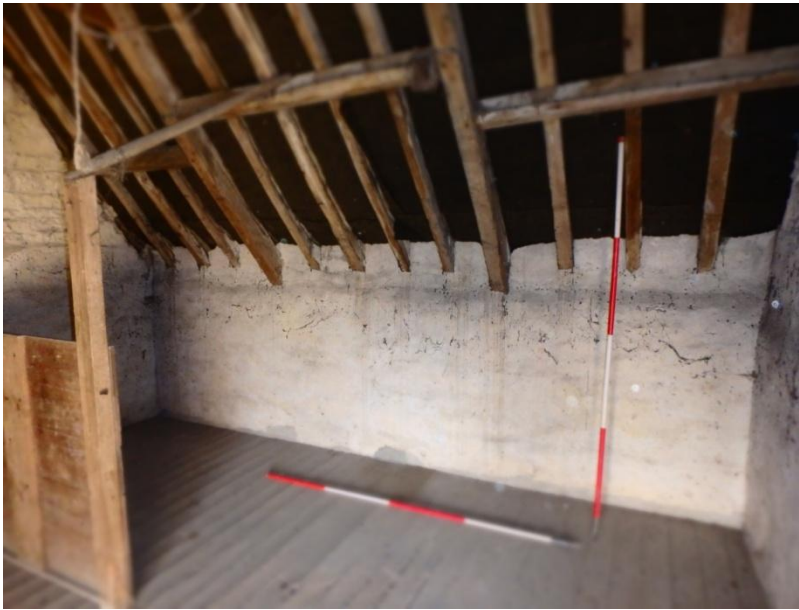
**Plate 108:** View of the north wall of Room D, from the south

**Plate 108** provides a view of the north wall of Room D. This wall has been rendered over probably with plasterwork or cement, which has in turn been whitewashed over. It can be also observed that the roof rafters are clearly inserted into the upper levels of this wall fabric, given the absence of a wallplate.

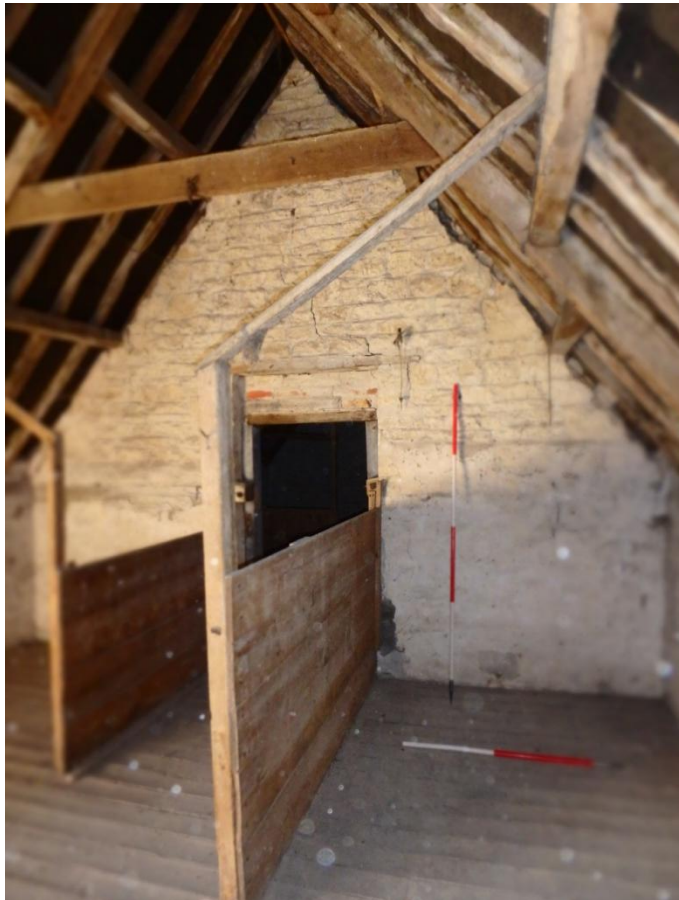
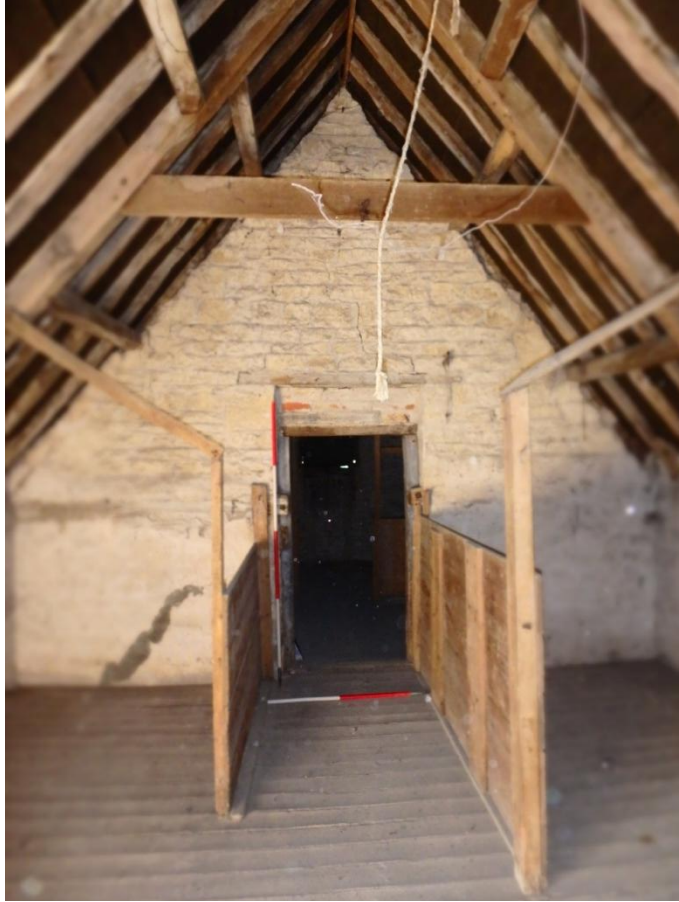
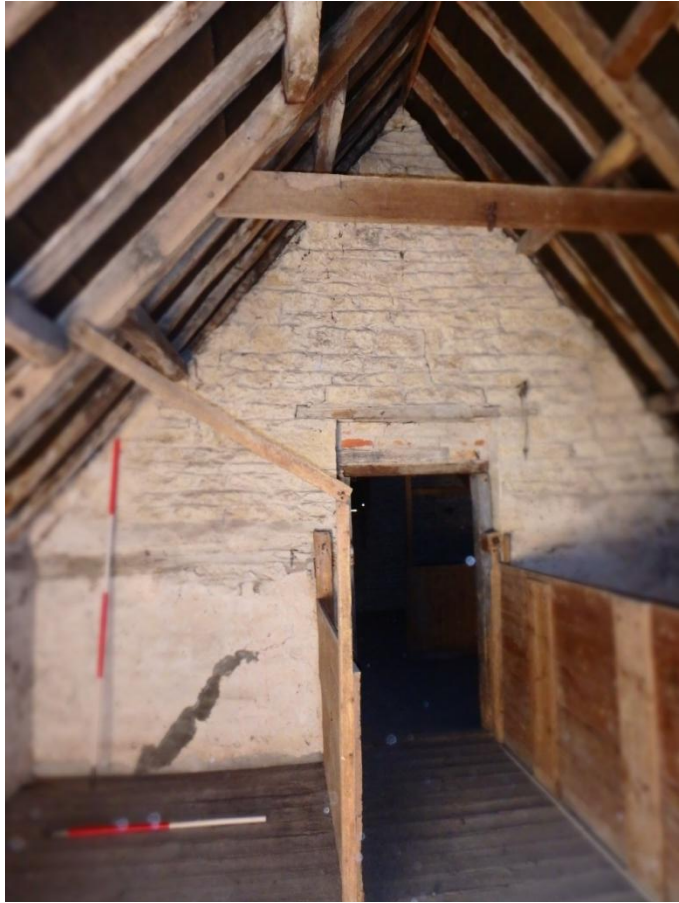
**Plates 109-111** provide various views of the west wall of Room D, which are the upper levels of the original West Elevation to the North Range and also provides the internal dividing wall between this room and Room C to the west. In the foreground are two timber stalls composed of a series of vertical planks which are attached to both the floor and also to frameworks of vertical and horizontal timbers. Both stalls are in turn attached to the roof structure by two further timbers. In the background is the west wall, the fabric of which is composed of courses of worked and shaped limestone blocks and courses of worked, shaped and faced reused limestone ashlar, which have been whitewashed over. The lower levels of this wall have been rendered over probably with plasterwork or cement, which has in turn been whitewashed over. There is in addition a central door opening, which consists of a simple frame of head and surrounds. Above the head are three courses of brick stretchers which are topped with a horizontal timber lintel. It would appear that the upper levels of this door opening have thus been infilled with brick and the height of the opening consequently lowered.

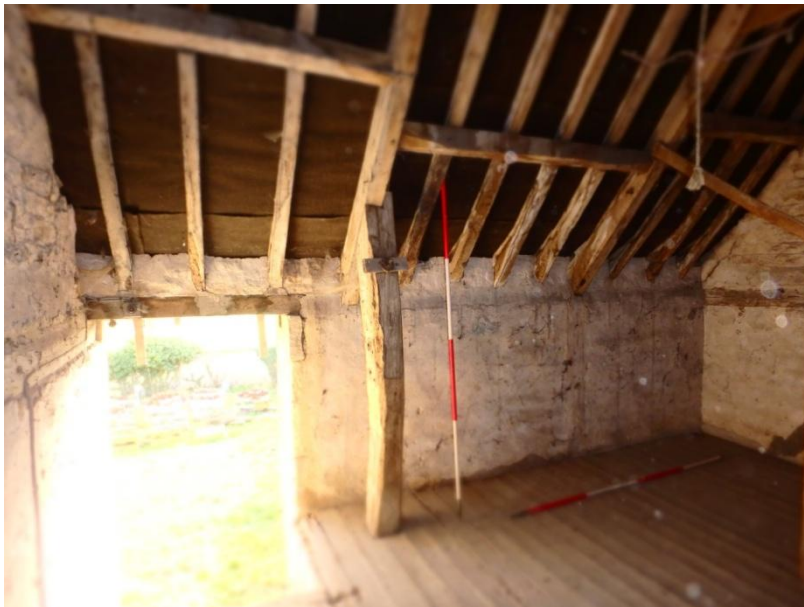
**Plate 112: View of the south wall of Room D, from the north**

**Plate 112** provides a view of the south wall of Room D. This wall has been rendered over probably with plasterwork or cement, which has in turn been whitewashed over. It can be also observed that the roof rafters are clearly inserted into the upper levels of this wall fabric, given the absence of a wallplate. To the left (east) is the opening which extended to the aforementioned and demolished former external stone stairwell of the South Elevation. There is an horizontal

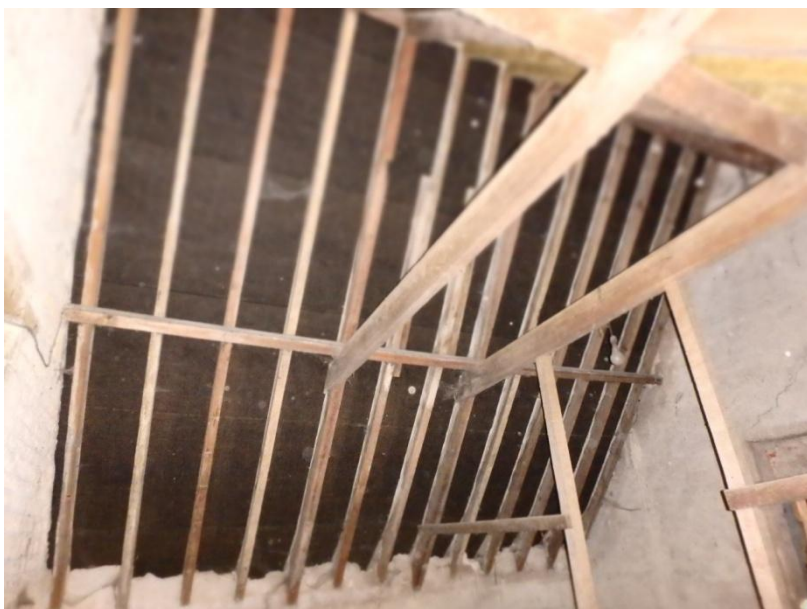
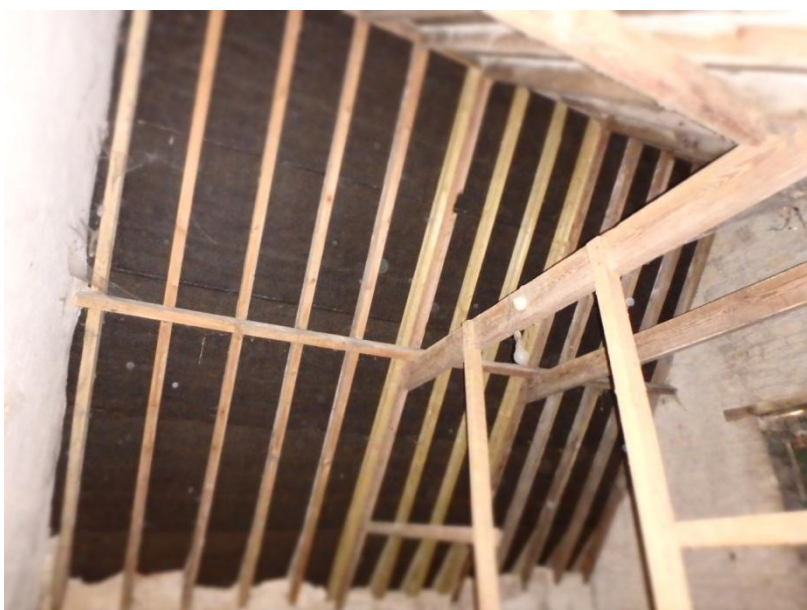
**Plates 113-116** feature in detail the nature of the roof supporting structure of this later Western Extension within Room C. This relatively simple roof supporting structure contrasts sharply with that of the earlier Cell 1 of the North Range. This later roof framework is composed of two principal and horizontal tie beams to which are attached a principal horizontal purlin to either side along with a series of common rafters which extends upwards to an horizontal apex timber. The rafters are inserted into the upper levels of the wall fabrics of the north and south walls given the absence of wallplates here and the principal purlins into the fabric of the east and west walls respectively.

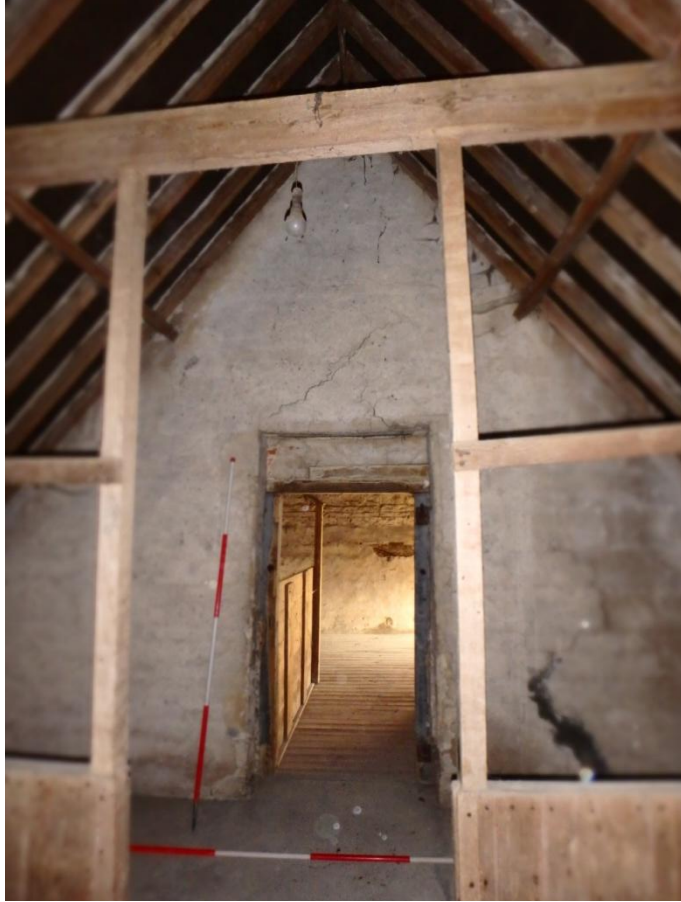
**Plate 117: View of the east wall of Room C, from the west**

**Plate 117** features the east wall of Room C. The fabric of this wall is composed of coursed worked and shaped limestone blocks and occasional limestone ashlar may also be discerned. However, this wall appears to have been rendered over with plasterwork or of cement, which has in turn been whitewashed over obscuring much of the underlying detail of the wall fabric.

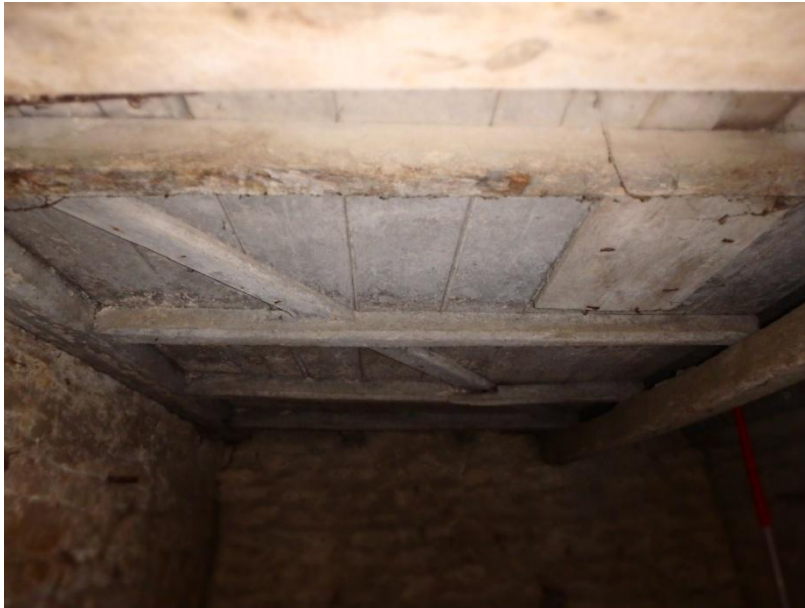
**Plate 124: View of the ceiling of Cell 5, from the west**

**Plate 124** features the 'ceiling' or mezzanine of Cell 5. This is constructed on an east-west orientated horizontal timber tie beam which extends across the length of Cell 5 and also to two wallplates which extend along the tops of the north and south walls of Cell 5. Inserted into the wallplates and attached to the tie beam are a series of horizontal timber floor joists upon which are attached a series of horizontal timber planks forming a 'floor'. **Plate 124** also features a portion of the north wall of Cell 5, which is composed of courses of shaped and worked limestone blocks, which have been whitewashed over.

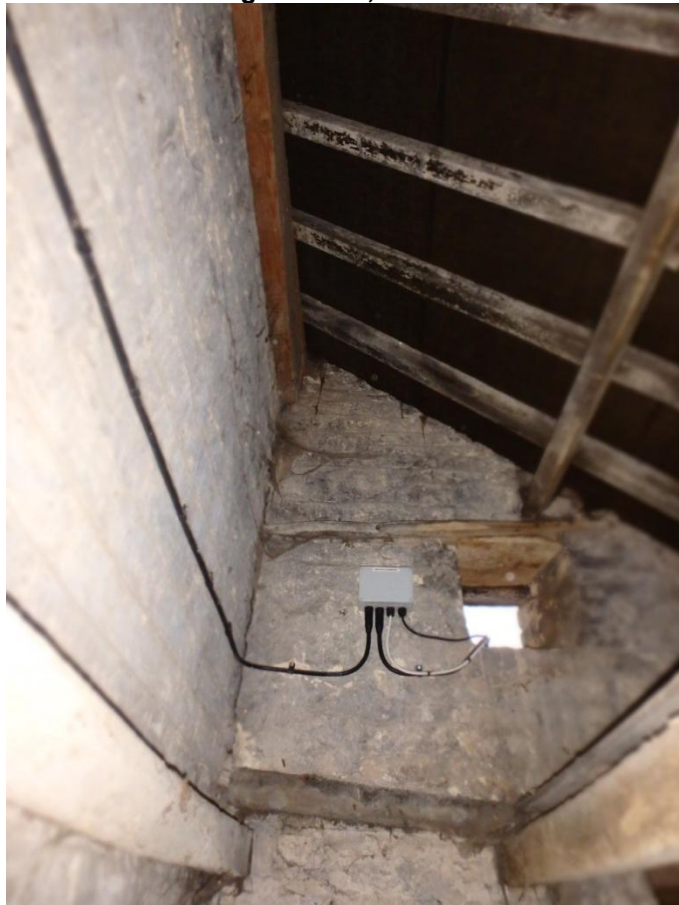
**Plate 125: View of the upper levels of the west wall of Cell 5, from the east**

**Plate 125** features the upper levels of both the west wall of Cell 5 and that of the North Elevation wall of the North Range. The fabric of both walls is composed of courses of shaped and worked limestone blocks, which have been whitewashed over. At the upper levels of the west wall is the inner face of a ventilation aperture which was previously recorded on the opposing external West Elevation of the Side Extension. There is an internal horizontal timber lintel above the aperture.

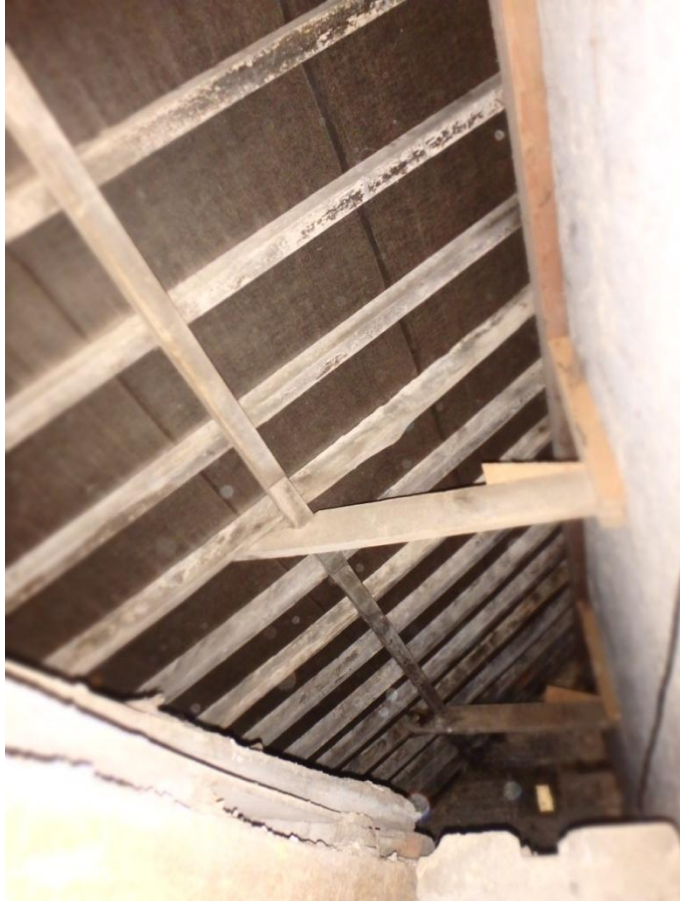
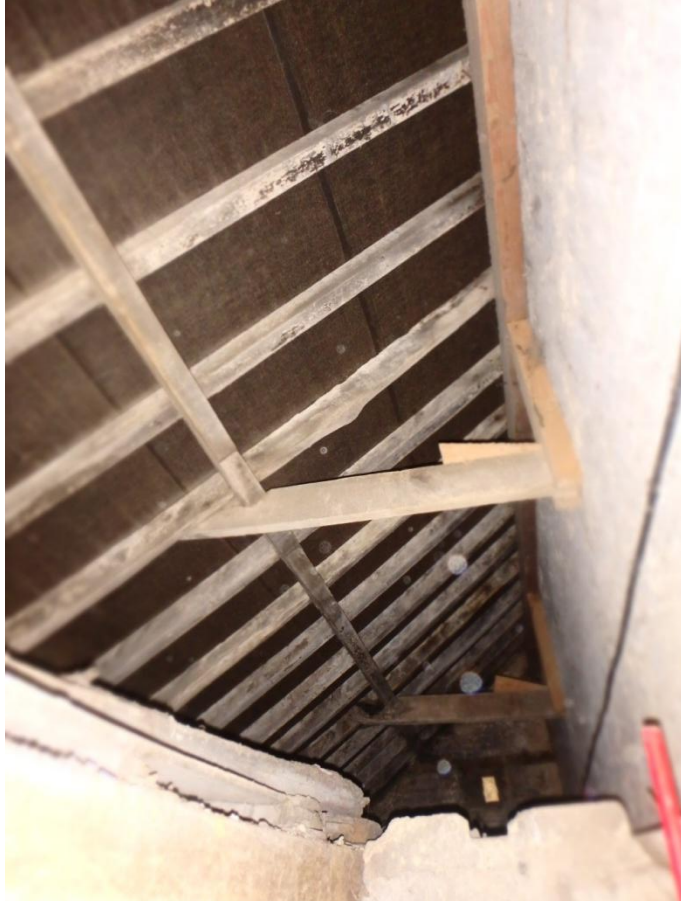
**Plates 126-127** provide views of the roof supporting structure of Cells 5 and 6 from the west. This half gabled roof structure is composed of one principal horizontal purlin and a series of common rafters which are attached to three short horizontal timber collars. These are in turn affixed to three short vertical timbers which in turn are attached to a horizontal timber wallplate which is affixed to the North Elevation wall. The principal purlin is inserted into the wall fabric of the west wall of Cell 5 and into the east wall of Cell 6 respectively. The rafters are attached to the wallplate in the north Elevation wall.
