LEVEL II HISTORIC BUILDING RECORDING  
AT FRITH FARM,  
RYHALL ROAD,  
LITTLE CASTERTON, RUTLAND.

**National Grid Reference: TF 0200 1120**

*An historic building survey equivalent to English Heritage Level 2 of Units 2 and 3 at Frith Farm, Ryhall Road, Little Casterton, Rutland was undertaken by Neville Hall MIFA on the 23rd of January 2016.*

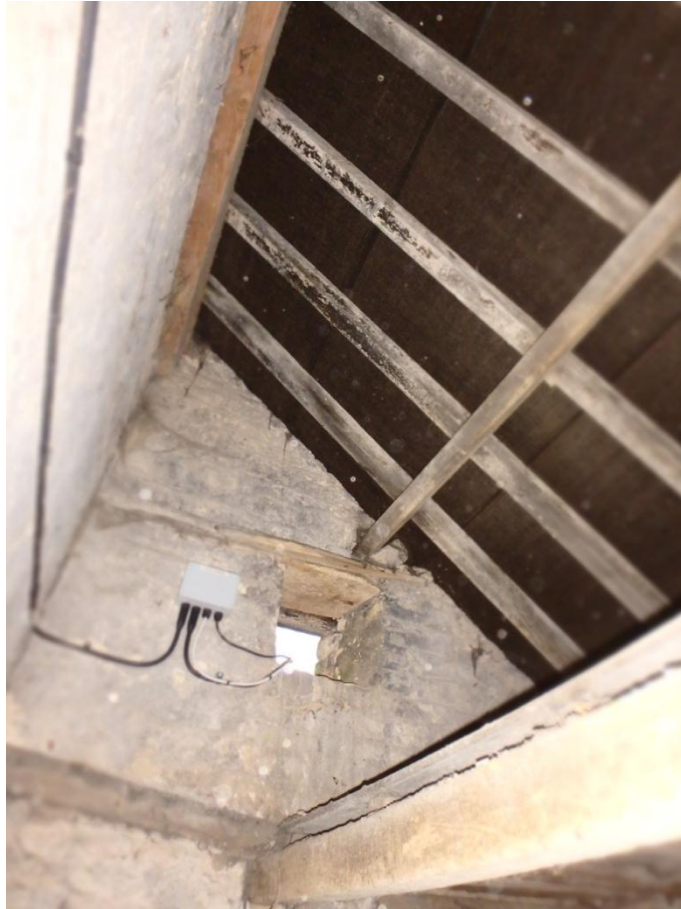
**Plate 128: View of the upper levels of the west wall of Cell 5, from the east**

**Plate 128** provides a further view of the upper levels of the west wall of Cell 5. The wall fabric is composed of courses of shaped and worked limestone blocks, which have been whitewashed over. At the upper levels of the west wall is the inner face of a ventilation aperture which was previously recorded on the opposing external West Elevation of the Side Extension. There is an internal horizontal timber lintel above the aperture.

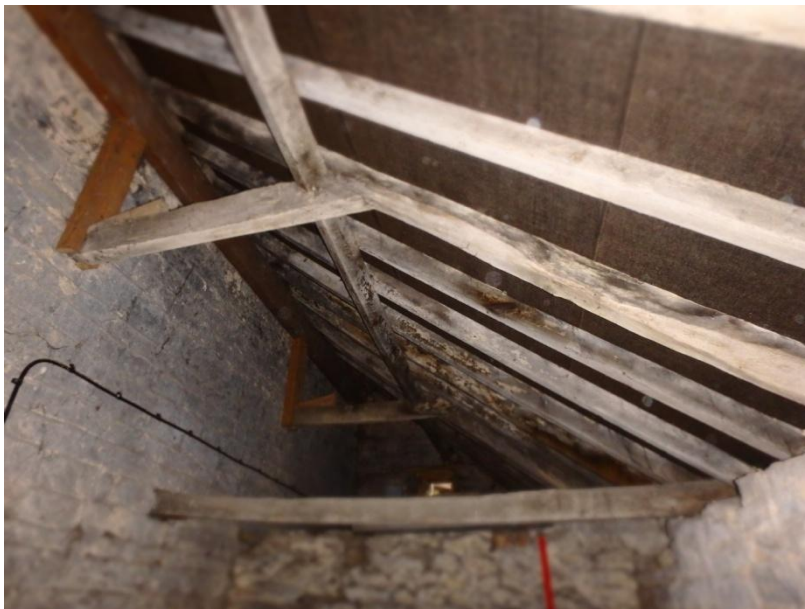
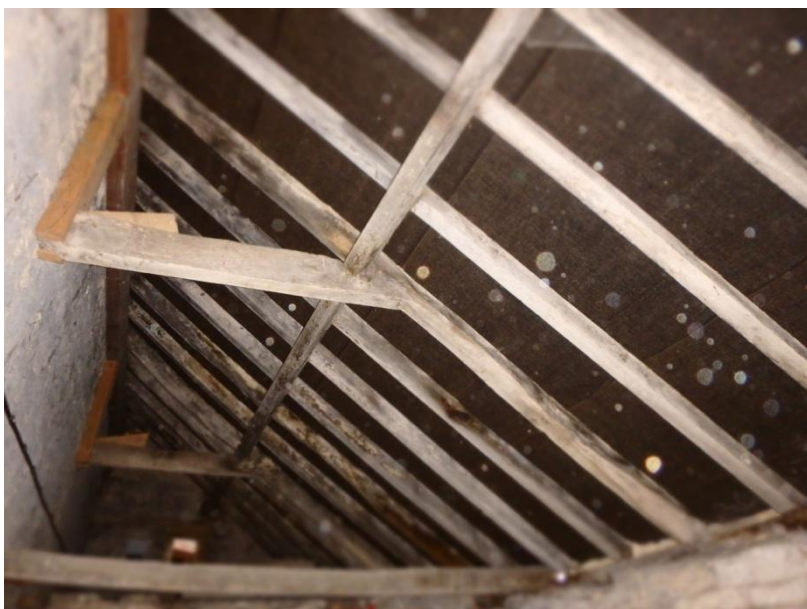
**Plates 130 and 131** provide further views of the roof supporting structure of Cells 5 from an eastern perspective. In the foreground is a second horizontal tie beam, which is orientated from north-south and which is inserted into the wall fabric of the North Elevation wall and into the opposing north wall of Cell 6. Above this is the half gabled roof supporting structure that is composed of one principal horizontal purlin and a series of common rafters which are attached to three short horizontal timber collars. These are in turn affixed to three short vertical timbers which in turn are attached to a horizontal timber wallplate which is affixed to the North Elevation wall. The principal purlin is inserted into the wall fabric of the west wall of Cell 5 and into the east wall of Cell 6 respectively. The rafters are attached to the wallplate in the North Elevation wall.

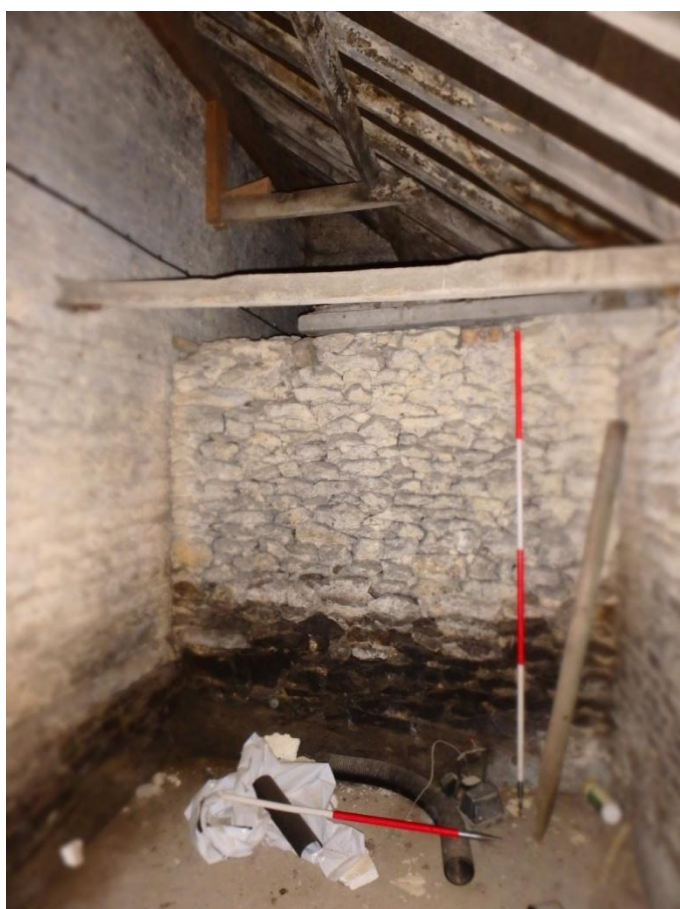
**Plate 132: View of the west wall of Cell 6, from the east**

**Plate 132** features the west wall of Cell 6. This is an internal dividing wall, which does not extend as far as the roof structure. The wall fabric is composed of courses of worked and shaped limestone blocks which have been whitewashed over. This wall does not appear to be bonded to the adjoining wall of the North Elevation, but abuts it.

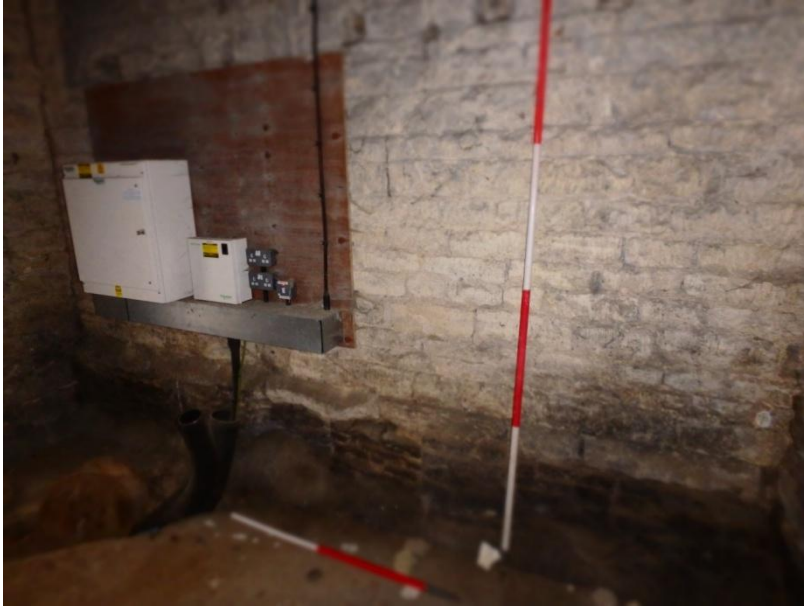
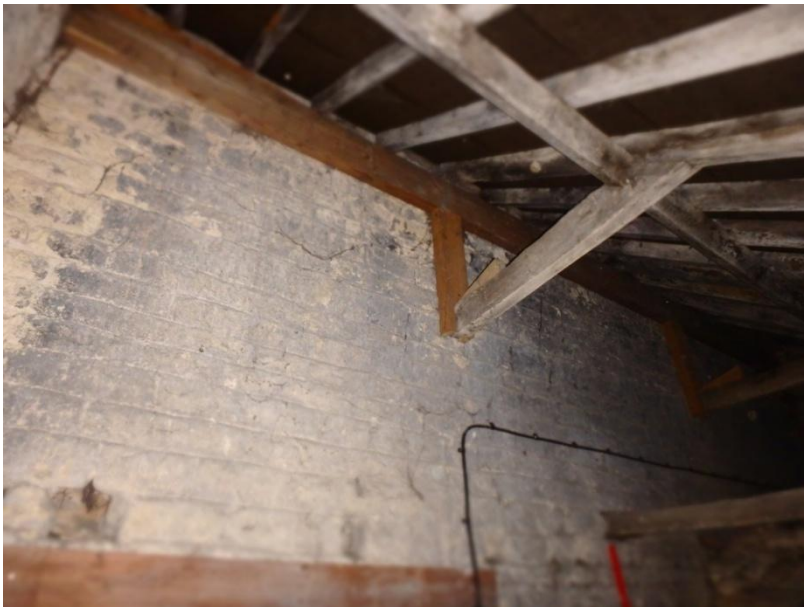
**Plate 133** features the lower levels of the wall of the North Elevation of the North Range. The chamfered foundation offset is once more featured along with the wall fabric which consists of the coursed worked and shaped limestone blocks which have been whitewashed over. **Plate 134** features the upper levels of this wall, into which is inserted elements of the roof supporting structure along with the aforementioned horizontal timber wallplate.

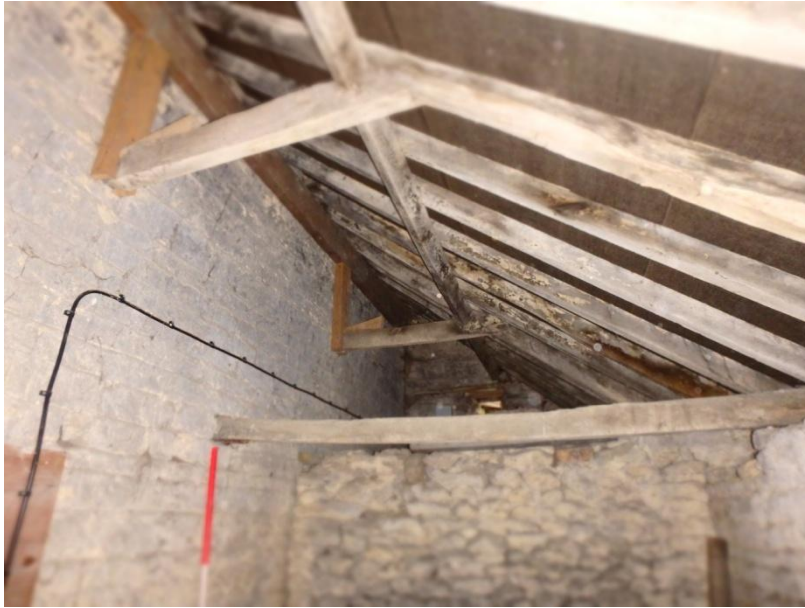
**Plate 135: View of the roof supporting structure of Cells 5-6, from the east**

**Plate 135** provides a further view of the aforementioned roof supporting structure of Cells 5 and 6 from the east

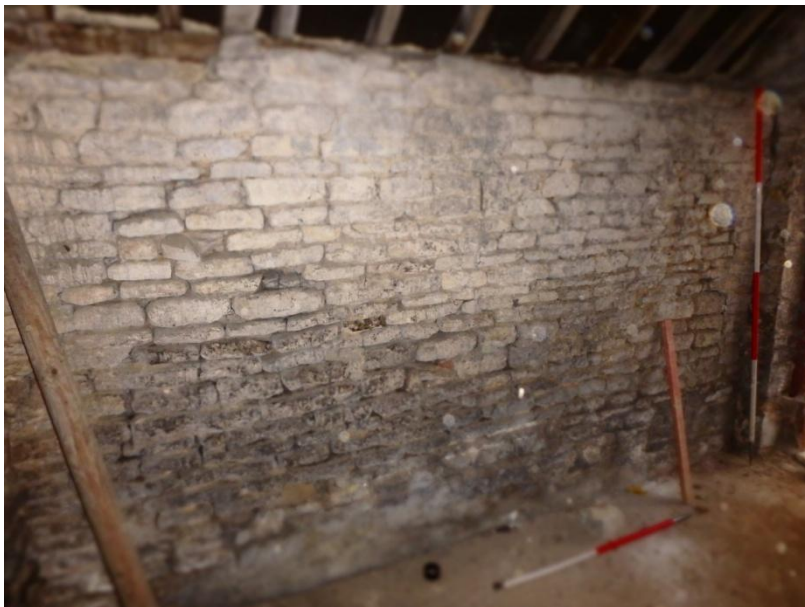
**Plate 136: View of the north wall of Cell 6, from the south-west**

**Plate 136** features the north wall of Cell 6 composed of courses of worked and shaped limestone blocks with the familiar light buff sandy mortar bonding material.

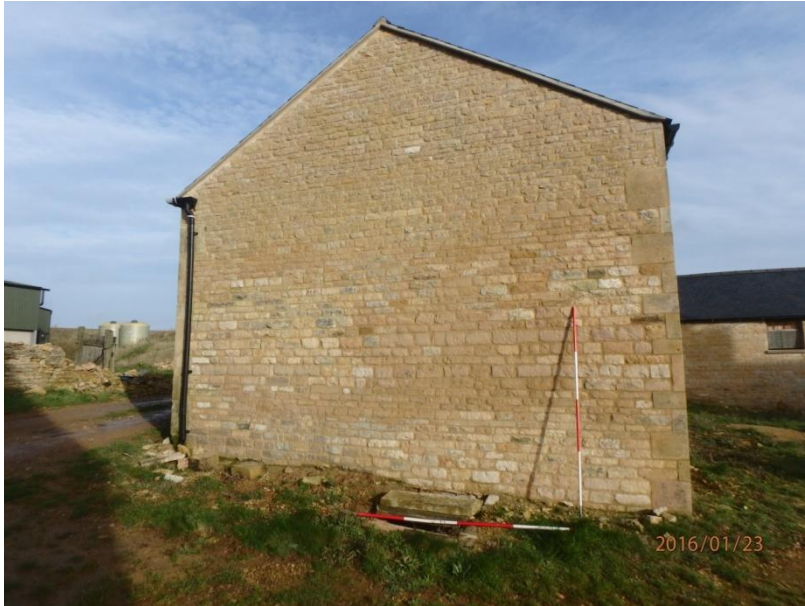
**Plate 138: View of the West Elevation of the North Range**

**Plate 138** features the West Elevation of this North Range. The wall fabric of this West Elevation is composed of courses of worked and shaped limestone blocks with much evidence of modern repointing. At either corner of the Elevation are two vertical columns of worked, shaped and faced limestone quoins along with a modern vertical Upvc downpipe at the northern end of this Elevation.

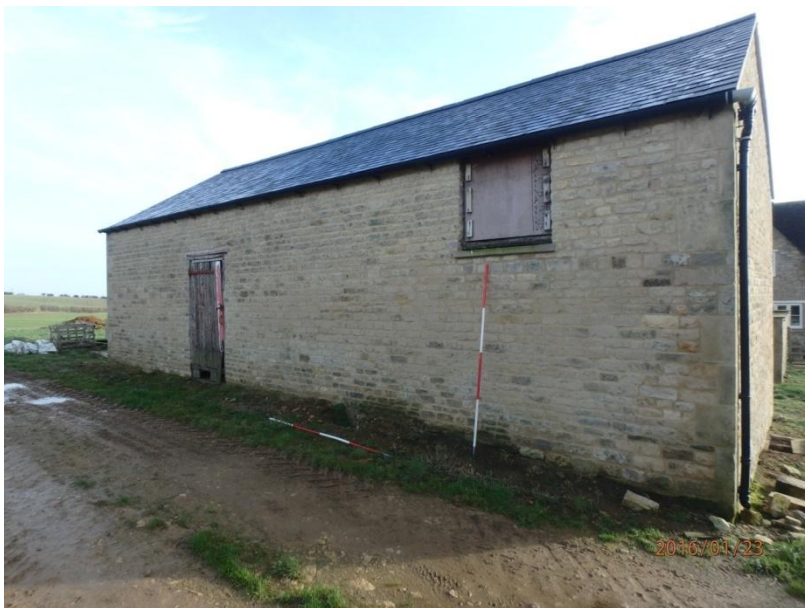
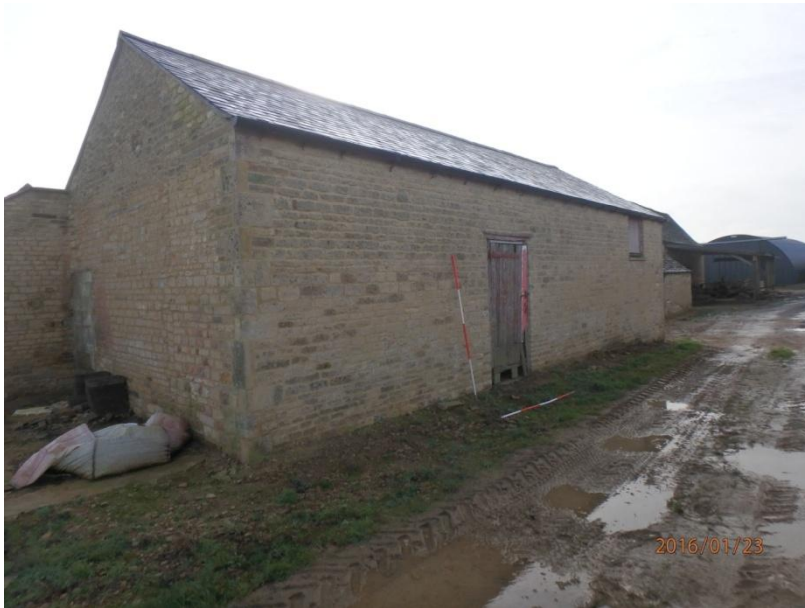
**Plates 139 and 140** provide images of the North Elevation of this North Range. The wall fabric of this North Elevation is composed of courses of worked and shaped limestone blocks with much evidence of modern repointing. At either corner of the Elevation are two vertical columns of worked shaped and faced limestone quoins. There is modern Upvc guttering at roof level.

At the western end of this Elevation is a window opening at just below roof level with a stone cill, which has also been boarded over. At the eastern end of this Elevation is a north facing door opening. The door itself is composed of a series of vertical tongued and grooved timber planks with two cast metal strap hinges to the left (east). There is a simple timber frame of head and surrounds with a horizontal timber lintel above the door head.

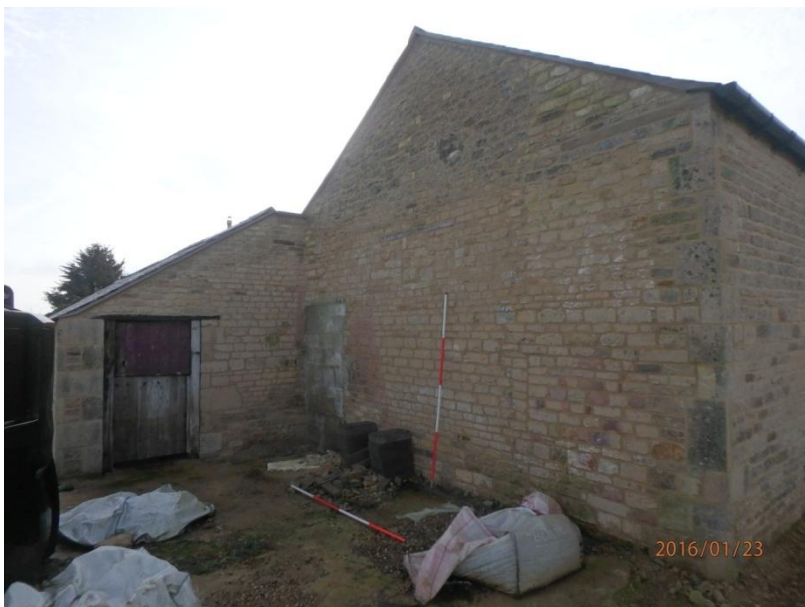
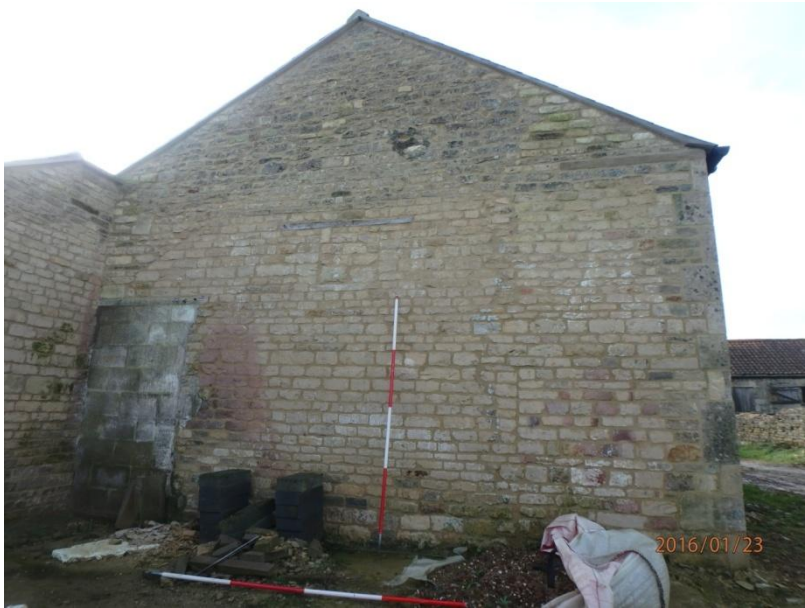
**Plates 141 and 142** both feature the East Elevation of this North Range. The wall fabric of this East Elevation is composed of courses of worked and shaped limestone blocks with modern repointing along with a vertical column of worked, shaped and faced limestone quoins at the northern end of this Elevation. To the left (south) is a former east facing door opening, which has been infilled with modern breeze block work.

To the right (north) of this and at the upper levels is a former window opening which is marked by an horizontal timber lintel with the infilling matching that of the surrounding wall fabric. Above this and clearly visible within the wall fabric of this East Elevation is the gabled roof line and a vertical division in the wall fabric which marks the location of a further single storey outbuilding, now demolished, which would have been situated to the east of this Elevation. To the north (right) of

this vertical division and towards ground level is a second infilled former window opening, the infilling similarly matching that of the surrounding wall fabric.

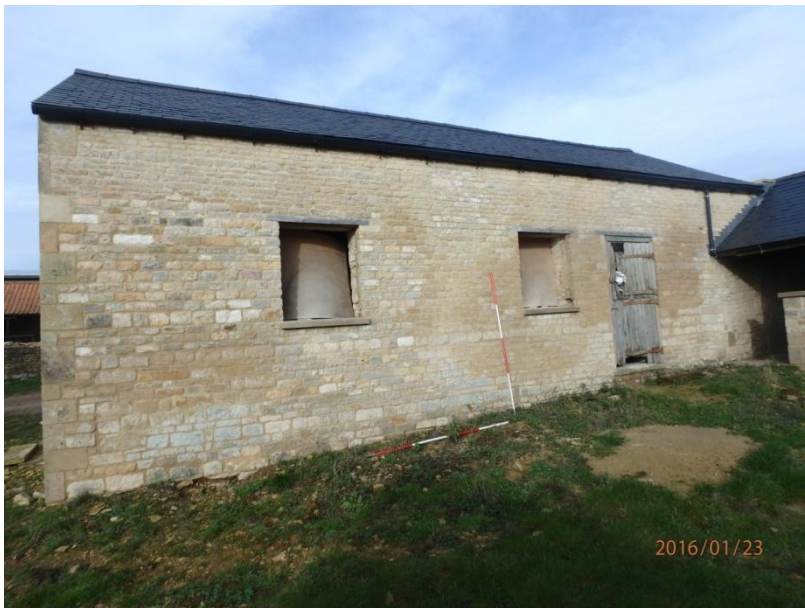
**Plate 143: View of the South Elevation of the North Range, from the south**

**Plate 143** features the South Elevation of this North Range. The wall fabric of this South Elevation is composed of courses of worked and shaped limestone blocks with modern repointing. Also visible is at least one course of reused worked, shaped and faced limestone ashlar with a column of worked, shaped and faced limestone quoins at the western end of this Elevation. There is modern Upvc guttering at roof level, which extends to a vertical modern Upvc downpipe at the eastern end of this Elevation.

Inserted into this wall fabric are two south facing window openings which have been boarded over. Both have modern stone cills and horizontal timber lintels. To the right (east) is a south

facing door opening. This is composed of two timber half doors of a series of vertical tongued and grooved timber planks with four cast metal strap hinges to the right (east). There is a simple timber frame of head and surrounds with a stone threshold and an horizontal timber lintel above the door head.

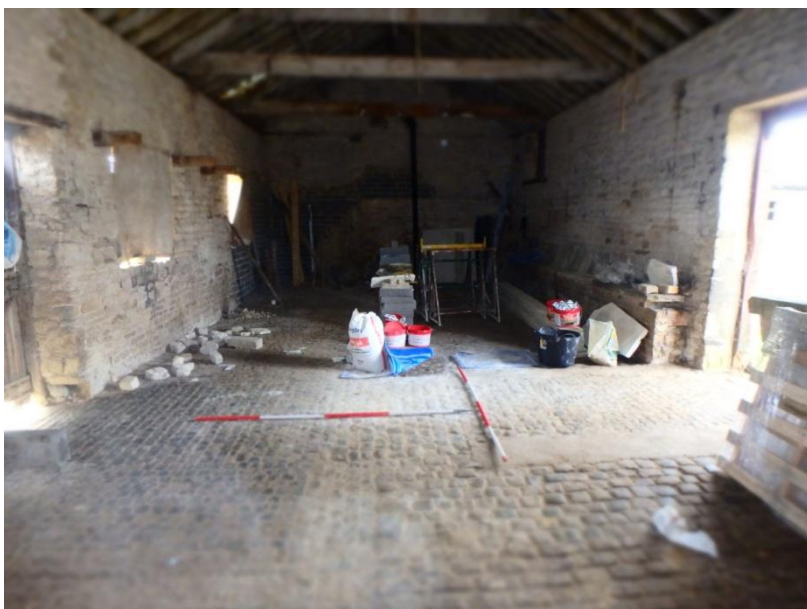
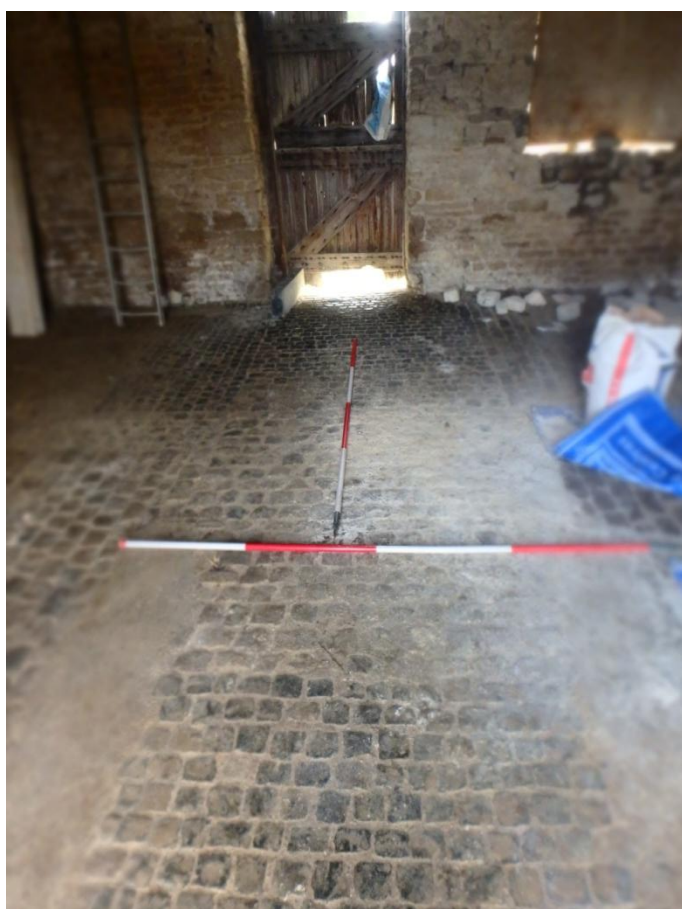
**Plates 144 and 145** provide images of the floor of the interior of the North Range which is composed of courses of stone cobbles or setts which are laid on bed within a series of decorative panels of different orientations.

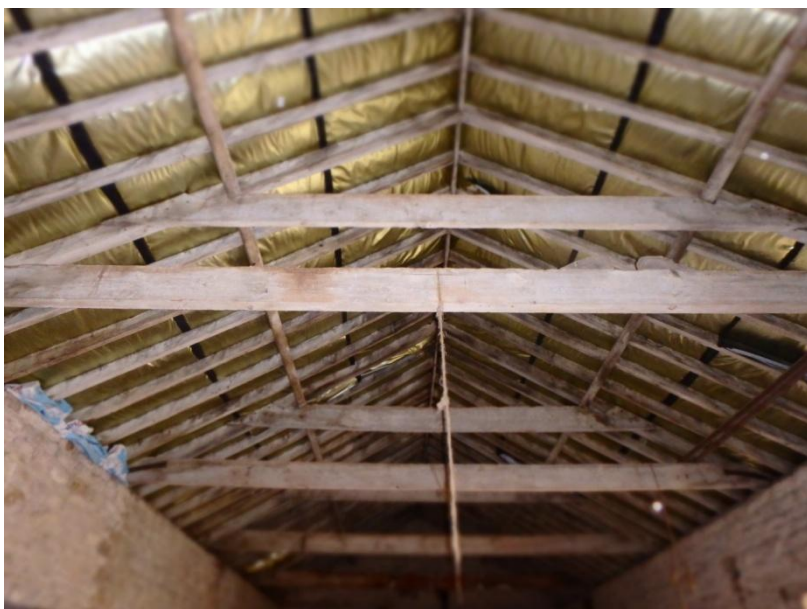
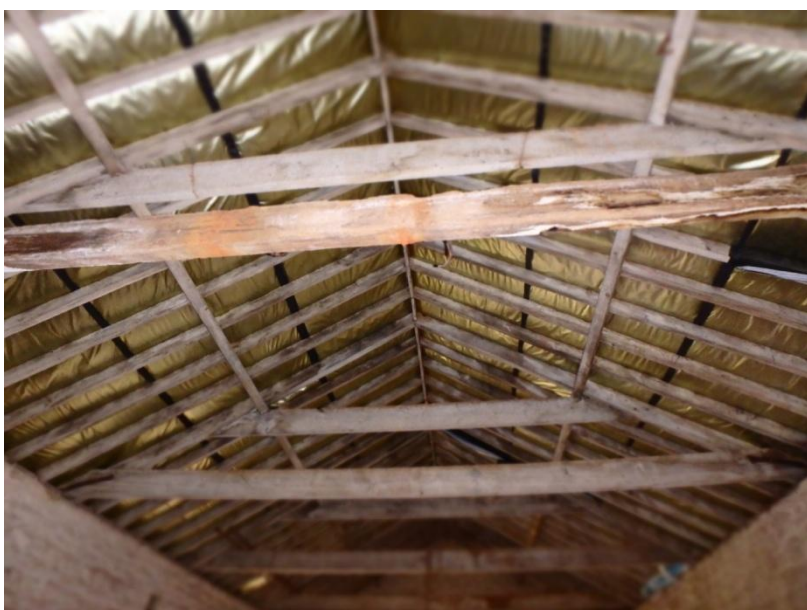
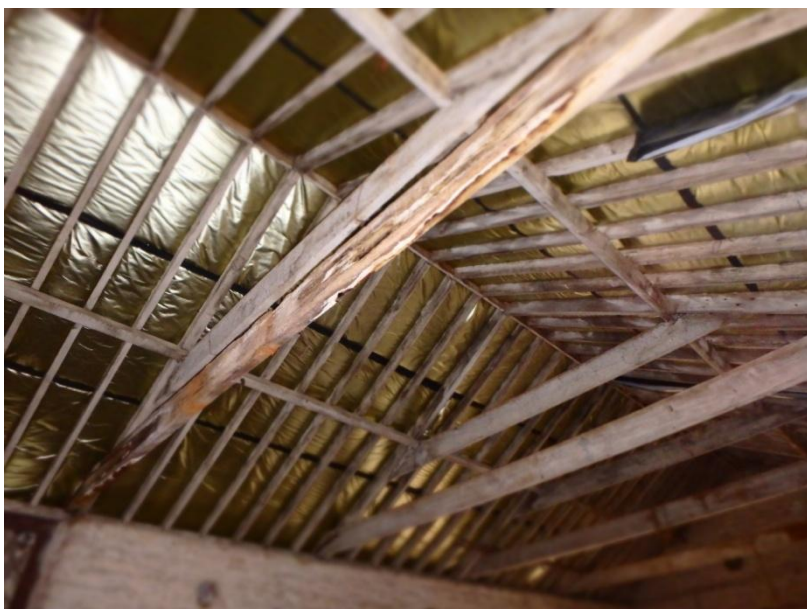
**Plates 146-149** provide various views of the roof supporting structure of the interior of this North Range. The main component part of this structure comprises three roof trusses which are composed in turn of principal rafters to which are attached three pairs of horizontal timber collars. The lower of these collars are also attached to the tops of the north and south walls and the upper collars to the principal rafters. The remainder of this roof structure is composed of a series of common rafters and two principal horizontal timber purlins to either side. The rafters extend upwards to horizontal roof apex timbers. The purlins are inserted into the fabric of the east and west walls.

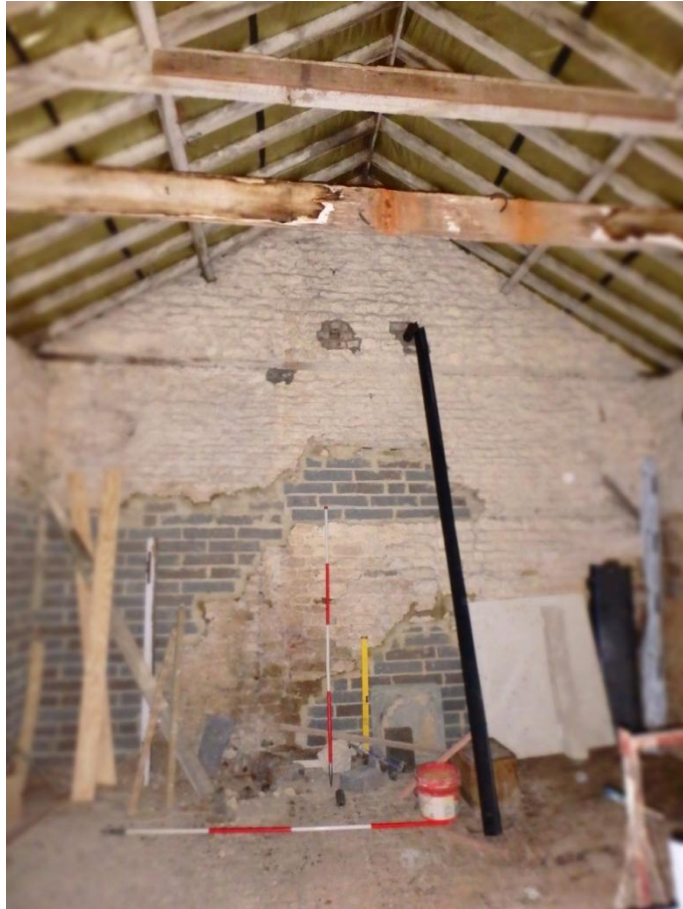
**Plate 150:** View of the west wall of the North Range, from the east

**Plate 150** provides a view of the west wall of the interior of this North Range. Much of this wall has been the subject of modern repair with breeze block work. The remainder of the wall fabric is composed of coursed worked and shaped limestone blocks which have been whitewashed over. There is in addition a modern steel brace supporting this wall and an horizontal timber wallplate at ceiling level.

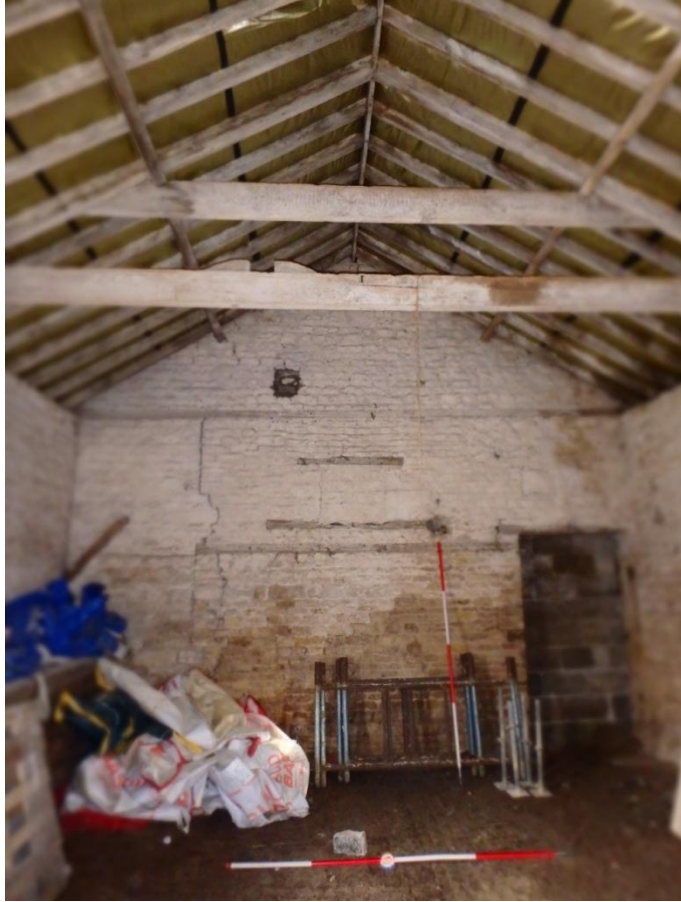
**Plate 152: View of the east wall of the North Range, from the west**

**Plate 152** features the east wall of the interior of this North Range. The wall fabric is composed of coursed worked and shaped limestone blocks. Much of this wall has been whitewashed over, but is absent from the lower levels revealing a bonding material of light buff sandy mortar. There is an

horizontal timber lintel at ceiling level. To the right (south) is the inner face of the breeze block infilled east facing door opening with internal horizontal timber lintel. To the immediate left (north) of this is a second horizontal timber which is incorporated into the wall fabric. Above this timber is the inner face of the former window opening which is denoted by a horizontal timber cill and horizontal timber lintel above this.

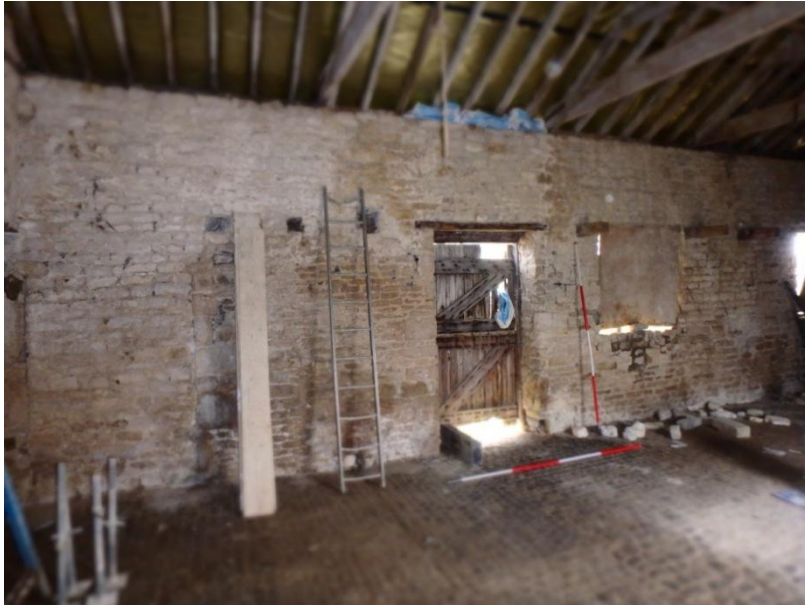
**Plate 154:** View of the eastern portion of the south wall of the North Range, from the north

**Plates 154 and 155** provide views of the south wall of the interior of this North Range. At the eastern end of this wall is further evidence of modern breeze block repair work. Otherwise the wall fabric is composed of coursed worked and shaped limestone blocks with some reused worked, shaped and faced limestone ashlar. Much of this wall has been whitewashed over,

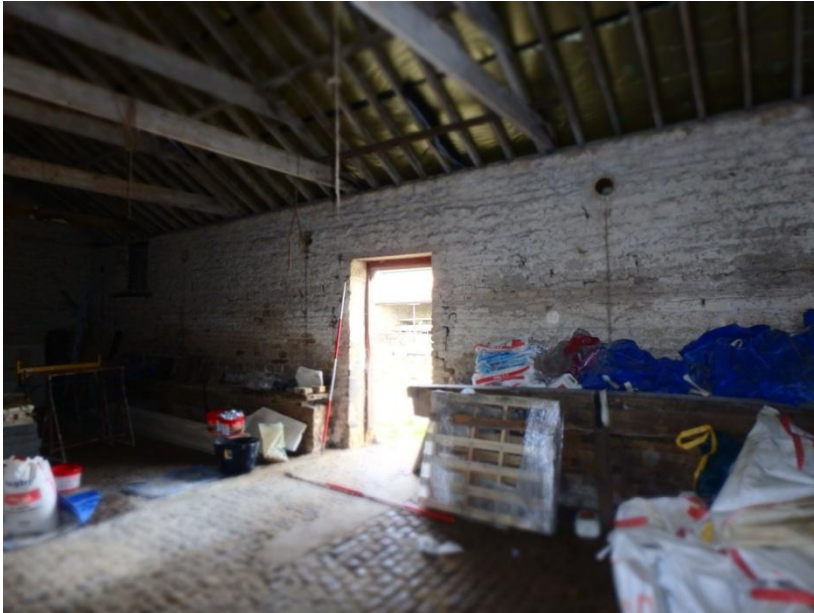
**Plate 156: View of the eastern portion of the north wall of the North Range, from the south**

**Plates 156 and 157** provide views of the north wall of the interior of this North Range. The wall fabric is composed of coursed worked and shaped limestone blocks which has been whitewashed over. The inner face of the north facing door opening was also revealed with a simple timber frame of head and surrounds with a horizontal timber lintel above the door head.

Also featured is the inner face of the window opening with simple timber frame. At the lower levels of this wall is a row of stone seating composed of a mix of brick headers and stretchers of seven courses in height and topped with a stone capping. This has been constructed over the stone floor setts.

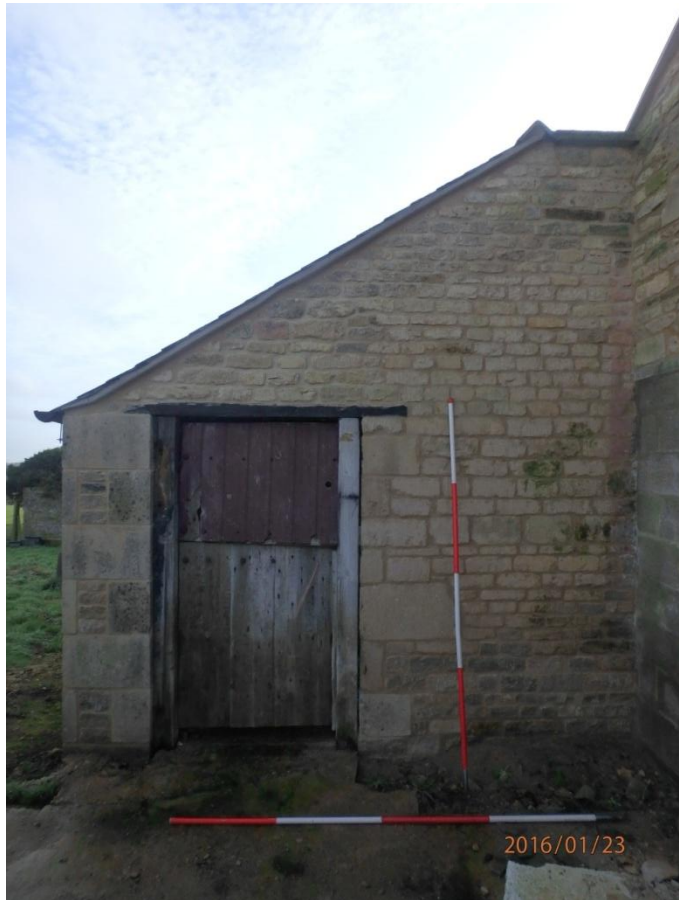
**Plate 158: View of the North Elevation of the East Range, from the north**

**Plate 158** provides a view of the North Elevation of the East Range. The East Range is a single storey outbuilding with a gabled roof in modern slate topped with ridge tiles also in modern slate. This North Elevation is bonded to the East Elevation of the North Range. The wall fabric of this North Elevation is composed of coursed worked and shaped limestone blocks with at least one course of worked, shaped and faced limestone ashlar with modern repointing. To the left (east), is a north facing door opening with two timber half doors composed of a series of tongued and grooved timber planks with a door frame of timber surrounds and an horizontal timber lintel above the opening. There are vertical columns of worked, shaped and faced limestone quoins to either side of the opening.

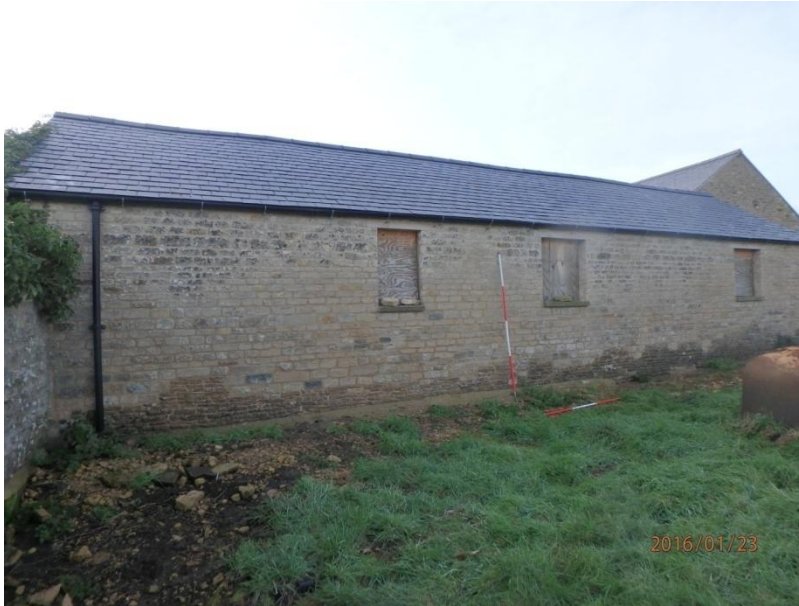
**Plate 159: View of the East Elevation of the East Range, from the east**

**Plate 159** features the East Elevation of the North Range. Much of the wall fabric is composed of courses of worked and shaped limestone blocks with modern repointing. There is modern Upvc guttering at roof level extending to a vertical modern Upvc downpipe at the southern end of this Elevation. Three east facing window openings are also featured within this East Elevation. All have modern stone cills and horizontal timber lintels and all have been boarded over.

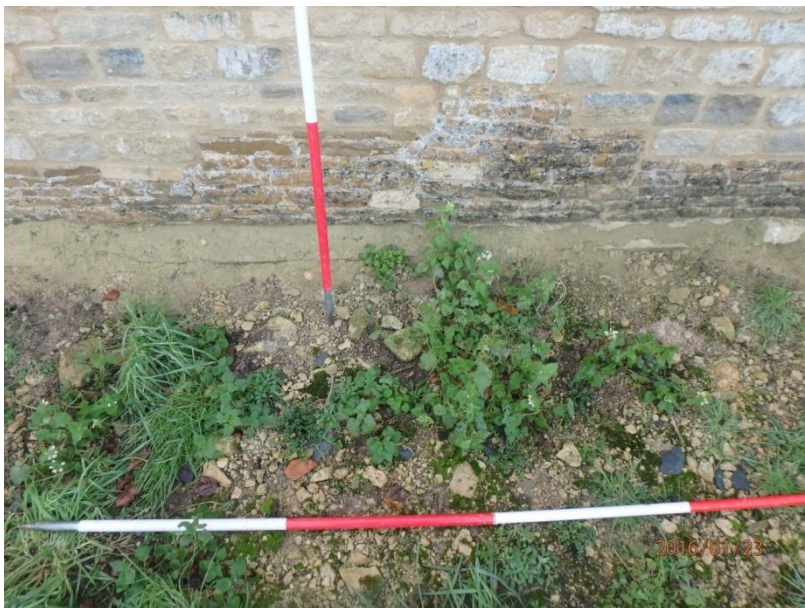
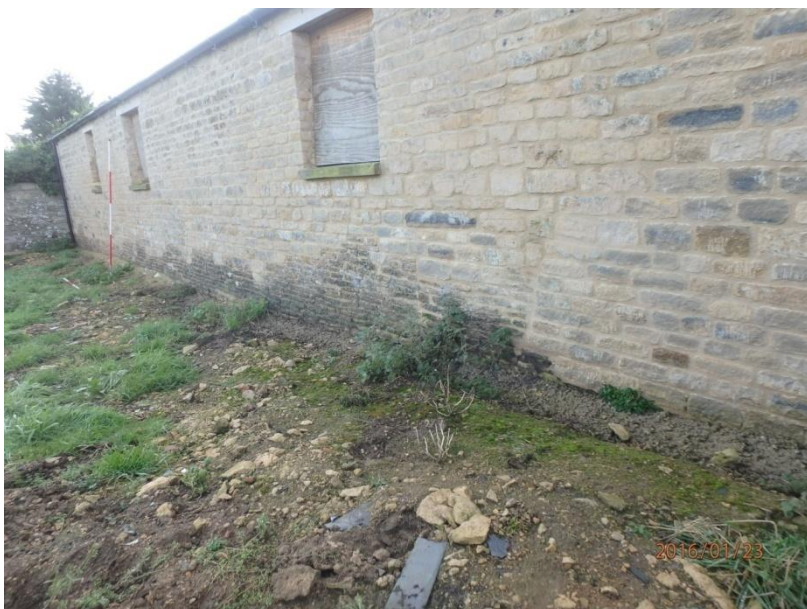
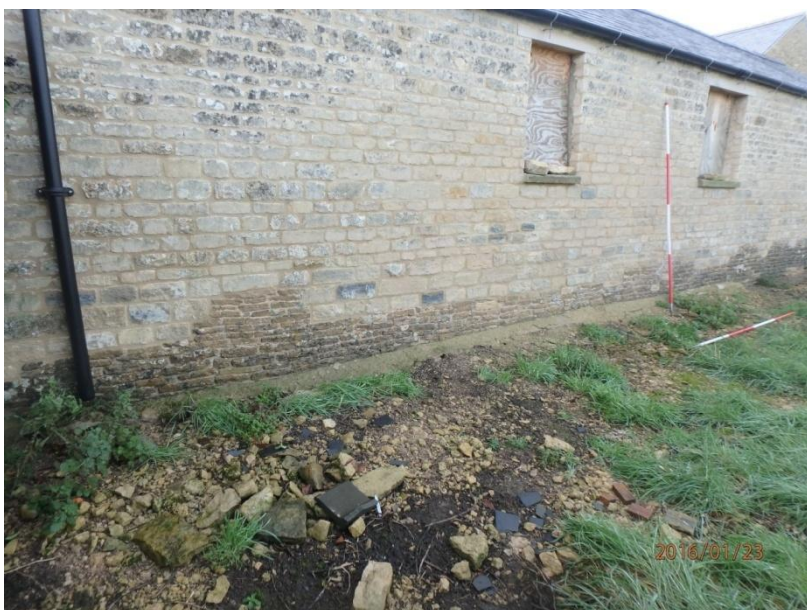
**Plate 160: Detail: View of the earlier foundations in the East Elevation of the East Range, from the east**

**Plate 161: Detail: View of the earlier foundations in the East Elevation of the East Range, from the north-east**

**Plate 162: Detail: View of the earlier foundations in the East Elevation of the East Range, from the south-east**

**Plates 160-162** are significant in that they feature in detail an earlier wall foundation composed of courses of small worked and shaped stone slabs and it is thus clear from this that this East Range has been constructed upon earlier foundations. **Plate 163** features the South Elevation of this East Range. The wall fabric of this South Elevation is composed of courses of worked and shaped limestone blocks along with courses of worked, shaped and faced limestone ashlar.

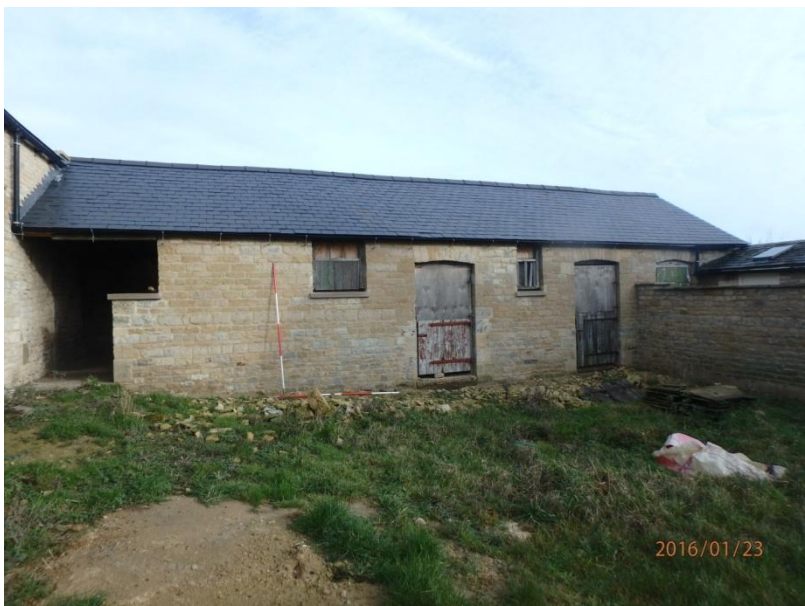
**Plate 164: View of the West Elevation of the East Range and enclosed courtyard, from the west**

**Plate 164** features the main portion of the West Elevation of the East Range along with a view of the west facing enclosed courtyard. The roof of this East Range is attached to the wall fabric of the adjoining North Range. At the northern end of the East Range is an open east facing alcove. There is modern Upvc guttering at roof level leading to a vertical modern Upvc downpipe at the southern end of this Elevation. The wall fabric of this West Elevation is composed of courses of worked and shaped limestone blocks along with courses of worked, shaped and faced limestone ashlar with modern repointing.

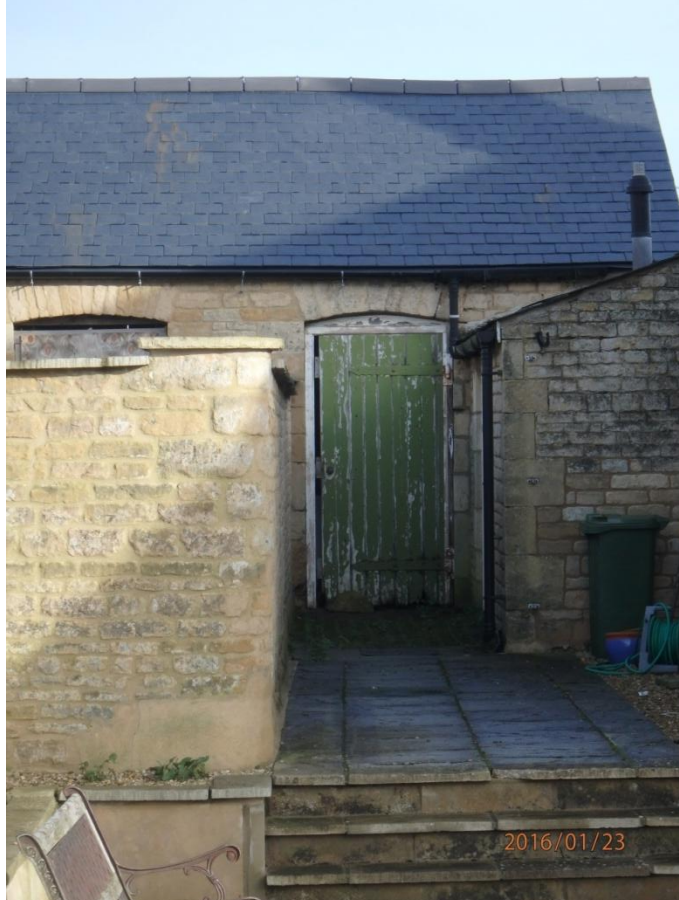
**Plate 165: View of the southern portion of the West Elevation of the East Range, from the west**

To the right (south) of this is a third west facing door opening at the southern end of this East Elevation, which is featured on **Plate 165**. This opening consists of a modern door of a series of modern tongued and grooved timber planks with two cast metal strap hinges to the right. The timber door frame consists of a curved head with surrounds. Above the head is a curved stone head in limestone blocks. There are vertical columns of worked, shaped and faced limestone quoins to either side.

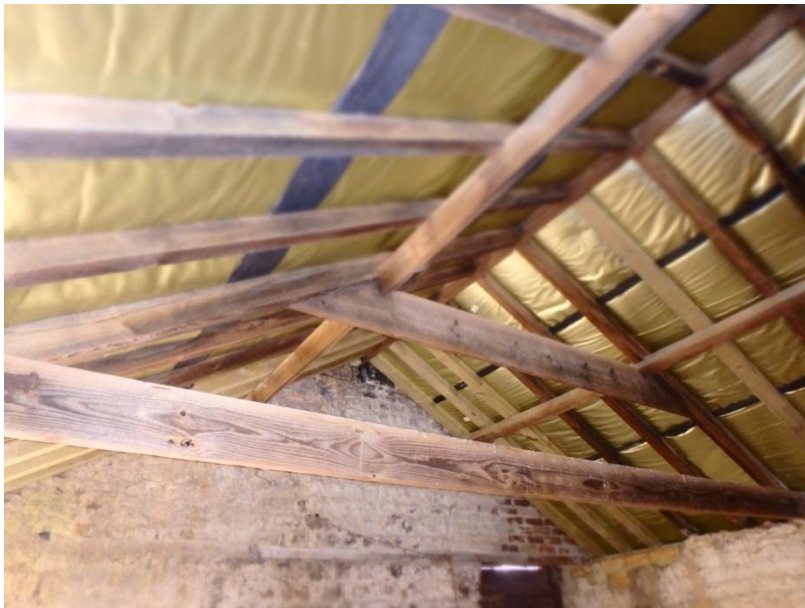
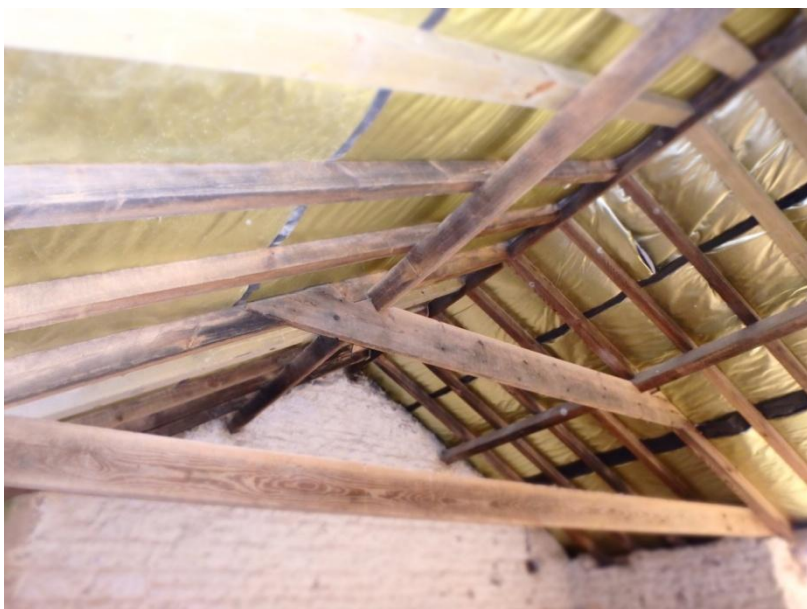
**Plates 166 and 167** both feature the roof supporting structure of Cell 7 from different perspectives. This is identical to that which was previously recorded within the adjacent North Range. The main component part of this structure comprises one roof truss which is composed in turn of principal rafters to which are attached one pair of horizontal timber collars. The lower of these collars are also attached to the tops of the north and south walls and the upper collars to the principal rafters. The remainder of this roof structure is composed of a series of common rafters and two principal horizontal timber purlins to either side. The rafters extend upwards to horizontal roof apex timbers. The purlins are inserted into the fabric of the east and west walls.

**Plate 166: View of the roof supporting structure of Cell 7, from the south**

**Plate 167: View of the roof supporting structure of Cell 7, from the north**

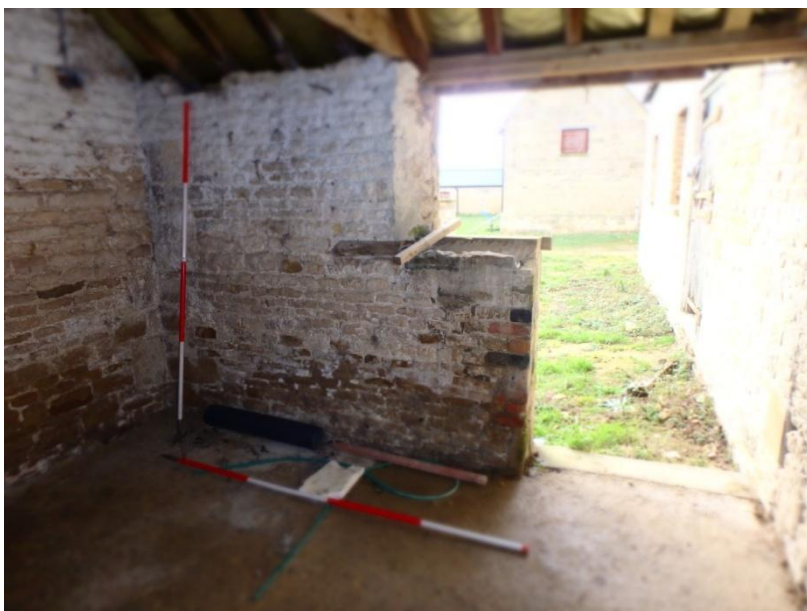
**Plate 168: View of the west wall of Cell 7, from the east**

**Plate 168** provides a view of the west wall of Cell 7. The northern portion of this west wall has been removed leaving this open to the west. However, the internal face of a partially removed former window opening can be discerned here by the presence of a modern stone cill. The wall fabric of this west wall is composed of courses of worked and shaped limestone blocks with the upper levels of the wall having been whitewashed over. Within the lower parts of this wall, this covering is absent exposing the bonding material of a light buff sandy mortar.

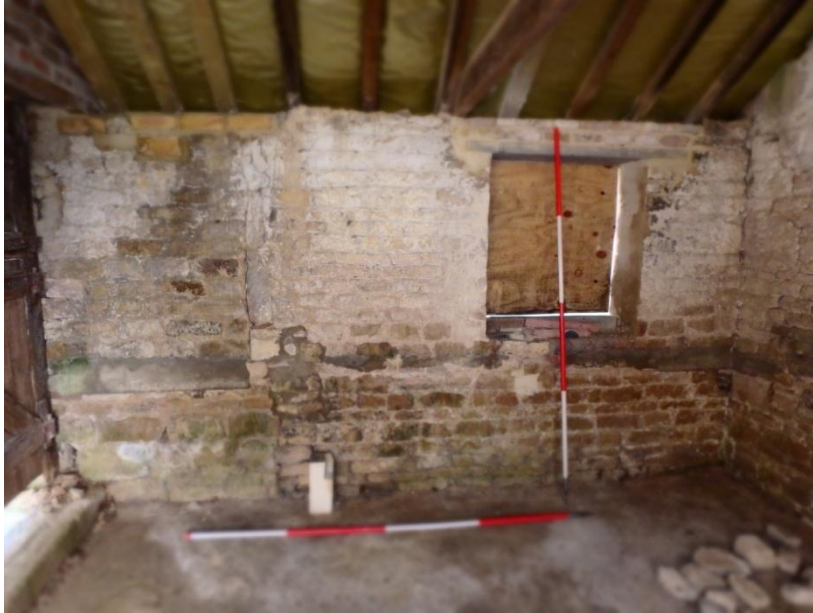
**Plate 169: View of the east wall of Cell 7, from the west**

**Plate 169** features the east wall of Cell 7. This image is significant in that it features at the very lowest levels of the wall, the inner face of the foundations of the aforementioned earlier building, which is featured in detail on **Plate 170**. These foundations are quite distinct from those of the wall fabric of the later building, which in this east wall is composed of courses of worked and shaped limestone blocks with the upper levels of the wall having been whitewashed over. Within the lower parts of this wall, this covering is absent exposing the bonding material of a light buff sandy mortar. Also of significance is that at the northern end of the earlier foundations, a distinctive vertical division line in the wall fabric can also be discerned, which probably marks the limit of the northern end of the earlier building. The wall fabric also included a horizontal band of modern concrete. The inner face of a window opening which was previously recorded on the opposing external East Elevation is also shown including the inner face of an modern stone lintel.
