LEVEL II HISTORIC BUILDING RECORDING  
AT FRITH FARM,  
RYHALL ROAD,  
LITTLE CASTERTON, RUTLAND.

**National Grid Reference: TF 0200 1120**

*An historic building survey equivalent to English Heritage Level 2 of Units 2 and 3 at Frith Farm, Ryhall Road, Little Casterton, Rutland was undertaken by Neville Hall MIFA on the 23rd of January 2016.*

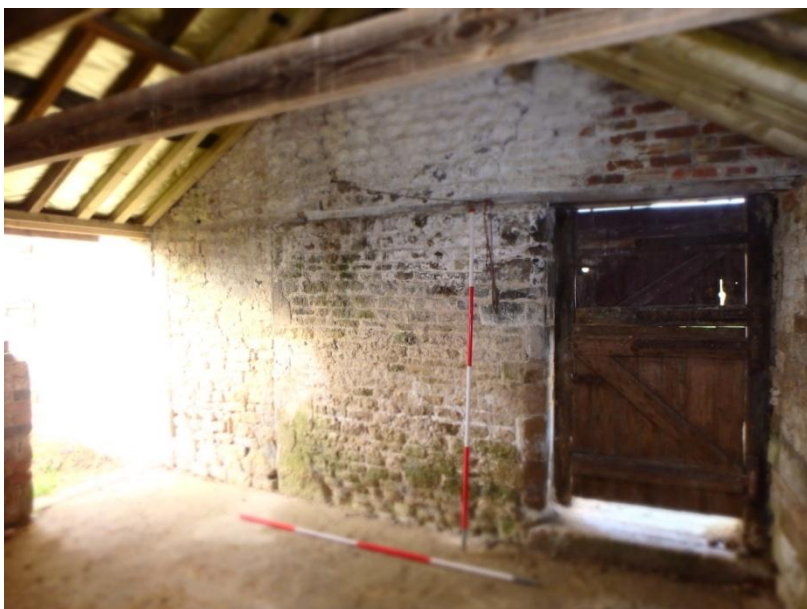
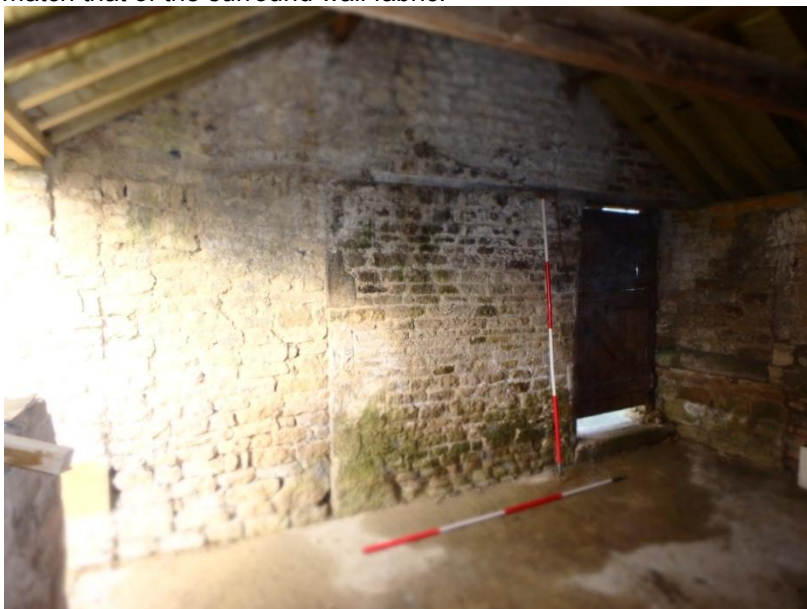
**Plate 171: View of the north wall of Cell 7, from the south**

**Plates 171 and 172** feature the north wall of Cell 7. The wall fabric of this north wall is composed of courses of worked and shaped limestone blocks with the upper levels of the wall having been whitewashed over. Within the lower levels, the wall fabric is exposed revealing the bonding material of a light buff sandy mortar. There is an horizontal timber wallplate which extends across the whole width of this wall and which doubles as a lintel for the door opening to the right. The inner face of this door opening is also revealed with simple timber frame of head and surrounds and an internal frame of angled and horizontal timbers upon which the external door planks are fixed to. There is also some modern brick repairs and infilling to the right and at the upper levels.

**Plate 172: View of the north wall of Cell 7, from the south**

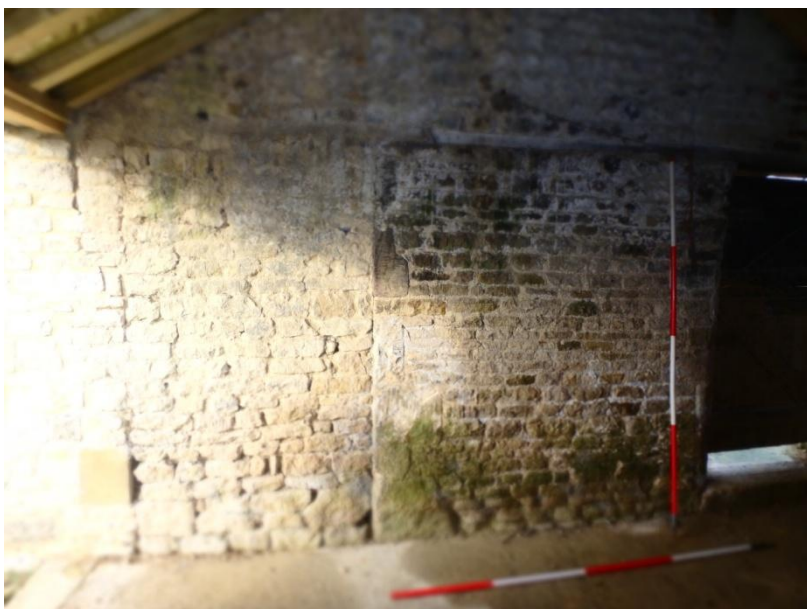
**Plate 173: Detail: view of infilled door opening in the north wall of Cell 7, from the south**

To the left (west) is an infilled former south facing door opening, which is also shown on Plates **171-172** and is featured on **Plate 173**. This is clearly discernible within the fabric of this north wall by two vertical divisions within the wall fabric to either side. The stone infilling also attempts to match that of the surround wall fabric.

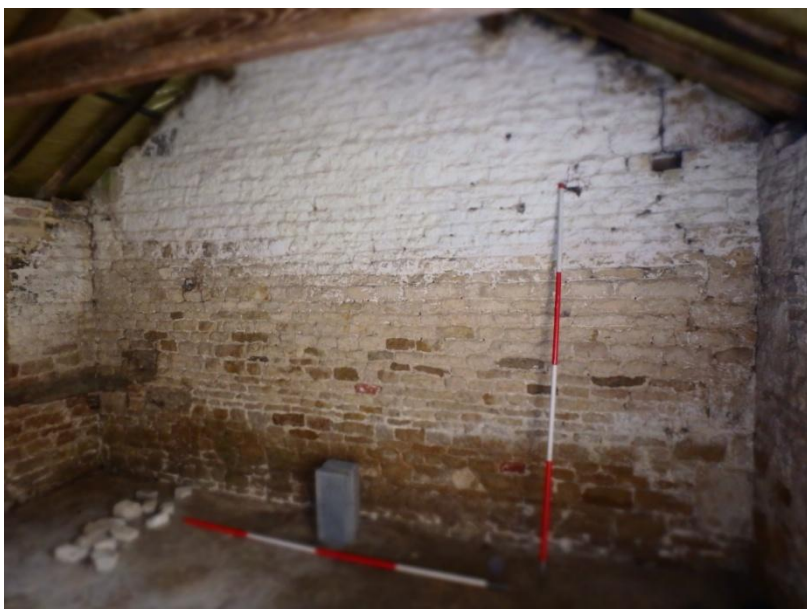
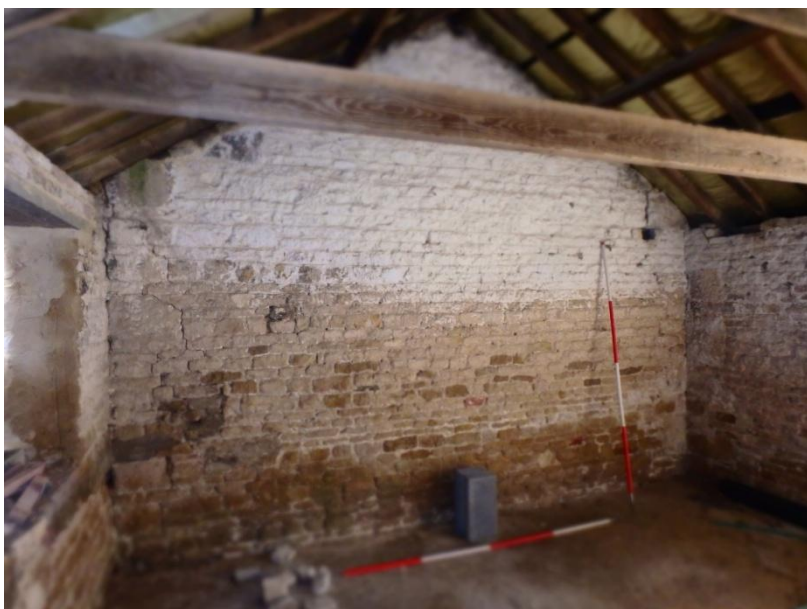
**Plates 174 and 175** provides views of the opposing South Wall of Cell 7. The wall fabric of this south wall is composed of courses of worked and shaped limestone blocks, of which the upper levels have been whitewashed over. The wall fabric is fully exposed at the lower levels with the bonding material of the light buff sandy mortar. This south wall is the internal dividing wall between Cell 7 and Cell 8 to the south.

**Plate 174: View of the south wall of Cell 7, from the north**

**Plate 175: View of the south wall of Cell 7, from the north**

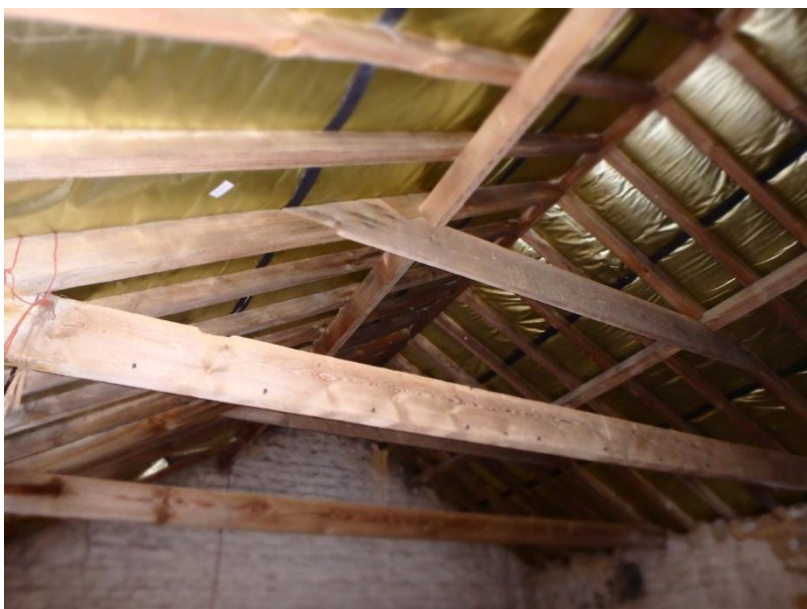
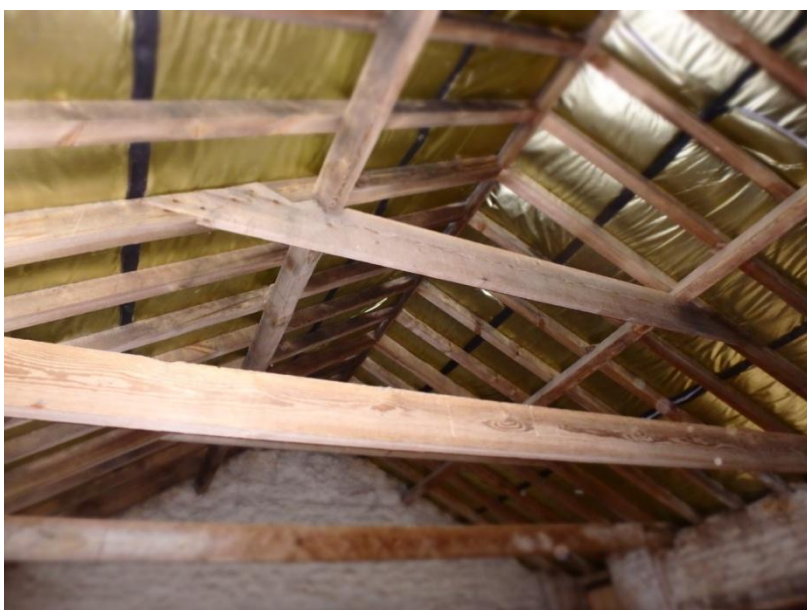
**Plates 176 and 177** both feature the roof supporting structure of Cell 8 from two different perspectives. This roof structure is identical in nature to that of the adjoining Cell 7. The main component part of this structure comprises one roof truss which is composed in turn of principal rafters to which are attached one pair of horizontal timber collars. The lower of these collars are also attached to the tops of the north and south walls and the upper collars to the principal rafters. The remainder of this roof structure is composed of a series of common rafters and two principal horizontal timber purlins to either side. The rafters extend upwards to horizontal roof apex timbers. The purlins are inserted into the fabric of the east and west walls. There is in addition a substantial horizontal timber tie beam which spans the width of Cell 8 and which is attached to the top of the east and west walls.

**Plate 176:** View of the roof supporting structure of Cell 8, from the north

**Plate 177:** View of the roof supporting structure of Cell 8, from the south

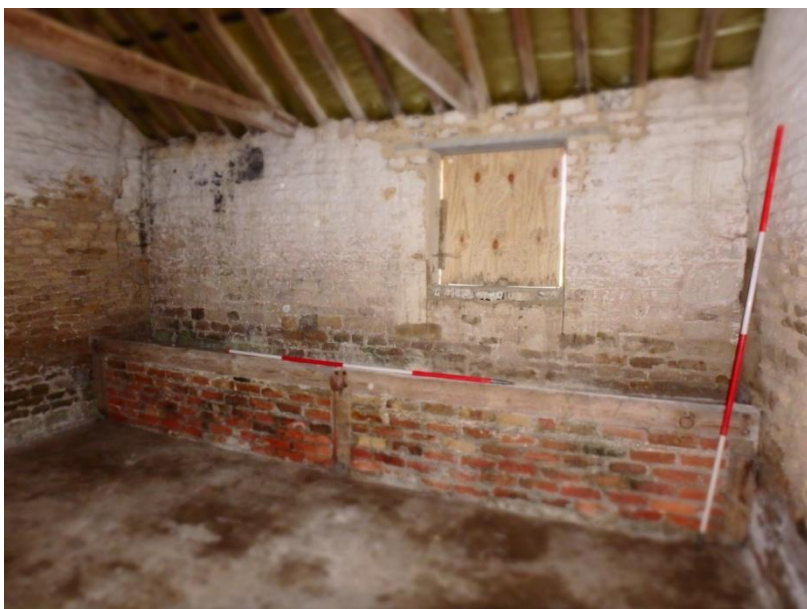
**Plate 178: View of the east wall of Cell 8, from the west**

**Plate 178** provides an image of the east wall of Cell 8. The wall fabric of this east wall is composed of courses of worked and shaped limestones blocks, the upper levels of this have been whitewashed over. The lower levels do not have this covering so exposing the wall fabric and the bonding material of the light buff sandy mortar. The inner face of a window opening, which was previously recorded on the opposing external East Elevation is also shown with a modern concrete stone lintel. At the lower levels of this wall is a trough constructed of courses of modern brick stretchers and atopped with an horizontal timber. The interior of the trough is rendered over with concrete.

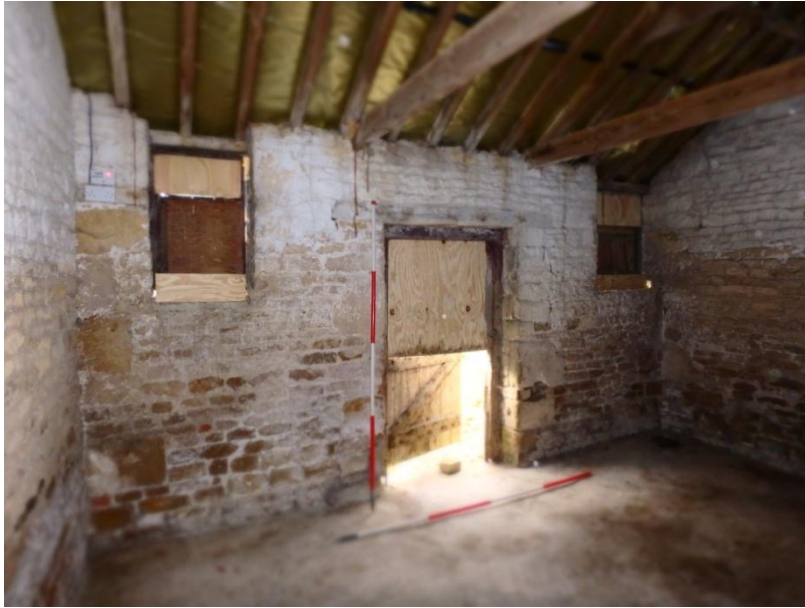
**Plate 180: View of the west wall of Cell 8, from the east**

**Plates 179 and 180** feature the opposing east wall of Cell 8. The wall fabric of this west wall is composed of courses of worked and shaped limestone blocks, the upper levels of this have been whitewashed over. The lower levels do not have this covering so exposing the wall fabric and the bonding material of the light buff sandy mortar. To the right (north) the inner face of a window opening is featured partially boarded over internally showing the inner face of the timber frame surrounds. To the left (south) of this is the west facing door opening with timber frame of head and surrounds and an internal timber frame of angled and horizontal timbers upon which the external door covering of planks is fixed to. There are vertical columns of worked, shaped and faced limestone quoins to either side of this door opening. To the left (south) of this is a second window opening, partially boarded over internally.

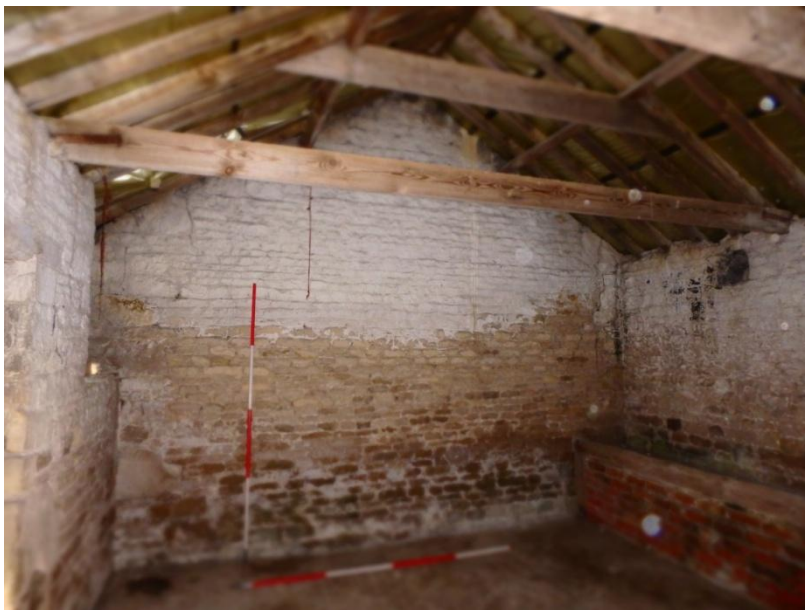
**Plate 181: View of the north wall of Cell 8, from the south**

**Plate 181** provides a view of the north wall of Cell 8. The wall fabric of this north wall is composed of coursed worked and shaped limestone blocks, the upper levels of this have been whitewashed over. The lower levels do not have this covering so exposing the wall fabric and the bonding material of the light buff sandy mortar.

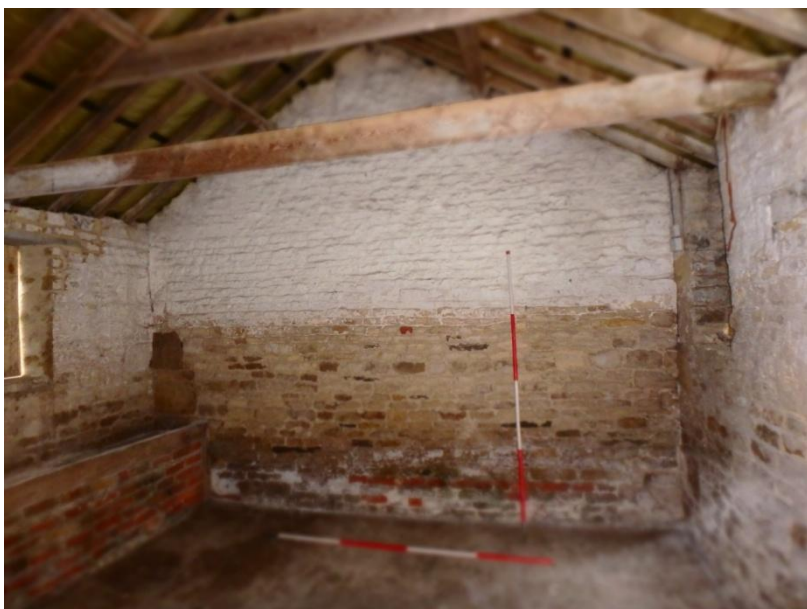
**Plate 182: View of the south wall of Cell 8, from the north**

**Plate 182** features the opposing south wall of Cell 8. This south wall is the internal dividing wall between Cell 8 and the adjacent Cell 9 to the south. The wall fabric of this south wall is composed of coursed worked and shaped limestone blocks, the upper levels of this have been whitewashed over. The lower levels do not have this covering so exposing the wall fabric and the bonding material of the light buff sandy mortar. There is also evidence of modern brick repair at the base of this wall.

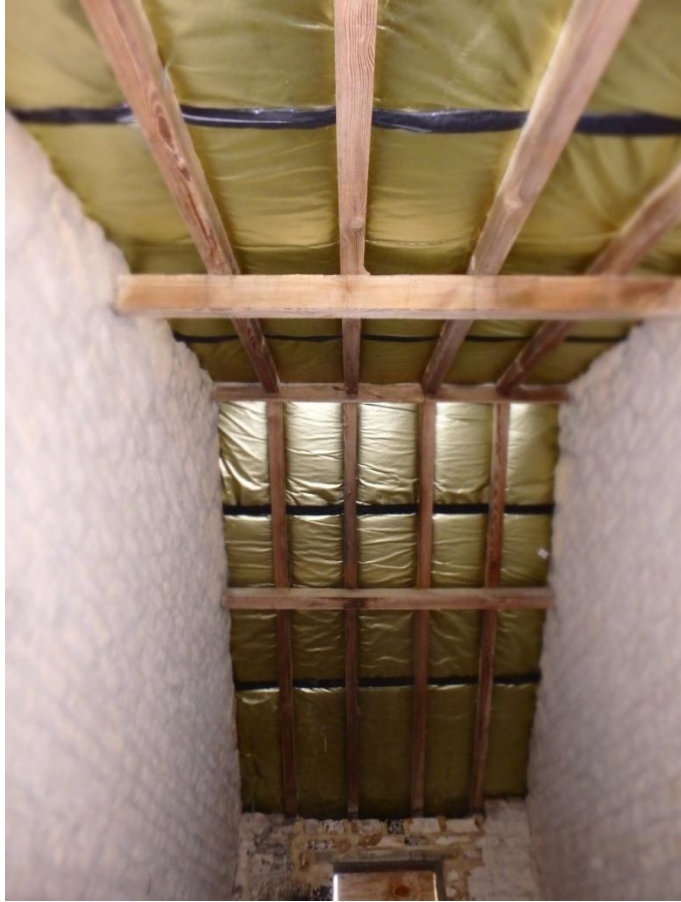
**Plate 183: View of the roof supporting structure of Cell 9, from the west**

**Plate 183** provides a view of the roof supporting structure of Cell 9, which is identical in nature to that which was previously recorded within the adjoining Cells 7 and 8. Here the roof structure is composed of parts of two horizontal timber purlins to which are attached a series of common rafters extending upwards to horizontal timbers at the roof apex. The purlins are inserted in the fabric of the north and south walls and the rafters atop the east and west walls of Cell 9.

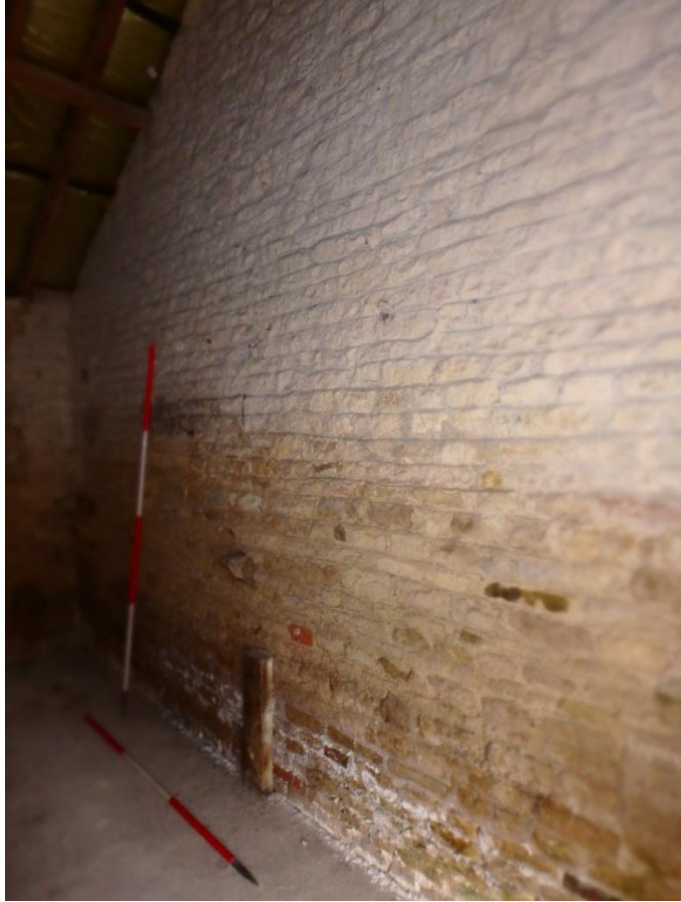
**Plate 184: View of the lower levels of the south wall of Cell 9, from the west**

**Plate 184** provides a view of the lower levels of the south wall of Cell 9. The fabric of this south wall is composed of courses of worked and shaped limestone blocks, the upper levels of which are covered over by whitewash. This covering is absent over the lower levels thus exposing the wall fabric and bonding material of the light buff sandy mortar.

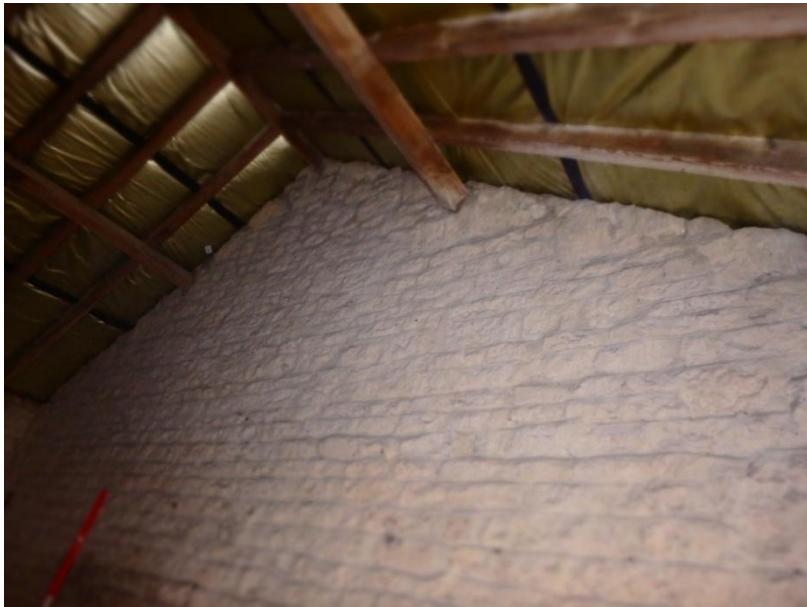
**Plate 185: View of the upper levels of the south wall of Cell 9, from the north**

**Plate 185** features the upper levels of this south wall.

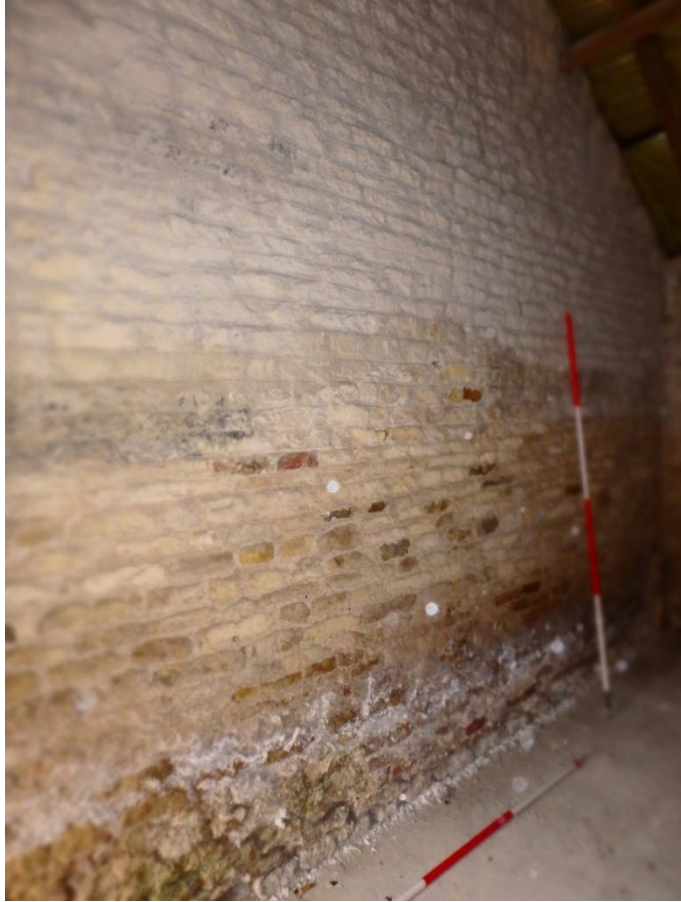
**Plate 186: View of the lower levels of the north wall of Cell 9, from the west**

**Plate 186** provides a view of the lower levels of the north wall of Cell 9. The fabric of this north wall is composed of courses of worked and shaped limestone blocks, the upper levels of which are covered over by whitewash. This covering is absent over the lower levels thus exposing the

wall fabric and bonding material of the light buff sandy mortar. There is also some very limited repair in brick.

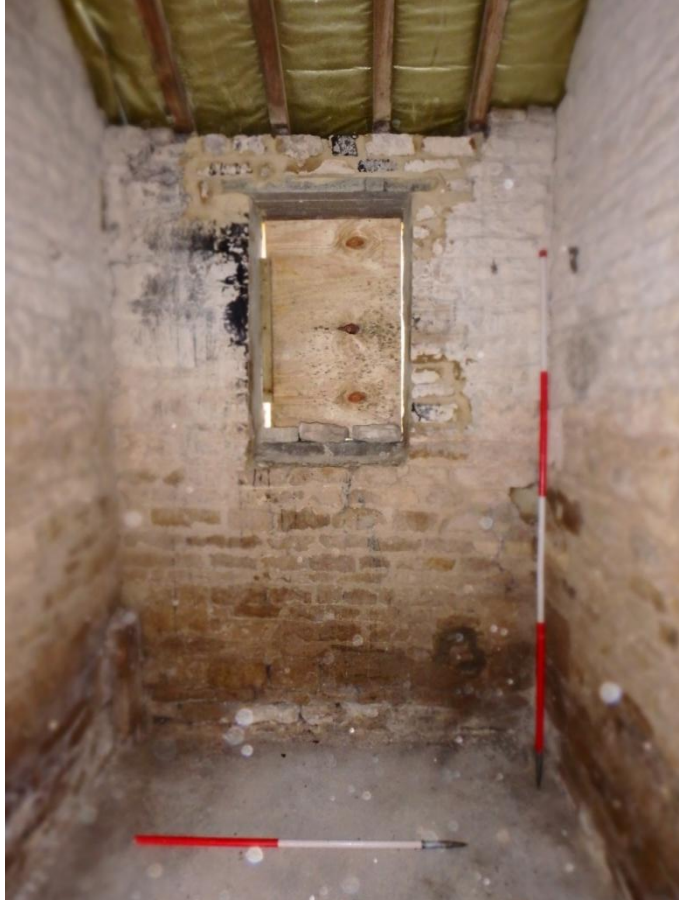
**Plate 188: View of the east wall of Cell 9, from the west**

**Plate 188** provides a view of the east wall of Cell 8. The fabric of this east wall is composed of courses of worked and shaped limestone blocks, the upper levels of which are covered over by whitewash. This covering is absent over the lower levels thus exposing the wall fabric and bonding material of the light buff sandy mortar. The inner face of a window opening is also shown with a simple frame of head and surrounds and above this head, a modern horizontal stone lintel.

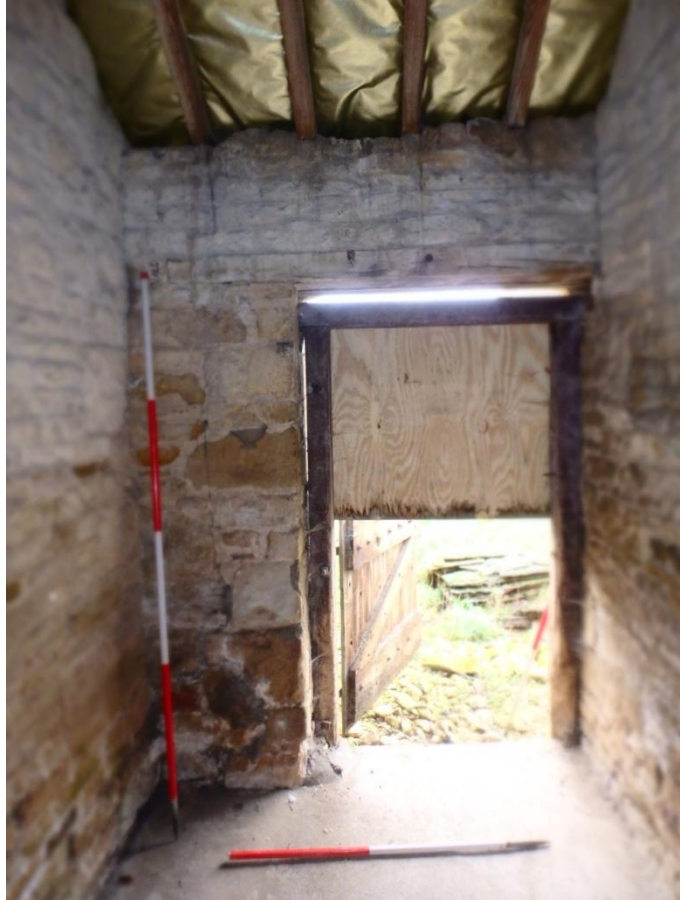
**Plate 190: View of the west wall of Cell 9, from the east**

**Plate 190** features the west wall of Cell 9. The fabric of this east wall is composed of courses of worked and shaped limestone blocks, the upper levels of which are covered over by whitewash. This covering is absent over the lower levels thus exposing the wall fabric and bonding material of the light buff sandy mortar. There are also reused worked, shaped and faced limestone ashlar incorporated into this wall fabric. The inner door frame of the west facing entrance of a simple head and surrounds along with the internal face of an horizontal timber lintel above this are revealed.

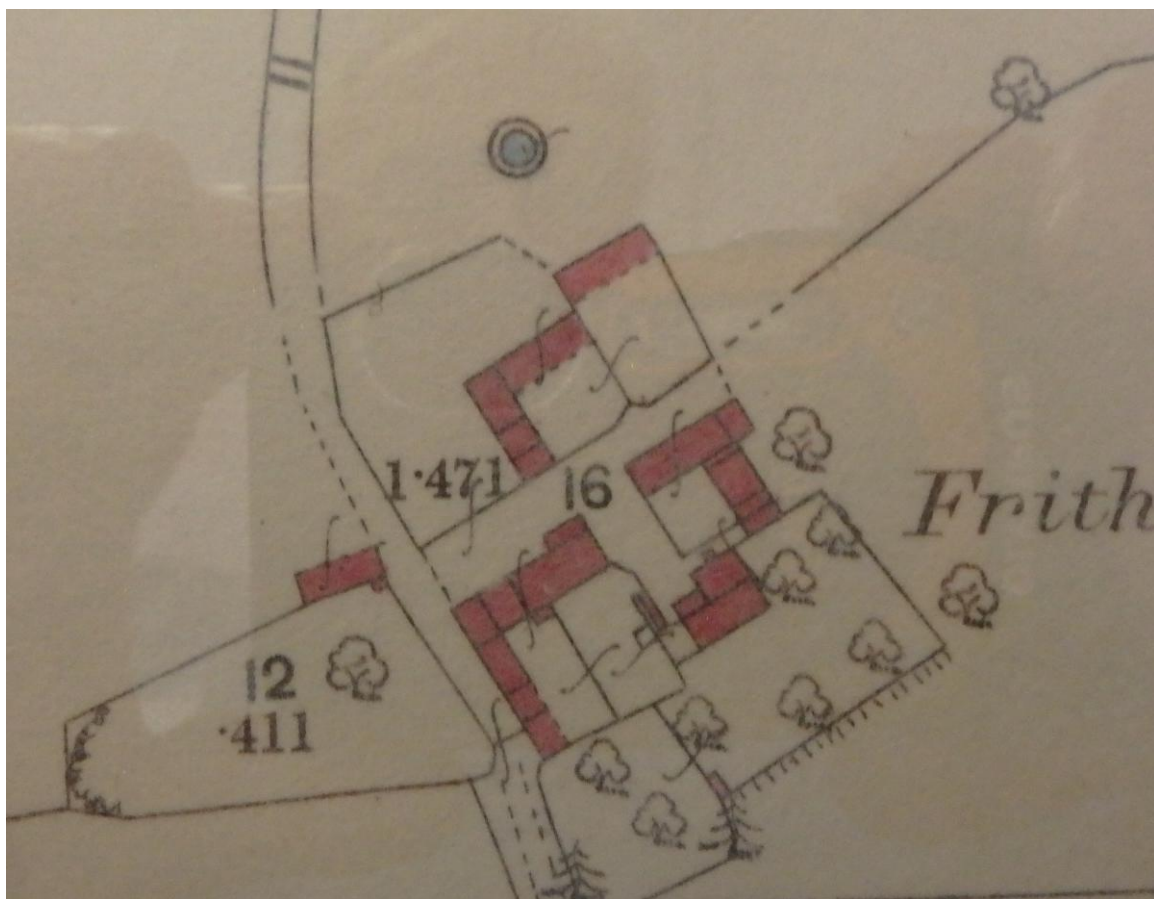
**Figure 5:** Extract from the First Edition 25 inch to one mile scale O.S. map of 1891, map sheet no. Rutland 6.16.

- 5.4 The extract from the First Edition 25 inch to one mile scale O.S. map of 1891 shows that the Frith Farm complex has undergone a great deal of expansion [**Figure 5**]. The unlisted southern portion or West Range to Unit 2 has been added to the Grade II listed barn of the North Range by this time. The farmhouse remains to the south-east, having undergone a slight increase in extent. In addition, the 'L'-shaped range to the east, (now known as Unit 3) is also in existence by 1891. Several other outlying farm outbuildings to the north and west have also been added to this complex by this time.
