AN ARCHAEOLOGICAL WATCHING BRIEF AT
THE CHURCH OF ST. MARY,
ST. MARY'S LANE,
CLAXBY, LINCOLNSHIRE.

National Grid Reference: TF 1112 9457
Site Code: SMCC16
Accession No: LCNCC: 2016.18

April 2016

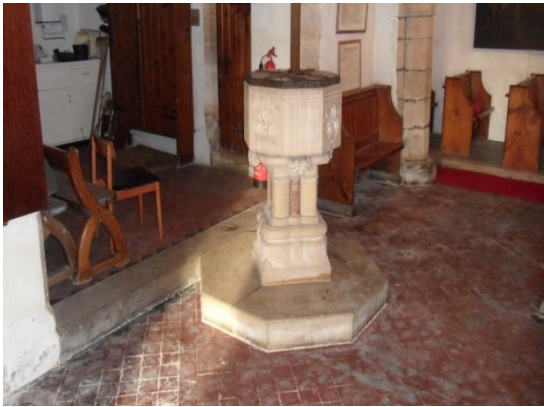
Plate 1: *In situ* font by the west tower, from the south-east

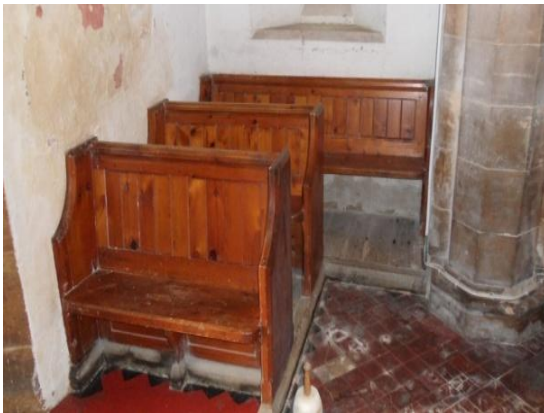
Plate 2: *In situ* pews in the south aisle, from the east

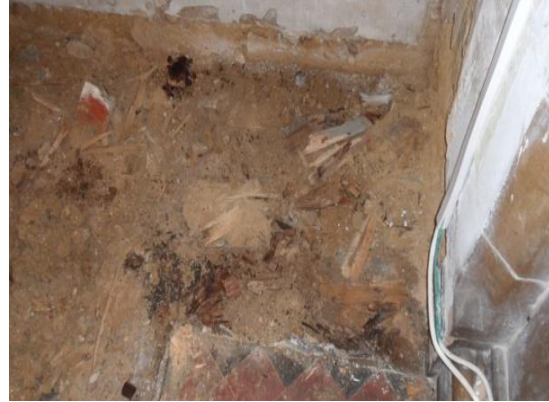
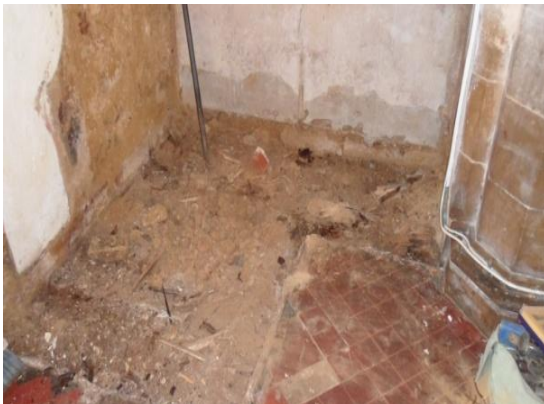
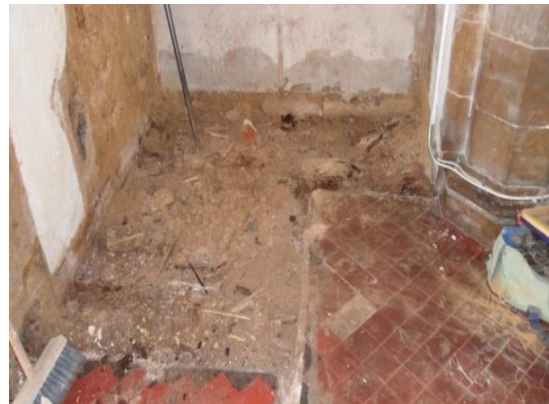
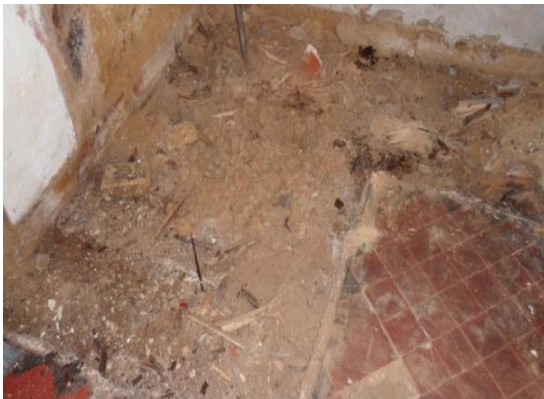
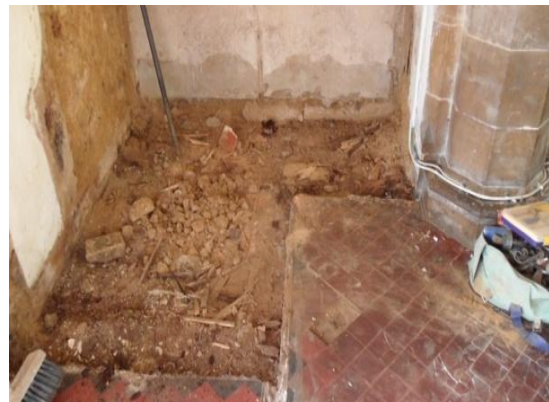
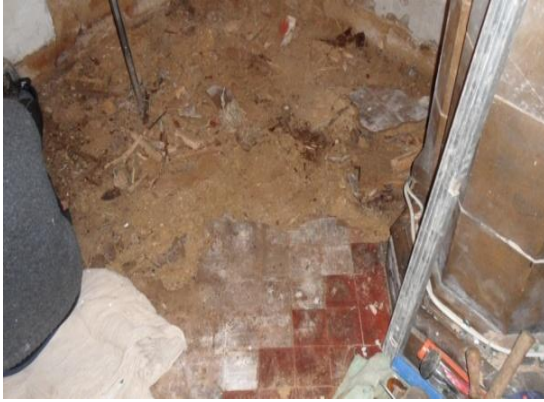
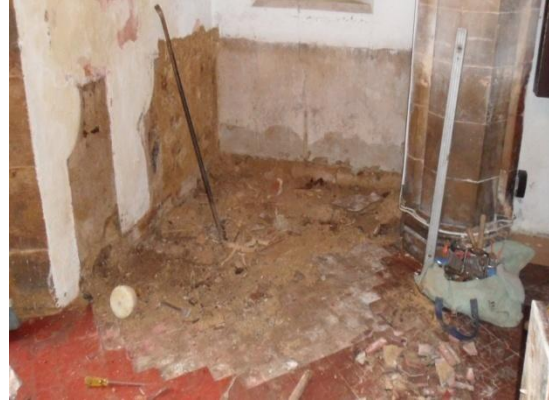
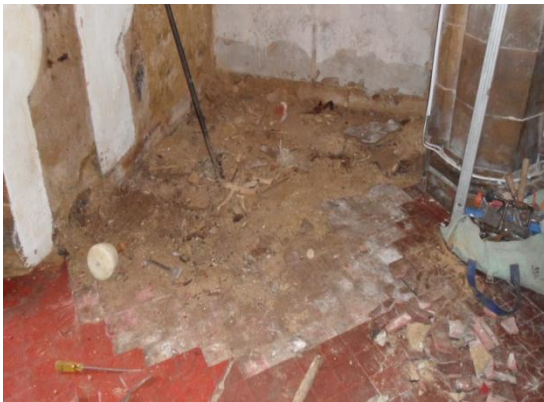
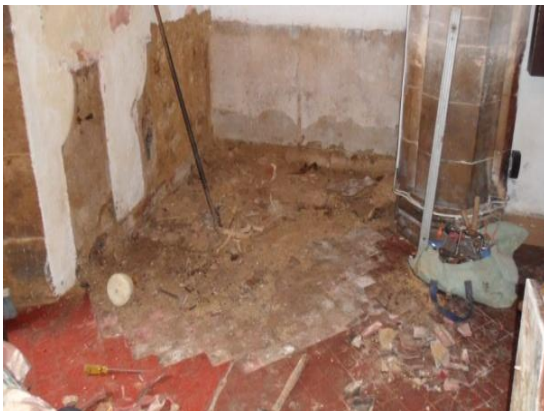
- 7.3 The removal of the pew platform and the supporting boards also revealed an uppermost deposit which consisted of a loose mortar and rubble mix (**101**) below which lay a sandy silt deposit (**102**) [**Plates 8-16**]. The removal of the deposit (**101**) by hand to a depth of 0.20m below the floor levels revealed a line of worked stone (**103**), which was aligned from east-west at the northern edge of the area of ground reduction along with a further

Plate 10: View of the revealed deposits (101) and (102), from the east

Plate 8: View of the revealed deposits (101) and (102), from the east

Plate 11: View of the revealed deposits (101) and (102), from the east

Plate 9: View of the revealed deposits (101) and (102), from the east

Plate 12: View of the revealed deposits (101) and (102), from the east

Plate 13: View of the revealed deposits (101) and (102), from the north-east

Plate 16: View of the revealed deposits (101) and (102), from the east

Plate 14: View of the revealed deposits (101) and (102), from the east

Plate 15: View of the revealed deposits (101) and (102), from the east

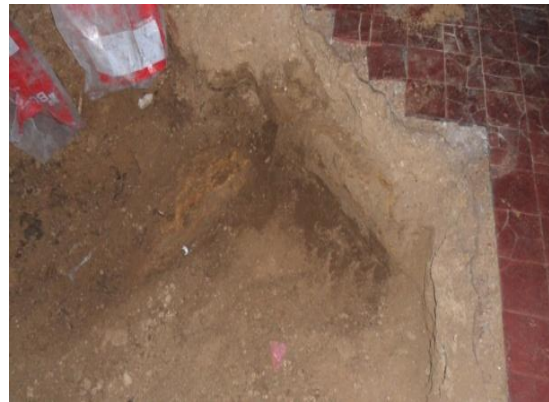
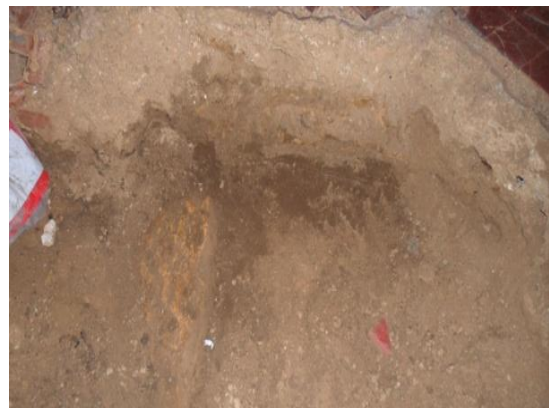
patch of partly worked stone (104), which was situated to the immediate south of (103). Further ground reduction entailed the partial removal of the underlying sandy silt deposit (102) and fully revealed both the line of worked stone (103) and the patch of partly worked stone (104) [Plates 17-18]. This ground reduction also revealed two lines of brick (100) at the base of the west and south walls of the south-western corner of the south aisle. These had supported the timber beams of the platform for the pews and was thus part of this construction. These were left *in situ*. Part of the line of (103) is featured on **Section 1**.

Plate 17: View of the revealed line of worked stone (103) and the patch of partly worked stone (104), from the east

Plate 18: View of the revealed line of worked stone (103) and the patch of partly worked stone (104), from the east

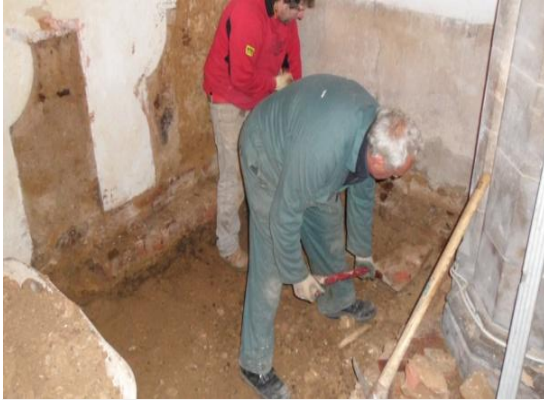
- 7.4 Further ground reduction to a final level of 0.39m below the surrounding floor levels revealed that the deposit (102) extended to the base of the excavation [Plate 19]. This reduction also revealed the full extent of the line of worked stone (103) along the northern edge of the reduced area and the patch of partly worked stone (104) to the immediate south of this. The brick base to the former pew platform (100) which extended along the south and west walls of the south-western corner of the south aisle was also fully exposed by this point [Plates 20-24].

Plate 19: Further ground reduction, from the east

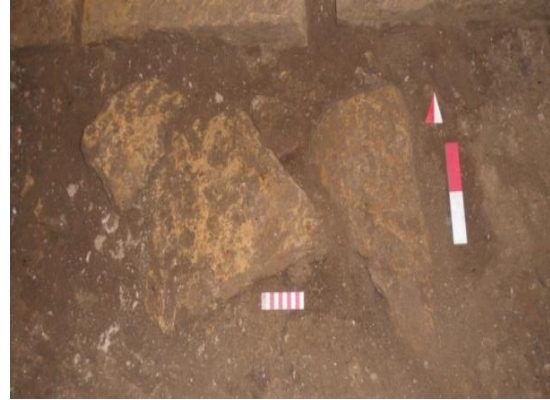
Plate 22: View of the patch of partly worked stone (104), from the south

- 104** Patch of roughly worked stones within (**102**) situated to the immediate south of (**103**) and thought to represent the remains of a base or pad to an external buttress to the original south wall of the earlier church. Length - 0.70m, width - 0.54m, depth - not determined.

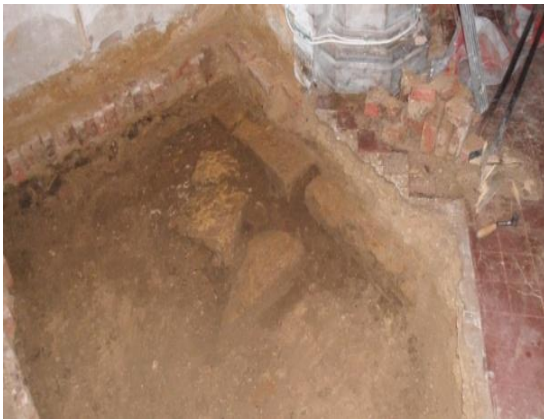
Plate 20: View of part of the line of bricks (100) at the west wall and of the fully exposed line of worked stone (103) and the patch of partly worked stone (104), from the east

- 100** Line of a single course of brick left in situ along the south and west walls of the south-western part of the south aisle and revealed by hand ground reduction here. These bricks supported the timber platform and beams of the removed timber pews and were part of the 1871 renovations by Fowler.

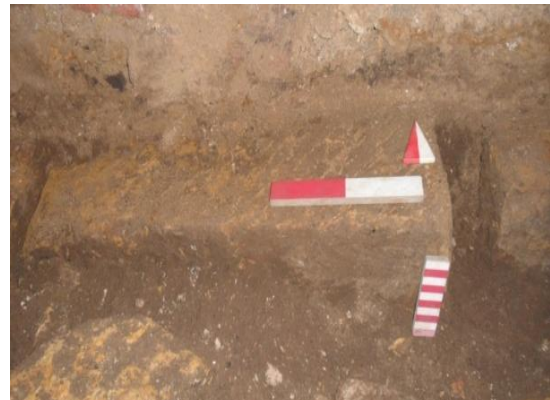
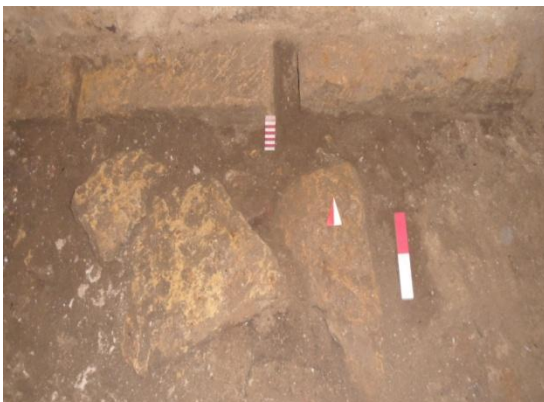
Plate 23: View of the line of worked stone (103), from the south

Plate 21: View of the line of worked stone (103) and the patch of partly worked stone (104), from the south

- 103** Line of worked, shaped and faced stones, east-west aligned revealed by the area hand ground reduction and situated along the northern edge of the excavated area. Represented the line of the original south wall of the earlier church, pre-1871. Above (**102**). Recorded in **Section 1**. Length - >0.86m, width - >0.14m, depth - 0.78m.

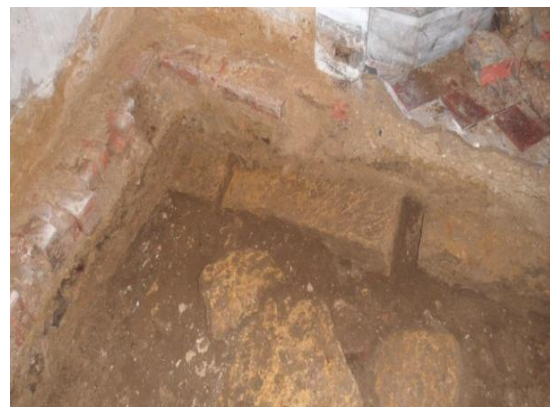
Plate 24: View of the line of worked stone (103) and part of the line of bricks (100) at the base of the west wall, from the south

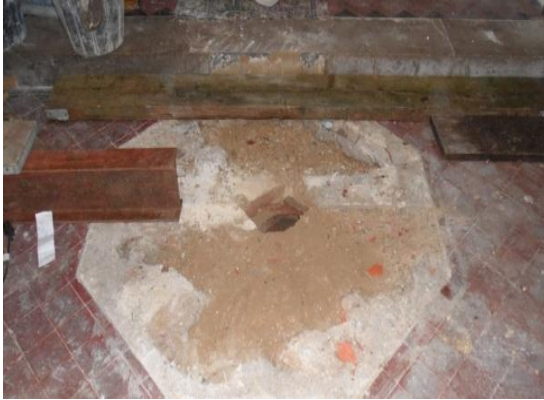
- 7.5 The font was then removed from its original location by the west tower and the surface below this exposed [Plate 25]. This revealed a rubble base of some 1.28m across. In the centre of this exposed surface was a brick lined void which acted as a drain. This drain measured 0.37m square and was 0.56m in depth from the surrounding floor level and was composed of two courses of brick. The exposed rubble lay on a lime mortar base. This rubble was then reduced by 4.5cm onto the mortar spread to allow the laying of replacement floor tiles.

Plate 25: View of the exposed surface below following the removal of the font, from the east

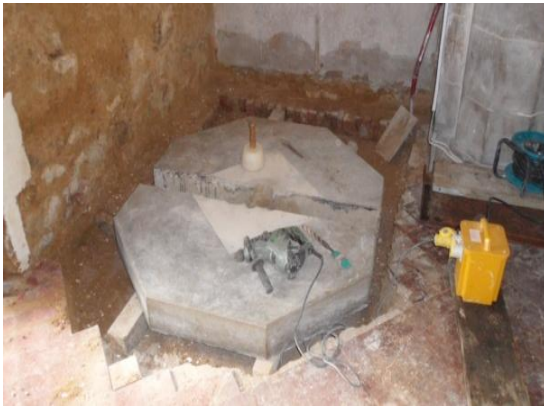
Plate 26: View of the base of the new font location in the south-western corner of the south aisle, from the east

- 7.6 Following the completion of the ground reduction to the required levels at the south-western corner of the south aisle, a new base for the font was laid down [Plate 26]. During this process, part of the wall rendering of the south wall at the south-western corner of the south aisle had been removed revealing the underlying wall fabric of coursed, worked, shaped and faced ironstone ashlar that were bonded by a light brown sandy lime mortar [Plate 27].

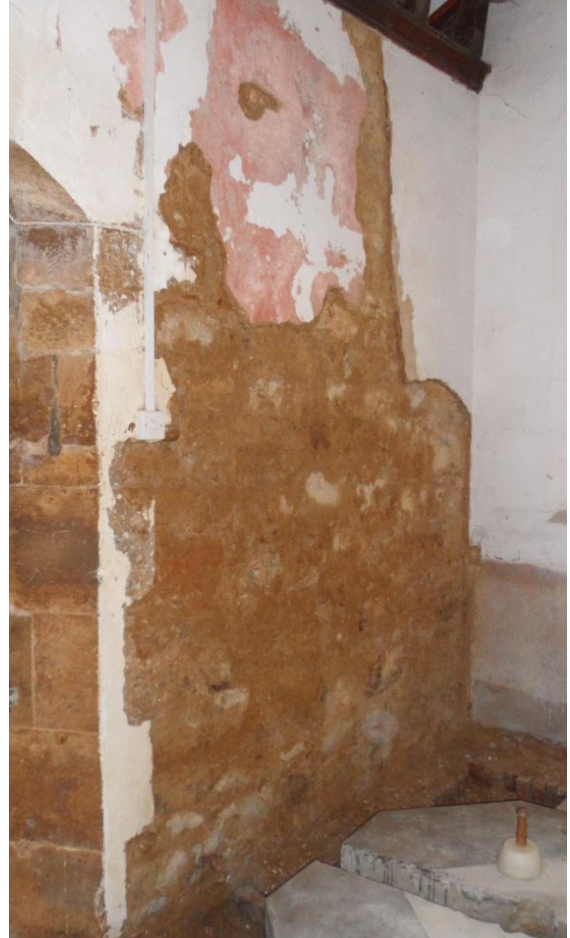
Plate 27: View of the exposed wall fabric of the south wall at the south-western corner of the south aisle, from the east
