ARCHAEOLOGICAL MONITORING & RECORDING
AT POPLAR TREE FARM, CARR LANE,
BLYTON, LINCOLNSHIRE.

National Grid Reference: SK 8449 9429
Site Code: CLBL16
Accession No: LCNCC: 2016.43
Planning Reference: 133795

April 2017

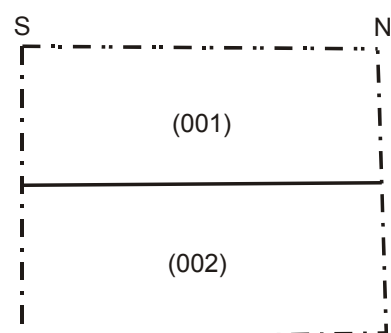
Representative Section 1, Service Trench, East Facing Section, scale 1:20

These monitored excavations extended through the remainder of the topsoil horizon (001) and into the underlying natural horizon of sands (002), which extended to the base of these excavations [Plates 15-16, 18-21, 23-24 and 26]. This deposit sequence was recorded within **Representative Sections 1-3** [Plates 17, 22 and 25].

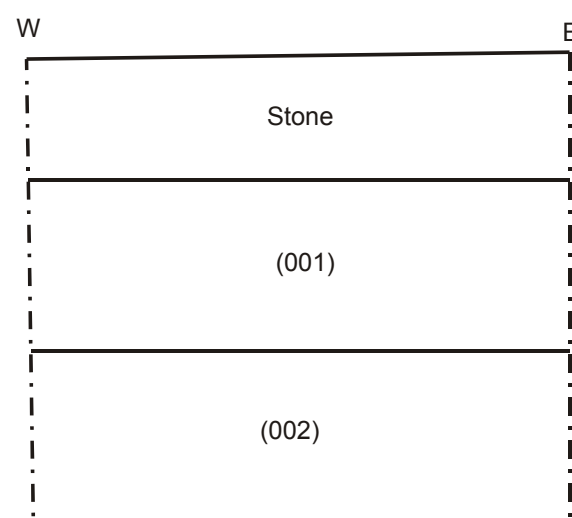
Section 4, Stanchion Base 1, South Facing Section, scale 1:20

This was located at the southern end of the eastern side of the new build area and was excavated to a length of 1.50m, a width of 1.30m and to a depth of 1.30m below the stone level. The deposit sequence in this excavation was recorded within **Section 4** [Plate 30].

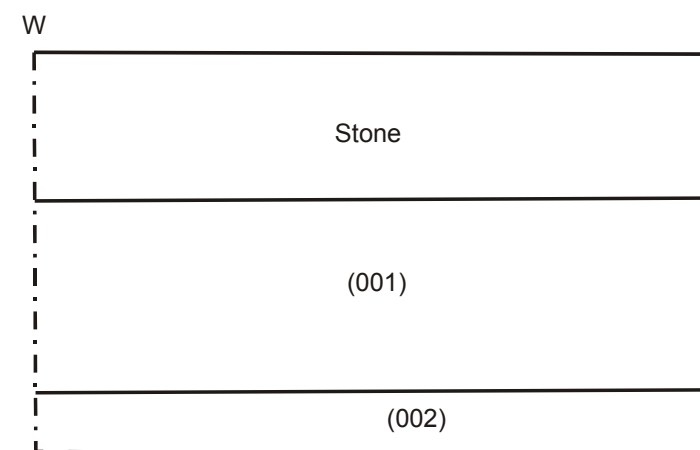
Section 7, Stanchion base 4, South Facing Section, scale 1:20

Stanchion Base 4 was located to the north of **Stanchion Base 3** and was excavated to a length of 1.90m, to a width of 1.30m and to a depth of 1.10m below the stone level. The deposit sequence in this excavation was recorded within **Section 7** [Plate 36].

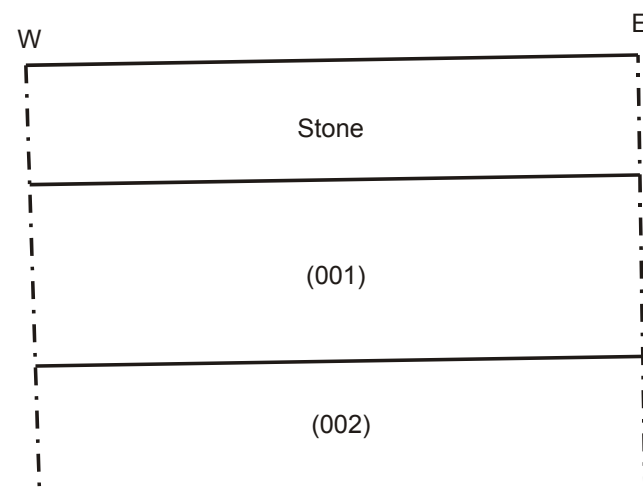
Section 5, Stanchion Base 2, South Facing Section, scale 1:20

Stanchion Base 2 was positioned to the north of **Stanchion Base 1** and was excavated to a length of 1.70m, to a width of 1.30m and to a depth of 1.20m below the stone level. The deposit sequence in this excavation was recorded within **Section 5** [Plate 32].

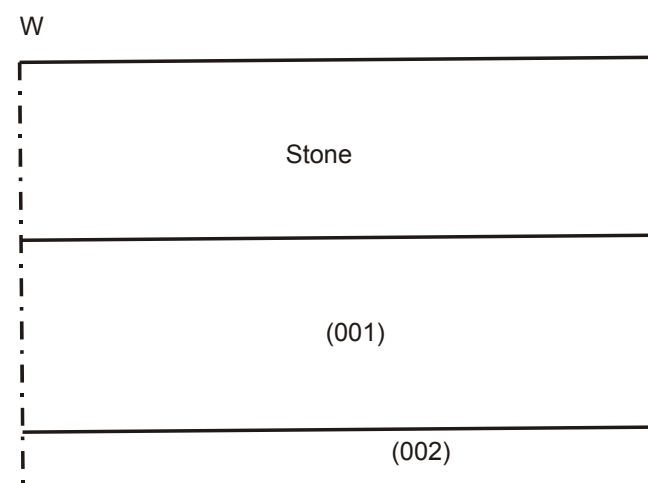
Section 8, Stanchion Base 5, South Facing Section, scale 1:20

Stanchion Base 5 was positioned to the north of **Stanchion Base 4** and was excavated to a length of 1.80m, to a width of 1.30m and to a depth of 1.20m below the stone level. The deposit sequence in this excavation was recorded within **Section 8** [Plate 38].

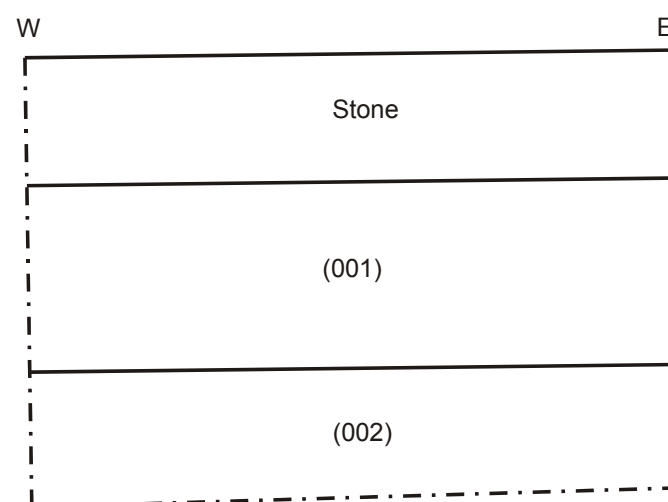
Section 6, Stanchion Base 3, South Facing Section, scale 1:20

Stanchion Base 3 was situated to the north of **Stanchion Base 2** and was excavated to a length of 1.80m, to a width of 1.30m and to a depth of 1.20m below the stone level. The deposit sequence in this excavation was recorded within **Section 6** [Plate 34].

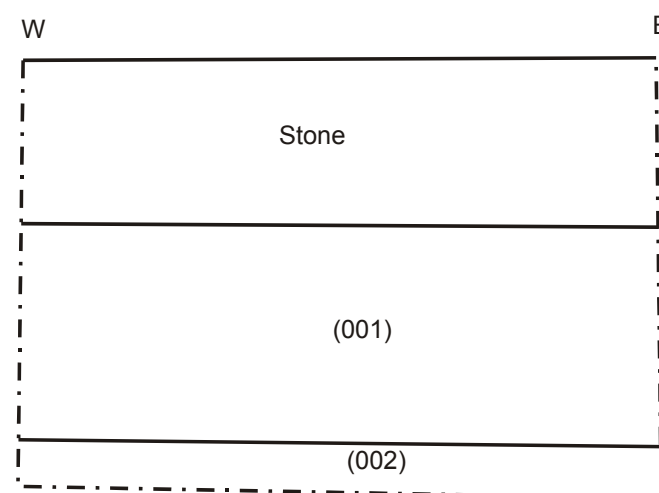
Section 9, Stanchion Base 6, South Facing Section, scale 1:20

Stanchion Base 6 was situated to the north of **Stanchion Base 5** and was excavated to a length of 1.80m, to a width of 1.30m and to a depth of 1.20m below the stone level. The deposit sequence in this excavation was recorded within **Section 9** [Plate 40].

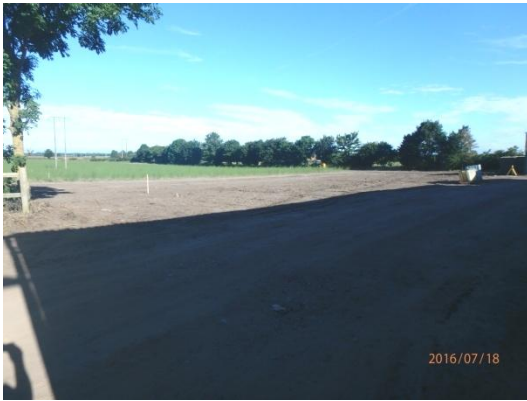
Plate 1: Pre-groundworks, from the south

- 7.1.1 **Plates 1 and 2** feature the site of the new general purpose agricultural building. The first phase of this monitored groundworks programme consisted of an initial phase of mechanical ground reduction which took place within the northern, eastern and central portions of the new build area. The mechanical ground reduction was carried out by a 14-ton 360° mechanical excavator which was fitted with a 2.0m wide toothless bucket. Within much of this monitored area, the ground reduction was confined to a topsoil horizon (**001**). Within the western and central portions of this monitored area, the depth of ground reduction extended to depths of between 0.10m-0.25m below ground levels. As this ground reduction was graded, the depth of this ground reduction was seen to deepen to the south to achieve maximum depths of between 0.50m-0.650m below ground levels [**Plates 3-14**]. At these depths, the ground reduction had extended through the topsoil horizon (**001**) and into the upper levels of an underlying natural horizon of sands (**002**). All newly exposed surfaces were walked over and were systematically scanned for any surface finds of which there were none.

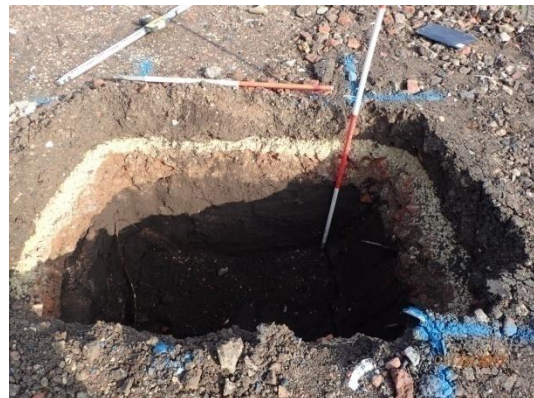
Plate 42: Section 10, Stanchion Base 7, from the south

Stanchion Base 7 was located to the north of **Stanchion Base 6** and was excavated to a length of 2.0m, to a width of 1.30m and to a depth of 1.30m below the stone level. The deposit sequence in this excavation was recorded within **Section 10 [Plate 42]**.

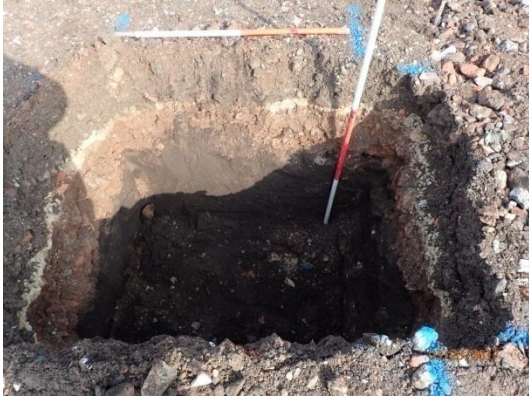
Plate 43: Section 11, Stanchion Base 8, from the south

Stanchion Base 8 was positioned to the north of **Stanchion Base 7** and was excavated to a length of 1.80m, to a width of 1.30m and to a depth of 1.20m below the stone level. The deposit sequence in this excavation was recorded within **Section 11 [Plate 43]**.

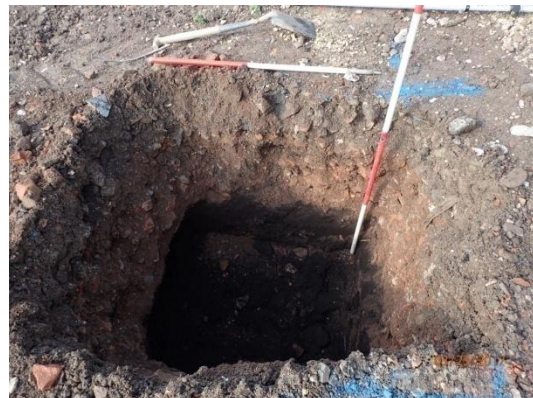
Plate 47: Section 13, Stanchion Base 10 from the west

Stanchion Base 10 was located to the west of **Stanchion Base 9** and along the northern edge of the new build area. **Stanchion Base 10** was excavated to a length of 1.70m, to a width of 1.30m and to a depth of 1.20m below the stone level. The deposit sequence in this excavation was recorded within **Section 13 [Plate 47]**.

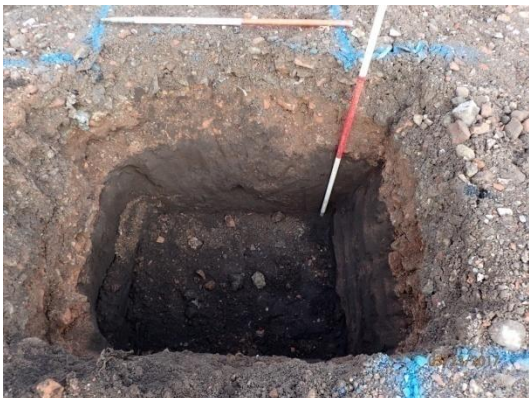
Plate 45: Section 12, Stanchion Base 9, from the south

Stanchion Base 9 was situated to the north of **Stanchion Base 8** and was excavated to a length of 1.70m, to a width of 1.30m and to a depth of 1.20m below the stone level. The deposit sequence in this excavation was recorded within **Section 12 [Plate 45]**

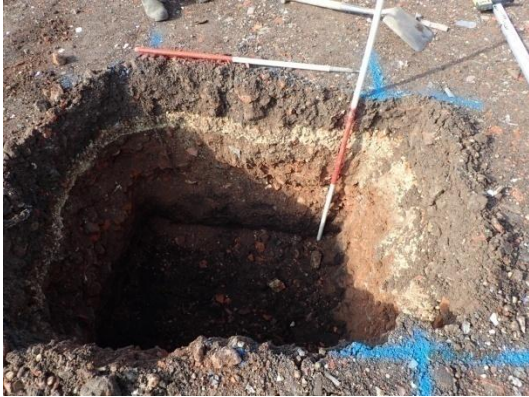
Plate 49: Section 14, Stanchion Base 11, from the west

Stanchion Base 11 was positioned to the west of **Stanchion Base 10** and was excavated to a length of 1.80m, to a width of 1.30m and to a depth of 1.20m below the stone level. The deposit sequence in this excavation was recorded within **Section 14 [Plate 49]**.

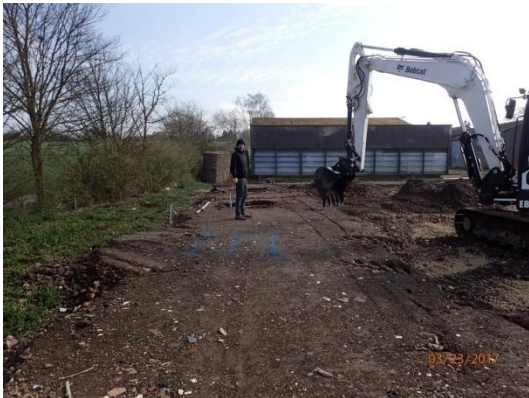
Plate 50: Excavation of the stanchion bases, from the west

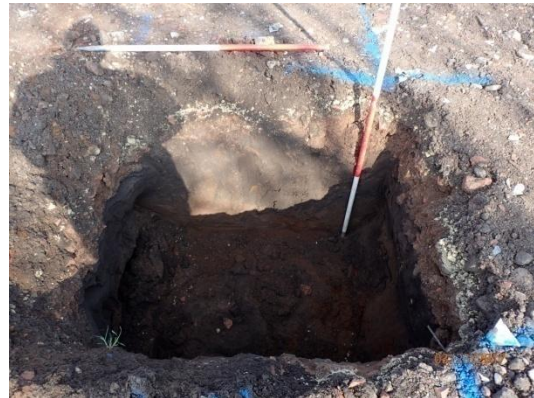
Plate 53: Section 16, Stanchion Base 13, from the west

Stanchion Base 13 was positioned to the south of **Stanchion Base 1** and at the south-eastern corner of the new build area. **Stanchion Base 13** was excavated to a length of 1.60m, to a width of 1.30m and to a depth of 1.20m below the stone level. The deposit sequence in this excavation was recorded within **Section 16 [Plate 53]**.

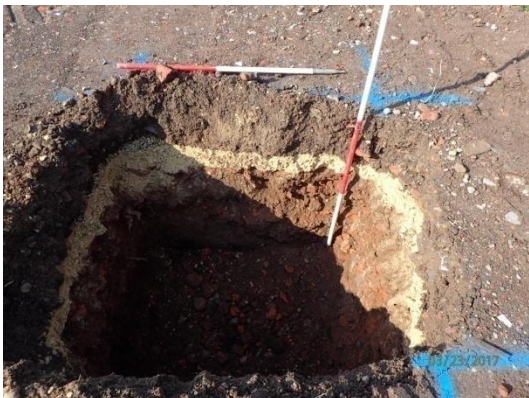
Plate 51: Section 15, Stanchion Base 12, from the west

Stanchion Base 12 was located to the west of **Stanchion Base 11** and was excavated to a length of 1.70m, to a width of 1.30m and to a depth of 1.20m below the stone level. The deposit sequence in this excavation was recorded within **Section 15 [Plate 51]**.

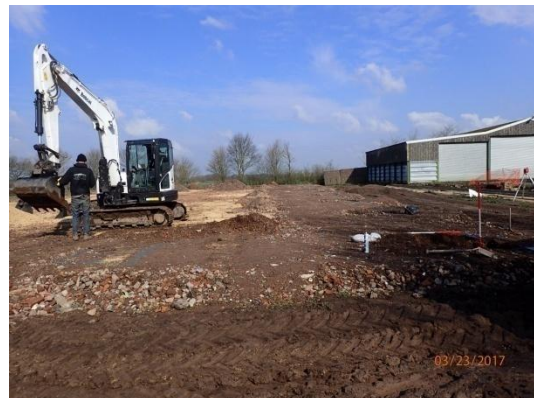
Plate 54: Excavation of the stanchion bases, from the south

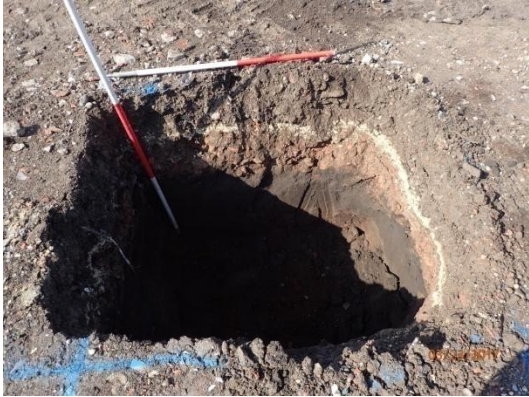
Plate 55: Section 17, Stanchion Base 14, from the west

Stanchion Base 14 was situated to the west of **Stanchion Base 13** and along the southern edge of the new build area. **Stanchion Base 14** was excavated to a length of 1.70m, to a width of 1.30m and to a depth of 1.20m below the stone level. The deposit sequence in this excavation was recorded within **Section 17 [Plate 55]**.

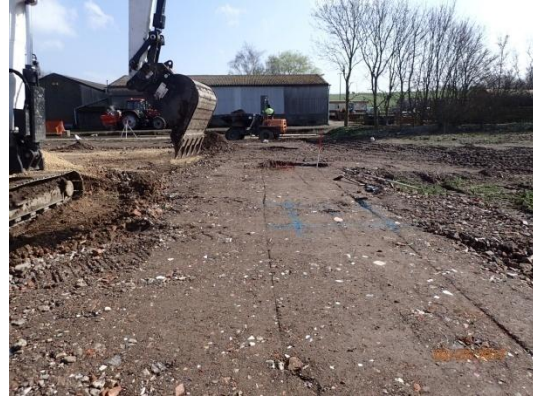
Plate 58: Excavation of the stanchion bases, from the west

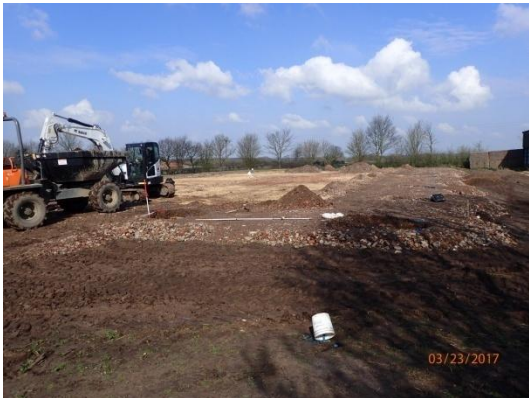
Plate 56: Excavation of the stanchion bases, from the south

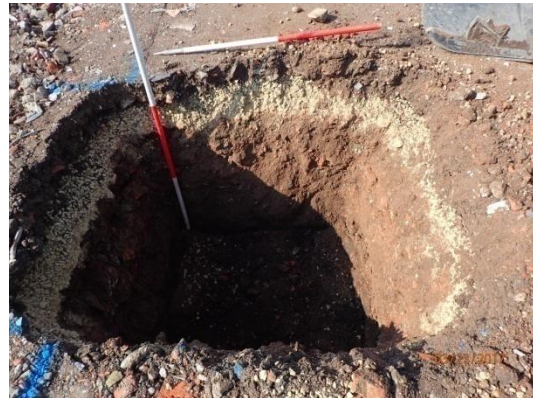
Stanchion Base 16 was positioned to the west of **Stanchion Base 15** and was excavated to a length of 1.90m, to a width of 1.30m and to a depth of 1.20m below the stone level. The deposit sequence in this excavation was recorded within **Section 17 [Plate 59]**.

Plate 59: Section 19, Stanchion Base 16, from the west

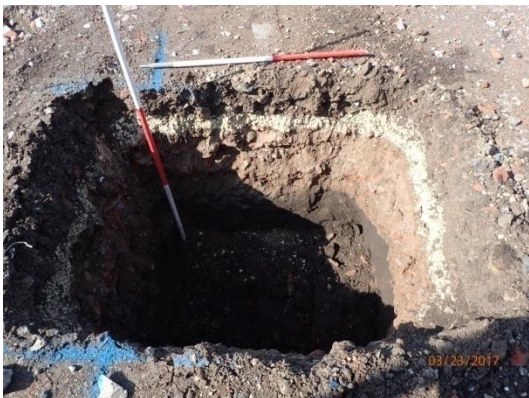
Plate 57: Section 18, Stanchion Base 15, from the west

Stanchion Base 15 was located to the west of **Stanchion Base 14** and was excavated to a length of 1.80m, to a width of 1.30m and to a depth of 1.20m below the stone level. The deposit sequence in this excavation was recorded within **Section 16 [Plate 57]**.
