**NEVILLE HALL
FREELANCE ARCHAEOLOGIST & CONSULTANT**

ARCHAEOLOGICAL MONITORING
ON LAND OFF JEKIL'S BANK,
HOLBEACH ST. JOHNS, LINCOLNSHIRE.

National Grid Reference: TF 3462 1819
Site Code: JHBO17
Accession No: LCNCC: 2017.82
Planning Reference: H09-0540-16

July 2017

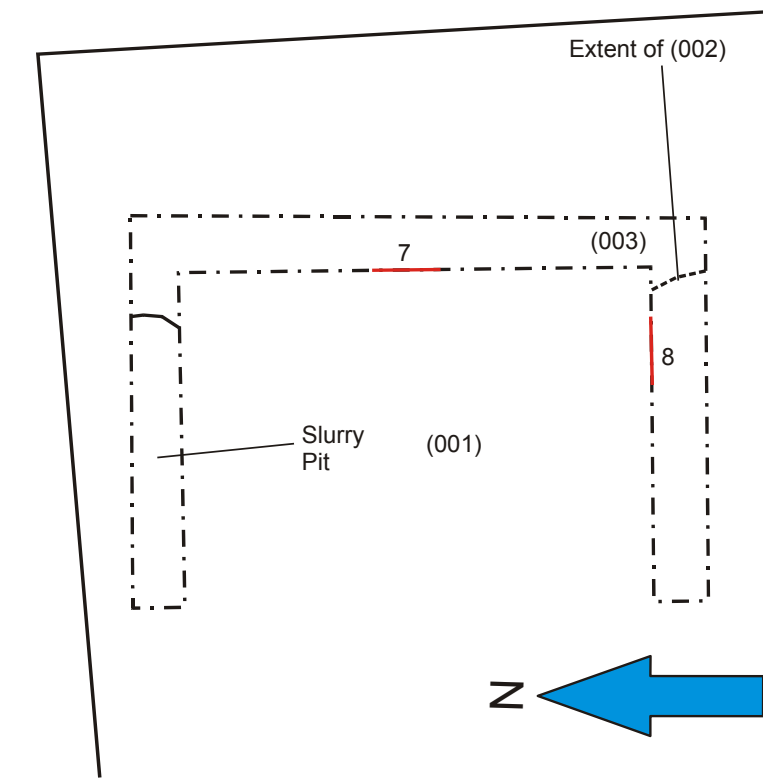
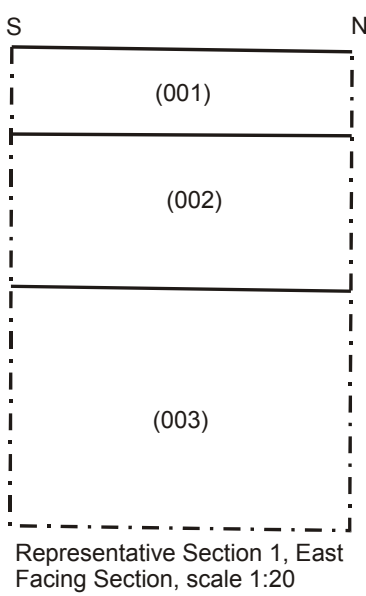
Figure 4 Plan of the Monitored House Plot 1 with Detached Garage at a scale of 1:100 & Representative Sections 1-8 at a scale of 1:20

- 7.1.4 Outside of the area of this first observed deposit sequence, confined to the southern portion and along the western fringes of the monitored new build area, the observed deposit sequence differed and consisted of the aforementioned modern imported landscaping deposit or topsoil horizon (001), an undated buried soil horizon or buried topsoil/ploughsoil horizon (004) and the underlying undated alluvial silt deposit (003), which extended to the base of these excavations. This second deposit sequence was recorded within **Representative Sections 2 and 4 [Plates 5, 19 and 24]**.

- 7.2.2 The excavation of the first foundation trench, which was adjacent and parallel to the northern site boundary extended through the modern imported landscaping deposit or topsoil horizon (001) and the modern made ground deposit (002). Underlying the deposit (002) was a large animal slurry pit which extended to the base of the excavation to a depth of 1.50m below ground levels and which extended along much of the length of this first foundation trench. Towards the eastern end of this first foundation trench, this slurry pit was observed to be cut into the underlying alluvial silt deposit (003). The depth of the foundation trench excavation at the north-eastern corner of the new build area was raised in level to 1.0m below ground levels.

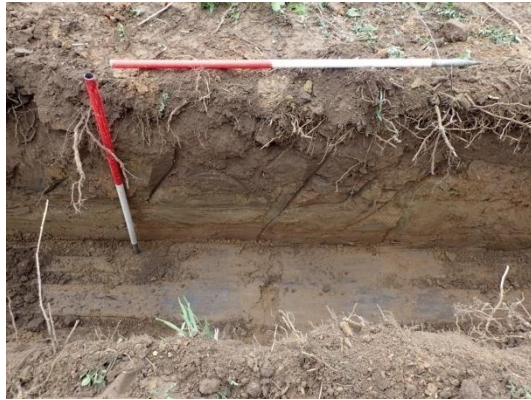
Plate 28: Representative Section 7,
from the east

- 7.2.3 The monitored mechanical excavation of the second foundation trench which ran parallel to the eastern site boundary, extended through the modern imported landscaping deposit or topsoil horizon (001), the undated buried soil horizon or buried topsoil/ploughsoil horizon (004) and the underlying undated alluvial silt deposit (003), which extended to the base of these excavations. This deposit sequence was recorded within **Representative Section 7 [Plate 28]**.

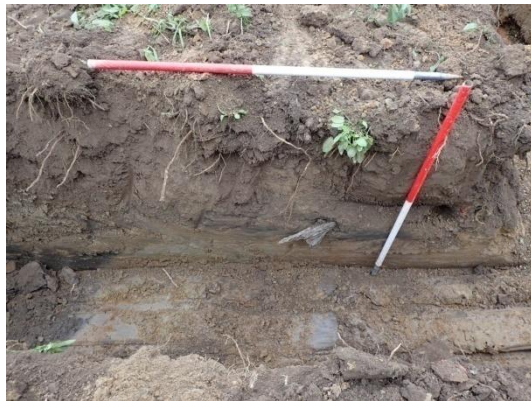
Plate 29: Representative Section 8,
from the south

- 7.2.4 The monitored mechanical excavation of the third and final foundation trench identified a different deposit sequence, which consisted of the modern imported landscaping deposit or topsoil horizon (001), the modern made ground deposit (002) and the underlying undated alluvial silt deposit (003), which extended to the base of these excavations. This deposit sequence was recorded within **Representative Section 8 [Plate 29]**.
