**NEVILLE HALL  
FREELANCE ARCHAEOLOGIST & CONSULTANT**

ARCHAEOLOGICAL MONITORING & RECORDING ON  
LAND TO THE REAR OF 43, CHURCH STREET,  
MIDDLE RASEN, LINCOLNSHIRE.

**National Grid Reference: TF 0870 8941**  
**Site Code: CSMI17**  
**Accession No: LCNCC: 2017.89**  
**Planning Reference: 135071**

June 2017

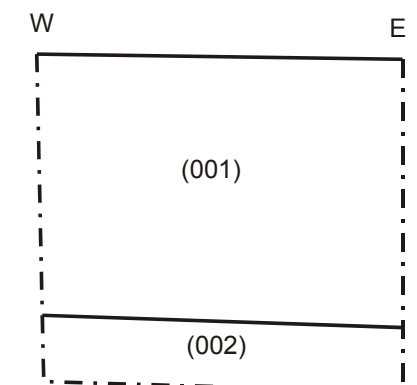
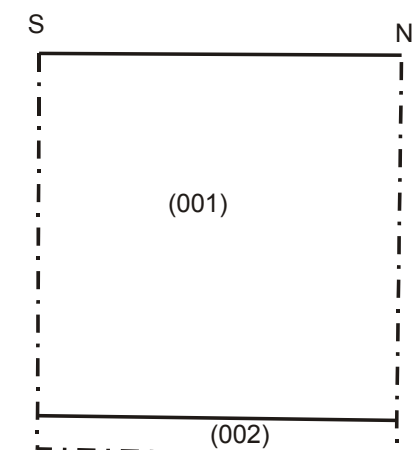
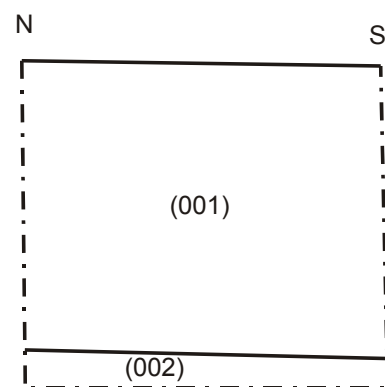
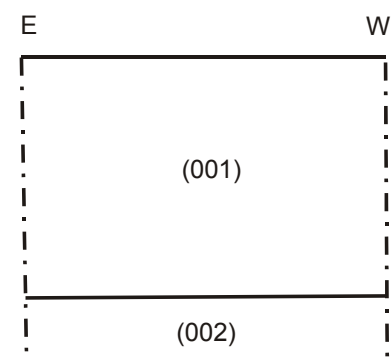
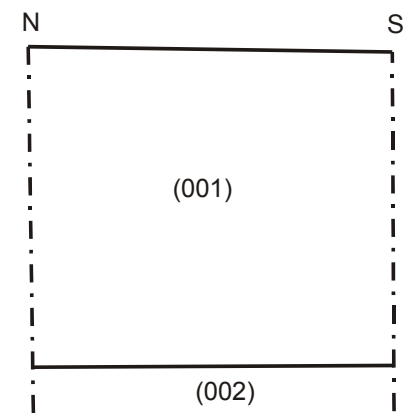
- 7.1.2 The monitored mechanical excavations extended through a deep and substantial topsoil/ploughsoil horizon (**001**), which overlay a natural horizon of sands (**002**), which extended to the base of the foundation trench excavations. This deposit sequence was recorded over this whole monitored area within **Representative Sections 1-5 [Plates 4, 13, 17, 21 and 28]**.

Representative Section 1, South Facing Section, scale 1:20

Representative Section 2, East Facing Section, scale 1:20

Representative Section 3, West Facing Section, scale 1:20

Representative Section 4, North Facing Section, scale 1:20

Representative Section 5, East Facing Section, scale 1:20

Figure 4: Plan of the monitored House Plot foundations at a scale of 1:100 & Representative Sections 1-5 at a scale of 1:20

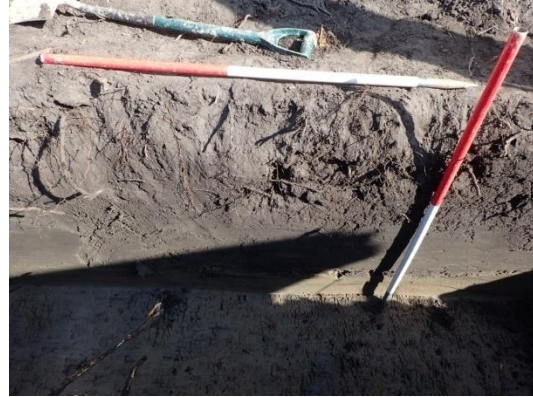
**Plate 4:** Representative Section 1, from the south

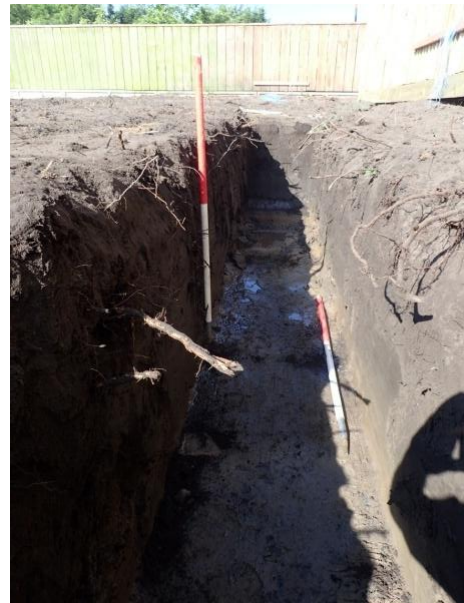
- 7.1.3 During the monitored mechanical excavation of the first foundation trench, which extended parallel to the northern site boundary, the cuts of three undated oval shaped pits - [**003**] with fill (**004**), [**005**] with fill (**006**) and [**007**] with fill (**008**) were observed and recorded at the base of this foundation trench prior to its flooding as this excavation was below the local water table [**Plates 6 and 8**]. No finds were retrieved from any of these pit fills. These features, which were only observed and recorded at the base of the trench excavations, were cut into the natural horizon (**002**) and were sealed by the topsoil/ploughsoil horizon (**001**). A fireplace was excavated towards the eastern end of this first foundation trench, which also exposed the east-west orientated line of a 19th century land drain. This ran parallel to the northern site boundary.

**Plate 6:** View of pit cuts [003] with fill (004) & [005] with fill (006), from the east

- 003** Cut of an undated ovular shaped pit, observed and recorded at the base of the house plot foundation trench excavations. Profile of the pit was not determined as it was not excavated. Cut into **(002)**. Appeared to be truncated by the pit cut **[005]**. Length - >1.20m, width - >0.50m, depth not determined as was not excavated.

- 005** Cut of an undated ovular shaped pit, observed and recorded at the base of the house plot foundation trench excavations. Profile of the pit was not determined as it was not excavated. Cut into **(002)**. Appeared to truncated pit cut **[003]**. Length - 2.05, width - >0.60m, depth not determined as was not excavated.

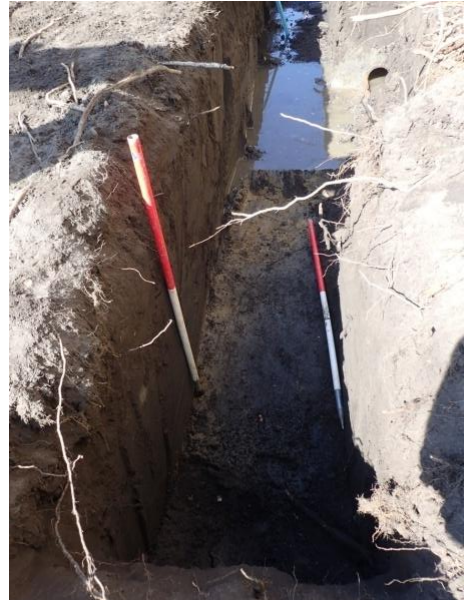
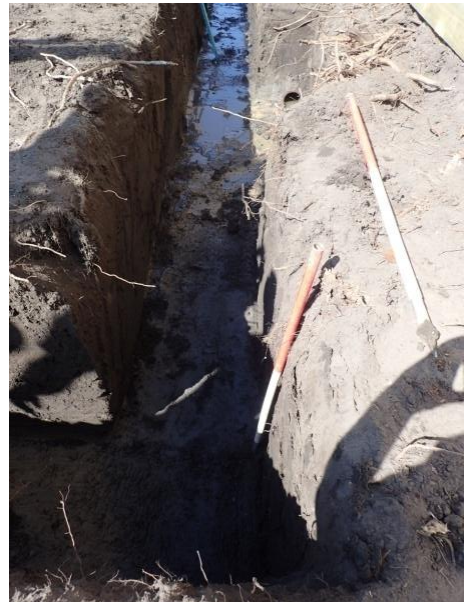
- 7.1.4 At the eastern end of this trench and at the north-eastern corner of the new build area, the excavations of the foundations here revealed the cut of a fourth undated ovular shaped pit [009] with fill (010) [Plates 10-11]. This was similarly only observed and recorded at the base of this excavation prior to the trench flooding. This feature was similarly sealed by the topsoil/ploughsoil horizon (001) and was cut into the natural horizon (002). There were no finds from the fill (010).

**Plate 10:** View of pit cut [009] with fill (010), from the east

**Plate 11:** View of pit cut [009] with fill (010), from the east

- 009** Cut of an undated ovular shaped pit, observed and recorded at the base of the house plot foundation trench excavations. Profile of the pit was not determined as it was not excavated. Cut into **(002)**. Length - >1.80, width - >0.70m, depth not determined as was not excavated.

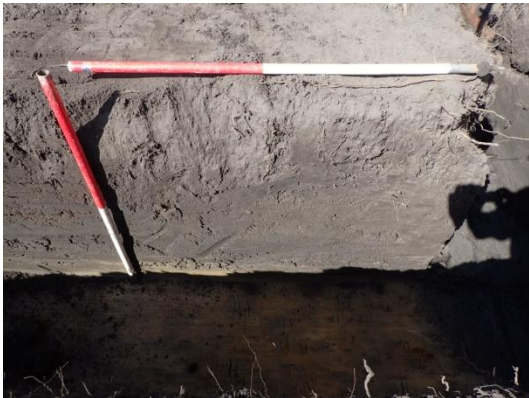
**Plate 13: Representative Section 2,** from the east

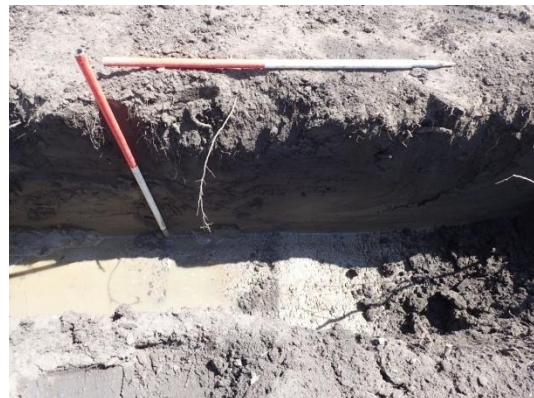
**Plate 17: Representative Section 3,** from the west

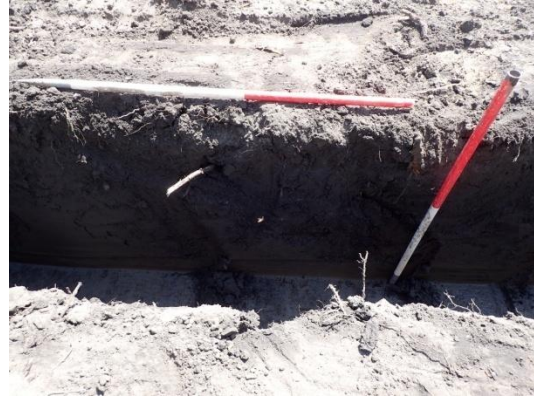
**Plate 21: Representative Section 4,** from the north

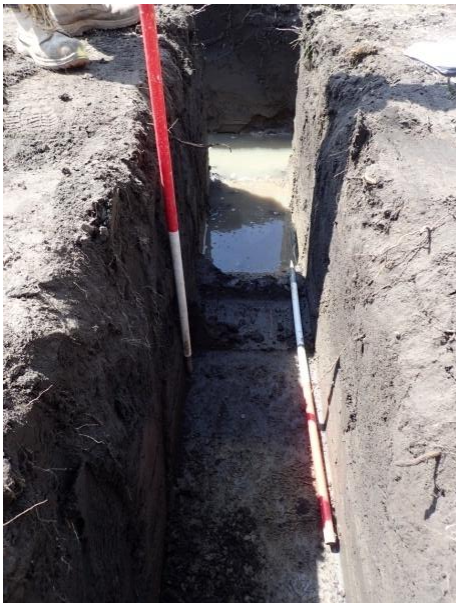
- 7.1.7 During the monitored mechanical excavation of one of the internal foundation trenches, the cut of a north-south orientated undated linear gully [013] with fill (014) was observed and recorded at the base of this excavation [Plate 19]. This feature was similarly sealed by the topsoil/ploughsoil horizon (001) and was cut into the natural horizon (002). There were no finds from the fill (014).

**Plate 19:** View of the linear gully cut [013] with fill (014), from the east

- 013** Cut of an undated north-south aligned linear gully, observed and recorded at the base of the house plot foundation trench excavations. Profile of the gully was not determined as it was not excavated. Cut into **(002)**. Length - >0.60m, width - 0.70m, depth not determined as was not excavated.

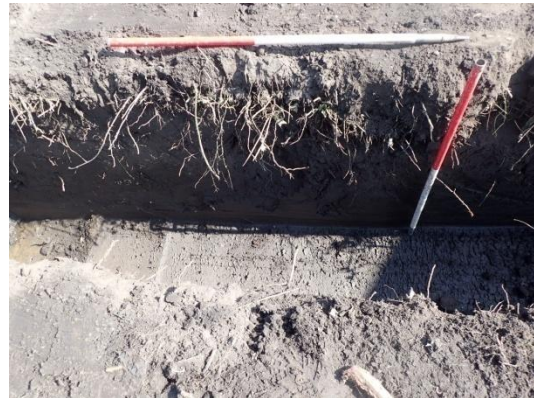
**Plate 28: Representative Section 5,**  
from the east

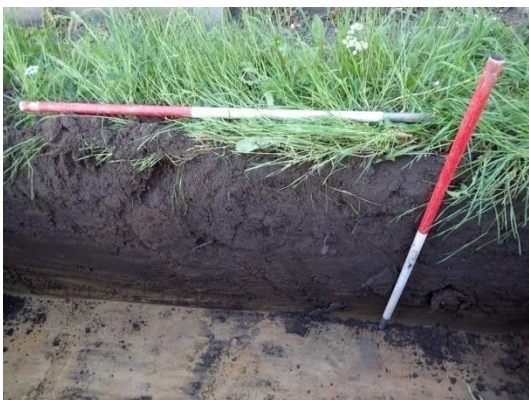
**Plate 32: Representative Section 6,**  
from the west

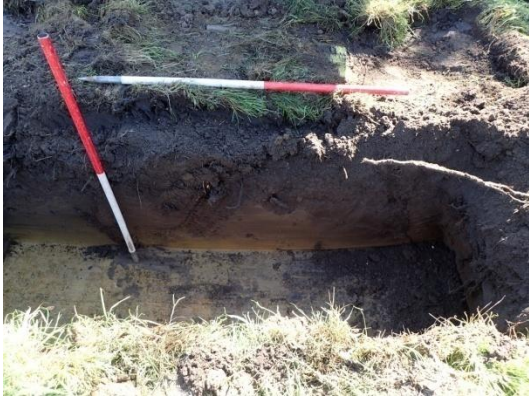
**Plate 36: Representative Section 7,**  
from the east
