**NEVILLE HALL
FREELANCE ARCHAEOLOGIST & CONSULTANT**

ARCHAEOLOGICAL MONITORING & RECORDING AT
9B, INGHAM ROAD,
STOW, LINCOLNSHIRE.

National Grid Reference: SK 8863 8215
Site Code: IRST16
Accession No: LCNCC: 2016.96
Planning Reference: 134431

September 2017

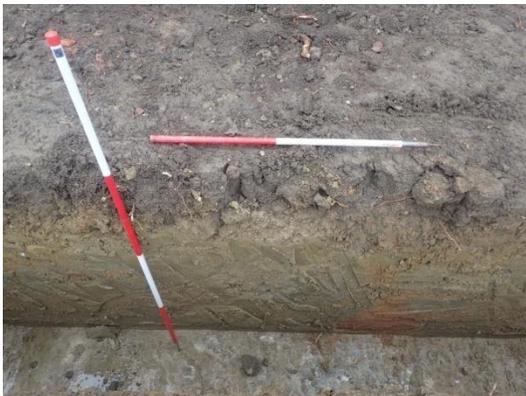
Plate 39: Representative Section 1, from the east

7.3.2 The first foundation trench to be excavated extended along and parallel to the western site boundary. The southern end of this trench extended through the new build footprint of the integrated garage. These excavations extended through the remainder of the buried modern topsoil horizon (005), an undated buried ploughsoil horizon (006), a natural horizon (007) and the mudstone bedrock (008) at the base of these excavations. This deposit sequence was recorded within **Representative Section 1** [Plate 39]. This same deposit sequence remained consistent throughout the area of the garage build footprint.

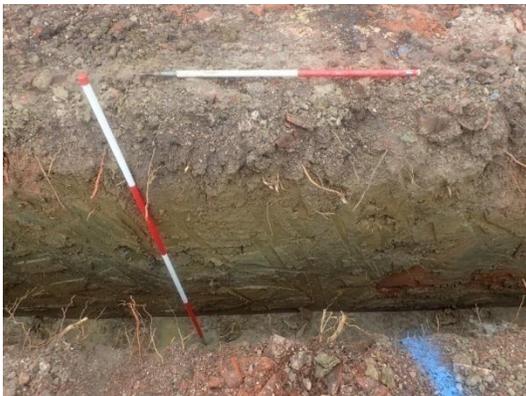
Plate 45: Representative Section 2, from the east

7.3.3 As the excavation of this foundation trench continued to the north, it extended into the new house plot build footprint. Here the mechanical excavation of this trench extended through the modern made ground deposit (001), the undated buried ploughsoil horizon (006), a natural horizon (007) and the mudstone bedrock (008) at the base of this excavation. This deposit sequence was recorded within **Representative Section 2** [Plate 45].

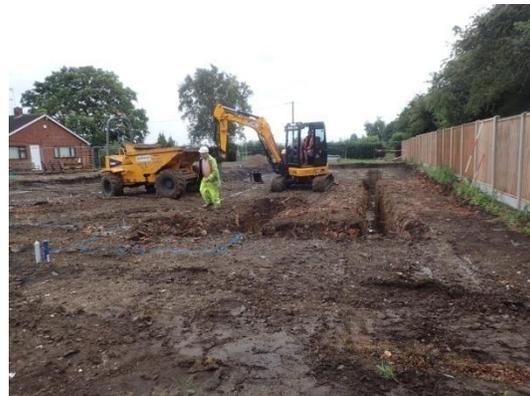
Plate 52: Representative Section 3, from the north

7.3.4 To the east, and within the build footprint of the new house plot, this same deposit sequence of modern made ground deposit (001), the undated buried ploughsoil horizon (006), a natural horizon (007) and the mudstone bedrock (008) at the base of this excavation continued and was recorded during the excavation of the foundation trenches here within **Representative Section 3** [Plate 52].

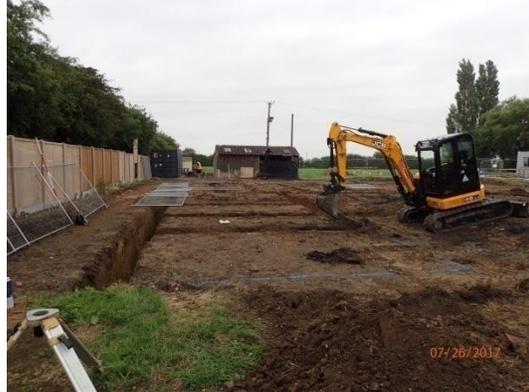
Plate 79: Representative Section 7, from the east

and consisted of the buried modern topsoil horizon (005), the undated buried ploughsoil horizon (006), the natural horizon (007) and the mudstone bedrock (008) at the base of the excavations here. This deposit sequence was recorded within **Representative Section 7 [Plate 79]**.

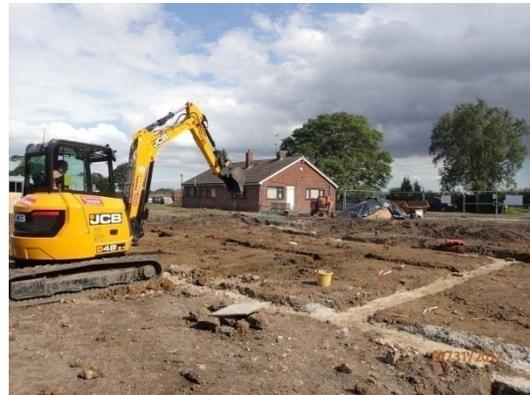
Plate 98: Representative Section 8, from the north

- 7.3.7 This was followed by the resumption of the monitored mechanical excavation of the remaining foundation trenches within the build footprint of the new house plot. Here within the central and eastern portions of the new house plot, the recorded deposit sequence consisting of the undated buried ploughsoil horizon (006), the natural horizon (007) and the mudstone bedrock (008) at the base of these excavations remained consistent with that recorded earlier in the groundworks programme here. This deposit sequence was recorded within **Representative Sections 8-9 [Plates 98 and 111]**.
