AN ARCHAEOLOGICAL WATCHING BRIEF
ON LAND OFF HIGH STREET AND SWINDERBY ROAD,
EAGLE, LINCOLNSHIRE.

National Grid Reference: SK 8765 6674
Site Code: HSEA16
Accession No: LCNCC: 2016.20
Planning Reference: 15/0620/FUL

PREPARED FOR MS JANE GOODRIDGE OF BENTLEY HOMES LTD.

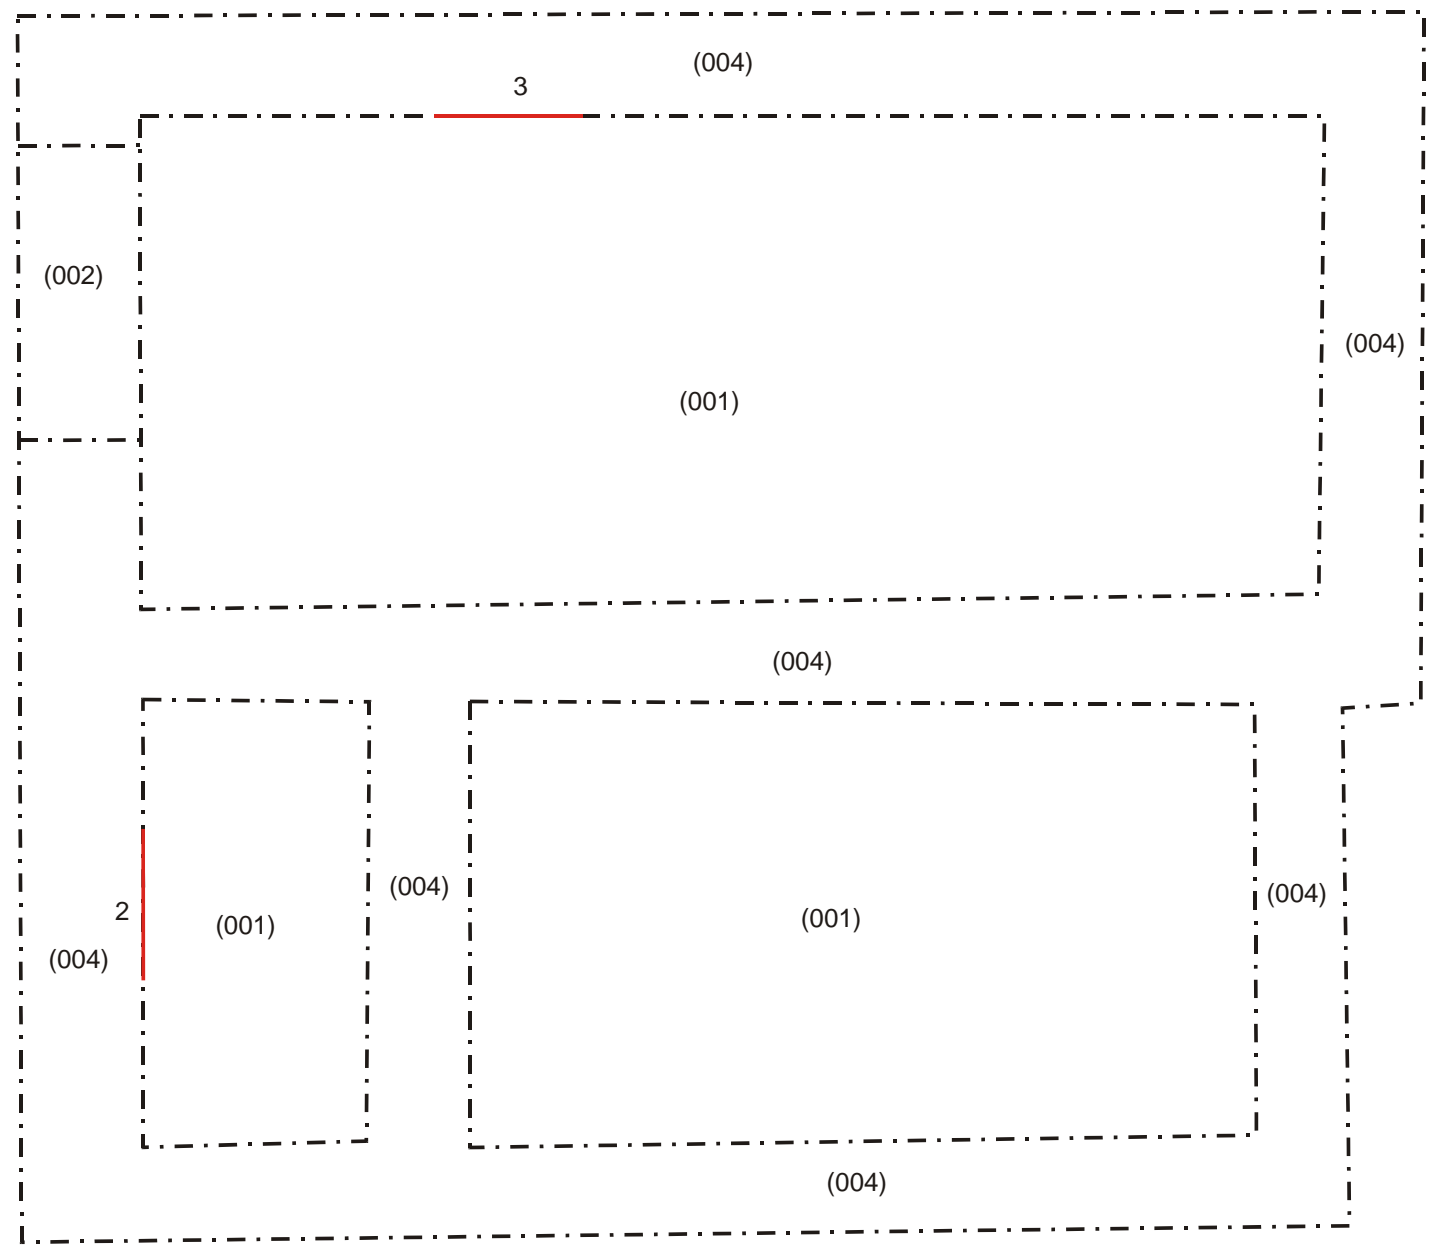
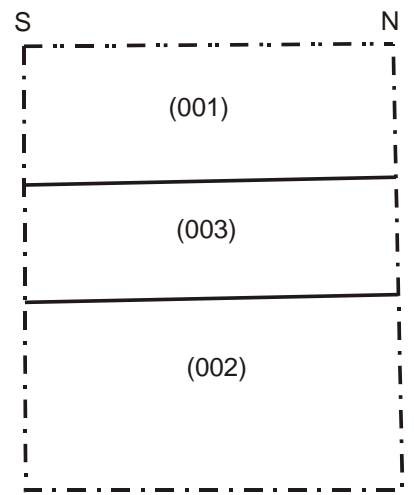
Figure 5: Plan of the Monitored House Plot 5 at a scale of 1:100 & Representative Sections 1-3 at a scale of 1:20

Representative Section 1, East Facing Section, scale 1:20

House Plot 5, Representative Section 2, East facing Section, scale 1:20

- 7.2.1 The foundations for House Plot 5 had already been set out prior to arrival [Plate 39]. The foundations for this house plot were mechanically excavated under archaeological supervision to varying lengths, to widths of between 0.70m-0.80m and to depths of between 1.10m-2.40m below already reduced site levels [Plates 40-41, 43-50 and 52]. These mechanical excavations, which were undertaken by an 8-ton 360° mechanical excavator that was fitted with a 0.80m wide toothed bucket and a 20-ton 360° mechanical excavator that was fitted with a 0.70m wide toothed bucket, extended through the remainder of the topsoil horizon (001) and into the underlying natural horizon (002), which extended to the base of these excavations here. This deposit sequence was recorded within Representative Sections 2-3 [Plates 42 and 51]. Where these mechanical excavations extended to greater depths, a second natural horizon (003) was identified underlying the second natural horizon (002).

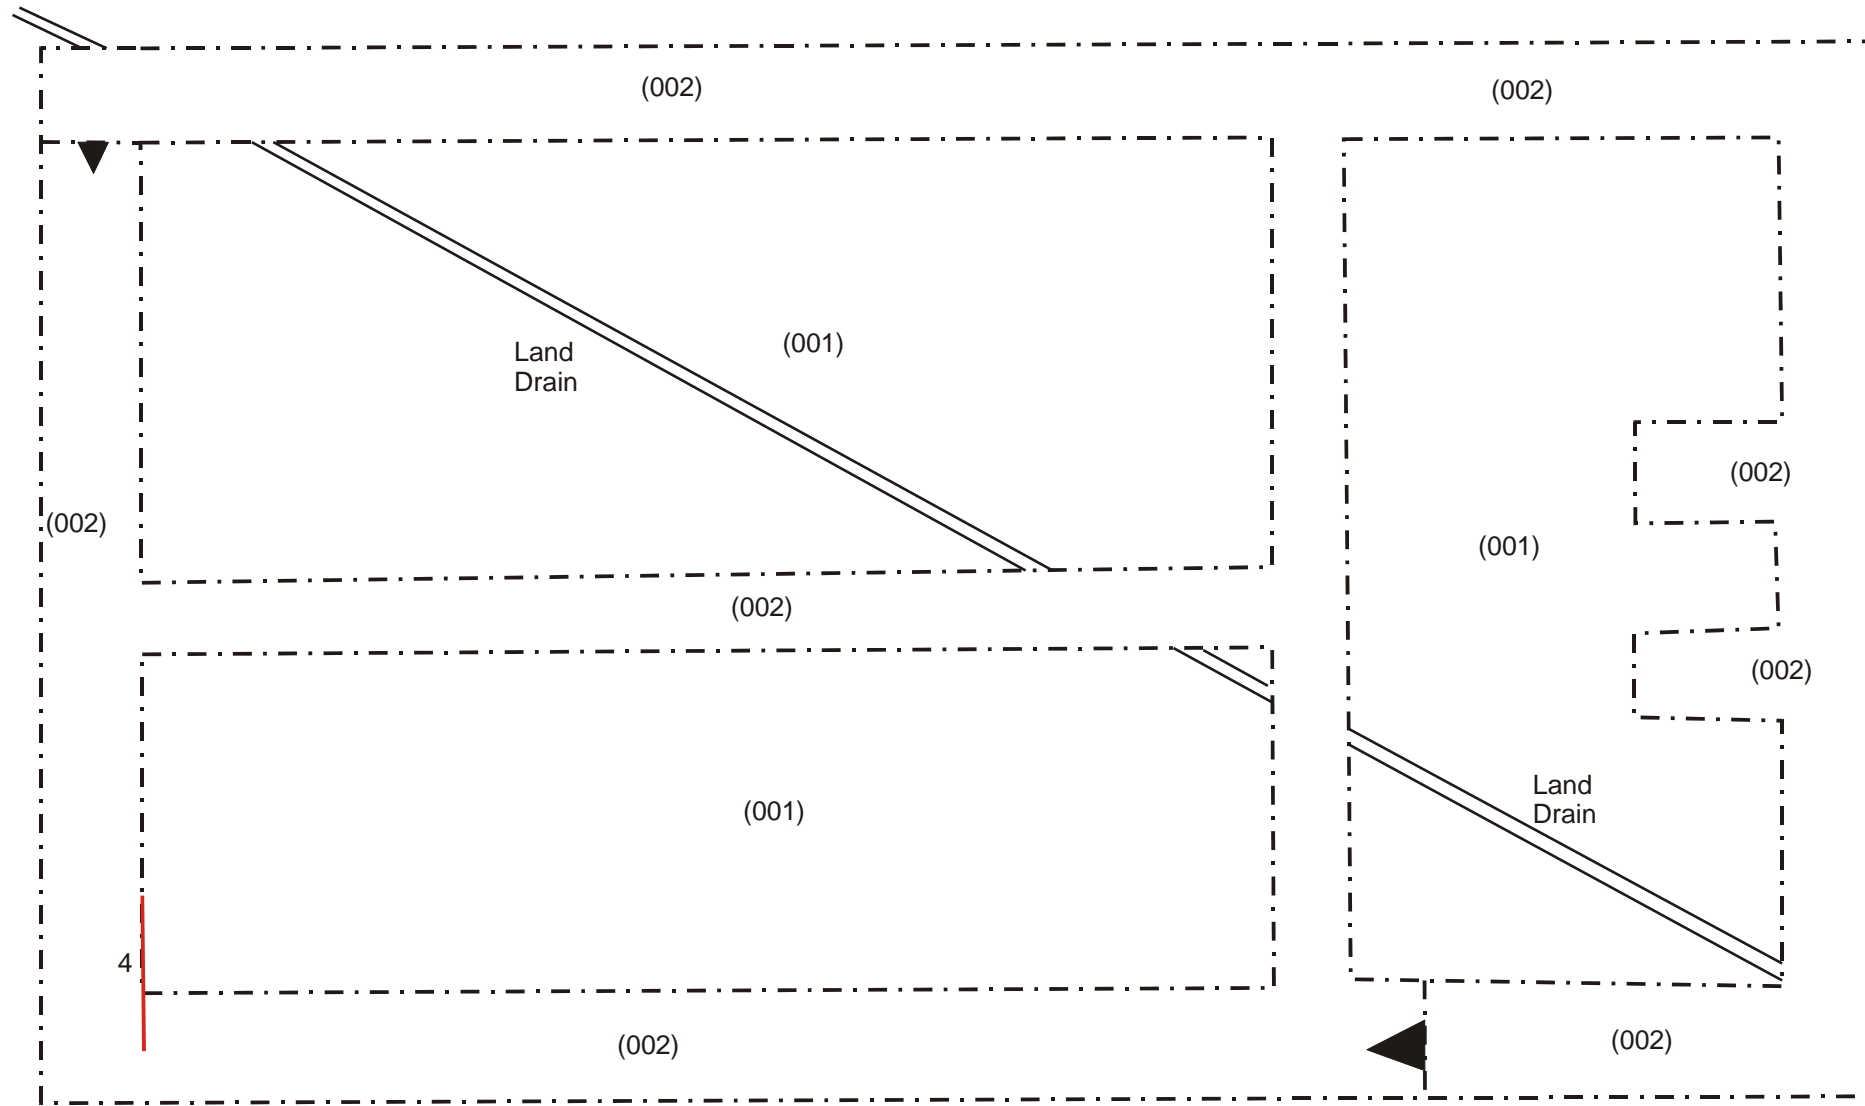
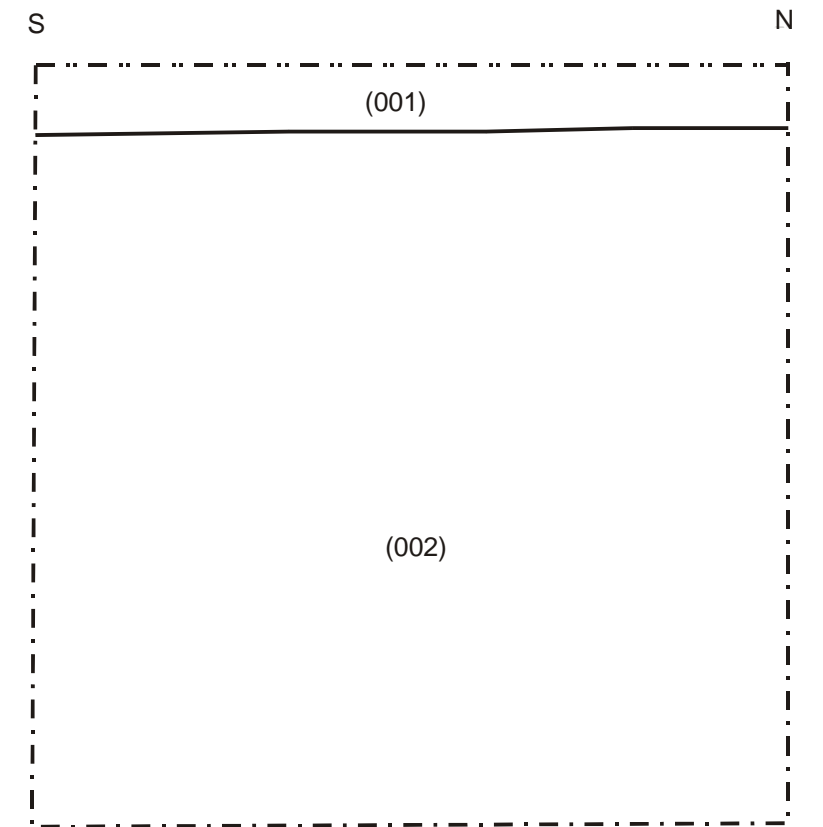
Figure 6: Plan of the Monitored House Plot 10 at a scale of 1:50 & Representative Section 4 at a scale of 1:10

House Plot 10, Representative Section 4, East Facing Section, scale 1:10

- 7.3.1 The foundations for this second house plot were mechanically excavated under archaeological supervision to varying lengths, to widths of between 0.50m-0.80m and to depths of between 0.70m-1.40m below already reduced site levels [**Plates 54-55**]. These mechanical excavations, which were undertaken by an 8-ton 360° mechanical excavator that was fitted with 0.50m and 0.80m wide toothed buckets, extended through the remnant of the topsoil horizon (**001**) (left after the initial site strip noted earlier), and through the underlying natural horizon (**002**), which extended to the base of these excavations. This deposit sequence was recorded within **Representative Section 4 [Plate 53]**.
- 7.3.2 No archaeological activity was identified within the area of this house plot, and there were no finds.

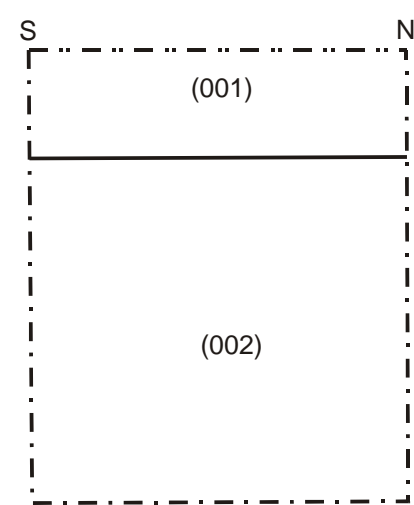
Figure 7: Plan of the Monitored House Plot 11 at a scale of 1:50 & Representative Section 5 at a scale of 1:20

House Plot 11, Representative Section 5, East facing Section, scale 1:20

- 7.4.1 The foundations for this house plot were mechanically excavated under archaeological supervision to varying lengths, to widths of 0.60m and to depths of between 0.80m-1.20m below already reduced site levels [**Plate 57**]. These mechanical excavations, which were undertaken by an 8-ton 360° mechanical excavator that was fitted with a 0.50m toothed bucket, extended through the remnant of the topsoil horizon (**001**) (left after the initial site strip noted earlier), and through the underlying natural horizon (**002**), which extended to the base of these excavations. This deposit sequence was recorded within **Representative Section 5 [Plate 56]**.
- 7.4.2 No archaeological activity was identified within the area of this house plot, and there were no finds.

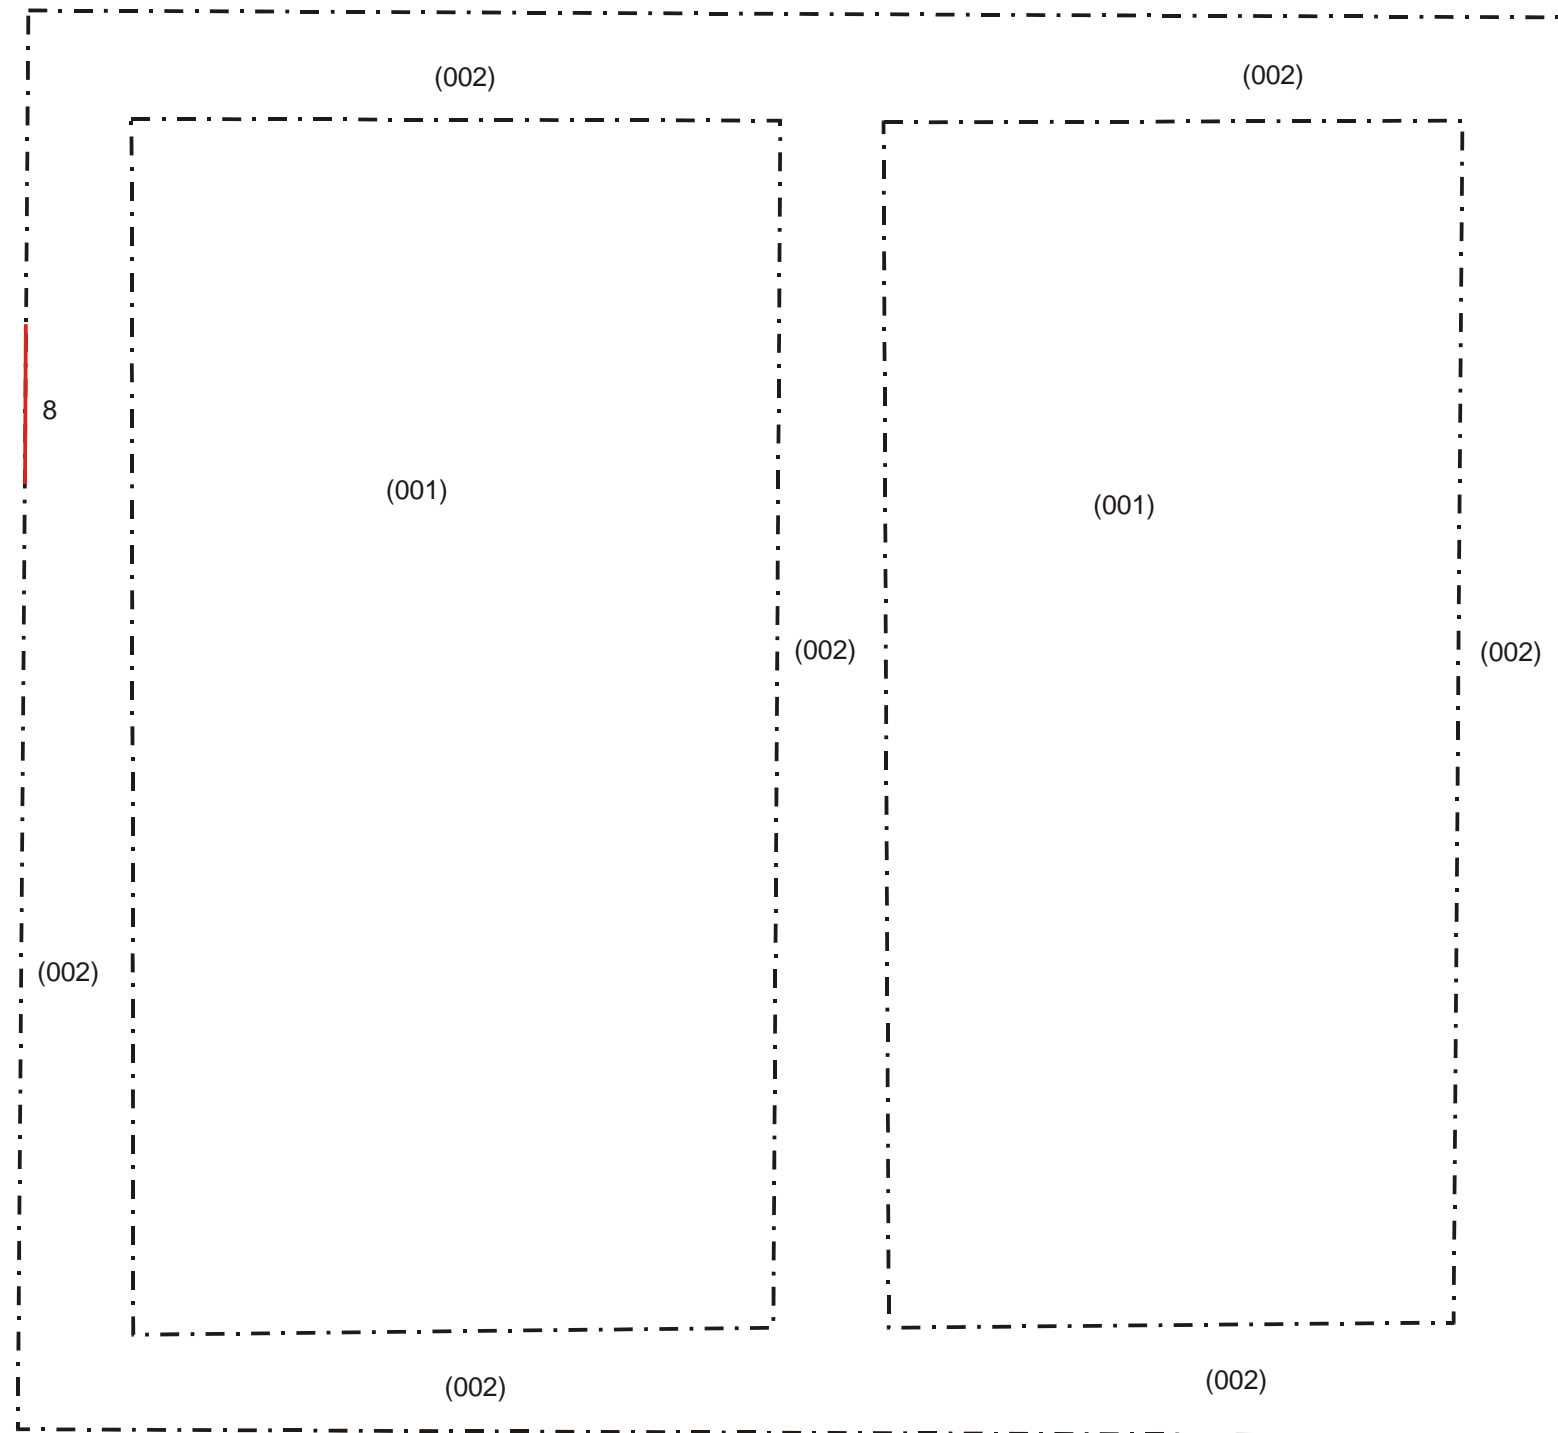
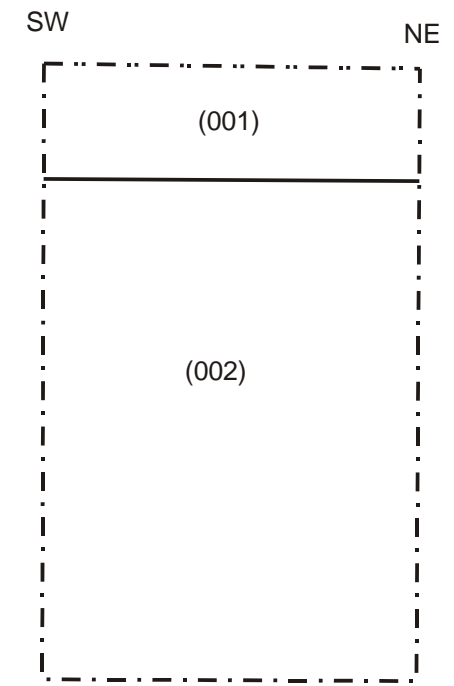
Figure 10: Plan of the Monitored House Plots 6 and 7 at a scale of 1:50 & Representative Section 8 at a scale of 1:20

House Plots 6 and 7, Representative Section 8, South-East Facing Section, scale 1:20

- 7.7.1 The foundations for these two semi-detached house plots were mechanically excavated under archaeological supervision to varying lengths, to a width of 0.70m and to depths of between 1.0m-1.70m below already reduced site levels [**Plate 65**]. These mechanical excavations, which were undertaken by an 8-ton 360° mechanical excavator that was fitted with a 0.50m wide toothed bucket, extended through the remnant of the topsoil horizon (**001**) (left after the initial site strip noted earlier), and through the underlying natural horizon (**002**), which extended to the base of these excavations. This deposit sequence was recorded within **Representative Section 8**.
- 7.7.2 No archaeological activity was identified within the area of these house plots, and there were no finds.

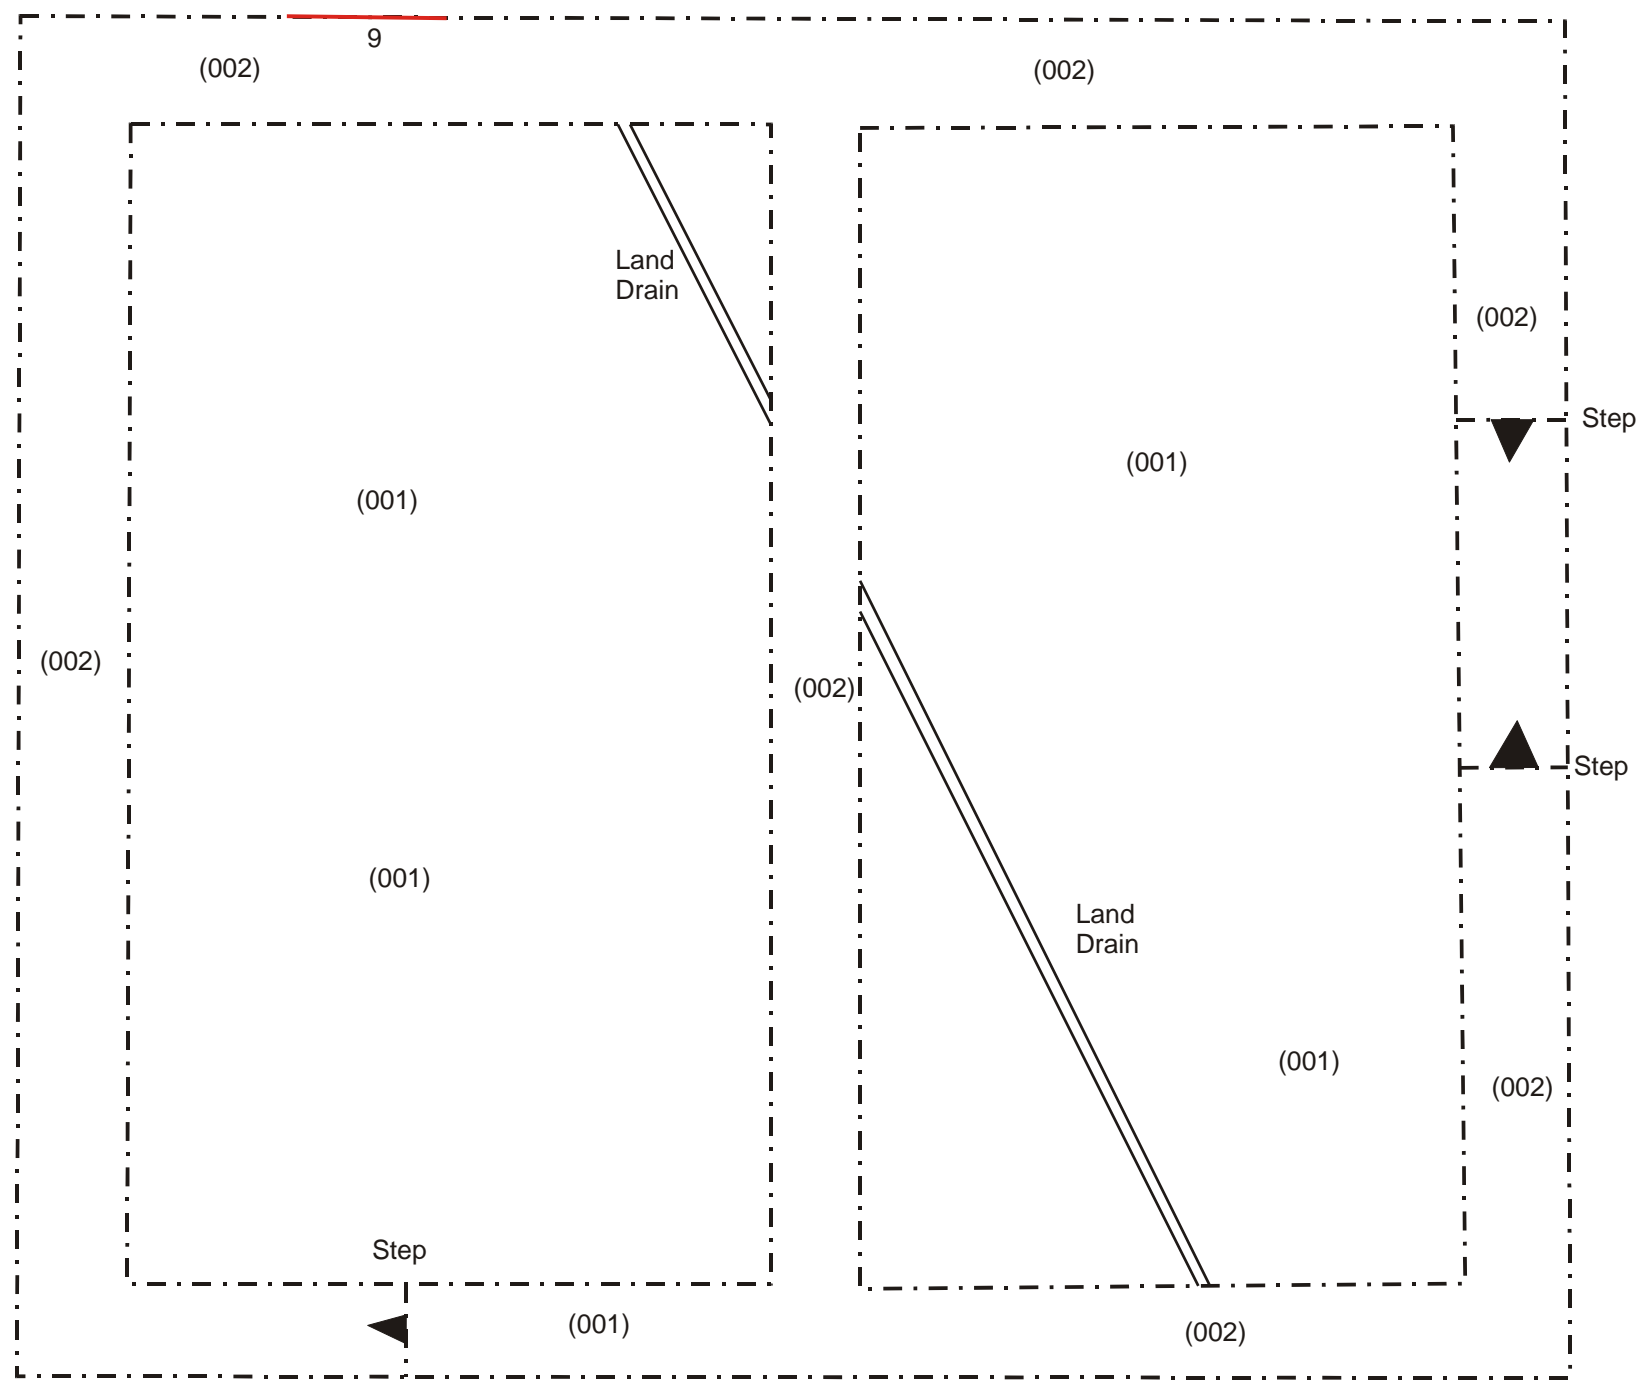
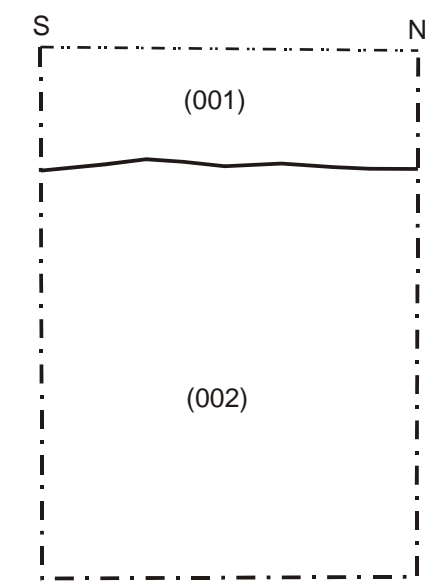
Figure 11: Plan of the Monitored House Plot 8 and 9 at a scale of 1:50 & Representative Section 9 at a scale of 1:20

House Plots 8 and 9, Representative Section 9, East Facing Section, scale 1:20

- 7.8.1 The foundations for these two semi-detached house plots were mechanically excavated under archaeological supervision to varying lengths, to widths of between 0.50m-0.70m and to depths of between 1.0m-1.90m below already reduced site levels [**Plate 66**]. These mechanical excavations, which were undertaken by an 8-ton 360° mechanical excavator that was fitted with 0.50m and 0.70m wide toothed buckets extended through the remnant of the topsoil horizon (**001**) (left after the initial site strip noted earlier), and through the underlying natural horizon (**002**), which extended to the base of these excavations. This deposit sequence was recorded within **Representative Section 9**.
- 7.8.2 No archaeological activity was identified within the area of these house plots, and there were no finds.

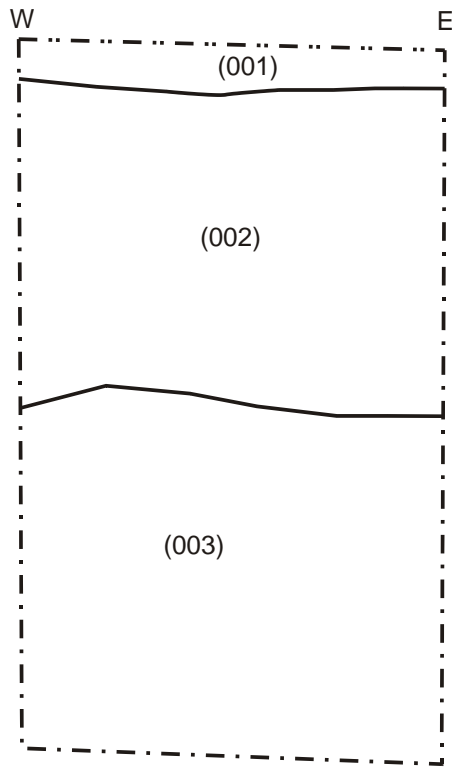
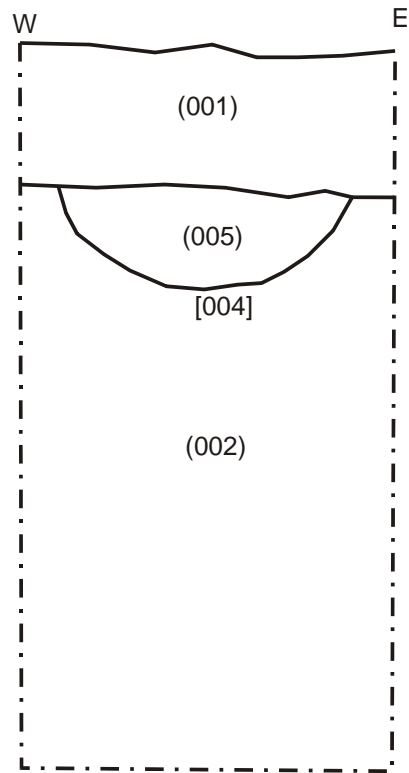
**Figure 12: Representative Sections 10-11 at a
scale of 1:20**

Foul Sewer Trench, Representative Section 11,
South Facing Section, scale 1:20

Second Service Trench, Representative
Section 10, South Facing Section,
scale 1:20

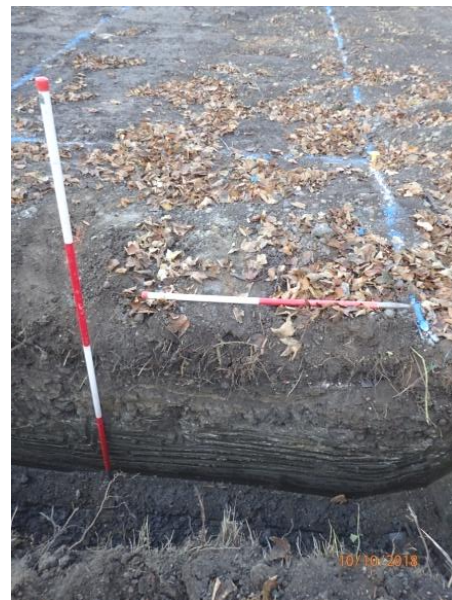
Plate 42: House Plot 5. Representative Section 2, from the east

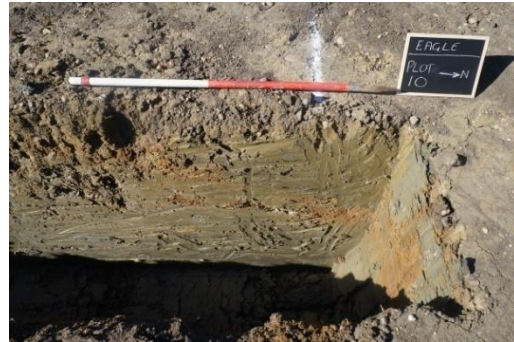
Plate 53: House Plot 10, Representative Section 4, from the east

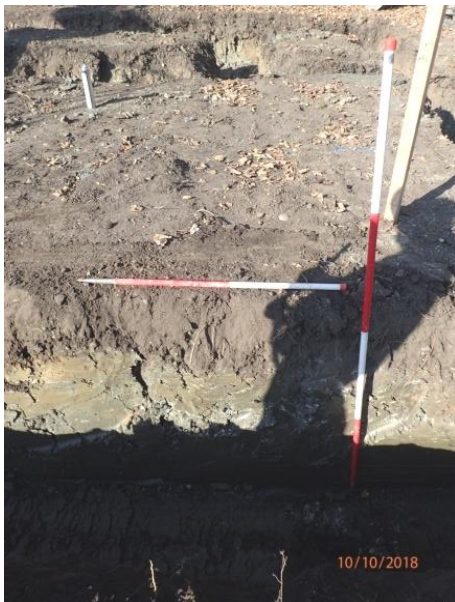
Plate 51: House Plot 5, Representative Section 3, from the south

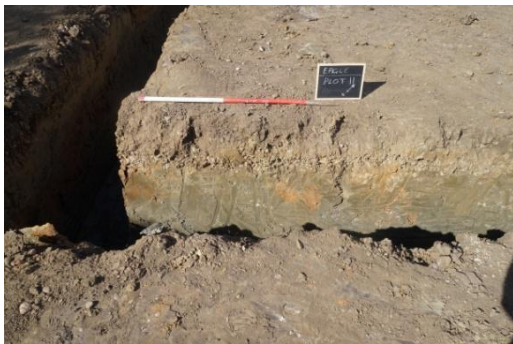
Plate 56: House Plot 11, Representative Section 5, from the east

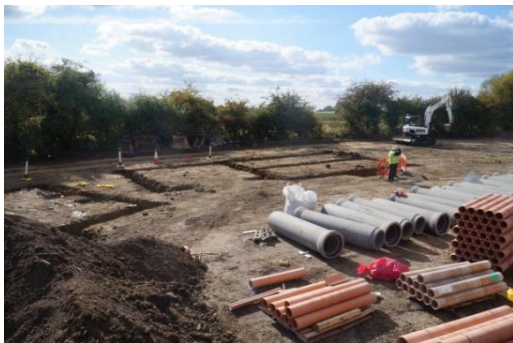
Plate 57: House Plot 11, excavated foundation trenches, from the north

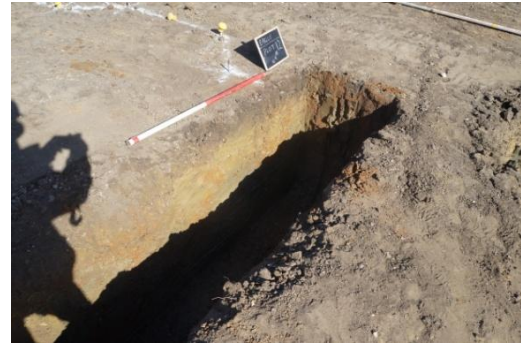
Plate 58: House Plot 12, Representative Section 6, from the south-east

- 7.5.1 The foundations for this house plot were mechanically excavated under archaeological supervision to varying lengths, to a width of 0.60m and to depths of between 0.90m-1.10m below already reduced levels [**Plate 60**]. These mechanical excavations, which were undertaken by an 8-ton 360° mechanical excavator that was fitted with a 0.50m wide toothed bucket, extended through the remnant of the topsoil horizon (**001**) (left after the initial site strip noted earlier), and through the underlying natural horizon (**002**), which extended to the base of these excavations. This deposit sequence was recorded within **Representative Section 6 [Plates 58-59]**.
- 7.5.2 No archaeological activity was identified within the area of this house plot, and there were no finds.

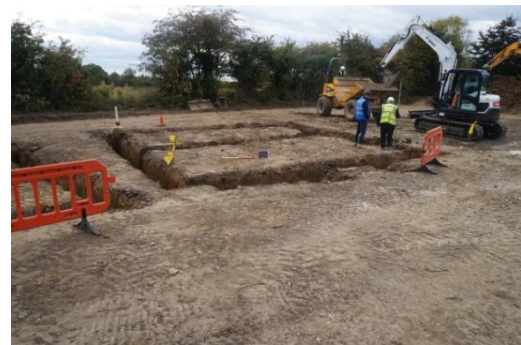
Plate 60: House Plot 12, excavated foundation trenches, from the north

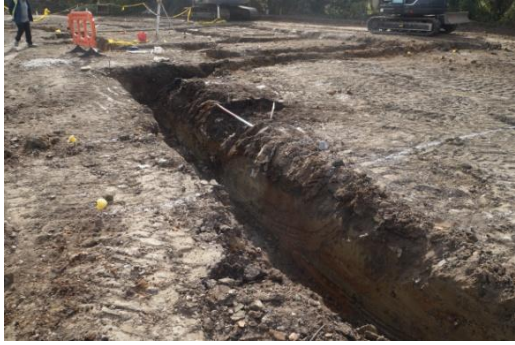
Plate 61: House Plot 13, excavated foundation trenches, from the west

- 7.6.1 The foundations for this house plot were mechanically excavated under archaeological supervision to varying lengths, to widths of between 0.50m-0.80m and to depths of between 0.70m-1.30m below already reduced levels [**Plates 61 and 63-64**]. These mechanical excavations, which were undertaken by an 8-ton 360° mechanical excavator that was fitted with 0.50m and 0.80m wide toothed buckets, extended through the remnant of the topsoil horizon (**001**) (left after the initial site strip noted earlier), and through the underlying natural horizon (**002**), which extended to the base of these excavations. This deposit sequence was recorded within **Representative Section 7 [Plate 62]**.

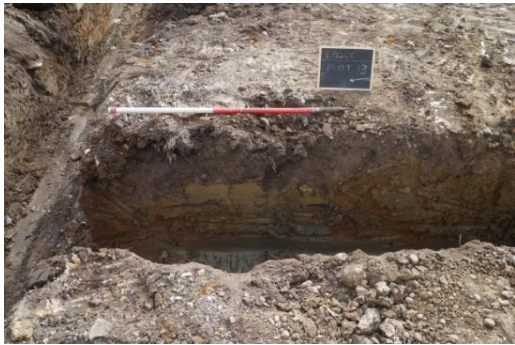
Plate 62: House Plot 13, Representative Section 7, from the north
