ARCHAEOLOGICAL MONITORING & RECORDING
ON LAND OPPOSITE 233, BROADGATE,
WESTON HILLS, LINCOLNSHIRE.

National Grid Reference: TF 2762 1960
Site Code: BGWH18
Accession No: LCNCC: 2018.177
Planning Reference: H22-0558-18

PREPARED FOR MR. ADRIAN BROTHERTON OF ASHGROVE ASSOCIATES

June 2019

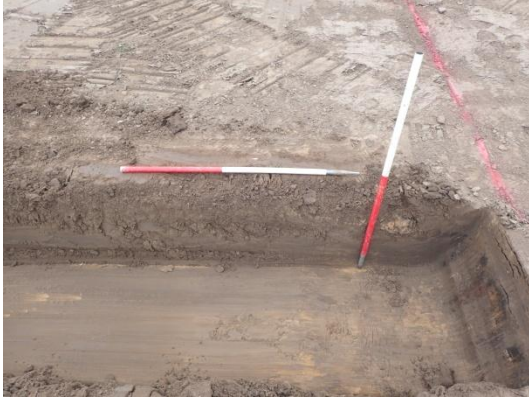
Plate 55: Representative Section 8,
from the north

- 7.3.1 This was followed by the archaeological monitoring of the mechanical excavation of the foundation trenches for **House Plot 2**, which was located to the south of **House Plot 1**. These foundation trenches were excavated from already reduced site ground levels to varying lengths, to widths of 0.80m for outside walls and of 0.45m in width for internal walls, and to depths of between 0.50m-0.80m below reduced levels [**Plates 54; 56-58; 60-61; 63-66; 68-71; 73-74 and 76-78**].
- 7.3.2 These monitored mechanical excavations extended through the remainder of the modern topsoil horizon (**001**) and into the upper levels of the underlying alluvial silt horizon (**002**), which extended to the base of these excavations. This deposit sequence was recorded within **Representative Sections 8-13** [**Plates 55; 59; 62; 67; 72 and 75**].

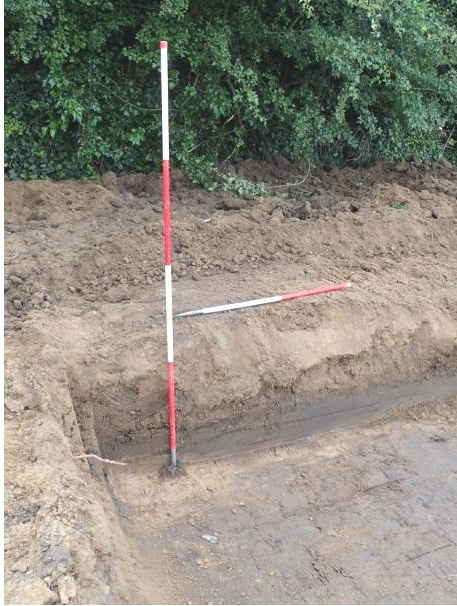
Plate 97: Representative Section 14, from the north

7.4.4 Over most of this area of ground reduction, the modern dumped deposit (**003**) was encountered at the base of this excavation. Modern fragments of plastic and sweet wrappers along with an aluminium can ring pull and sherds of modern 20th century pottery were recovered from this dumped deposit (**003**). This deposit sequence was recorded within **Representative Section 14 [Plate 97]**. It was also observed that this area of modern dumped deposits extended as far northwards as the southern portion of the adjoining **House Plot 2**, where this dumped deposit was observed within two of the southernmost foundation trenches here.

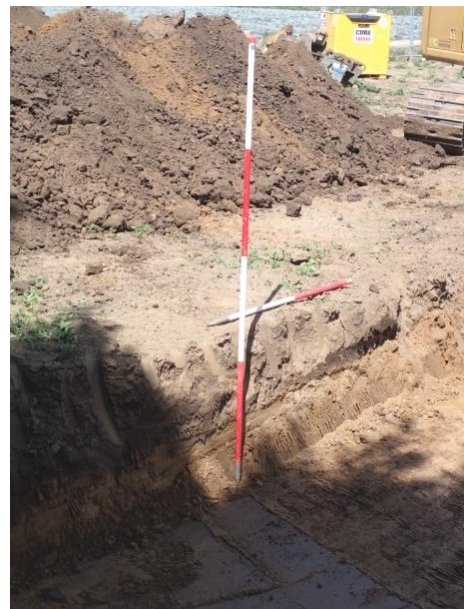
Plate 102: Representative Section 15, from the south-east

7.4.5 Only at the western end of this area of ground reduction, was the usual and familiar site deposit sequence consisting of the modern topsoil horizon (**001**) and the underlying undated alluvial silt horizon (**002**) encountered. The deposit sequence here was recorded within **Representative Section 15 [Plate 102]**. The western edge of this area of modern dumping was also noted here.
