**NEVILLE HALL
FREELANCE ARCHAEOLOGIST & CONSULTANT**

ARCHAEOLOGICAL MONITORING AND RECORDING AT
HORTECH SYSTEMS LTD., HALL GATE,
HOLBEACH, LINCOLNSHIRE.

National Grid Reference: TF 3577 2444
Site Code: HGHO20
Accession No: LCNCC: 2020.18
Planning Reference: H09-1086-19

October 2020

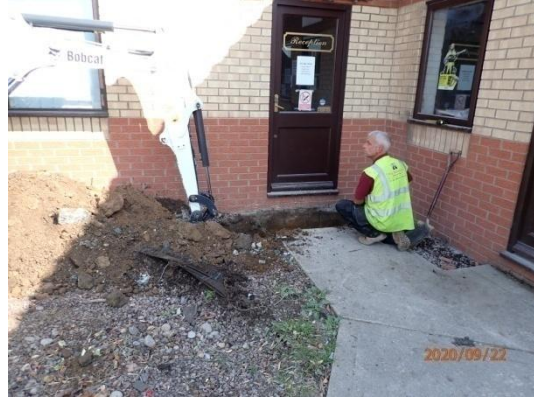
Plate 10: Excavation of the foundations, from the west

stanchion bases. The various strip foundation trenches, (the extent of which are featured on **Figure 6**), were excavated under archaeological supervision to varying lengths, to widths of between 0.80m-0.90m and to depths of 0.60m-0.80m below the yard levels. Within the area of these strip foundation trenches and also to the rear of the new build area, the five stanchion bases were also mechanically excavated under archaeological supervision (Stanchion Bases 1-5). The extent and position of these various further foundation excavations are also shown on **Figure 6**. These five stanchion bases were excavated to depths of between 0.80m-1.0m below the yard levels [**Plates 8-11, 13-22, 24-29, 32-35, 33-45 and 47-52**].

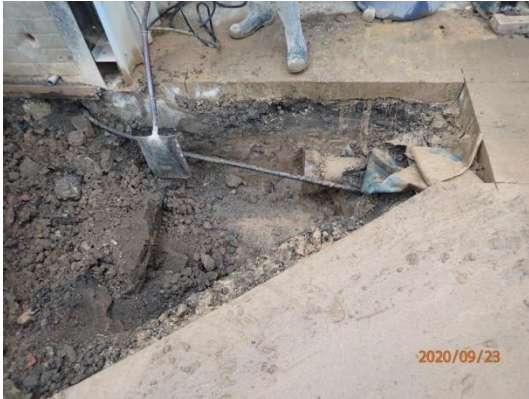
Plate 31: Hand excavations around the area of a modern drain, from the north

- 7.4 Simultaneously with these foundation excavations, the aforementioned exposed modern brick lined drain and connecting ceramic pipe in the south-eastern part of the new build area were both removed by hand [**Plate 31**]. Here this drain was found to be cut into the alluvial silt horizon (**002**), which also extended to the base of the excavations here.
