**NEVILLE HALL
FREELANCE ARCHAEOLOGIST & CONSULTANT**

ARCHAEOLOGICAL MONITORING & RECORDING ON
PLOT 2, LAND ADJACENT TO 2, CHURCH STREET,
GLENTWORTH, LINCOLNSHIRE.

Site Code: CSGE20

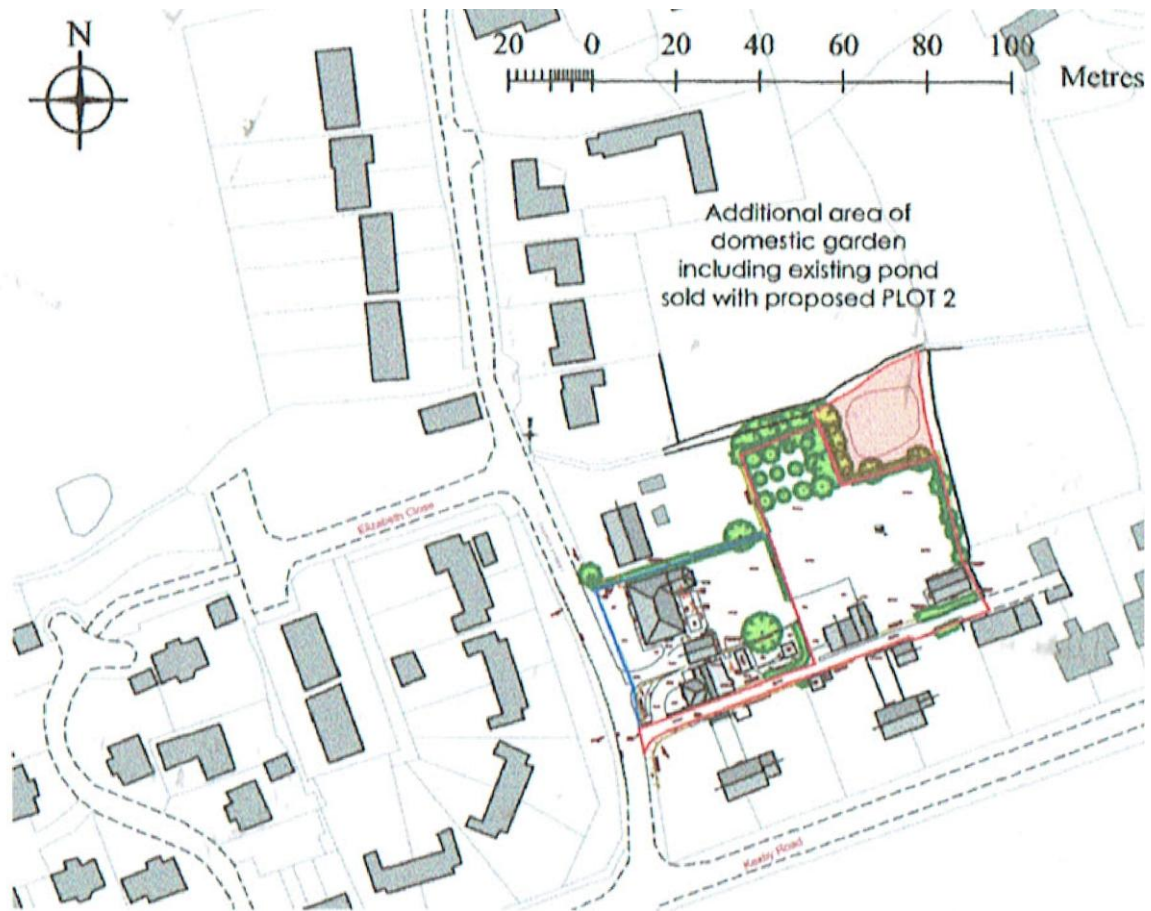
Figure 2: Site location at an original scale of 1:1,250 showing the existing site layout, (not to scale), (extract from Architects plan)

- 5.23 **Figure 2** shows the existing layout of the development site.

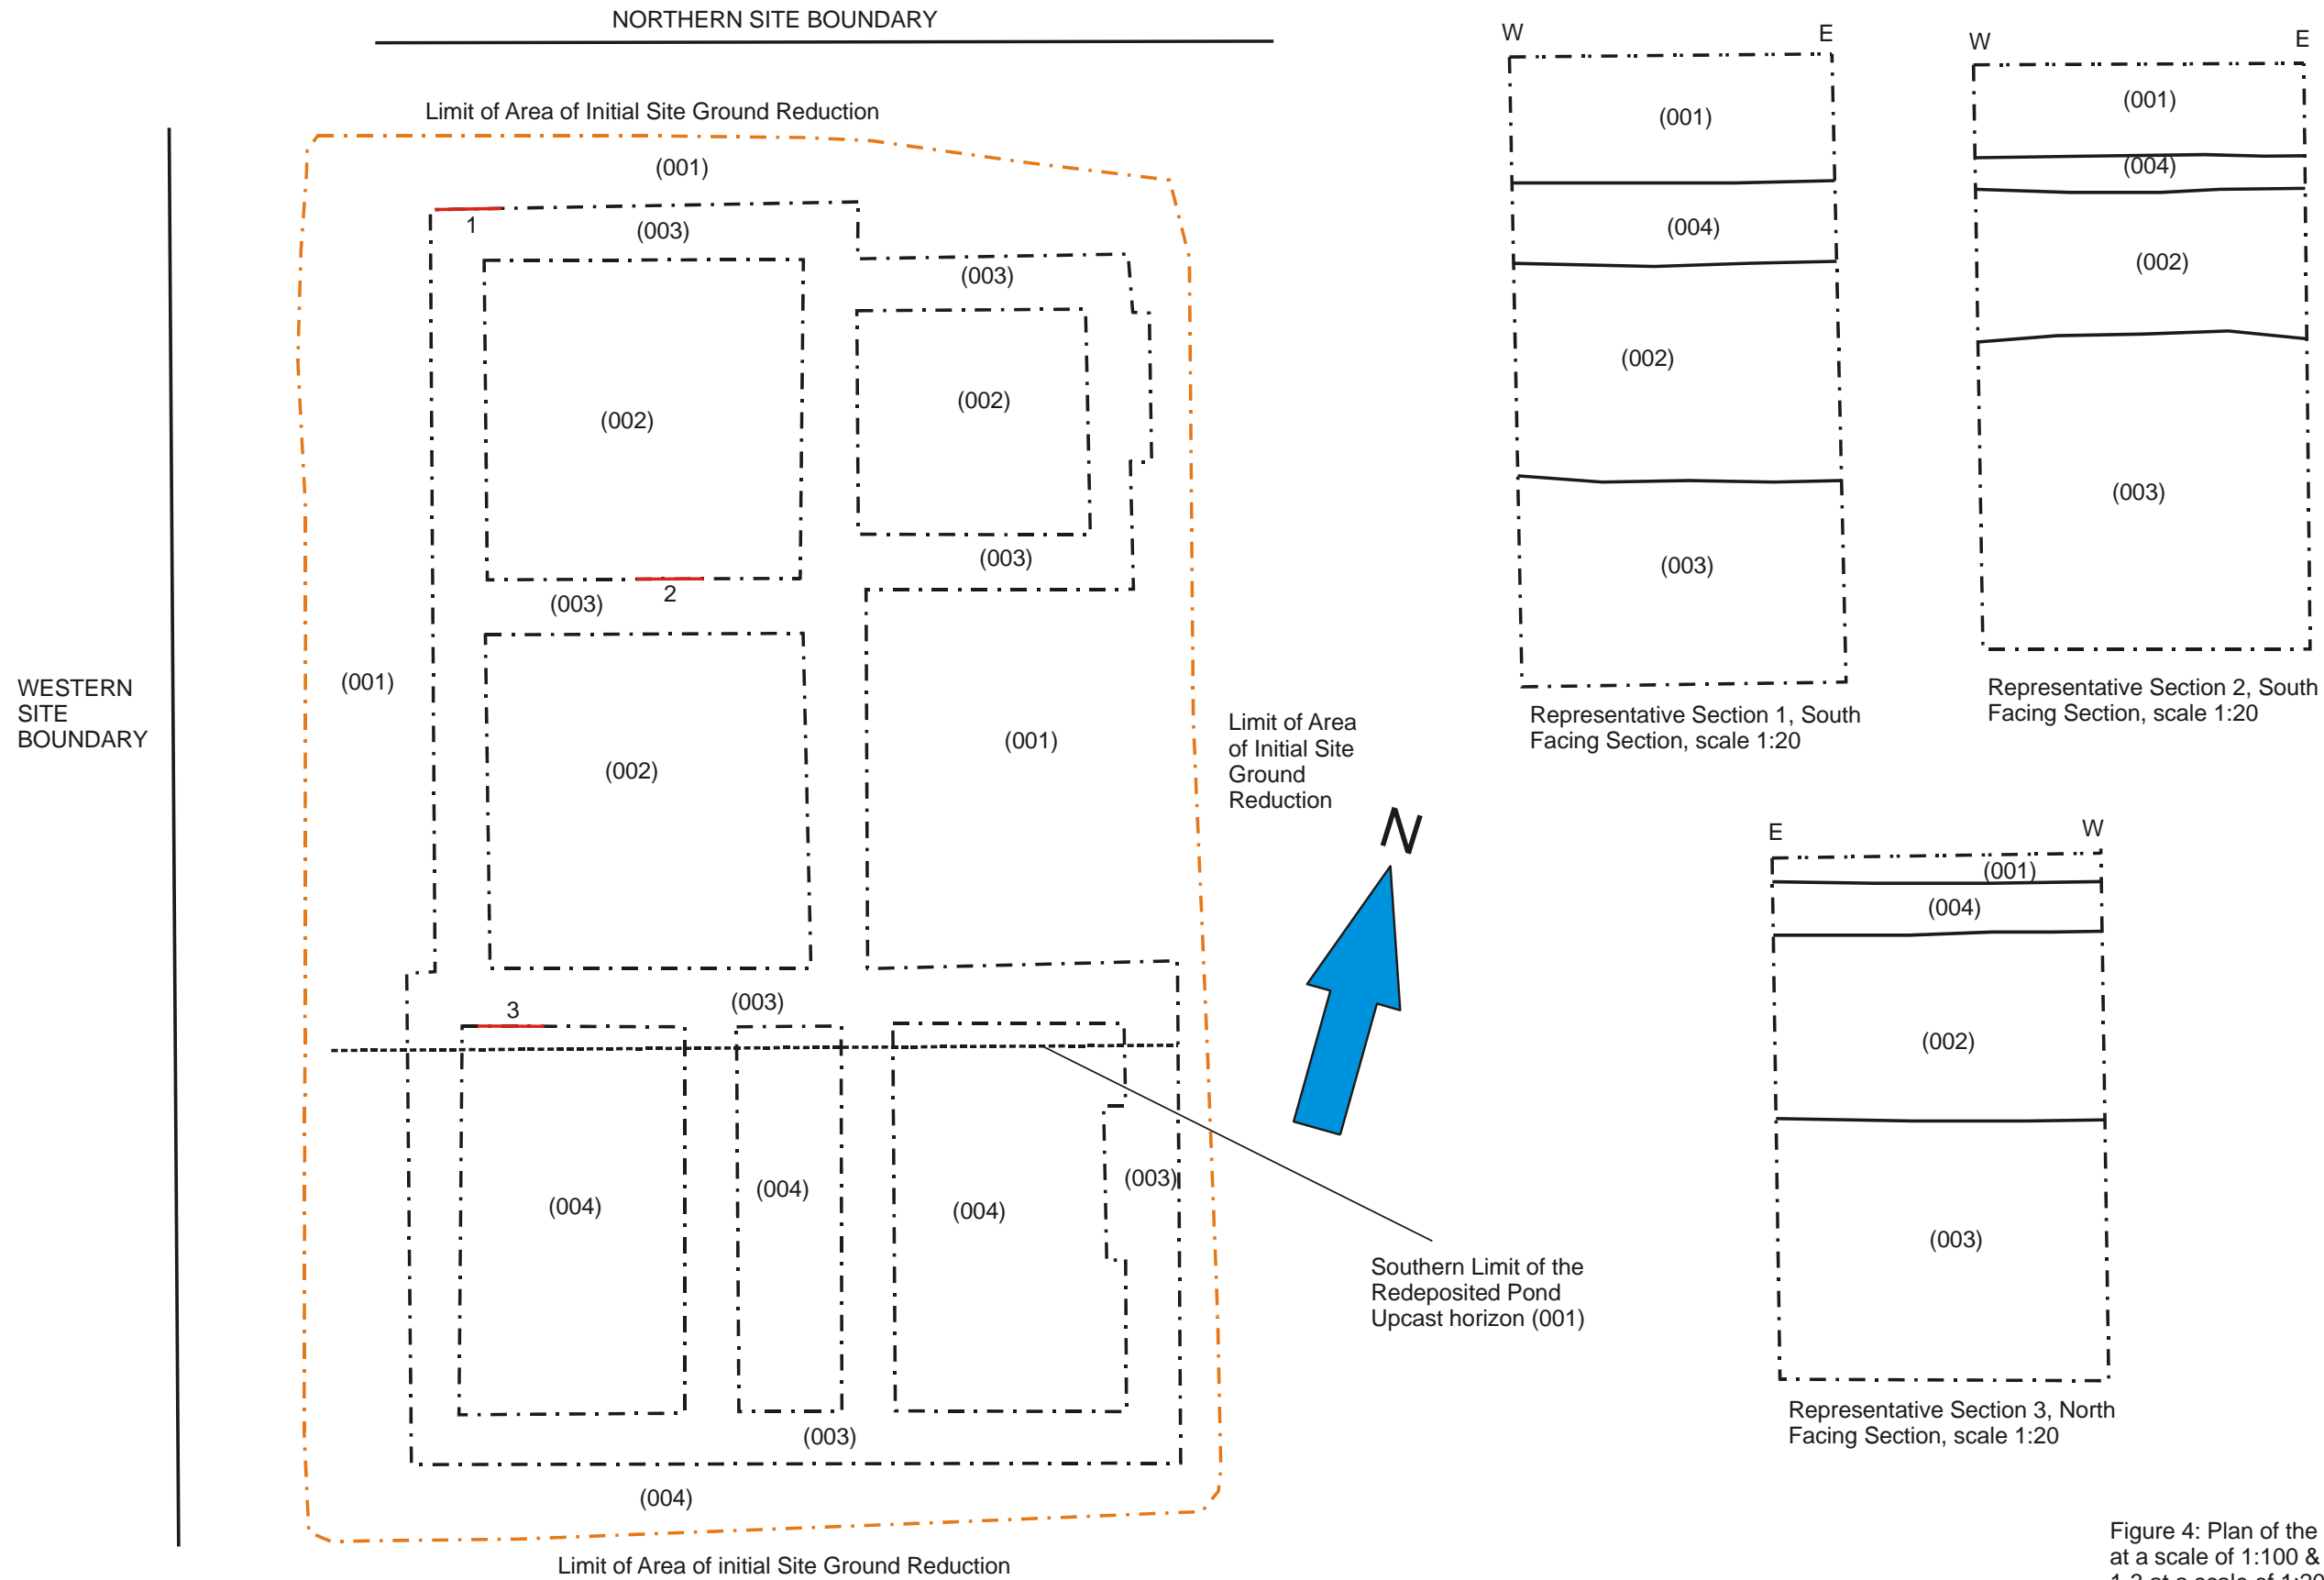
Figure 4: Plan of the Monitored Groundworks at a scale of 1:100 & Representative Sections 1-3 at a scale of 1:20

- 7.3 These monitored mechanical excavations extended through a redposited pond upcast horizon (001), (the product of the excavation of a modern pond to the north of the new build area), a buried topsoil horizon (004), (which occurred as a relatively thin band of material), the first natural horizon (002) and through a second natural horizon (003), which extended to the base of these excavations. This deposit sequence was recorded within **Representative Sections 1-3** [Plates 8, 43 and 62]. The buried topsoil horizon (004) was found to increase in depth to the south as the redeposited pond upcast horizon (001) above it was seen to correspondingly decrease in depth, also to the south.

- 7.6 At the southern end of the new build area, the base of the foundation trenches were stepped up in level, such that here the foundation trench excavations extended to shallower depths of between 1.30m--1.70m below the initially slightly reduced site levels [Plates 59-61, 63-81]. Here the redeposited pond upcast horizon (001) appeared to peter out, such that the site deposit sequence at this southern end of the new build area consisted of the (buried) topsoil horizon (004), the first natural horizon (002) and the second natural horizon (003), which extended to the base of these excavations.

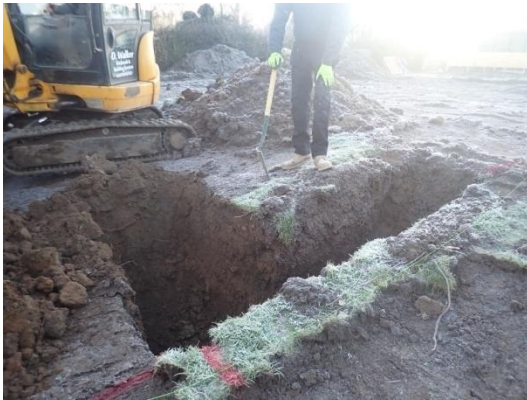
- 7.2 The foundation trenches for the new residential dwelling were excavated under archaeological supervision to varying lengths, to a widths of between 0.80m-1.0m and to depths of between 1.80m-2.20m below the site reduced levels [Plates 3-7, 9-19, 24, 31, 39-42 and 44-58].

Plate 3: Excavation of the foundations, from the west

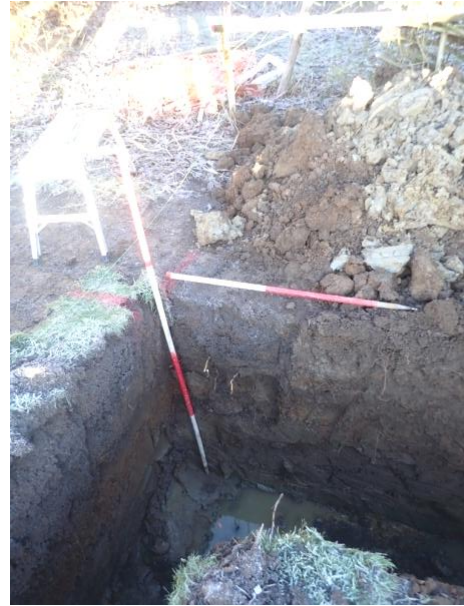
Plate 8: Representative Section 1, from the south

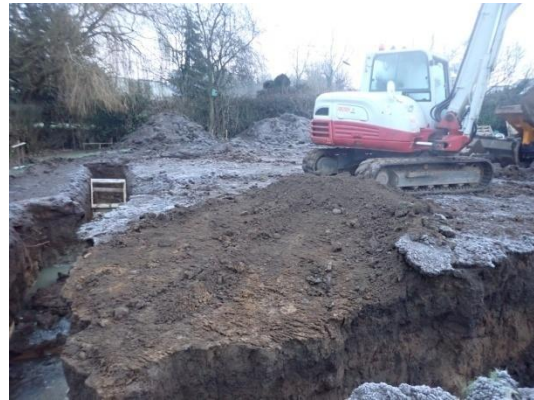
- 7.4 Simultaneously with the mechanical excavation of the foundation trenches, internal mechanical ground reduction also took place within the interior of the new build area. This ground reduction took place below the already slightly and initially reduced site levels, and commenced at the northern end of the new build are and thence continued to the south. These excavations took place over most of the area of the new build interior and extended through the redeposited pond upcast horizon (001), the buried topsoil horizon (004) and extended into the upper levels of the first natural horizon (002). These excavations extended to depths of between 0.60m-0.90m below the initially and slightly reduced site levels [Plates 20-23, 25-30, 32-34, and 37-38].

Plate 20: Internal ground reduction, from the west

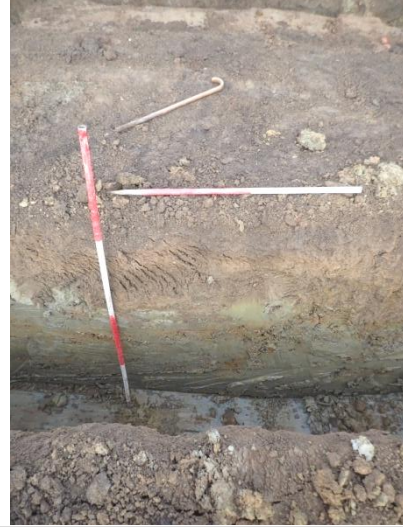
Plate 43: Representative Section 2, from the south

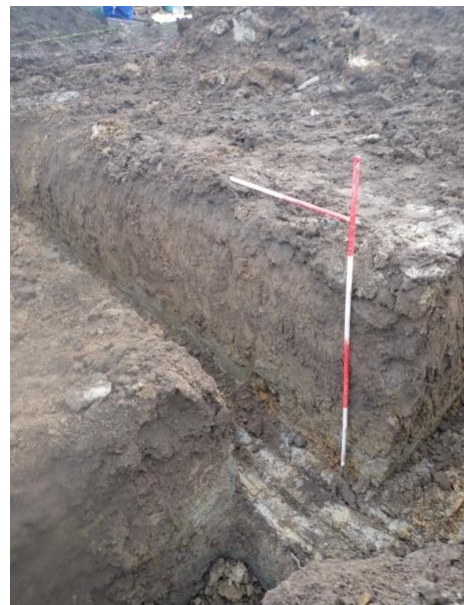
Plate 62: Representative Section 3, from the west
