ARCHAEOLOGICAL MONITORING  
AT DAIRY FARM,  
ASTERBY END,  
ASTERBY, LINCOLNSHIRE.

**National Grid Reference: TF 2656 7963**  
**Site Code: DAFA 08**  
**Accession No: LCNCC: 2008.149**  
**Planning reference: N/008/01145/08**

July 2009

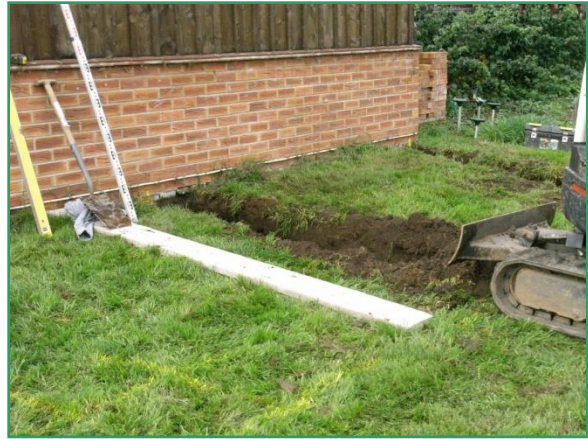
**Plate 2:** Work in progress, excavated foundation trenches, from the east

The monitored groundworks for the construction of the new Store commenced with the excavation of two parallel and south-north orientated foundation trenches, which extended northwards from the north wall of an existing standing building [Plate 2]. Each of these foundation trenches were excavated to a length of 2.50m, to a width of 0.60m, and to depths of 1.0m below ground levels.

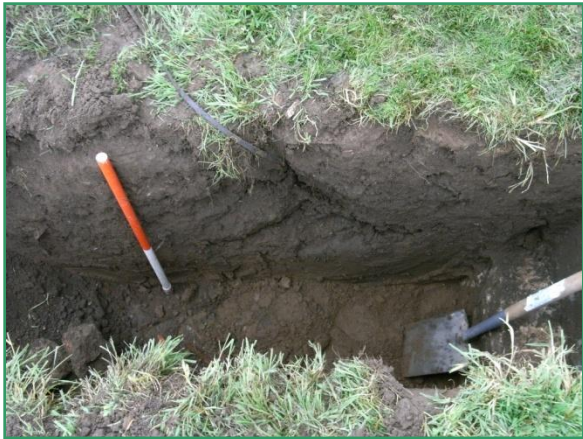
**Plate 3: Representative Section 1,** from the west

Beneath the removed turf, the same deposit sequence, comprising redeposited topsoil (**001**), overlying a buried topsoil horizon (**002**) and an underlying natural horizon (**003**) were encountered in both of these trenches. **Representative Section 1** recorded this deposit sequence within the easterly foundation trench [Plate 3].

The redeposited topsoil horizon (**001**) undoubtedly represented a built up ground level, probably as a result of upcast and spoil from the construction of the adjacent standing building and from the nearby Dairy House, itself constructed in the mid 1990s. This was evident from the large

quantities of demolition and construction materials found within this horizon, including house bricks, tiles and modern plastic material. The demolition material originated from former buildings on the site. The interface between the base of the horizon (001) and the top of the buried topsoil horizon (002) represented the level of the former ground surface.

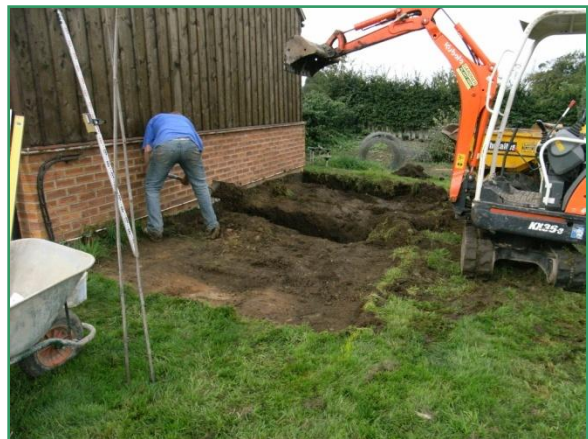
**Plate 4:** Work in progress, removal of turf within build footprint, from the east

Following the mechanical excavation of the two foundation trenches, a limited strip took place within the build footprint of the new Store. This strip was confined to within the redeposited topsoil horizon (001) and extended to depths of 0.40m below ground levels. The stripped area was for the construction of a concrete floor surface for the new build [Plates 4-6].

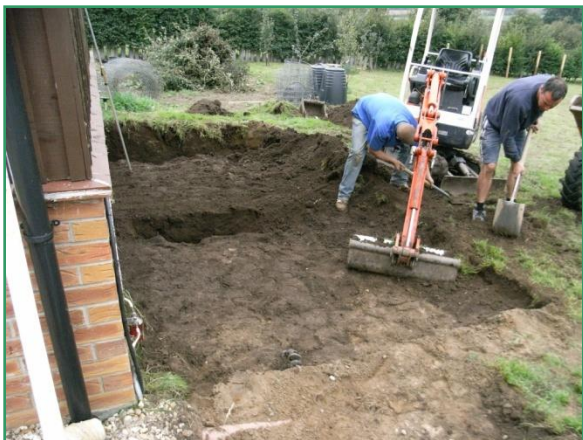
**Plate 5:** Topsoil strip within build footprint, from the east

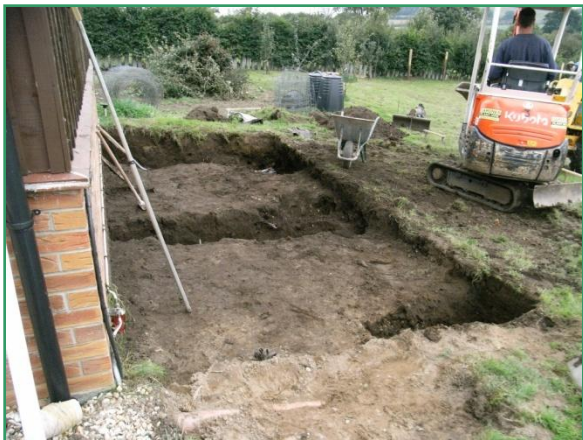
**Plate 6:** Completed excavation of new build footprint showing foundation trenches and posthole to north-east, from the east

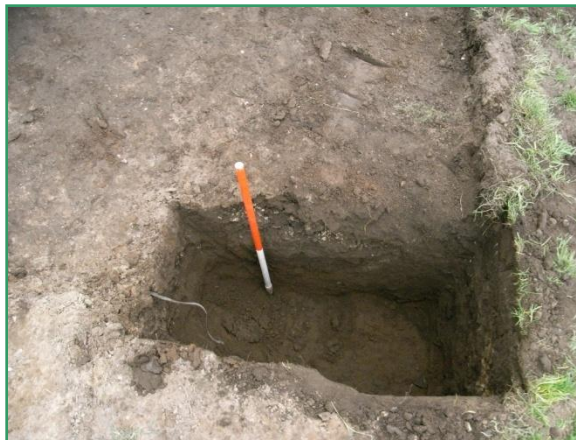
**Plate 7: Representative Section 2,** from the north

The mechanical excavation of a posthole at the north-eastern corner of the new build footprint revealed the same deposit sequence. This posthole was excavated to a length of 1.0m, to a width of 0.60m and to a depth of 0.90m below ground levels [Plate 8]. A second section – **Representative Section 2**, was recorded here [Plate 7].

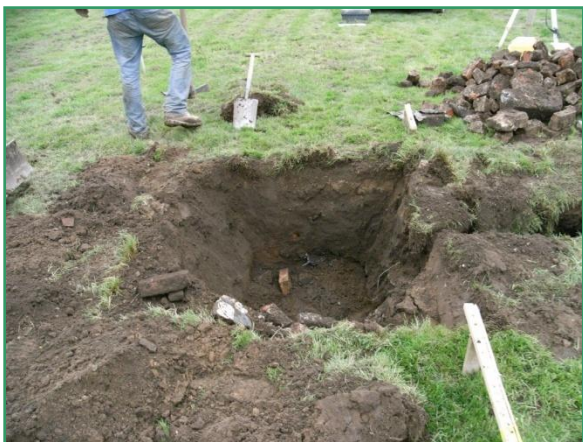
**Plate 9:** Excavated soakaway, from the south

This was followed by the mechanical excavation of a soakaway trench, which extended eastwards from the posthole, and was orientated west-east [Plate 8]. This was 3.40m in length and 0.60m in width. Its depth increased to the east reaching a maximum depth of 0.45m below ground levels, which was still within the redeposited topsoil horizon (001). A soakaway was then excavated at the eastern end of this trench [Plate 9]. This was square shaped and measured both 1.60m in length and width, and was excavated to a depth of approximately 1.0m. The same deposit sequence was identified within this soakaway also, and was recorded within a third section – **Representative Section 3** [Plate 10].

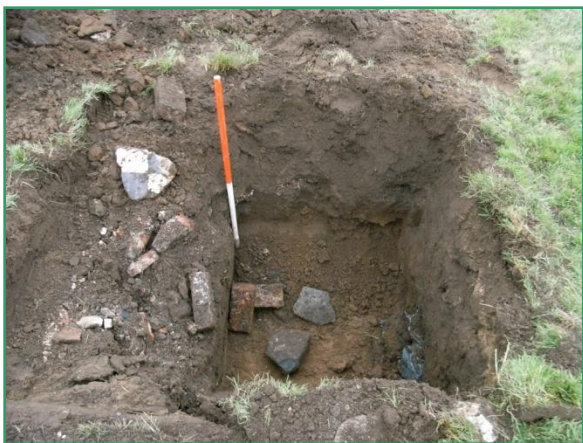
**Plate 10: Representative Section 3,** from the west

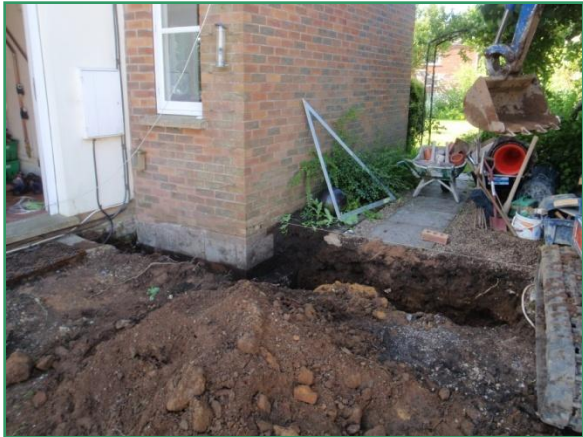
**Plate 11:** Work in progress, from the north

The groundworks for the construction of the new Conservatory began with the mechanical excavation of the eastern foundation trench [Plate 11]. This extended westwards from Dairy House, and was excavated to length of 4.10m, to widths of between 0.60m-1.10m, and to a depth of approximately 1.0m. These excavations exposed both the foundations of a modern extension to the present Dairy House, and also those of its predecessor, whose earlier foundations the present house had been constructed upon in the mid 1990s [Plate 13].

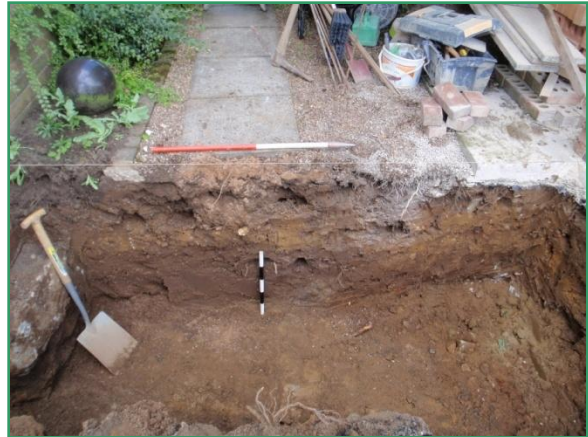
**Plate 12: Representative Section 4,** from the north

These excavations revealed a sequence of deposits which were associated with the construction of the adjacent modern extension to the present Dairy House. This sequence was recorded as **Representative Section 4** [Plate 12], and extended along the whole length of the foundation trench. The uppermost deposit comprised made ground (005), which in turn overlay a horizon of redeposited topsoil (006). This deposit continued beneath the foundations of the adjacent modern extension, and it was apparent that these footings had been constructed not only within but also on this deposit. Although this foundation was excavated to a depth of approximately 1.0m, the natural horizon (007) was reached only at the base of this excavation.

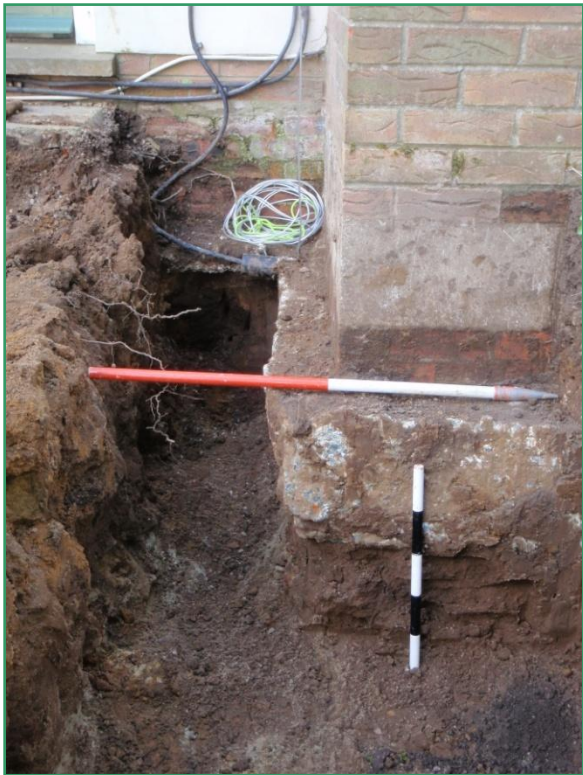
**Plate 13:** View of the foundations of the modern house & of the earlier Dairy House, from the west

During the recording of the outside wall of the present house, it was noted that there was a 'kink' in its alignment. This corresponded to a break in the present house being constructed on the foundations of the earlier house, and its subsequent construction on contemporary modern breeze block foundations. These breeze block foundations were exposed in the second and subsequent third east-west aligned foundation trenches.

The foundations of the earlier Dairy Farmhouse had been built on the topsoil horizon (008) and extended to a depth of 0.55m, whilst the modern extension foundations extended to a depth of 0.75m below ground levels.

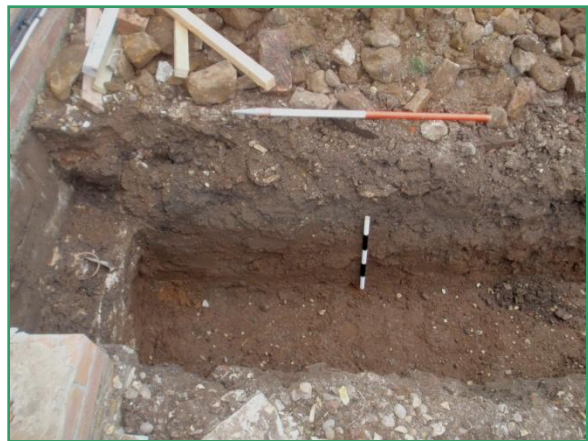
**Plate 15: Representative Section 5,** from the north

The deposit sequence identified in this second trench was recorded within **Representative Section 5** [Plate 15], and contrasted sharply with that recorded in the first trench to the south. This consisted of a made ground deposit (009), which was undoubtedly associated with the construction of the present house, and corresponded to the deposit (005) to the south. This was above a topsoil horizon (008), which in turn directly overlay the natural subsoil horizon (007), which was reached at the base of the excavation. The made ground deposit (009) and the topsoil horizon (008) notably contained a large quantity of small-large ironstone fragments within their make-up, a minority of which exhibited some evidence of rough working and facing. This suggested that these fragments comprised demolition material and had originated perhaps from one of the outbuildings associated with the earlier Dairy Farmhouse. The majority of these

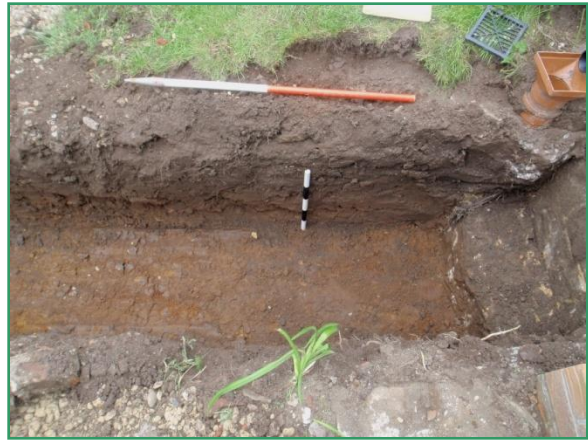
**Plate 17: Representative Section 6,** from the south

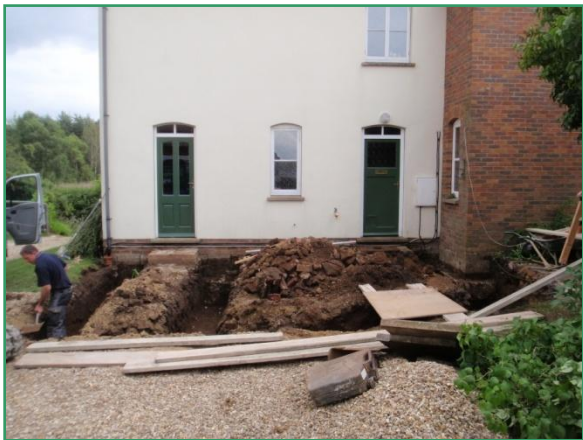
**Plate 18:** Completed foundation excavations, from the west

The third east-west orientated foundation trench was then excavated along with the completion of the excavation of the connecting north-south aligned trench [Plate 18]. The deposit sequence identified in the latter trench comprised the topsoil horizon (008), which here was found to be substantial, directly overlying the natural horizon (007). In the third and final east-west orientated foundation trench, the redeposited topsoil (004) overlay the topsoil horizon (008), which in turn was above the natural horizon (007). This sequence in this trench was recorded within the **Representative Section 6 [Plate 17]**. The redeposited topsoil horizon (004) appeared to have been laid down for landscaping purposes around the periphery of the present house.

The final east-west orientated trench measured 3.25m in length, 0.80m in width and was excavated to a depth of 1.0m. The connecting south-north aligned foundation trench was excavated to a length of 7.20m, a width of 0.80m and to a depth of 1.0m [Plate 18].
