AN ARCHAEOLOGICAL WATCHING BRIEF
AT 2, NORTHGATE,
LINCOLN, LINCOLNSHIRE.

National Grid Reference: SK 97947 72084
Site Code: NGLI10
Accession No: LCNCC: 2010.26
Planning Reference: 2009/0670/F

PREPARED FOR PLACE : ARCHITECTURE LIMITED

October 2010

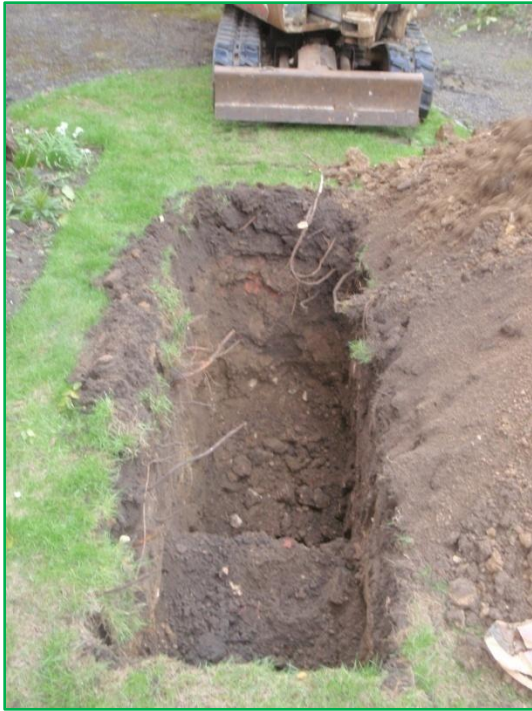
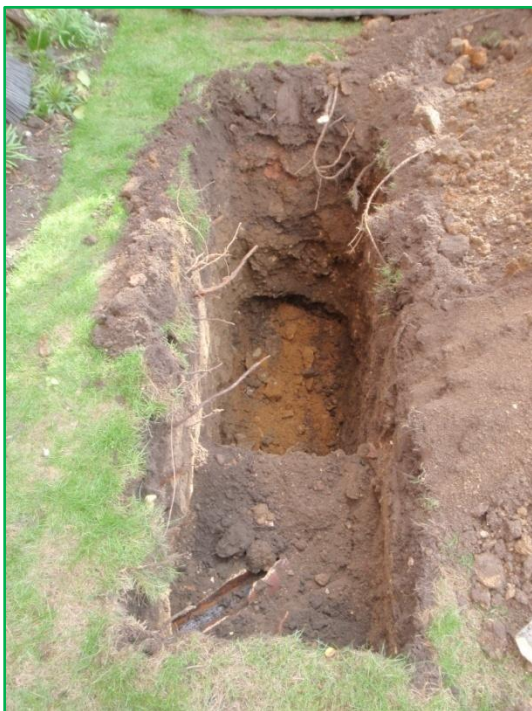
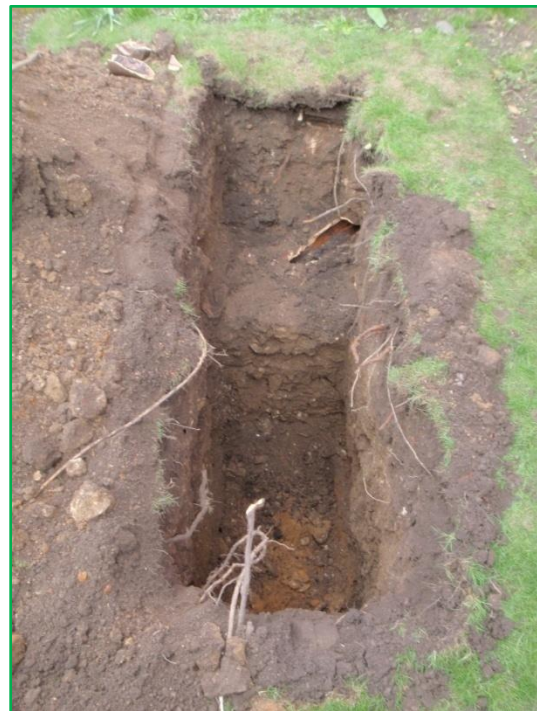
Test Pit 1 was positioned and excavated to the immediate south of the existing house on the site. It was initially excavated to a length of 0.70m, but as the excavation fractured a live drainage pipe, this excavation was eventually extended to a length of 2.0m. The test pit was excavated to a width of 0.60m, and to a maximum depth of 1.56m below ground levels [**Plates 1-2 and 4**].

Plate 1: Work in progress, **Test Pit 1**, from the west

Plate 2: As **Plate 1**, from the west

Plate 4: Completed excavation, **Test Pit 1**, from the east

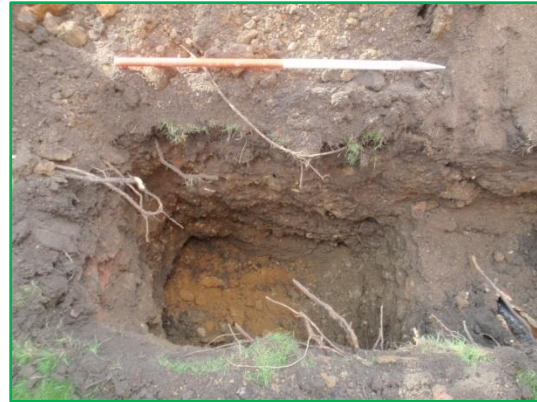
Plate 3: Representative Section 1, **Test Pit 1**, from the south

Below a modern topsoil (**001**) were two probable post-medieval quarry pit dills (**002**) and (**003**). The fill (**003**) was recorded at the base of this excavation. This deposit sequence was recorded within **Representative Section 1 [Plate 3]**. A single sherd of residual Roman pottery was recovered from the fill (**002**).

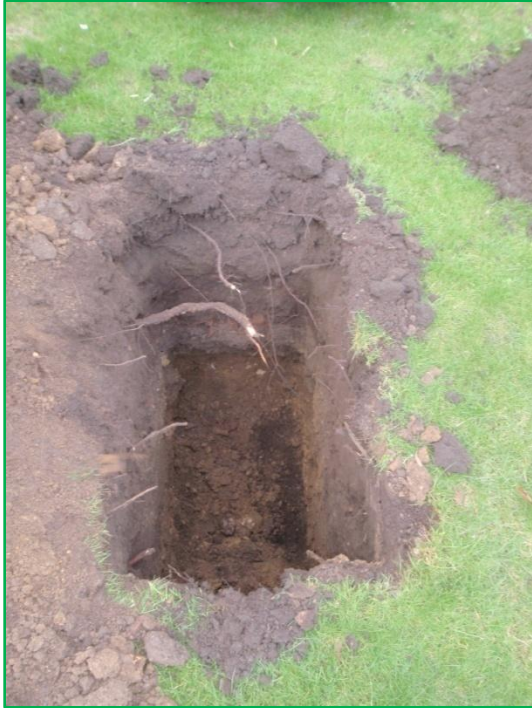
Test Pit 2 was located to the south of the former rear extension to the house and within a grassed area. This was excavated to a length of 1.10m, a width of 0.60m and to a final depth of 2.30m below ground levels [**Plate 5**].

Plate 5: Work in progress, **Test Pit 2**, from the east

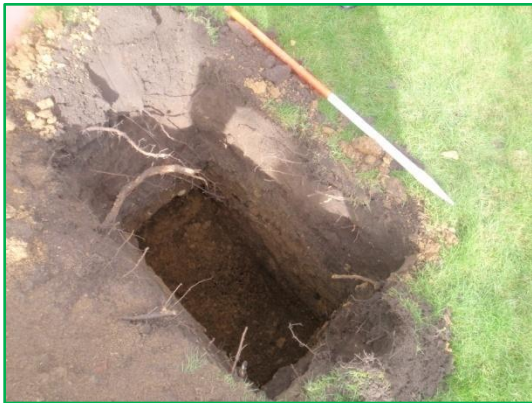
Plate 6: Representative Section 2, Test Pit 2, from the south

Below the modern topsoil horizon (001) were the probable post-medieval quarry pit fills (002) and (003) respectively. Below (003) was a third and final quarry pit fill (004), which was possibly of medieval origin. The fill (004) in turn overlay the natural horizon (005) of weathered limestone and flint fragments. This deposit sequence was recorded within **Representative Section 2 [Plate 6]**. A single sherd of 18th–19th century pottery was recovered from the quarry pit fill (002).

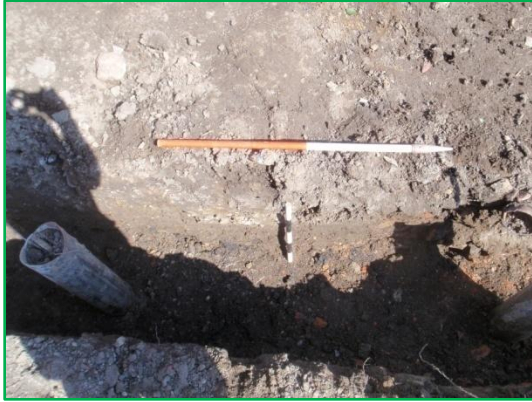
Plate 14: Representative Section 3,
from the south

The previous rear extension had been demolished and the site cleared prior to the commencement of the archaeological monitoring. Following the insertion of the vertical pile caps, the position of the ring beams had also already been set out prior to arrival **[Plate 7]**. The northerly east-west orientated foundation trench was both hand and mechanically excavated to a width of 0.70m and to depths of between 0.55 and 0.60m below ground levels **[Plates 8 and 10-13]**. Several brick wall foundations from the previous rear extension on the site were encountered during the course of these excavations. The deposit sequence in this trench comprised a post-site demolition made ground deposit (006), which in turn overlay two modern made ground deposits (007) and (008). Both were probably associated with the construction of the former modern rear extension. This deposit sequence was recorded within **Representative Section 3 [Plate 14]**. The full extent of the made ground deposit (008) is shown on **Figure 4**.

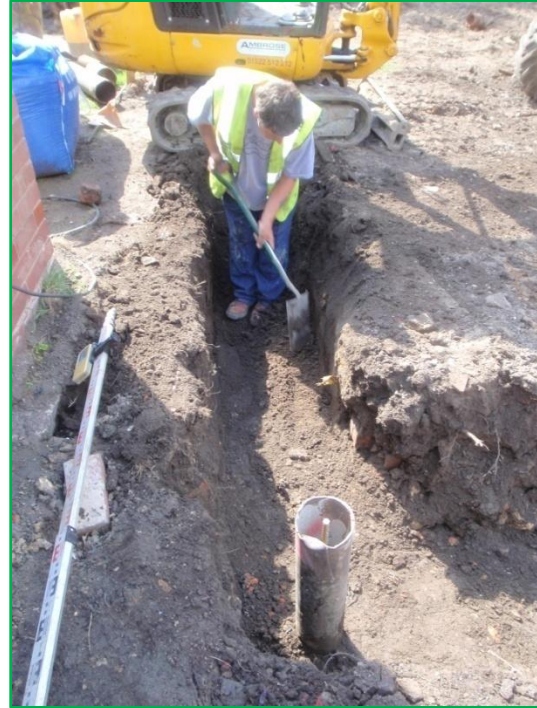
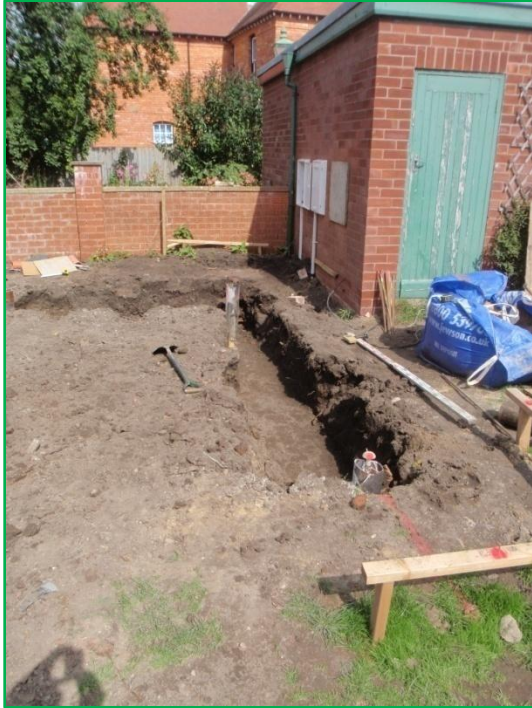
The most easterly north-south orientated foundation was mechanically excavated to a width of 0.70m and to an average depth of 0.60m **[Plates 16 and 18]**. Here it was apparent that the deposit sequence had changed radically with the modern topsoil horizon (001) (also identified in the nearby test pits) extending to the base of the excavation. This excavation was undoubtedly outside of the footprint of the previous rear extension and so had not been subjected to disturbance from the construction of it. The topsoil deposit was recorded within **Representative Section 4 [Plate 17]**.

Plate 16: Work in progress, ring beam
excavations, from the north

Plate 18: As **Plate 16**, from the south

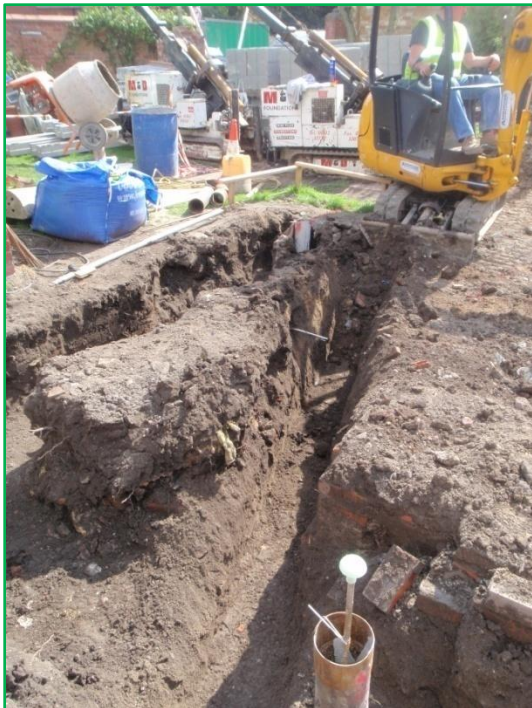
This was followed by the hand and mechanical excavation of a service trench that extended from the northern boundary of the site eastwards and approximately southwards to the south eastern corner of the new build **[Plate 19]**. The deposit sequence of the post demolition deposit (006) overlying the topsoil horizon (001) and the quarry pit fill deposit (002) (noted elsewhere in the test pits) was observed in this excavation. This trench was excavated to widths of between 0.40-0.80m and to an average depth of 0.80m.

Plate 19: Excavation of a service trench, from the north

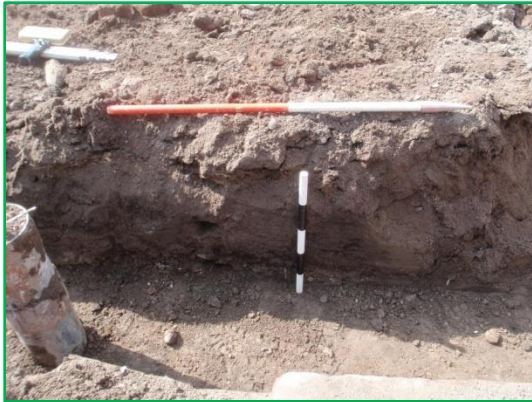
Plate 22: Representative Section 5,
from the east

A further two foundation trenches, the first orientated west-east and the second from north-south were then excavated to a width of 0.70m and to a depth of 0.60m **[Plates 20-21 and 23]**. To the south, the deposit sequence of the topsoil horizon (001) overlying the quarry pit fill (002) was recorded in **Representative Section 6 [Plate 24]** and to the north, the post-demolition deposit (006) overlying the topsoil deposit (001) and the quarry pit fill deposit (002) was recorded in **Representative Section 5 [Plate 22]**. The remnants of the brick foundations for the former extension were also noted opposite **Representative Section 5**. The deposit sequences recorded in these two sections indicated that they were outside the disturbance generated by the construction of the previous extension. A single residual sherd of 2nd century pottery was recovered from the fill (002).

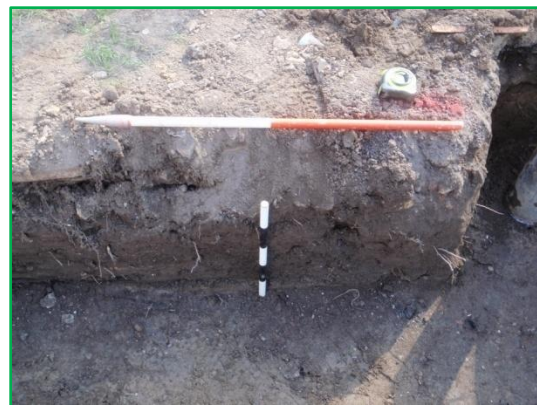
Plate 26: Representative Section 7,
from the west

The southerly foundation trench to the new build was extended eastwards and widened slightly to 0.80m to incorporate a slight 'steeping out' to the south [Plate 25]. A brick wall foundation of the former extension was observed extending along the southern side of this trench, otherwise the recorded deposit sequence comprised the topsoil (001) overlying the quarry pit fill (002). A further south-north trench was then excavated [Plate 25]. Here the deposit sequence comprised the post-demolition site deposit (006) overlying the modern made ground deposit (007) and the quarry pit fill (002). This was recorded in **Representative Section 7** [Plate 26].

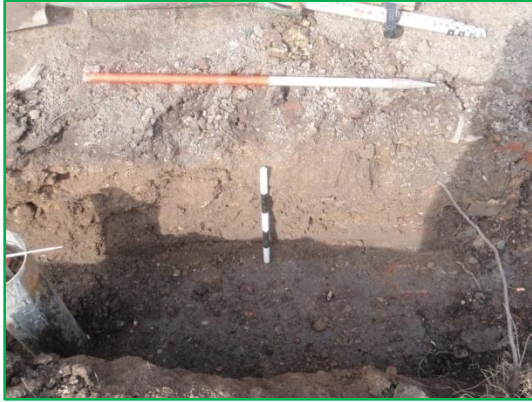
Plate 28: Representative Section 8,
from the east

The final section of the southerly foundation trench to the new extension was excavated eastwards from the existing building. This was followed by the excavation of the final north-south orientated foundation trench within the rear extension build footprint [Plates 27 and 29]. In both of these trenches the deposit sequence comprised the post-site demolition deposit (006) overlying the modern made ground deposit (007), which in turn overlie the quarry pit fill (002) at the base of these excavations. This sequence was recorded within the final **Representative Section 8** [Plate 28].
