AN ARCHAEOLOGICAL WATCHING BRIEF
AT CRESTWOOD HOUSE,
52, HIGH STREET, ST. MARTINS,
STAMFORD, LINCOLNSHIRE.

Site Code: HSST11

March 2011

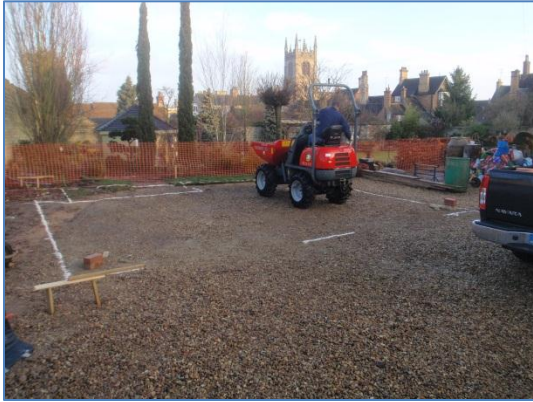
Plate 1: Pre-groundworks, from the south

The foundations for the new double garage had already been set out prior to arrival [**Plate 1**]. The ground surface was observed to slope naturally downwards to the north and it was clearly apparent that the development site was situated on a raised artificial terrace.

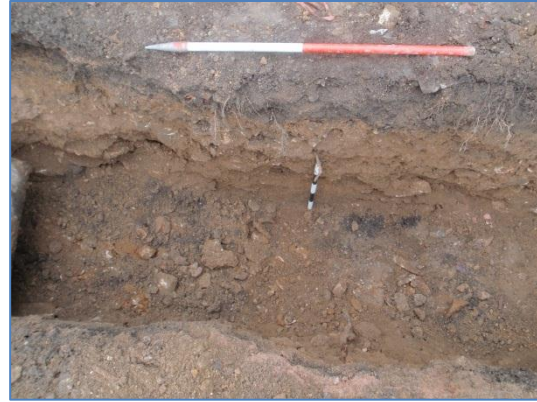
Plate 3: Representative Section 1, from the east

The mechanical excavation of the foundations for the new double garage was continually monitored and recorded [Plates 2, 4-7, 9, 12 and 14-17]. Throughout all of the monitored foundation trenches, the same deposit sequence was observed and recorded. This sequence comprised a modern imported topsoil horizon (001), which overlay a substantial made ground deposit (002), of post-medieval origin. This in turn overlay a buried topsoil horizon (003) of earlier post-medieval origin, which was quite thin in places and appeared to be truncated. This deposit was generally observed at the base of the excavations, though within the easterly foundation trench, the natural horizon (004) of cornbrash was reached. This deposit sequence was recorded within the two **Representative Sections 1 and 2** [Plates 3 and 13]. There were no finds from any of these deposits.

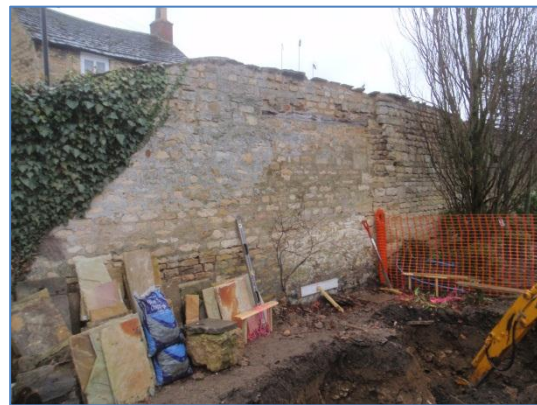
Of particular note was a buried wall foundation (005) of at least two courses in height and constructed of irregular and roughly worked limestone blocks at an average level of 0.90m below current ground levels [Plates 10-11]. There was no evidence of any associated mortar bonding. This footing was cut into the buried soil horizon (003) and was sealed by the made ground deposit (002). It was clear that this foundation had also been truncated (along with the buried topsoil horizon (003)) and like (003) had been sealed by the subsequent deposition of the made ground (002). This buried wall footing was also probably associated with an infilled window opening with timber lintel that was observed within the fabric of the western site boundary wall [Plate 8]. These combined structural components suggest a possible outbuilding of post-medieval origin at this location. This is confirmed by the results of the aforementioned map regression. The map of 1773 clearly shows a rectangular shaped outbuilding at this location, of which the infilled window opening, parts of the western site boundary wall and the foundation (005) were component parts of.

Plate 8: Infilled window opening with timber lintel in the western site boundary wall, from the east

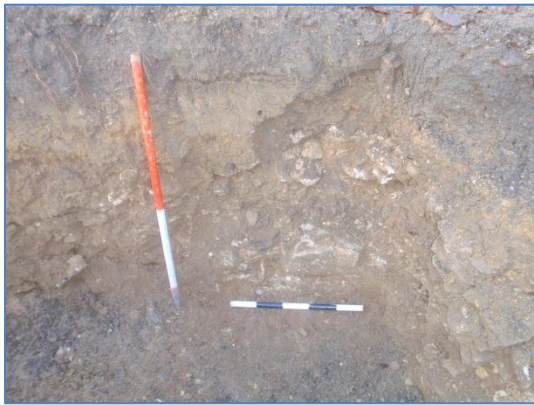
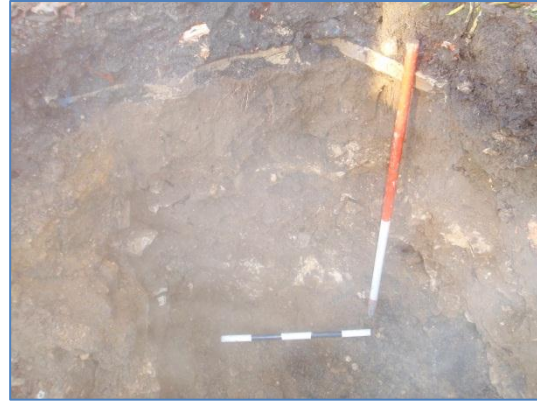
Plate 10: Footing (005), from the east

Plate 11: Footing (005), from the east

- 005** Buried wall footing of post-medieval origin. Constructed of roughly worked & irregular shaped limestone blocks. No mortar bonding evident. Two courses in height were visible. Sealed by **(002)** & cut into **(003)**. Length - >1.75m, width - >0.10m, depth – 0.20m.
