Branton House Farm, Branton, Doncaster

Archaeological Desk-Based Assessment

Site Name: Branton House Farm

Address: Branton House Farm, Chapel Lane, Branton, Doncaster, DN3 3NG

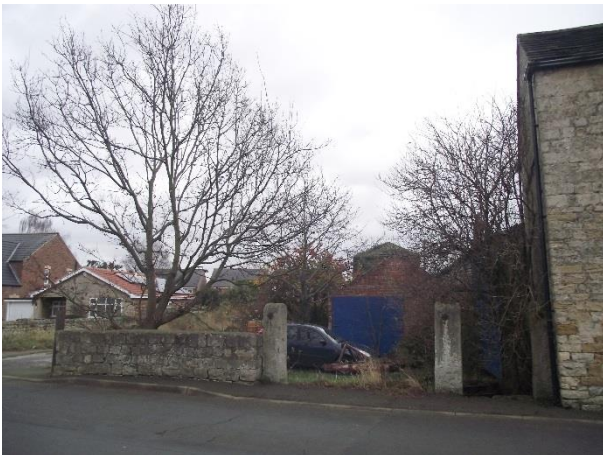
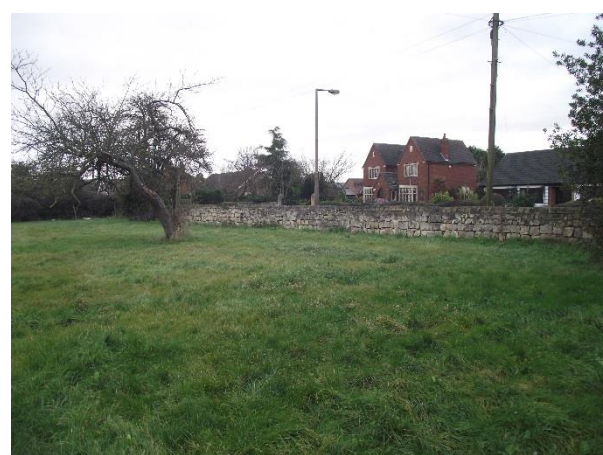
- 8.02 The site is enclosed by a stone coursed wall to Whiphill Top Lane to the east and a partially surviving stone wall with semi-circular capping stones to Chapel Lane to the west. These walls are presumed to be 19th century in date. There is a hedged and shrub/tree boundary to the south separating the farm from 20th century suburban housing and a mixture of fencing, a low stone wall with fencing and a hedged boundary to the north, again separating the farm from modern suburban housing.

Stone wall with vehicular and pedestrian monolith gateposts to the north-west (left) and stone wall to the east (right)

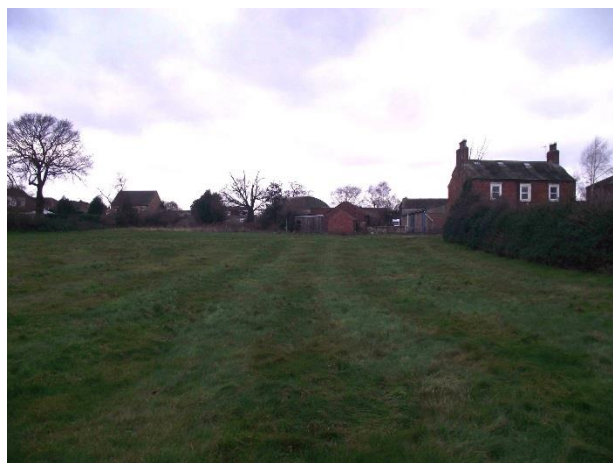
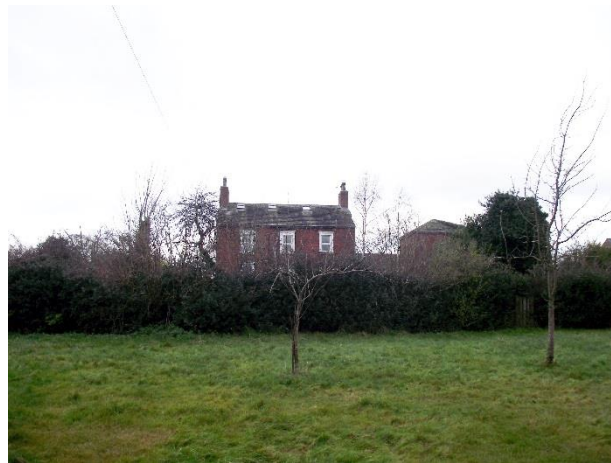
Open field (left) and former orchard (right) with hedged, and (in part) brick, boundaries to the gardens

- 8.03 There is a field to south of the farm buildings with short pasture grass in the eastern half and longer grass and scrub in the western half. The north-east part of the site is occupied by a series of gardens divided by hedging with the remnants of the orchard closest to Whiphill Top Lane. The eastern part of the house can be accessed via the gardens.

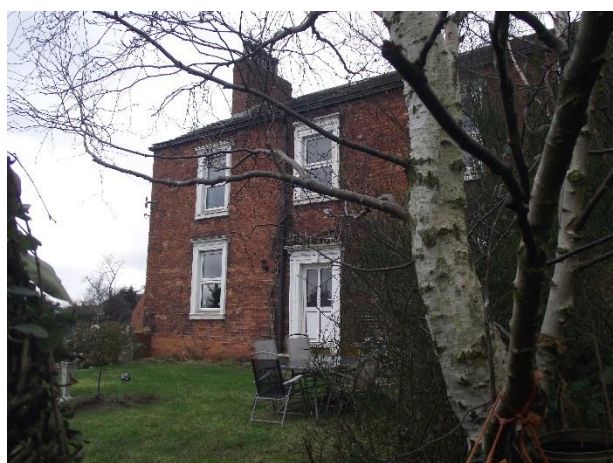
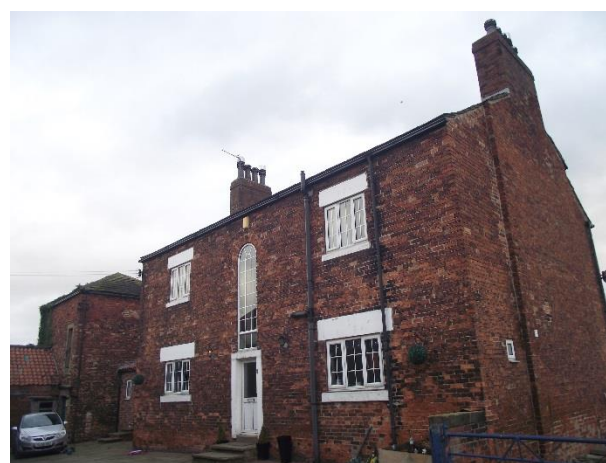
- 8.04 The farmhouse is a two-storey red brick dwelling with a barrel-vaulted cellar, Scottish Bond brickwork and a dual pitched stone roof. It has a single storey extension built c.1998 to the north, which replaced an earlier building. Its three bay frontage overlooks gardens facing Whiphill Top Lane while the rear overlooks the farmstead. The house has two gable end brick chimneystacks. The fenestration is modern double-glazing with moulded stone architraves to the front and substantial plain stone sills and lintels at the rear. A tall narrow stair window with an arched head overlooks the farmyard. The entrances have stone surrounds. Internally the house has been much modernised, although retains the occasional historic fireplace (most are modern reproductions), some historic six-panelled raised and fielded doors, a 19th century kitchen range, meat hooks suspended from a ground floor ceiling and a timber open well staircase with stick balusters. A number of the rooms also retain moulded cornices. The farmhouse continues to provide residential accommodation.

Farmhouse with more decorative frontage overlooking gardens (left) and rear elevation overlooking farmyard (right). Note the physical and visual proximity of the dovecote

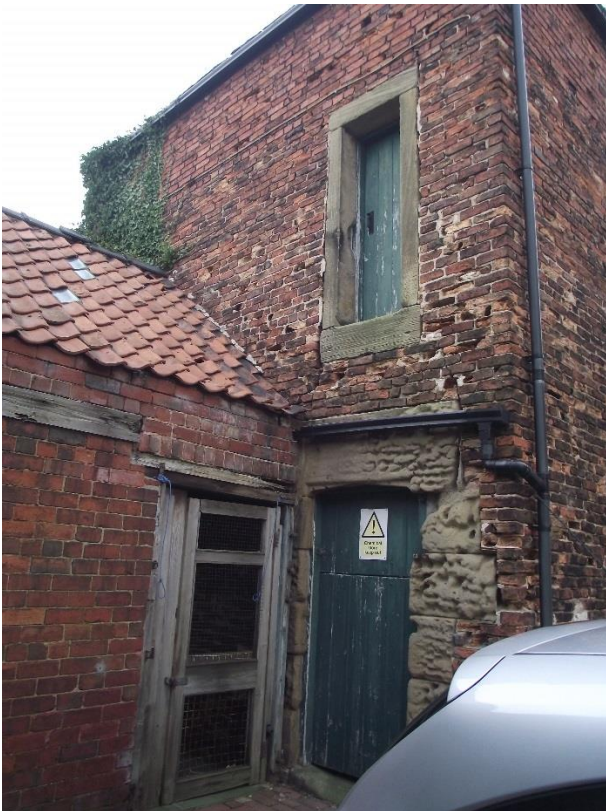
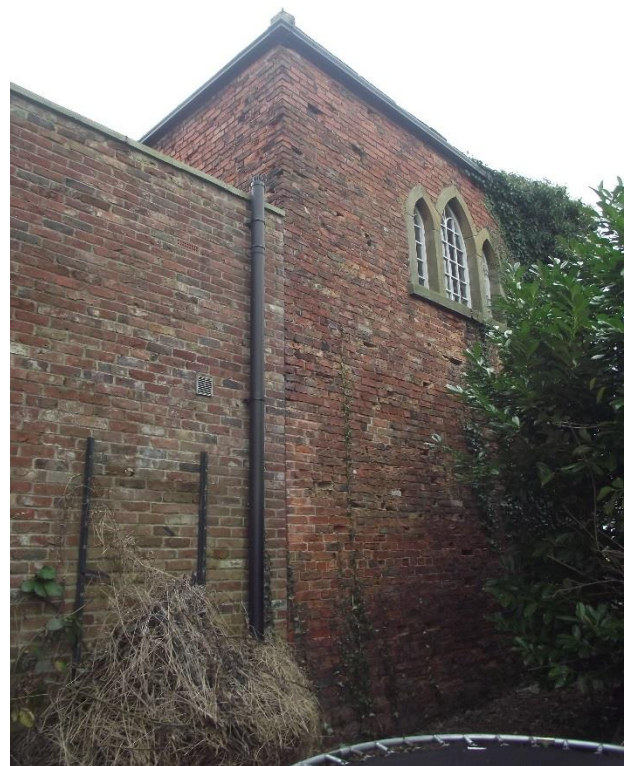
- 8.05 The two-storey dovecote is a brick building with a square plan and a stone pyramidal roof. The ground floor entrance is via a sandstone Gibbs style surround with a first floor entrance above via a timber-boarded door surrounded by a plain sandstone surround. The ground floor formed stables and one metal feeding rack survives with visible remnants of a further two. The first floor formed the dovecote. There is currently no access to the first floor and it is uncertain if any nesting boxes survive. The dovecote is ornamented with a Gothick style three-light window with multi-pane glazing and Gothick 'Y' tracery at the head set in a sandstone surround in the east elevation, visible from Whiphill Top Lane. This is an unusual style window for a dovecote. At least some of the glazing is assumed to be a later addition as ingress would have been required for the doves. The north elevation is entirely overgrown with ivy and may obscure a further entrance. The Gibbs surround and Gothick window – both popular Regency styles – indicate that the dovecote is likely to date from between the late 18th to the early 19th century (although it may be slightly later and instead reference an earlier style). The building is currently disused.

Dovecote ground and first floor entrances (left). Note the ground floor Gibbs style sandstone surround. The east elevation (right) displays a decorative Gothick window

- 11.03 In the light of the conclusions above, it is recommended that a photographic survey of the dovecote and barn is undertaken prior to any redevelopment and that a programme of archaeological monitoring and recording will be beneficial during any groundworks.

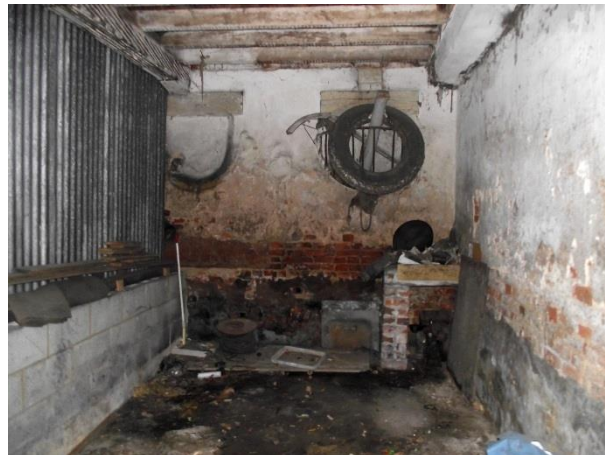
Part of the ground floor interior with feeding racks

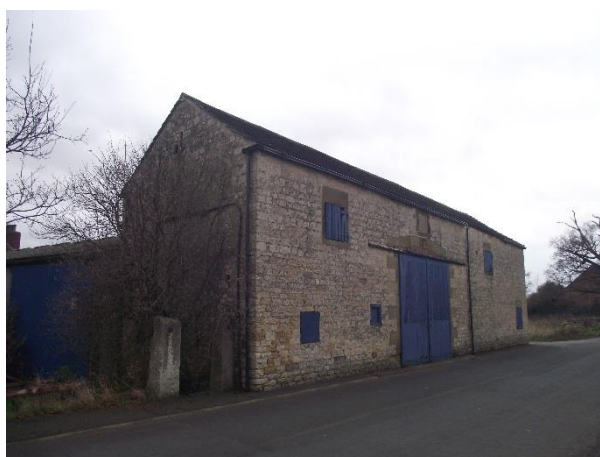
- 8.06 The early-mid 19th century barn faces Chapel Lane. Currently disused, it was a building for storing and threshing the corn and pulse crops grown on the farm. It is a two storey stone barn occupying a rectangular footprint. Harvested crops would have been stacked up to, or very close to, the ridge. The barn has opposed wide openings, originally linked by the threshing floor. The taller of these openings offers direct access to Chapel Lane. Both openings have arched heads and long and short work in the ashlar surrounds. The original doors, window and upper level pitch-hole openings generally have ashlar surrounds, which contrast with the roughly coursed external stone walls. The openings have timber shutters. The barn also has some slit hole air vents. The slate roof is a later renewal.

View of the barn along Chapel Lane

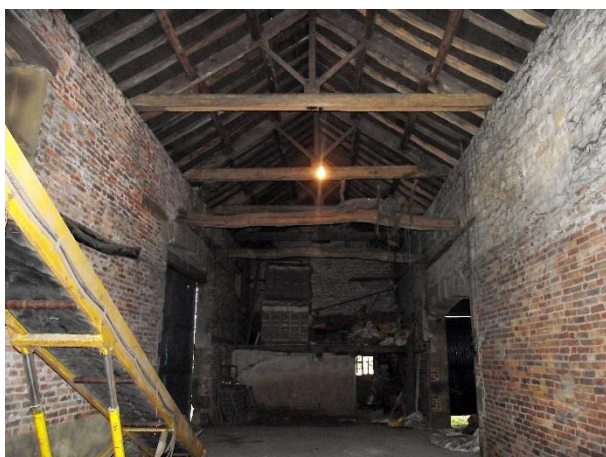
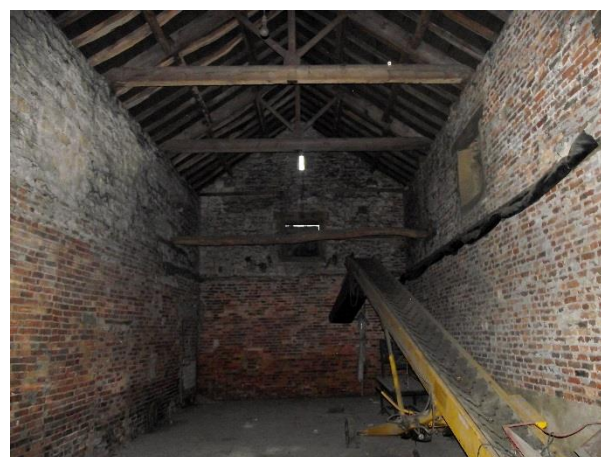
- 8.07 Internally, the walls of the barn, particularly at lower level, are faced with an inner skin of largely original handmade brickwork. This displays some later inventions such as two blocked opposed openings at the south end. The roof is composed from king post trusses, which have largely been renewed. The timber rafters were renewed when the roof was replaced. The roof structure also displays staggered purlins. Below the roof structure are three historic waney edged beams that help tie the sidewalls in place. The barn has a later concrete floor. A storage bay with loft has been inserted at the north end, possibly to incorporate threshing machines or other 19th century mechanised innovations. A fragment of this machinery survives *in-situ* at ground level.

Internal views looking north towards the later loft (left) and south towards the gable end with pitch hole and vent (right)

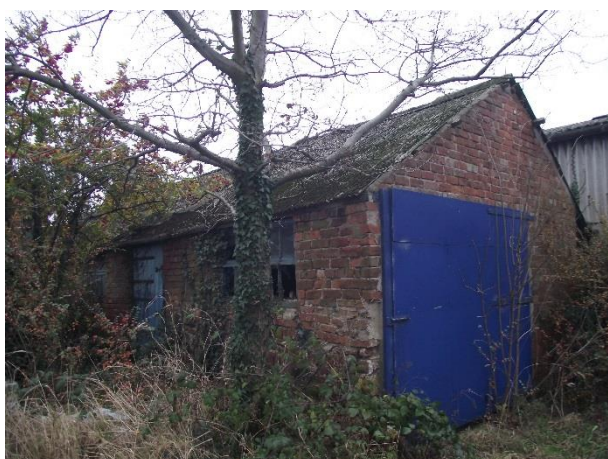
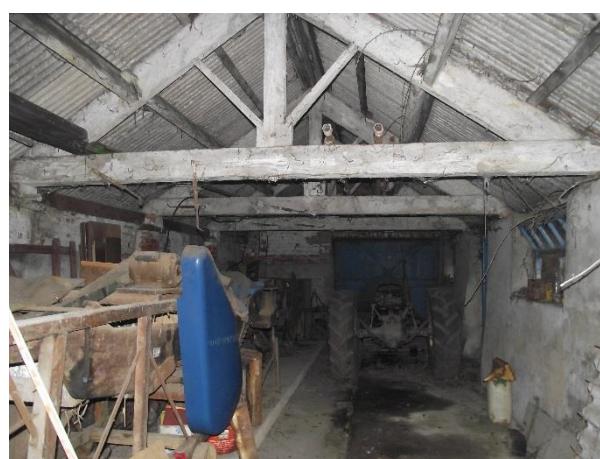
- 8.08 Built between 1855 and 1892 the original function of this building is uncertain due to a later rebuild. The brick piers along the south wall raise the possibility that this was originally open fronted to the south i.e. to the farmyard – perhaps forming an open fronted shelter shed for cattle or other livestock. The building has since been significantly rebuilt. The line of the originally (lower) roof and north wall is preserved at the gable ends and some original stone roofing tiles have been left *in-situ*. The roof has been raised and replaced with corrugated sheeting, and the building widened slightly to the north. The south wall may have been infilled with brick at this date, preserving the location of the brick piers, which support the king post roof trusses. The interior has been much altered and is currently used for storage. The remains of some fixings along the interior of the south wall, the rendering of the lower part of the wall and the creation of a stepped concrete floor with a concrete trough running the length of the south wall and a nearby drain, all raise the possibility that the building was used as a milking shed during part of the 20th century. A wide opening in the west wall suggests a requirement to fit cattle or machinery into this space. The other doors are stable doors and there are workshop type multi-light windows in the north wall.

Exterior view, looking south-east (left) and interior view, looking west (right)

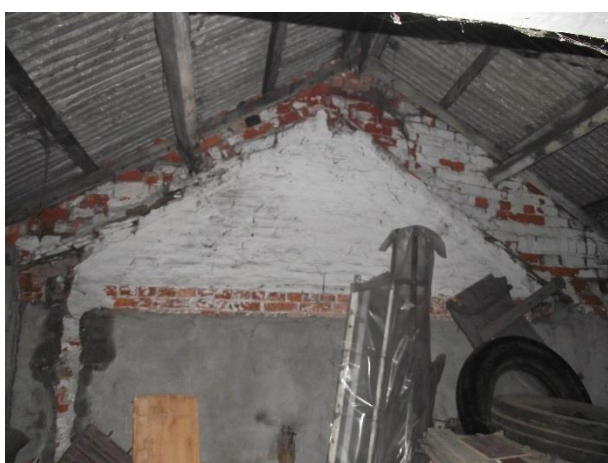
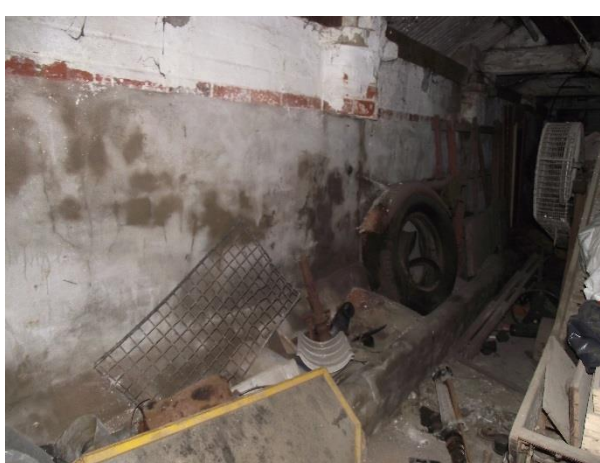
Evidence of the earlier roofline and roofing materials (left) and possible conversion into a milking shed with trough, rendered lower wall with fixings and drainage channel (right)

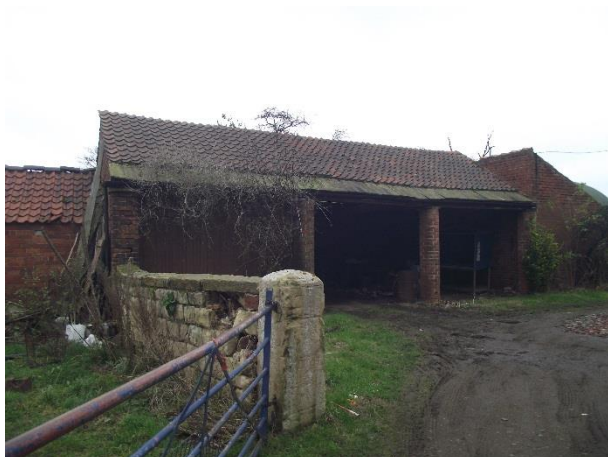
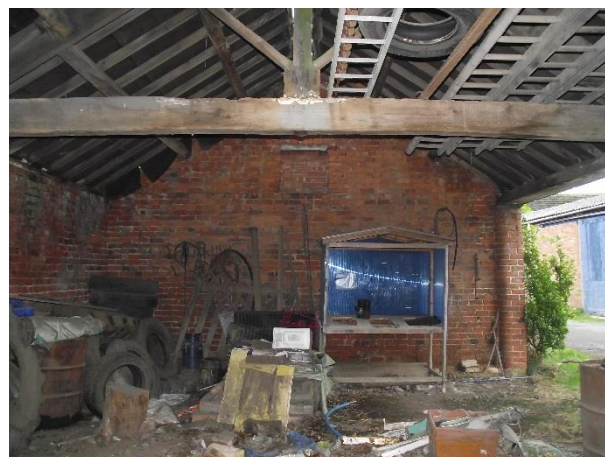
- 8.09 The cartshed is a brick built structure open on the north side with chamfered brick piers with stone pads and caps supporting the roof. It was built between 1855 and 1982 and may originally have stored hay or straw, or possibly unthreshed corn in a loft space (now missing but with evidence of a pitch hole in the west gable end). Furthermore, use as a hay barn cannot be ruled out as nationally their construction increased considerably after 1885 when they were built by landowners to combat the depression. Use as a cartshed with a hayloft above is supported by the storage of a variety of implements inside the building and by the small single storey attached shed built to the east (between 1893 and 1930) presumably to house smaller hand tools, spare parts and so forth.

- 8.10 The building has a dual pitched roof with 'S' profile pantiles rising above a course of large stone roofing tiles. Internally the roof structure comprises king post trusses. Interestingly, some of the brickwork, particularly areas of the internal brickwork, appears to have been reused from an earlier building as it is handmade brick of a character more commonly encountered in the late 18th or early 19th centuries. Other areas of brickwork are consistent with the mid-late 19th century date supported by the cartographic evidence.

The entrance to the cartshed (left) and an internal view looking west showing the pitch-hole and king post roof (right)

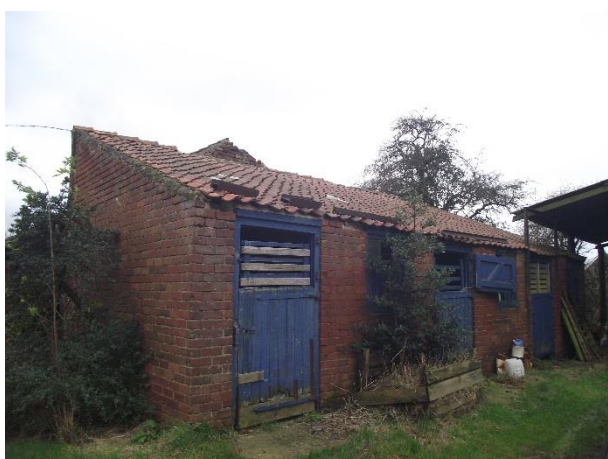
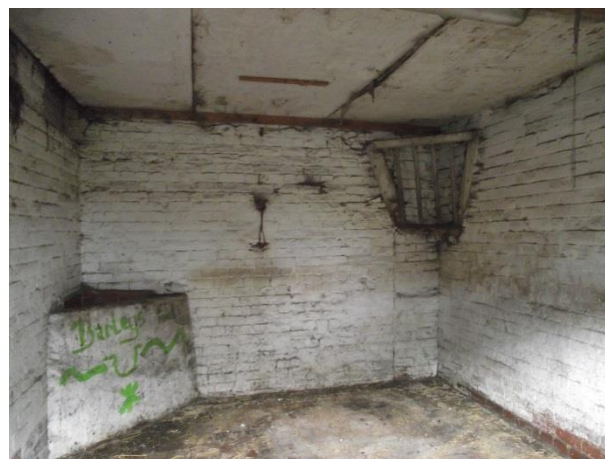
- 8.11 The brick stables were built partially against the west wall of the cartshed between 1893 and 1930. They comprise three loose boxes with brick partitions under a mono-pitch pantile roof with 'S' profile tiles. There are three stable doors, each with an adjacent ventilated opening in the west wall. The floors are stone setts and there are corner troughs. The hayloft above may have linked to the hayloft above the adjacent cartshed via the pitch-hole (now blocked) in the west wall of the cartshed.

Exterior view of the stables with stable doors (left) and interior view with feeding rack, trough and tethering hook (right)

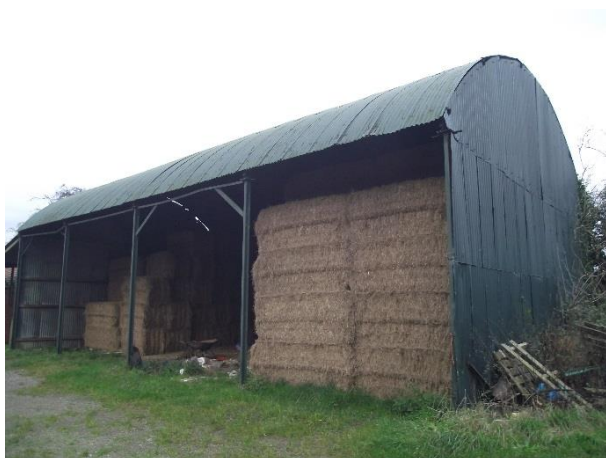
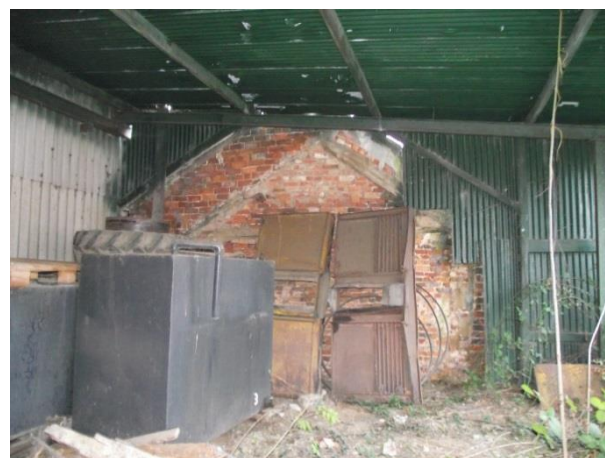
- A small brick building of unknown use built against the west wall of the dovecote (not accessed) – possibly a shed – with a dual pitched pantile roof.
- A late 20th century Dutch barn adjoining the stables with a steel frame and three corrugated walls and corrugated sheet roof. Currently stores bales of hay.
- A partly open sided shed with corrugated rear wall on a blockwork base, a corrugated roof and a concrete floor with a steel and timber frame, located between the cowhouse / milking shed and the brick building described above. Stores farm machinery.
- Two modern sheds east of the barn. The narrow linear range has brick walls with two large high openings in the south wall and a corrugated roof. The wide span multi-purpose shed occupies the location of the former farmyard. It has corrugated and blockwork walls and stores farm machinery.

Open sided shed looking towards the adjoining the former cowhouse / milking shed (left) and Dutch barn (right)

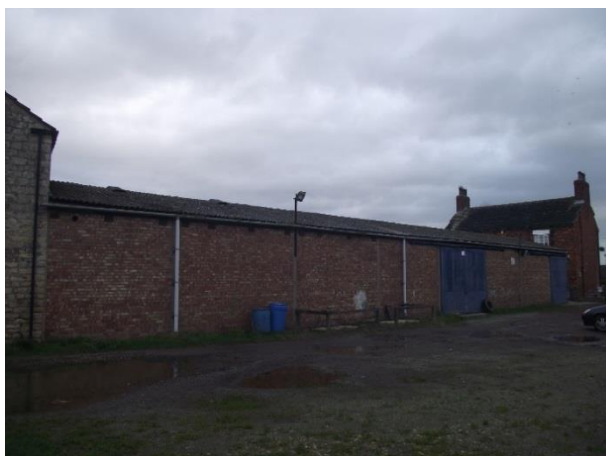
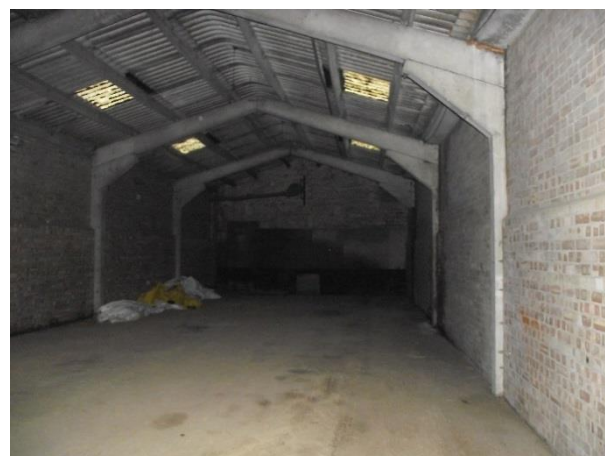
South wall of the shed (left) and interior view (right)
