Ripon Cathedral: Installation of a Noticeboard in the Churchyard

Report on an Archaeological Watching Brief

Site Name: Ripon Cathedral Churchyard, Noticeboard

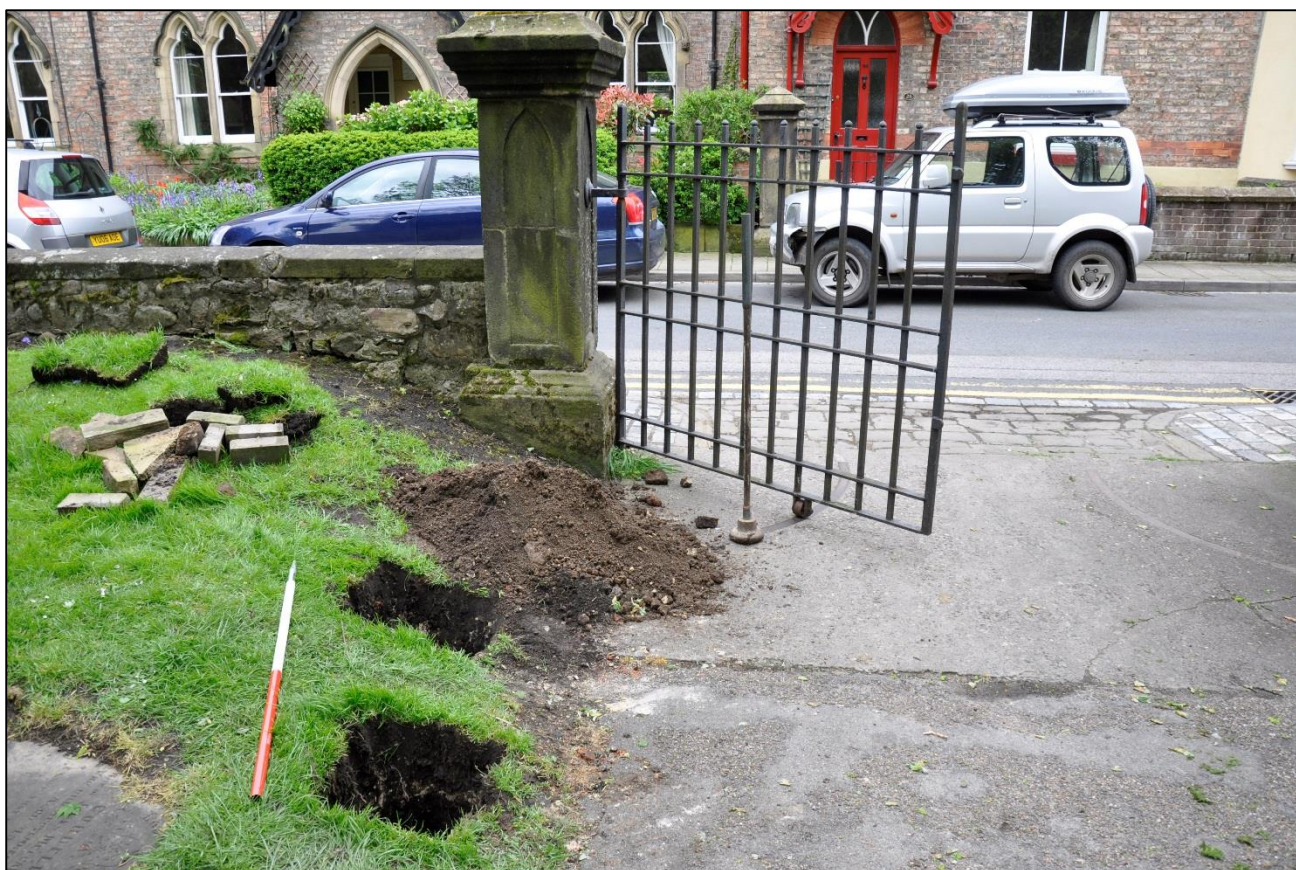
Location of Trenches 1 and 2 by the southeast entrance to Ripon Cathedral churchyard

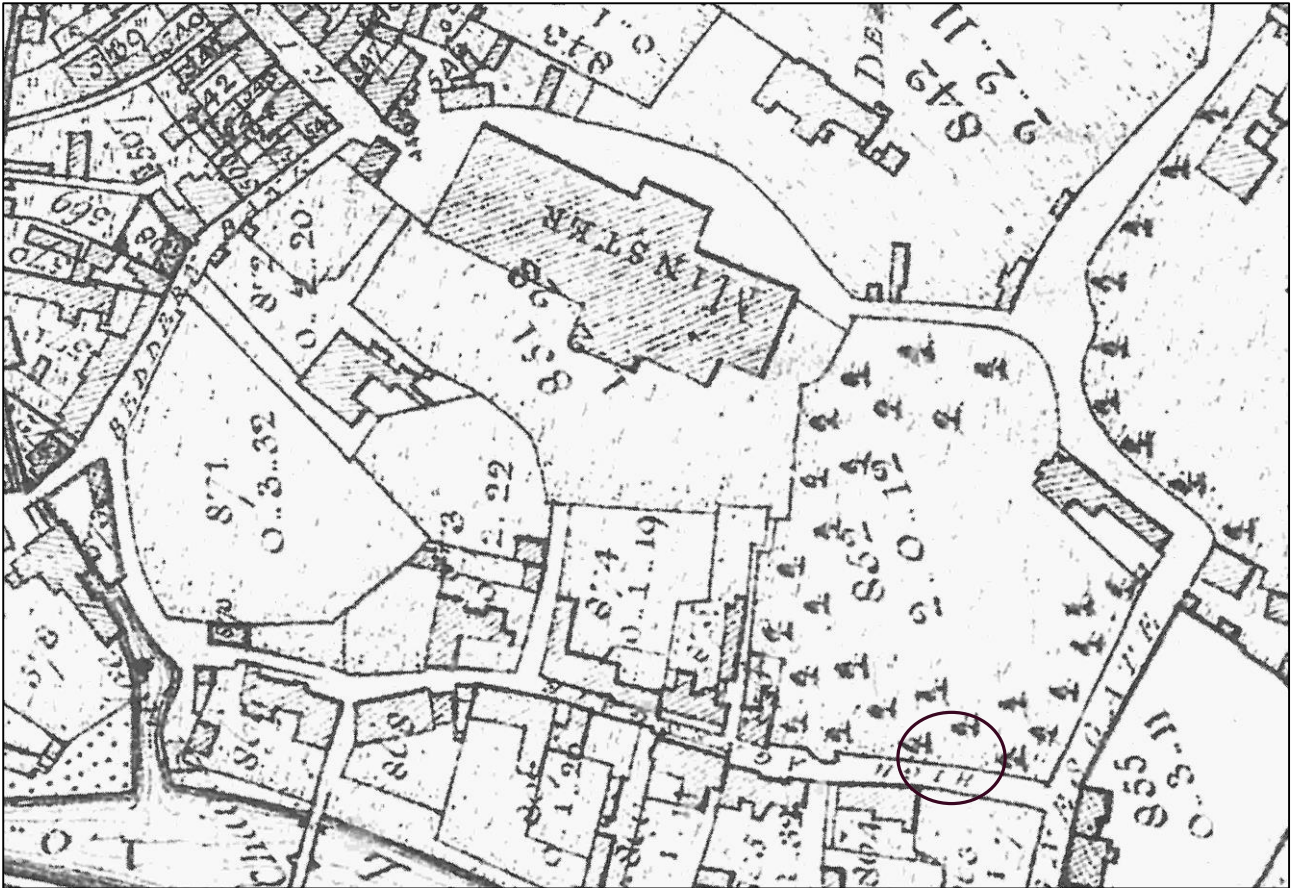
Map of Ripon, John Humphries, 1800: note that the eastern part of the churchyard is a 19th century extension (see map below) with the southern entrance to the cathedral churchyard further west as the current southeast entrance had not yet been created

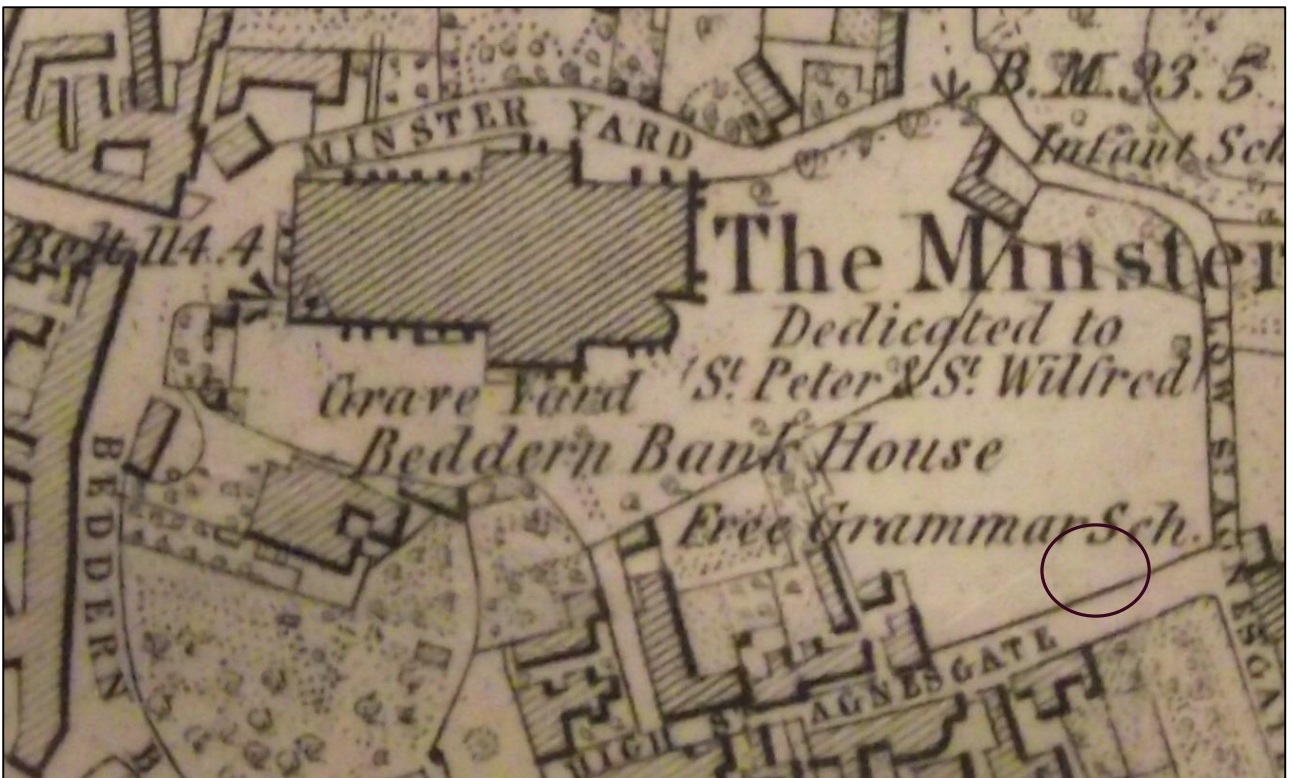
Ordnance survey map, 1856: note that the churchyard has been extended to the northeast, although the southeastern corner remains outside the scope of the burial ground at this date

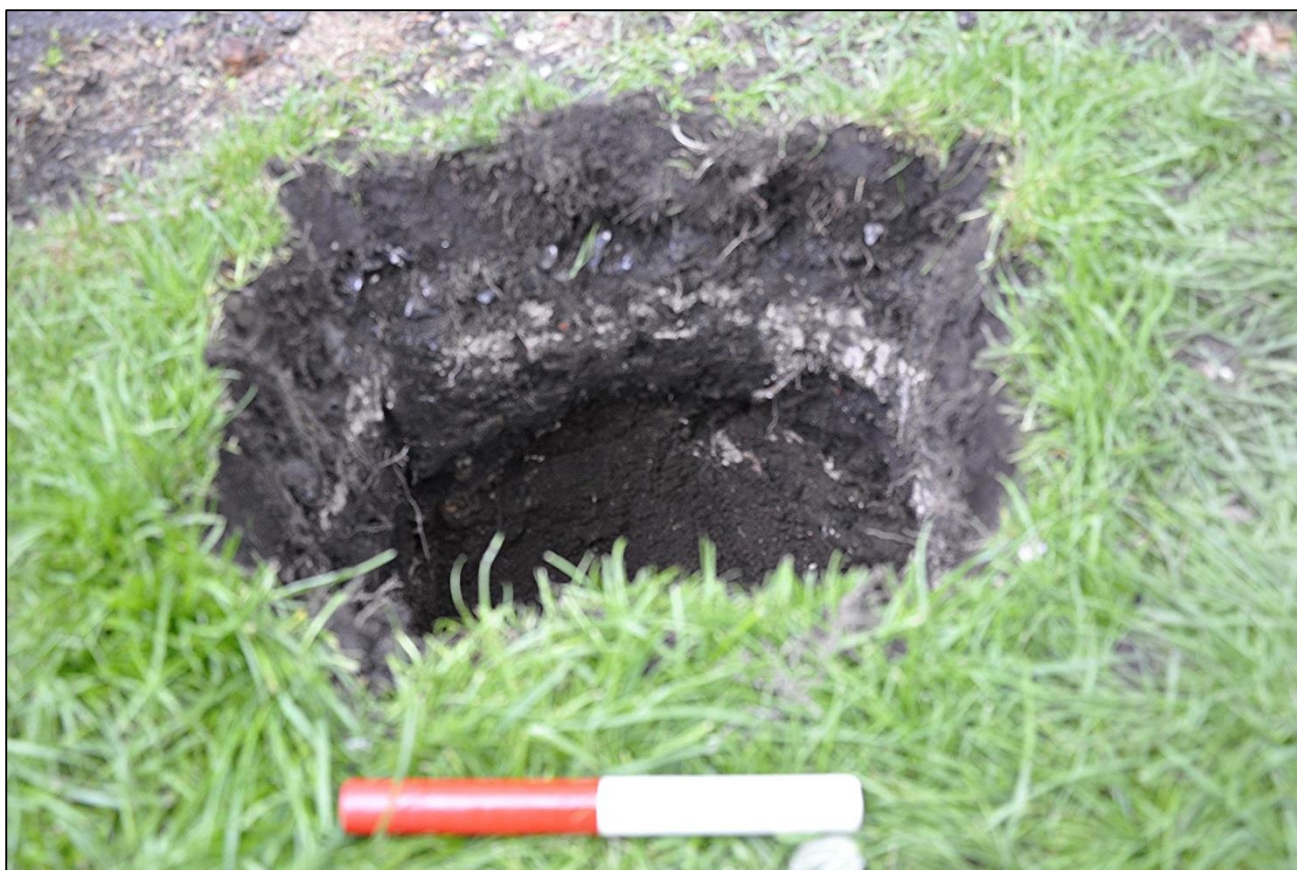
Trench 1 (with 200mm scale)

- 5.03 Trench 1 was located nearest to the gate. Measuring 460mm x 430mm in plan the grass covered topsoil (1000) was a soft dark brownish grey sandy silt containing some rounded river cobbles, fragments of brick and lime mortar (ceramic building material - CBM) and fragments of tarmac. It reached a depth of 420mm-450mm. Below this was a thin layer of concentrated pieces of CBM and tarmac (1001) approximately 25-50mm thick beneath which was a subsoil layer (1002) comprising a mid-brown sandy silt with further inclusions of cobbles, CBM and tarmac. This extended to the base of the trench, which reached a total depth of 780mm from the ground surface.

- 6.02 No significant archaeology was found to be present. Layers 1001 in Trench 1 and 2001 in Trench 2 form part of the same deposit of material in this area. The concentration of brick, tarmac and lime mortar fragments with cobbles in this layer (and their sporadic presence in the topsoil and subsoil - layers 1000, 1003 and 2000, 2003 in Trenches 1 and 2 respectively) indicate that there was a period of construction or, more likely, demolition / dumping in this location. The bulk of the material would then have been moved elsewhere leaving these thin layers and CBM *in situ*. Given the concentration of this material above the subsoil, the activity associated with it probably occurred during the 19th or early 20th centuries.

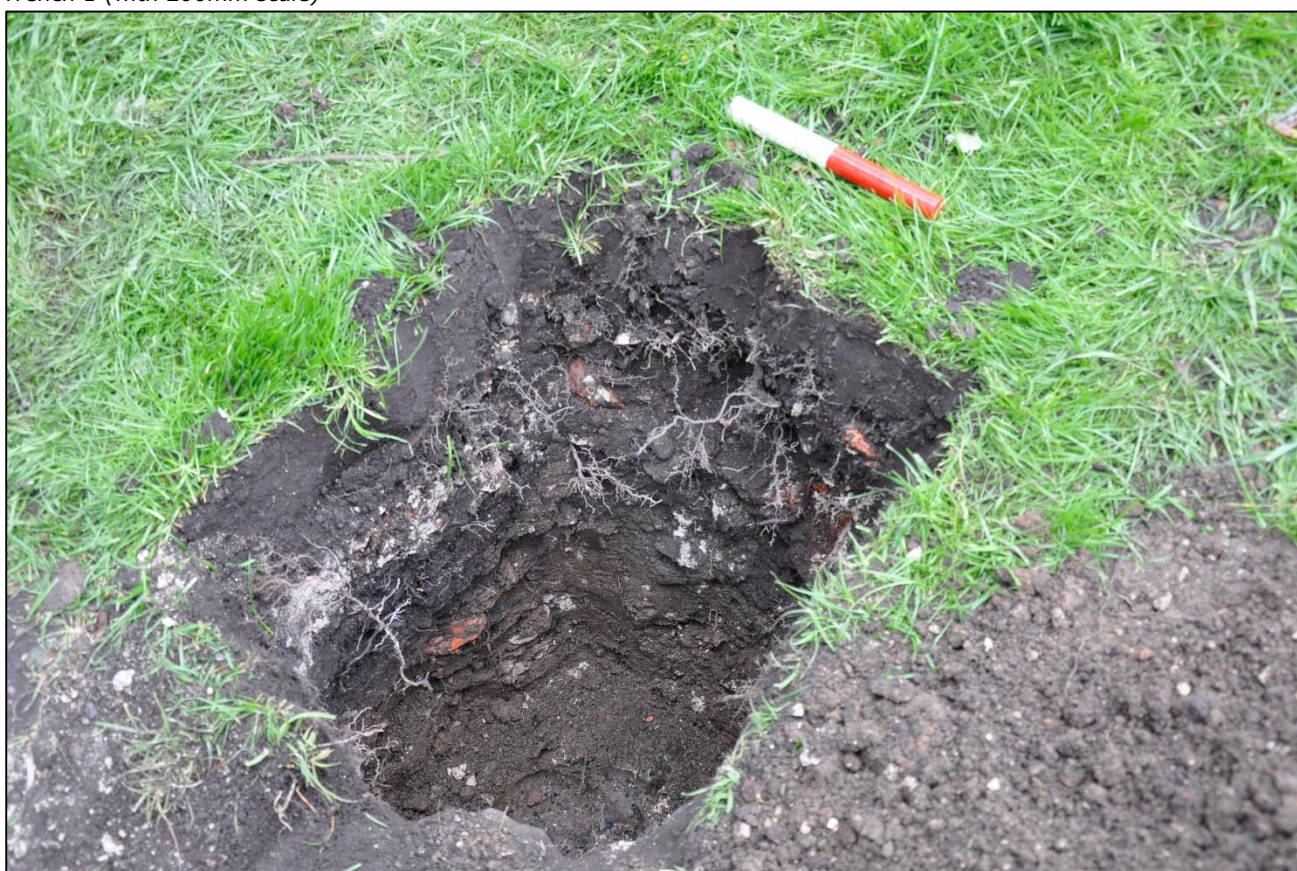
Trench 2 (with 200mm scale)

- 5.04 Trench 2 measured 400mm x 360mm in plan with a depth of 680mm. The topsoil (2000) was the same as the topsoil layer (1000) in Trench 1. The layer of CBM (2001) and subsoil (2002) matched layers 1001 and 1002 respectively in Trench 1 and contained the same inclusions.
