**Disabled Access Ramp
Sheriff Court
Kirkwall
Orkney
KW15 1PD**

**Archaeological Watching Brief
Data Structure Report**

Project No: 321

March 2012

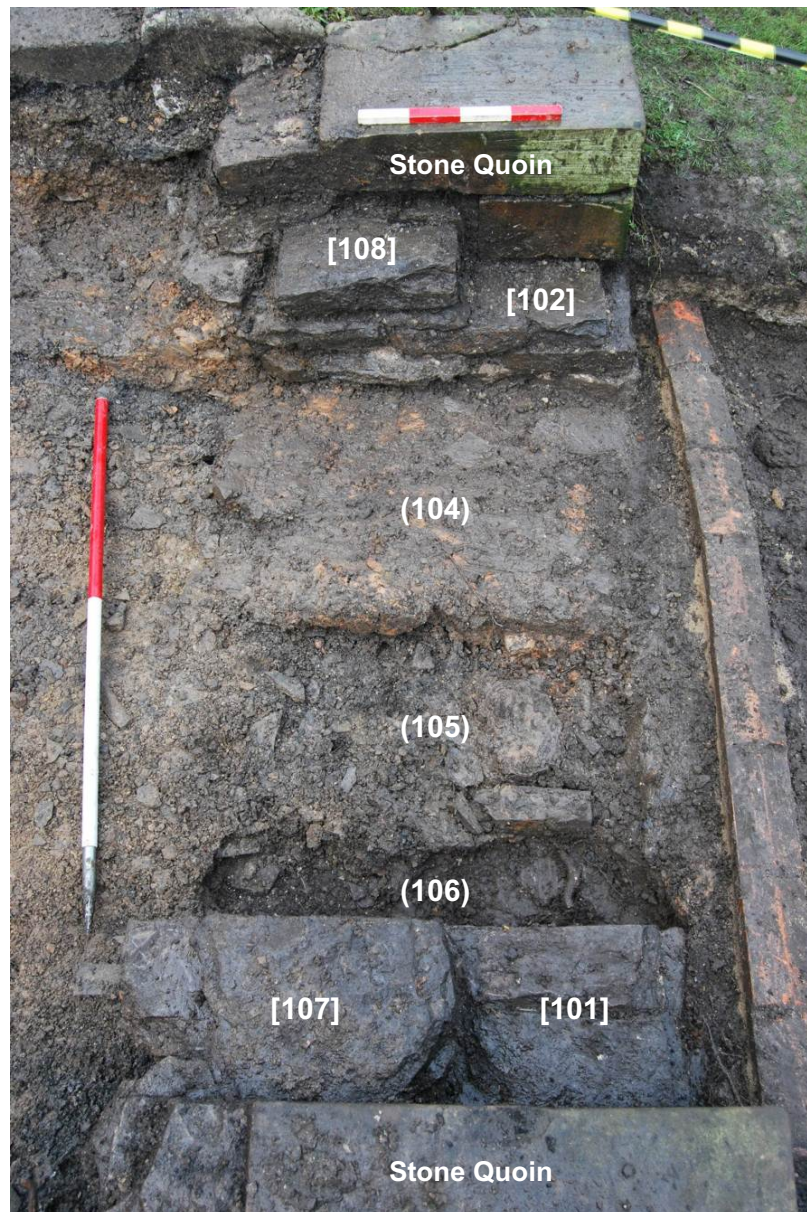
Plate 1. Construction cut [103] with walls [101] and [102]

Directly below the stone slab courses ([107], [108]) were two east-west aligned sections of mortared wall: [101] on the eastern side of the trench, and [102] extending into the western side of the trench.

The mortared wall **[101]** measured 0.87m in width and was excavated to a depth of four courses (0.40m in height), it protruded into the trench by 0.53m from the west facing section. This section of wall comprised Caithness flagstone orientated towards the north with a 0.05m step inwards between the top and second course. The largest stone of the third course had mortar adhered to the west face which may suggest that the wall line had continued further west and originally joined the segment of wall **[102]**. It is unclear whether this was the case as there is no evidence of a robber cut (see Discussion below).

Wall **[102]** was similar in width to **[101]** at 0.86m. It protruded from the east facing section by 0.41m OD. Three courses of mortared Caithness flagstone type stones were observed and the wall maintained the same stepped northern face as **[101]**. The east-facing section of the wall showed possible signs of where stones, now absent, may have keyed in to extend the wall further to the east where it may have joined up with **[101]** (Plate 1).

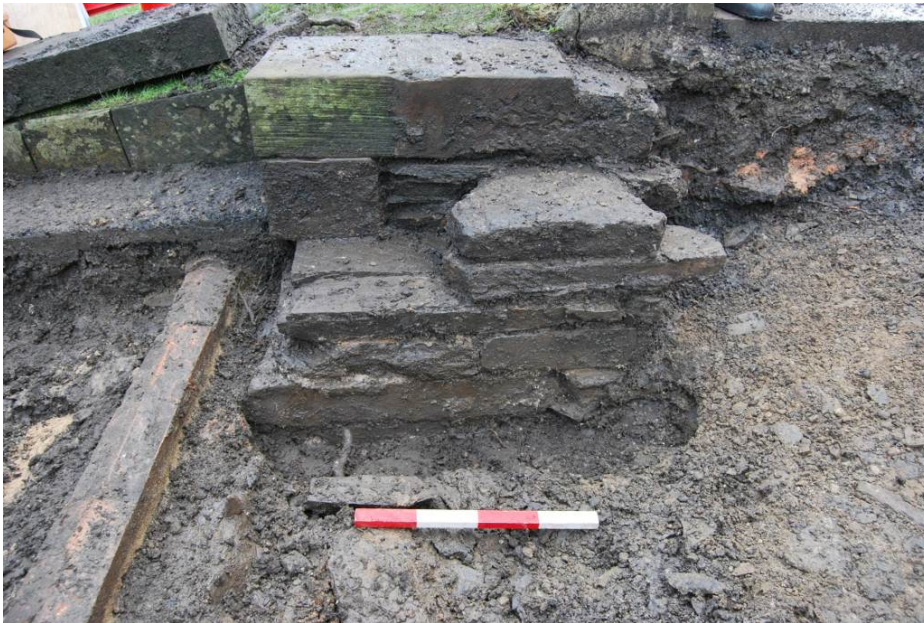
Plate 2. Cut **[103]** with wall **[101]**, later stone slabs **[107]** and the stone quoins above

At the base of the excavated extent of the trench was cut **[103]**. This cut had near vertical sides and appeared to extend the width of the trench (east to

west) extending along the front and rear edges of wall [101] (see Plate 3). This suggests that it was a construction cut for walls [101] and [102] which would have originally been a single section of wall.

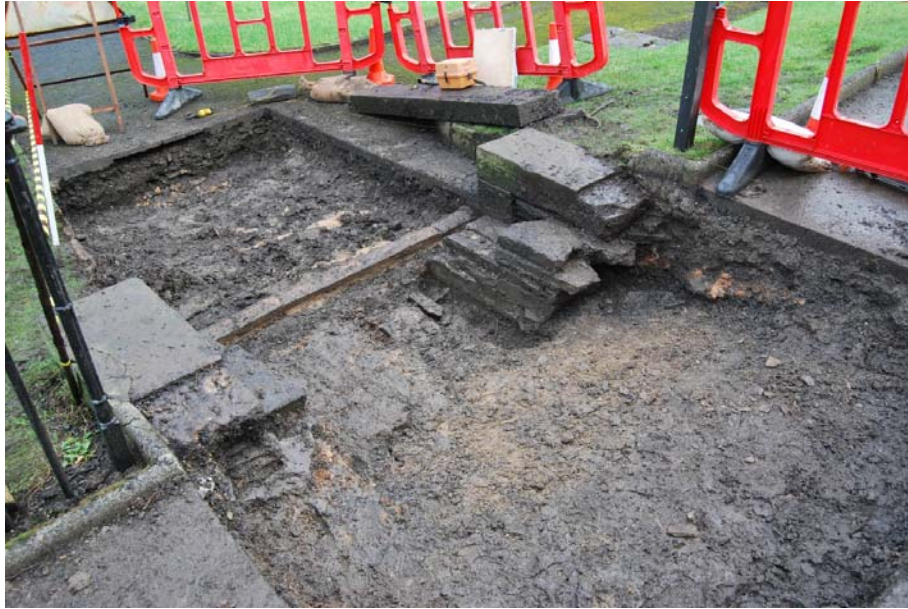
Plate 3. General view of monitored area showing medieval wall features

The earliest feature identified in the monitoring area was a linear construction cut **[103]** for wall **[101]/[102]** 0.87m wide and 1.32m in length where visible. This cut was excavated to a depth of 0.12m and appeared to have near vertical sides at this height. The southern edge of the cut has been truncated and most likely obscured by robbing activity and backfill deposits **(104) (105)** during the placing of the stone steps.

Cut **[103]** most likely dates back to the construction of the Earl's Palace brewhouse sometime in the 17th century and offers evidence for the Palace extending across the monitoring area. The wall segments 101, 102 are most likely 17th Century in date and are the remains of the Brewhouse, the remnant walls of which can be seen jutting out from the fabric of the standing remains of the Palace. The southern (internal) edges of walls **[101]/[102]** line up with the internal edge of the remaining Brewhouse wall, however given the distance of the trench to the extant wall, on the basis of this excavation, the northern, external edge of the wall may not align with the corresponding Brewhouse wall. This raises the question as to whether the wall actually continued across as one, or whether the gap between the two segments of wall represents an entrance way, with a slightly larger thickness of wall in this area.

The archaeological features described above were recorded in situ and mitigation agreed upon to allow for walls [101] and [102] to be preserved *in situ*. Modern dry stone step footings [107] and [108] that were on top of these walls were recorded and then removed under archaeological observation. Walls [101] and [102] were covered with terram and sand and boxed in with fibreboard whilst under observation before the gravel foundation layers for the concrete were spread and concrete poured.

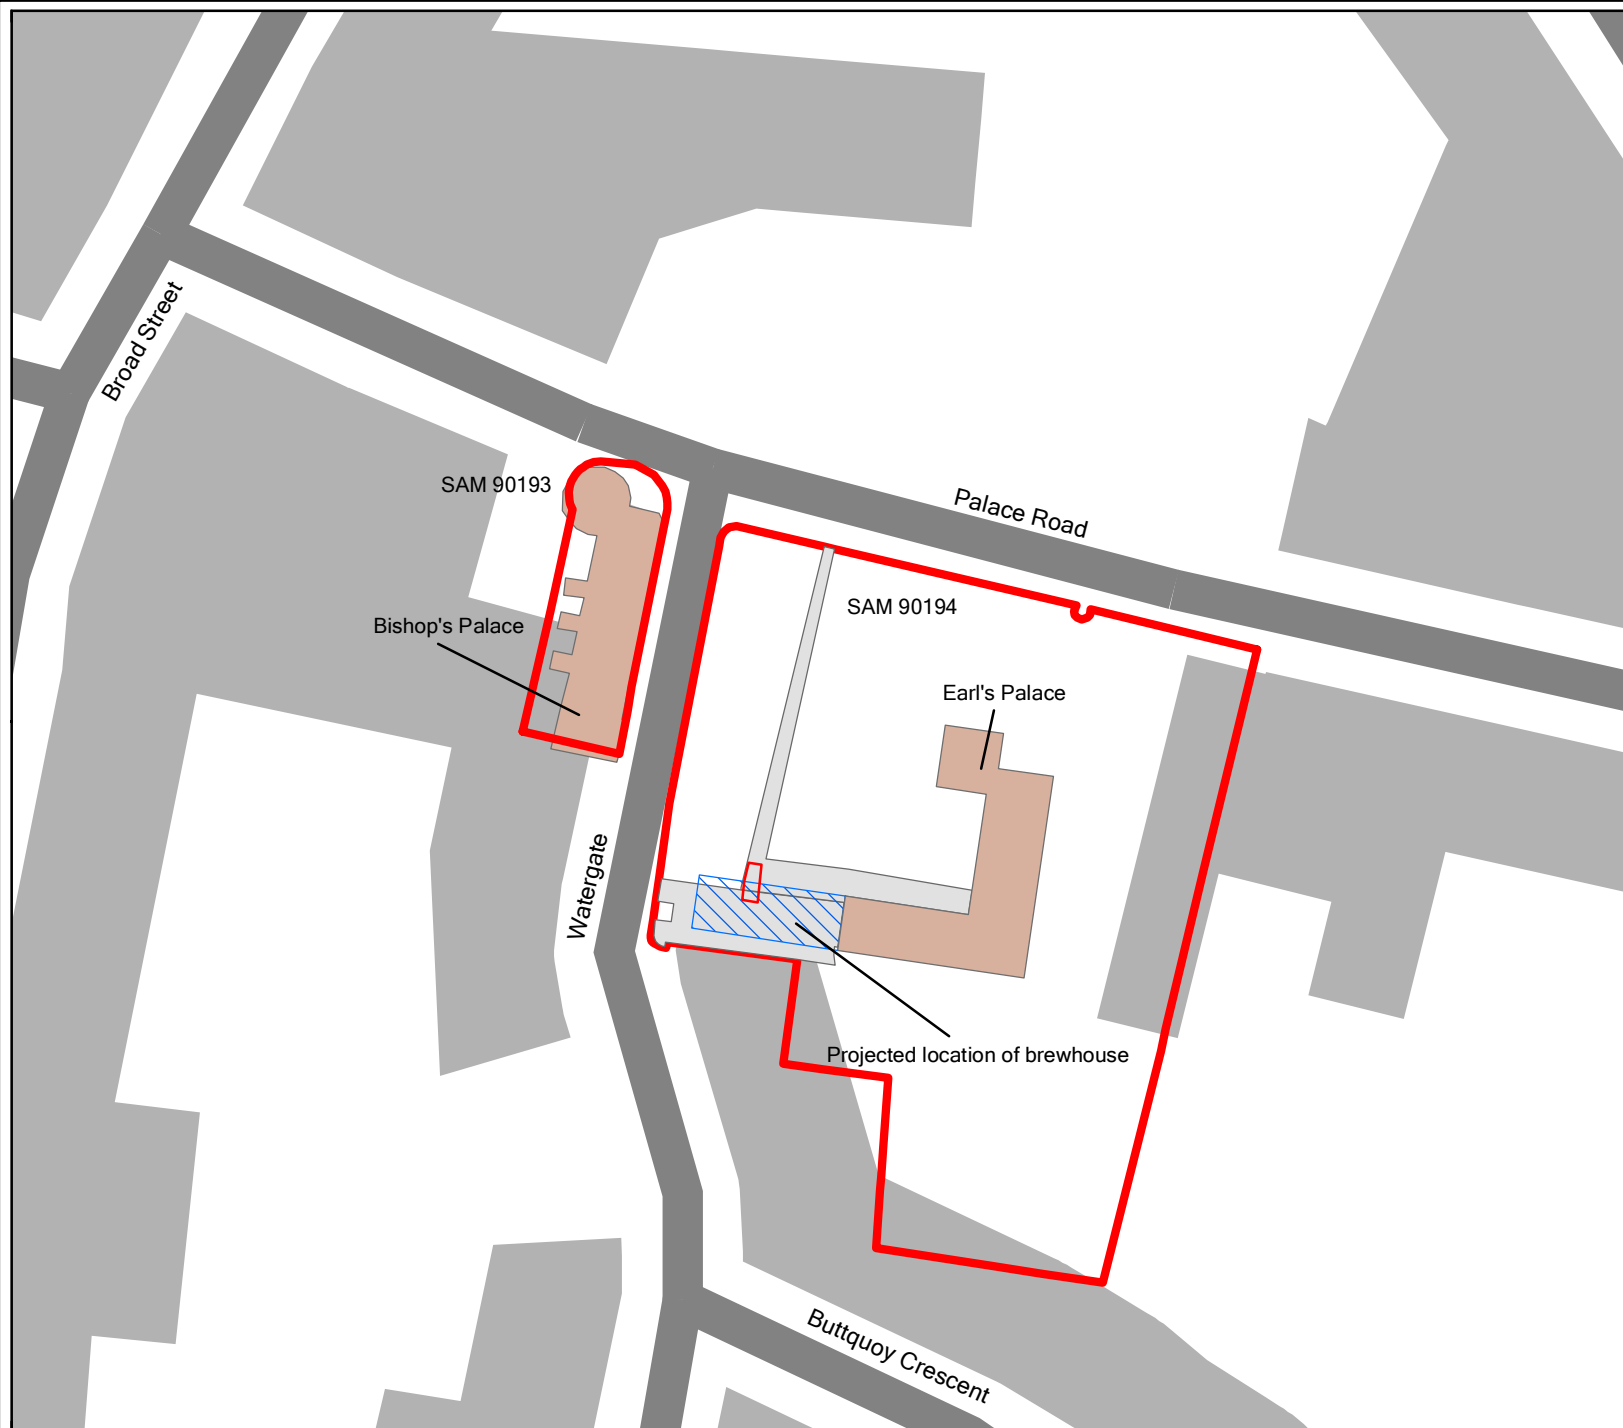
Figure 2. Location of archaeological monitoring

The site is located within the grounds of the Earls Palace, Watergate, Kirkwall, National Grid reference HY449107 (See Fig 2). The site is situated on a steep slope at c.14.4mOD, (Broad Street, downslope, is at 4.6mOD and upslope at the junction of Palace Road and School Place is at 17.4mOD) and lies within the area designated as a Scheduled Ancient Monument (SAM No 90194).

- Area of monitoring
- Earl's and Bishop's Palaces
- Projected location of brewhouse
- Areas of tarmac
- SAM area
- Area of settlement
- Road

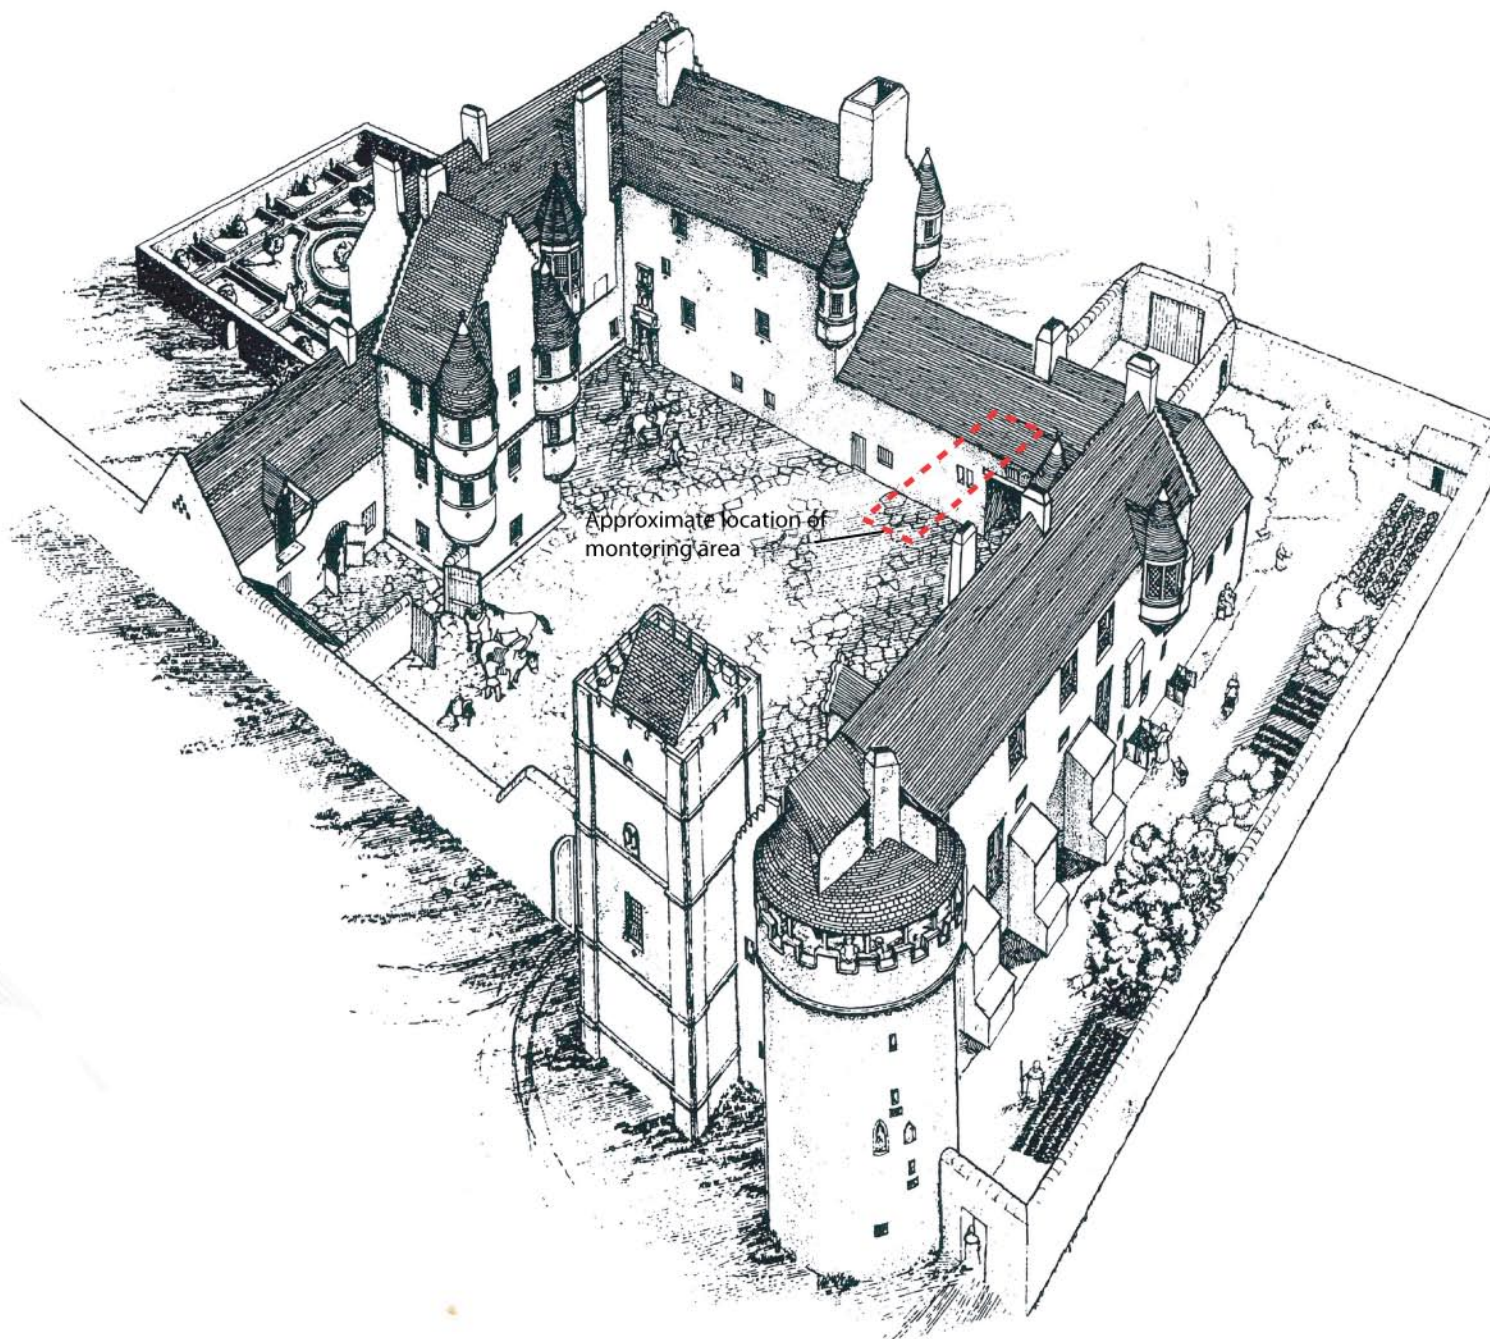
Subsequently, progressive construction as successive Bishops of Orkney added parts to the Bishop's Palace (Pringle 1999) was undertaken throughout the medieval period. In 1568 ownership of the Bishops Palace was passed to Earl Patrick the First Earl of Orkney. The building known today as the Earl's Palace (SMR/OR No 01564) was built by Earl Patrick between c. 1601 and 1607 (Pringle 1999). Situated to the south east of the Bishops Palace it was built as an addition to the existing complex of buildings known as The Palace of the Yards. Much of the Earl's Palace remains upstanding today, however a stretch of the building, now demolished is thought to have spanned across the area of the Access Ramp trench (See Figure 4).

Approximate location of monitoring area

Figure 4. Artist's impression of the Earl's Palace showing the location of the site (from Pringle, 1999)

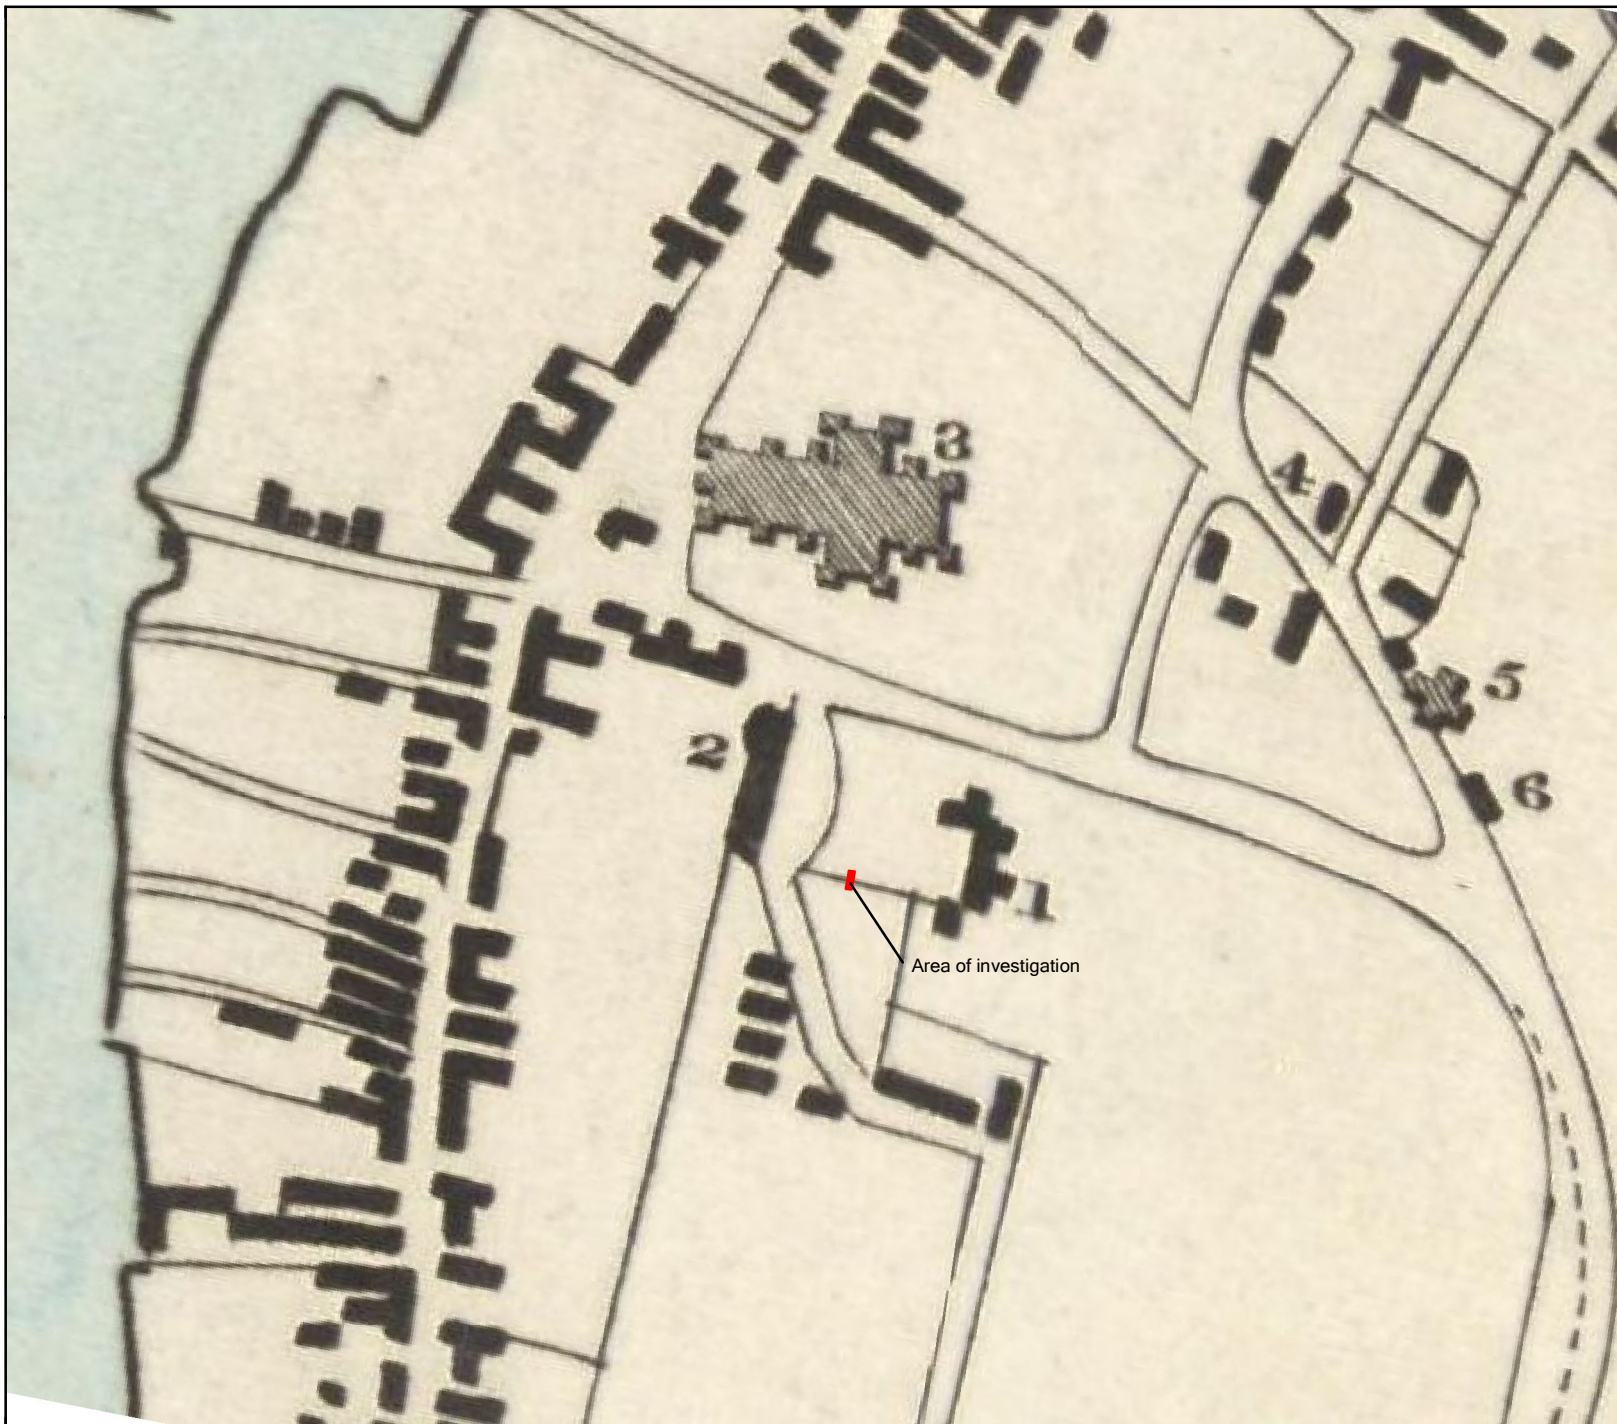
To the south of the site the land appears to have remained open, the 1832 Great Reform Act Plans of Kirkwall show five possible tenement\burgh properties the associated grounds for which may fall into the area of the site (Figure 5).

Figure 5. 1832 'Great Reform Acts, Plans and Reports' map, Kirkwall

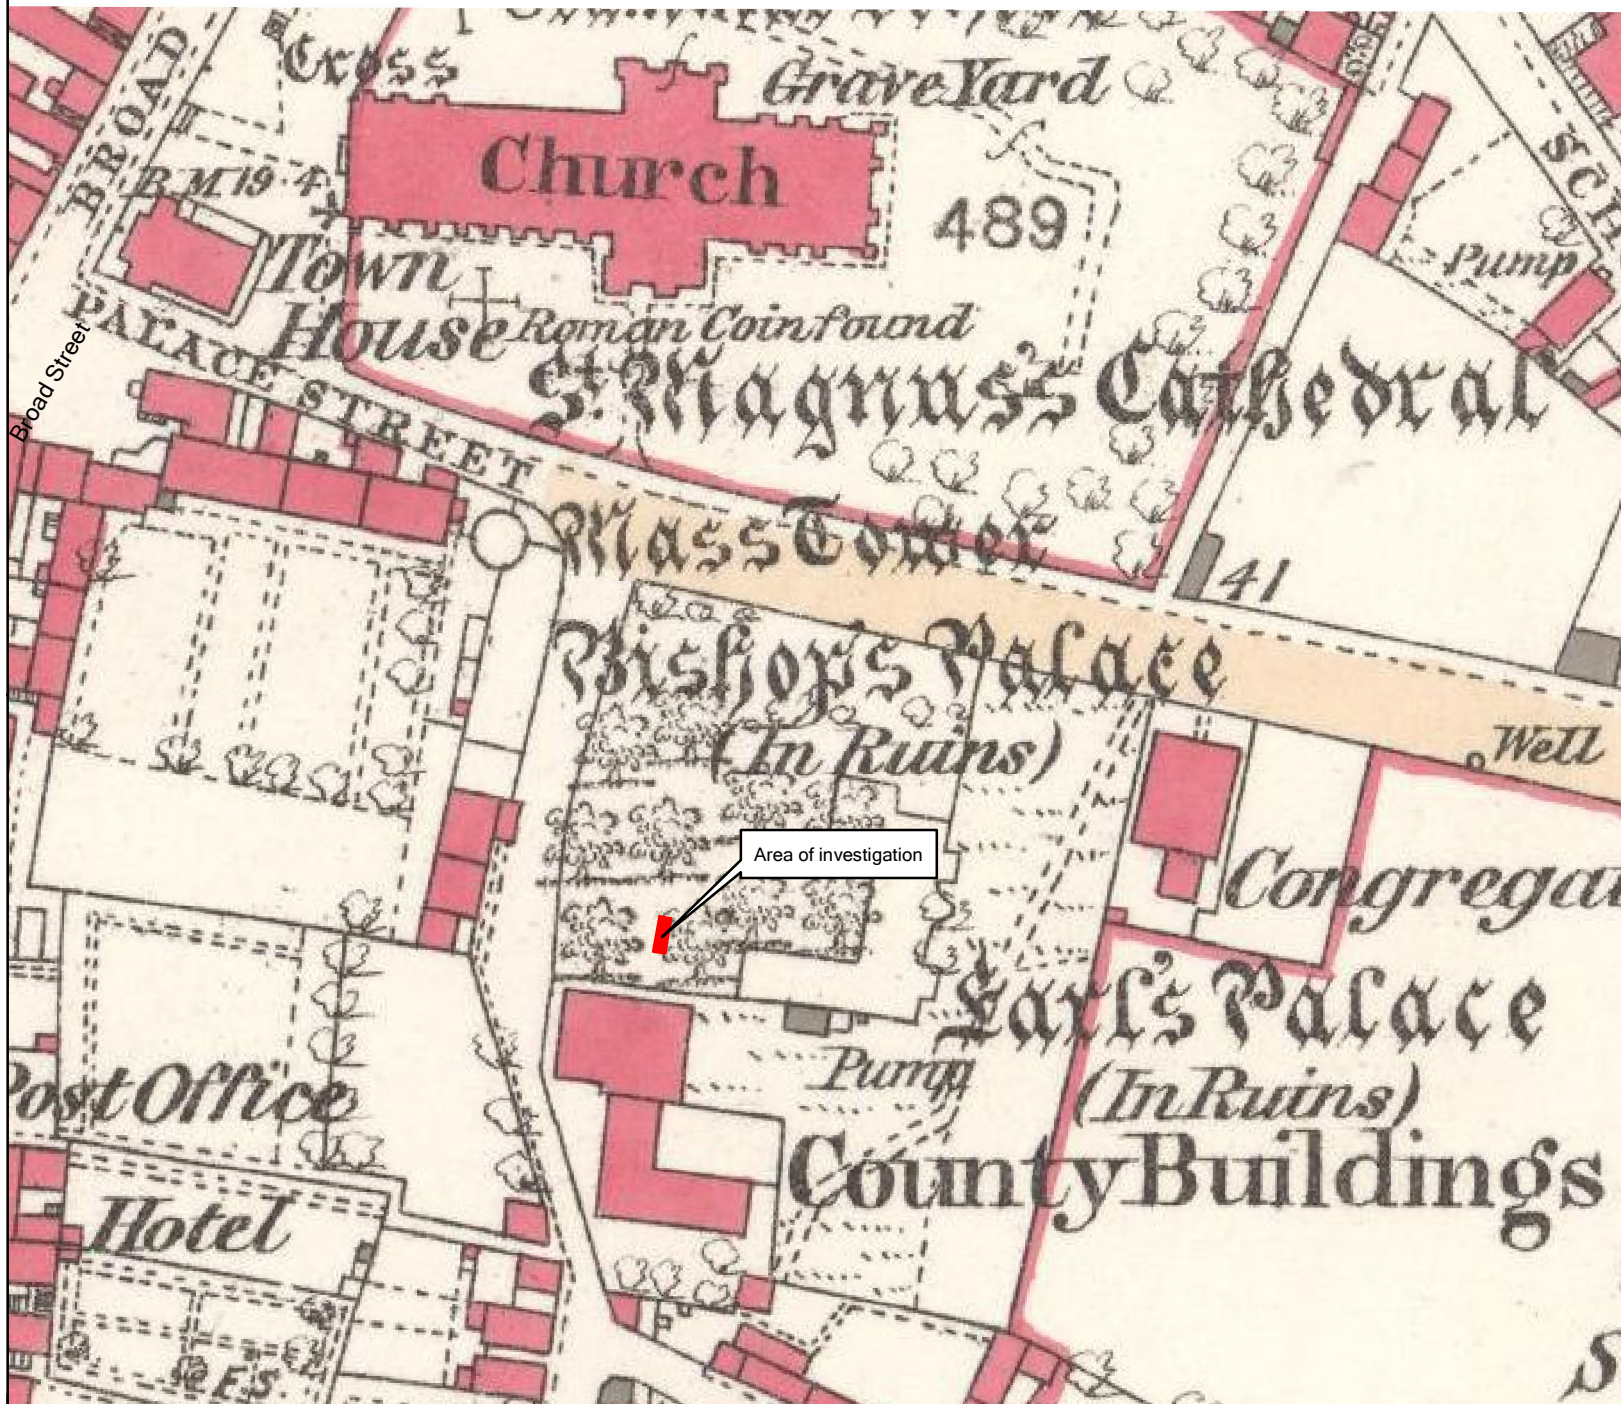
The Kirkwall Sheriff Court was built in 1876 by architect David Bryce (Figure 6). The construction of this building may have had an impact on the surrounding remains of the Earl's Palace.

Figure 6. 1855 - 1882 OS Map 25 First Addition, Kirkwall, Scotland
