Twatt Airfield Water Pipeline Sandwick Orkney

Archaeological Watching Brief Data Structure Report

Watching Brief

Data Structure Report

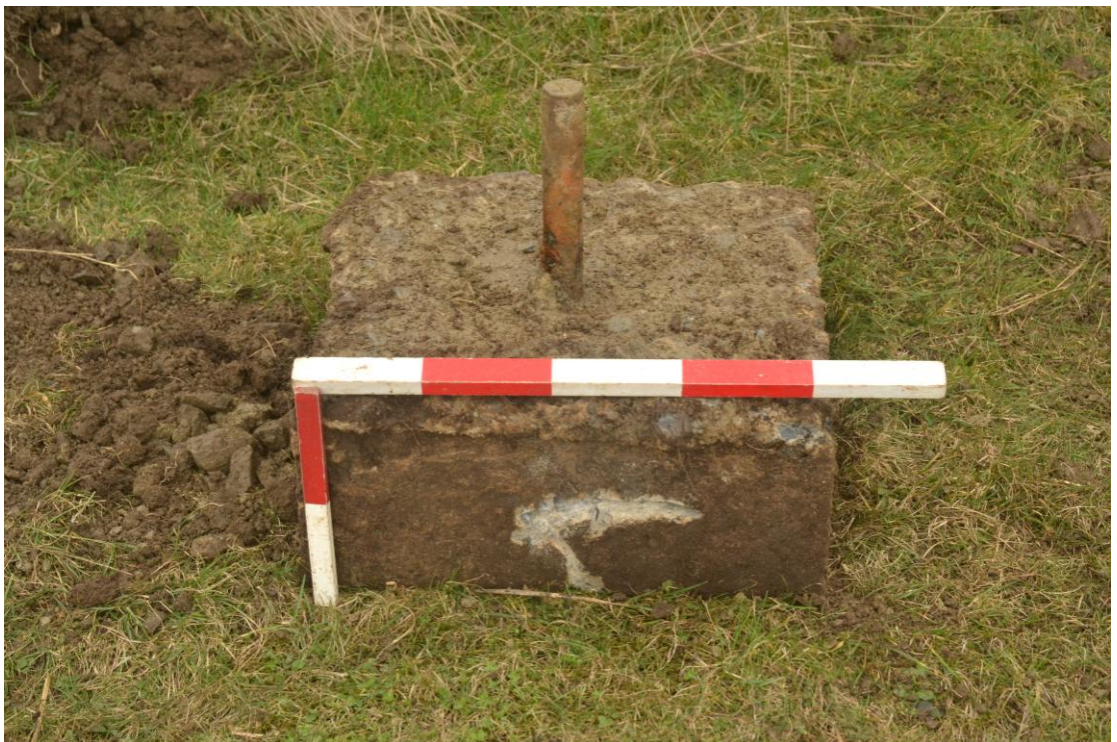
Plate 1: WW2 gatepost from (207): ex-situ

The pipeline route then crossed over the access track to Newhall, which represents one of the main access routes to the former airfield, leading to the sick bay and the western technical area (Lamb, 2007: 41). Immediately underlying the modern road surface, a thin, patchy hardcore was recorded, up to 0.18m deep, representing this wartime road surface. Set into the west of this surface, a gatepost of WW2 date was recovered, located 1.80m to the North of the existing gatepost. It consisted of a length of iron bar, 0.40m in length, set centrally into a roughly cast concrete block, 0.42 x 0.42 x 0.16m (see plate 1).
