# **Rennibister Wind Turbine Firth Orkney**

## **Evaluation Data Structure Report**

April 2013

**Project No: 405**

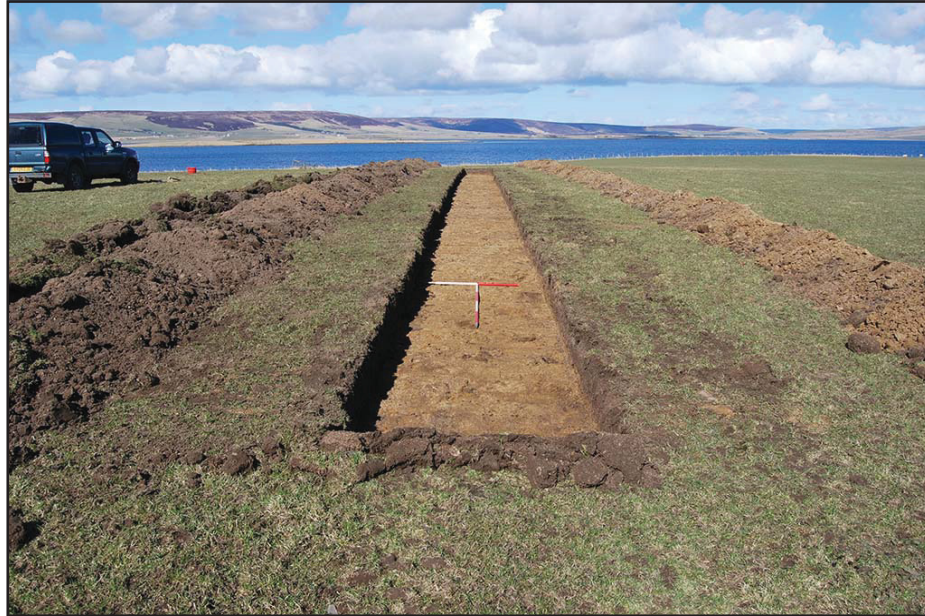
Trench 1 (Figures 1 and 2) measured 50.60m by 1.5m, was aligned NNW to SSE and was machine excavated to a maximum depth of 0.4m. The turf and topsoil **100** measured between 0.3m and 0.23m thick, and was shallowest in the middle of the trench, which corresponded to a rise in the topography. The topsoil consisted of a dark orange brown silty clay with 2% sub-angular to rounded flagstone inclusions between 10mm and 100mm. In the NNW

Plate 1: Overall shot of Trench 1, looking NNW

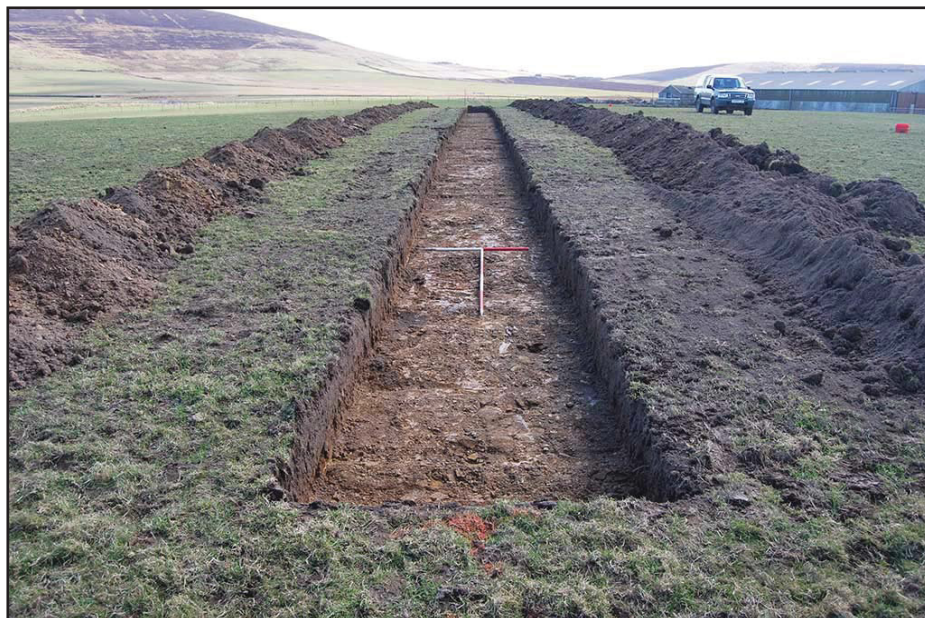
Plate 2: Overall shot of Trench 1, looking SSE

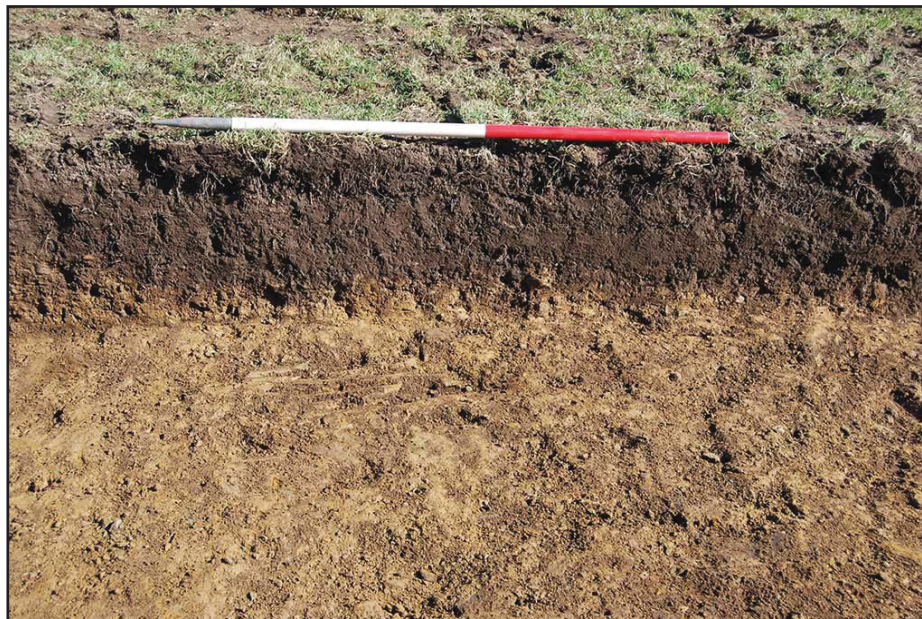
The nature of the natural topography consists of glacial till **101** varying in height from 7.99m OD in the NNW to 8.73m OD in the middle of the trench.

Plate 3: Representative section, SSE end of trench, looking ENE

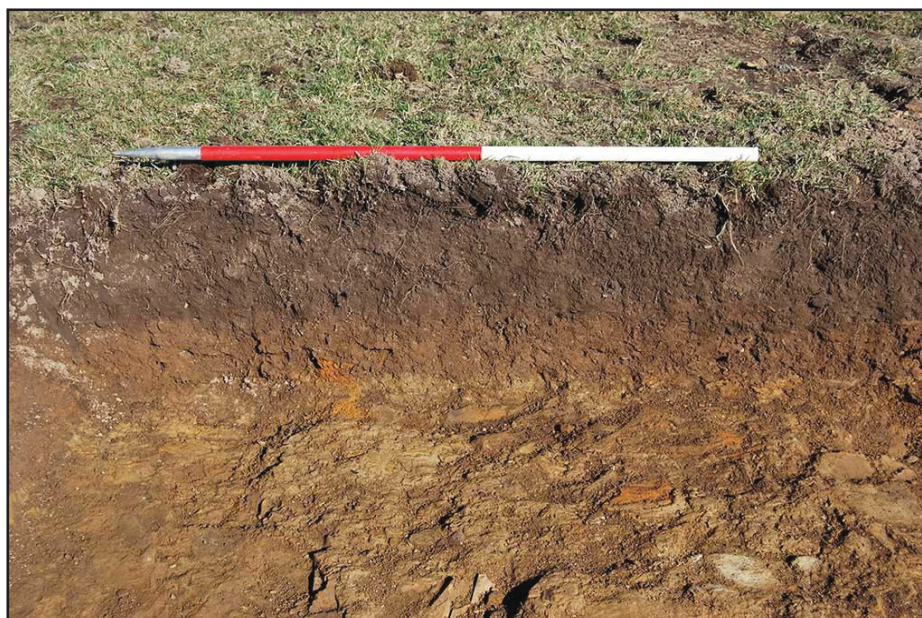
13.5m of the trench, topsoil **100** overlay **102**, a deposit of mid yellow brown silty clay with 2% sub-angular to sub-rounded flagstone inclusions which ranged in size from 10mm to 60mm. Layer **102** was either a deposit of subsoil, or alternatively could have been the remains of a furrow base, it measured 0.15m thick to the NNW, and thinned out to the SSE. Context **102** sealed the underlying glacial till **101**, which was overlain by the topsoil in the areas of the trench where **102** was not present. Glacial till **101** comprised a firm light orange brown silty clay with 30% sub-angular to sub-rounded flagstone inclusions, between 20mm and 600mm in size. Small, localised patches of the weathered upper surface of underlying bedrock were evident protruding through the glacial till, which appeared to slope off to the NNE at an angle of c.30°. The bedrock was light brown fine grained slightly laminated sandstone, which had mid orange brown ferrous patches and laminations present. Throughout the course of Trench 1, the upper disturbed portion (predominantly around 0.1m) of glacial till **101** was removed, to ensure that no poorly defined archaeological features were present cut into this deposit.

The soil profile consisted of topsoil **100** overlying subsoil / furrow base **102** in the NNW end of the trench, which sealed glacial till **101**. The topsoil was between 0.3m and 0.23m thick, and the subsoil was a maximum of 0.15m thick in the NNW end of the trench. No significant archaeological features were revealed within Trench 1. The deposit of subsoil **102** in the NNW end of the trench may represent the base of a furrow from rig and furrow cultivation of the area. Numerous NNW to SSE geophysical trends were seen in the geophysical survey of the area (ORCA 2013), one of which

Plate 4: Representative section showing 102, NNW end of trench, looking ENE
