4-10 Cramond Place, Cramond, City of Edinburgh Archaeological Evaluation and Monitoring

November 2015

4-10 Cramond Place, Cramond, Edinburgh Archaeological Evaluation and Monitoring Job No: 217

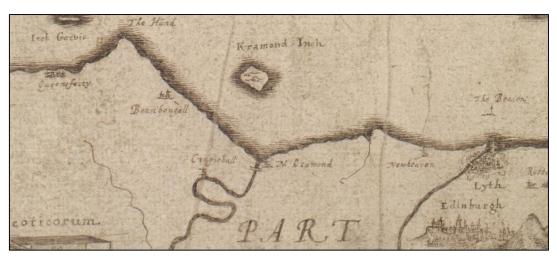
Figure 2: Extract from James Gordon's map of Fyfe Shire MDCXLII . NLS

3.2.2 The earliest maps of that show Cramond are from James and Robert Gordon's 17th century series of maps of Scotland. The 1642 imprint (Figure 2) by James Gordon mentions Cramond by name but does not give any detail of the land usage of the time.

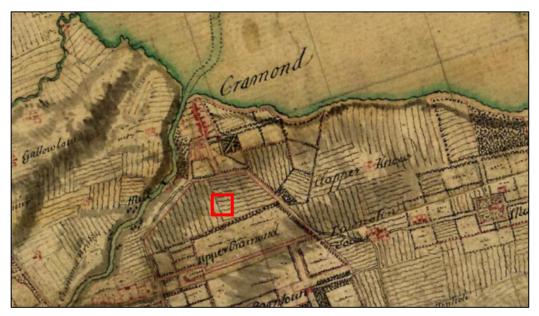
3.2.3 William Roy's 'Military Survey of Scotland' conducted between 1747 and 1755 (Figure 3) provides much greater detail than shown on earlier maps. Roy's work revolutionised map making in Scotland, containing a lot more terrain detail than previously shown.

Figure 3: Extract from William Roy's Military Survey of Scotland showing the location of the site outlined in red). © The British Library Board. All Right Reserved (Roy Military Survey of Scotland)

3.2.4 William Roy's map shows the location of the site within the surrounding area and is the earliest of the maps consulted to show any detail of the landscape around the site. Though there is clearly occupation activity to the north, it would appear that at this time (1752-1755) the area immediately surrounding the site was given over to agricultural land usage.

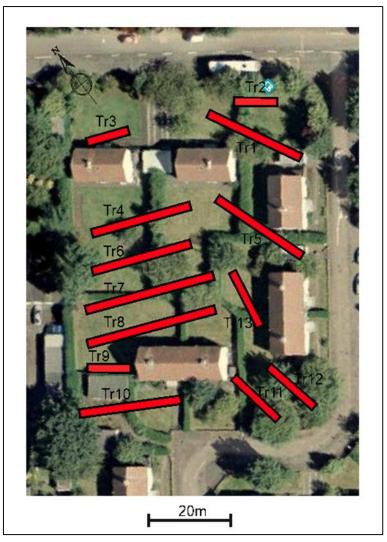
Figure 7: Trench Location plan

6.1.1. 13 trenches were opened varying in length from 10.0m to 32.50m providing a total coverage of 424m², or 10.2% of the total development area. Trenches were sited to avoid the disturbed footprints of the demolished buildings and to investigate all undisturbed areas. The existence of buried services meant that some trenches had to be slightly relocated from those suggested in the original written scheme of investigation, but were placed providing good coverage across the site.

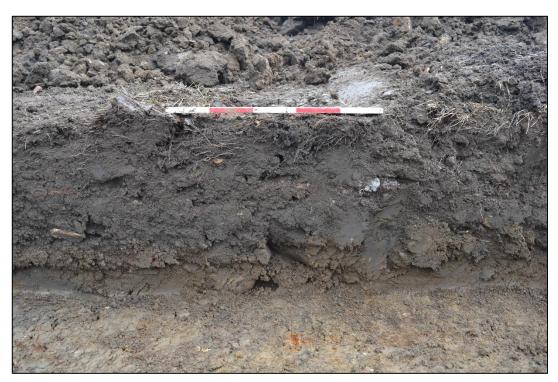
Figure 8: Sample stratigraphy section (from Trench 12)

6.1.2 Across the site, a similar soil profile was noted. This generally comprised a dark grey sandy loam topsoil measuring 0.20m deep. This overlay a mid-brown sandy silt loam to a depth of 0.40m to 0.50m, interpreted as a buried ploughsoil. In some trenches, made ground and demolition rubble was noted. Undisturbed natural subsoils reached at depths of 0.50m to 0.75m across site varied from a light brown silty sand to a mid brown sandy clay. A lighter sandy natural subsoil was more prevalent in the south west of the site though patches of it were also found in trenches to the north and east.

In some trenches (Trenches 1-6) an interface subsoil was noted between the buried ploughsoil and the natural subsoil.

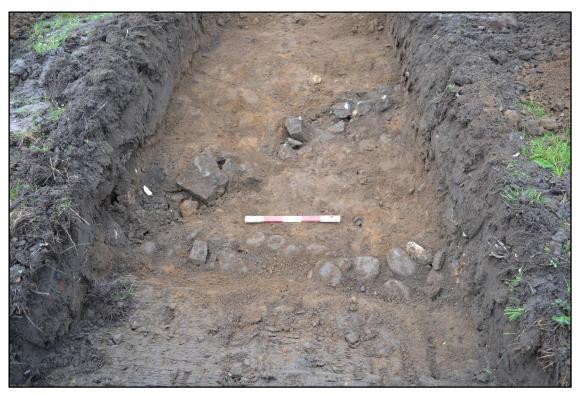
6.1.3 No features or deposits of archaeological significance were noted in any of the trenches. Stone–filled land drains often known as "soakaway" drains were noted in many of the trenches mostly with north-south or northwest–southeast alignments respecting the topography sloping slightly to the north. A sample of these were excavated and recorded. The only recovered artefacts comprised 19th century ceramics most of which were surface finds.

Figure 9: field "soakaway" drains in Trench 13

- 8.1.1 The archaeological monitoring and evaluation works undertaken revealed no finds or features of archaeological significance.
- 8.1.2 The evaluation trial trenches excavated provided good spatial coverage across the site Whilst the only features noted were numerous field drains relating to recent and Post-Medieval agricultural improvements. No features or artefacts were recovered.
- 8.1.3 ARCHAS recommend that no further archaeological work is required.
