**Quality Street,
Dysart,
Fife,
Archaeological Evaluation
Data Structure Report**

Client: Fife Council
Project: Quality Street, Dysart, Fife
Document Title: Archaeological Evaluation DSR

Job No: 228

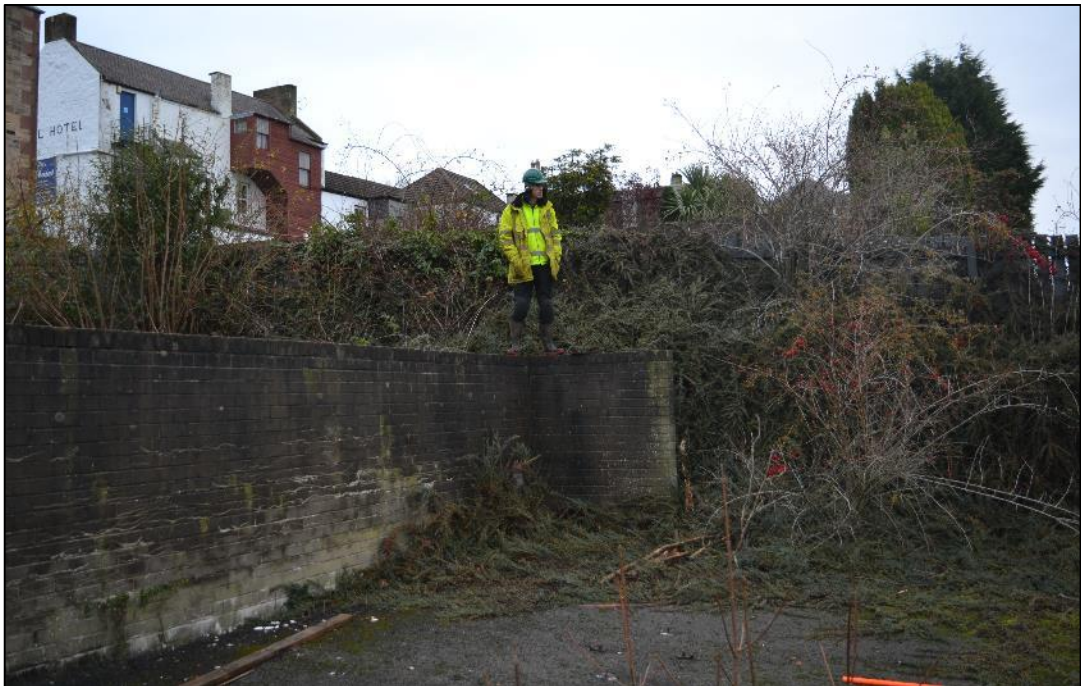
- 1.2.6 To the west of this, two terraced areas are enclosed by high brick walls and accessed via flights of steps from the Quality Street side. These terraced areas are surfaced with tarmac (Plate 1).

Plate 1: Looking north east across the terraced areas at the western side of the site. Note the drop from the Royal Hotel in the background, which borders the north east side of the development area (Photograph 006)

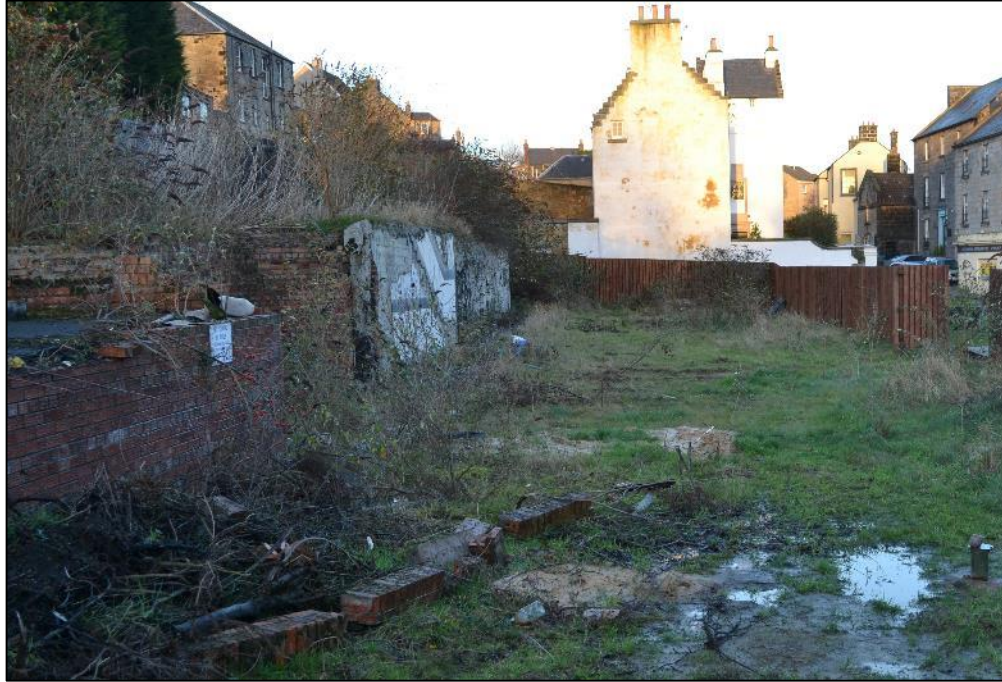
- 1.2.7 The south eastern part of the site is bordered by a large brick and concrete revetting wall (Plate 2). This is the remnants of the previous 20th century structure on the site. This part of the development area is level with Quality Street.

Plate 2: Looking north east along the southern part of the site, with Quality Street to the right. Note the large revetting wall (left)

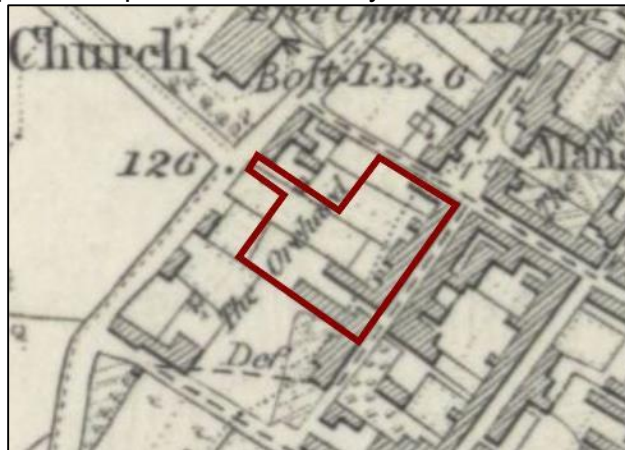
Figure 2: Extract from the 1st edition Ordnance Survey 6 inch Fife Sheet 23 from 1856 with the general site area indicated in red

- 2.1.3 The Ordnance Survey 1st edition 6 Inch to 1 mile, Fife Sheet 23 produced in 1856 (Figure 2) shows the proposed development area to contain a number of structures facing onto Quality Street, with long back courts running towards Townhead.
- 2.1.4 By the production of the 2nd edition Fife Series in 1895 (Figure 3), the general layout of the south western portion of the site remains the same. However more buildings have been constructed across the north eastern part of the site facing onto Cross Street or the East Port.

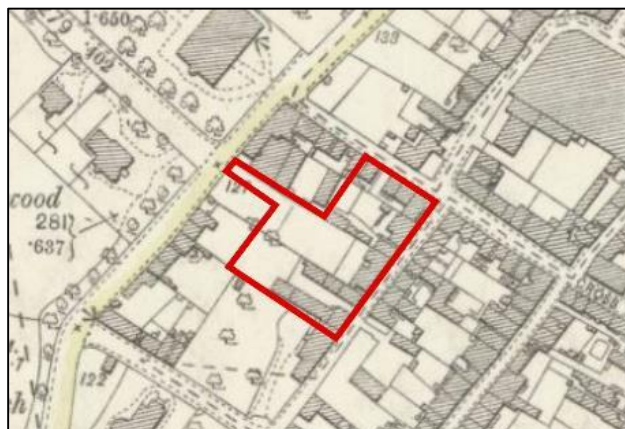
Figure 3: Extract from the 2nd edition Ordnance Survey Fife Series map from 1895 (25 inch to 1 mile) with the general site area indicated in red

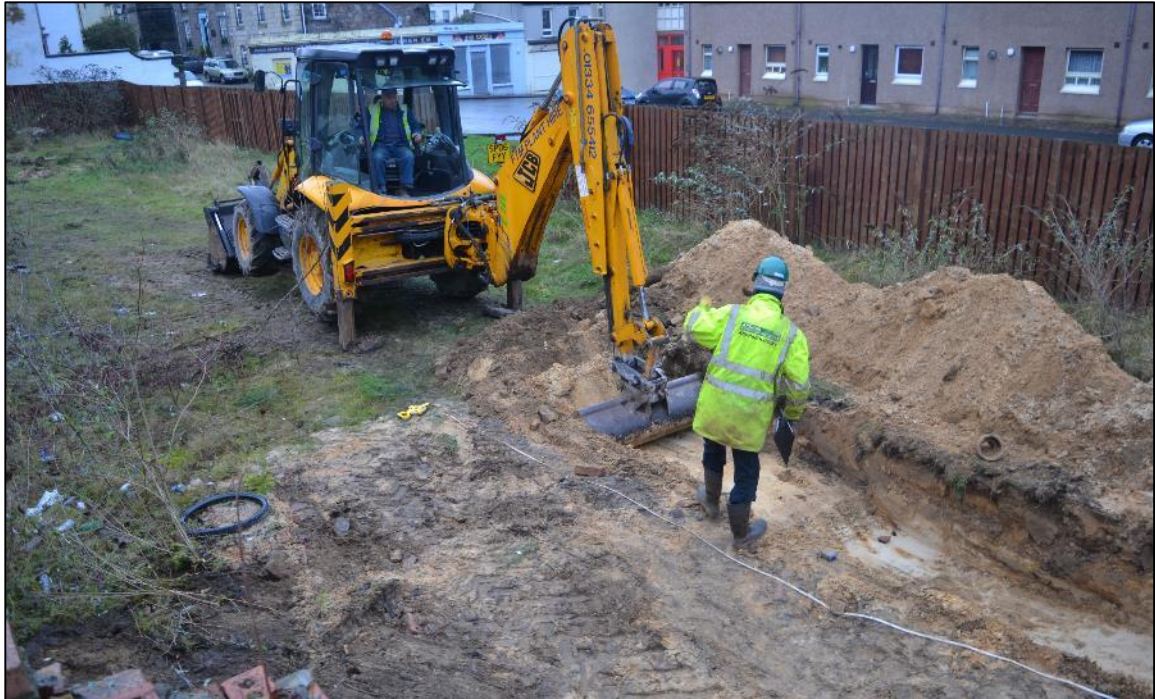
- 3.1.5 All trenches were excavated using a JCB 3CX mechanical excavator fitted with a 1.6m wide toothless ditching bucket (Plate 3). All trenches were opened under the direct supervision of a qualified and experienced archaeologist.

Plate 3: Opening Trench 2 looking east

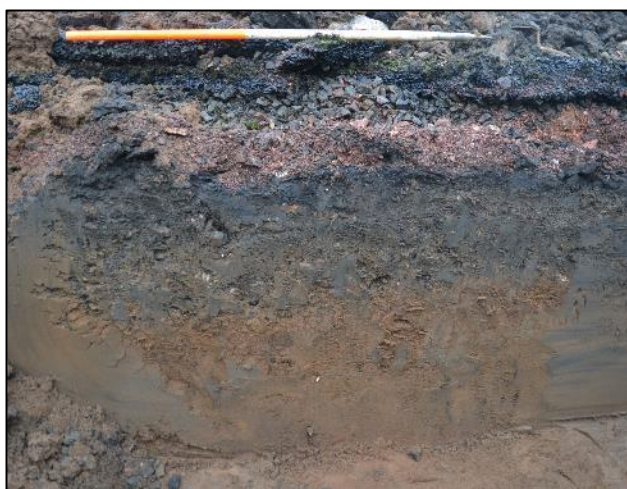
- 4.2.1 Trench 4 was aligned east west and excavated through a layer of tarmac in the upper area to the west of the site (Plate 1). The upper deposit of tarmac overlay a layer of crushed pink sandstone (**001**).
- 4.2.2 Removal of (**001**) revealed 0.20-0.50m of dark grey silty sand (**002**). This modern made ground contained various fragments of CBM and was likely a levelling material used to create the terraces on site.
- 4.2.3 Underlying (**002**), (**003**) (Plate 4) was a mid-yellow brown, silty sand with occasional bioturbation, that was largely clean. At the western end of the Trench, a deep hole was excavated through (**003**) in order to ascertain whether this was indeed the natural subsoil, or an imported deposit (Plate 5). Following excavation to 0.60m in Trench 1, no change in (**003**), was noted, confirming this as undisturbed natural subsoil.

Plate 4: North facing section of Trench 1

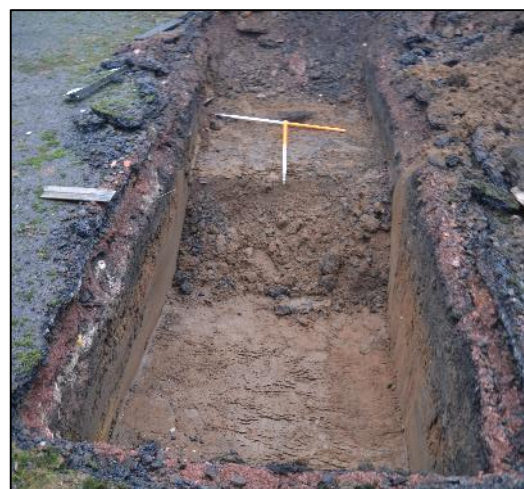
Plate 5: Post-excavation view of Trench 1 showing the deep pit dug at the west end

- 4.2.4 One small feature at the eastern end of Trench 1 was excavated, cut into the natural subsoil (**003**). [**104/105**] proved to be a small pit from which was recovered a fragment of modern window glass (not retained).

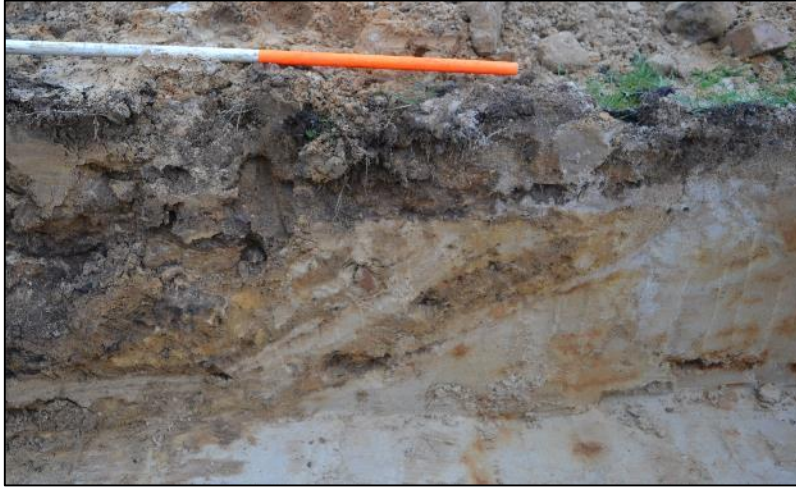
- 4.3.1 Trench 2 was the first trench to be excavated at the lower, Quality Street side of the site, and was aligned north-east to south-west. Topsoil (**201**) identified at the south west end of the Trench was 0.03m in depth and overlay a very clean yellowish white fine sand (**202**). This deposit was confirmed to be undisturbed natural subsoil.
- 4.3.2 Excavation further along the length of Trench 2 showed that the natural subsoil (**202**) underlay made ground (**207**) 0.80m in depth (Plate 6). The made ground (**207**) was very mixed and mottled, with flecks of charcoal and 20th century building debris present within it. It sat within a deep cut [**208**], which had a very uneven base cut into the natural subsoil (**202**). This deposit probably relates to the terracing, and subsequent removal or grubbing out of the 20th century building foundations.

Plate 6: North west facing section of Trench 2 showing [208] cutting through (202) with made ground (207) to the left

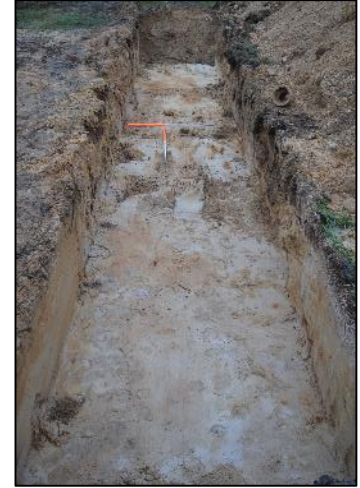
Plate 7: Post-excavation view of Trench 2

- 4.3.3 Two small features were noted cut into the natural subsoil surface at the south western end of the Trench. Feature (205/206) contained a fragment of modern glass (not retained), while the second feature (203/204) also had the appearance of a modern deposit. (203/204) was roughly circular in plan, with a diameter of 0.15m and a depth of 0.05m.

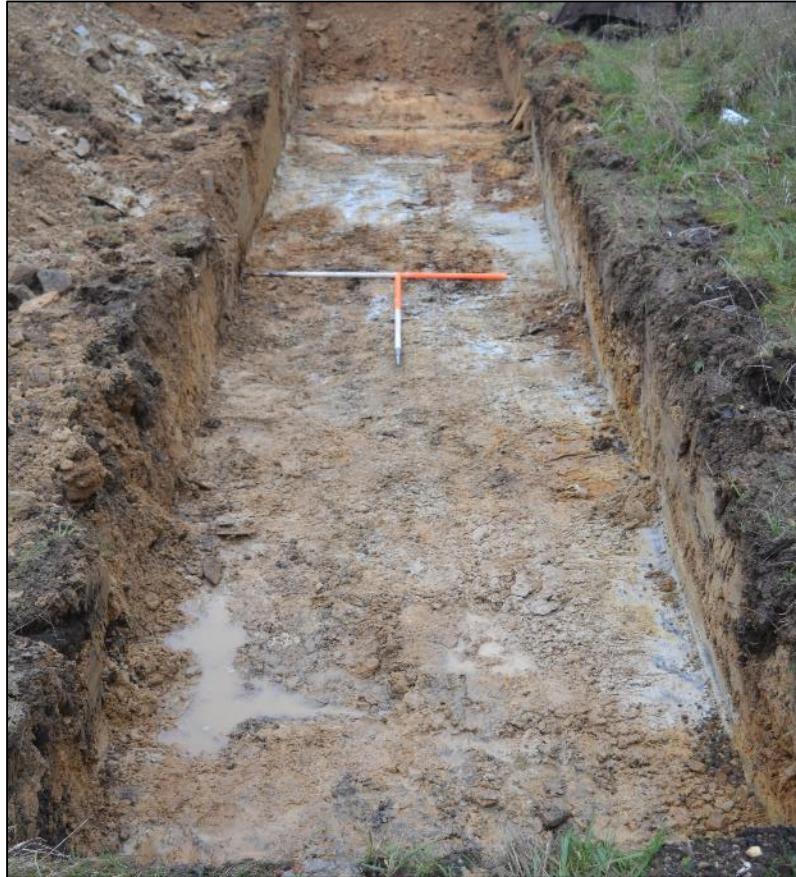
- 4.4.1 The stratigraphy of Trench 3 was broadly similar to that identified in Trench 2.
- 4.4.2 The topsoil (301) was 0.03m in depth overlying a slightly grubby orange sand with flecks of charcoal and patches of modern debris (302) along the full 10m length of the trench. This deposit was 0.50-0.55m deep, sloping slightly from north-west to south-east. The base of this deposit was uneven, interspersed with small depressions and possible pits, all containing the same mixed deposit of made ground.

- 4.4.3 Underlying (302), the natural sand (303) was interspersed with outcrops of tabular sandstone. This sloped towards the south east.
- 4.4.4 (302) almost certainly comprised the same cut or digging event as the deep deposit of made ground in Trench 2, but unlike in Trench 2, the cut itself was not visible within the trench. (302) probably comprises the mixed soil and small fragments of building detritus leftover from the grubbing out or removal of the pre-existing building's foundations.

Plate 8: Post-excavation view of Trench 3 looking north east

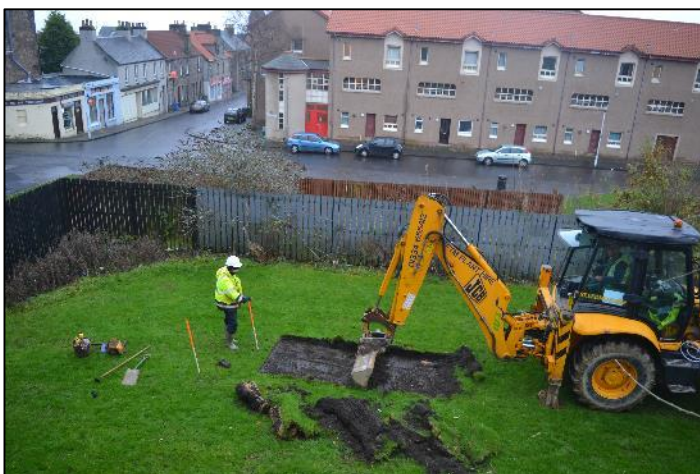
- 4.5.1 Trench 4 was located in the 'L' shaped upper area of the site bordered by the Royal Hotel (Plate 9). Although some landscaping may take place here, no significant development is proposed. This trench was envisaged as a small addition to those already excavated, placed in an area of the site seemingly unaffected by the 20th century development. It was hoped Trench 4 would confirm the extent of the terracing and landscaping which had taken place.
- 4.5.2 The trench was situated in the one part of this area where clear landscaping would take place and plotted atop an area of proposed paving at the rear of the proposed flats.

Plate 9: Looking east across Trench 4 from the Royal Hotel

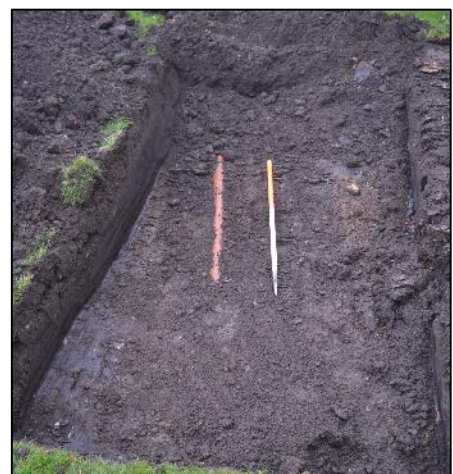
Plate 10: Services within Trench 4

- 4.5.3 Excavation revealed the topsoil (**401**) in Trench 4 to be rich and dark loam found overlying a dark grey silty sand (**402**) with modern brick fragments and 19th century ceramic sherds.
- 4.5.4 However, (**402**) was confined to the edges of the trench, with a clear linear spread of looser material (**403**) aligned north-east south-west across the centre of the trench. Excavation demonstrated that this comprised a modern service trench containing a plastic pipe (Plate 10). This service was not noted on any of the service plans. As this pipe occupied most of Trench 4 and would continue both north east and south west across the whole area to be paved, excavation in this area was halted.

- 5.1.6 Trench 4 was located in an area of the site where no construction will occur, with only landscaping anticipated. This trench was terminated due to the discovery of services.
