**62-64 St John's Road,  
Corstorphine,  
City of Edinburgh  
Archaeological Evaluation  
Data Structure Report**

**April 2016**

Client: Pink Architects  
Project: 64-65 St John's Road, Corstorphine  
Document Title: Archaeological SBR & Evaluation DSR

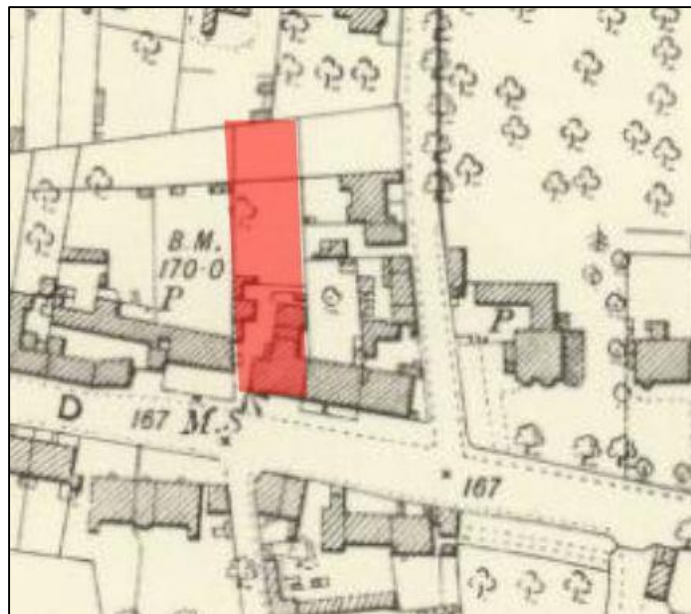
- 4.2.3 25 inch to 1 mile OS mapping of the Corstorphine area was completed in 1895 with the production of Edinburghshire 003.09 (Figure 7). Although there is no real change to the structures, the level of detail provided shows the phasing to some degree, and confirms the indications provided by the 1<sup>st</sup> edition that buildings to the rear of the 'cottage' fronting St John's Road are separate builds, almost certainly constructed after the 'cottage' itself. The back court area has been divided into three separate sections, the northernmost of which survived until the walls were demolished as part of the present project.

**Figure 7:** Extract from the 25 inch to 1 mile Edinburghshire 003.09 from 1895 showing occupation of the site as indicated red. NLS

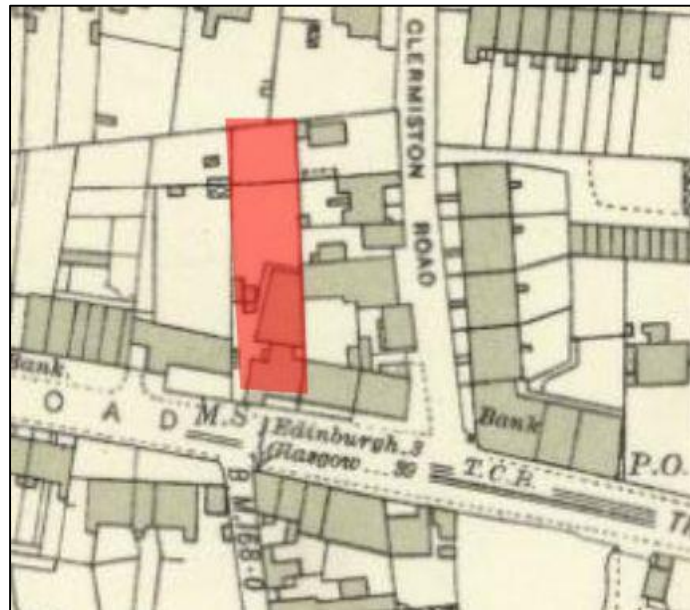
4.2.4 25 inch to 1 mile OS maps published in 1908 and 1913 show little further, substantive change. However, the 25 inch to 1 mile Edinburghshire 003.09 from 1933 reveals significant change to the back court area. The 'cottage' fronting onto St John's Road remains in position, but all the buildings to the rear have been demolished and rebuilt or altered. The large building to the north of the 'cottage' corresponds with that which stood on the site until recently.

**Figure 8:** Extract from the 25 inch to 1 mile Edinburghshire 003.09 from 1933 showing occupation of the site as indicated red. NLS

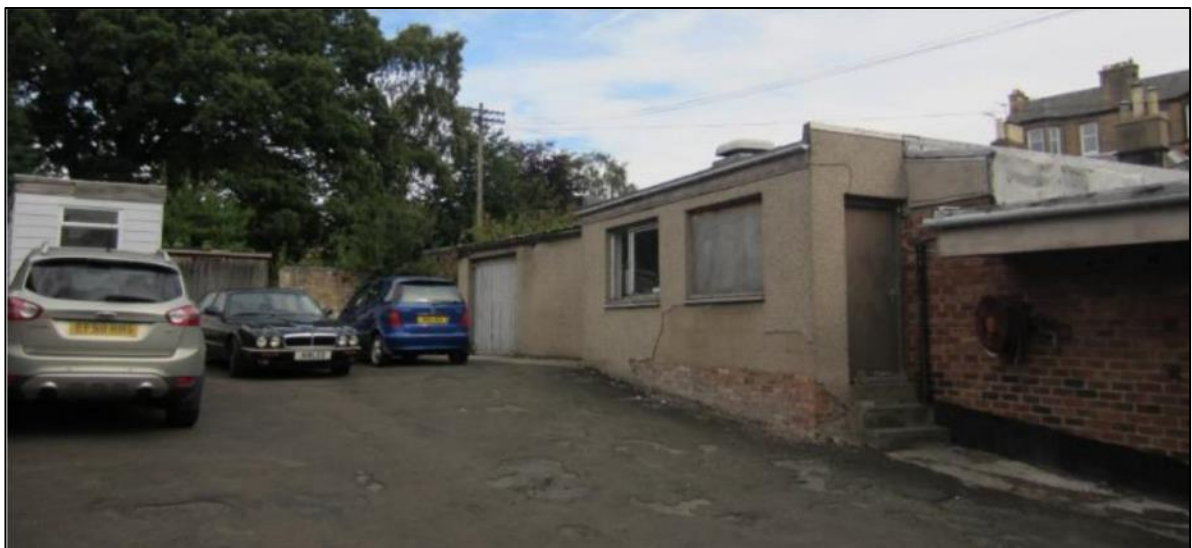
**Plate 1:** Looking north east across the demolished structures Image courtesy of Pink Architects

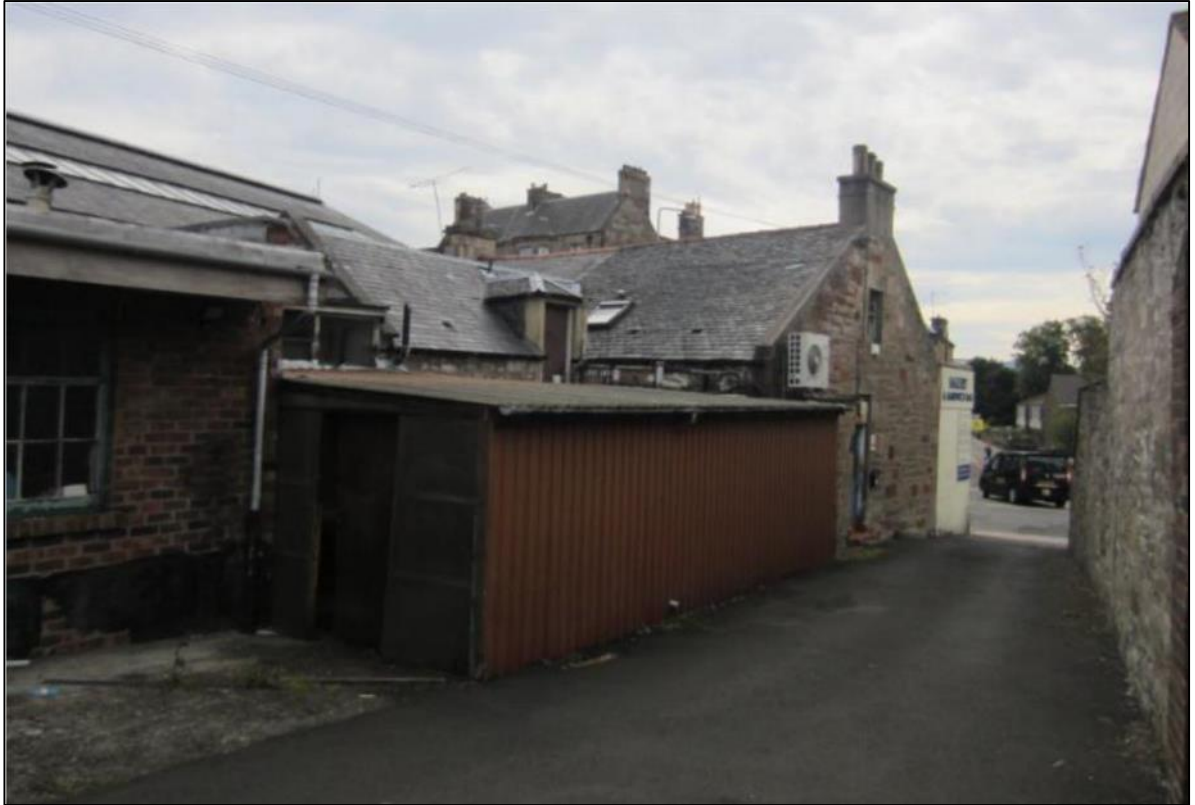
4.2.5 In absence of the opportunity to examine the buildings themselves, images taken by the architects were consulted in order to better understand and characterise the buildings. The images (Plate 2 - Plate 5) show a series of what appear to be early to mid-20<sup>th</sup> century brick built buildings, the northernmost of which is dry cast, with a corrugated roofed, timber structure extant in the return between the 'cottage' and the brick built structures.

**Plate 2:** Looking south across the demolished structures Image courtesy of Pink Architects

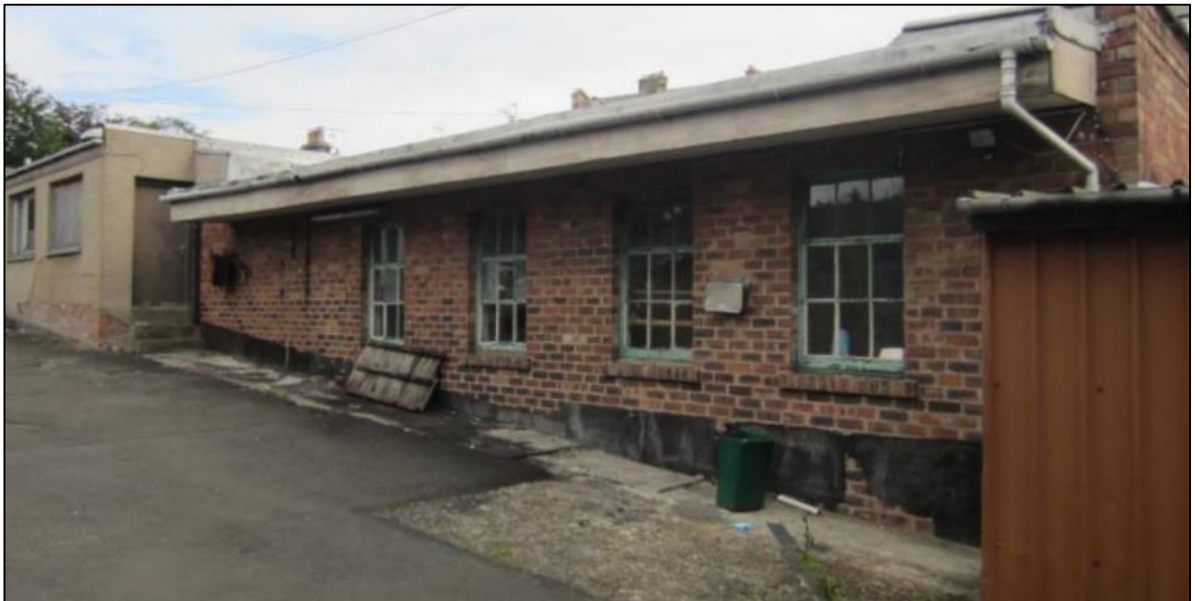
**Plate 3:** Looking north east across the demolished structures Image courtesy of Pink Architects

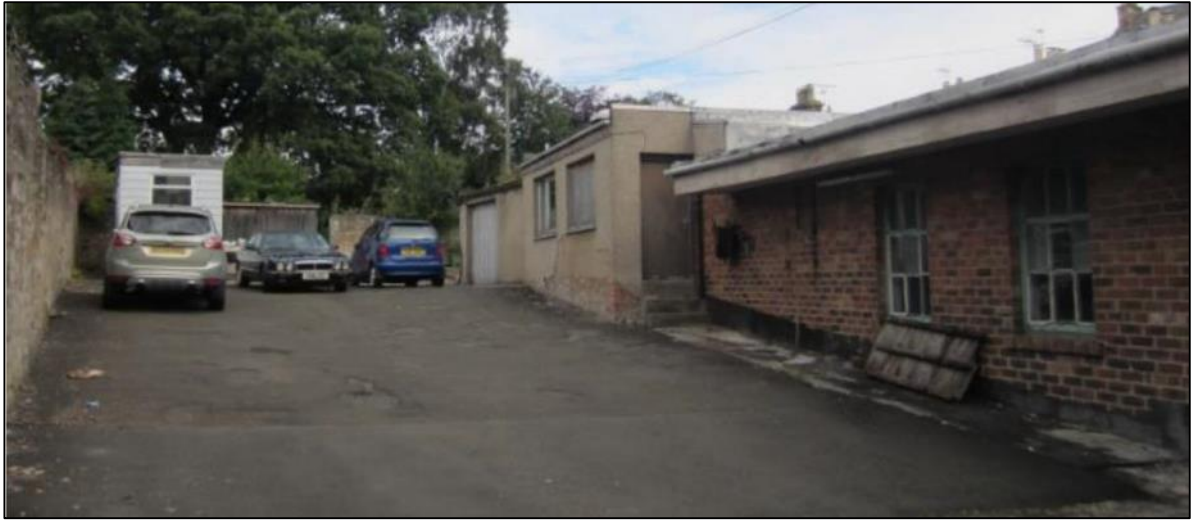
**Plate 4:** Looking north east across the demolished structures Image courtesy of Pink Architects

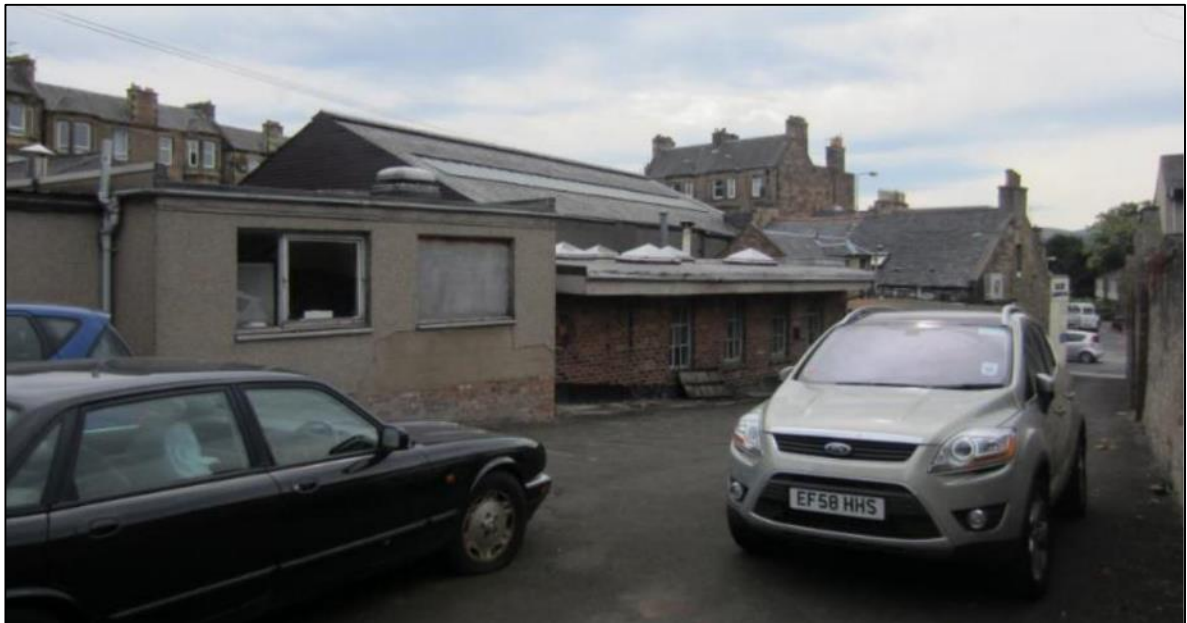
**Plate 5:** Looking south west across the demolished structures Image courtesy of Pink Architects

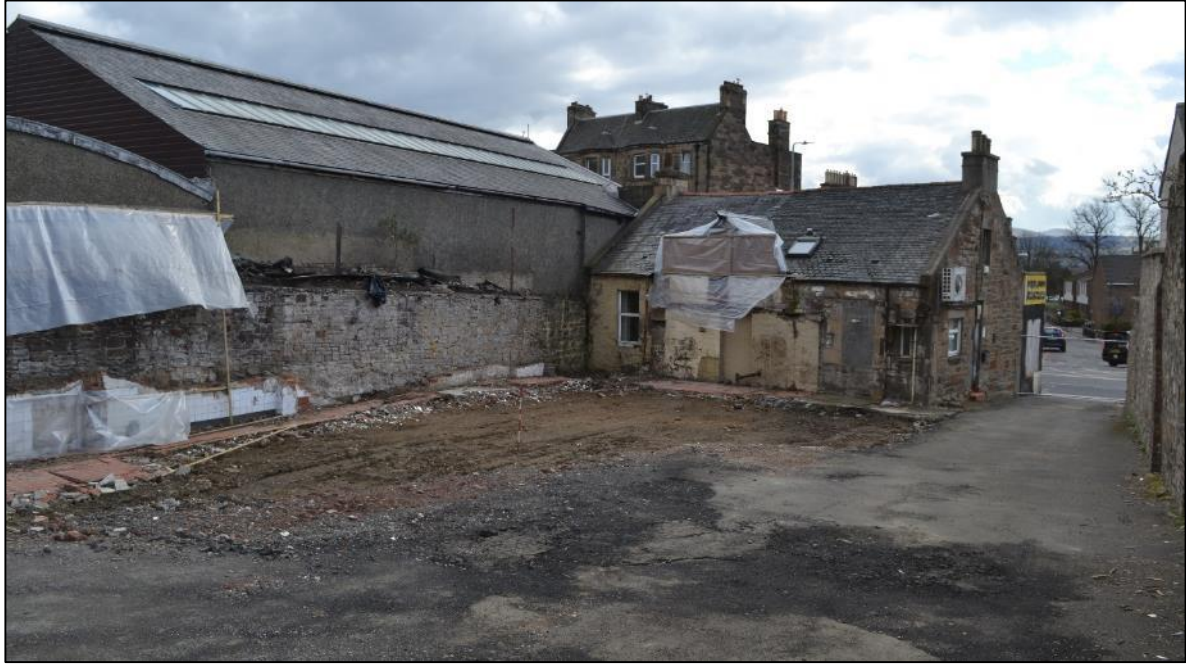
**Plate 6:** View of site looking south post-demolition of structures to the rear of the plot (Photograph 003)

- 4.2.7 The buildings to the rear of the 'cottage' had been comprehensively removed (Plate 6), but enough building debris and structural elements, particularly along the eastern perimeter wall (Plate 7 and Plate 8), survived to give an indication as to their build and nature of construction.

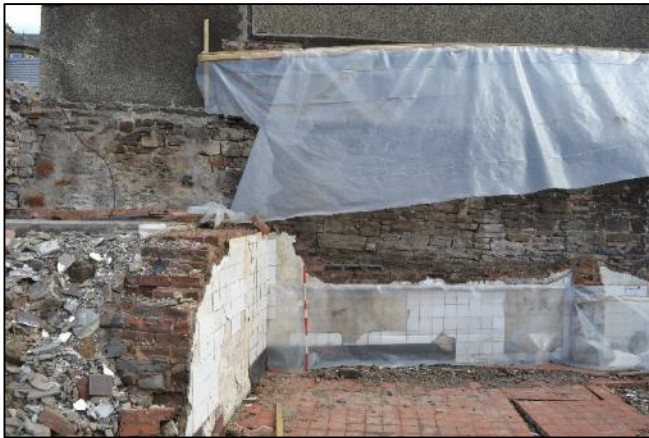
**Plate 7:** Detail of eastern perimeter showing remains of 20<sup>th</sup> century buildings (Photograph 030)

4.2.8 No evidence of significance or antiquity of the demolished buildings was noted, instead it was demonstrated that the buildings were of 20<sup>th</sup> century origin and negligible interest.

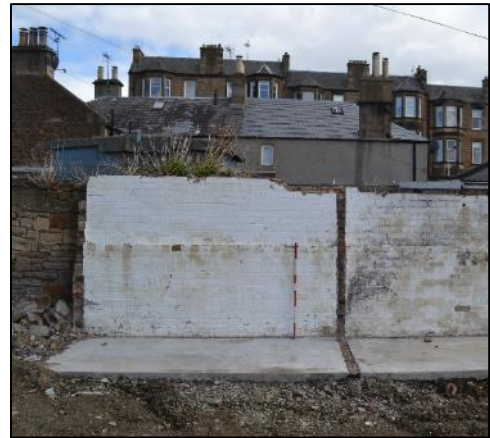
**Plate 8:** Detail of eastern perimeter showing remains of 20<sup>th</sup> century buildings (Photograph 032)

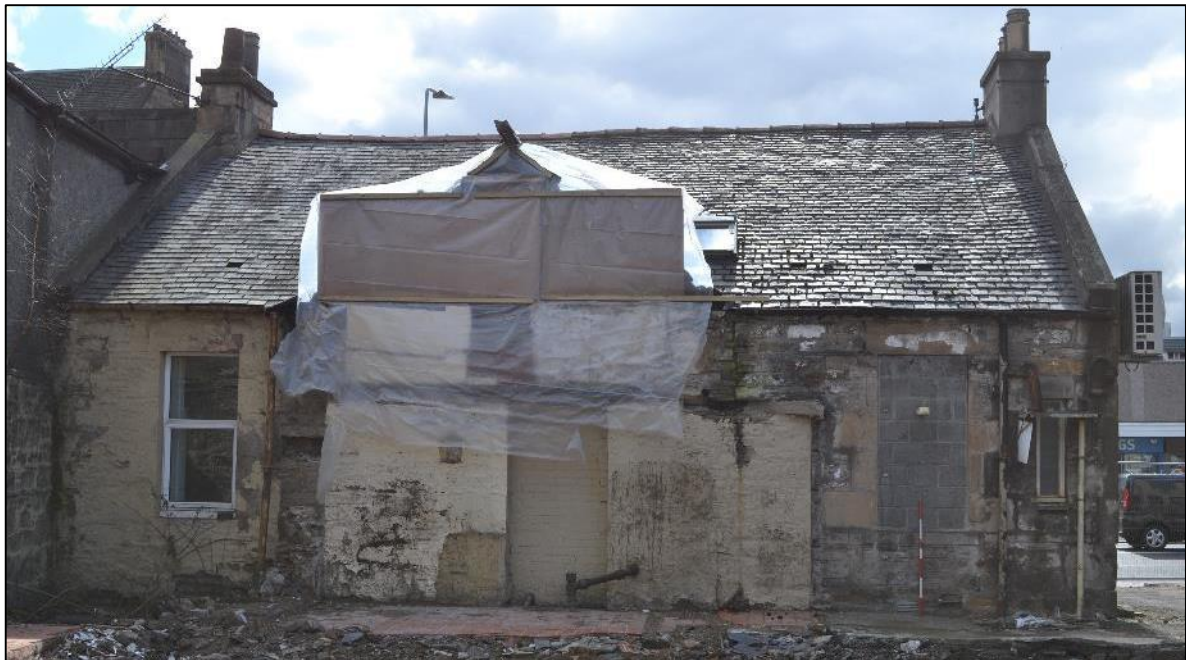
4.3.4 The rear façade of the cottage (Plate 9) was the only one which showed any signs of alteration, but none of this was considered significant or considered a key feature that provided new information.

**Plate 9:** Rear (North facing) external elevation of the 'cottage' (Photograph 022)

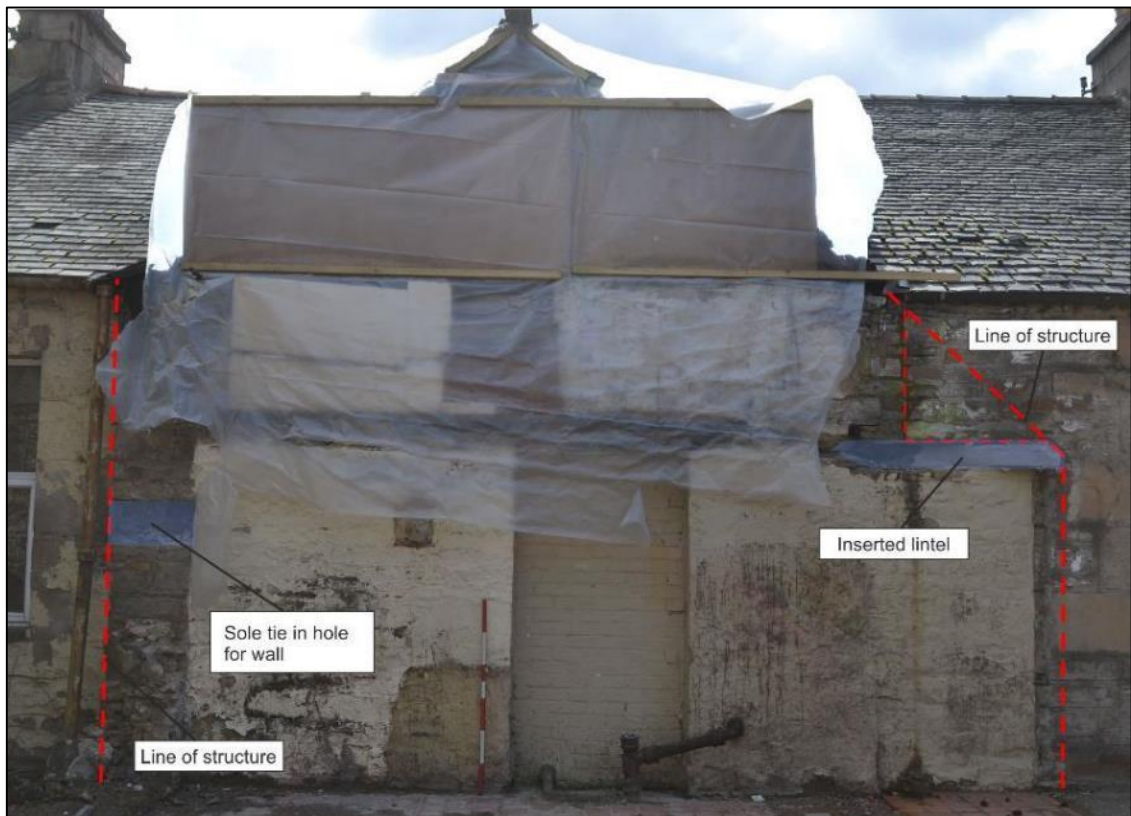
4.3.6 The map evidence (Section 2.5.5 and Section 4.2) was inconclusive about whether the small protruding part of the structure to the rear of the 'cottage' was an addition or part of the primary build. Assessment of the rear façade shows the latter to be the case. Although there are clear indications that this part of the structure was tied into the main build (notably the broken lintel which would have supported the former roofline and possible upper level), these are likely to be insertions as the tying in is not extensive (Plate 10). This is particularly evident along the scar showing the location of the eastern wall where the stonework of the 'cottage' is still shown to be intact, with only one hole created in the façade for a tie in stone of the new wall. Access to the extension would have been through the opening in the rear of the 'cottage', now bricked up.

**Plate 10:** Middle of rear façade showing scars from secondary (now demolished) additions to the 'cottage' (Photograph 024)

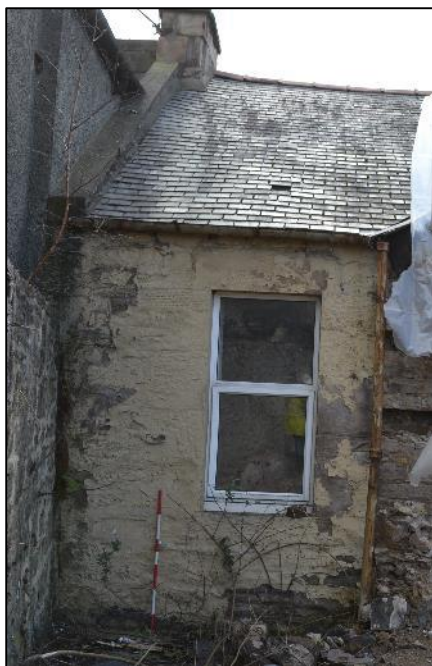
4.3.5 The eastern end of the rear facade remains unaltered, with the original window opening extant (**Error! Reference source not found.**), looking into what would have been a very small, obscured and inaccessible open space due to the proximity of the 20<sup>th</sup> century structures demolished as part of this project.

**Plate 11:** Detail of east end of rear facade (Photograph 025)

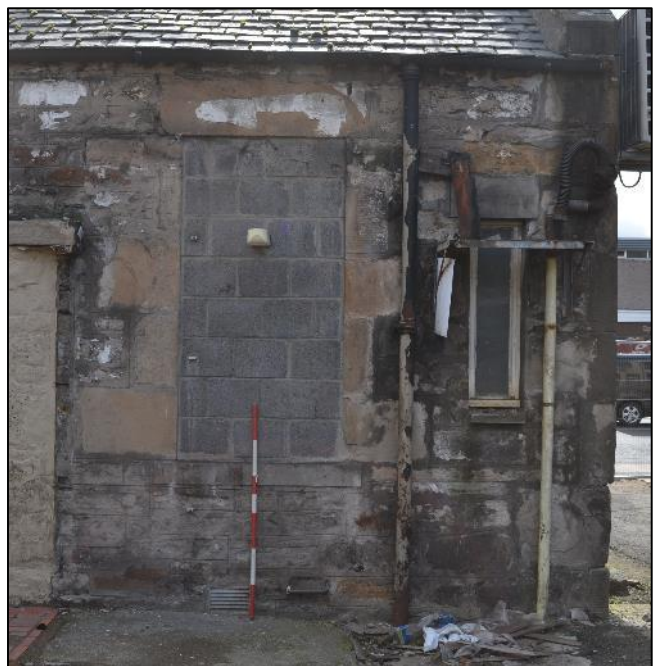
4.3.8 At the western end of the rear façade, the main primary window has been blocked by lightweight cinder bricks. A smaller, narrow, secondary window has been inserted into the fabric just to the west of this (**Error! Reference source not found.**). Anecdotal evidence from discussions with the owner suggests that this window was installed within memory to allow the occupant of the 'cottage' to see past the extension buildings to the rear towards the end of the yard.

**Plate 12:** Detail of west end of rear façade (Photograph 023)

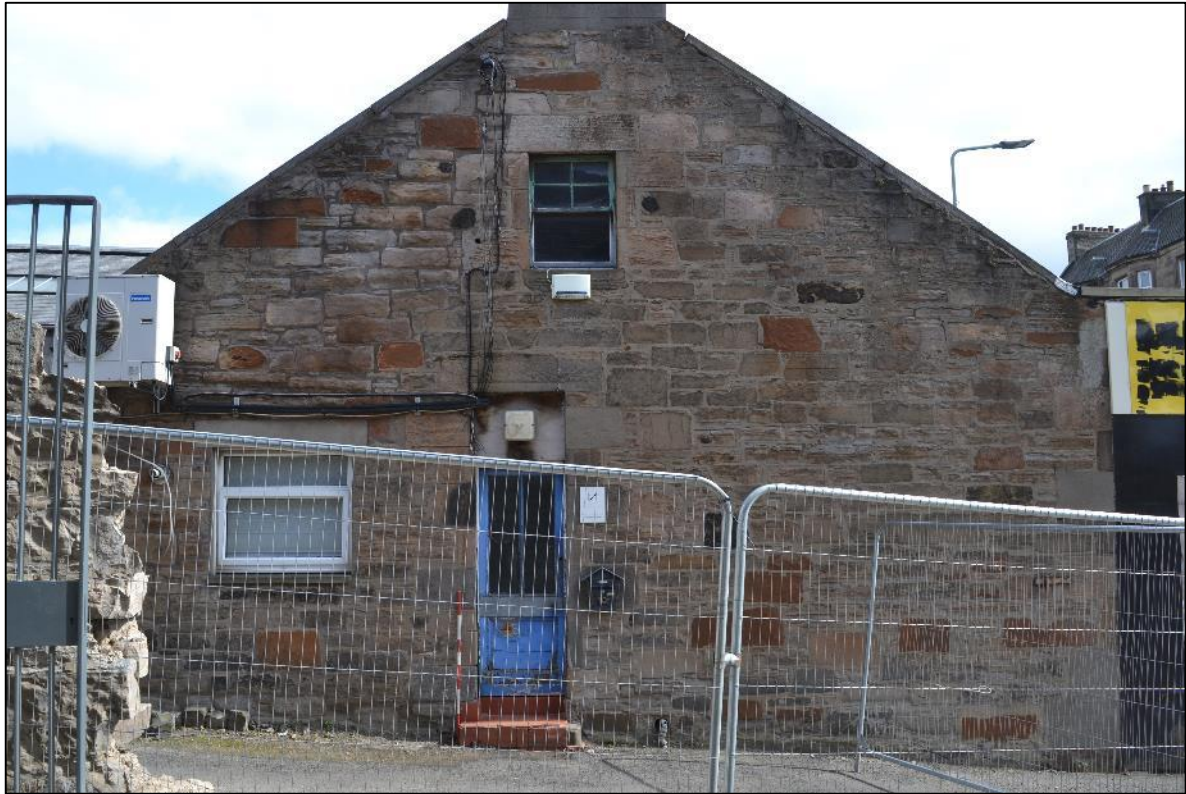
4.3.9 The western gable has very little alteration or repair of note, appearing to be one homogenous build of medium sized, roughly dressed and coursed sandstone blocks (Plate 13).

**Plate 13:** West facing external gable of the 'cottage' (Photograph 020)

4.3.10 The build to the north of the attic window on the top half of the gable appears noticeably different, with the stones more rounded and proud of the pointing (Plate 13 – top left). However, this is clearly due to a different pointing material and technique applied during repairs to the structure.

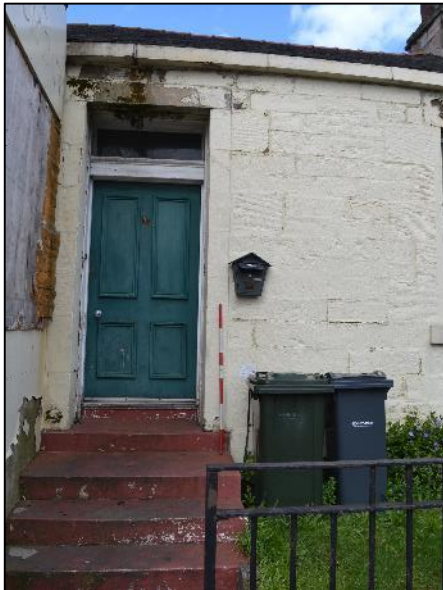
4.3.13 The location of the 'cottage' along one of the main arterial routes into Edinburgh made photographing the frontage in its entirety problematic (Plate 14 and Plate 15).

**Plate 14:** Main entrance in external façade (South facing) fronting onto St John's Road (Photograph 037)

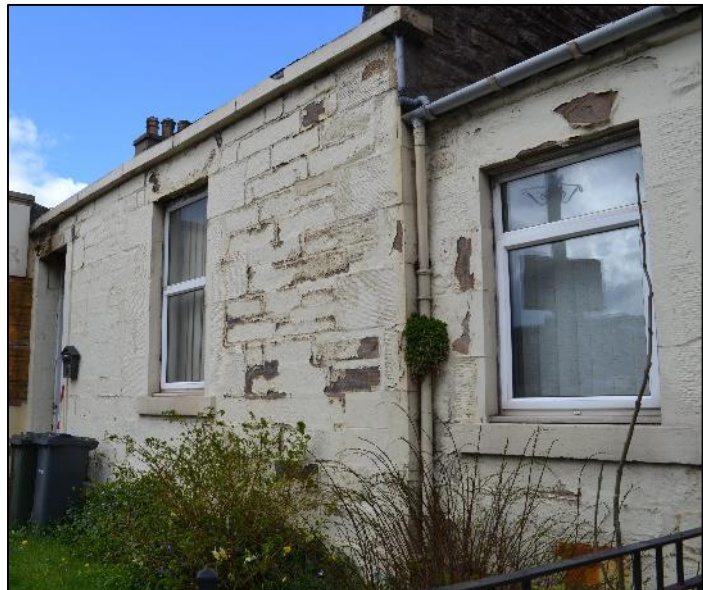
**Plate 15:** Oblique view looking north east across the external façade fronting onto St John's Road. Note the small room (right) (Photograph 038)

- 4.3.14 The south west corner of the building is now occupied by a modern shop extension which until recently housed the bakery service area.
- 4.3.15 Other than the modern extension, the frontage shows no signs of alteration. It is unclear whether the small room on the eastern edge of the building is primary, or a secondary addition. This was clearly part of the structure, bridging the gap between it and its neighbour, in the photograph of c.1871.

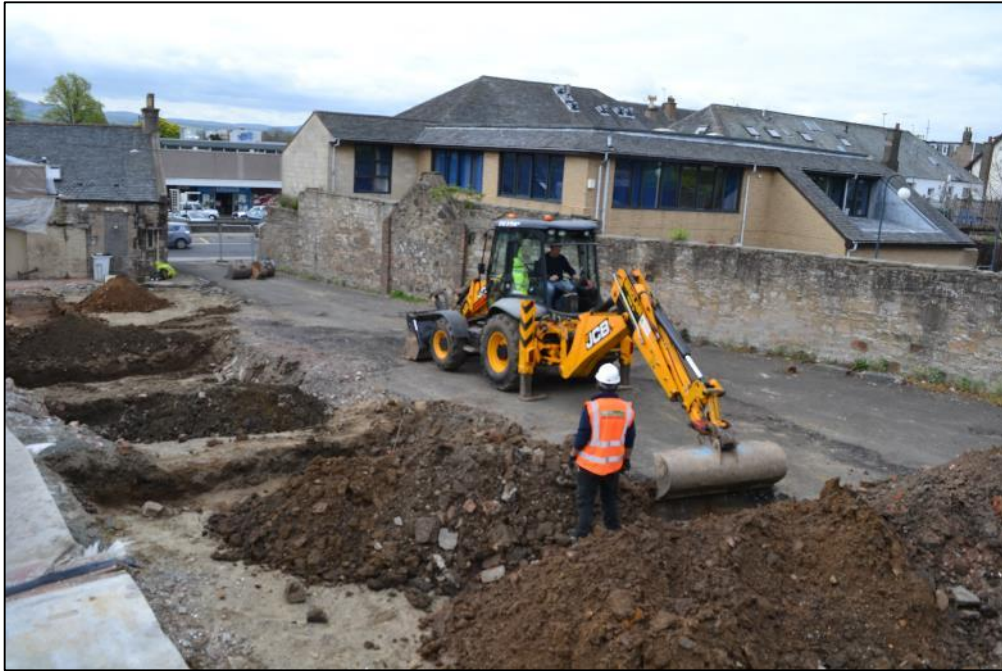
- 5.1.1 The archaeological evaluation at 62-64 Corstorphine Road failed to reveal archaeological deposits of significance.
- 5.1.2 The area proposed for development comprises 607m<sup>2</sup>. In the WSI ARCHAS committed to investigating at least 10% of this area, while maintaining good spatial coverage. Although the logistics of working in such a constrained area meant it was not possible to excavate all of the anticipated trenches, six trenches were opened during the evaluation (Plate 16) covering a total of 84m<sup>2</sup> or 14% of the overall area.

Plate 16: Working shot showing trenches being opened across site (Photograph 074)

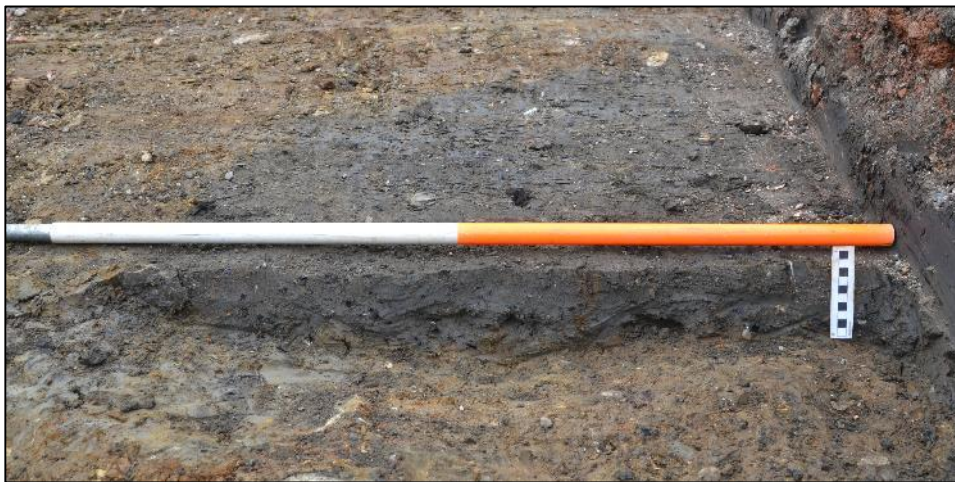
- 5.2.5 At the western end of Trench 1 a shallow pit (**105**) was identified, abutting and extending beyond the northern trench edge of the trench. Excavation of (**105**) showed the feature to be very shallow (0.11m deep) with gently sloping sides and a roughly flat base (Plate 17). The feature fill contained frequent flecks of charcoal and post-medieval ceramic sherds, pipe stem and bottle glass.

**Plate 17: Post-excitation view of (105) (Photograph 109)**

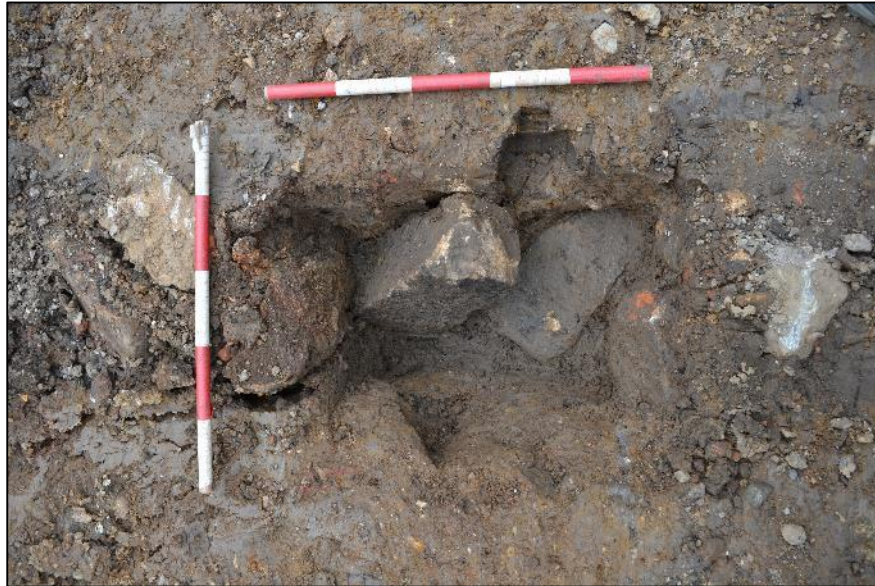
- 5.2.6 Trench 2 ran near parallel to Trench 1, located a short distance to the south, but within the footprint of the now demolished 20<sup>th</sup> century structures.
- 5.2.7 Removal of the made ground and demolition rubble (**201**) revealed the natural subsoil (**202**), shown to be the same as (**103**) in Trench 1.
- 5.2.8 A N-S aligned rubble drain (**203**) ran across Trench 1. This was not on the same alignment as (**104**) but is likely to be part of the same drainage complex. Excavation of (**203**) (Plate 18) revealed 19-20<sup>th</sup> century glazed ceramic.

**Plate 18:** Mid-excavation view of rubble drain (203) (Photograph 108)

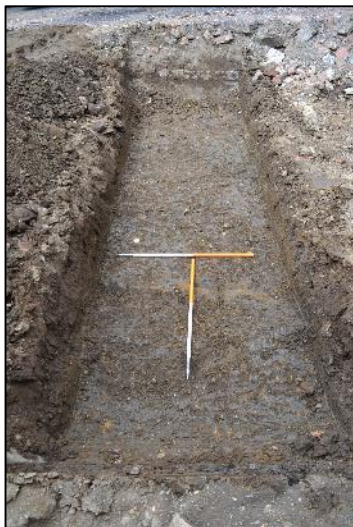
5.2.11 As anticipated, like Trench 3, Trench 4 was also archaeologically sterile with demolition rubble (401) overlying natural subsoil (402) (Plate 19 and Plate 20).

**Plate 19:** Post-excavation view of Trench 4 (Photograph 084)

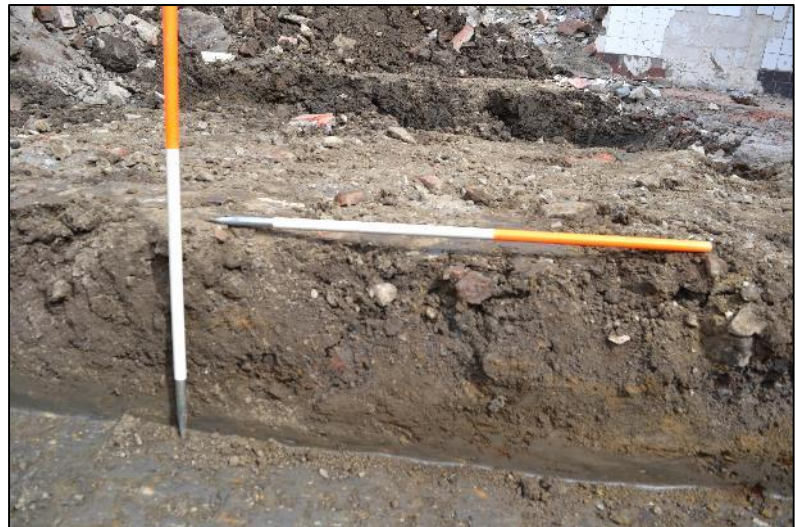
**Plate 20:** S facing section of Trench 4 showing (401) (Photograph 085)

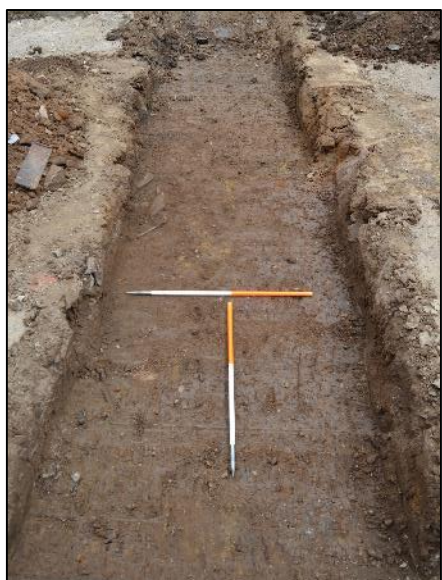
5.2.13 Most of Trench 5 was found to be archaeologically sterile. Like the trenches to the north, Trench 5 contained a quantity of made ground and demolition rubble (**501**) overlying a natural subsoil – here a heavy, firm mid brown clay (**502**) (Plate 21 and Plate 22). The topography of the site and the nature of the natural subsoil in comparison to Trenches 3 and 4 indicated that any terracing or landscaping in this area had not been so extensive.

**Plate 21:** Post-excitation view of Trench 5. Note (503) against the west baulk (left) (Photograph 086)

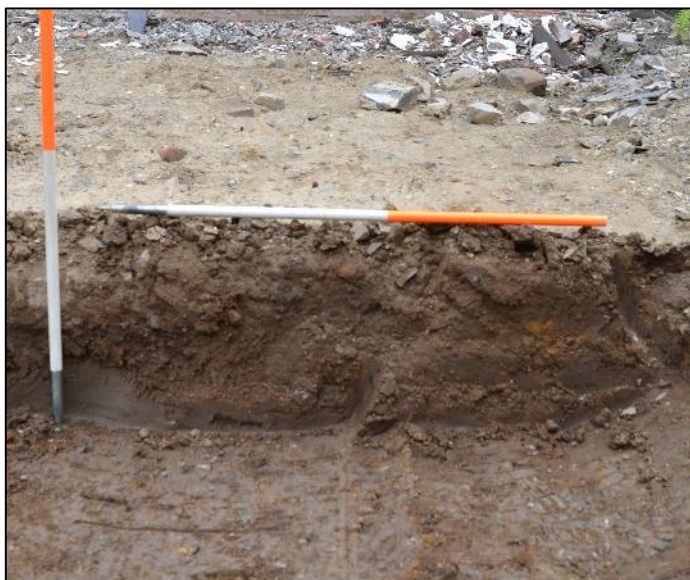
**Plate 22:** W facing section of Trench 5 (Photograph 087)

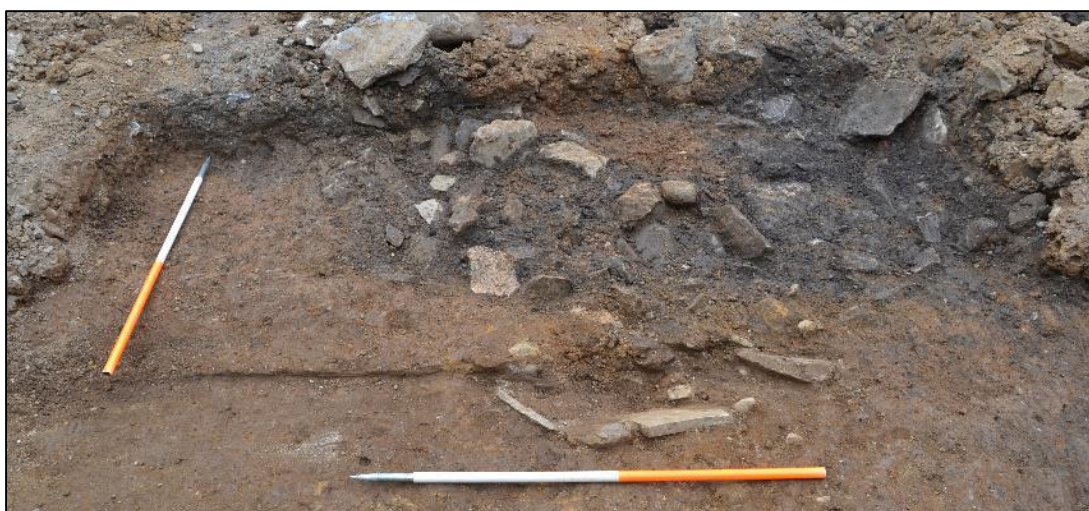
5.2.14 One feature was noted against the east facing baulk, seeming a small stone lined depression (**503**). As a result Trench 5 was extended by 3m<sup>2</sup> to the west in order to fully reveal the feature (Plate 23).

**Plate 23:** Mid-excitation view of (503) looking west (Photograph 112)

5.2.15 What had initially appeared as small and stone lined was demonstrated to be the edge of a much larger feature packed with medium sized stones and slabs. The mechanical removal of (501) in order to extend the trench also revealed a salt glazed ceramic drainage pipe running into (503), while cleaning the surface of the feature large quantities of 19<sup>th</sup> -20<sup>th</sup> century brick, ceramic and glass were revealed.

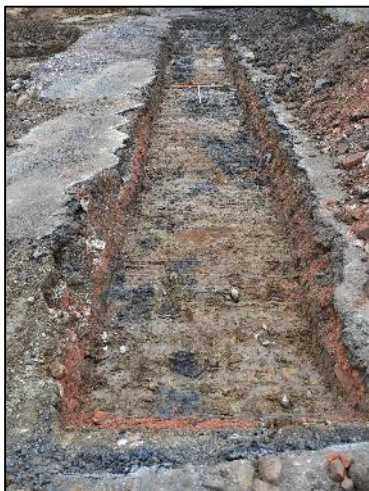
5.2.21 The natural subsoil seemed to be uneven and rutted, with a number of darker areas. After investigation, three features were recorded cut into the natural subsoil (Plate 24).

**Plate 24:** Mid-excitation view of Trench 6 looking S (Photograph 092)

5.2.22 Although all three features are geographically separate, it is suggested that all are contemporaneous as they form a regular alignment (see Plate 24). This was interpreted as perhaps the result of the movement of water down the natural slope of the site.

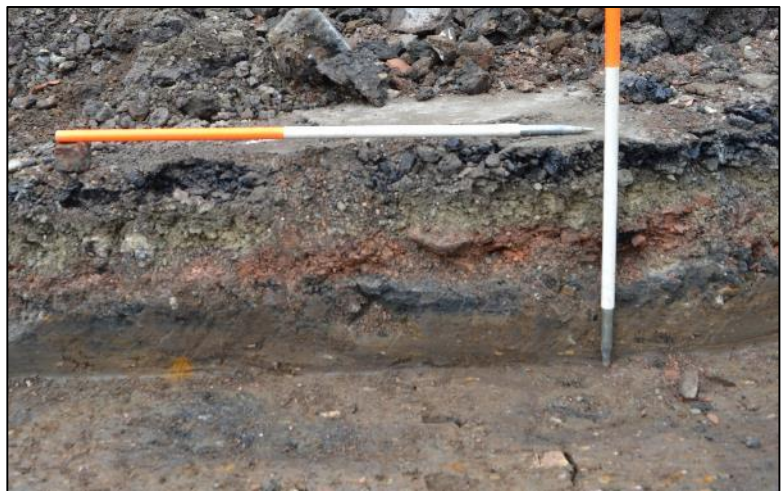
**Plate 25:** E facing section of Trench 6 showing (601) and (602) (Photograph 094)

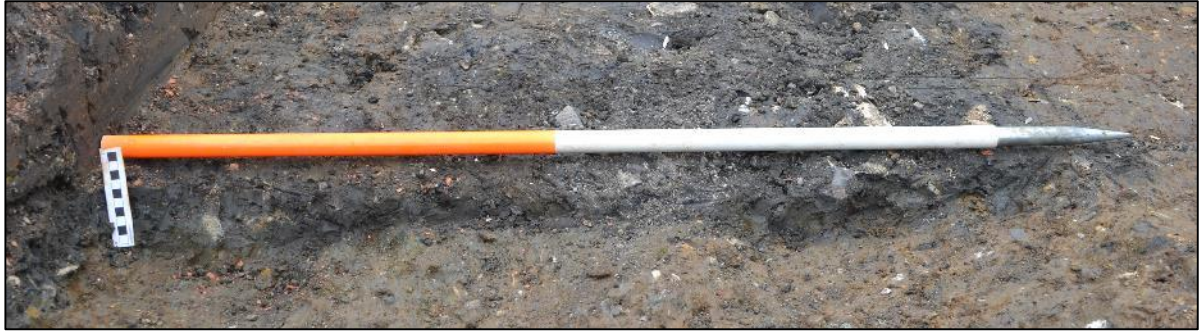
5.2.24 Irregular deposit (**605**) across the centre of Trench 6 also contained 19<sup>th</sup>-20<sup>th</sup> century ceramic, and had a fill very similar to (**604**) and (**606**). It was also similarly shallow (Plate 26). However, this deposit also contained a quantity of animal bone **SF005**.

**Plate 26:** S facing section of (605) (Photograph 103)

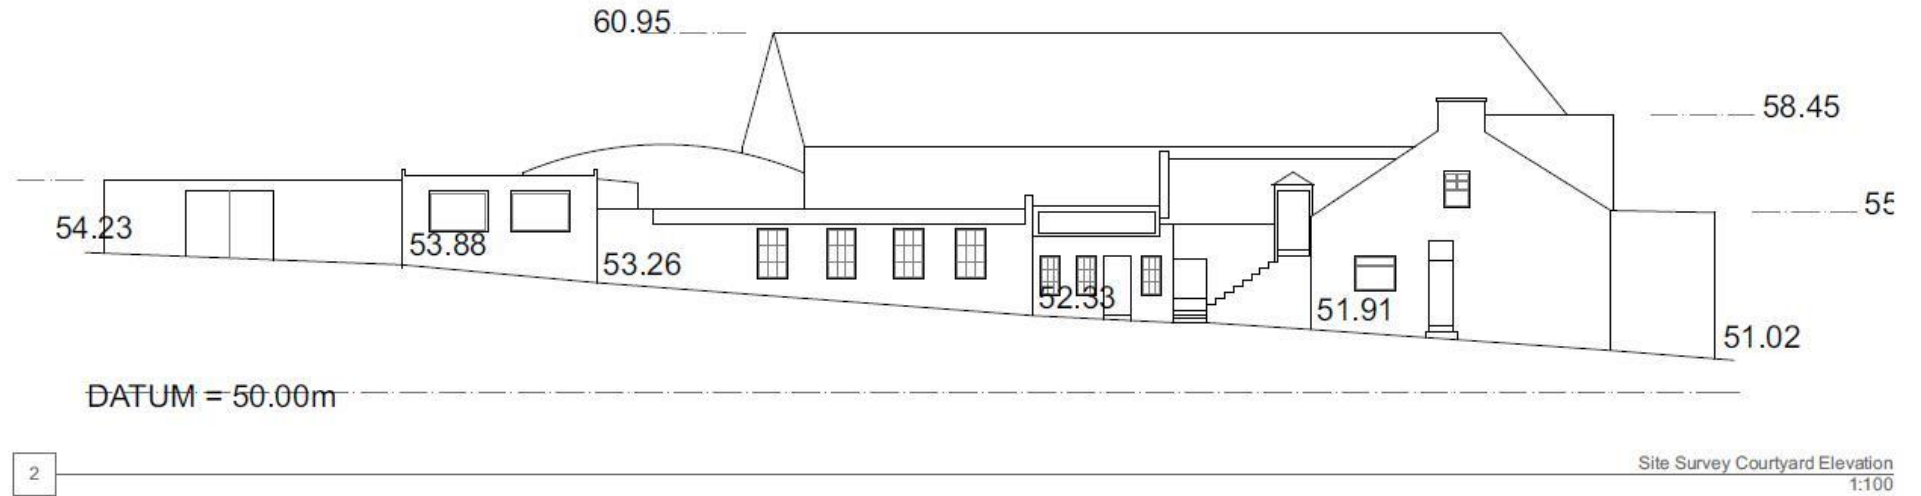
Figure 9: West facing external elevations of the building complex at 62-64 St John's Road. Courtesy of Pink Architects
