**21 Dumbarton Road,
Stirling,
Stirling Council
Archaeological Evaluation
Data Structure Report**

November 2016

Client: Mr Mark Crawford
Project: 21 Dumbarton Rd, Stirling
Document Title: Archaeological Evaluation WSI

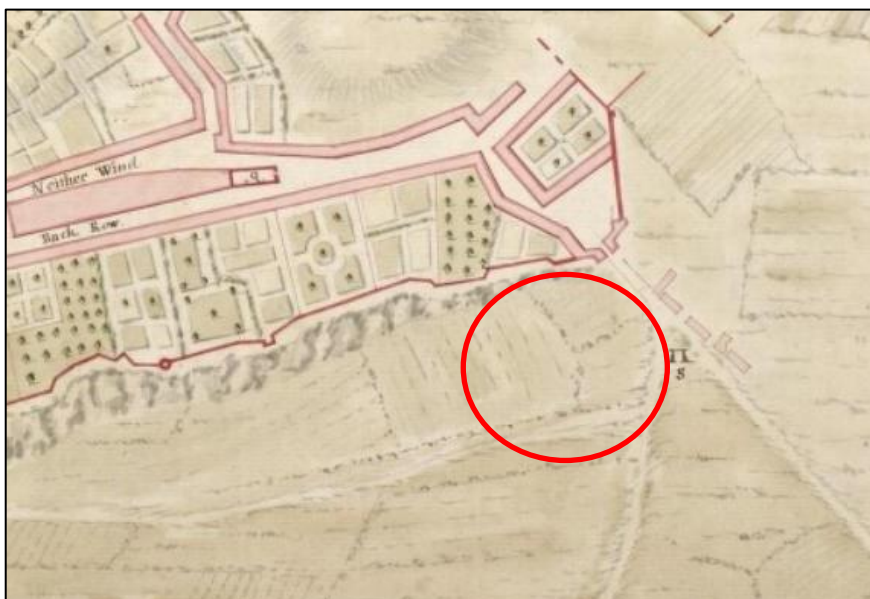
Figure 2: Extract from John Laye's 'Plan of the Town and Castle of Sterling 1725' showing the general location of the development area in undeveloped farmland. NLS

- 2.3.1 John Laye's 'Plan of the Town and Castle of Sterling 1725' clearly shows the proposed development area in relation to the town wall and the existing street pattern as undeveloped farmland (Figure 2).

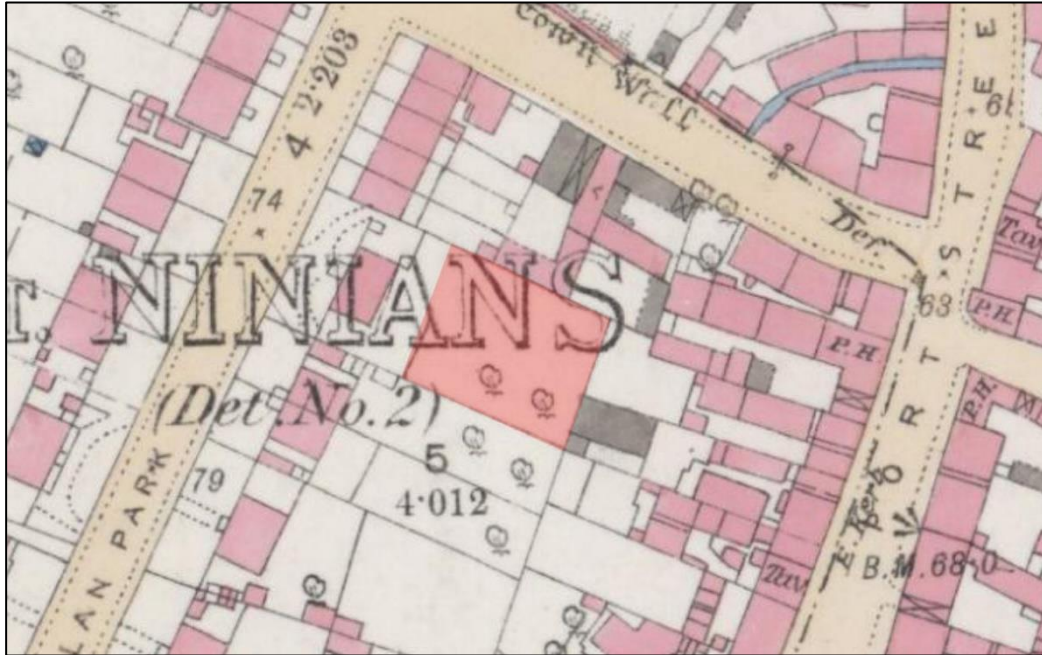
Figure 4: Extract from the 1st edition The 25 inch to 1 mile Stirling Sheet XVII.3 published in 1865 and showing the development area (red) as a clearly defined garden plot free of any development. NLS

- 2.3.7 This picture of the proposed development site as unaltered back courts remains until post-1947 when the 25 inch to 1 mile Stirlingshire n017.03 map clearly shows this area as the undeveloped back garden of the property on Allan Park.

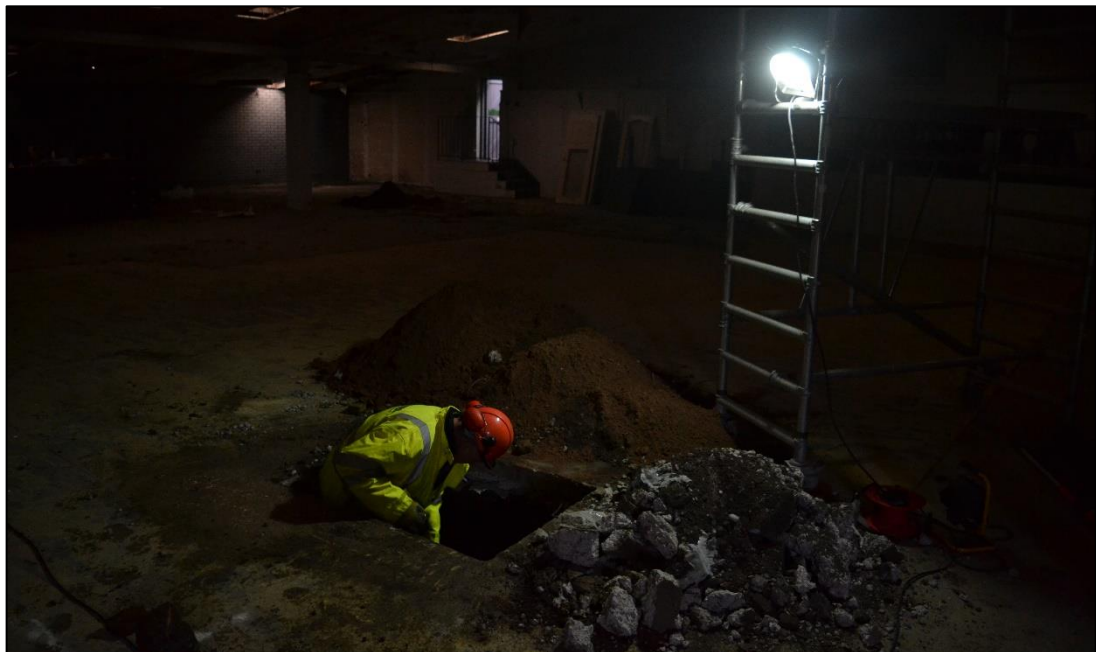
Plate 2: Working shot showing Trench 2 being cleaned and investigated (Photograph 011)

4.3.1 Trench 2 was opened where two boreholes had been previously drilled, creating a weak point in the concrete floor surface (**201**). (**201**) proved to be much shallower than in Trench 1, yet retained the steel reinforcing bars.

4.3.2 Like in Trench 1, the concrete overlay a deep deposit of levelling blaes (**202**). The working surface (**203**) was also present with the fine grain yellow brown sand of the natural subsoil (**204**) being apparent at a depth of 0.75m. 0.20m of (**204**) was removed to confirm that this was indeed undisturbed natural subsoil (Plate 3).
