**Erection of Equestrian Centre,
Farmhouse & Dwellings,
Bankwood Farm,
Carnwath
South Lanarkshire,
Archaeological Evaluation
Data Structure Report**

December 2016

Client: Ms Aileen Stormonth
Project: Bankwood Farm, Carnwath
Document Title: Archaeological Evaluation WSI

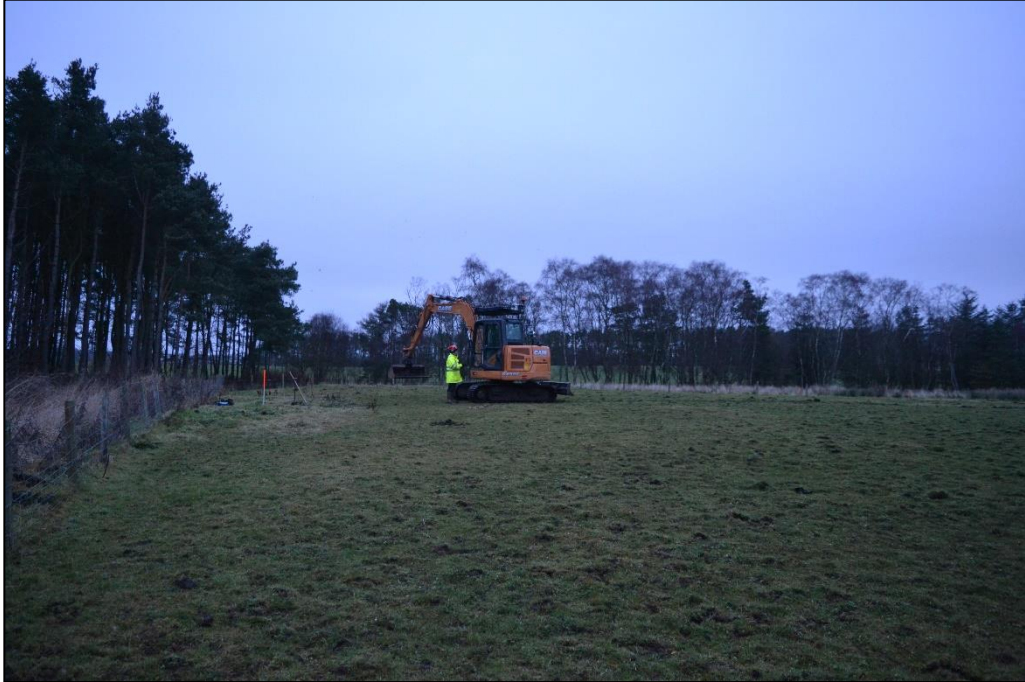
Plate 1: View north across western part (Plot A) of the proposed development site (Photograph 003)

- 1.2.5 For ease of description in the text, these three areas have been assigned new identifiers – these can be viewed in Plate 1.

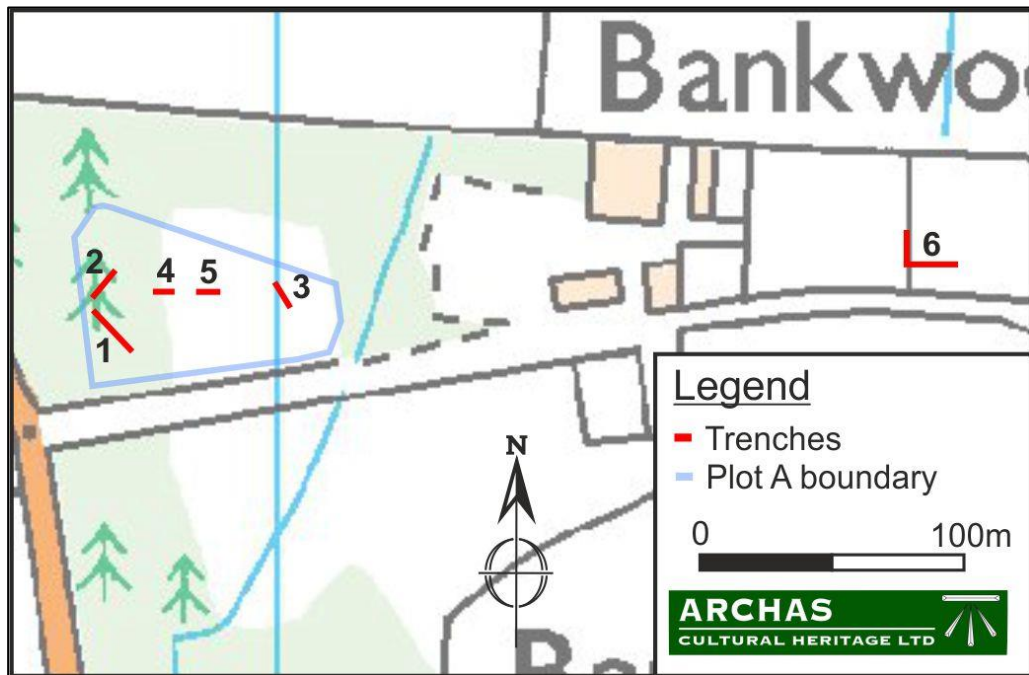
Figure 3: Trenches as excavated. ARCHAS Cultural Heritage after Ordnance Survey. Crown Copyrights. All Rights Reserved.

- 3.2.6 In the event, a total of six trenches of varying sizes were opened across Bankwood Farm (Figure 3). Five of these were opened in Plot A, with one large trench opened in Plot C.

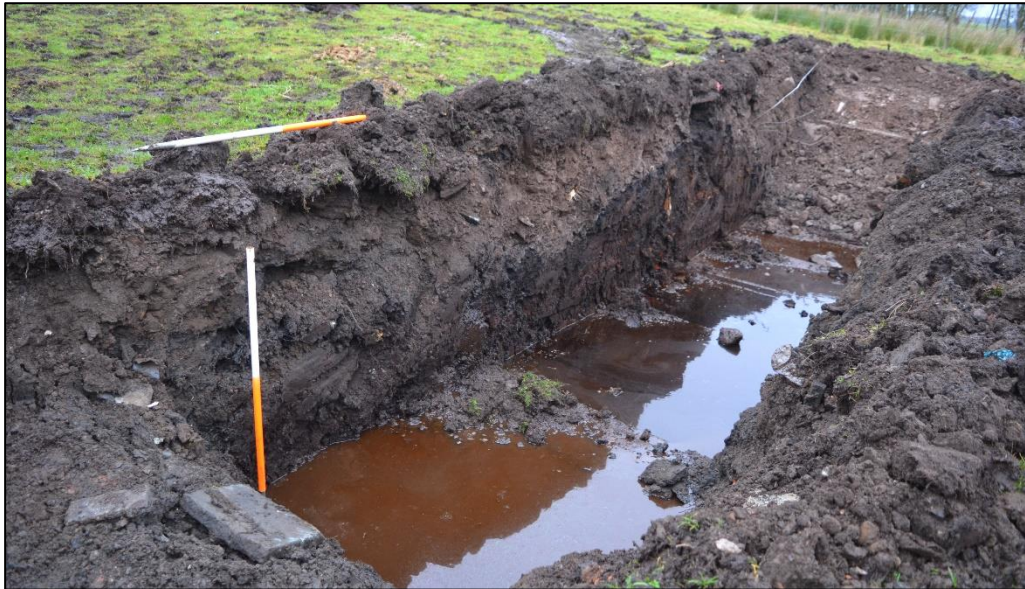
Plate 2: Oblique view looking NW over the NE facing section of Trench 3. Note the variation in depth of (302) (Photograph 017)

- 4.2.5 In trenches 1 and 2, the buried subsoil was pretty consistent with a depth of around 0.20m.
- 4.2.6 In Trench 3 the level and depth of the subsoil varied significantly from c.0.20-1m. While this was also clearly disturbed, it is thought that this may have represented an earthen mound around a tree due to the number and size of the roots within (**302**) at this point (Plate 2).

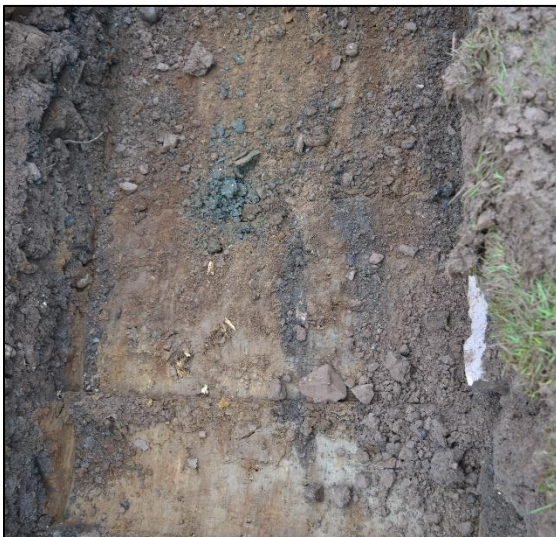
Plate 3: View of excavator scars in base of Trench 3. Please note it was not safe to insert a scale. (Photograph 022)

- 4.2.7 Trenches 4 and 5 showed evidence for greater disturbance. Here the buried subsoil was less homogenous, containing areas of building rubble and gritty industrial detritus (Plate 4). In addition, Trench 3 revealed scars from a toothed mechanical excavator scraped into the subsoil (**303**), indicating the depth of disturbance (Plate 3).

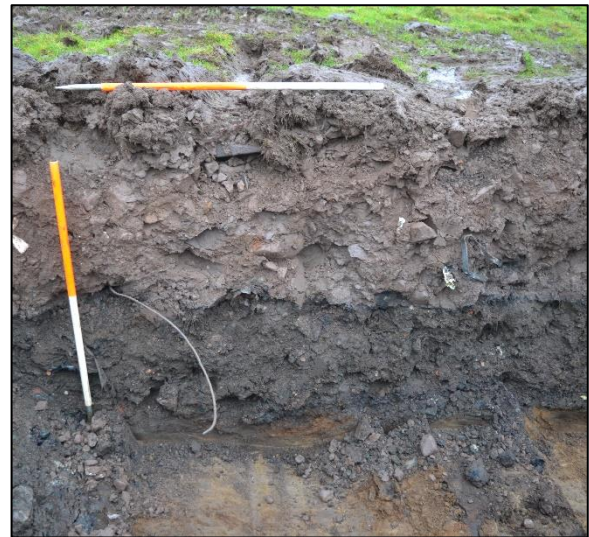
Plate 4: The south facing section of Trench 4 showing made ground (401) and disturbed subsoil (402). (Photograph 024)

- 5.2.1 Plot A was the largest of the three areas proposed for evaluation, but trenches here revealed up to 1.30m of mixed made ground as well as disturbance of the buried subsoil. Scars from the teeth of a mechanical excavator were recorded in the otherwise undisturbed subsoil of Trench 4 demonstrating the extent of the disturbance.

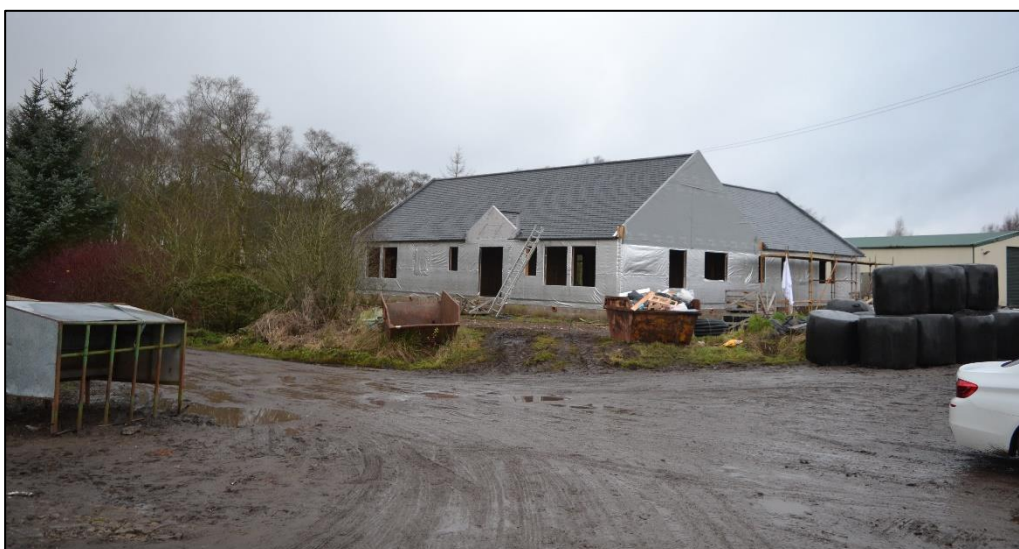
Plate 5: Existing development on Plot B (Photograph 036)

- 4.3.1 Prior to attending site the possibility of significant ground disturbance in Plot B had been discussed with WoSAS with the agreement that professional judgement would decide whether excavation was required in this area.
- 4.3.2 In the event it was not possible to open trenches on Plot B as this area was already in the process of redevelopment (Plate 5).

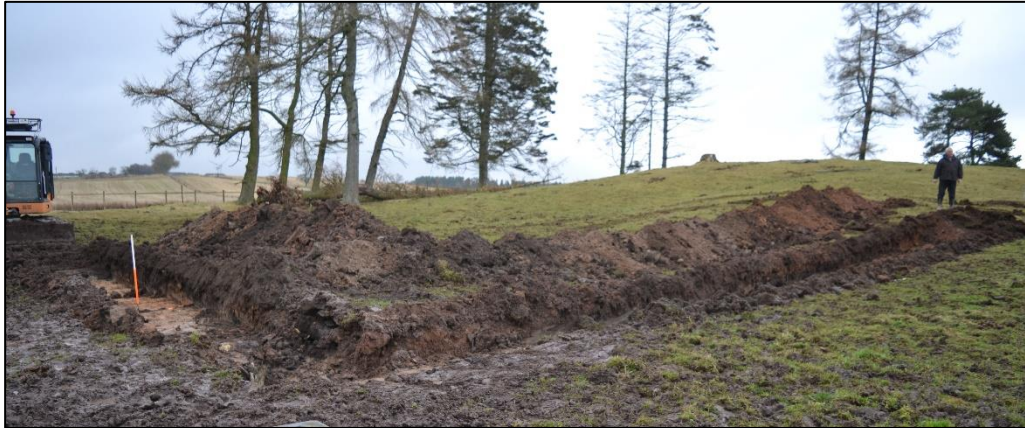
Plate 6: Post-excitation view of Trench 6 (Photograph 032)

- 4.4.2 Trench 6 was initially excavated from west to east for a total of 20m, before a secondary excavation was completed from the northern side of the western end, measuring a further 11m in a northwards direction (Plate 6).
