**Land East of Shira Lodge,
Main Road,
Cardross,
Argyll and Bute
Archaeological Evaluation
Data Structure Report**

Client: Homes for Heroes & the Chrystal Trust for
Bloomhill Fields
Project: East of Shira Lodge, Cardross Job No: 261
Document Title: Archaeological Evaluation DSR

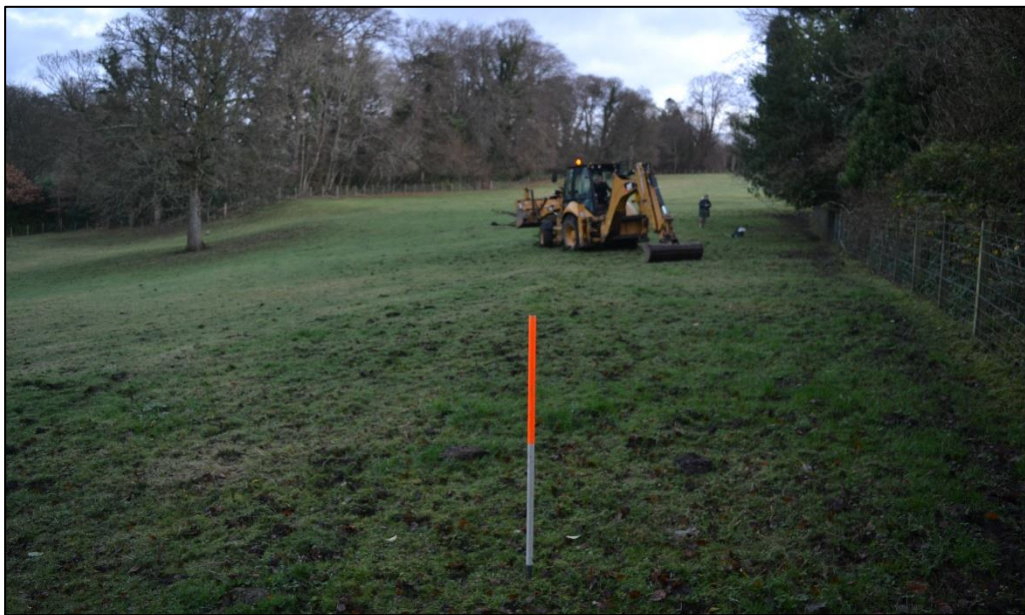
Plate 1: Looking NE across the proposed development area (Photograph 003)

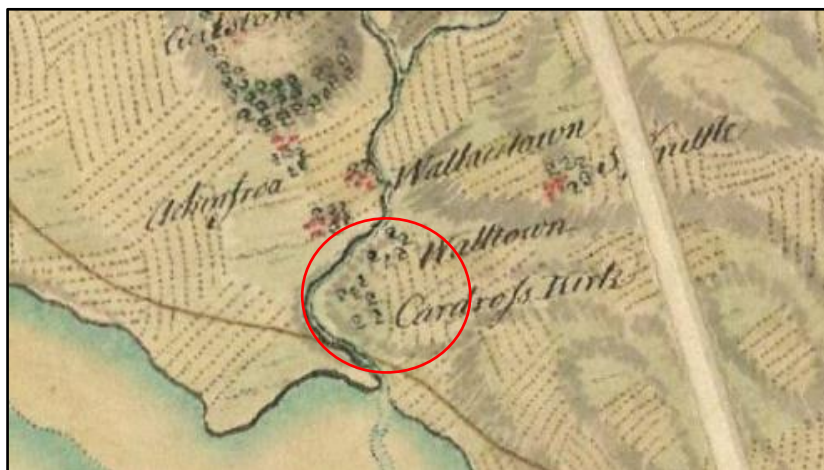
Figure 2: Extract from William Roy's Military Survey of Scotland 1747-55 showing the general development area in undeveloped farmland. NLS

2.3.1 William Roy's Military Survey of Scotland completed from 1747-55 clearly shows the approximate location of "Cardross Kirk" in relation to the Kilmahew Burn and depicts most surrounding fields either as under cultivation or undeveloped farmland (Figure 2).

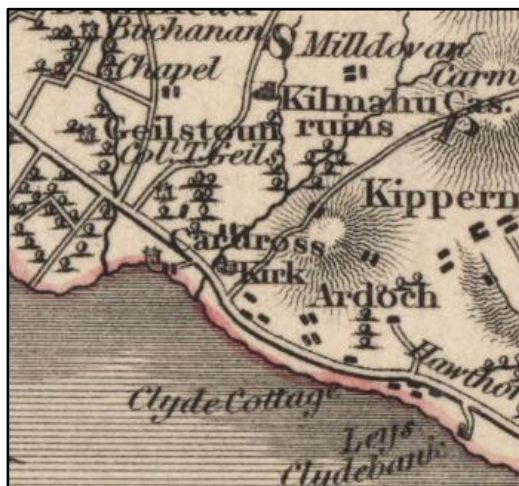
Figure 3: Extract from John Thomson's Atlas of Scotland showing "Dunbartonshire" from 1832 with Cardross Kirk noted. NLS

2.3.2 John Thomson's plan of Dunbartonshire within his Atlas of Scotland in 1832 shows Cardross Kirk as probably the only building present at that time.

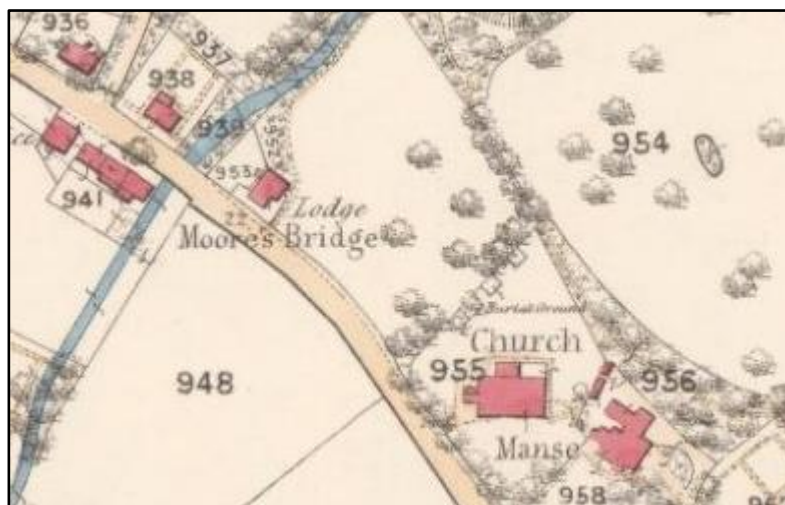
Figure 4: Extract from the 25 inch to 1 mile Sheet XXI.4 published in 1857 showing the development area as a clearly defined plot free of any development much as survives today. NLS

- 2.3.3 The first Ordnance Survey map of the area was compiled in 1857 as part of the Ordnance Survey 25 inches to the mile series.
- 2.3.4 The 25 inch to 1 mile Dumbarton Sheet XXI.4 (Cardross) from 1857-63 clearly shows the development area as a well-defined plot, surrounded by Shira Lodge, the Church and the Manse as these exist around the perimeter of the site today. A *burial ground* is shown on the western limits of the church boundary where the early grave slabs are presently noted.

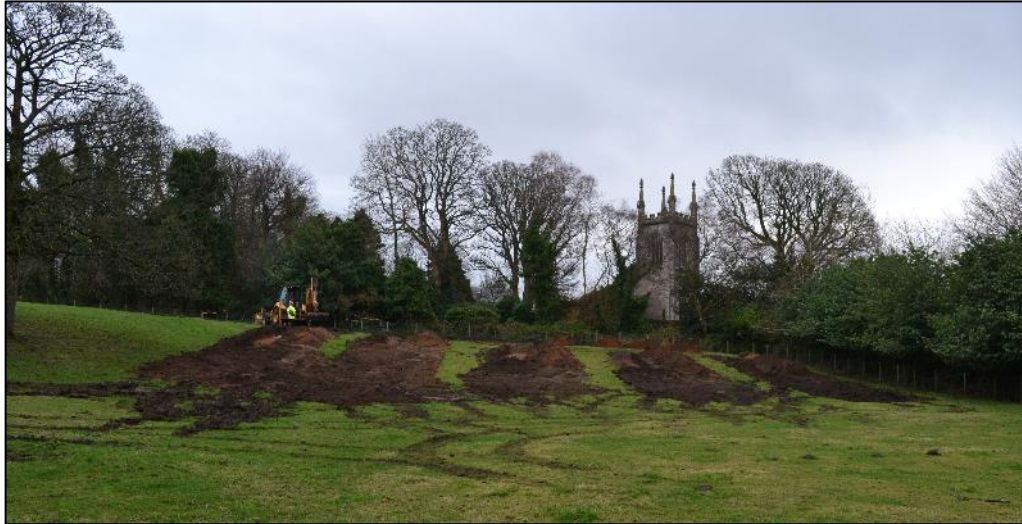
Plate 2: Working shot showing the locations of the trenches during backfilling (Photograph 039)

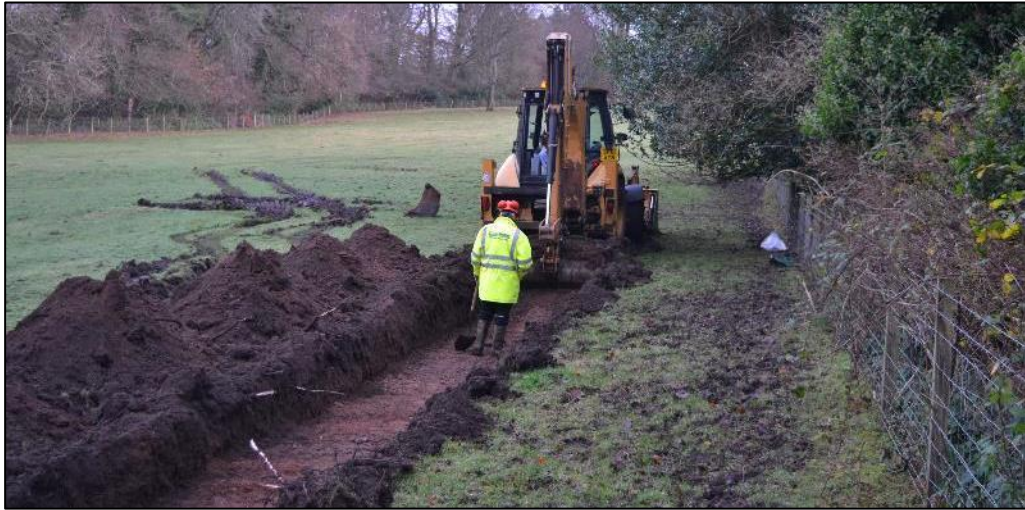
- 4.2.1 Trench 1 was excavated on a north east to south western alignment adjacent to the perimeter of Cardross Old Parish Church (Plate 3). Much of the site is located on sloping topography, but Trench 1 runs along an area flat ground at the top of the hill and was considered the most likely place for archaeological deposits to be located. The location Trench 1 was a specific requirement for the evaluation following discussions with WoSAS.

Plate 3: Working shot showing the location of Trench 1 with the boundary of Cardross Old Parish Church adjacent (right) (Photograph 004)

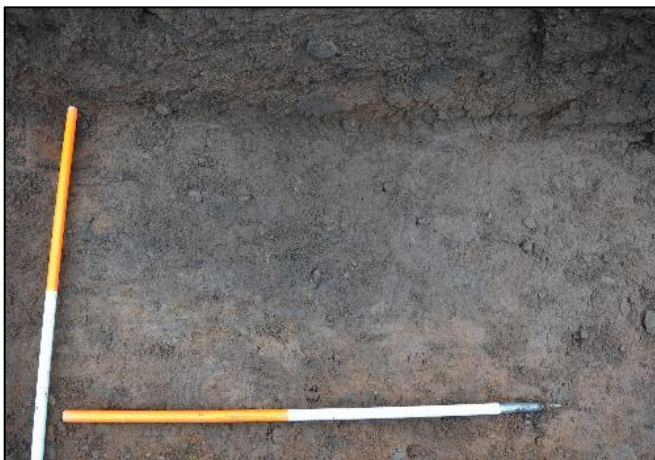
- 4.4.1 A small, negatively cut feature [**304/305**] was recorded below the topsoil (**301**) and ploughsoil (**303**) 11m from the north eastern end of Trench 3.
- 4.4.2 Located against the south western baulk of Trench 3, this feature was investigated and proved to be an amorphous spread with diffuse, gradual, undulating edges and a clear, sloping base. The fill (**305**) comprised mid grey brown silt with infrequent small rounded Fe stone inclusions and occasional flecks of charcoal.

Plate 4: Pre-excitation view of [**304/305**] (Photograph 022)

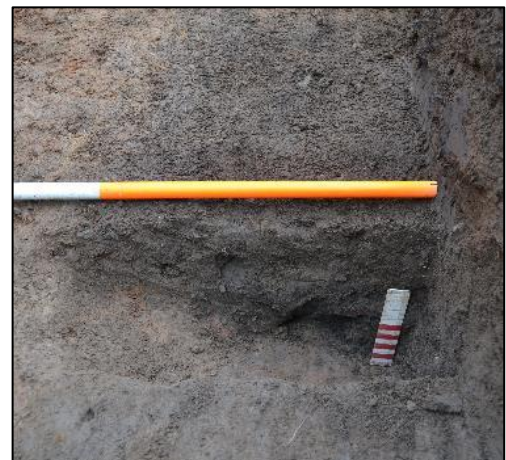
Plate 5: NW facing section of [**304/305**] (Photograph 035)

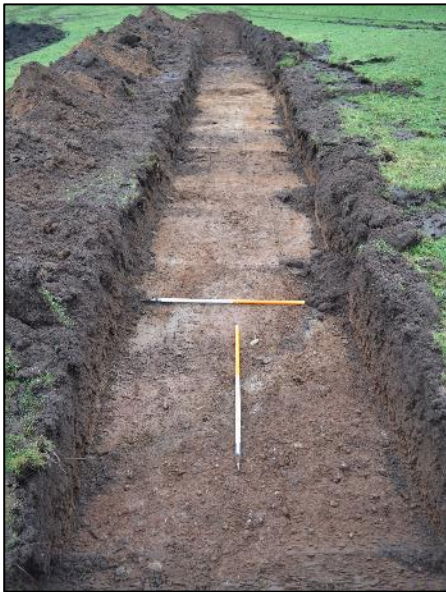
4.5.1 Trench 4 also contained a topsoil (**401**), transition ploughsoil (**403**) and undisturbed natural subsoil (**402**) (Plate 6 and Plate 7). However, two possible features were also recorded.

Plate 6: Post-excitation view of Trench 4 (Photograph 023)

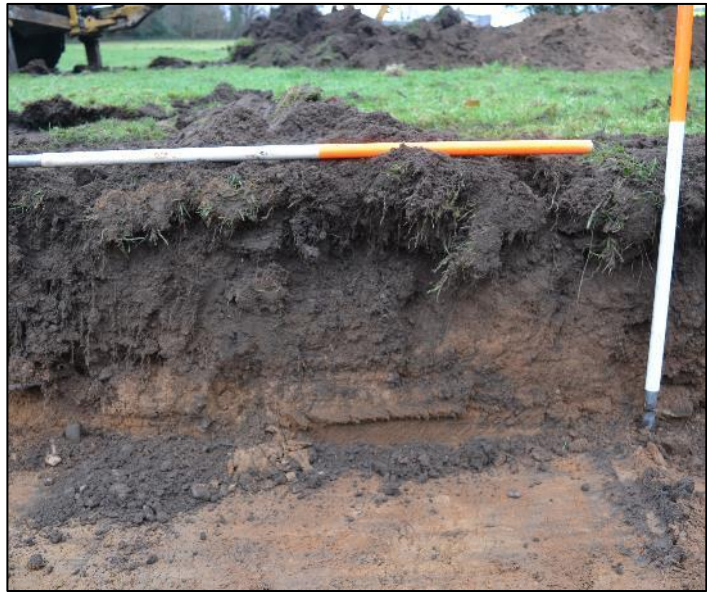
Plate 7: SW facing section of Trench 4 (Photograph 024)
