**Extension to Caravan Park and associated works  
Linwater Park,  
Newbridge,  
Edinburgh,  
Data Structure Report**

**September 2018**

Client: Mr and Mrs Guinan  
Project: Linwater Caravan Park  
Document Title: Archaeological Evaluation Data Structure Report

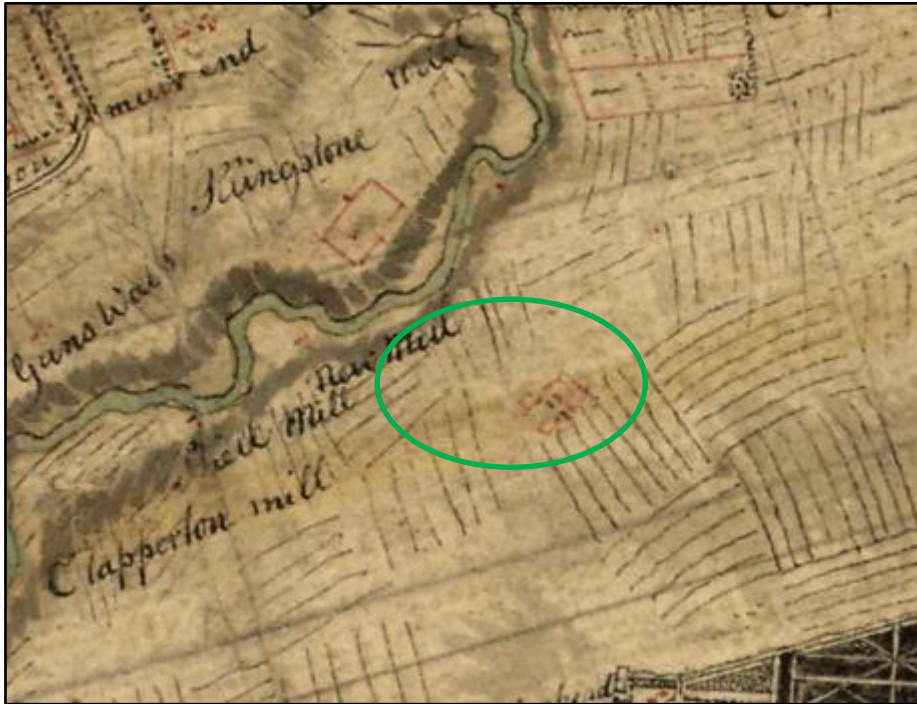
- 2.3.2 The first map to depict the area in any substantial detail is William Roy's 'Military Survey of Scotland (1752-55) (Figure 2). He depicts the area of the proposed development as under cultivation suggesting both that the area has long been associated with agriculture and so there is potential for rig and furrow for example to survive cut into the subsoil. Roy also depicts a small settlement close to the proposed development.

**Figure 2:** Extract from William Roy's *Military Survey of Scotland (Lowlands)* (1752-55). © The British Library Board. All Rights Reserved (Roy Military Survey of Scotland). The area of the proposed development in green.

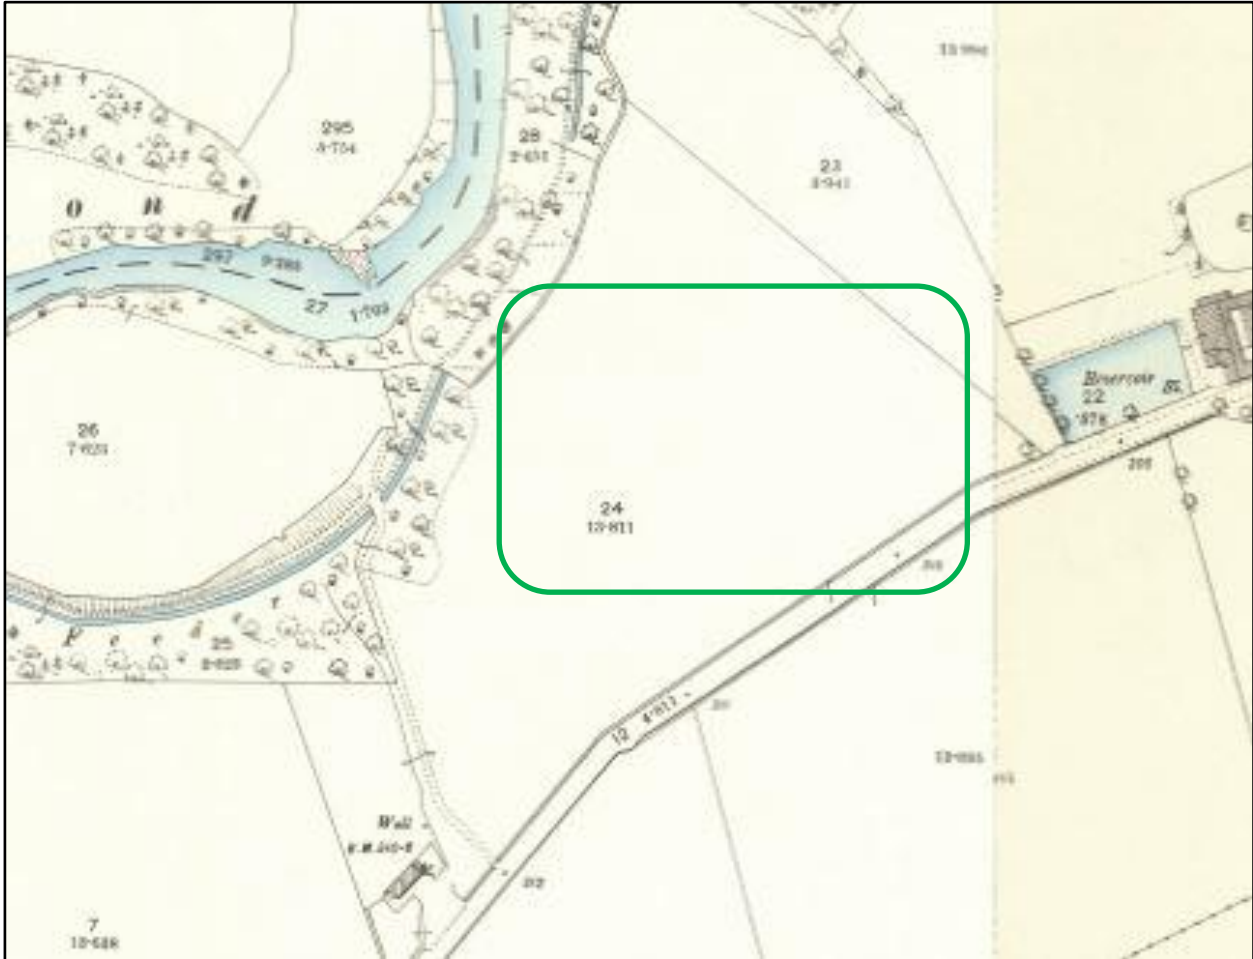
**Figure 3:** Extract from the 25-inch edition Ordnance Survey (1895) Linlithgowshire, Sheet 010.07. The approximate area of the proposed development in green. NLS

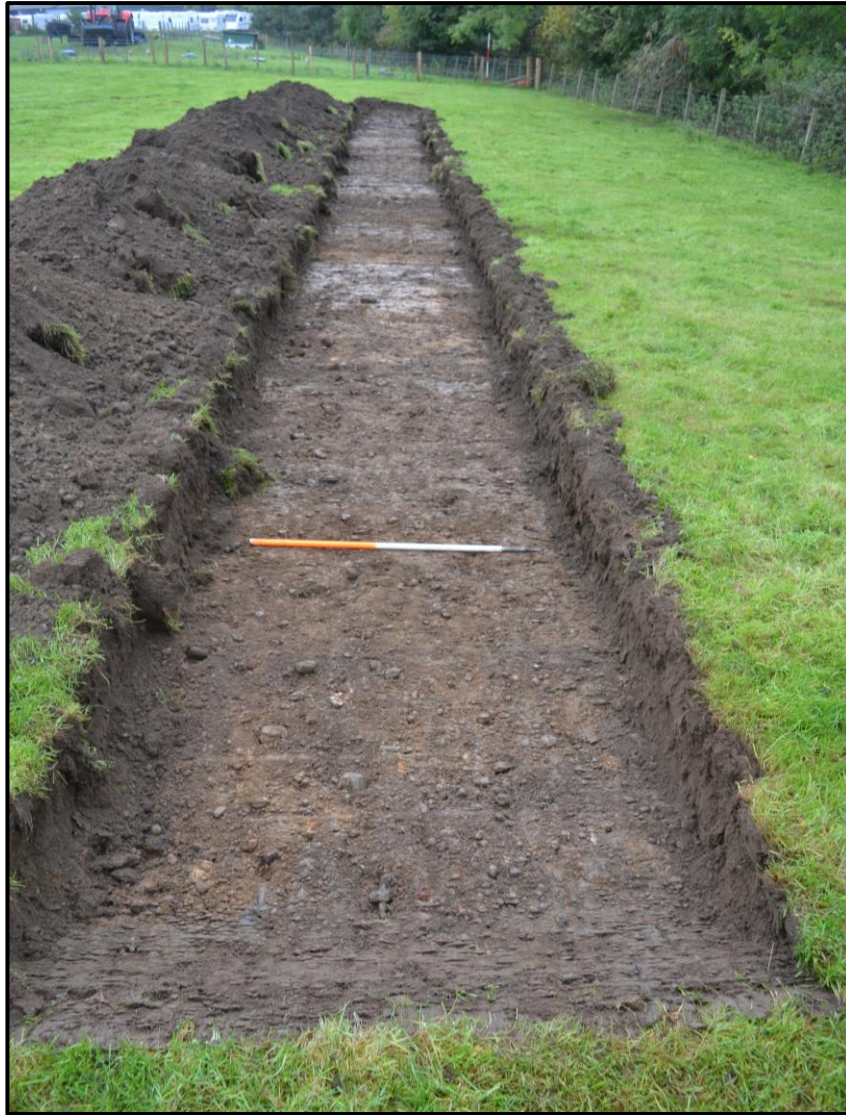
**Plate 1: Trench 2 Post Excavation**

4.2.4 Trench 2 measured 28m in length and was excavated on an east west just south of Trench 1.

4.2.5 The turf and topsoil (**201**) proved to be a moderately compact dark brown sandy gravelly topsoil 0.30m in depth with frequent small gravelly stone inclusions and heavy bioturbation.

4.2.6 The natural subsoil (**202**) comprised a firmly compact, beige, light brown gravelly sand subsoil. Clear within this subsoil, were patches of black material similar to charcoal often with waterworn large pebbles of what is suggested is oil shale. 10m from the SSE end of the trench, the subsoil became more like a gritty clay with fewer inclusions such as shale.
