## **2 BOYS HALL ROAD, WILLESBOROUGH, KENT**

ARC BOY 99

Environmental Statement Route Window 32

# 2 BOYS HALL ROAD, WILLESBOROUGH, KENT

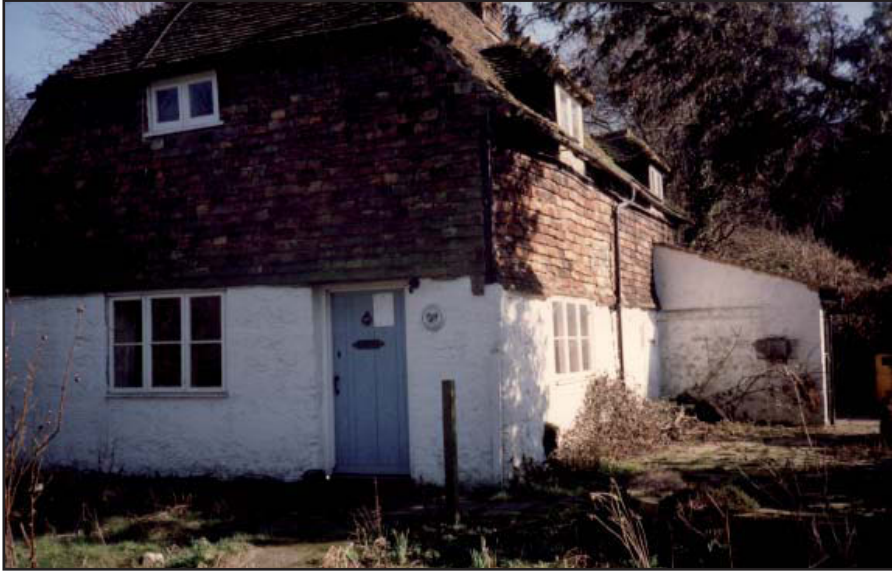
Plate 1: General view, west elevation

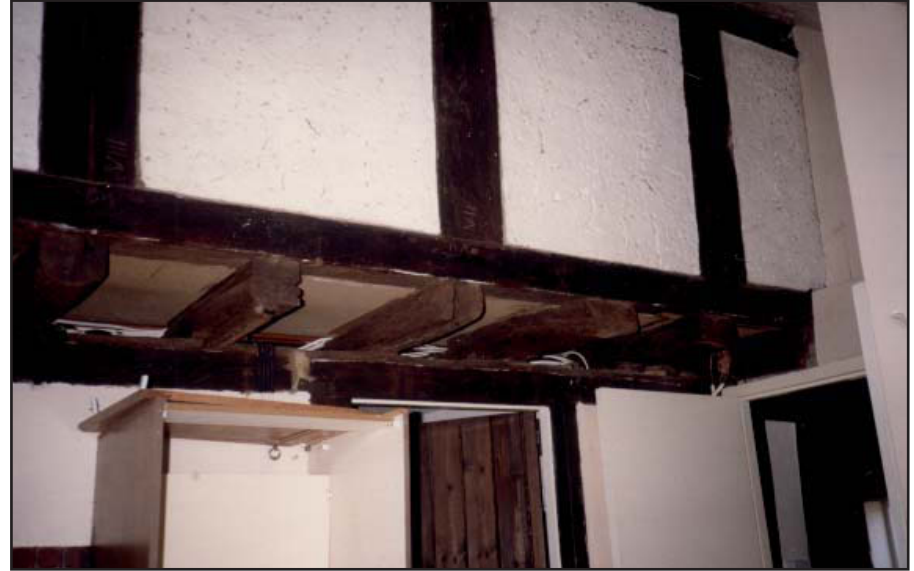
3.2.2 *Interior:* Two-bay plan with central stack and jettied front to north, covered by outshot (Plate 2). The *outshut* now contains kitchen and bathroom, etc. The *framing* of the visible walls, ceiling and jetty is plain and of modest scantling, with short chiselled carpenters' marks. Several instances of redundant peg holes suggests that some of the timber is re-used. The carpenters' marks on the framing include numbers VIII and VI in such a position as to suggest that the present timber frame is complete and does not have a missing bay, as initially was thought possible. The post below the centre of the jetty has a long straight jowl, and the ends of the jetty joists are cut back square as if for a fascia board. There are three original posts between the outshot and the main structure, but if the original front door was in this elevation its position is not obvious (it was probably opposite the chimney stack). The central *chimney stack* is of brick, with a large fireplace (and oven on the south) in the principal *west room*, and a smaller fireplace in the east room (much of the visible brick is old, but some either rebuilt or vigorously cleaned) (Plate 3). The ceiling of the west room has been replaced in the southern half (with a reused wallplate), but the whole appears to be integral with the framing, i.e. the room was not an open hall; the wall plates seem to indicate that the original structure was timber-framed on the ground floor rather than being a first-floor built on a ragstone wall.

Plate 2: Internal view, jettied front to north

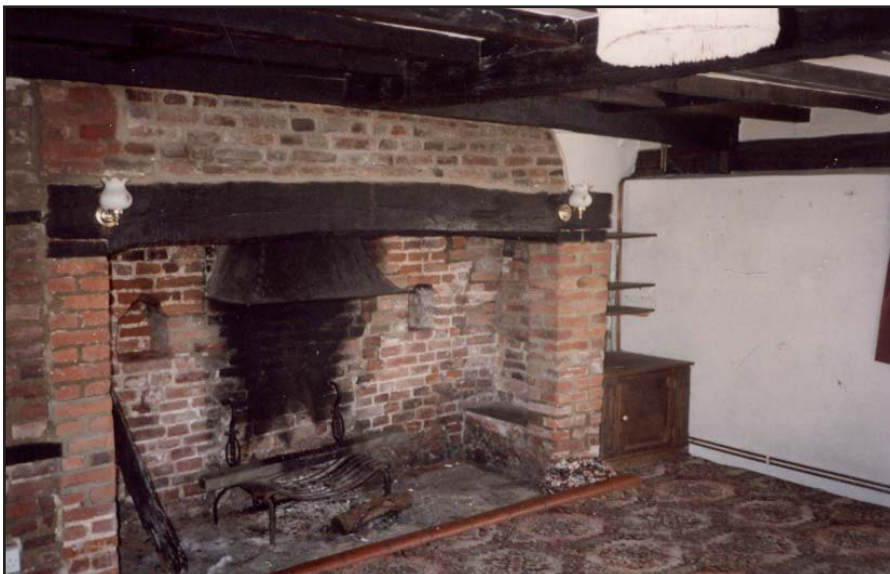
Plate 3: West room, main fireplace

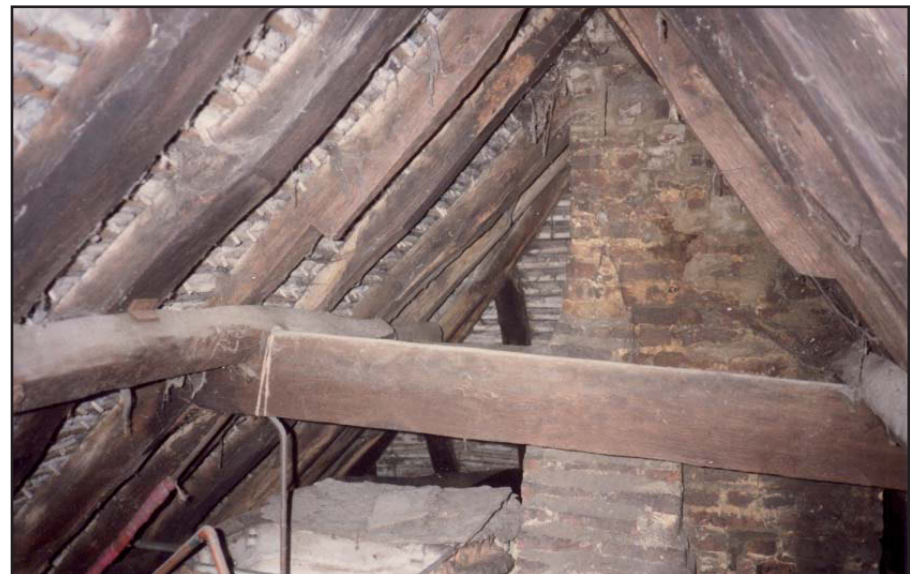
- 3.2.4 The chimney stack, although rebuilt on the outside, was all of original brick in the attic and both halves were clearly of one build (Plate 4). The tie beam of the central truss has been severed to provide access to the bedrooms, and no evidence was found for other tie beams.

Plate 4: Roof truss and chimney
