4 BOYS HALL ROAD, WILLESBOROUGH, KENT

ARC BOY4.BS.99

Archaeological record in advance of demolition

CTRL Contract No. 430

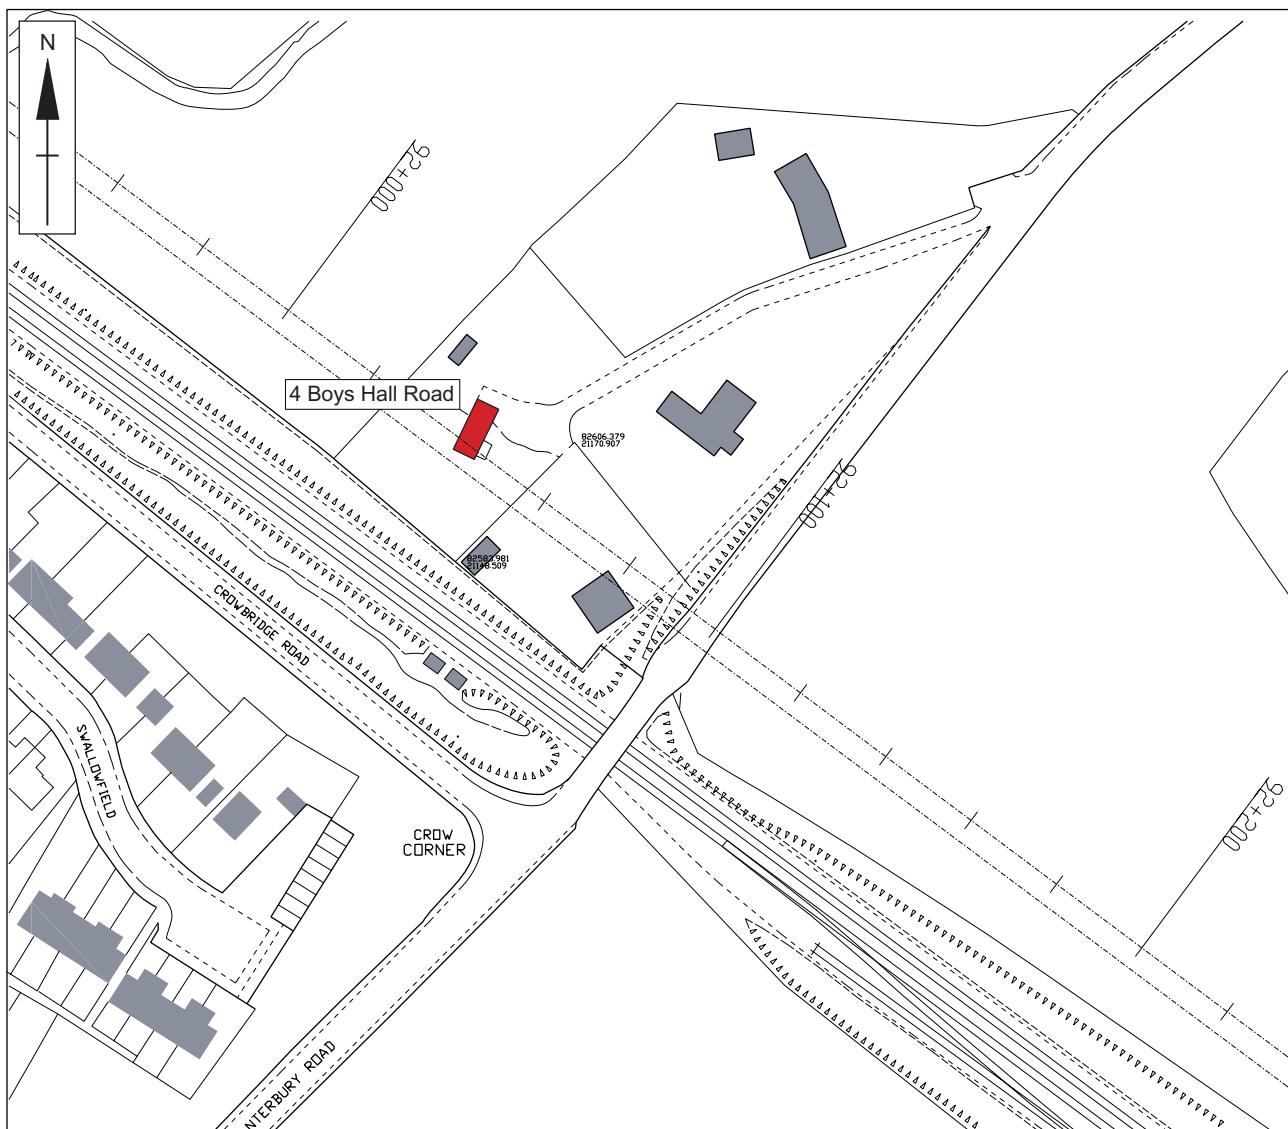
Figure 2: Site Plan

- 2.1 No.4 Boys Hall Road is located within the suburb of Willesborough, c.2km to the south-east of the town centre of Ashford (Fig.1). It is situated immediately adjacent to the north of the main line London-Folkstone railway (Fig.2).

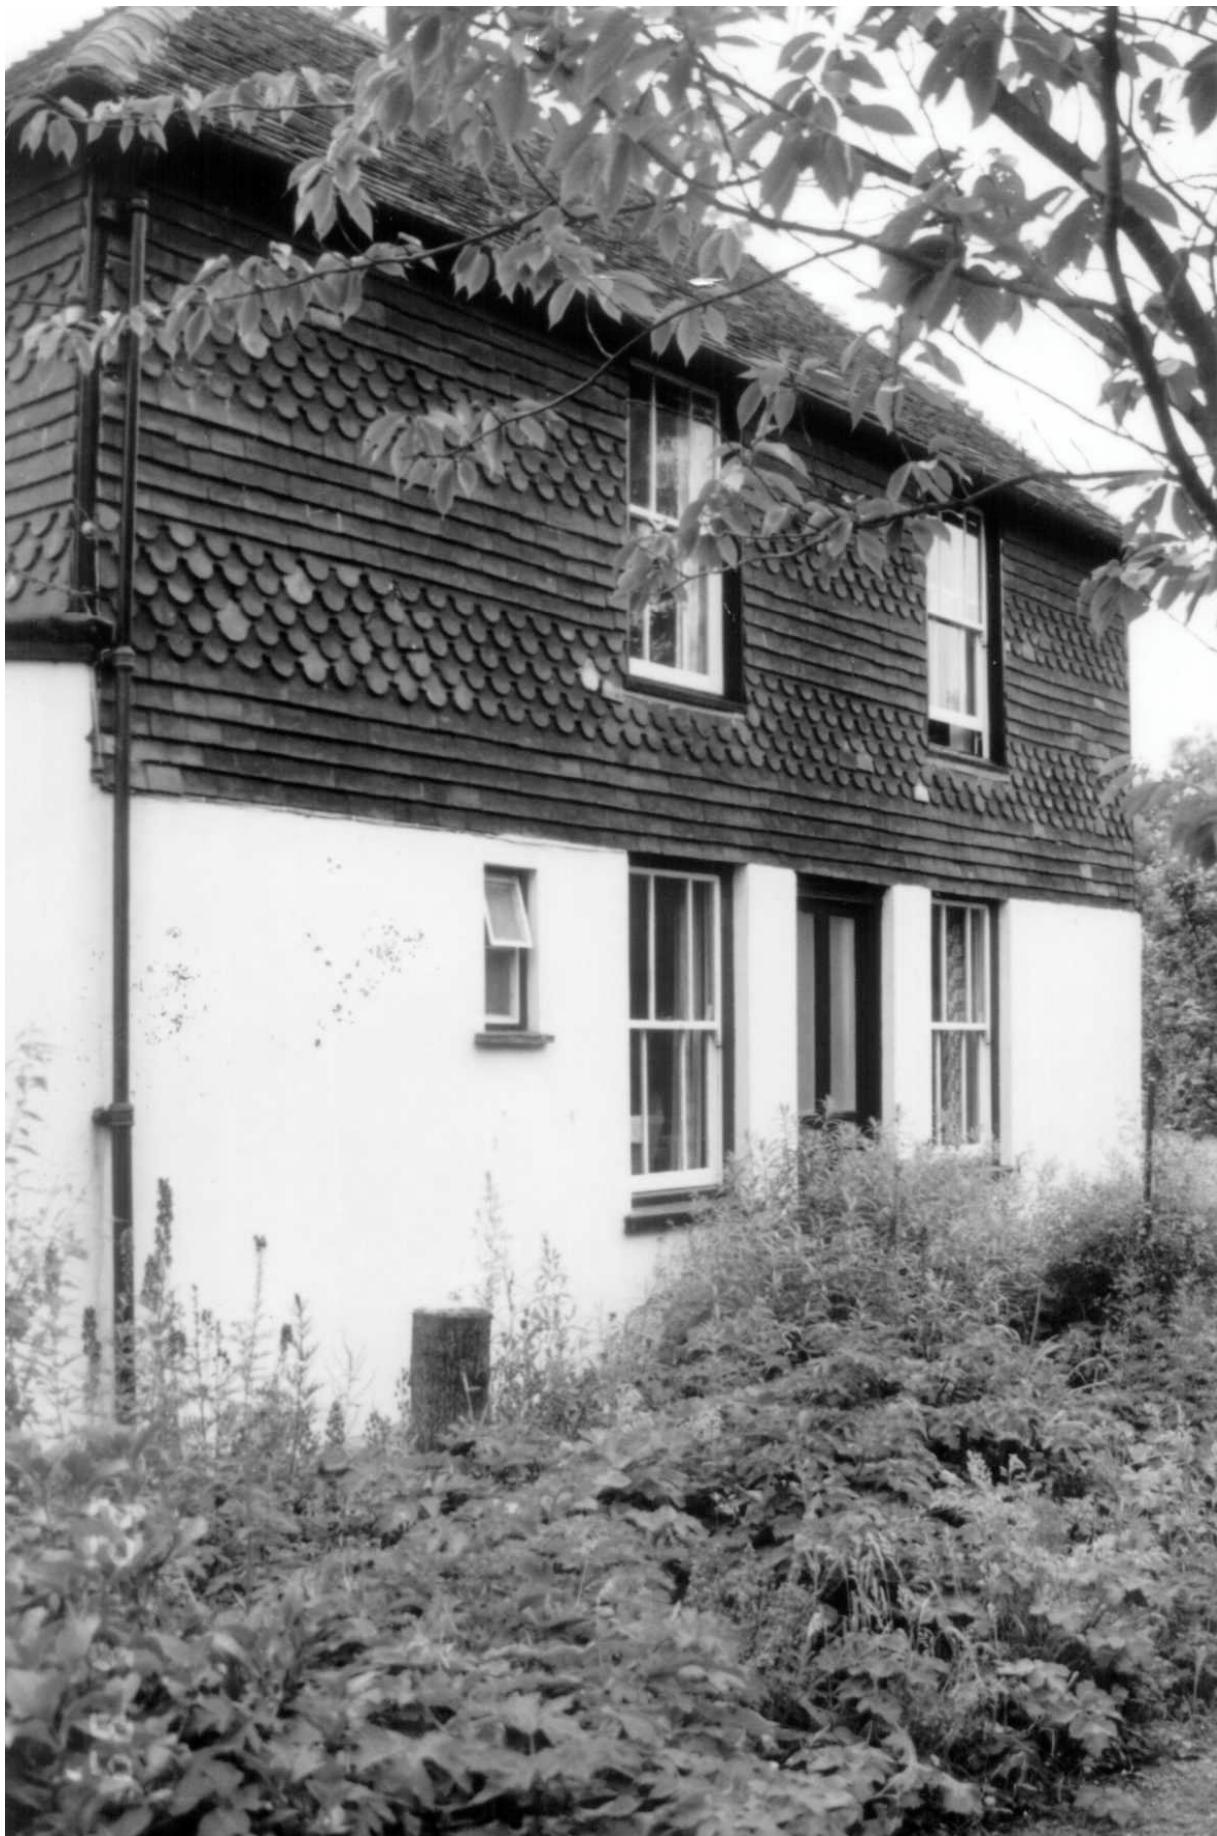
Figure 3: Exterior view from the north-west (photographed in 1993).

The ‘main block’ of the house has an overall length of 8.50m long and stands 4.50m to eaves. The roof is hipped at each end and the maximum height to the ridge is 6.80m. The west elevation represents the principal elevation of the building with a central doorway approached by two concrete steps. Located symmetrically to either side of the central door are two openings formerly housing single-light, two-panel vertical sash windows. This pattern of fenestration is mirrored at first floor level. The ground floor of the main block is of rendered and whitewashed brick; the first floor level is of stud construction and was formerly tile hung with alternating bands of plain and rounded tiles (see Fig.3).

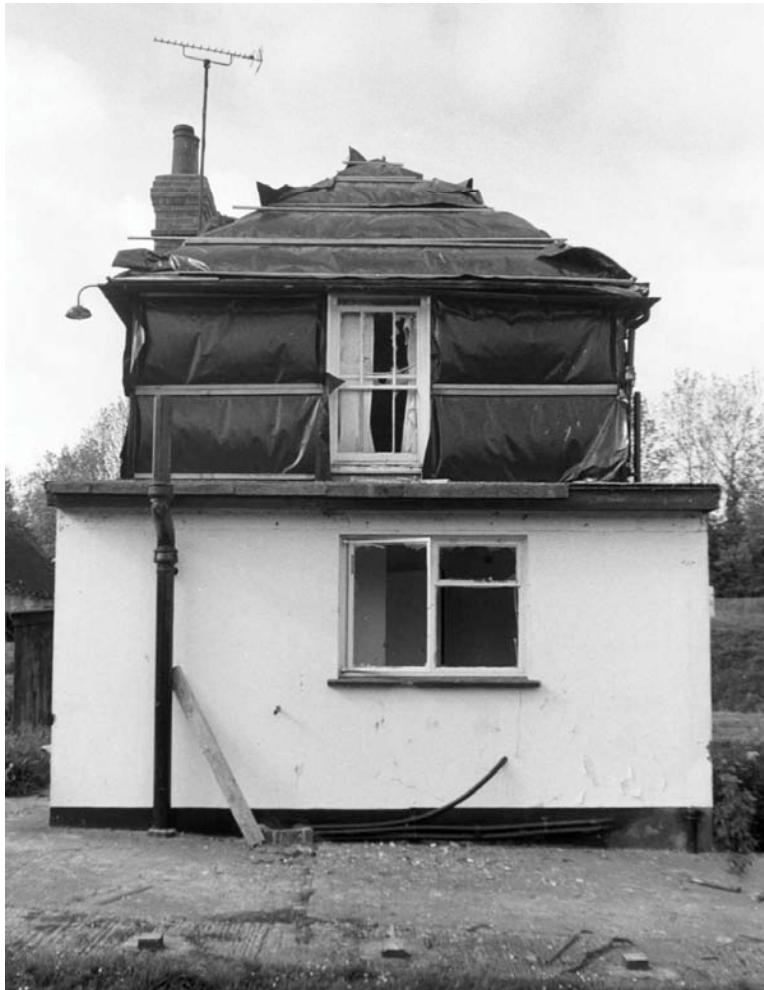
Figure 4 : North elevation

The north elevation, which represents a hipped end elevation of the ‘main block’ is partly obscured at ground floor level by a secondary pent-roofed single-storey bathroom extension. It is 4.56m wide and stands c.4.50m to eaves level. The extension is of rendered brick and displays a two-light iron framed casement window, slightly off-centre to the west of the north wall, which stands to a height of 2.25m. Above the roof level of the extension, the first floor of the ‘main block’ is visible. Formerly tile hung, this elevation displays a centrally located single-light vertical sash window with three pane panels divided by vertical glazing bars. Two tall stacks, serving fireplaces in the central and southern rooms of the house, rise at the east of the elevation. A small, pent-roofed shed of timber and corrugated iron construction is appended to the east elevation.

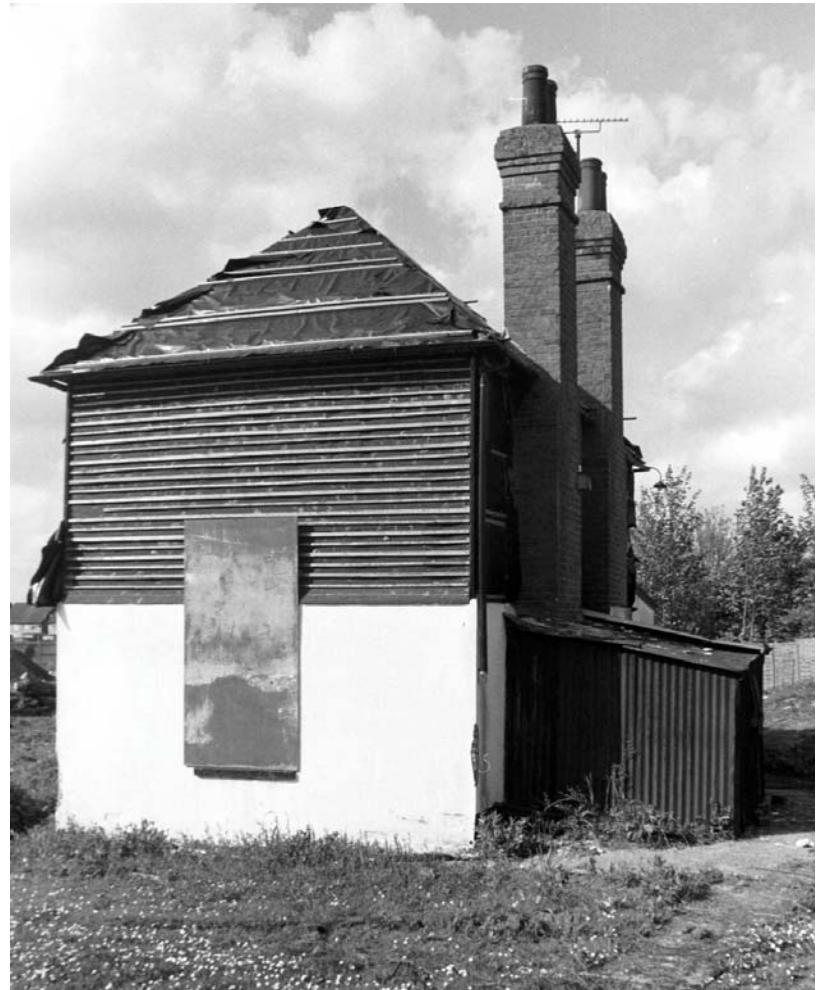
Figure 5: South elevation

The south elevation represents an unobscured hipped, end elevation of the ‘main block’. It is 4.56m wide and stands 4.50m tall to eaves level. The ground floor is of rendered and whitewashed brick, with a centrally located single light, two panel vertical sash window with three pane panels divided by vertical glazing bars. The upper storey is of timber studwork construction and was formerly tile hung with alternating bands of plain and rounded tiles. Again, the stacks and appended shed (see §.4.2.1) are visible to the east.

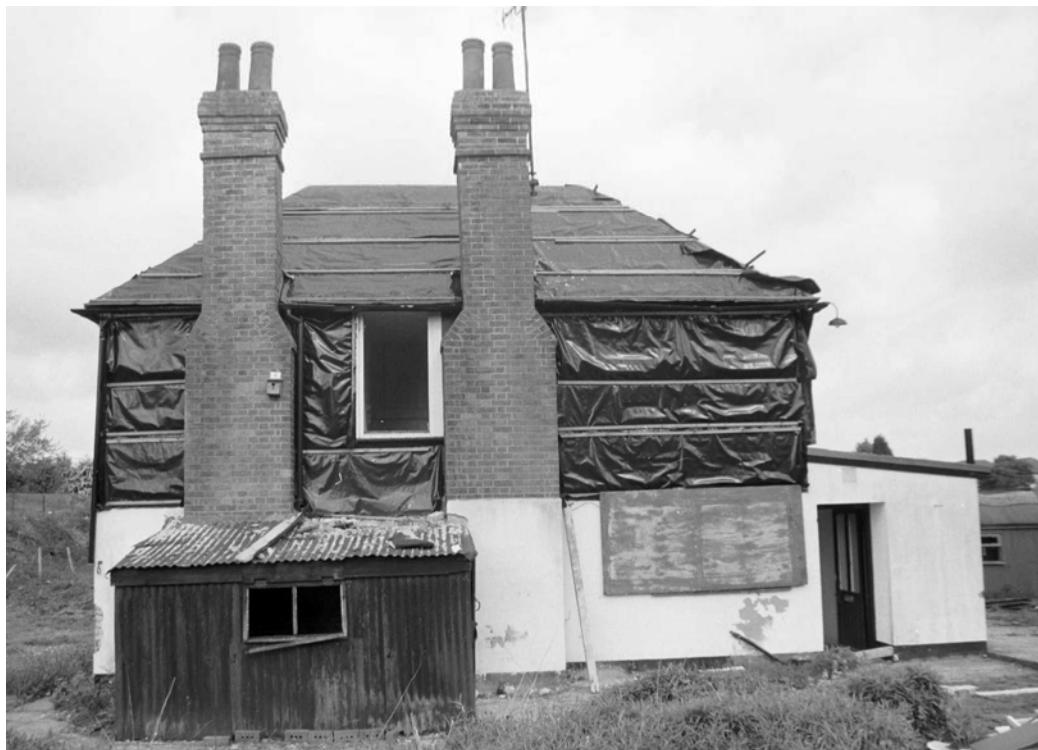
Figure 6: East elevation

The main block of the house has an overall length of 8.50m long and stands 4.50m to eaves. The roof is hipped at each end and the maximum height to the ridge is 6.80m. The ground floor is of rendered, white-washed brick. A single, three-light iron casement window is located to the north of the elevation lighting the kitchen (GF01). To the centre and south of the elevation two brick stacks in Flemish bond, rise to a maximum height of 7.25m. The lower part of the central stack would appear to be contemporary with the primary build of the ground floor brickwork with neatly bonded joints; the southern stack is, however, a later addition clearly evidenced by straight joints where the brickwork of the stack meets the walls of the house. The southern stack is partly obscured by a timber and corrugated iron lean-to shed. At first floor level the walls are of timber stud construction, formerly hung with decorative tilework. Between the two stacks at this level is a window opening formerly housing a single-light vertical sash window with three pane panels divided by vertical glazing bars. At the north end of the elevation is located a pent roofed

bathroom extension of rendered brick construction. A doorway at the junction of the extension and the ‘main block’ gives access to the house via an entrance lobby, GF04 (see below).

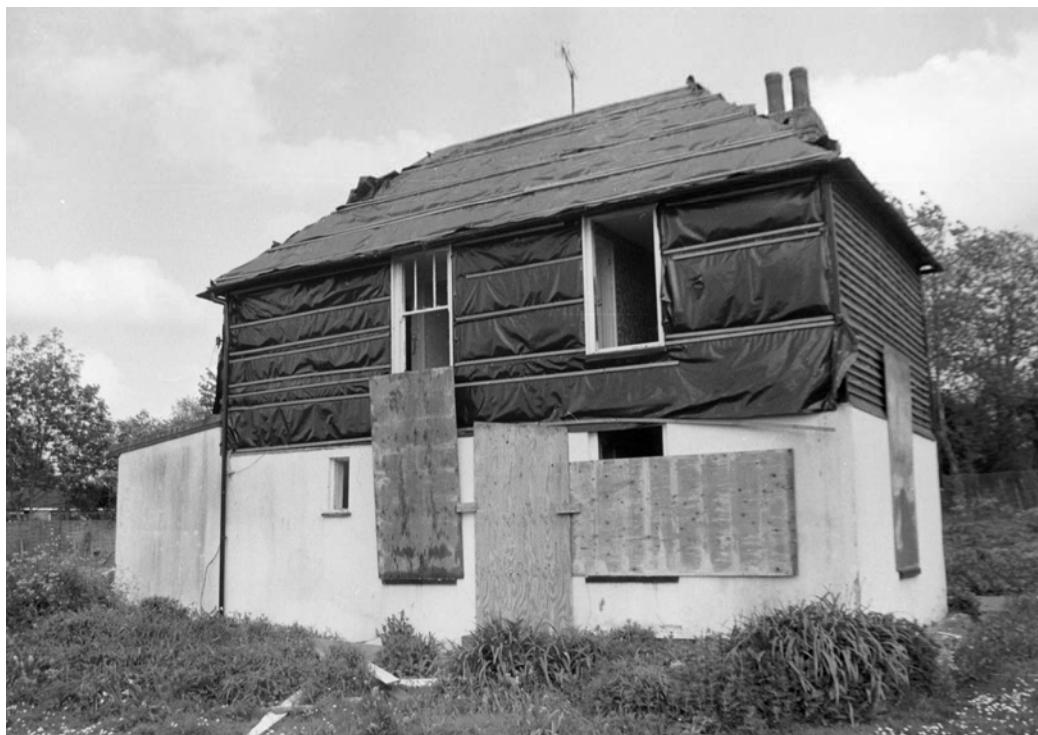
Figure 7: West elevation

To the north of the main block is a modern, single storey, pent-roofed extension which houses bathroom accommodation (GF05; see §.4.3.1.5 below). The west wall of the extension is free from architectural features.

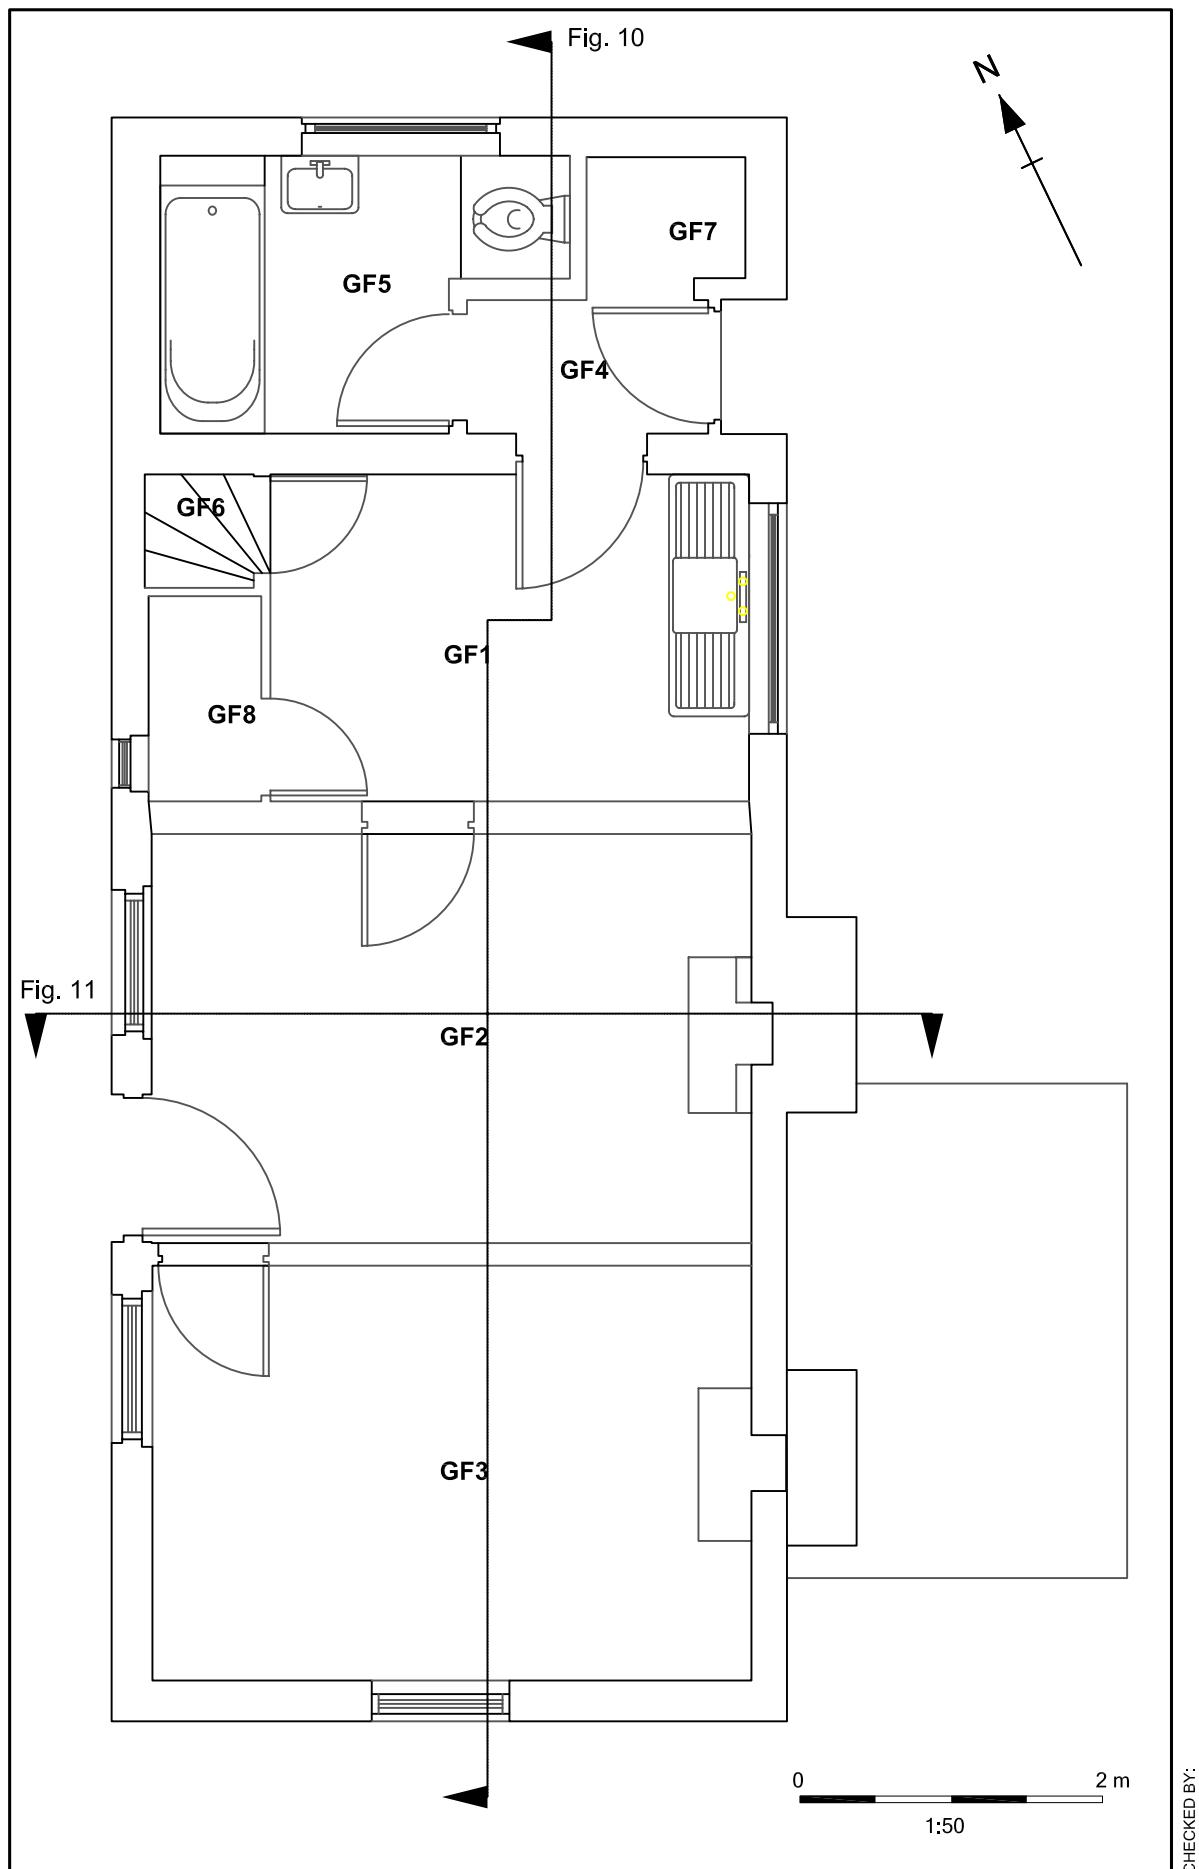
Figure 8: Ground floor plan

The building is rectangular in plan with overall dimensions of 10.65m x 4.46m and stands c.4.50m to eaves, aligned approximately NNE-SSW. The ground floor is of brick construction in Flemish bond, rendered in a hard grey cementacious mortar and whitewashed, representing an original layout of three cells in-line. To the north is located a brick built, single storey, pent-roofed extension. A further pent-roofed timber and corrugated iron shed is appended to the western elevation. The first floor level is secondary and is of timber stud construction, originally tile hung with alternate bands of plain and curved tiles (see Fig.3). Internally, accommodation is arranged over two levels. Two stacks rise to the centre and southern end of the east elevation. The roof is hipped at each end. The building can be logically broken down into the ‘main block’ represented by the two storey three cell range, with appended single storey extensions to the north and east (shed).

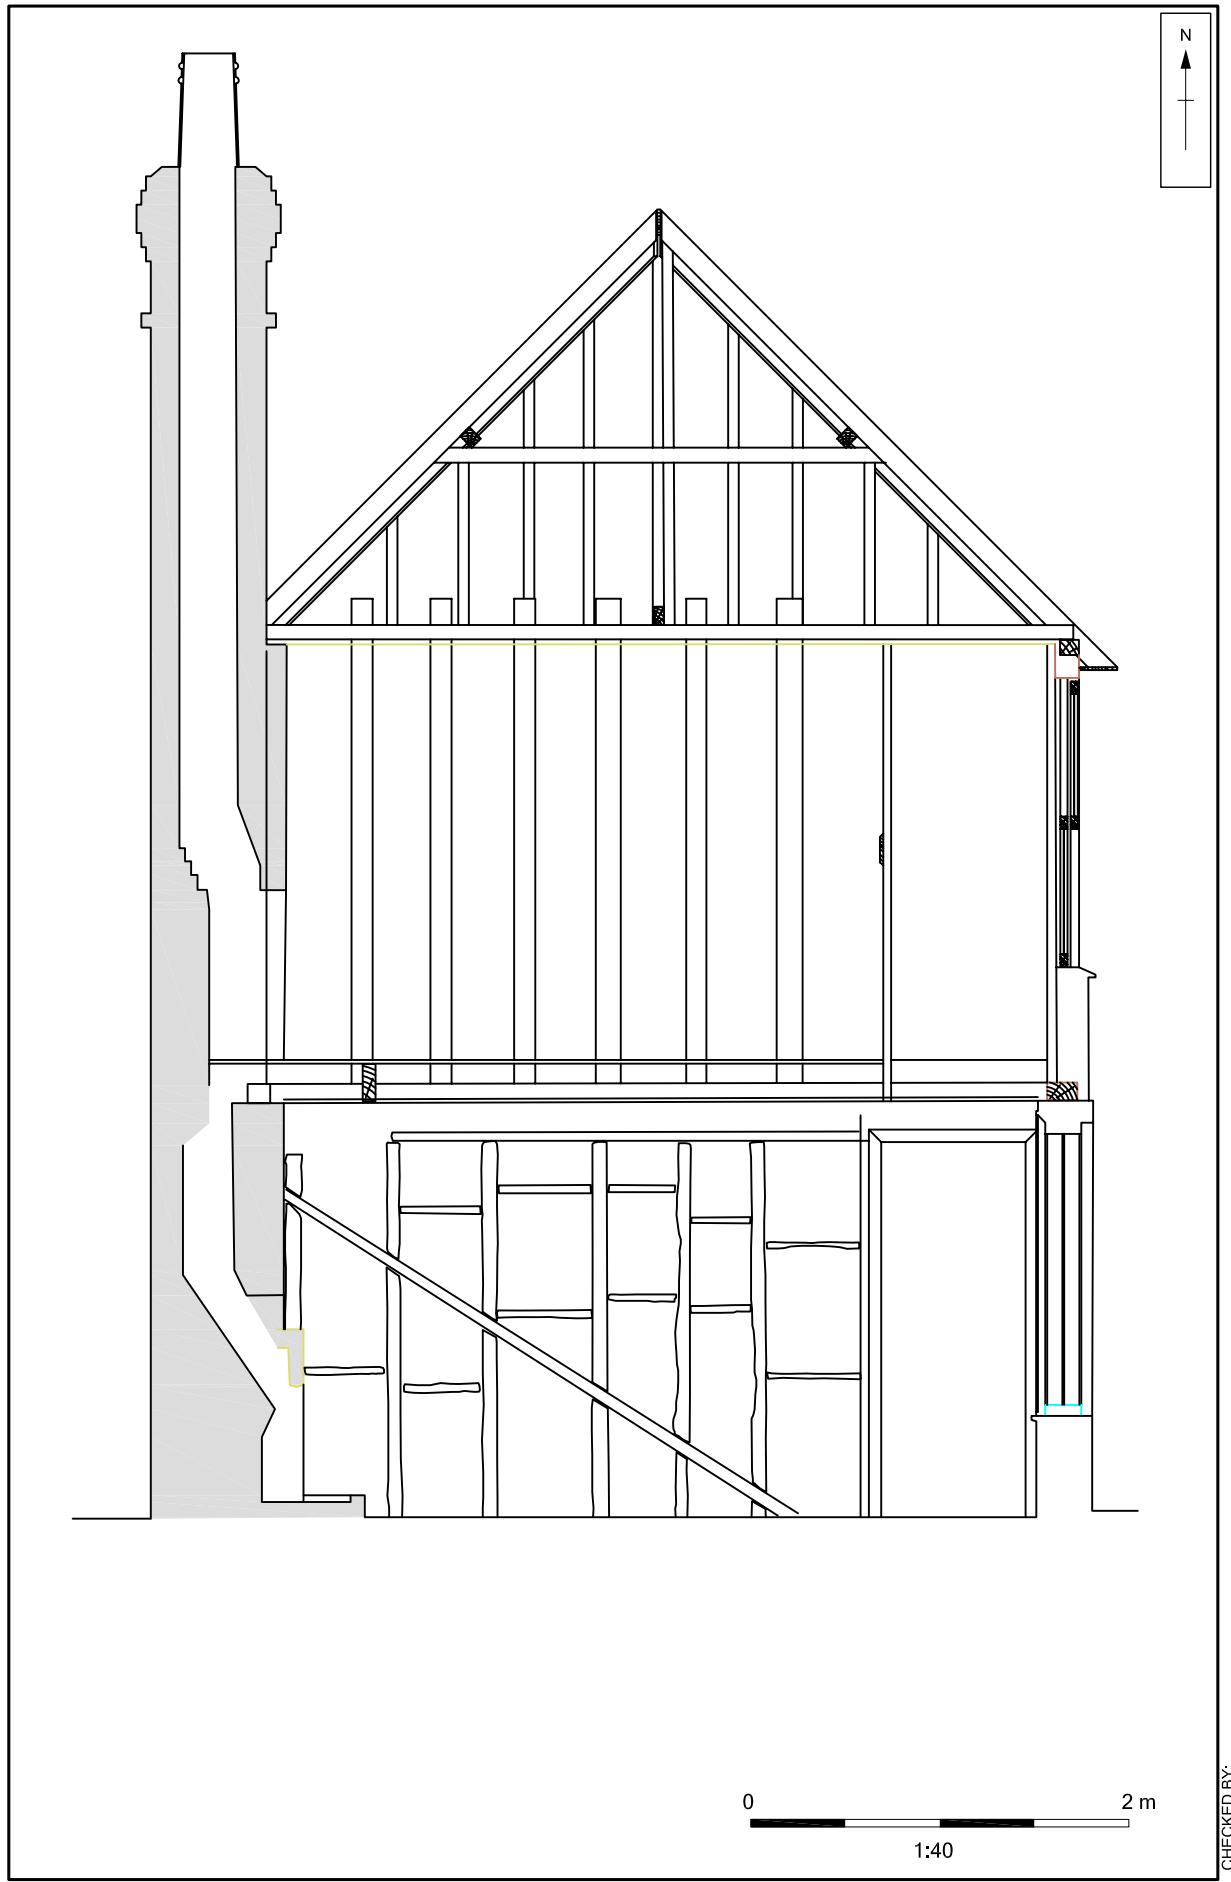
Figure 11: Transverse section

The roof is of simple common rafter construction (pitch 45°), hipped to north and south (hip pitch 43°), supported on single tier of clasped purlins and is of softwood throughout.

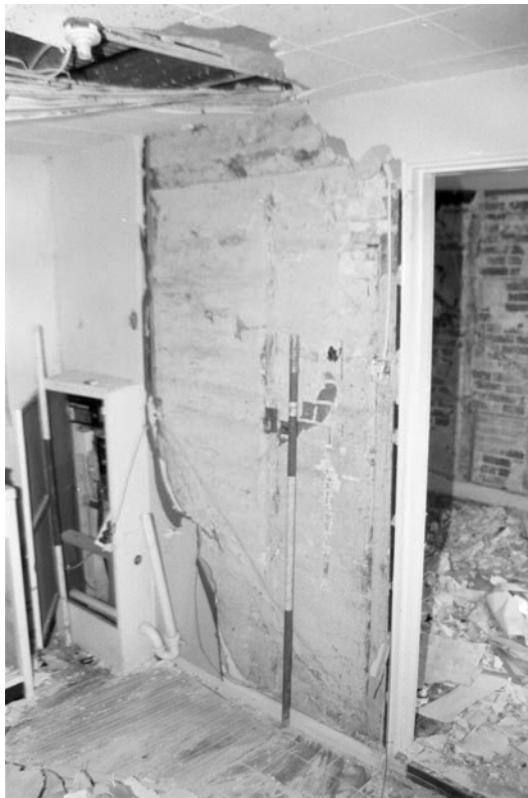
South wall: timber stud partition wall with horizontal and diagonal bracing and brick nogging infill (see Fig.12). Rendered with plaster, overlaid with recent painted hardboard. Single doorway to the centre of the wall (door removed) gives access to room GF02 to the south – this opening would appear to be primary to the partition.

Figure 12: Room GF01, south wall

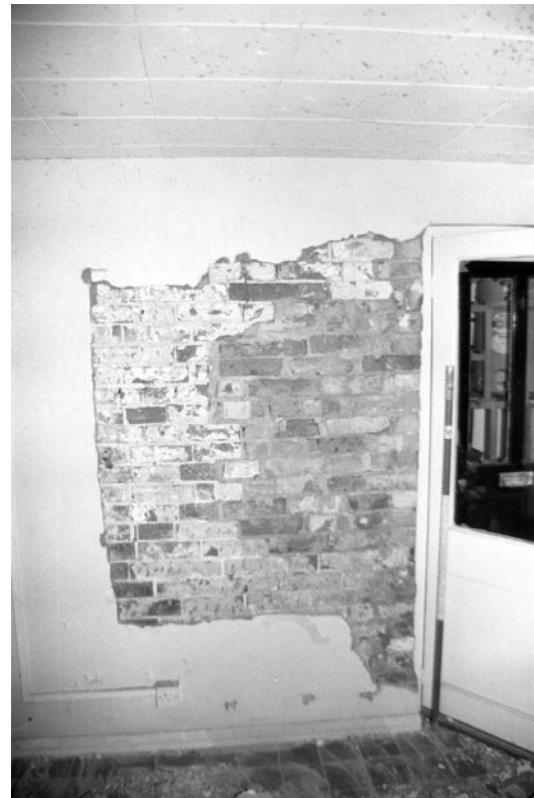
North wall: wall of brick construction in Flemish bond, covered by a grey-brown cementacious modern render. A single doorway (softwood 2 panel door, upper panel glazed) to the east gives access to lobby GF04. The lower western jamb of the doorway appears to be primary, though the upper part (from c.1m above floor level) clearly constitutes a rebuild (see Fig.13). The eastern jamb is also rebuilt.

Figure 13: Room GF01, north wall: note area of rebuild to western jamb

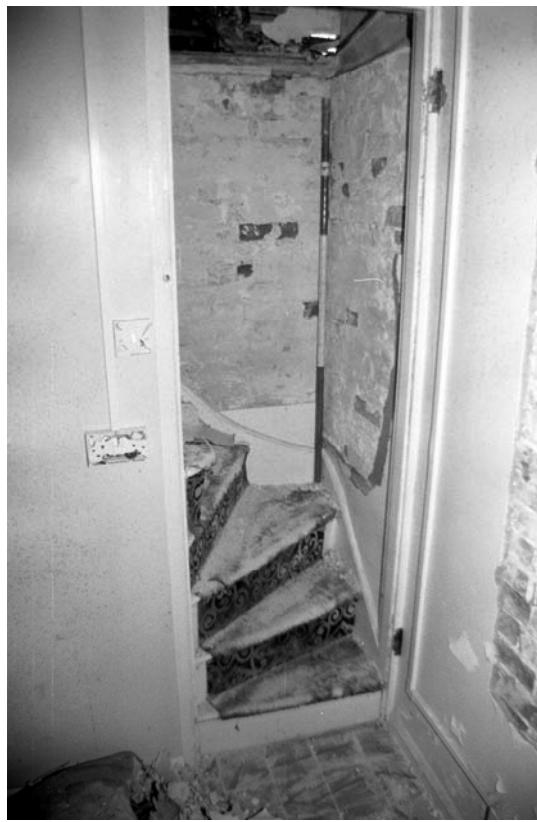
West wall: stud and hardboard partition divides GF01 from understair cupboard GF08 and stair GF06 which is accessed via a door at the north end of the wall (see Fig.14).

Figure 14: Room GF01(W), door to stairway GF06

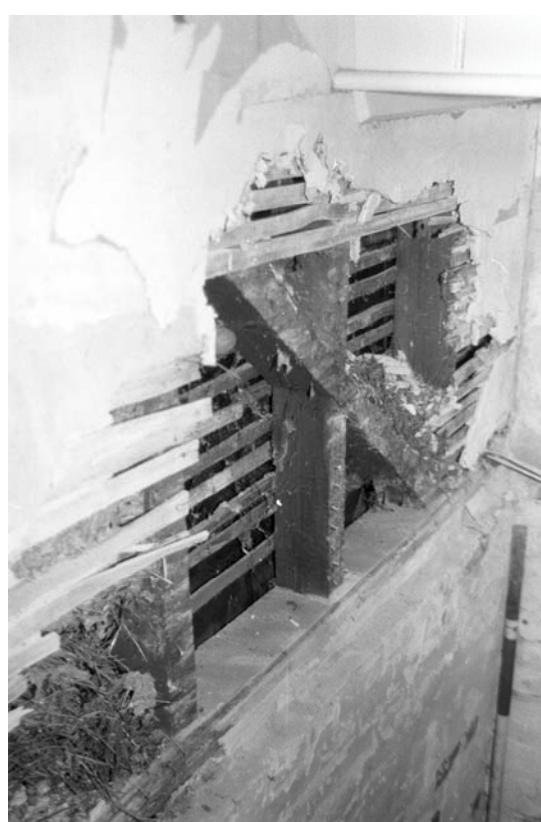
North wall: brick constructed wall with remnants of thin plaster coating applied directly to brickwork along with traces of limewash render. Clad with hardboard

Figure 15: Room GF06, upper storey studwork resting brickwork of Ground floor within stairwell

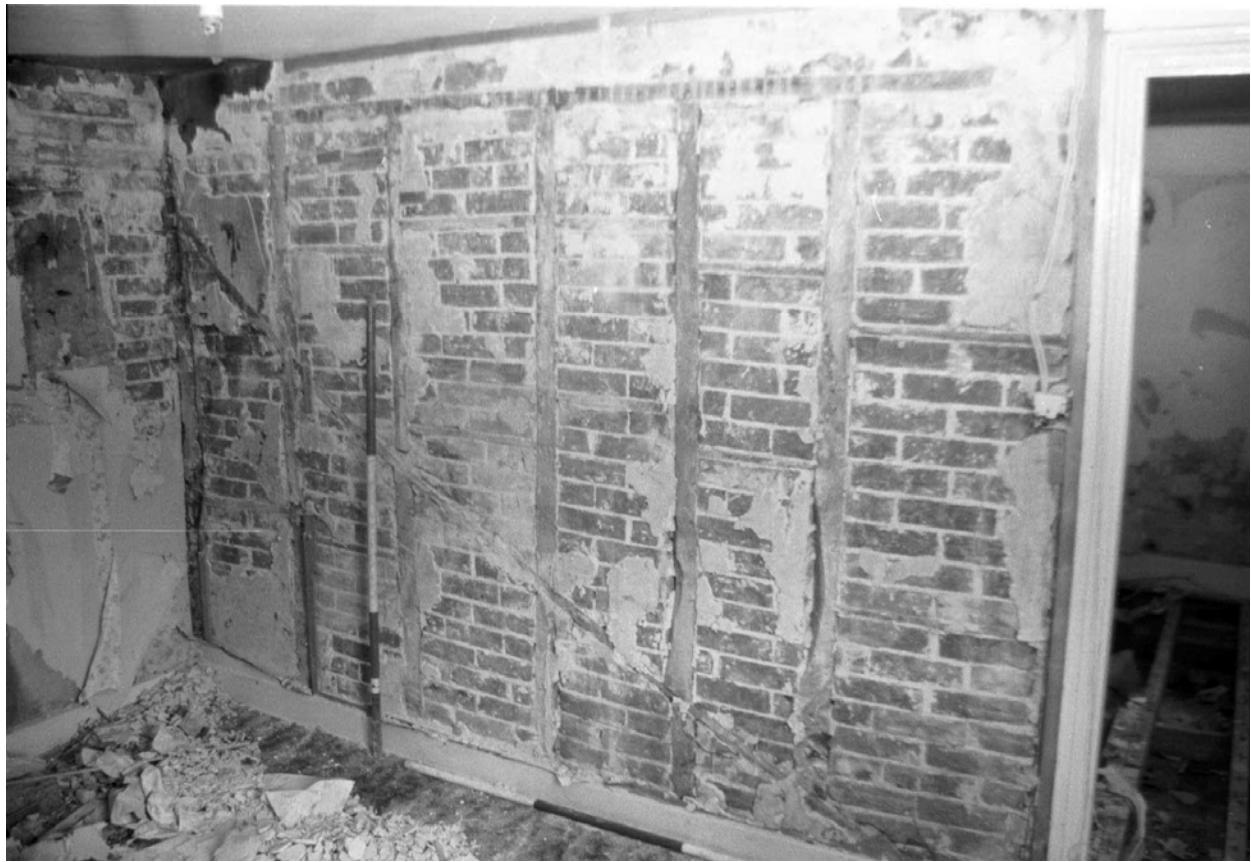
South wall: timber stud partition wall with horizontal and diagonal bracing and brick nogging infill (see Fig.16). The wall is not tied in to the main external walls except in its upper two courses. Doorway to the west gives access to room GF03 to the south (door removed).

Figure 16: Room GF02, south wall; detail of studwork construction with brick nogging infill

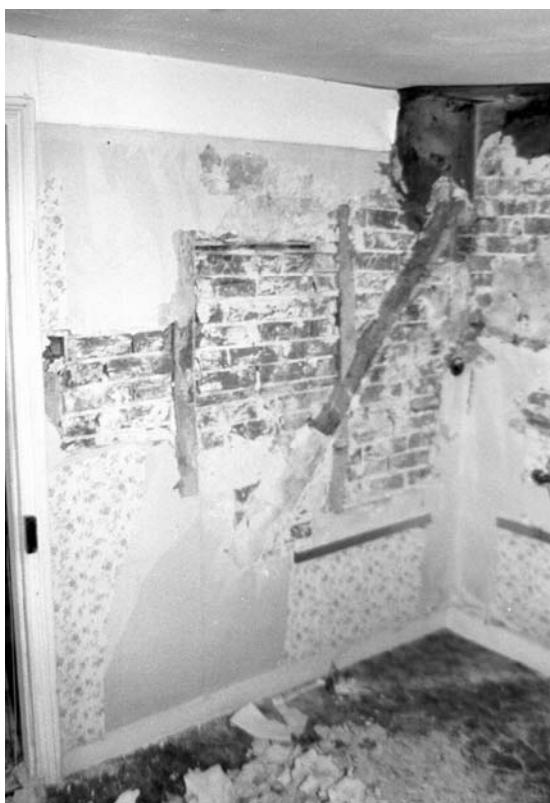
North wall: timber stud partition wall with horizontal and diagonal bracing and brick nogging infill (see Fig.17). In places, the stud work, and in particular the main diagonal strut, are not finished flush with the surface of the brickwork and here, re-used peg-tiles have been utilised to create a flush surface for rendering (see Fig.18). The wall is not tied in to the main external walls except in its upper two courses. Remnants of white and red lime-wash survive. Doorway gives access to GF01 to the north.

Figure 17: Room GF02 north wall (east)

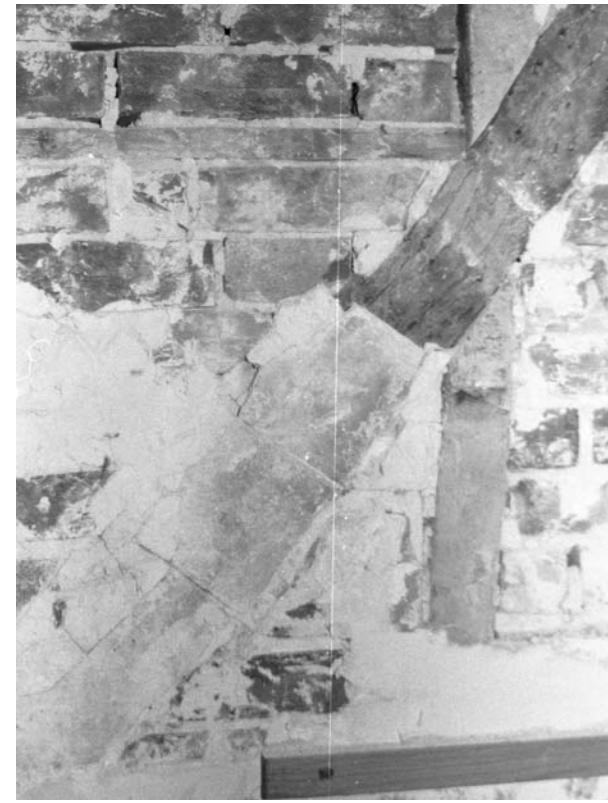
Figure 18: Room GF02, north wall: detail of peg tiles used to level up wall surface prior to plastering

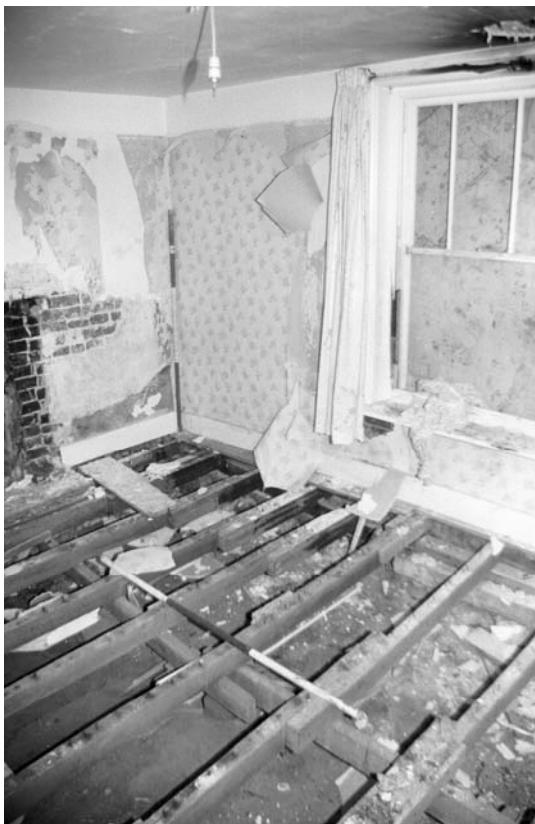
South wall: brick constructed wall with a buff lime-plaster applied directly to the brickwork. A centrally located vertical sash window with three pane panels may represent a secondary insertion, though the eastern jamb would appear primary (see Fig.19).

Figure 19: Room GF03 looking south-east

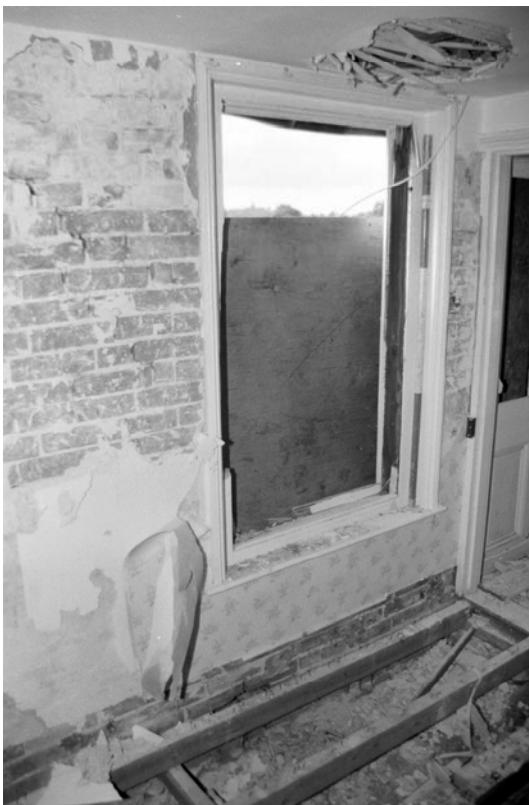
Figure 21: Room GF03 looking north-west

West wall: brick constructed wall in Flemish bond with a surface render of buff plaster applied directly to the brickwork. Offset to the north of the wall, the casing for a single light vertical sash window survives though the window itself was missing at the time of survey (see Fig.21). The opening would appear to be primary, though the upper four courses of brick were again noted to be a rebuild (see Fig.22).

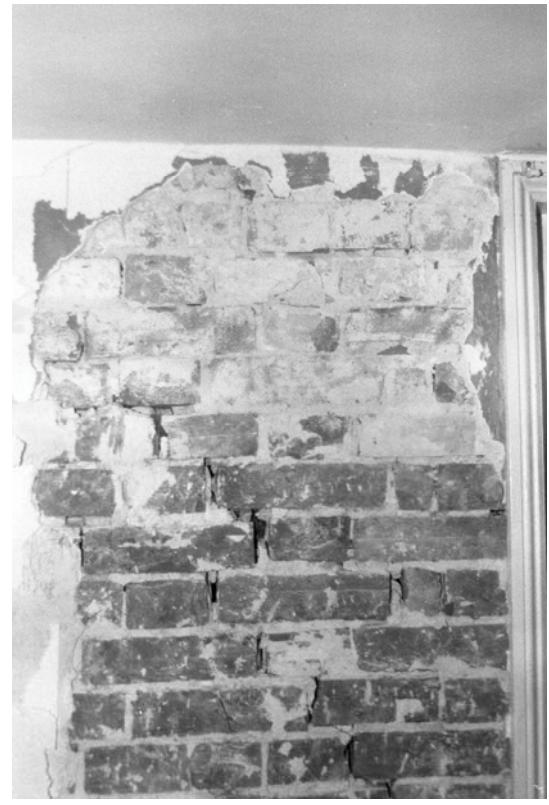
Figure 22: Room GF03: detail of rebuild of upper wall to south of west window

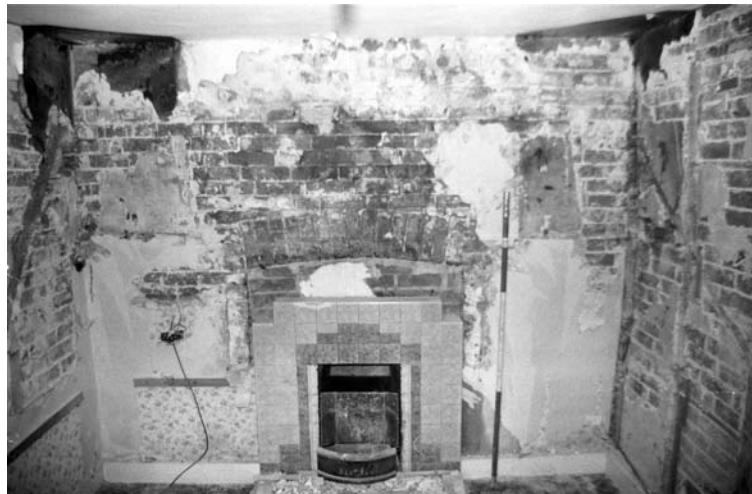
East wall: brick constructed wall in Flemish bond within a soft, buff lime-mortar. Coated with lime plaster similar to bonding mortar. Stripping of plaster revealed that the upper four courses of the wall had been rebuilt (see Fig.23-24), as noted elsewhere, and probably represent an adaptation contemporary with the addition of the upper storey. A centrally located fireplace with shallow segmented arch (height to springing 1.13m, centre +0.45m) appears to be primary to the construction of the wall. The primary fireplace has been partly blocked and a tiled fireplace of 1950s design inserted (see Fig.23).

Figure 23: GF02, east wall, note area of rebuild to upper wall

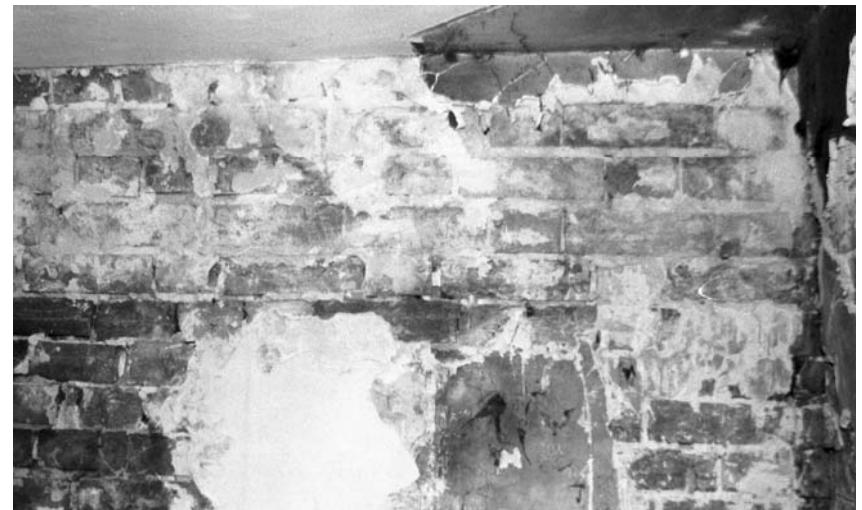
Figure 24: Room GF02 detail of rebuild of upper 4-5 courses of brickwork in west wall

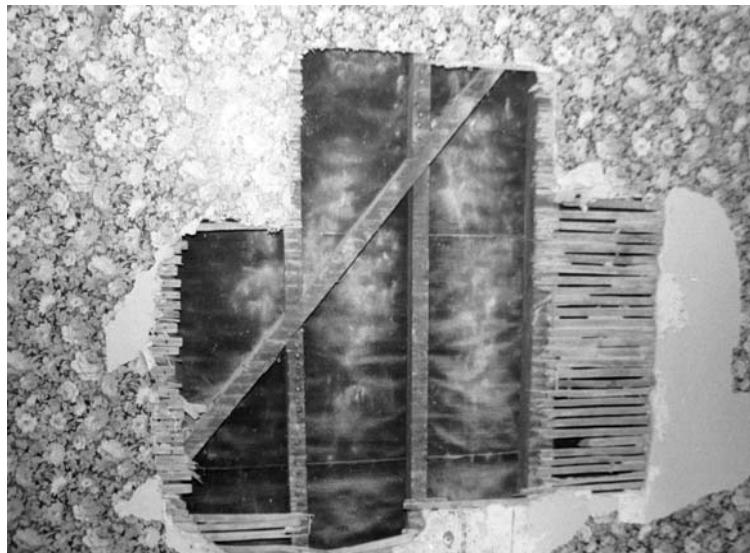
South wall: Timber stud wall (0.05m x 0.10m studs @ 0.37m centres) with diagonal bracing with applied lath and plaster (see Fig.25). Studs rest upon a horizontal plate which sits on the brickwork of the ground floor wall. No architectural features.

Figure 25: Room FF01, south: detail of first floor wall construction

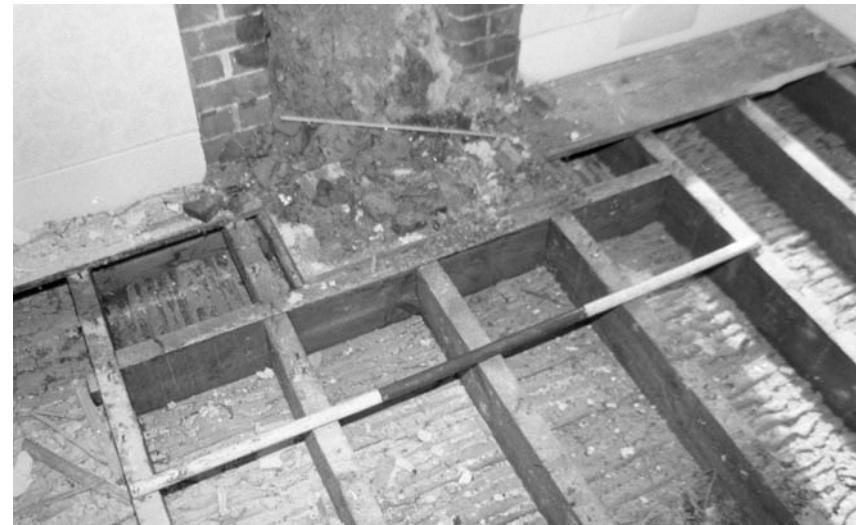
Floor: A total of eight east-west aligned softwood joists (0.05m x 0.18m scantling @ 0.36m centres). No boards surviving at time of survey (see Fig.26).

Figure 26: Room FF02, detail of first floor construction plus fireplace trimmer
