Hainton Estate

Assessment of Traditional Farm Buildings

Appendix – Individual Farmstead Summaries

17/12/2014

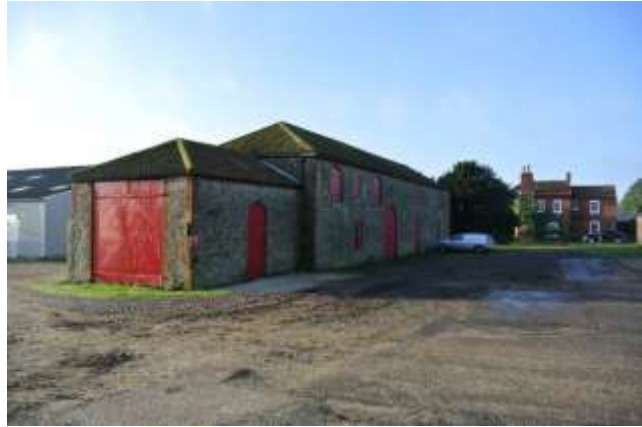
Surviving threshing barn

Traditional materials: The barn is built of stone rubble with red brick dressings to openings and quoins. The farmhouse and later 19th century buildings are built entirely of brick in English Garden Wall Bond. The wood mill and store are timber framed and clad. The majority of roofs are in pantile with the exception of the later U shaped range which is of Welsh slate. The min threshing barn has been re-roofed in corrugated asbestos.

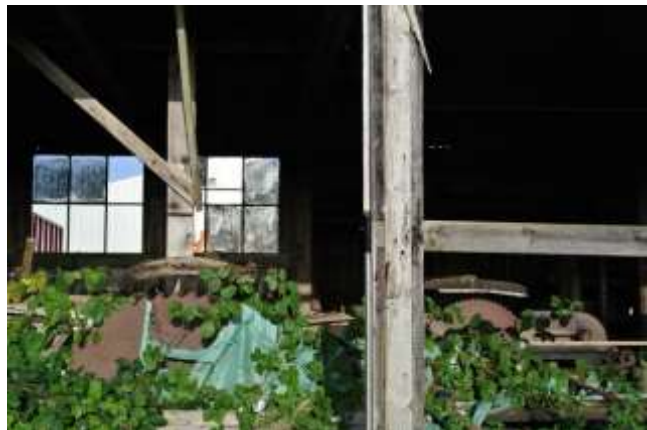
Survival as a group: Historic buildings are well maintained with exception of derelict timber-framed woodworking shop and wood-store to south east which are in poor condition. Despite the loss of the courtyard of farm buildings attached to the barn (2), traditional buildings at Home Farm survive as an observable group, continuing to serve as a hub for management of the Hainton Hall estate.

Saw mill and workshop

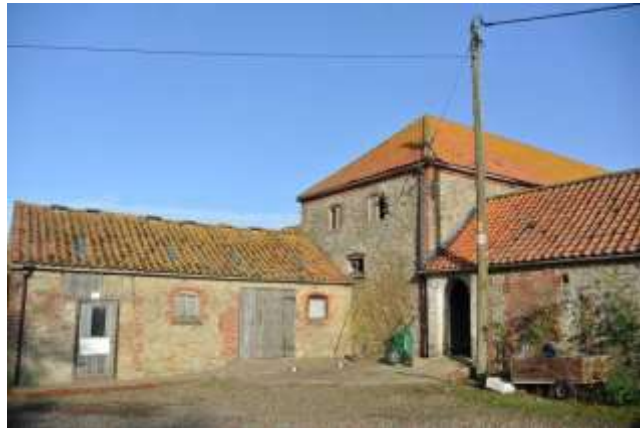
Two storey Threshing barn with attached ranged viewed from domestic yard

Survival as a group: Many traditional features remain in a fair state of repair, however there are small areas of partial demolition and structural weakness. Nonetheless, Horse Pasture Farm survives as an intact group of traditional buildings that reflect a profitable adaptation of earlier forms of mixed farming to a more advanced and intensive regime developed as part of the Agricultural Revolution.

Recent investment has secured a long-term future for the water tower however a number of other traditional buildings have marginal uses or lie vacant. With parts of the farm already deteriorating, emphasis falls on securing sustainable uses for surviving traditional buildings, particularly those not directly serving the farmhouse, either through conversion or adaptation.

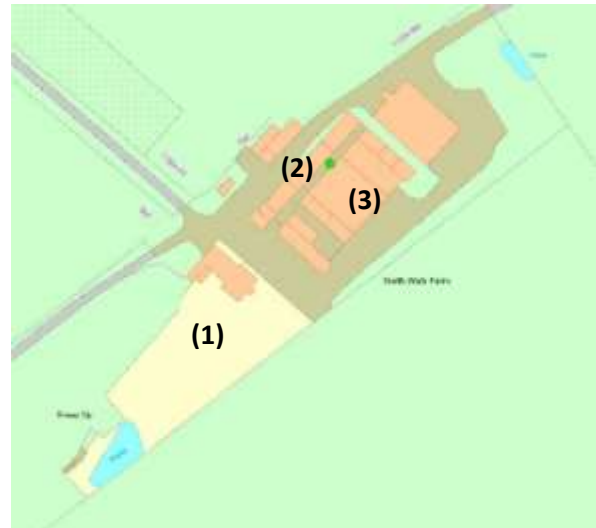
Description: An early 19th century farmstead with house, threshing barn and stable/ancillary range. Substantially expanded mid-late 19th century to incorporate three crew yards and granary/cartshed extension. Yards covered mid-20th century and modern unit added to north east.

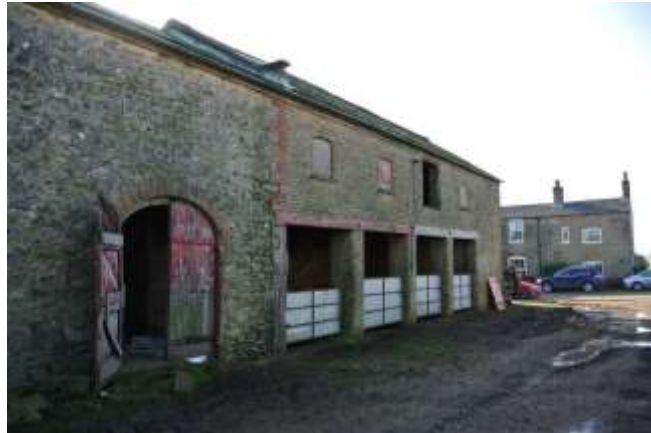
Barn with attached cartshed/granary

Survival as a group: Many buildings appear to be in fair condition, although there is demolition and structural decay in other areas, and many spaces are used for dumping and/or stockpiling of waste/firewood. Despite deterioration of crew yard ranges attached to the barn (2), the buildings at North Walk Farm remain as a largely intact traditional farmstead group.

Many of the traditional buildings have marginal uses, are derelict or lie vacant. With parts of the farm already deteriorating, emphasis falls on securing sustainable uses for surviving traditional buildings, particularly those not directly serving the farmhouse, either through conversion, adaptation or redevelopment.

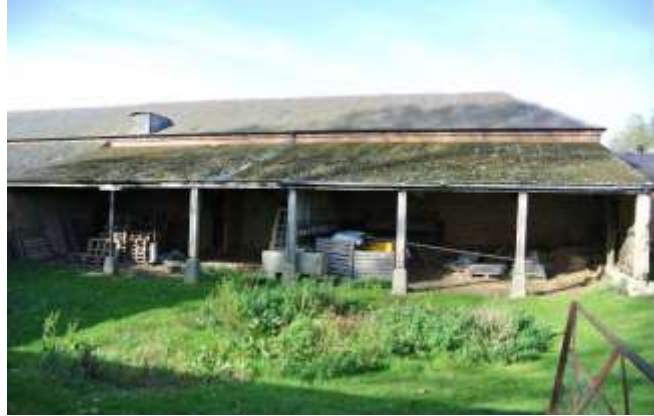
Shelter sheds facing crew yard

Survival as a group: Traditional buildings are in a good state of repair and the farm survives largely in its original form with few extensions or additions.

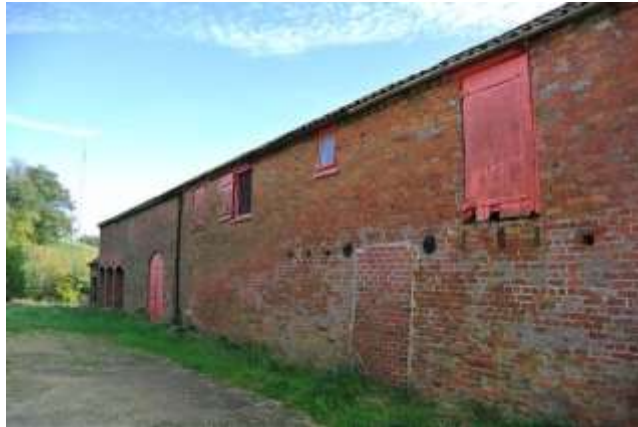
Long threshing barn range with cartshed

Survival as a group: Traditional buildings are in a good state of repair and the farm survives largely in its original form with few non-traditional extensions or additions.

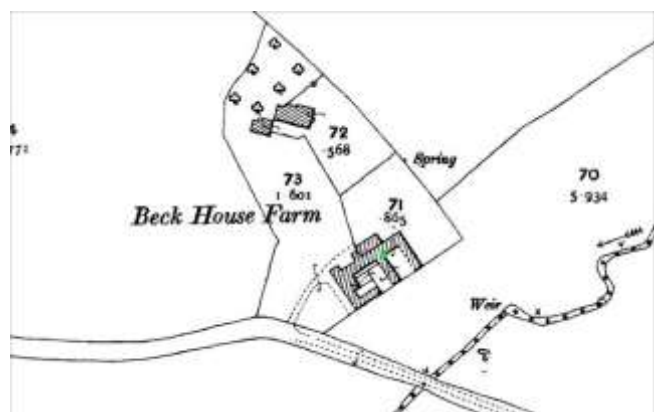
2nd Edition Ordnance Survey Map

Beck House is a mid-19th century E-plan farmstead which appears to have been rebuilt and subsequently extended in a complex series of stages from an earlier 19th or 18th stone built barn range. The same phasing, observable in the materials used, shows the major extension of the detached farmhouse (1) which lies some distance to the north. The site is dominated by a long range consisting of a barn flanked by two single

storey stone rubble ranges (2). Two crew yards (3), defined by 3 ranges with stabling and shelter sheds, face southeast. The westernmost range is two storeys in height with cartshed facing onto the main entrance track and a return leg to the crew yard with pigsty and stabling. Additional lean-to shelter sheds within crew yards relate to a further phase of development, as do the post-war and modern sheds in the north.

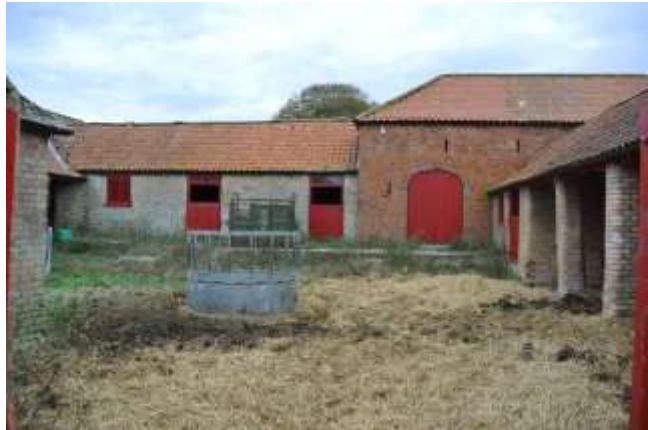
Western of two crew yards

Survival as a group: Working buildings appear to be in good to fair condition, with few structural issues. The farmhouse is derelict and assessed as beyond repair.

The farmhouse is derelict and in need of demolition. Working buildings are in good condition and many continue to be used for agricultural purposes. As such the existing situation might only be improved by securing longer term and less marginal uses for some working buildings.

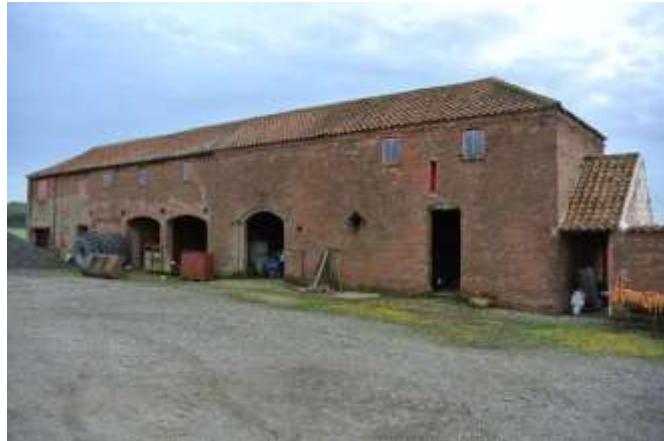
Main barn with integrated cart shed range

Survival as a group: Traditional buildings are in fair to poor condition, with some structural issues and widespread demolition or deterioration. Despite this the working layout of the E plan farm survives in plan.

The farmhouse is an active farm where many traditional buildings have fallen into disuse and are quickly deteriorating or derelict. Many are beyond economic repair.

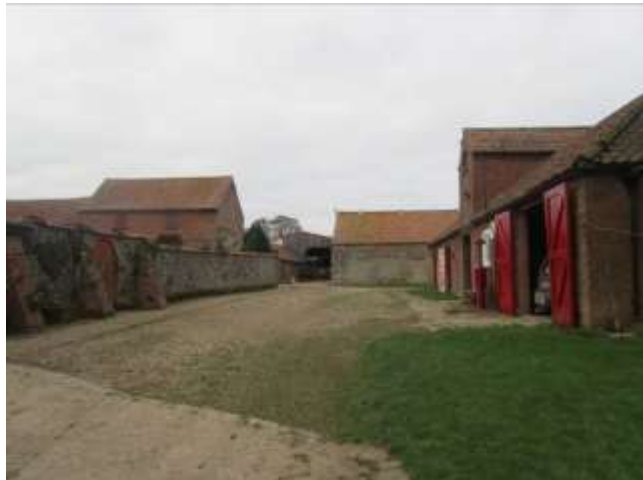
Stable and cartshed range alongside main farmhouse

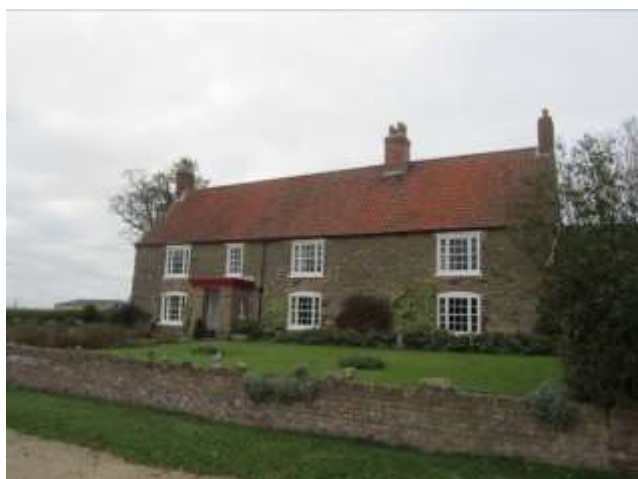
Mill Platt Farm House

built in brick laid in English Garden Wall Bond, with the earlier western cartshed frontage (with stone rear) in a notably redder and narrower brick. Roofs are in pantile with the exception of the main house which is concrete tile.

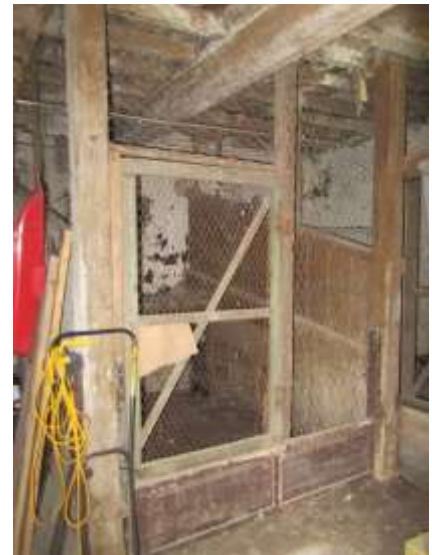
Survival as a group: Working buildings appear to be in fair to poor condition with few structural issues. The farmhouse is in good to fair condition.

Internal stabling fixtures and fittings

The house is an attractive residential let with useful storage in outbuildings. A number of structural issues require attention in order to safeguard the building, and future development is likely to require the removal of internal fittings associated with stabling.

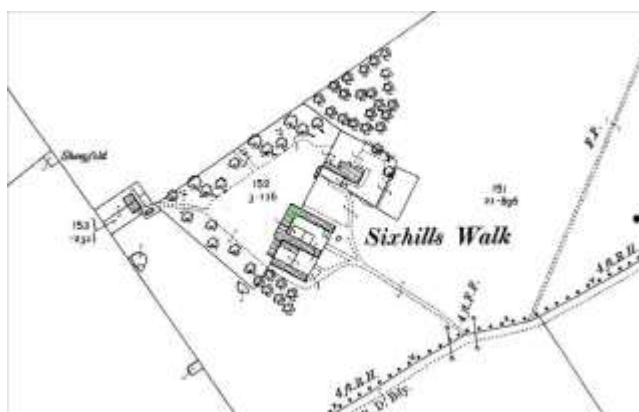
2nd Edition Ordnance Survey Map

E-plan farmstead with large crew yards (3) facing south east. The rear of the yards are defined by a large range including barn and attached cartshed (2) facing northwest with granary above. Long single storey ranges with shelter sheds and stabling facing into yards run to the south west. The southern of the two yards is enclosed with a mid-height wall and gate, whereas the northern yard, which is covered by a free standing roof. The northern most range, notable for its brick construction and central gabled bay, faces towards the house and provides domestic stabling, cartshed and tack room. Set within large mature gardens, the house (1) itself is located c.40m to the north and faces south, away from working buildings. The property is served by a short private driveway which joins with the lane provided access to working areas.

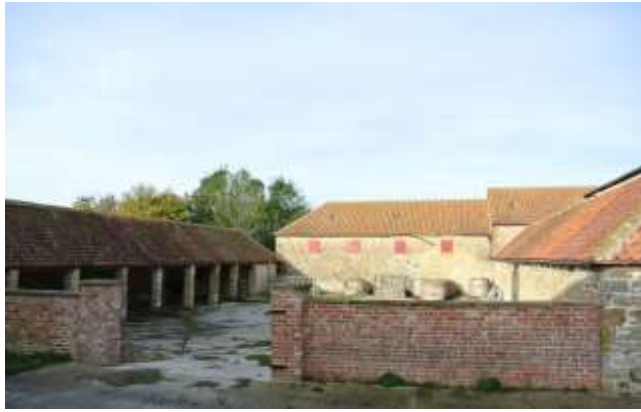
View over the western crew yard toward the cartshed/granary and barn range

Survival as a group: Traditional buildings are in a good state of repair and the farm survives largely in its 19th century form with few non-traditional extensions of additions other than the freestanding modern cover and shed.

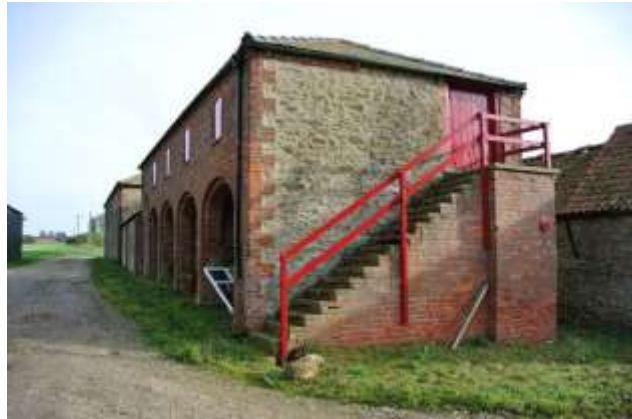
Main barn and cartshed/granary range

Survival as a group: Many buildings appear to be in good to fair condition, although there is some deterioration to internal parts. Despite the deterioration of some crew yard ranges attached to the barn (2), the buildings at North Walk Farm remain as a largely intact traditional farmstead group.

Many of the traditional buildings have marginal uses or lie vacant. With parts of the farm already deteriorating, emphasis falls on securing sustainable uses for surviving traditional buildings, particularly those not directly serving the farmhouse, either through conversion, adaptation or redevelopment.

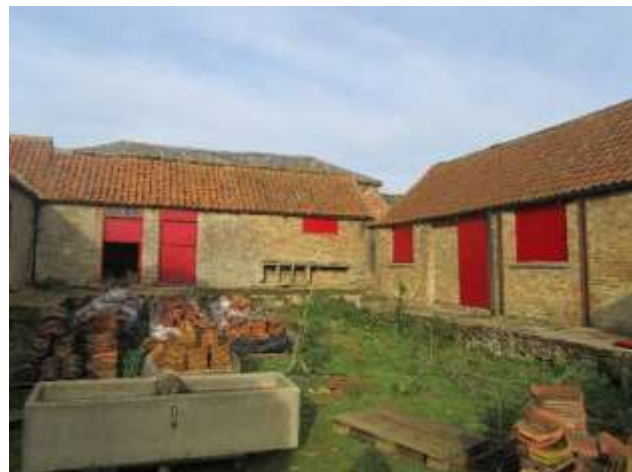
Western crew yard with pig trough to rear range

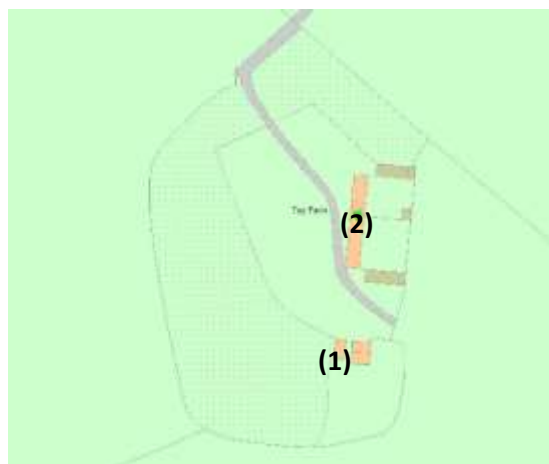
Grid Reference: TF 18270 86415

Description: An early 19th century outfarm with linear range of threshing barn, cartshed/granary and stable/shed set within a large grassed stacking yard surrounded by trees. Later expanded into an E plan farmstead with 3 detached ranges forming 2 crew yards, now derelict. Two workers' cottages, now joined, lie immediately to south.

Survival as a group: The main N/S linear range including the barn survive in good condition, whereas later ranges enclosing crew yards are beyond repair and heavily overgrown. Cottages appear well maintained.

The main range of buildings is in good condition but lacks any specific use. The remainder of working buildings are beyond repair. As such emphasis falls on rapidly securing sustainable uses for surviving traditional buildings either through conversion, adaptation or redevelopment, and the redevelopment of the former crew yards. The farm's dramatic and secluded setting is likely to be a key asset in this endeavour.

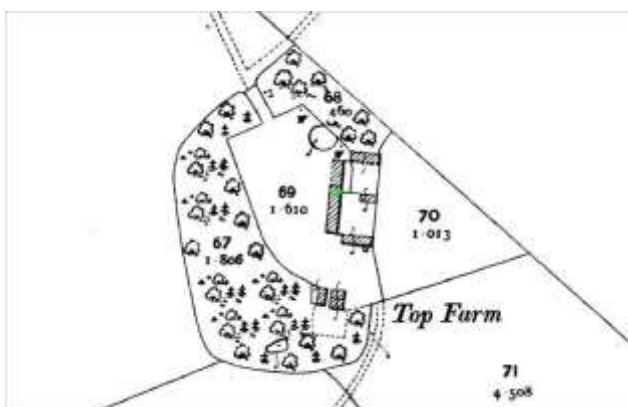
2nd Edition Ordnance Survey Map

Landscape setting: Top Farm is an isolated farm located c.1-2 km away from country roads to the east and west. The site includes a large grassed yard and is surrounded on three sides by a U shaped wood plantation which opens up the East allowing for spectacular long ranging views of the Lincolnshire Wolds and on to the Central Lincolnshire Vale. Located on the upper slopes of a low promontory between two small valleys, the farm is an understated feature of the landscape, observable only from the south and east. Top Farm lies within an expansive landscape of rectilinear fields relating to the private enclosure of land in the

18/19th centuries. The site is contained by mature trees and a low retaining wall along its eastern side. This creates a very intimate sense of place, emphasising the open views of countryside to the east and the limited access points into adjacent fields.

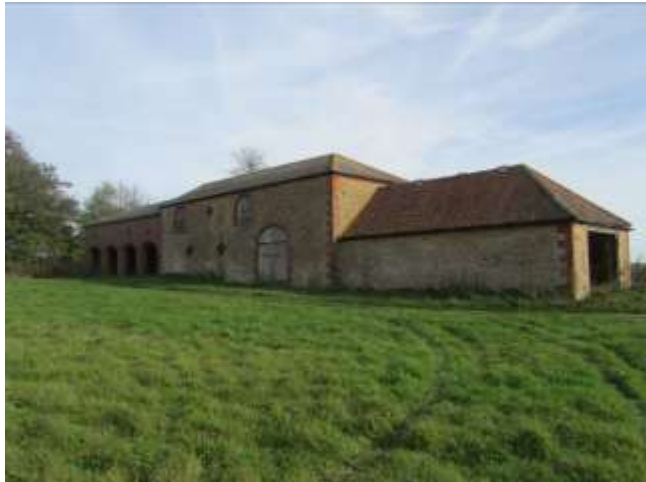
Main barn and cartshed/granary range

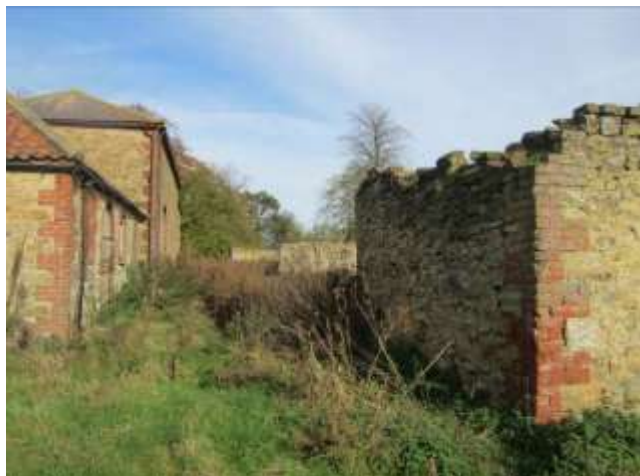
Track between main barn and cartshed/granary range and three parallel crew yards ranges

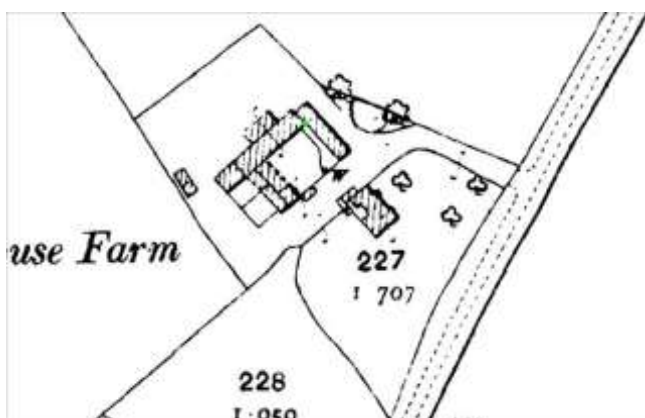
2nd Edition Ordnance Survey Map

Landscape setting: Mill House Farm is an isolated farm located c.50m west of the A157, an historic main road connecting Louth with Lincoln. Located on the edge of the Wolds, land falls away from east to west, affording far ranging westerly views across the Central Lincolnshire Vale to Lincoln Cathedral. Elsewhere there are shorter views over rising slopes towards Hainton Estate and over towards Rookery Farm. The farm is a conspicuous feature in the landscape, particularly from the adjacent main road. Mill House Farm lies within a landscape of rectilinear fields relating to the private enclosure of land in the 18/19th centuries. The site includes large grassed paddock in the south and yard in the northwest. The site partially bounded by post and wire fencing alongside

quickset hawthorn hedgerows along the road and mature plantation to the south, but is often open and unbounded. This puts emphasis on the crew yard walls and gates, and creates a close and immediate connection between tracks leading from them and shelter sheds leading out into the adjacent countryside.

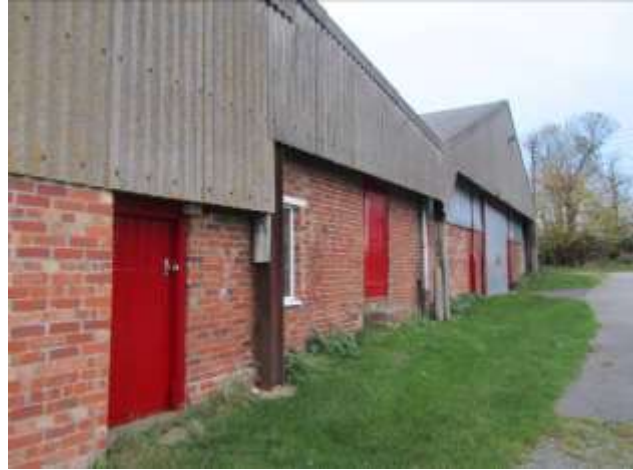
Covered frontages of crew yards facing southwest

Survival as a group: Traditional buildings to the rear of the yards are in a good state of repair, however the crew yard ranges are in poorer condition with areas of demolition. Nonetheless there are a wealth of internal fixtures and fittings that have been preserved by the addition of large sheds over the crew yards during the mid-20th century.

The farmhouse is an attractive residential let with good access onto the main road. Working buildings have marginal uses or are empty and, although protected from further damage, those beneath the modern sheds are falling into disrepair. The modern sheds enclosure large functional spaces, useful to larger machinery and plant, and therefore the desire to reinstate the crew yard ranges is likely to be low. Long term sustainable uses also need to be found for traditional buildings not covered by the sheds, to ensure their continued maintenance.

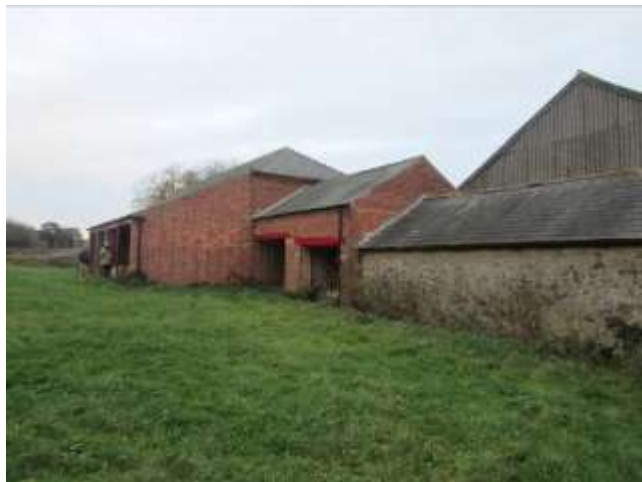
Range of buildings forming rear of the crew yard

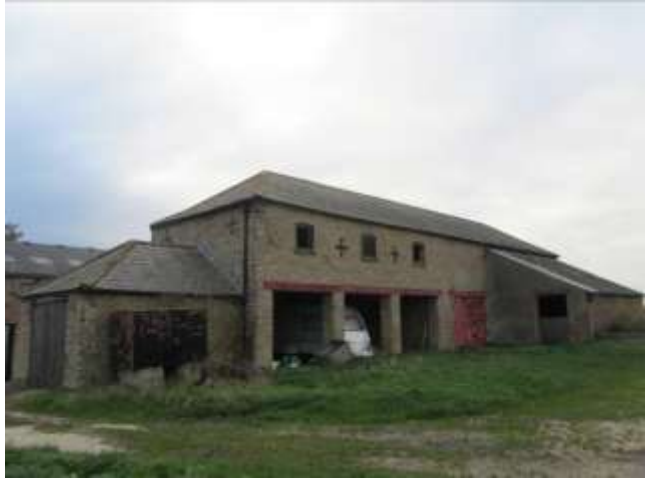
Main barn and cartshed/granary range

Survival as a group: Traditional buildings are in a poor state of repair, yet the original form of the farm remains apparent, with few significant extensions or additions other than the post-war shed.

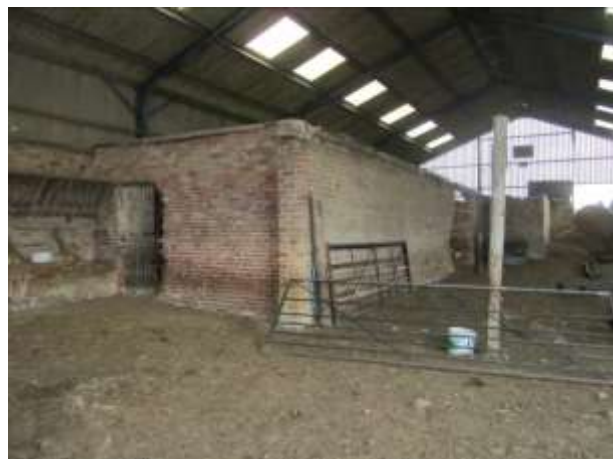
Covered crew yard with derelict range

The farm is in deteriorating condition, and many buildings within the crew yard are in poor condition. The farm has an attractive setting, and the main house alongside the workers' cottages

create a small residential group that might be usefully expanded by the residential conversion of traditional buildings. Without immediate investment many traditional buildings will fall beyond repair.
