Plymstock Lime Kiln
Pomphlett
Plymouth
Devon
Historic Building Recording

CA Project: 3738
CA Report: 12038

Project Name: Plymstock lime Kiln,
Location: Pomphlett, Plymouth, Devon
NGR: SX 54075 51300
Type: Historic Building Recording
Date: 2nd March 2012

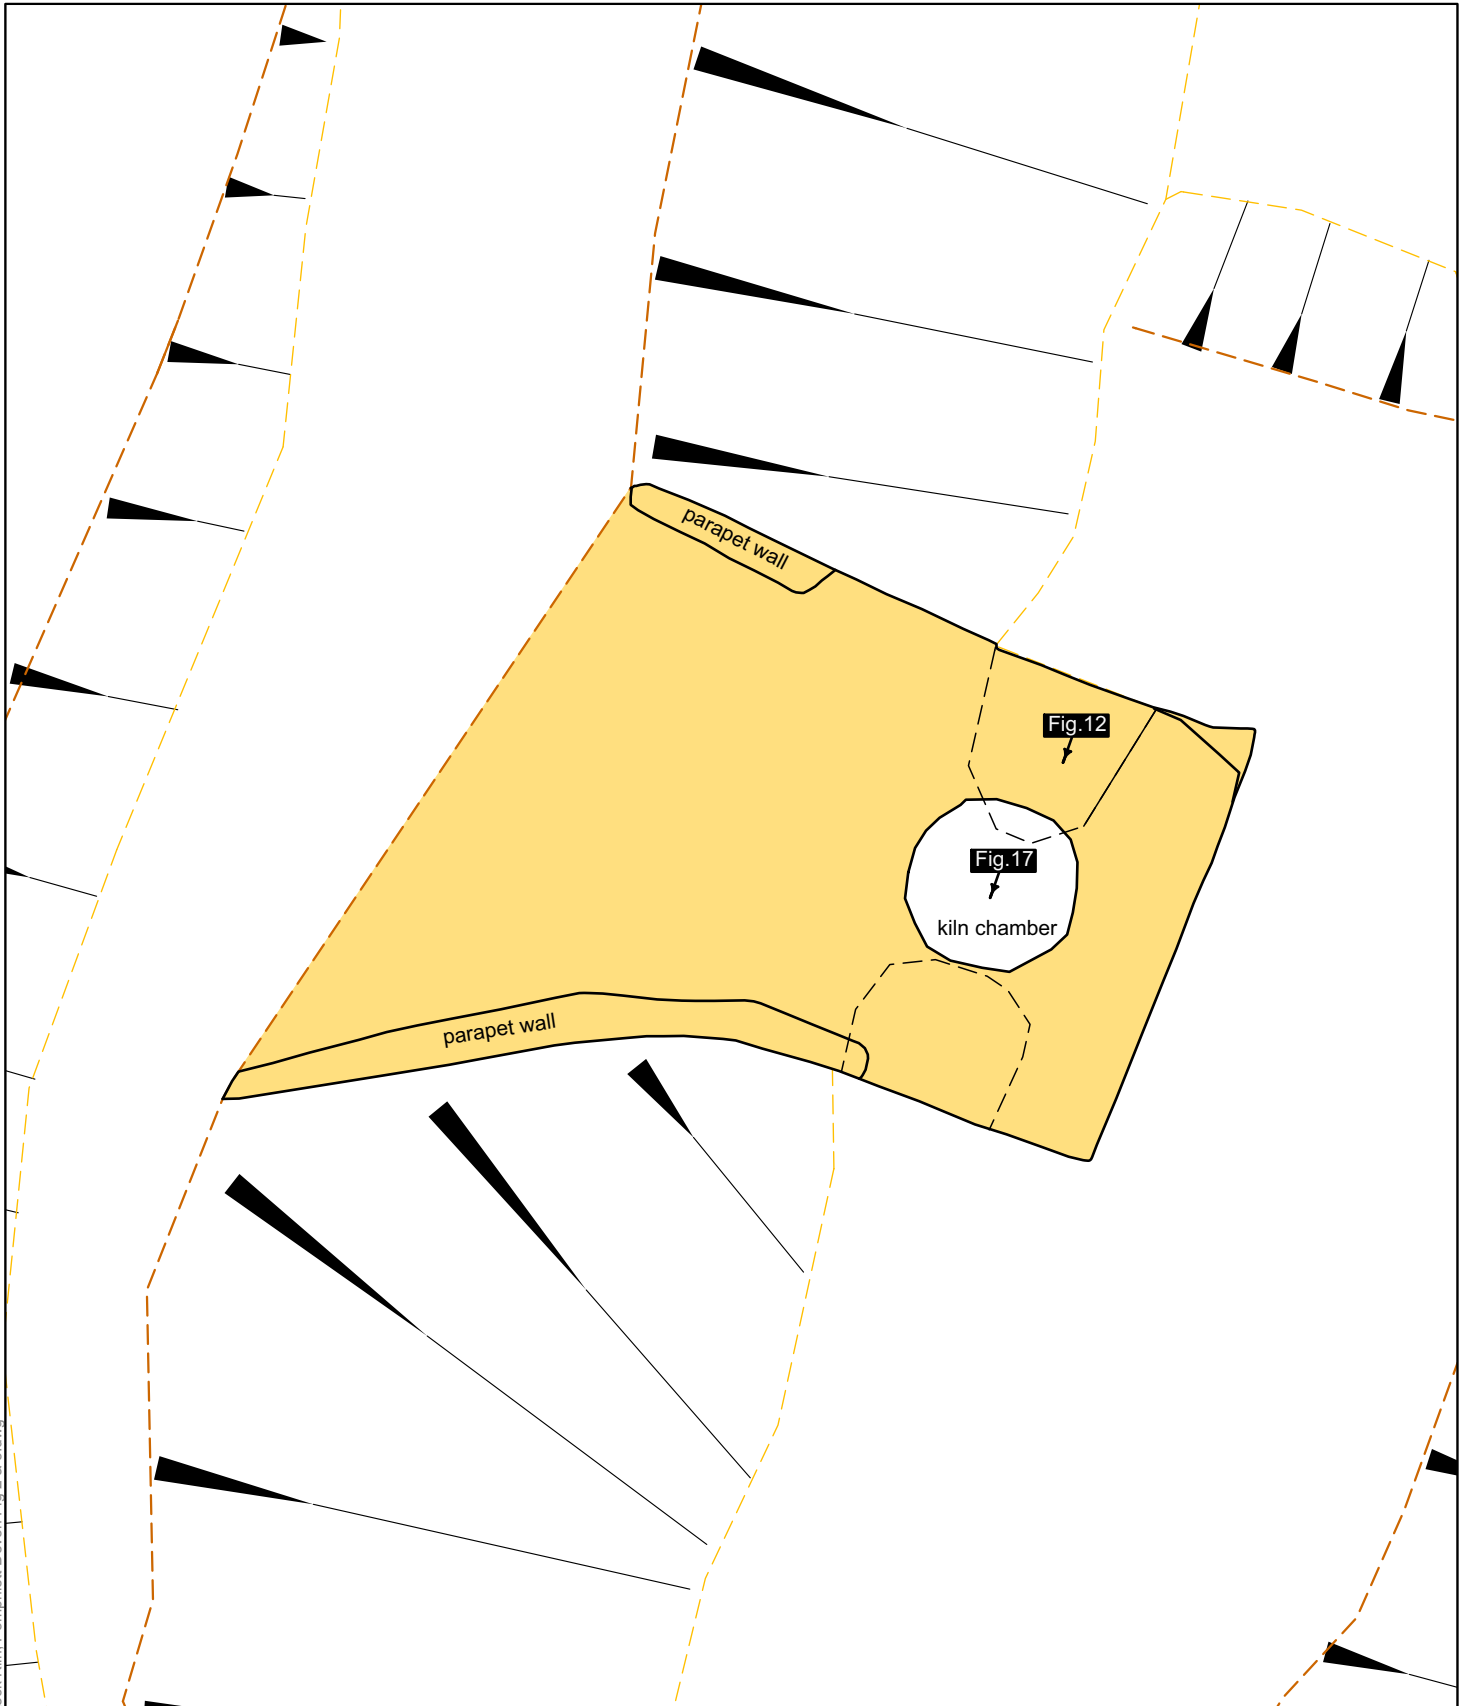
FIGURE TITLE
 Plan of the lime kiln

- 3.1 The kiln was a plain broadly rectangular-plan structure (although the east and west walls splayed somewhat to widen the entrance to the upper platform, Fig. 3) built of large, roughly-dressed Middle Devonian Carboniferous Limestone (the immediately local bedrock, RGS 1974), set in a hard, well-mixed lime mortar, pinkish pale-grey in colour with coarse sand aggregate (worn quartz and chert clasts typically 2-3mm but rarely up to 6-8mm). The stone was blue-grey with a reddish cast, possibly due to iron content and varied in shape from roughly-squared to triangular to irregular (Fig. 6). In size the blocks were up to 0.45m x 0.35m in the visible face. The lower parts of the corners were made of large, roughly-squared quoins (Fig. 6).

- 3.7 These were large covered openings to give access to the access holes at the base of the kiln. In plan the form was a square with a three-sided apse at the end (Fig. 3). The square bay was covered with a stone barrel vault with an almost flat crown. The two, angled, sides of the apse were covered in part by a partial semi-dome but this was cut across by the steeply-corbelled ceiling that extends out from the end wall over the firing hole (Fig. 12). This projected squarely from the end bay and rose to meet the flat section of the barrel vault roughly at the inner end of the square bay. On the sides it increases in width as it rises and merges into the rough semi-dome over the angled walls. The corbelling, the semi-domes and the barrel vault are all heavily sooted. The floor of the eastern recess was of clay with a covering of soot about 20mm thick.

approached on a gentle uphill path from the west (Fig. 15). Little could be seen at this level as the kiln was covered in grass and low vegetation, but it was clear that it was surrounded by a low wall, a parapet formed by the upward extension of the side walls (Figs 3 and 16). This was nowhere more than 0.3m high. In the middle of the south end was the open mouth of the circular kiln chamber. It was lined in fire brick (Fig. 17), of a rather odd size, 8¼x 4¼" x 3⅞" (209mm x 108mm x 79mm). They had a vertical-sided, round-ended, shallow frog with PHIL... impressed. They were laid header fashion, on their sides, as soldiers, and stretcher-wise. The chamber was half-filled with soil, the rear axle of an ancient van or trailer, plus vegetation, and tips of material. The curving plan seems to have been to ease the approach from the track from the west, which otherwise would require a sharp, right-angled turn, presumably in reverse, as the cart approached the kiln mouth.

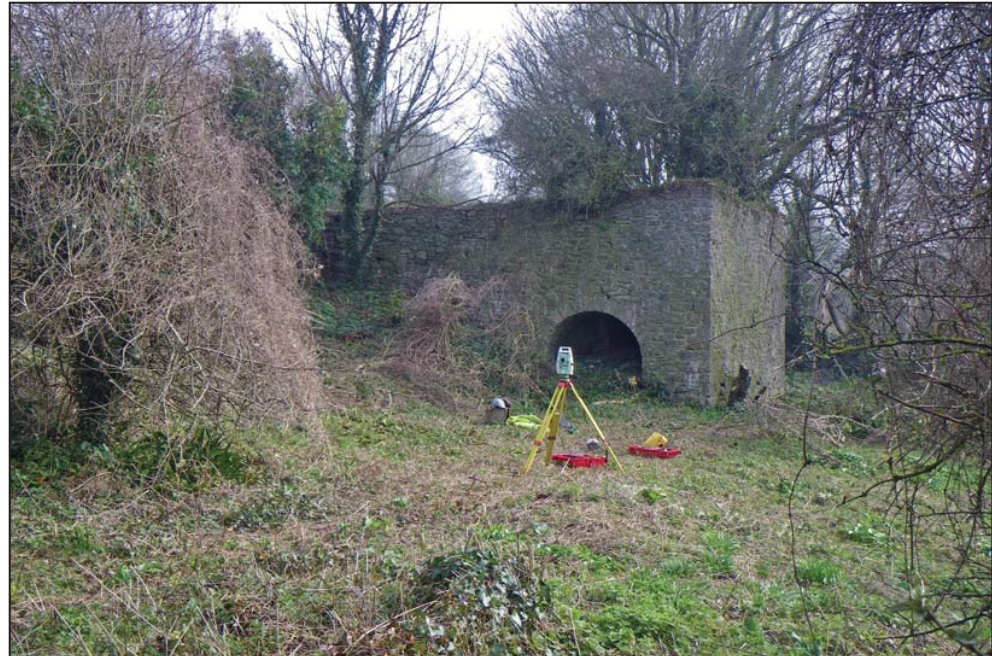
- 3.3 On this face the southern end was well-pointed but the northern end joints were more open (Fig. 4). In addition the mortar at that end, while otherwise similar, was coarser, with larger aggregate. This may have been a weathering effect, or differential maintenance, but there is a possibility that this part has been rebuilt. The upper one metre or so of this north end was laid in slightly smaller stones (but still c. 0.3m x 0.2m). Above the level of squared quoins, there was a triangular area of stones set in a paler mortar. This could be seen to be a rebuild or repair (Fig. 9).

- 4 The kiln from the west under survey
- 5 The kiln from the east
- 6 The west elevation of the kiln (scales 1m)
- 7 The arched recess in the western elevation (scales 1m)

- 3.2 The south face was plain walling but the east and west each had an arched recess, leading to firing holes (Figs 4 and 5). The recesses were arched with large stone

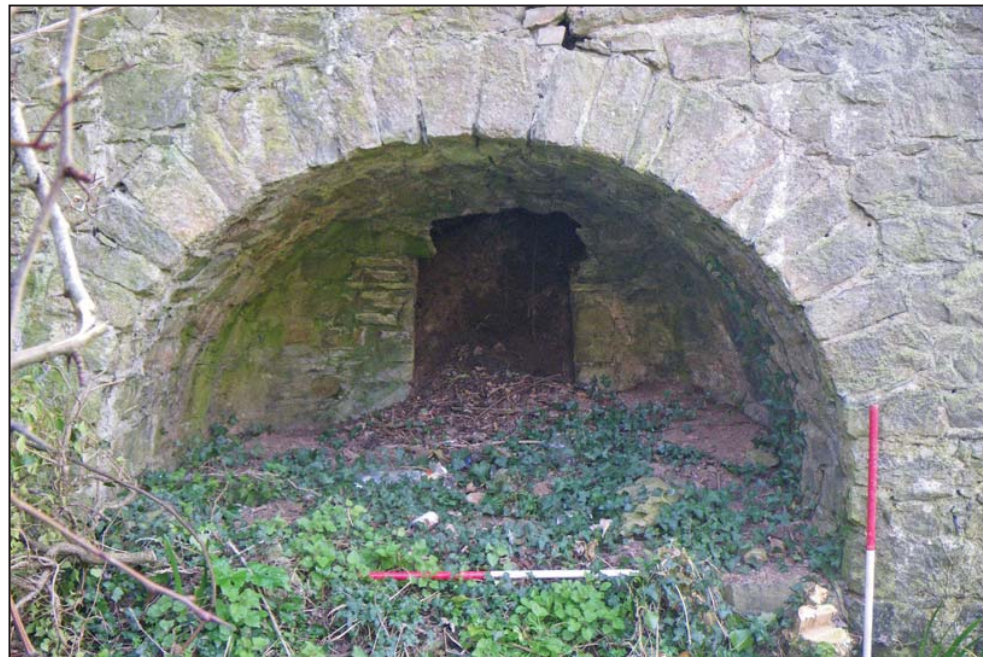
7

voussoirs. Thin schist slabs were used as packing/spacers between the voussoirs as they varied in width considerably (Fig. 7). The arch over the east recess was noticeably less well made than the western one, with a straight section of what should have been an arc and some non-radial voussoirs (Fig. 8).

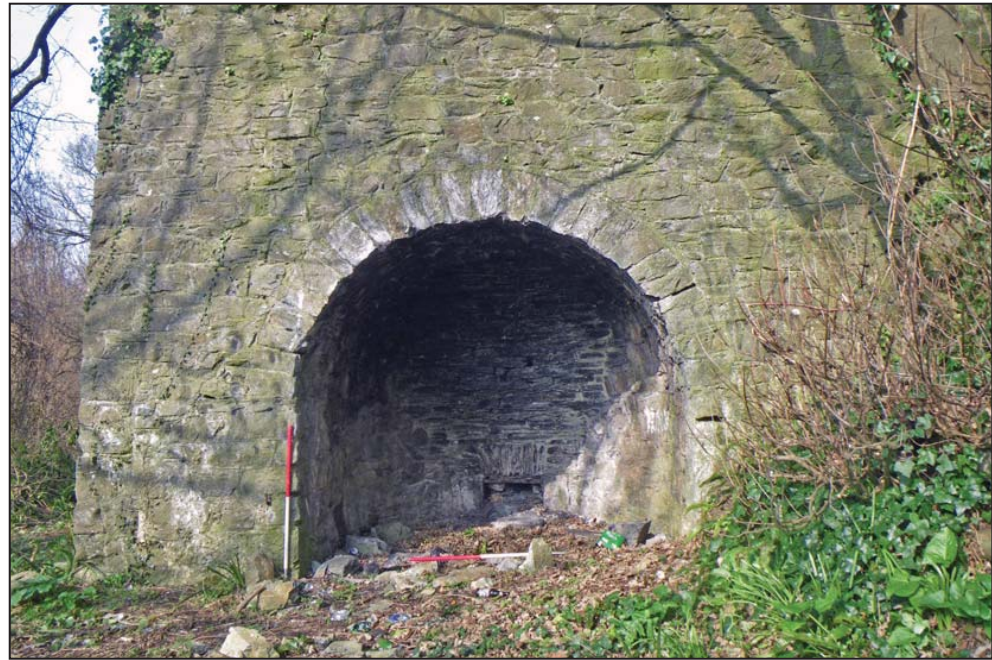
- 8 The arched recess in the eastern elevation (scales 1m)
- 9 The west elevation south corner, showing rebuilt upper section
- 10 The south elevation of the kiln
- 11 East elevation of the kiln, to the north-west (scales 1m)

- 3.10 On the east, the arrangements were intact. The firing hole had square limestone jambs with a flat-arched lintel of schist, supported by an iron bar. The corbelled ceiling rose from this lintel. The external arch on this side was less well-formed, with straight sections and at least one non-radial voussoir. There was evidence for two iron pintle-hinge hangers on the southern jamb of the arch, but only on the straight section of jamb below the arch. Nothing could be seen on the north side nor on the western recess. A large wrought-iron, double-sided strap hinge for such a pivot was found *ex situ*, west of the kiln, the timber door or gate having rotted out. The two sides were held together by bolts. The pintle loop was very worn (Fig. 14).

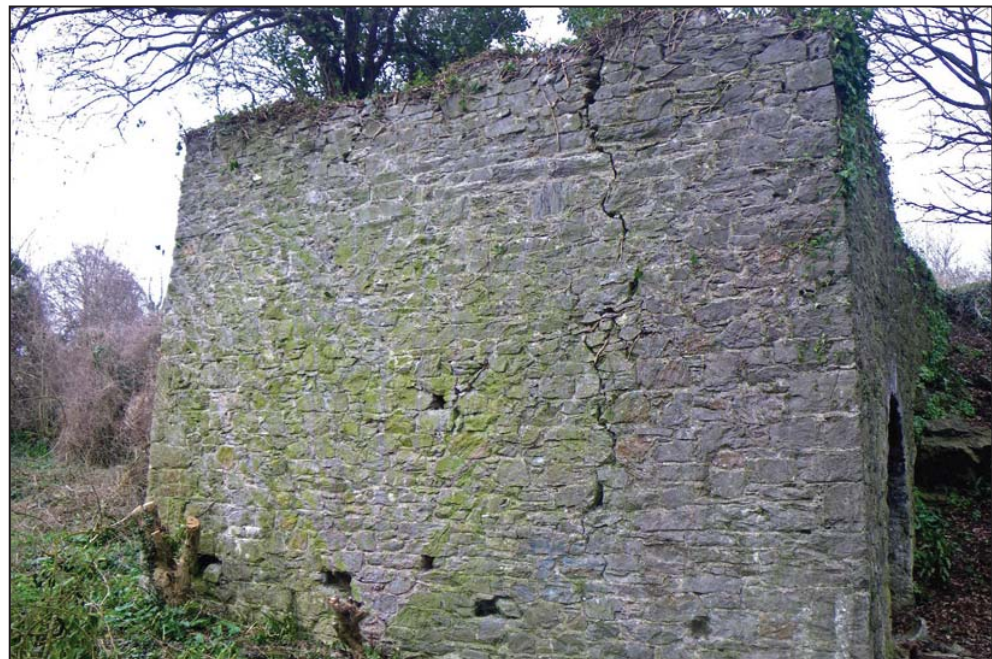
10

- 3.4 The stones here had a less red cast, but this was still noticeable. It may be that the colour had been affected by the recently removed ivy. Some schist packing was visible in the low west end of the elevation, but was not present anywhere else on this face. There are two putlog holes one above the other in the centre in lower half of the face (Fig. 10). Other holes in this face appear to be merely missing stone holes.

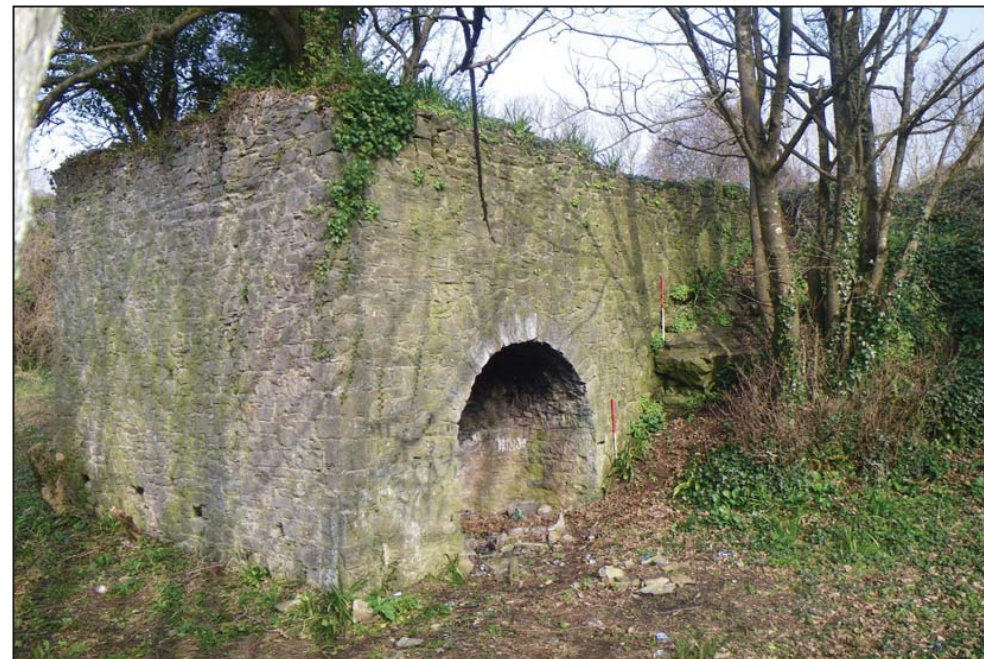
11

- 3.6 The original large quoins survived on the south-east corner so that no evidence of rebuild or repair was visible on this face, which was otherwise similar to the others (Fig. 11). The mortar, however, may have been repointed as it is here struck, rather roughly but pretty clearly. The actual mortar was the same as elsewhere.

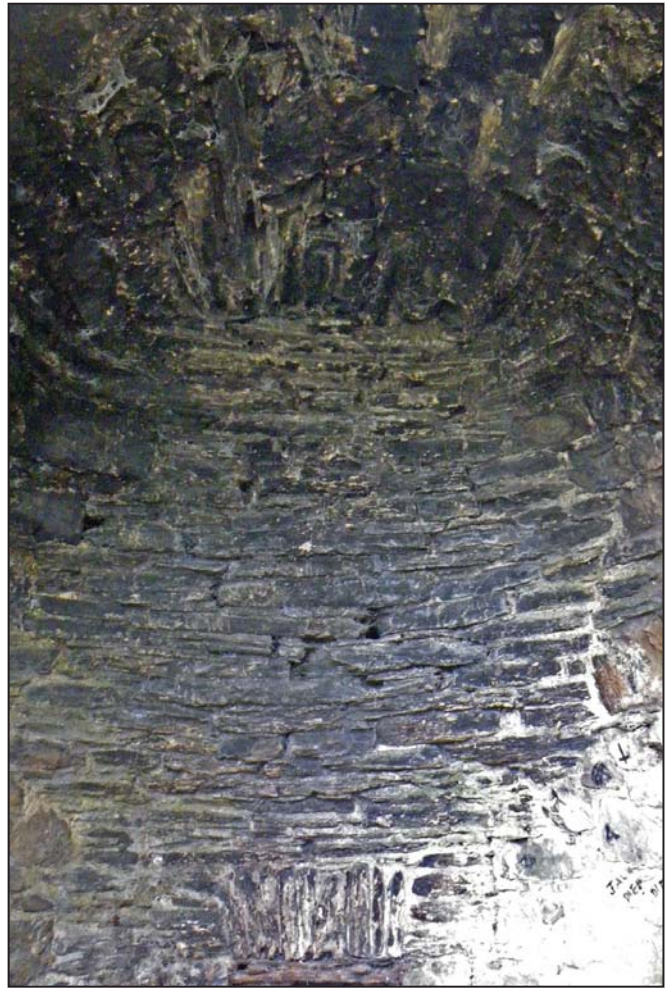
- 12 The eastern recess barrel vault meeting semi-dome meeting corbelling
- 13 The inner end of the western recess, the lintel collapsed and the debris in the kiln chamber visible beyond (scales 1m)
- 14 The strap hinge and eastern recess pintle (scales 1m)
- 15 The approach track from the upper platform, running right foreground to centre left, looking north-west

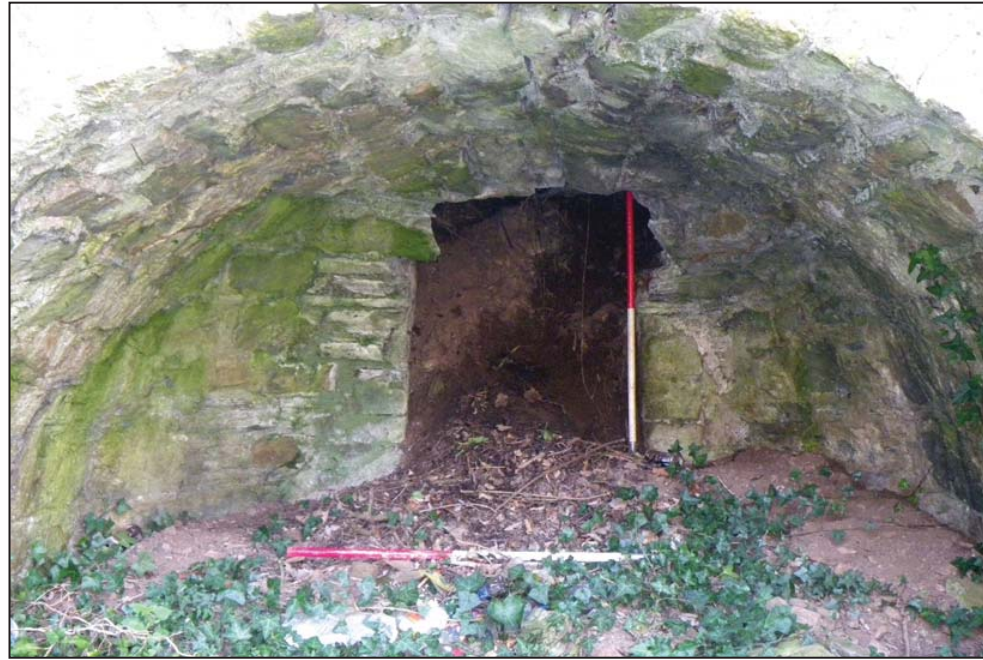
13

- 3.8 The lintel of the firing hole in the west recess was missing (Fig. 13) and there it is just possible to see, through a small gap, into the kiln cylinder (mostly choked with debris). The brick lining could be best seen here. There was no obvious system in the coursing, although its orientation (headers, soldiers, stretchers) seemed to be arranged approximately to vary every three or four courses. It was one brick length thick.

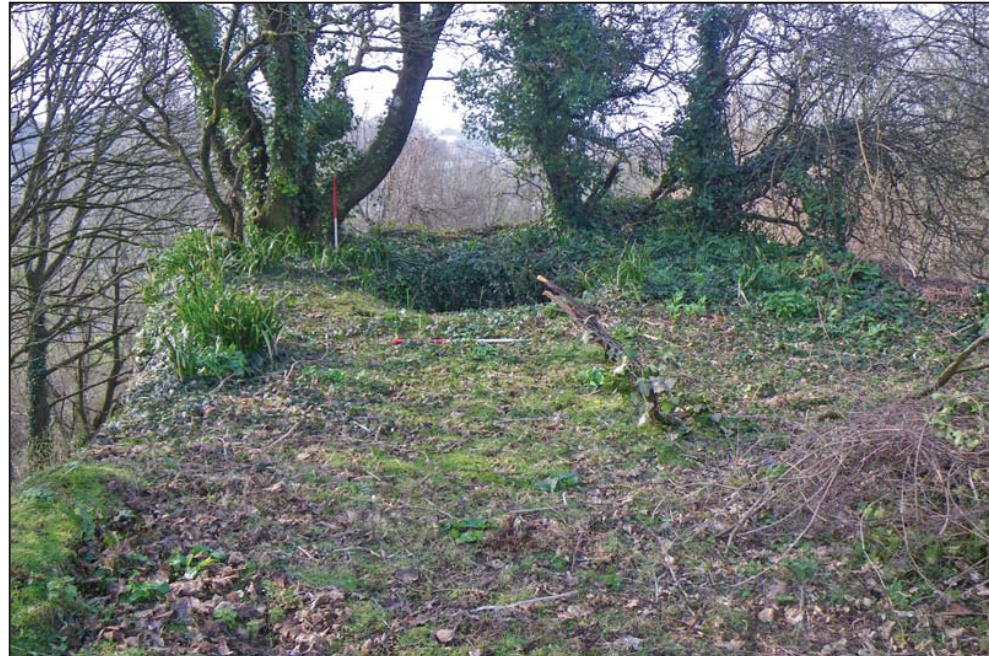
- 16 The upper platform looking south, kiln mouth centre (scales 1m)
- 17 The brick lining of the kiln chamber, western side
- 18 The 1894 Ordnance Survey 1:2,500 map of Plymouth
- 19 The track west of the kiln leading down to the site of Pomphlett Farm, looking west

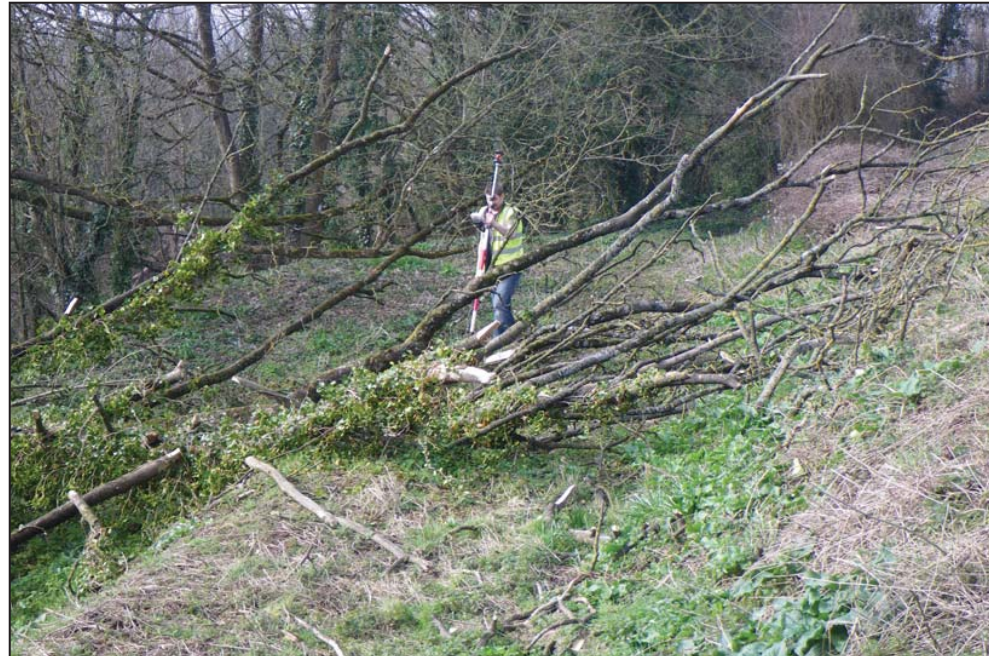
- 3.13 A branch from this track led to the base of the kiln and the floor of the quarry and another branch went even further downslope and bypassed the quarry and continued some distance to the east (Figs 3 and 20). These details do not appear on the 1:2,500 OS maps of 1894 to 1933 and later. Just east of the kiln was a north-south step in the quarry floor with indications of a fence along it, including a metal gatepost. Beyond this was a flat and level area partly enclosed by the quarry face and partly by a low, dry-stone wall on the east (Figs 3 and 21). These presumably represented the working areas of the kiln production process, perhaps with stores, workshops and offices, no clear sign of which otherwise was visible.

- 20 The branching of the three tracks just west of the kiln looking west
- 21 The levelled enclosed area at the east of the old quarry looking east, wall under vegetation to right
- 22 1907 Ordnance Survey 1:2,500 map of Plymouth
