Archaeological Assessment of Wood End Farm, Walsall, 2004

Project No. 1184

Archaeological Assessment of Wood End Farm, 265 Sutton Road, Walsall

BCSMR 2647 and 10269

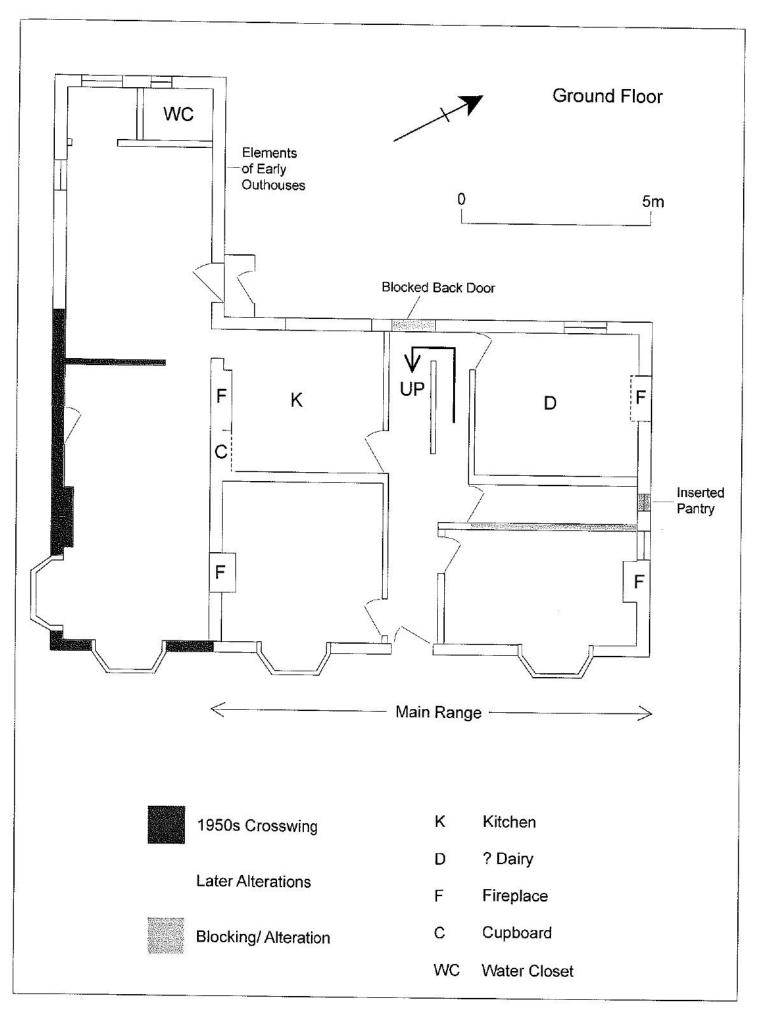
Fig.12

The farmhouse consists of a three-bay wide, two storey, double-pile plan main range aligned parallel to, but set back from, the modern line of the Sutton Road. The building has been much altered externally with the addition of a later cross-wing to the south-west gable of the main range that incorporates elements of earlier outhouses tacked onto the back of the main farmhouse, together with the insertion of later-Victorian style sash windows and modern bays to the front elevation (Fig. 12).

Internally, the plan of the main range is based upon a conventional double-pile design consisting of two pairs of rooms arranged front and back on either side of a central staircase and hall and front and back doors. Each main corner room is heated at ground and first-floor level, although a pantry has been inserted at ground-floor level and the upstairs plan has been much altered to provide access to the first floor of the later cross range. Downstairs the front rooms probably consisted of a parlour and sitting room with a kitchen, that still retains a row of hooks for hanging meat, and, possibly, a dairy in the north-east corner rear room, given the pastoral character of the farm. Access to a single-roomed barrel-vaulted cellar was from underneath the main staircase, while another opening to the outside is situated at the base of the northeastern gable, but was probably not for access (Plate 7). The cellar has a raised plinth and a drain which is characteristic of storage of dairy produce. Other service rooms such as a scullery and stores were sited in a series of outhouses behind the kitchen which were later encapsulated into the cross-wing that contains a large wood-panelled living room of post-war design, together with a kitchen and toilet at ground-floor level, and two further bedrooms and a toilet at first-floor level. Few other original internal features survive, although the staircase is a light and intricate design, typical of early nineteenth century (Plate 8) and several of the doors in the main range have similarly light carpentry work incorporating a six panel design.

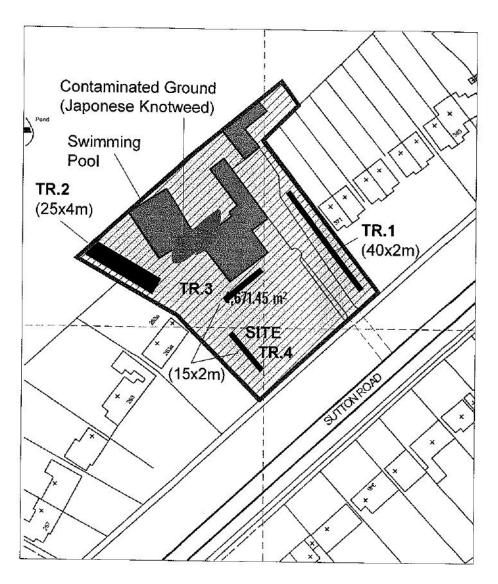
Fig.13

The Study Area has been the focus of activity and occupation from the early post-medieval onwards, and the remains of structures dating to this period, first depicted on Talbot's Estate Map of 1784 may survive within the bounds of the proposed development area. For these reasons it is recommended that a programme of trial trenching be implemented prior to redevelopment of the site taking place. Proposed locations of trenches are outlined on Fig. 13, the lengths of trenches are based upon a 5% sample of the total area of the proposed development area, as advised by the brief (Shaw 2004, 3).

Trench 1 has been located to transect the line of the turnpike road and the southern range of farm buildings identified on the 1902 Ordnance Survey Map. Trench 2 has been located to locate the remains of the structure depicted on Talbot's Estate Map, and the L-shaped building on Curtis' Estate Map. Trench 3 has been located to identify whether there is any evidence of early structures along the frontage of the turnpike road. Trench 4 has been located to identify any possible leats from the pond depicted on the opposite side of the road on the 1886 Ordnance Survey Map (and may ultimately be L-shaped).

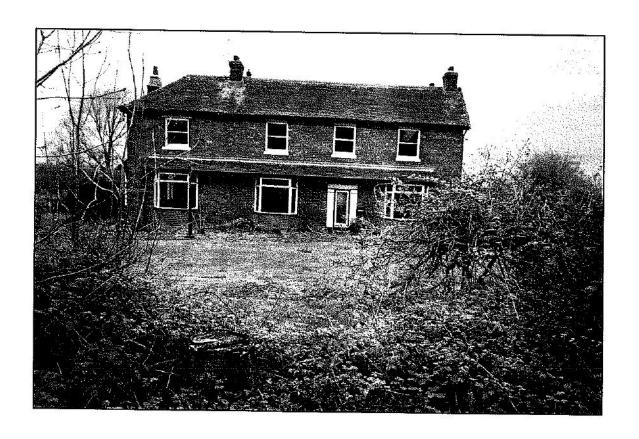
Plate 1

1950s Cross-wing alteration

Later bay windows

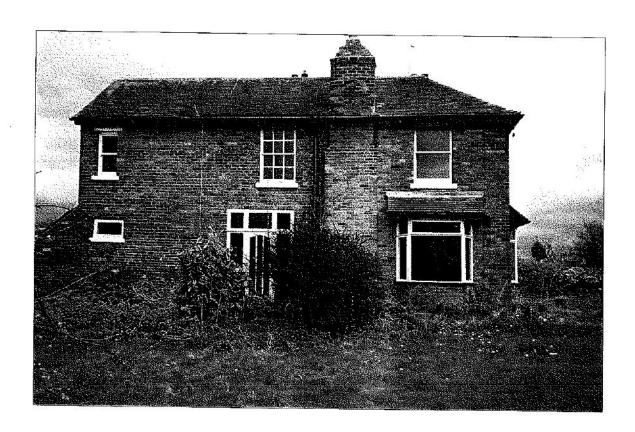
Plate 2

1950s Cross-wing alteration
Later bay windows

Re-used ? original window frame

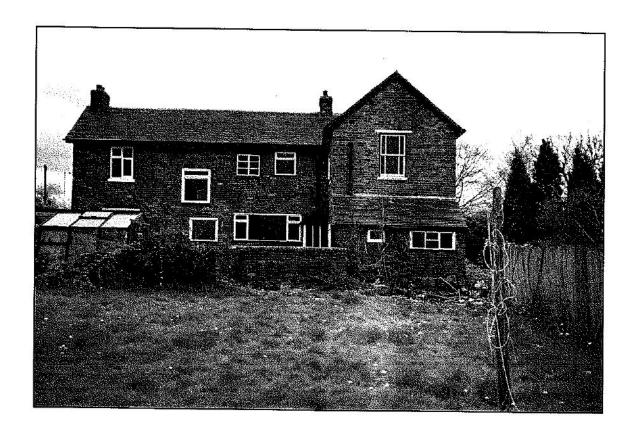
Plate 3

1950s Cross-wing

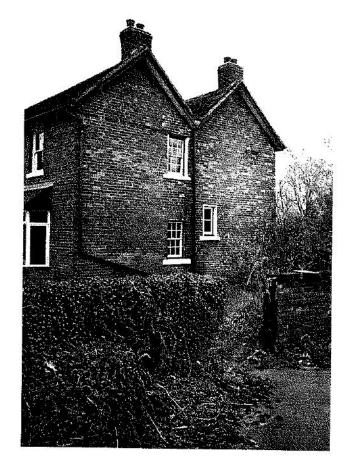
Plate 4

Externally, the original build of the double-pile main range is of locally-produced red brick in a variant of Flemish stretcher bond. The bricks measure approximately 9 by 4½ by 2½ inches and are irregularly fired and bonded in several places. Nearly all of the window and door openings have been modified at some stage in the life of the building which makes the identification of the original design difficult, although the window design was probably flat-headed with plain brick angled to create a decorative effect (Plate 5), and the original door openings in simpler segmented arches of a single course of plain voussoir bricks laid on edge (Plate 6). Three surviving twelve-light balanced sash windows may be original, but all other windows have been inserted and are of various different designs. The roof covering is of red clay tile throughout, the main range is covered by a pair of ridge roofs with a central gutter valley between. The later cross wing has a hipped roof to the frontage and a plain gable to the rear.

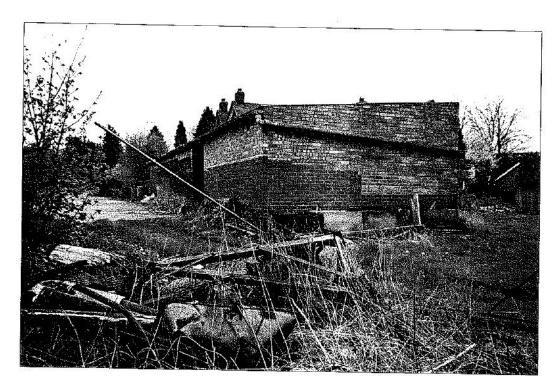
Plate 9

The shed is situated to the north-east of the back of the farmhouse and accessed via an engineering-brick paved yard. The present structure is mainly of post-war build incorporating 'Fletton-type' bricks, it has asbestos sheet roof and guttering, and comprises two coal stores and a large workshop area. While the building incorporates several earlier elements, probably belonging to animal sheds including a set of pigsties at one end, only isolated patches of these buildings survive and it is difficult to ascribe specific functions to them beyond that identified above, although they clearly cover a broad period of build mainly from the later 19th century.

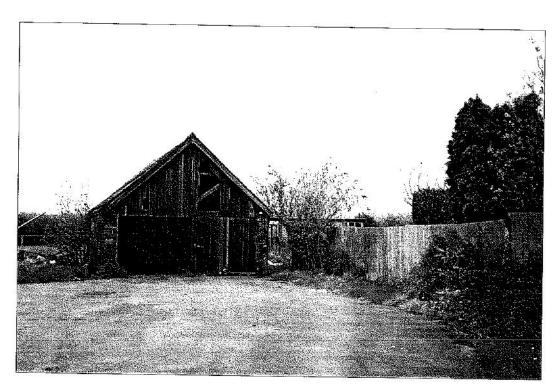
Plate 10

The cart shed is a single-storey free-standing red brick structure with an open front towards a concrete yard area situated to the north-east of the farmhouse. The building is of three bays defined by sawn, nailed and bolted king-post roof trusses that are also numbered. These trusses are supported on brick piers with brick panelling between. The front piers house large counter balance stones and hinges for heavy doors and there are two small window openings high up in the rear gable. The roof is red tile and the bricks measure $9\frac{1}{2}$ by $4\frac{1}{2}$ by 3 inches. The bonding is irregular but mainly raking Flemish stretcher bond. Internally there is a modern concrete floor.

The building is first depicted on the First Edition Ordnance Survey mapping of the mid 1880s, and the build quality and materials are generally consistent with a structure of around this date. The open frontage and location overlooking the main farmyard and road indicates that the building was probably a cart shed which is also consistent with its general design, and the pastoral orientation of the farm, which would require fewer items of machinery compared to an arable farm.
