## PART THREE

### PORTSMOUTH DOCKYARD IN THE TWENTIETH CENTURY<sup>1</sup>

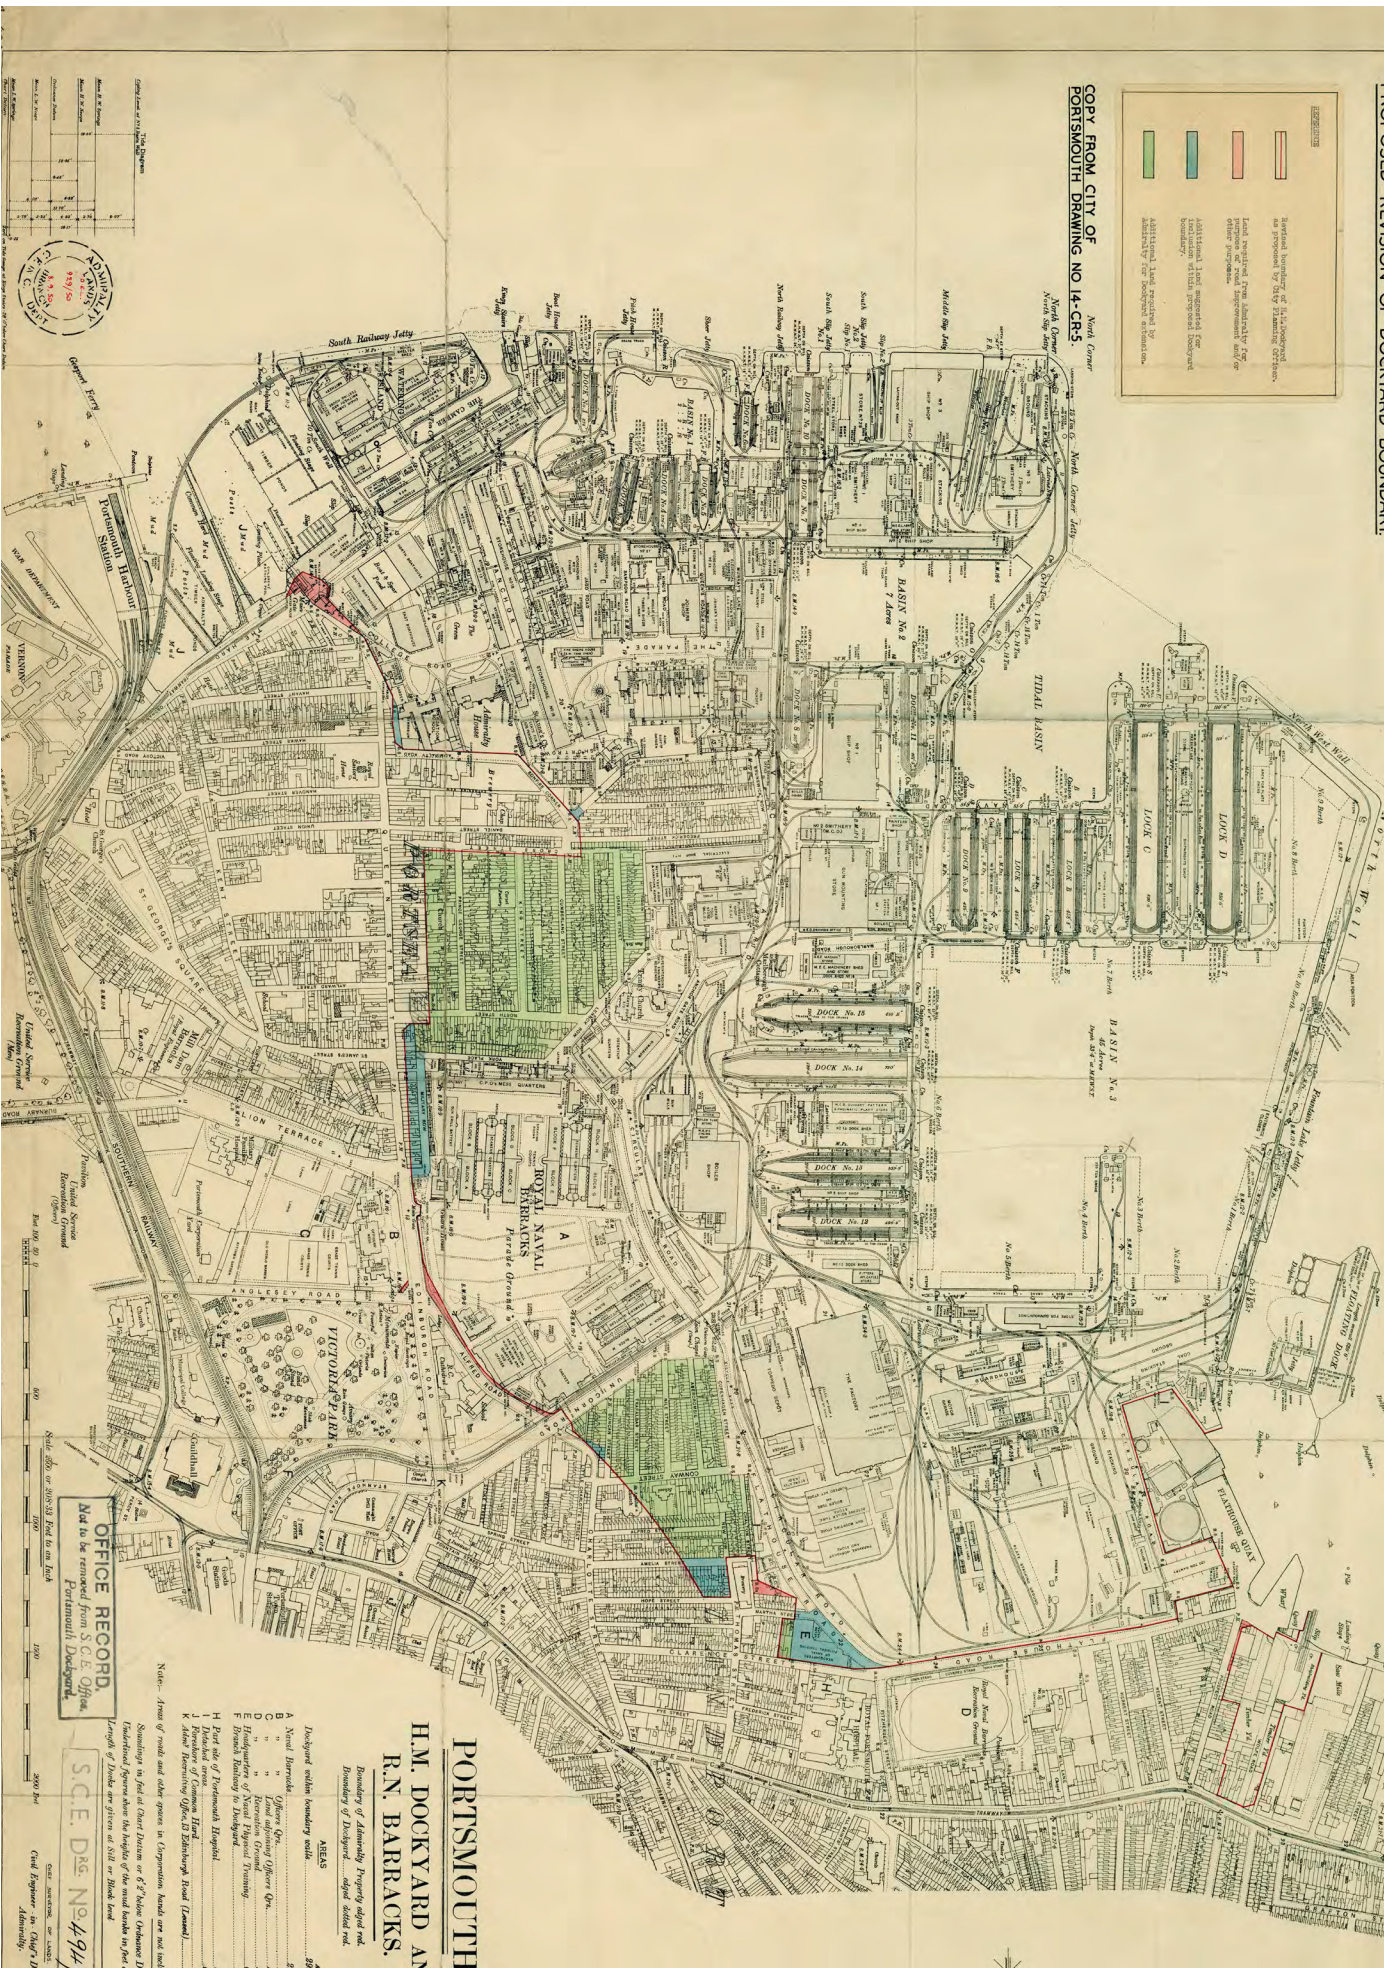
Fig. 191. MD95/03039 (1936). Plan Showing Proposed Revision of Boundary of HM Dockyard Portsmouth. Reproduced by permission of Historic England.

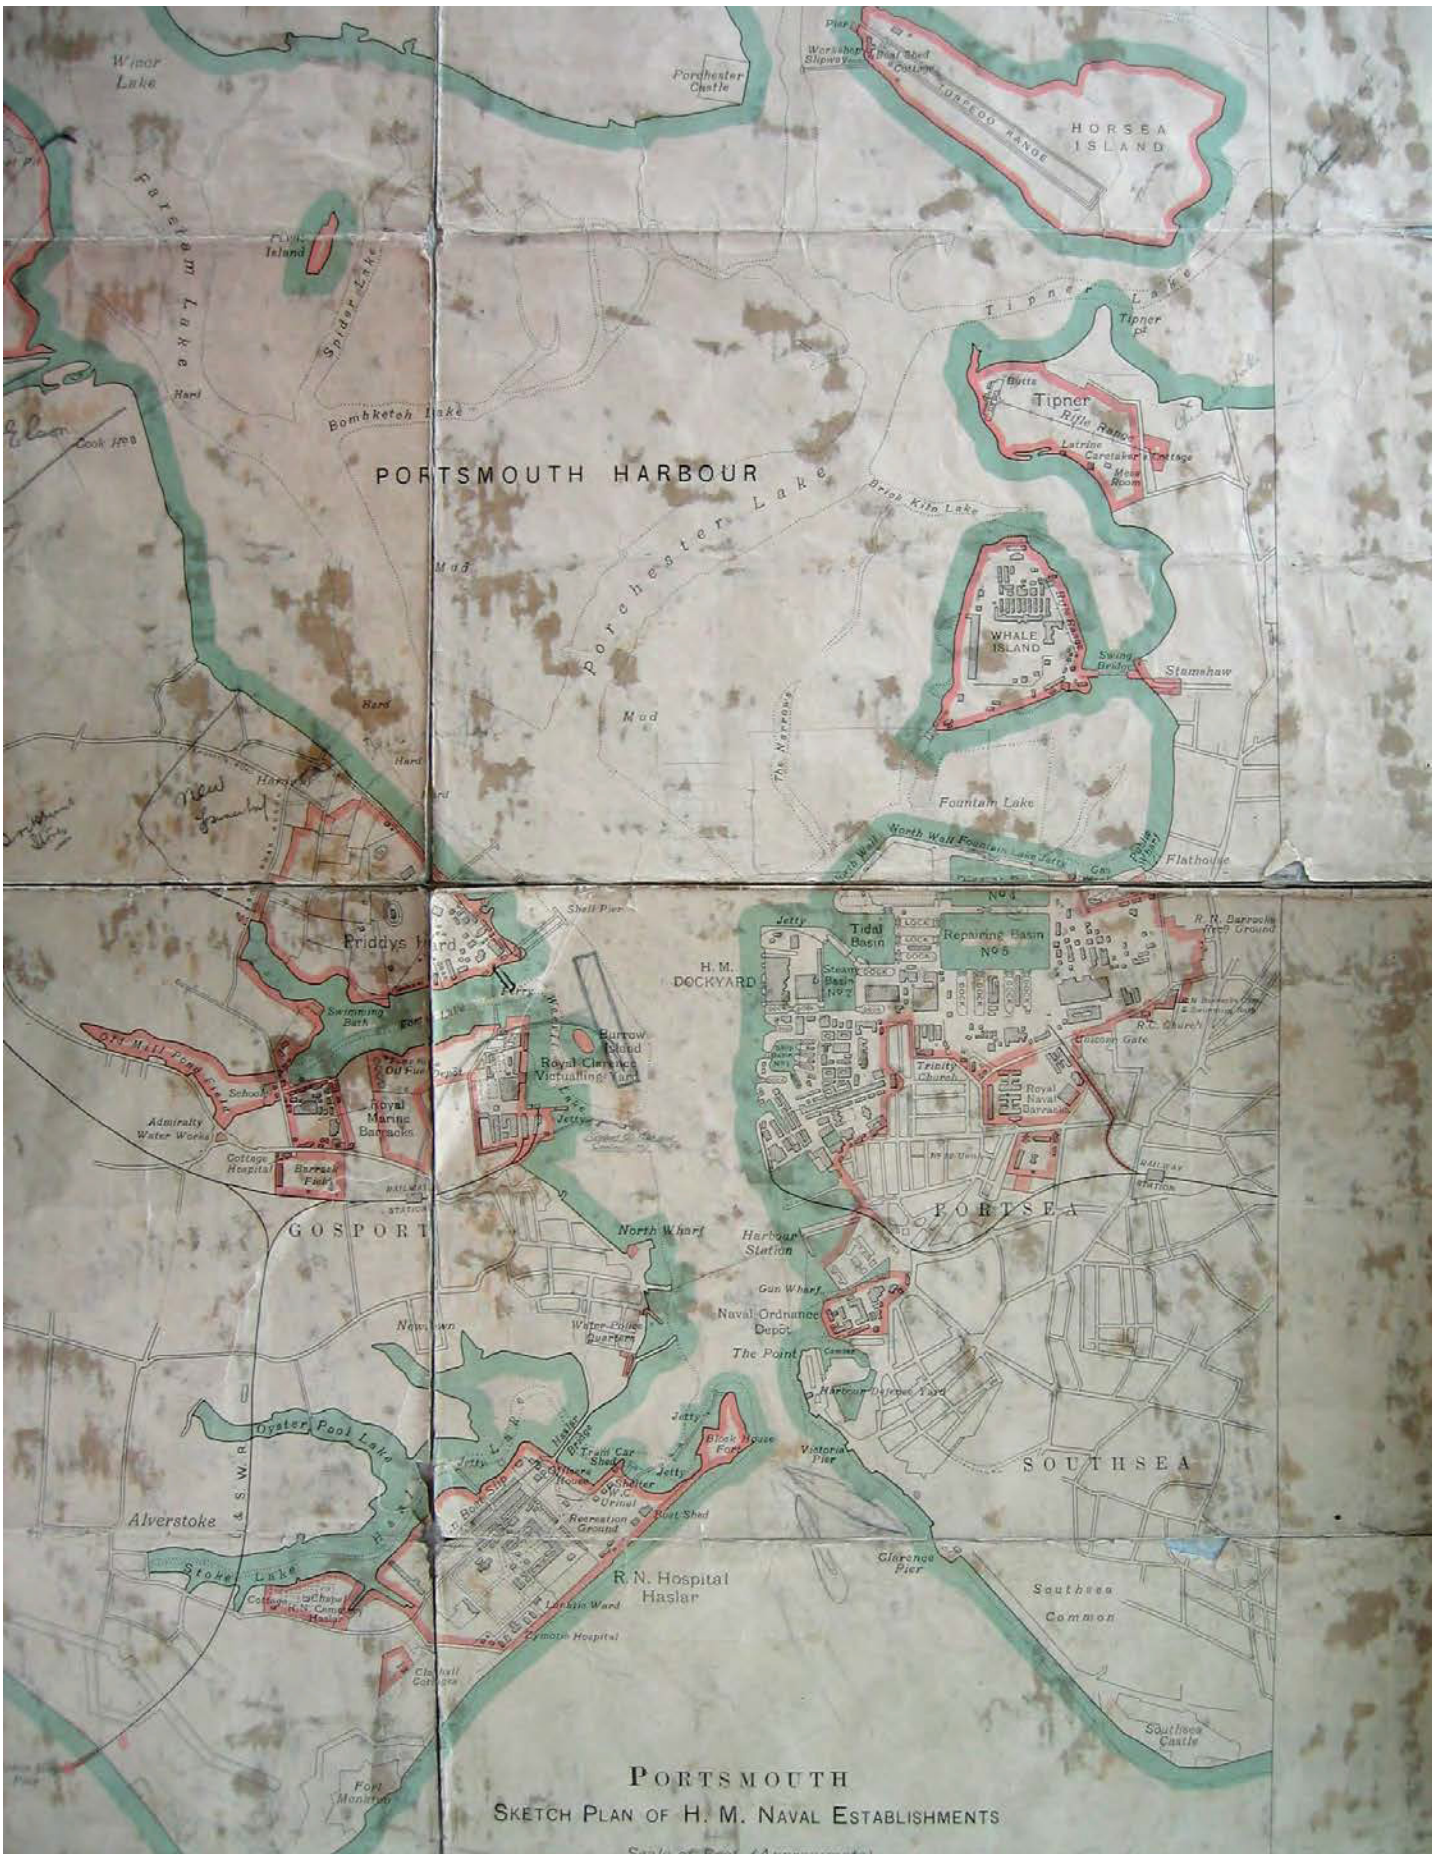
Fig. 192. HM Naval Dockyard, Portsmouth: Miscellaneous. Sketch plan of naval establishments, showing Portsea, Gosport, Haslar and Bedenham (section). Drawing no. B4. Scale not shown. Director of Works, Admiralty. TNA (1910). WORK 41/310. Reproduced with the permission of The National Archives.

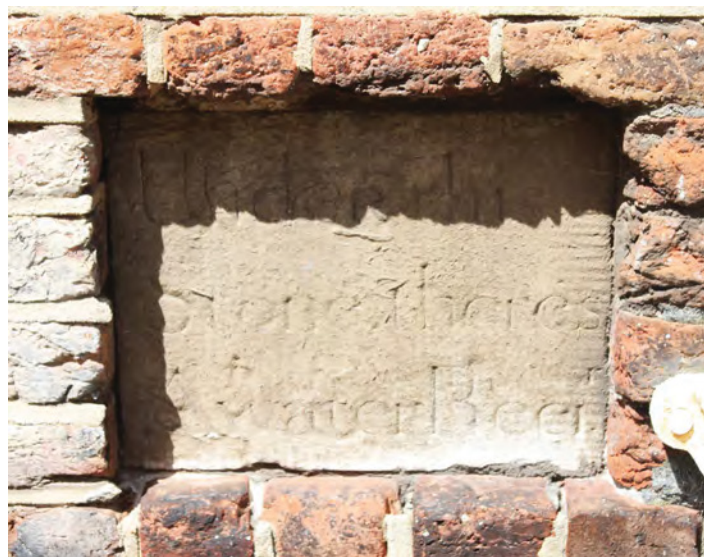
Fig. 199. Set into the south elevation of Portsmouth Building 1/81 is a dressed Portland stone or replacement concrete plaque which reads 'Under this Stone there is a water Beer', marking an old well or water tank surviving from the seventeenth century dockyard. This would have supplied the garden to the original Commissioner's House (1666) which lay north of Stony Lane until the house was demolished in the 1780s. A. Coats 2013. Reproduced with the permission of the MoD.

Fig. 199. Set into the south elevation of Portsmouth Building 1/81 is a dressed Portland stone or

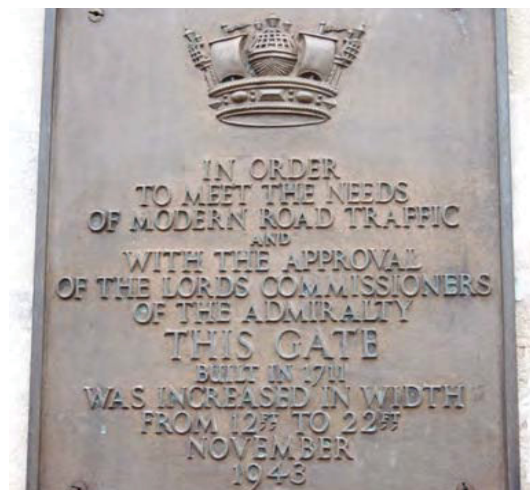
Fig. 205. Admiralty plaque to mark the widening of the then Portsmouth Main Gate (November 1943). A. Coats 2013. Reproduced with the permission of the MoD.

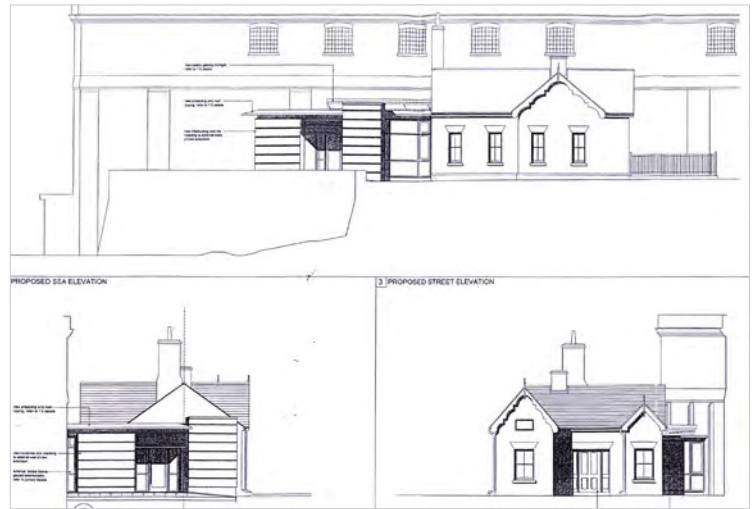
Fig. 212. Tourist Information Centre Richard Partington Architects: Elevations, No. 2023.005A. PNBPT, 9.10.2001. Reproduced with the kind permission of Portsmouth Naval Base Property Trust.

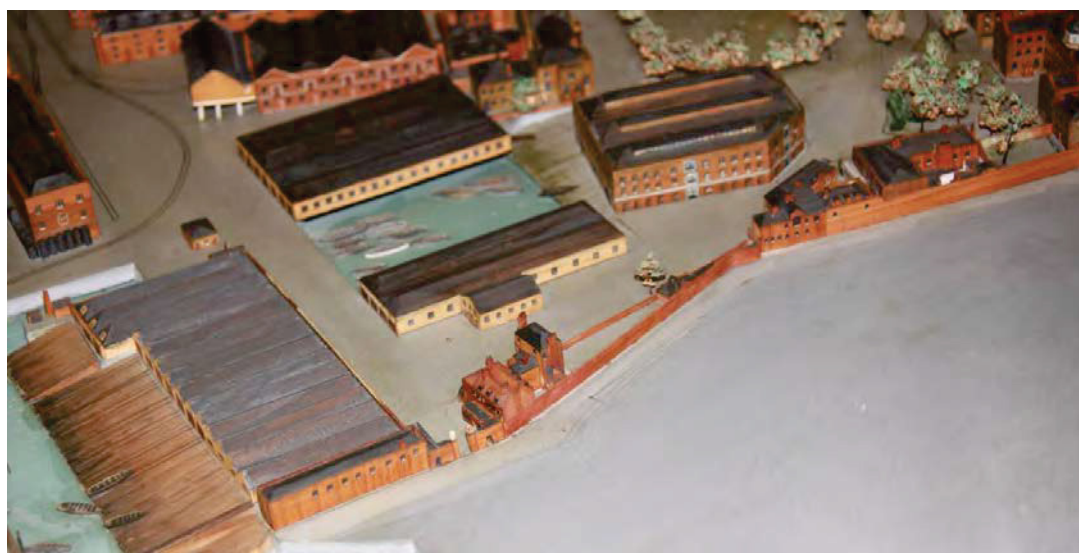
*Above right:* Fig. 221. MD95/03032 (1850 annotated to 1955). Plan of Portsmouth Dockyard in 1900 showing development and enlargement from 1540 to 1900, PSA Drawing based on 1850 map showing changes in yellow and later buildings in red dotted lines. Section showing Portsmouth Mast Houses, indicating that the site was 'Destroyed by Fire 1941 (Enemy Action)', not acknowledging that Boat House No. 4 was there by then. It also shows the 'New Site of Muster Bell'. Reproduced by permission of Historic England.

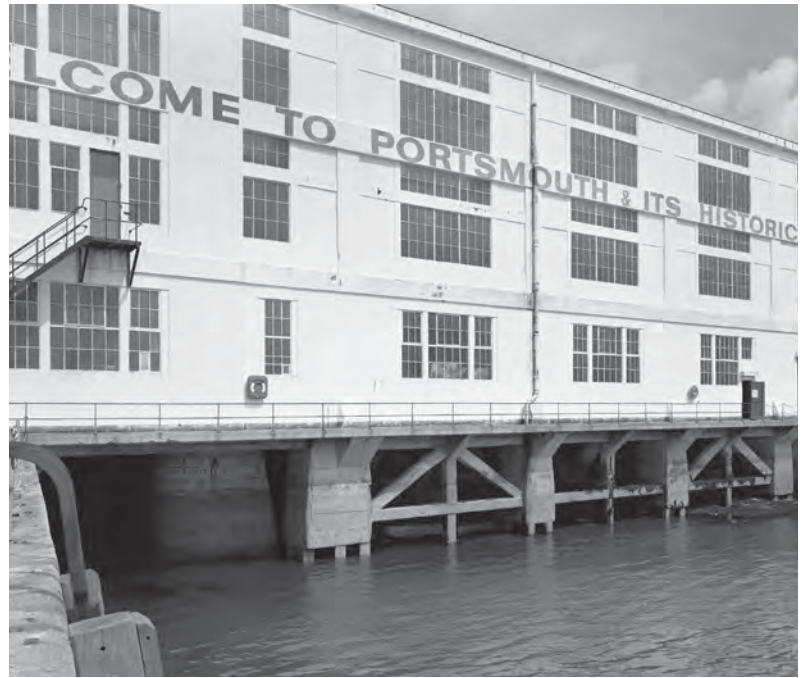
Fig. 229. BB97/09274. West elevation of Boathouse No. 4 showing the concrete supporting trusses at high tide (28 Jul 1997). ©Crown copyright.HE.

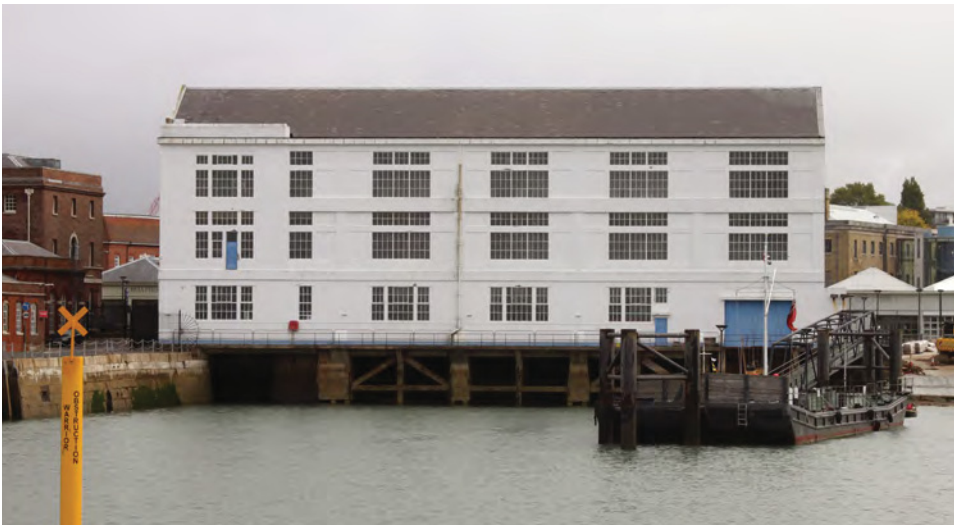
Fig. 230. West (harbour) elevation of Portsmouth Boathouse No. 4 (1940, 1/6). A. Coats 2015. Reproduced with the kind permission of Portsmouth Naval Base Property Trust.

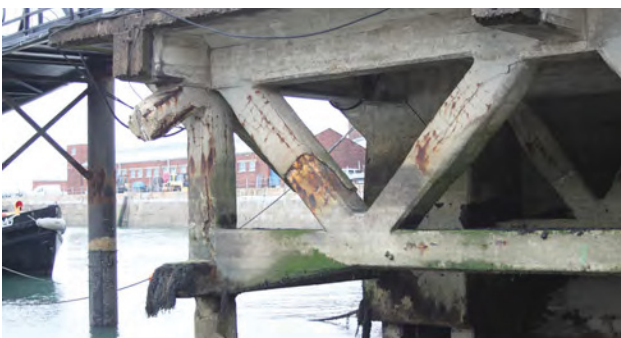
Fig. 231. Southern extent of the concrete and steel trusses forming the undercroft of Portsmouth Boathouse No. 4 (1940, 1/6) on its west (harbour) elevation. A. Coats 2015. Reproduced with the kind permission of Portsmouth Naval Base Property Trust.

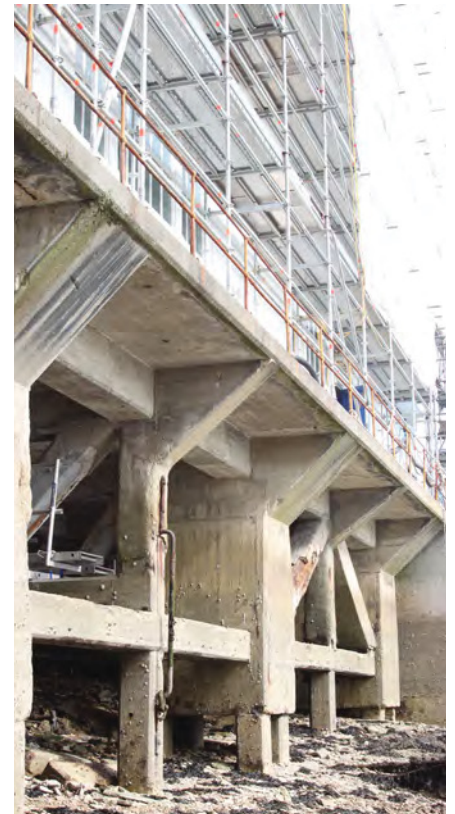
Fig. 232. West elevation of the undercroft of Portsmouth Boathouse No. 4 (1940, 1/6) at low tide, showing its beams and trusses. A. Coats 2015. Reproduced with the kind permission of Portsmouth Naval Base Property Trust.

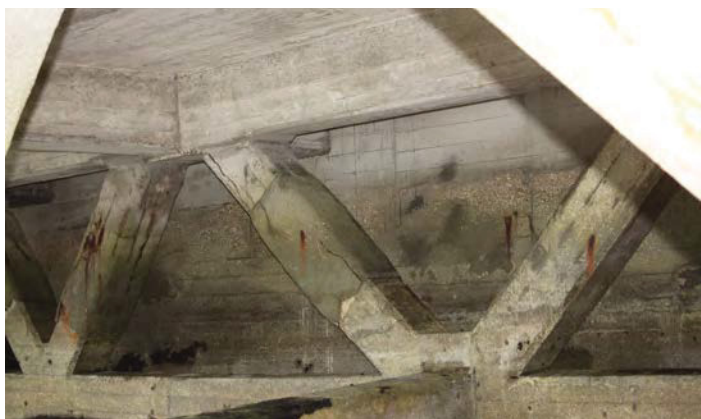
Fig. 233. Northern extent of the concrete and steel trusses forming the undercroft of Portsmouth Boathouse No. 4 (1940, 1/6) on its west (harbour) elevation, showing the shuttered concrete west seawall. A. Coats 2015. Reproduced with the kind permission of Portsmouth Naval Base Property Trust.

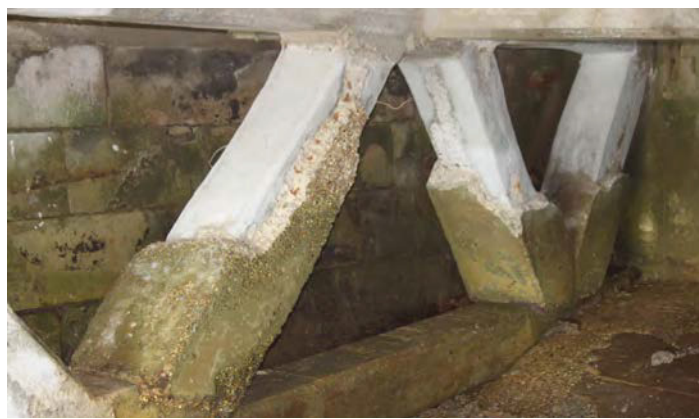
Fig. 234. Northern extent (east end) of the concrete and steel trusses forming the undercroft of Portsmouth Boathouse No. 4 (1940, 1/6) showing the eighteenth century Portland stone north seawall and slipway stones. Concrete repairs to the trusses were carried out in 2014–15. A. Coats 2015. Reproduced with the kind permission of Portsmouth Naval Base Property Trust.

Fig. 234. Northern extent (east end) of the concrete and steel trusses forming the undercroft of Portsmouth Boathouse No. 4 (1940, 1/6) showing the eighteenth century Portland stone north seawall and slipway stones. Concrete repairs to the trusses were carried out in 2014–15. A. Coats 2015. Reproduced with the kind permission of Portsmouth Naval Base Property Trust.

This plan for a viable reuse aimed to extend the life of the building through a conservation management plan of refurbishment and maintenance. The reinforced concrete undercroft and parts of the walls and roof are affected by chloride ingress and carbonation-induced corrosion. The worst damage has occurred in the undercroft within the splash zone, much of which has been patched. Lowe and Preston suggested that future specialist treatment could comprise impressed current cathodic

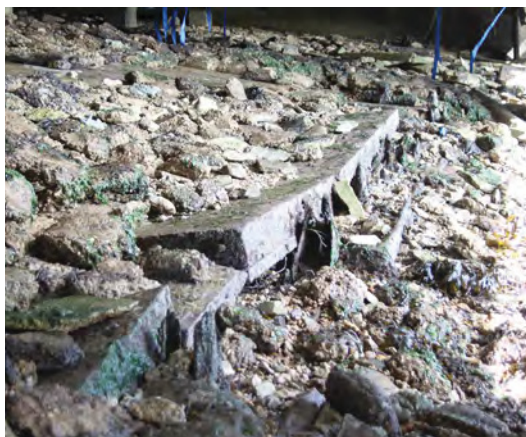
Fig. 235. Lowest level of the eighteenth century Portland Stone slipway stones, held in place by a line of wooden posts, visible beneath a layer of solidified bags of concrete, below Portsmouth Boathouse No. 4 (1940, 1/6). A. Coats 2015. Reproduced with the kind permission of Portsmouth Naval Base Property Trust.

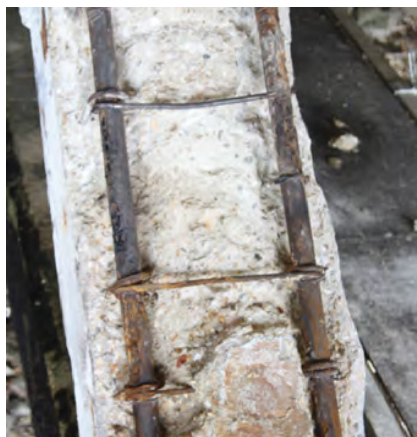
Fig. 236. Underside of a Portsmouth Boathouse No. 4 (1940, 1/6) concrete truss, showing its corroded iron reinforcing bar. A. Coats 2015. Reproduced with the kind permission of Portsmouth Naval Base Property Trust.

Fig. 236. Underside of a Portsmouth Boathouse No. 4 (1940, 1/6) concrete truss, showing its corroded iron reinforcing bar. A. Coats 2015. Reproduced with the kind permission of Portsmouth Naval Base Property Trust.

protection or a galvanic system of protection. In the building itself chloride ingress and carbonation-induced corrosion are localised around leaking windows and areas of roof. Because the southern elevation was not completed, ineffective roof drainage has caused rain water pooling and corrosion to the gutter lining. Repairs to windows and roofs will address further deterioration, with the application of impressed current cathodic protection to the worst affected areas, 'such as the integral gutters on the NW wall.' The external elevations are suffering from carbonation-induced corrosion which could be treated by anti-carbonation paints. On the western elevation, chloride ingress will be treated with impressed cathodic protection in conjunction with treatment of the undercroft. When built, the windows were zinc sprayed, which is not as durable as hot-dip galvanised. They could have been stripped; grit blasted; damaged sections repaired or replaced; hot-dip galvanised and powder coated or replaced with Crittall Corporate W20 windows. Portsmouth City Council advised that any treatment of the windows should be applied throughout. Installation of secondary glazing is also being investigated. A new entrance is proposed through the south elevation and new mezzanine floors for exhibitions and staff facilities. (Lowe & Preston, 2013, pp. 3, 35, 43-6, 51-3) The undercroft trusses were repaired 2014–15, refurbishing the concrete and installing sacrificial anodes to consume future oxidation. A University of Portsmouth student, Ahmed Alwaal, is assessing the longevity of concrete repairs made previously to BH4, and testing the current repairs for his PhD, 'Heritage concrete structures', completion due 2018 (supervisors Dr Stephanie Barnett and Dr Robert Inkpen).

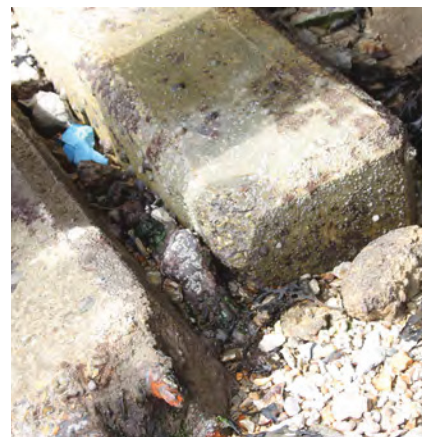
Fig. 237. Unused reinforced concrete beams lying beneath Portsmouth Boathouse No. 4 (1940, 1/6). A. Coats 2015. Reproduced with the kind permission of Portsmouth Naval Base Property Trust.

Fig. 237. Unused reinforced concrete beams lying beneath Portsmouth Boathouse No. 4 (1940, 1/6). A. Coats 2015. Reproduced with the kind permission of Portsmouth Naval Base Property Trust.

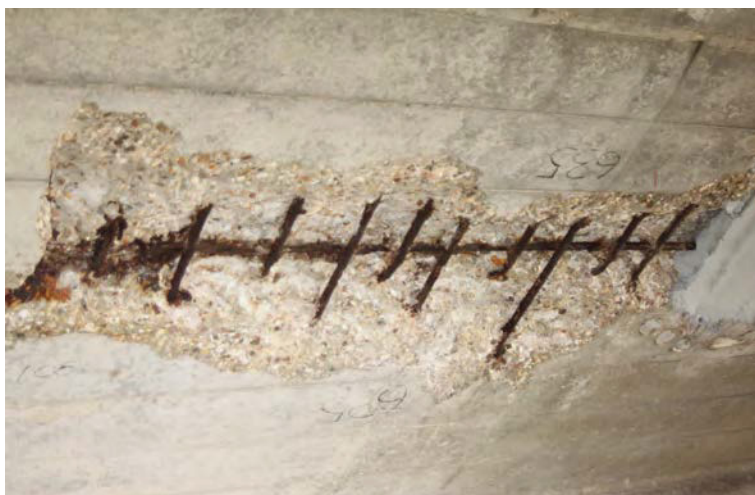
Fig. 238. Underside of Portsmouth Boathouse No. 4 (1940, 1/6) showing the shuttered concrete surface with twentieth century repairs using steel wire which has corroded. Concrete repairs were carried out in 2014–15. A. Coats 2015. Reproduced with the kind permission of Portsmouth Naval Base Property Trust.

Fig. 238. Underside of Portsmouth Boathouse No. 4 (1940, 1/6) showing the shuttered concrete surface with twentieth century repairs using steel wire which has corroded. Concrete repairs were carried out in 2014–15. A. Coats 2015. Reproduced with the kind permission of Portsmouth Naval Base Property Trust.

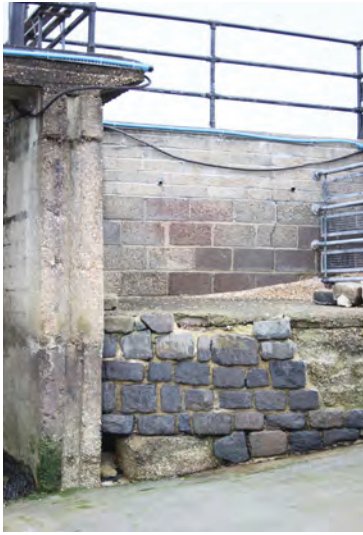
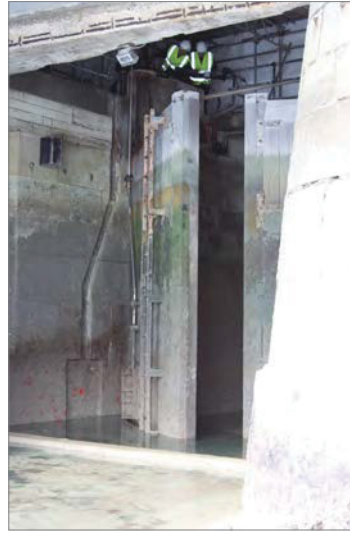
Fig. 240. Lock entrance to Portsmouth Boathouse No. 4 (1940, 1/6), showing the wooden lock gates which connect the channel running beneath Boathouse No. 4 and into the Mast Pond with the harbour. On the right is the battered eighteenth century Portland Stone sea wall, at the top a reinforced concrete beam supporting the building, and on the left shuttered concrete above Portland stone. A. Coats 2015. Reproduced with the kind permission of Portsmouth Naval Base Property Trust.

In 1999 the mast pond lock gates in a channel connecting the Mast Pond to the Harbour, running beneath Boathouse No. 4 and the road, were replaced. In that year Southern Archaeological Services (SAS) carried out a survey (SAS, 1999, pp. 12-13; Fig. 10), establishing that the channel is stone-lined, built in at least two phases, in the same position as that shown on maps dating from 1668. These suggest that in 1668 the channel was open to the top, with a gate near the inner (eastern) end, with the outer (western) end wider than the centre. By 1716 the gate is shown as wider, probably carrying a walkway. A map of 1743 shows most of the eastern end covered, with faint lines possibly delineating a tunnel, the style of stonework consistent with this date. The report refers to a boathouse being built in the nineteenth century, with the western end of the tunnel lined with stone. The three gate system dates from this period. Coad, 1989, p. 180 shows a Boathouse in 1850 south of the channel. Two of the three gates form a lock, reflecting a change of use from a 'simple cut, with water levels controlled by a single gate, which would allow easy passage of masts' to 'use of the Mast Pond to include extensive work on boats.' (SAS, 1999, pp. 12-13; Fig 10)

The survey found that the floors of the lock chambers and tunnel are of stone, covered with timber in places. At the west end of the western chamber the floor stones are cut to fit the angle of the gates. The battered lock walls are made of 1 x 0.75m squared and dressed ashlar blocks. The blocks of the bottom two courses are smaller: (1 x 0.24m), slightly offset. The ashlar is cut each side by two vertical channels, interpreted as cuts for stop-boards to control water levels. An inlet on the north side of the lock chambers is thought to connect with the system of culverts running beneath the dockyard. A twentieth century timber mat bolted to the stone floor is associated with a fixed vertical panel which blocked the channel. The entrance to the tunnels is marked by large quoins of a later date than the tunnel itself. There is a handrail designed to pull boats through by hand. The tunnel roof is of dark red local brick, mostly laid with stretchers parallel to the long axis of the tunnel. SAS note that the gates appear to be too close together to allow passage of boats used in the late nineteenth and early twentieth centuries. No trace was found of de Gomme's defensive structures. (SAS, 1999, pp. 13-14, Fig. 11) This investigation demonstrated changes in the use of this site (from a mast house to a boathouse) and use of the Mast Pond for boats rather than masts, deriving from the building of Boathouse No. 6 in 1845.

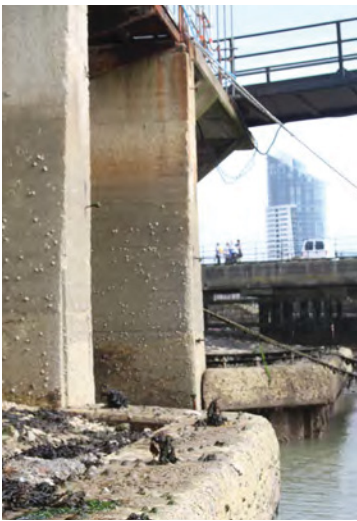
Fig. 241. Dock entrance to Portsmouth Boathouse No. 4 (1940, 1/6) on the west (harbour) elevation. A. Coats 2015. Reproduced with the kind permission of Portsmouth Naval Base Property Trust.

Fig. 241. Dock entrance to Portsmouth Boathouse No. 4 (1940, 1/6) on the west (harbour) elevation. A. Coats 2015. Reproduced with the kind permission of Portsmouth Naval Base Property Trust.

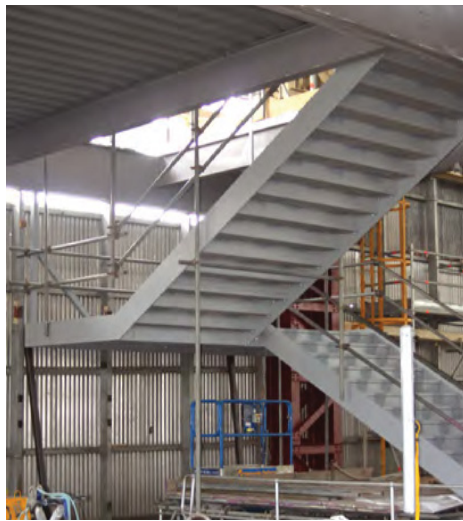
Fig. 242. Interior of the corrugated steel wall forming the south elevation of Portsmouth Boathouse No. 4 (1940, 1/6), showing the newly constructed stairway and mezzanine floor. A. Coats 2015. Reproduced with the kind permission of Portsmouth Naval Base Property Trust.

Fig. 242. Interior of the corrugated steel wall forming the south elevation of Portsmouth Boathouse No. 4 (1940, 1/6), showing the newly constructed stairway and mezzanine floor. A. Coats 2015. Reproduced with the kind permission of Portsmouth Naval Base Property Trust.

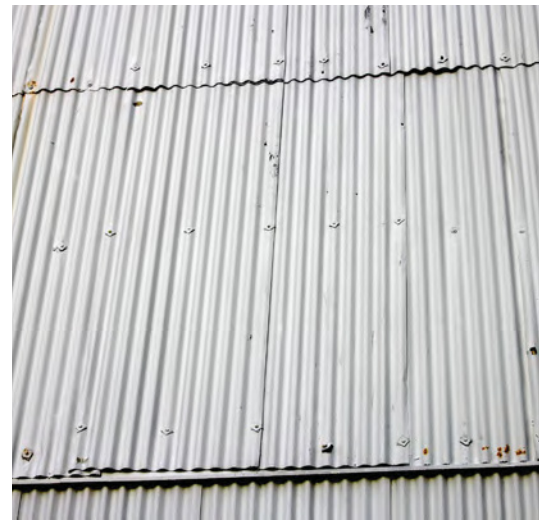
Fig. 243. Exterior of the corrugated steel wall forming the south elevation of Portsmouth Boathouse No. 4 (1940, 1/6). A. Coats 2015. Reproduced with the kind permission of Portsmouth Naval Base Property Trust.

Fig. 243. Exterior of the corrugated steel wall forming the south elevation of Portsmouth Boathouse No. 4 (1940, 1/6). A. Coats 2015. Reproduced with the kind permission of Portsmouth Naval Base Property Trust.

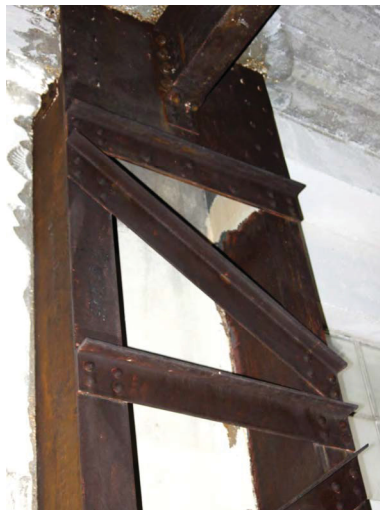
Fig. 244. Interior steel frame and beam of Portsmouth Boathouse No. 4 (1940, 1/6). A. Coats 2015. Reproduced with the kind permission of Portsmouth Naval Base Property Trust.

Fig. 244. Interior steel frame and beam of Portsmouth Boathouse No. 4 (1940, 1/6). A. Coats 2015. Reproduced with the kind permission of Portsmouth Naval Base Property Trust.

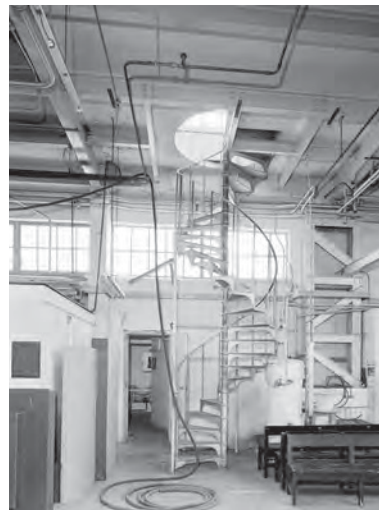
Fig. 245. BB97/09263. Photograph of the spiral staircase in north end of Boathouse No. 4, Portsmouth (28 Jul 1997). ©Crown copyright.HE.

Fig. 245. BB97/09263. Photograph of the spiral staircase in north end of Boathouse No. 4, Portsmouth (28 Jul 1997). ©Crown copyright.HE.

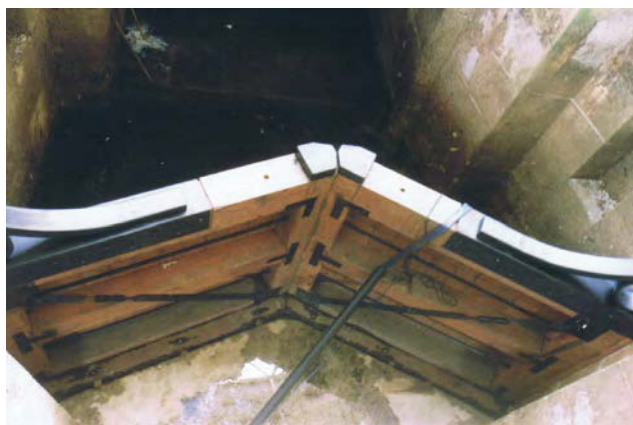
Fig. 246. Photograph of Portsmouth Boathouse No. 4 tunnel: west opening, view south, ready for pintles (PNBPT, 22.9.1999 no. 38). Reproduced with the kind permission of Portsmouth Naval Base Property Trust.

Fig. 246. Photograph of Portsmouth Boathouse No. 4 tunnel: west opening, view south, ready for pintles (PNBPT, 22.9.1999 no. 38). Reproduced with the kind permission of Portsmouth Naval Base Property Trust.

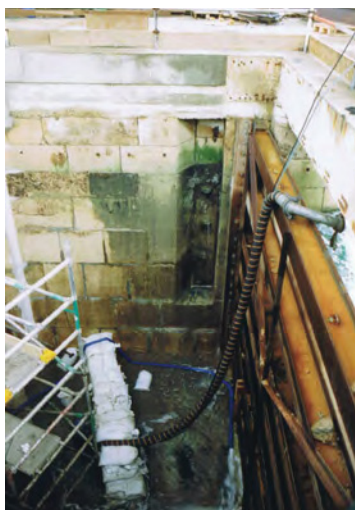
Fig. 247. Photograph of Portsmouth Boathouse No. 4 tunnel: east opening, view south, ready for pintles (PNBPT, 22.9.1999 no. 40). Reproduced with the kind permission of Portsmouth Naval Base Property Trust.

Fig. 247. Photograph of Portsmouth Boathouse No. 4 tunnel: east opening, view south, ready for pintles (PNBPT, 22.9.1999 no. 40). Reproduced with the kind permission of Portsmouth Naval Base Property Trust.

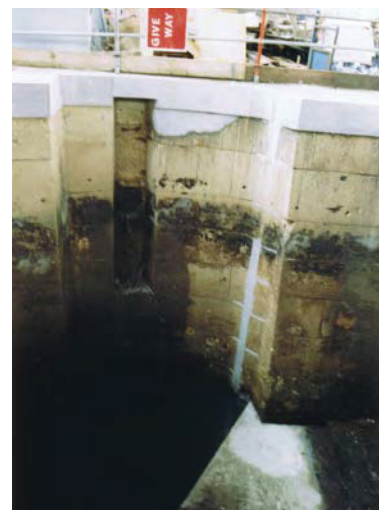
Fig. 248. Photograph of Portsmouth Boathouse No. 4 lock gates: east opening (PNBPT, 3.11.1999 no. 48). Reproduced with the kind permission of Portsmouth Naval Base Property Trust.

Fig. 248. Photograph of Portsmouth Boathouse No. 4 lock gates: east opening (PNBPT, 3.11.1999 no. 48). Reproduced with the kind permission of Portsmouth Naval Base Property Trust.

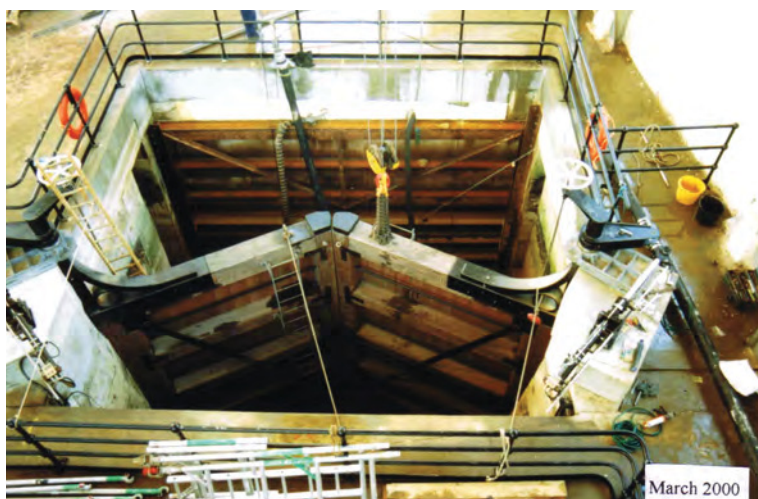
Fig. 249. Photograph of Portsmouth Boathouse No. 4 lock gates: adjustments to gates (PNBPT, 1.3.2000 no. 53). Reproduced with the kind permission of Portsmouth Naval Base Property Trust.

Fig. 249. Photograph of Portsmouth Boathouse No. 4 lock gates: adjustments to gates (PNBPT, 1.3.2000 no. 53). Reproduced with the kind permission of Portsmouth Naval Base Property Trust.

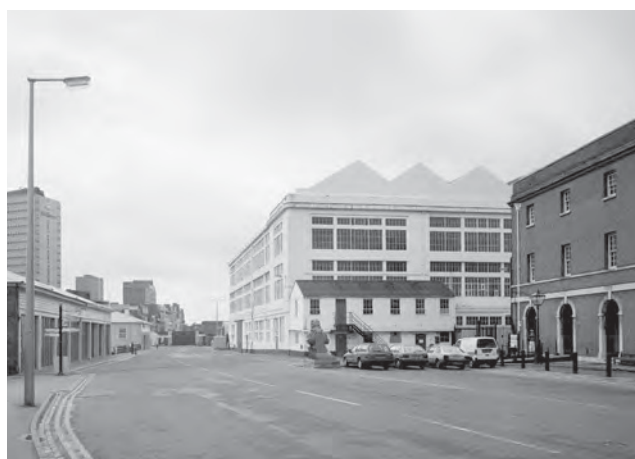
Fig. 250. BB97/012856. Photograph of the northwest corner of Portsmouth Boathouse No. 4 with Boathouse No. 4 Annex on the north side (28 Jul 1997). ©Crown copyright.HE.

Fig. 250. BB97/012856. Photograph of the northwest corner of Portsmouth Boathouse No. 4 with Boathouse No. 4 Annex on the north side (28 Jul 1997). ©Crown copyright.HE.

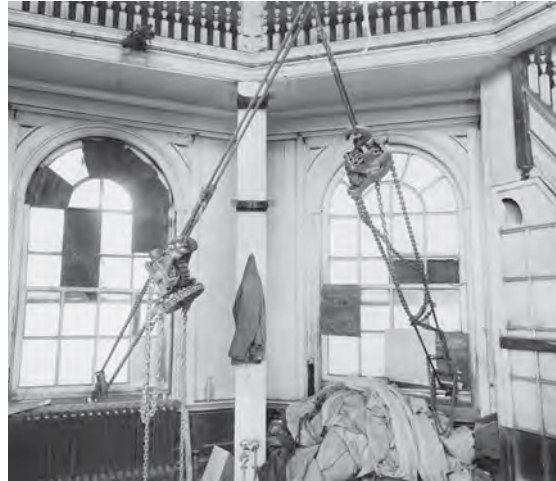
Fig. 256. P241/53 FL00981/01/001. Photograph showing progress of the reconstruction of the Former Naval Academy's cupola, following its bomb damage in 1941 (09 Mar 1953). Reproduced by permission of Historic England.

Fig. 256. P241/53 FL00981/01/001. Photograph showing progress of the reconstruction of the Former Naval Academy's cupola, following its bomb damage in 1941 (09 Mar 1953). Reproduced by permission of Historic England.

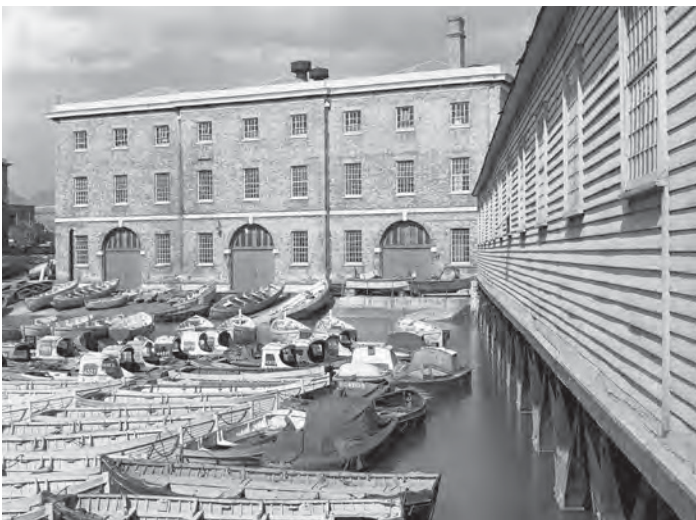
Fig. 257. AA98/04652. Photograph of the west elevation of Portsmouth Boathouse No. 6 showing boats hauled onto its ramp and the Mast Pond holding many dockyard boats (1956). Reproduced by permission of Historic England.

Fig. 257. AA98/04652. Photograph of the west elevation of Portsmouth Boathouse No. 6 showing

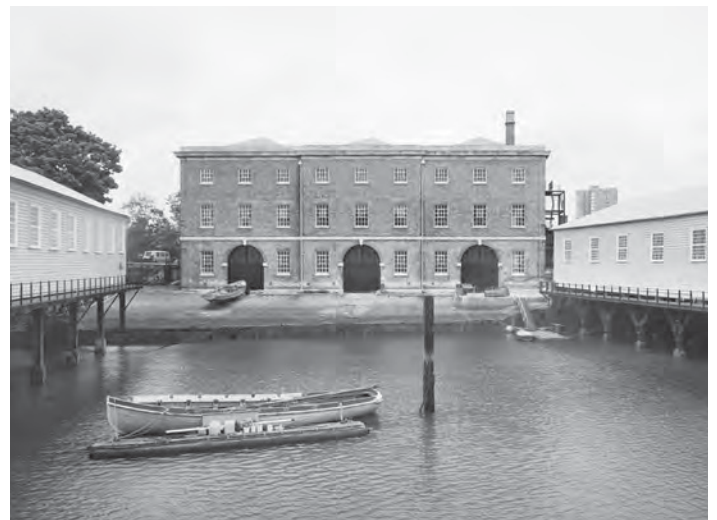
Fig. 258. BB012873. Photograph of the west elevation of Portsmouth Boathouse No. 6 with fewer boats in the Mast Pond after the heritage area was established and before refurbishment in 2001 (11 Jun 1991). ©Crown copyright.HE.

Fig. 258. BB012873. Photograph of the west elevation of Portsmouth Boathouse No. 6 with fewer boats in the Mast Pond after the heritage area was established and before refurbishment in 2001 (11 Jun 1991). ©Crown copyright.HE.

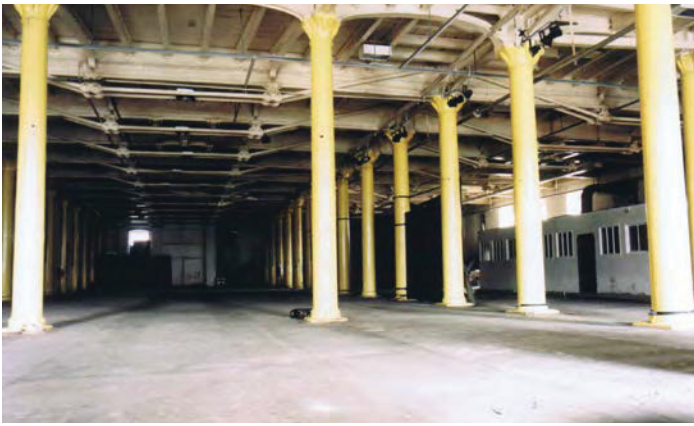
Fig. 264. Portsmouth Boathouse No. 6. Photograph of the ground floor, looking east showing the cast iron pillars and trusses. PNBPT Record Photograph no. G41 (June 1998). Reproduced with the kind permission of Portsmouth Naval Base Property Trust.

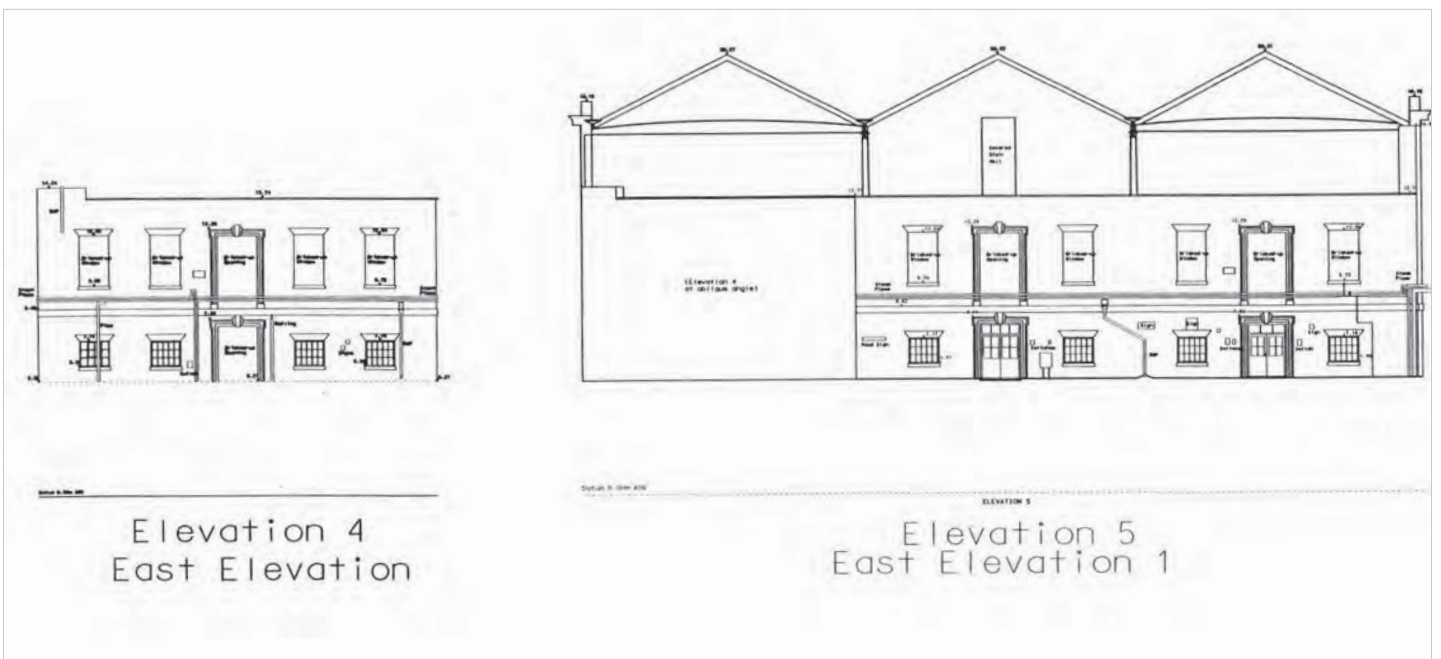
Fig. 271. Boathouse No. 6 East Elevation Survey (16.11.98). PNBPT, MacCormac Jamieson Prichard drawing no. 9615/522 A. Reproduced with the kind permission of Portsmouth Naval Base Property Trust.

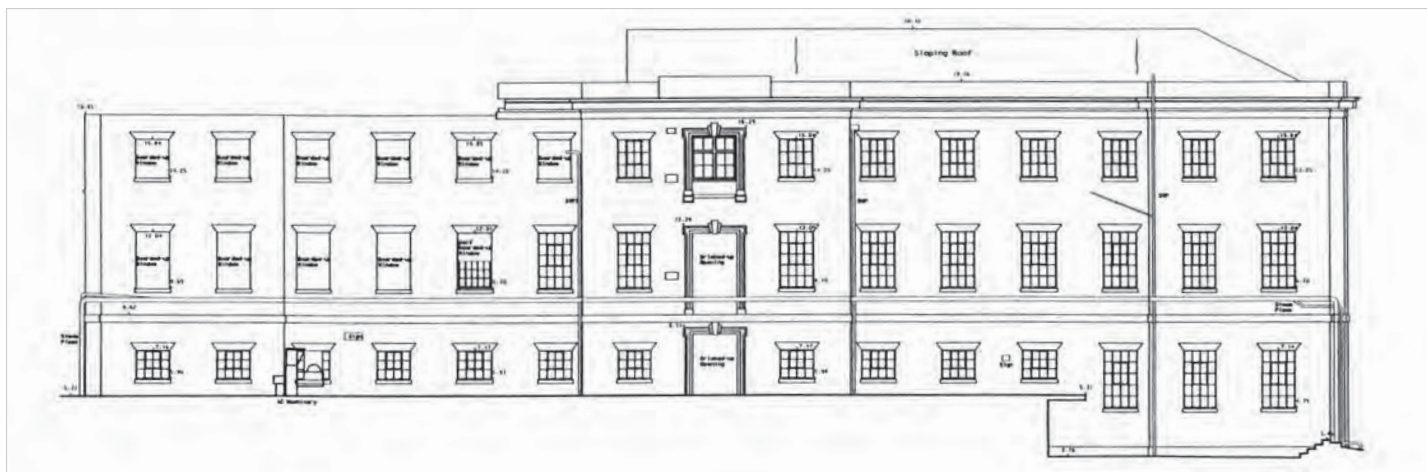
Fig. 272. Boathouse No. 6 North Elevation Survey (16.11.98). PNBPT, MacCormac Jamieson Prichard drawing no. 9615/521 A. Reproduced with the kind permission of Portsmouth Naval Base Property Trust.

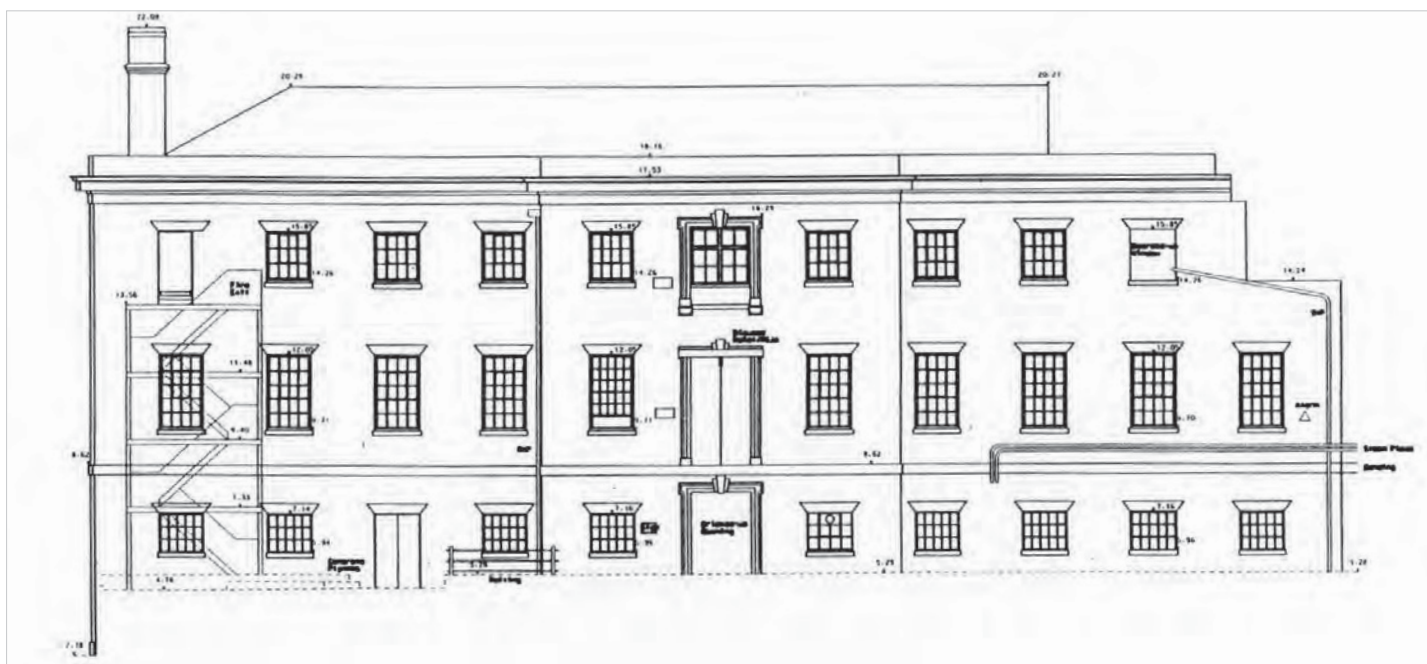
Fig. 273. Boathouse No. 6 South Elevation Survey (16.11.98). PNBPT, MacCormac Jamieson Prichard drawing no. 9615/523 A. Reproduced with the kind permission of Portsmouth Naval Base Property Trust.

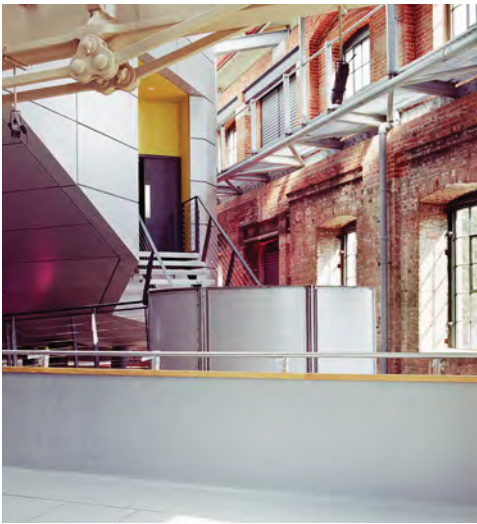
Fig. 275. AA026355. Photograph of the eastern interior of Portsmouth Boathouse No. 6 showing the cinema structure inserted within the area damaged by a bomb in the Second World War (2001). ©Historic England.

Fig. 275. AA026355. Photograph of the eastern interior of Portsmouth Boathouse No. 6 showing the cinema structure inserted within the area damaged by a bomb in the Second World War (2001). ©Historic England.

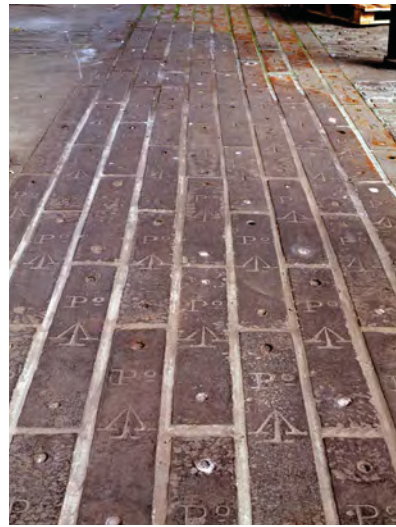
Fig. 292. AA045923. Photograph of the floor of the Chain Test House, the pathway consisting of Portsmouth Dockyard cast iron ballast pigs (9.7.2003). ©Historic England.

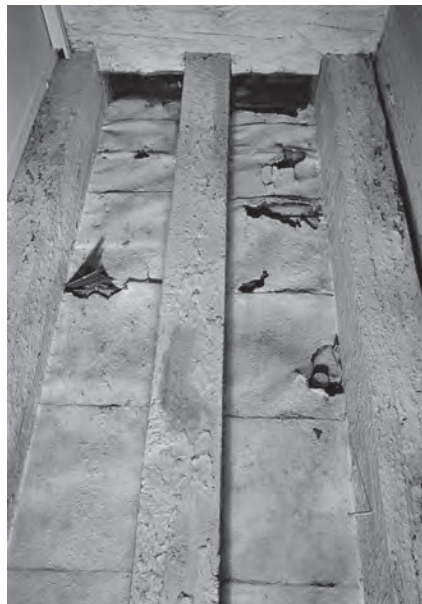
Fig. 310. J360/06/72. Photograph of Storehouse Nos 9, 10, 11: Mr Hartley's fire plates on first floor joists and floorboards (c.1971). ©Crown copyright.HE.

Fig. 310. J360/06/72. Photograph of Storehouse Nos 9, 10, 11: Mr Hartley's fire plates on first floor joists and floorboards (c.1971). ©Crown copyright.HE.
