## PART THREE

### PORTSMOUTH DOCKYARD IN THE TWENTIETH CENTURY<sup>1</sup>

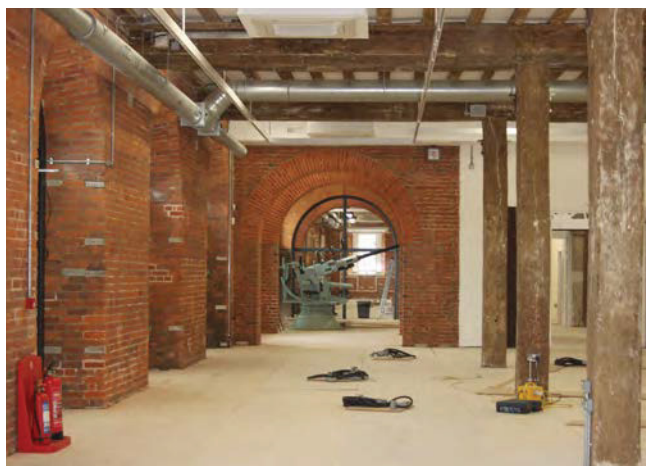
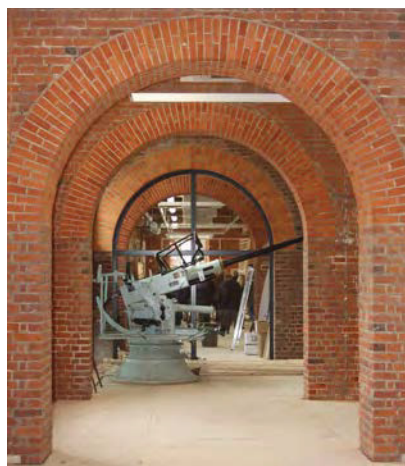
Fig. 313. Ground floor of Portsmouth Storehouse No. 10 (1776, 1/59) detail of renewed brick arches displaying twentieth century ordnance in the twentieth century Babcock Galleries (2014) A. Coats 2013. Reproduced by kind permission of the Trustees of the National Museum of the Royal Navy.

Above: Fig. 312. Ground floor of Portsmouth Storehouse No. 10 (1776, 1/59) looking south along the eastern bay, showing renewed brickwork and timber pillars and beams during its refurbishment for the twentieth century Babcock Galleries (2014) A. Coats 2013. Reproduced by kind permission of the Trustees of the National Museum of the Royal Navy.

Fig. 312. Ground floor of Portsmouth Storehouse No. 10 (1776, 1/59) looking south along the eastern bay, showing renewed brickwork and timber pillars and beams during its refurbishment for the twentieth century Babcock Galleries (2014) A. Coats 2013. Reproduced by kind permission of the Trustees of the National Museum of the Royal Navy.

Fig. 313. Ground floor of Portsmouth Storehouse No. 10 (1776, 1/59) detail of renewed brick arches displaying twentieth century ordnance in the twentieth century Babcock Galleries (2014) A. Coats 2013. Reproduced by kind permission of the Trustees of the National Museum of the Royal Navy.

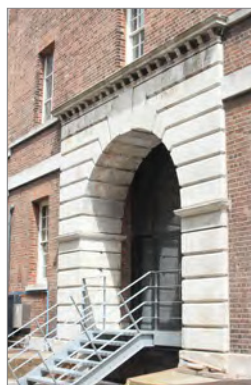
Fig. 314. Currently the rear (west) elevation of Portsmouth Storehouse No. 10 (1763, 1/59), which was originally the front elevation

facing the North Camber, showing the new glazed entrance refurbished for the twentieth century Babcock Galleries (2014). A. Coats 2014. Reproduced by kind permission of the Trustees of the National Museum of the Royal Navy.

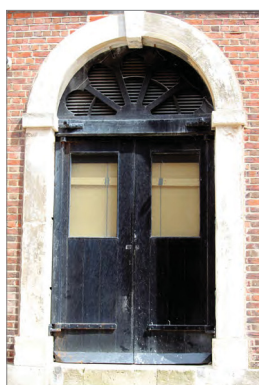
Fig. 315. A rear (west) door of Portsmouth Storehouse No. 10 (1776, 1/59), facing the North Camber. A. Coats 2014. Reproduced by kind permission of the Trustees of the National Museum of the Royal Navy.

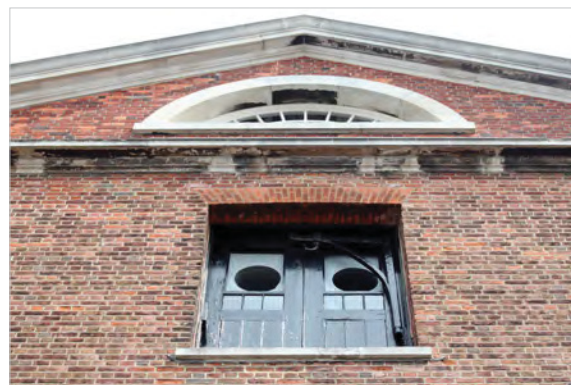
Fig. 316. A refurbished rear pediment of Portsmouth Storehouse No. 10 (1776, 1/59), showing the access doors to the upper floor and cast iron bracket (2014). A. Coats 2014. Reproduced by kind permission of the Trustees of the National Museum of the Royal Navy.

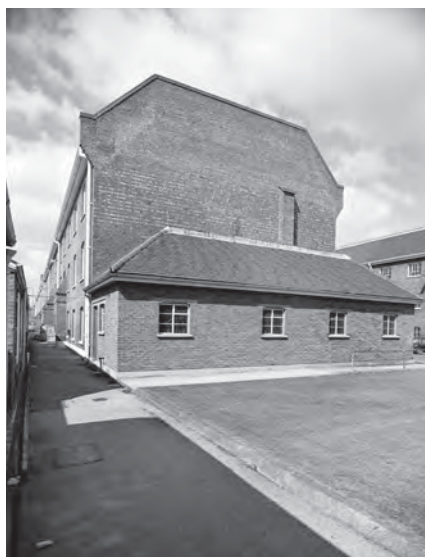
Fig. 317. J188/01/71. Photograph of Storehouse Nos 15, 16 and 17 (28 Apr 1971) from the west, showing the former site of Storehouse No. 14 or West Sea Store (1771), which suffered a direct hit on 24 August 1940. ©Crown copyright.HE.

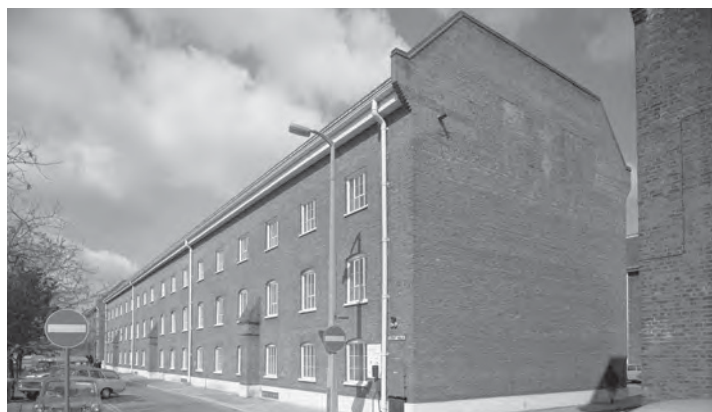
Fig. 318. J188/03/71. Photograph of Storehouse Nos 15, 16 and 17 (28 Apr 1971) from the east, showing 'GR 1771' inserted in darker bricks on the east elevation of Storehouse No. 16. ©Crown copyright.HE.

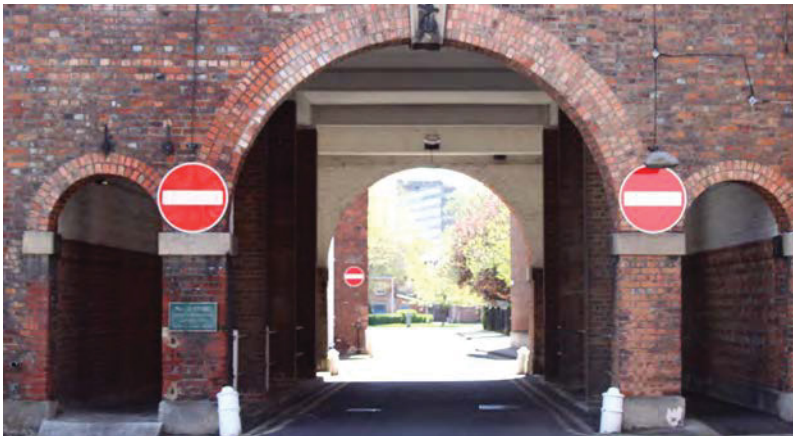
Fig. 319. Arches cut through the former Portsmouth Great Ropehouse (1771, 1/65), north elevation, when it ceased making rope in 1868. A. Coats 2013. Reproduced with the permission of the MoD.

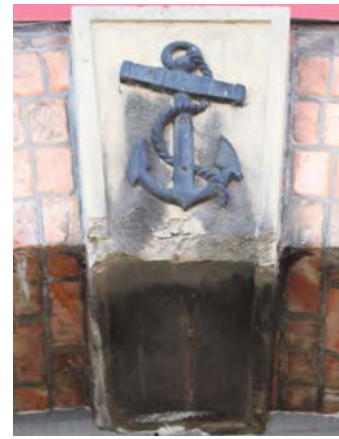
Fig. 320. Keystone (probably twentieth century) on the north elevation of the vehicular arch cut through the former Portsmouth Great Ropehouse (1771, 1/65) in 1868. A. Coats 2013. Reproduced with the permission of the MoD.

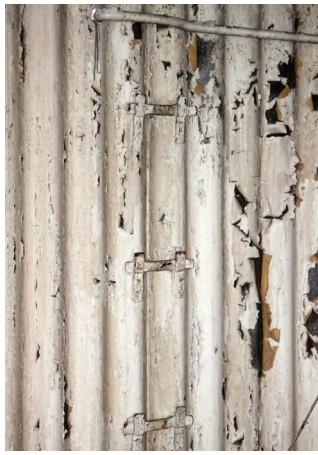
Fig. 327. Original corrugated iron and fittings inside Portsmouth Fire Station (1843, 1/77). A. Coats 2012. Reproduced with the permission of the MoD.

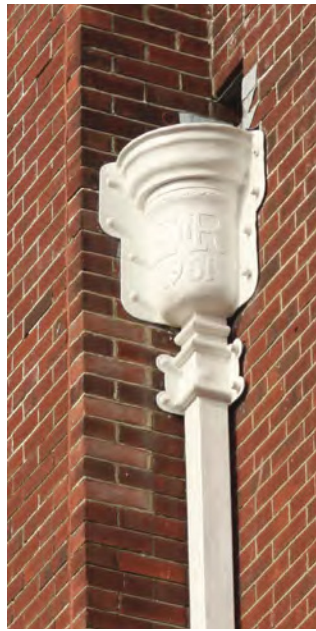
Fig. 328. Rainwater hopper dated 1961, west elevation of Portsmouth Fleet Headquarters, Jago Road (1961, 1/80). A. Coats 2014. Reproduced with the permission of the MoD.

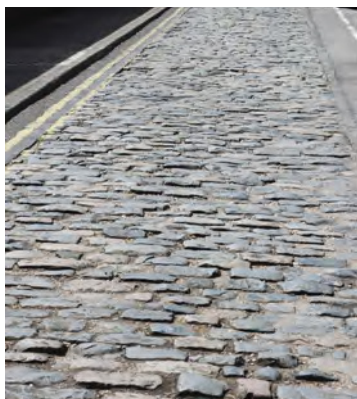
Fig. 330. In Portsmouth Admiral's Walk, a seven foot wide section of setts running along the north side of 1/81 (c.1850–90). A. Coats 2013. Reproduced with the permission of the MoD.

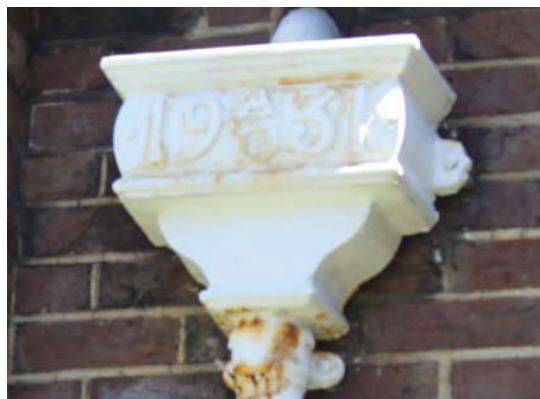
Fig. 331. Rainwater hopper dated 1931 on Portsmouth South Office Block Annexe (1931, 1/87C). A. Coats 2013. Reproduced with the permission of the MoD.

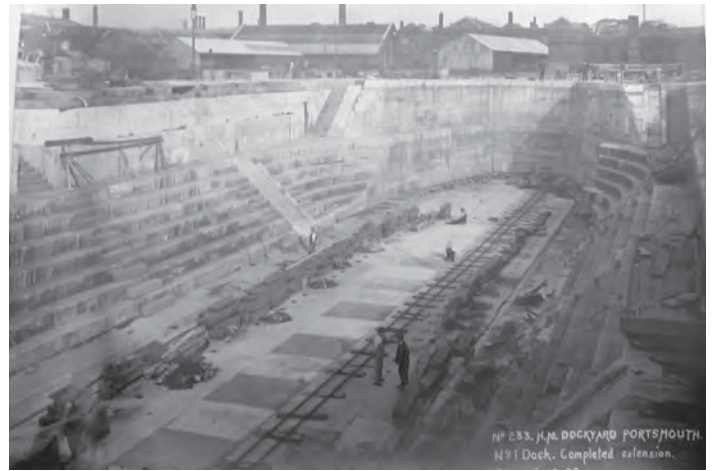
Fig. 335. Dock No. 1 (6.1.1909). Photograph of completed extension, looking northeast. TNA, ADM 195/79 (1857–1915). 100 photographs depicting construction works at Portsmouth Dockyard. Reproduced with the permission of The National Archives.

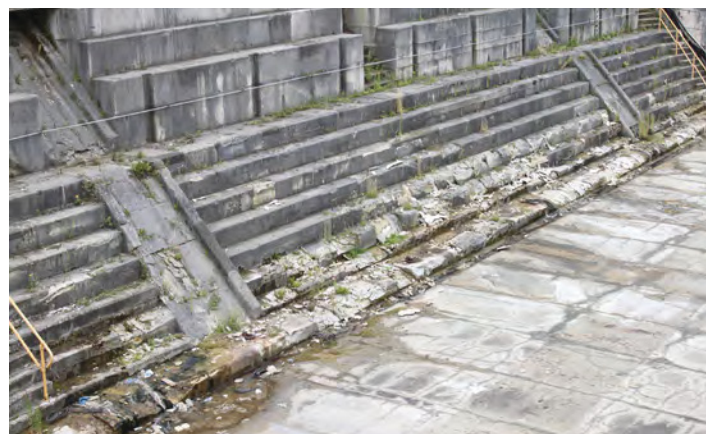
Fig. 339. Portsmouth Dock No. 6 (1700), showing disintegration of the lower altar stones through weathering. Following the straightening of the western jetties for the new *Queen Elizabeth* class aircraft carriers in the early 2000s, it is no longer connected to the harbour and no longer has the environmental protection of seawater. A. Coats 2012. Reproduced with the permission of the MoD.

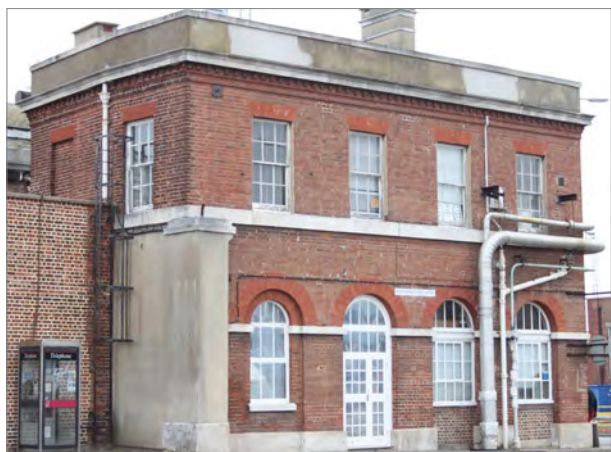
Fig. 352. Former Portsmouth Chief Inspector's Office (1857, 1/138) at the western side of the first Marlborough Gate, adjoining the original Dockyard Wall (1711). A. Coats 2013. Reproduced with the permission of the MoD.

Fig. 352. Former Portsmouth Chief Inspector's Office (1857, 1/138) at the western side of the first Marlborough Gate, adjoining the original Dockyard Wall (1711). A. Coats 2013. Reproduced with the permission of the MoD.

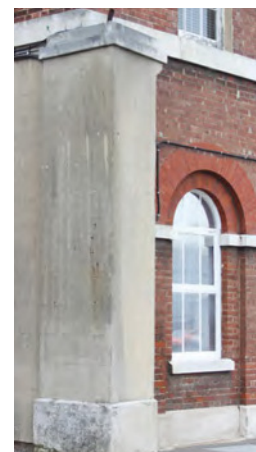
Fig. 354. Western gate pier of the first Portsmouth Marlborough Gate (1711, 1/138). A. Coats 2013. Reproduced with the permission of the MoD.

Fig. 354. Western gate pier of the first Portsmouth Marlborough Gate (1711, 1/138). A. Coats 2013. Reproduced with the permission of the MoD.

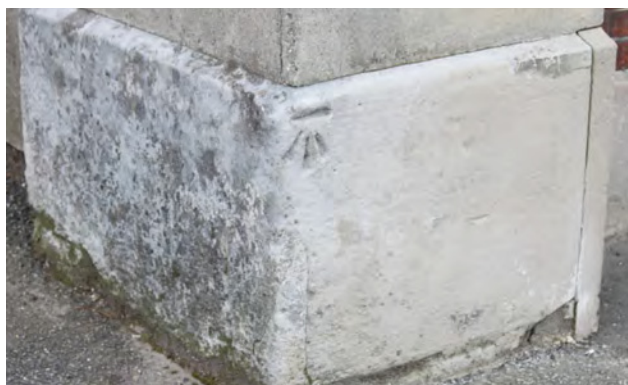
Fig. 355. Plinth bearing a broad arrow at the base of the western gate pier of the first Portsmouth Marlborough Gate (1711, 1/138). A. Coats 2013. Reproduced with the permission of the MoD.

Fig. 355. Plinth bearing a broad arrow at the base of the western gate pier of the first Portsmouth Marlborough Gate (1711, 1/138). A. Coats 2013. Reproduced with the permission of the MoD.

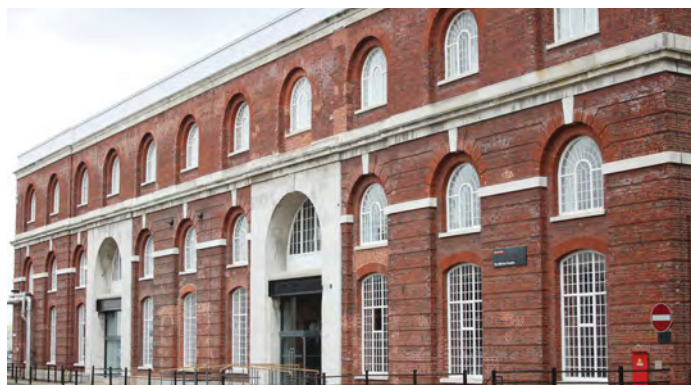
Fig. 356. West elevation of the refurbished Portsmouth Iron and Brass Foundry (1854, 1/140), now BAES HQ. A. Coats 2012. Reproduced with the permission of the MoD.

Fig. 356. West elevation of the refurbished Portsmouth Iron and Brass Foundry (1854, 1/140), now BAES HQ. A. Coats 2012. Reproduced with the permission of the MoD.

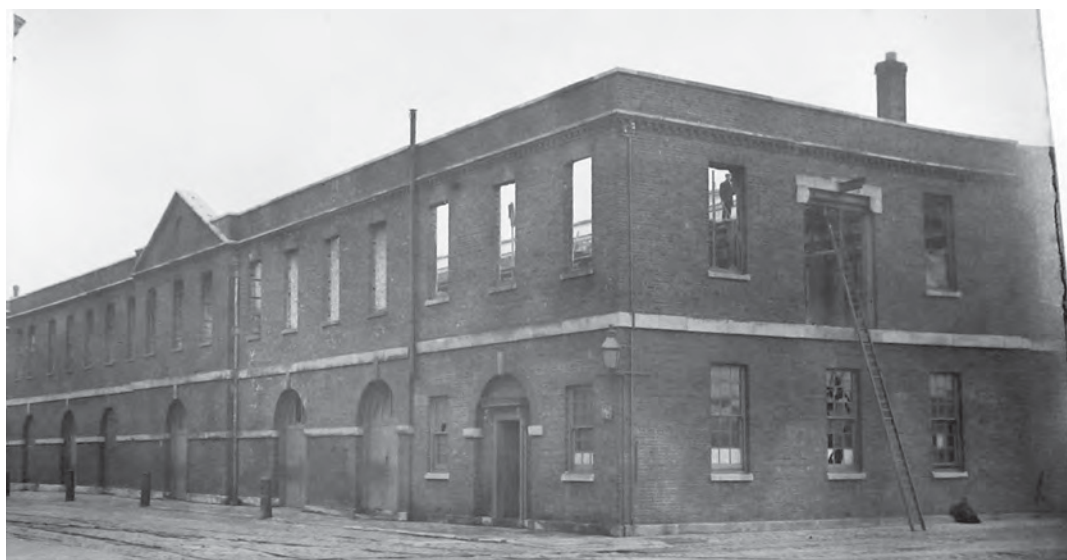
Fig. 357. Storehouse No. 33 before reconstruction after fire 23.3.1908, photograph no. 99. TNA, ADM 195/79 (1857–1915). 100 photographs depicting: construction works at Portsmouth Dockyard. Reproduced with the permission of The National Archives.

Fig. 357. Storehouse No. 33 before reconstruction after fire 23.3.1908, photograph no. 99. TNA, ADM 195/79 (1857–1915). 100 photographs depicting: construction works at Portsmouth Dockyard. Reproduced with the permission of The National Archives.

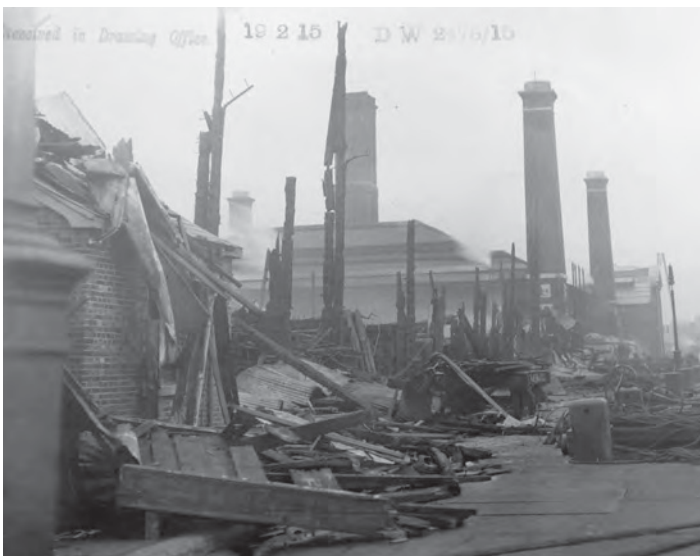
Fig. 360. Damage to Portsmouth No. 1 Slip Jetty looking east, 1.2.1915, with the Smithery and the Steam Factory in the background. TNA, ADM 195/79 (1857–1915). 100 photographs depicting: construction works at Portsmouth Dockyard. Reproduced with the permission of The National Archives.

Fig. 360. Damage to Portsmouth No. 1 Slip Jetty looking east, 1.2.1915, with the Smithery and the Steam Factory in the background. TNA, ADM 195/79 (1857–1915). 100 photographs depicting: construction works at Portsmouth Dockyard. Reproduced with the permission of The National Archives.

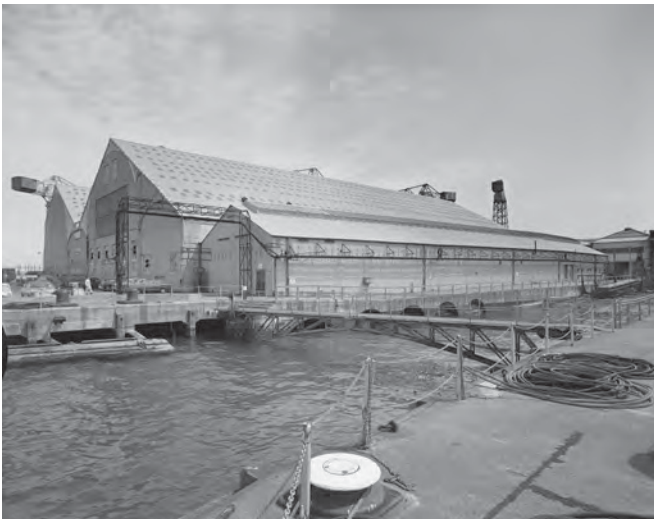
Fig. 368. J297/06. Photograph of Ship Shop Nos 3-4, south of Slip No. 5, before their demolition in 1980 (23 June 1971). ©Crown copyright.HE.

Fig. 368. J297/06. Photograph of Ship Shop Nos 3-4, south of Slip No. 5, before their demolition in 1980 (23 June 1971). ©Crown copyright.HE.

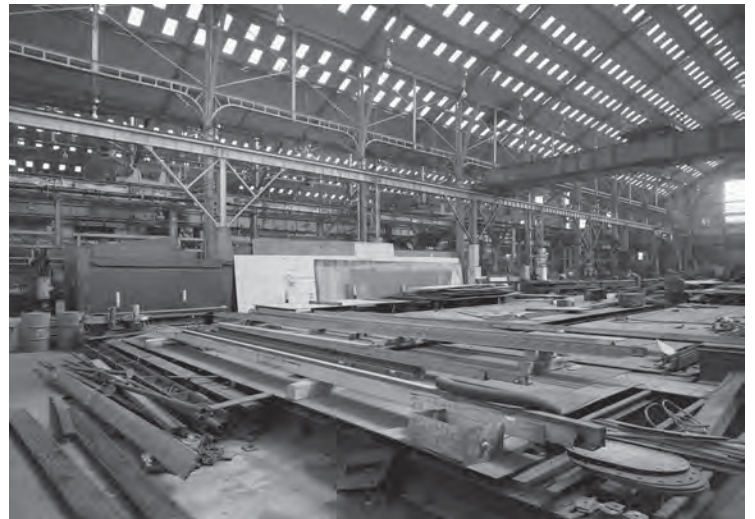
Fig. 369. J297/11. Photograph of the interior of Ship Shop Nos 3-4 before their demolition in 1980 (23 June 1971). ©Crown copyright.HE.

Fig. 369. J297/11. Photograph of the interior of Ship Shop Nos 3-4 before their demolition in 1980 (23 June 1971). ©Crown copyright.HE.

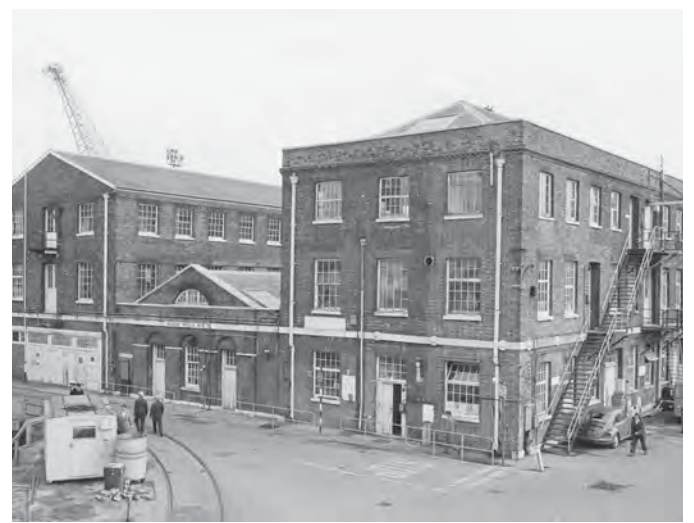
Fig. 370. PK318/07 FL00982.02.001. Photograph of the Block Mills from the southeast (n.d. c.1970s). ©Crown copyright.HE.

Fig. 370. PK318/07 FL00982.02.001. Photograph of the Block Mills from the southeast (n.d. c.1970s). ©Crown copyright.HE.

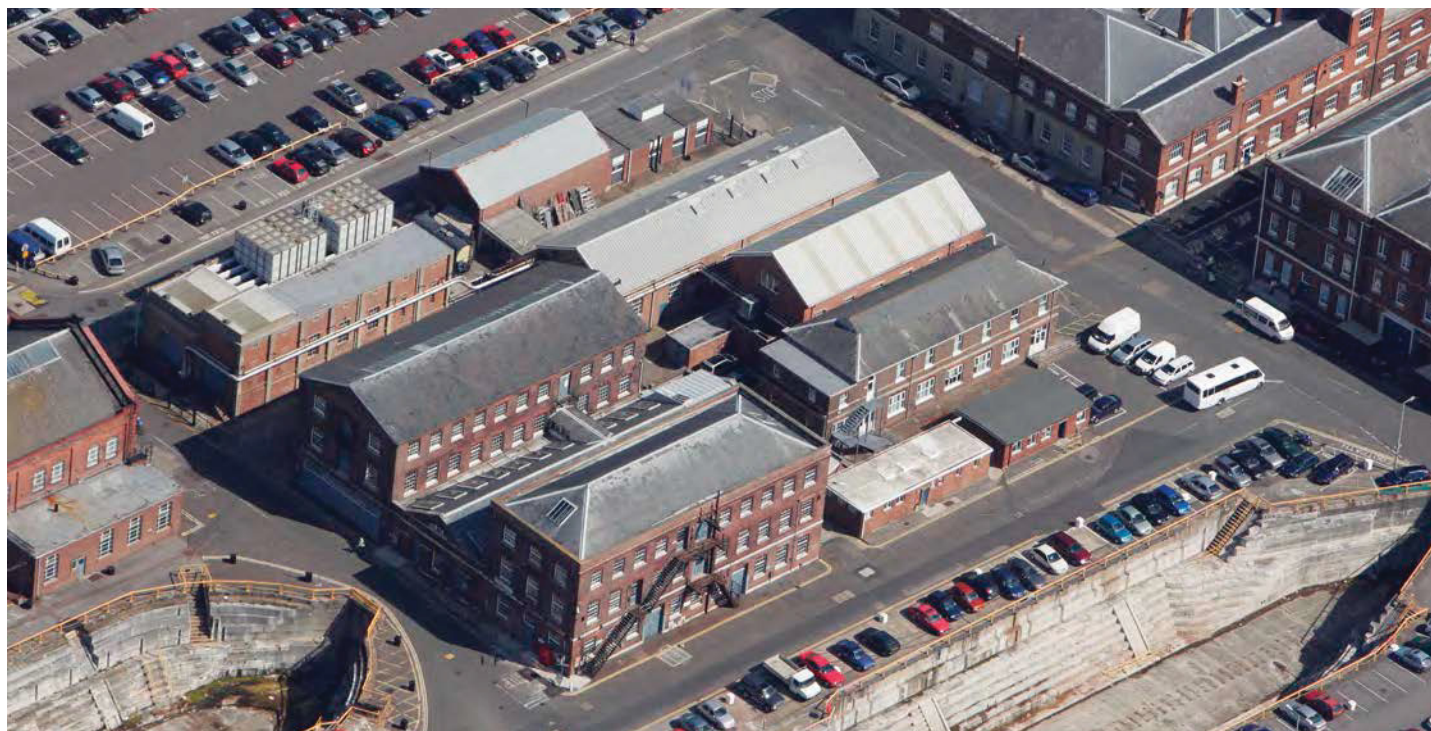
Fig. 371. PK318/07 FL00982.02.002. Photograph of the Block Mills from the southwest with the head of Dock No. 6 on the left (n.d. c.1970s). ©Crown copyright.HE.

Fig. 371. PK318/07 FL00982.02.002. Photograph of the Block Mills from the southwest with the head of Dock No. 6 on the left (n.d. c.1970s). ©Crown copyright.HE.

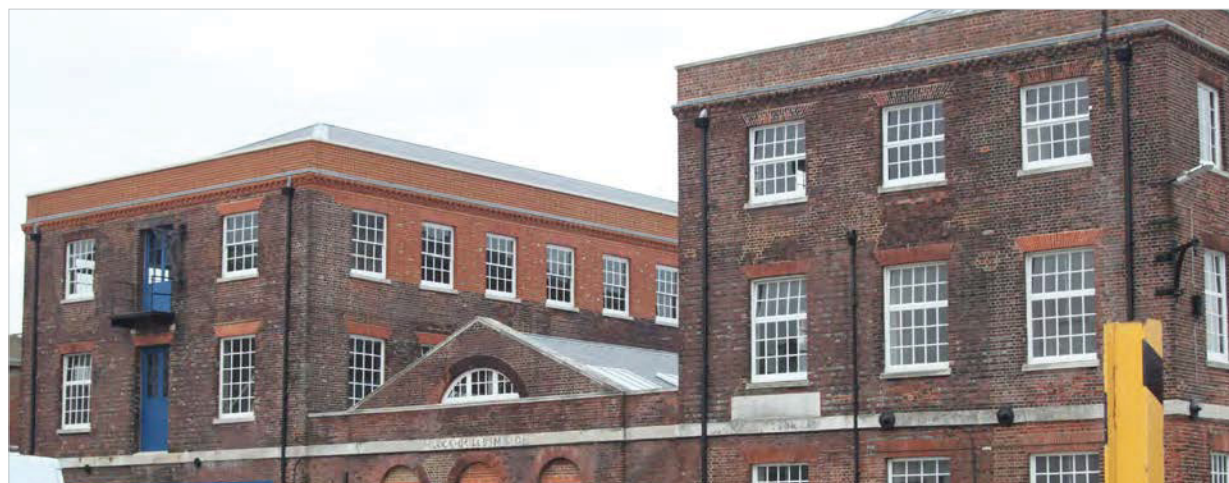
Fig. 372. 23852/27 SU 6300/81. Aerial photograph of the Block Mills from the southwest, before its refurbishment in 2007-8, when the external staircases were removed (11 Apr 2005). ©Historic England.

Fig. 372. 23852/27 SU 6300/81. Aerial photograph of the Block Mills from the southwest, before its refurbishment in 2007–8, when the external staircases were removed (11 Apr 2005). ©Historic England.

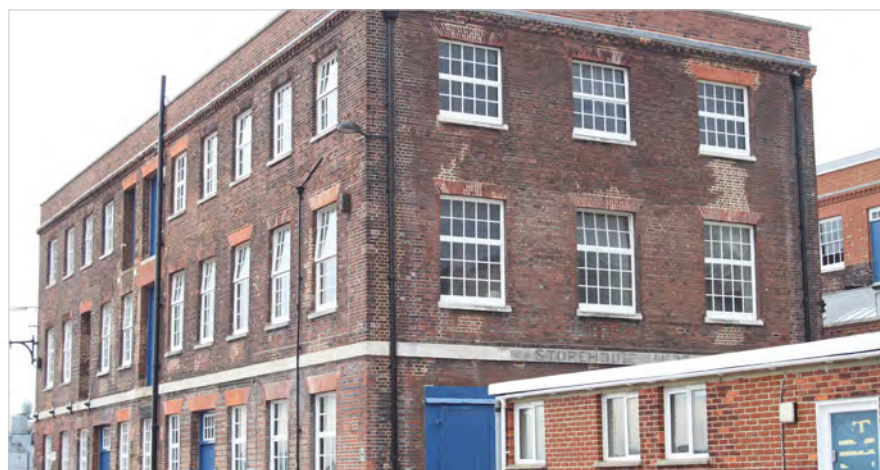
Fig. 373. West elevation of the Portsmouth Block Mills (1802, 1/153), showing the rebuilt North Range. A. Coats 2010. Reproduced with the permission of the MoD.
