Combined House and Barn at Killamarsh.

By S. O. ADDY, M.A.

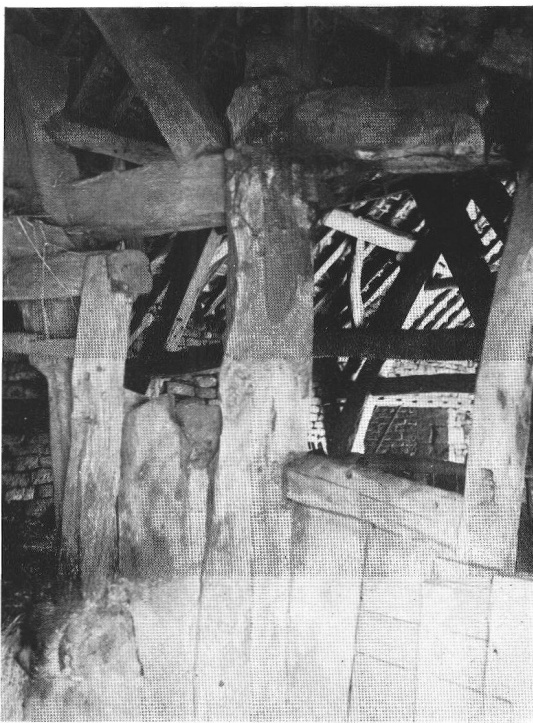
INTERIOR OF BARN AT BOLSTERSTONE.

Derbyshire, is an excellent specimen, and I here give a photograph, taken also about fifteen years ago. It was "built on crucks," which extend from the ridge-beam nearly to the ground.

The timbering of the interior of these old barns and buildings is often elaborate and picturesque, and the massive oak beams are older than the oldest neighbouring houses. The interior of a barn at Bolsterstone, near Sheffield, near the confines of

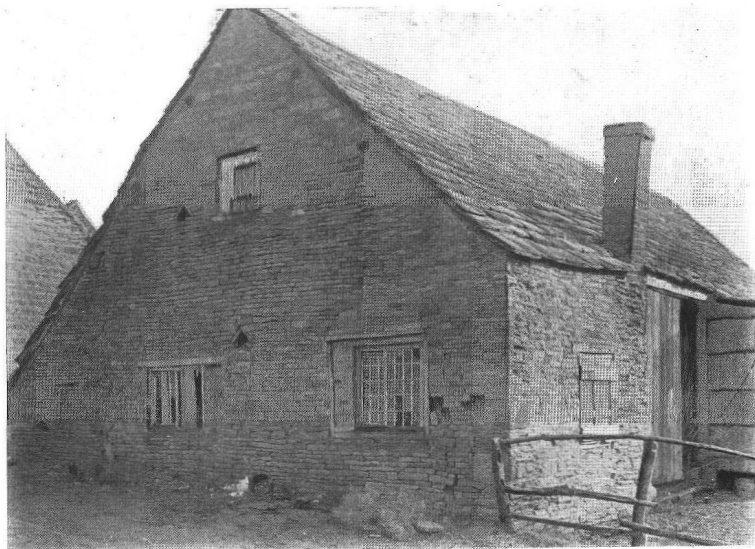
BARN AT KILLAMARSH.

EXAMPLES of the combined house and barn are still pretty numerous in England. But it is not easy to find examples in which an internal communication between the dwelling-house and the part of the building in which cattle are housed still exists. Such a building stood at Killamarsh, Chesterfield, about fifteen years ago, when I made the subjoined plan, and took a photograph of the outside.

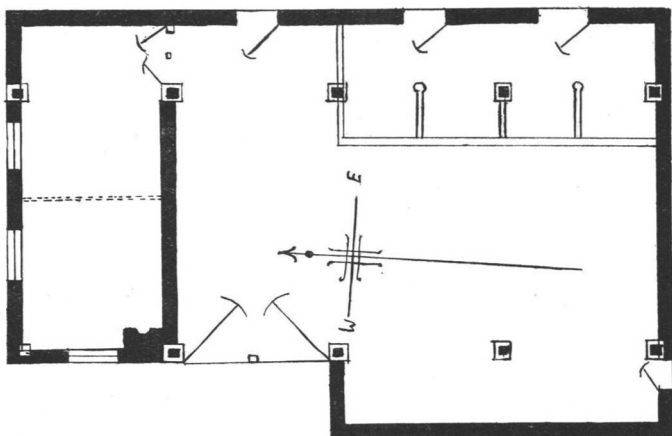
In the German farmhouse the great barn doors are at one end of the building, and the master's house at the opposite end. In England they are in one of the long sides, and the threshing floor divides the dwelling from the cattle stalls and barn.

When I saw the place the house had ceased to be inhabited, and was used, if I remember rightly, as a joiner's shop. There were no "crucks" in the building, but there were nine upright wooden pillars or posts, their bases being shown in the plan. The building was made of thin stones, and the eastern side of the roof sloped down to the lintels of the doors by which the cattle were admitted. The cattle were fed from the barn floor, as in the German farmhouse.

PLAN OF BUILDING AT KILLAMARSH.
