## THE PEACOCK INN, CHESTERFIELD

BY PATRICIA BORNE, TERRY COURTNEY AND PHILIP DIXON

The Peacock Inn project was undertaken between May and August 1974 with the following objectives:

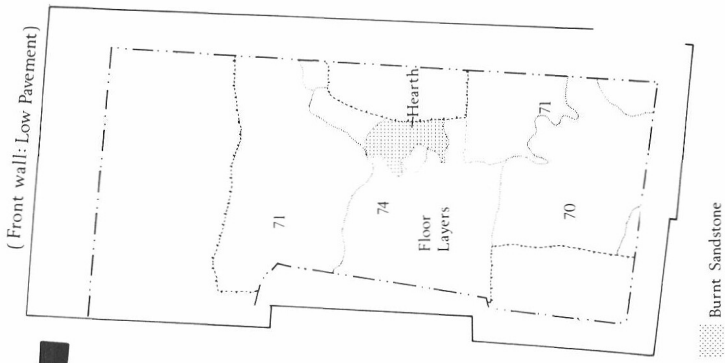
The Peacock Inn: Period IIIa, Period IIIb

Two sandstone walls (of the Period IIIb stone house) were exposed in the excavated cutting; that of the north side of the building (F14), and that of the west end (F16) and apparent continuation F27. The two walls were laid in foundation trenches F72 and F19/F63 respectively and the trenches packed with stone rubble and sand. The inner facings and stone rubble cores of the clay bonded walls were visible, but the outer facings lay beyond the limits of the excavation, as must have any southern west-east return wall.

The north wall F14 was built in foundation trench F72 which had been dug through the floor layers of the Period IIIa house. The trench was partly sealed by F17. The walls F14 and F27 were roughly bonded and doubtless built at the same time. The foundation trenches for the two ends of the west wall F27/F16 were both narrow.

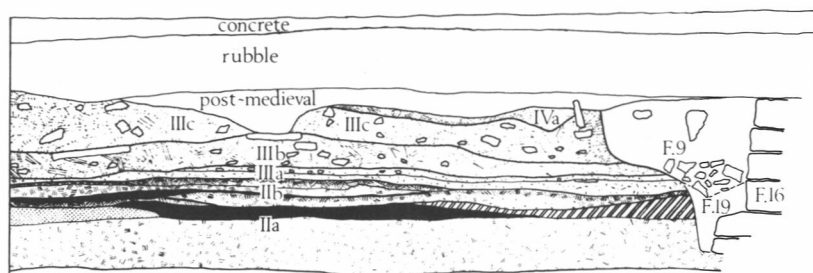
IVa	F.22	Yellow/brown clay
	F.9	Robber Trench
IIIc	F.24	Clay
IIIb	F.58	Yellow/brown clay & angular stones
	F.16	N-S stone wall
	F.19	Foundation Trench
IIIa	F.70	Hard packed sand & crumbly sandstone
	F.71	Earthy clay with charcoal
IIb	F.79	Clay with burnt upper surface
	F.83	Clay with burnt patches
	F.84	Thin charcoal spread
	F.85	Earthy clay with hard, reddened surface
	F.89	Slightly burnt, hard, red clay surface
IIa	F.90	Powdery charcoal/slag spread
	F.94	Hearth
	F.92	Thick, compact clay layer
I	not shown	Features cut into natural

The south baulk section profile (Fig. 6) shows that F16 was built in a trench (F19) dug through the Period IIIa floor levels, F70/F71. This trench corresponds with F63, the narrow foundation trench for F27 at the north end of the wall. This west wall was built from the west side.

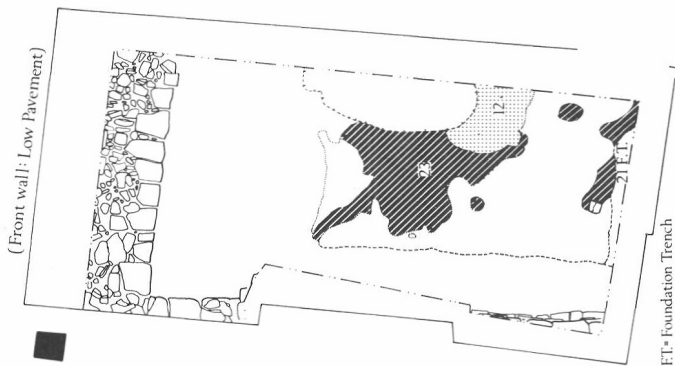
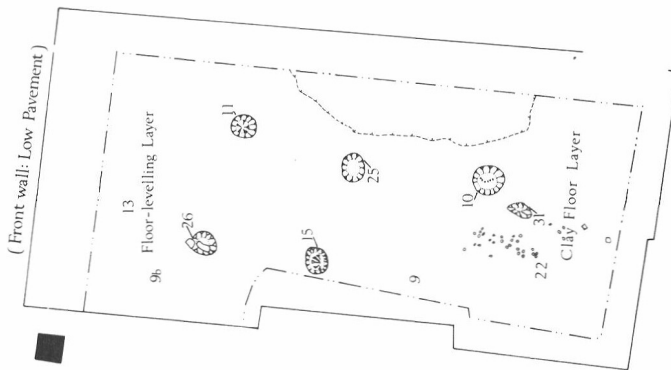
PERIOD IIIc

N.B. Post-holes 26 & 31 are sealed by F13,  
 Post-holes 10, 11, 15 & 25 cut F13.

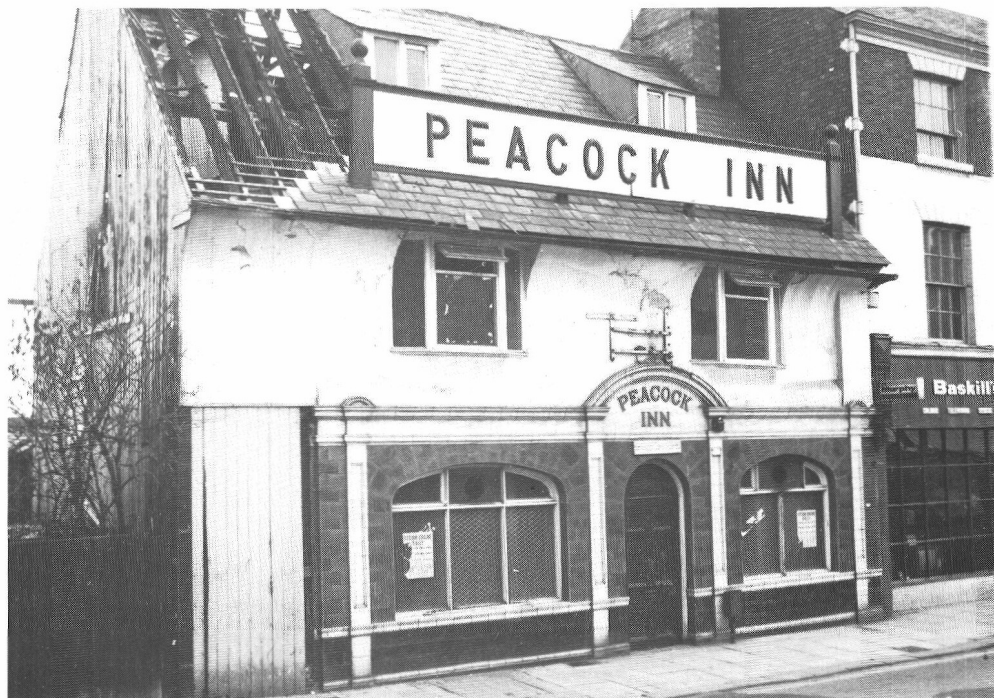
1 (a) The Peacock Inn from the north: Bays 2 and 3. Steep pitch of roof and cove under eaves indicate the survival of a timber-framed building behind the later façade.

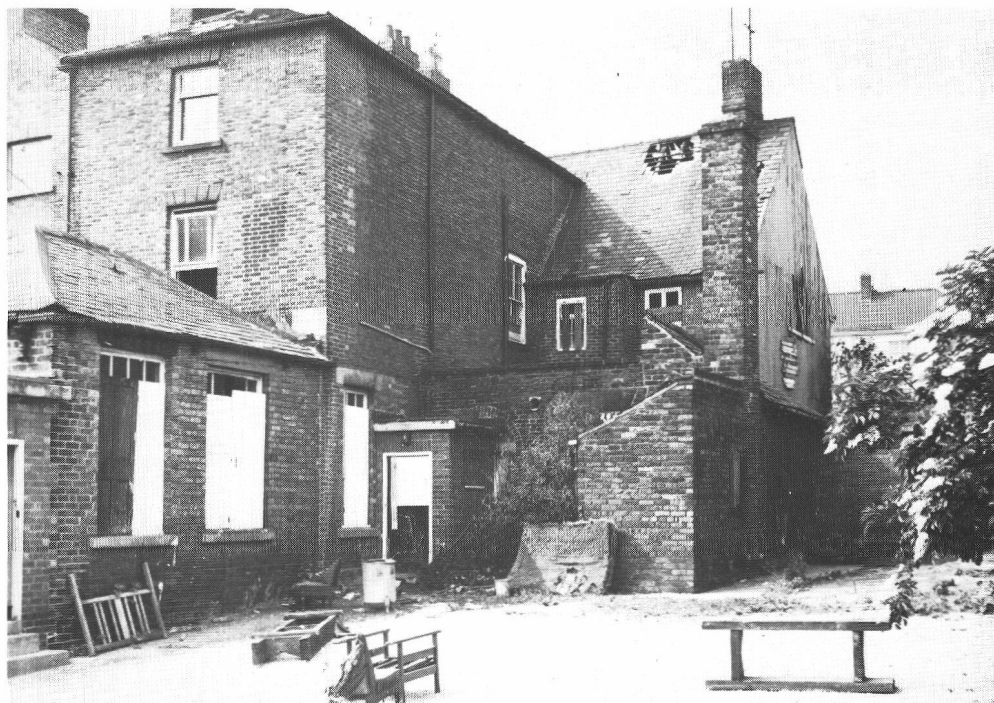
1 (b) The Peacock Inn from the south: 19th century wing, outbuildings and rear of Bay 2.

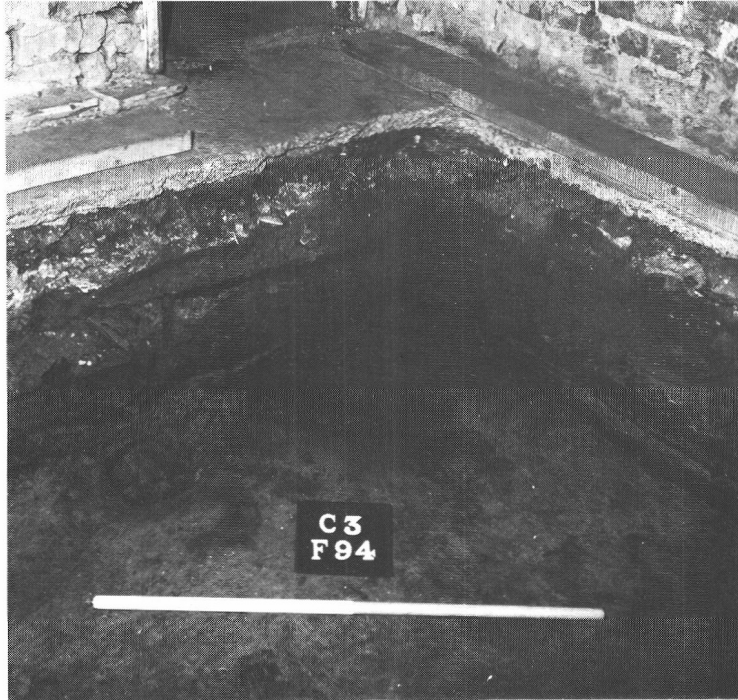
2 (a) Bay 3 excavation: Period IIa hearth (F94) with later floor levels visible in sections. North is to the left.

In the south-east corner of CIII a hearth site (F94) was established, comprising burnt sandstone slabs. A thick (up to 6 cm) layer of powdery slag and charcoal (F90) spread outwards from the hearth, petering out within 2 m to the north-west. This layer contained the earliest potsherds from the CIII strata: a vessel base of a fabric similar to 11th century Derby ware was found, but abraded, clearly residual, and of no significance for dating purposes (Fig. 19, 4). The hearth was overlain by a patch of burnt red hard clay. During the period of use of this hearth, the adjacent floor area were made up by spreading thicknesses of sand where necessary.

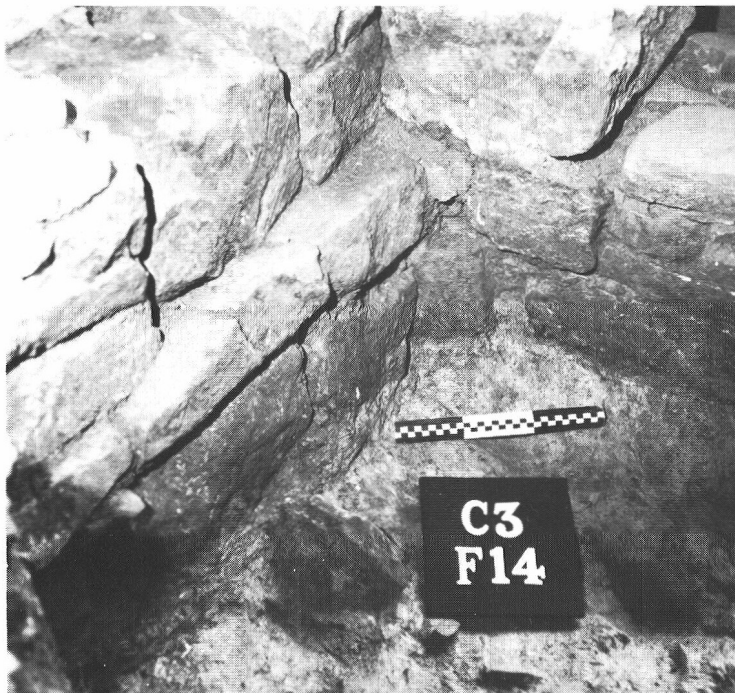
2 (b) Period III stone walls: F27 (left, west), and F14 (top, north).

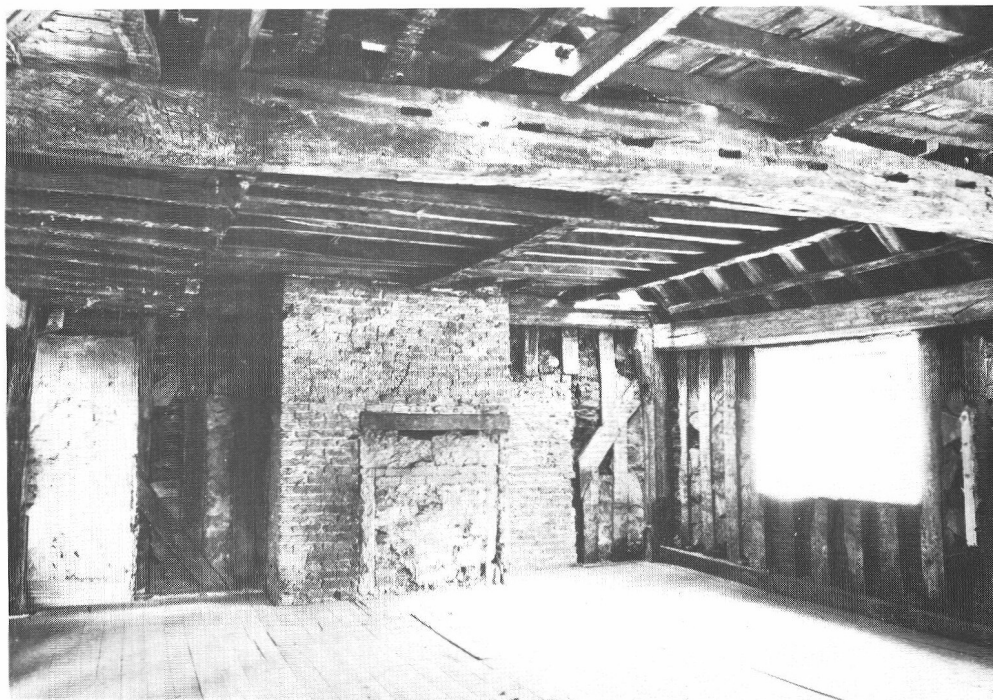
3 (a) The Peacock Inn: Bay 3, first floor, looking north-west. Some original stone infill survives between studs. Inserted second floor rests on tie-beams of Trusses III and IV.

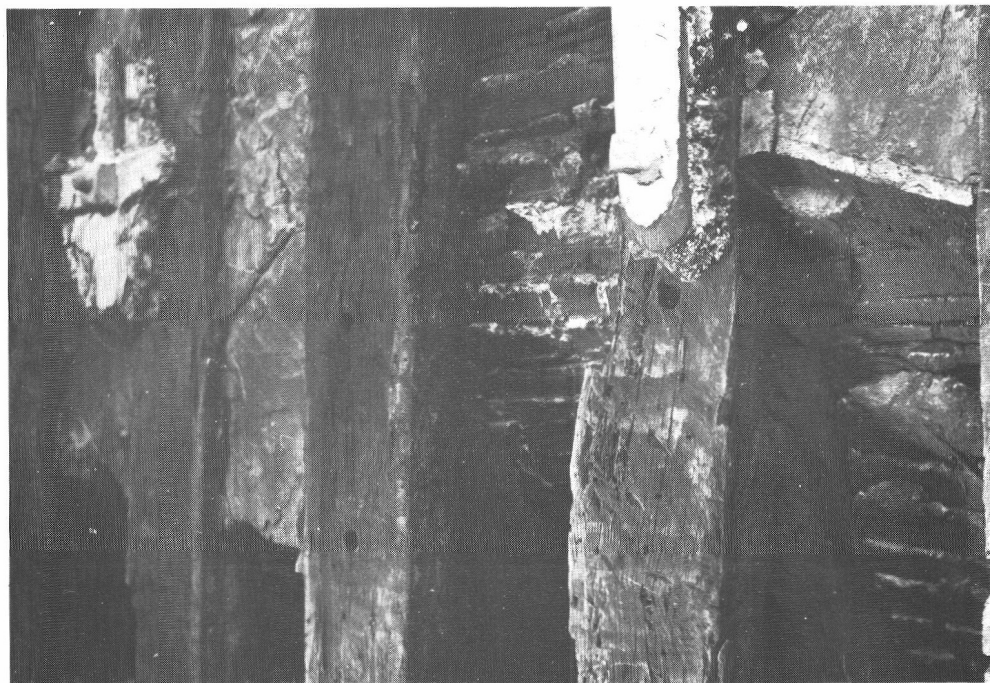
3 (b) The Peacock Inn: Bay 3, first floor, north wall from the interior showing studs and coving brackets, both grooved for infill.

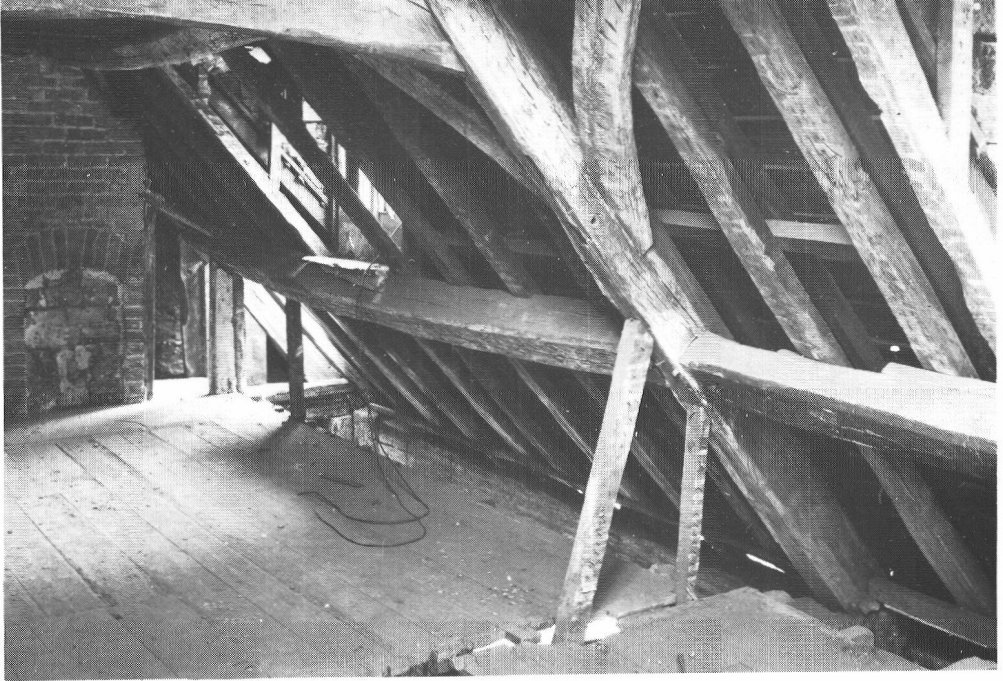
4 (a) The Peacock Inn: north roof slope looking west. East face of Truss III with recently-raised collar. The new roof has been constructed outside the original rafters. Floor, chimney, dormer and horizontal timbers for attic ceiling are all inserted.

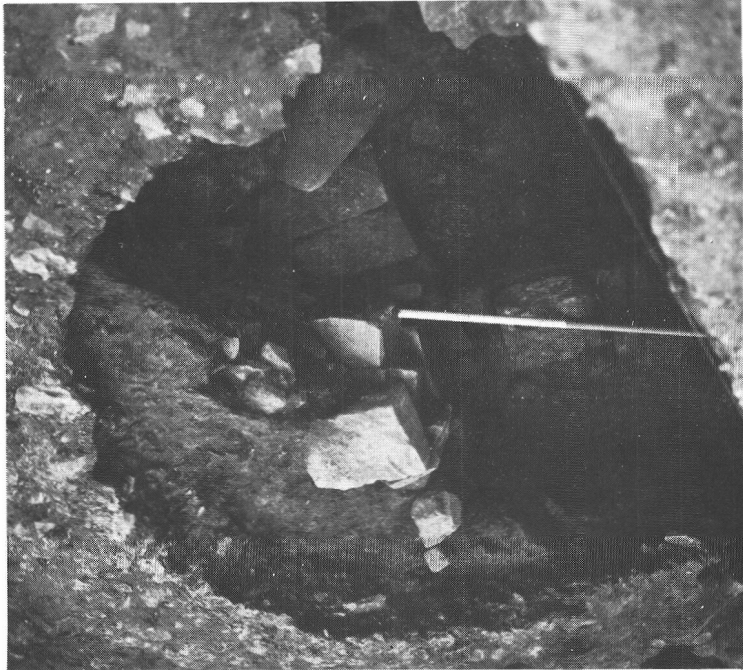
4 (b) The Peacock Inn: CVII excavation F545, stone-lined cess pit (Period III). North is at the top of the photograph.

The pit comprised a stone-lined square soak-away built within a sub-circular shaft. The stone walls of the pit—F557 (E), F558 (N), F559 (W), F560 (S)—were partly dry and partly bonded with grey clay, and the spaces between them and the sides of the shaft filled with tightly-packed yellow clay. The pit walls were constructed of sandstone, the east wall F557 having the largest and most regular coursing. The north wall F558 had been doubled in thickness with an extra facing of blocks built on to the original and probably too narrow wall. This wall included some small river-worn boulders.

The pit fill consisted of dark-grey, sticky clay (F561), grading downwards into a yellow clay (F562) containing water-worn boulders and coal fragments. Both the clay elements were streaked with cess stains.

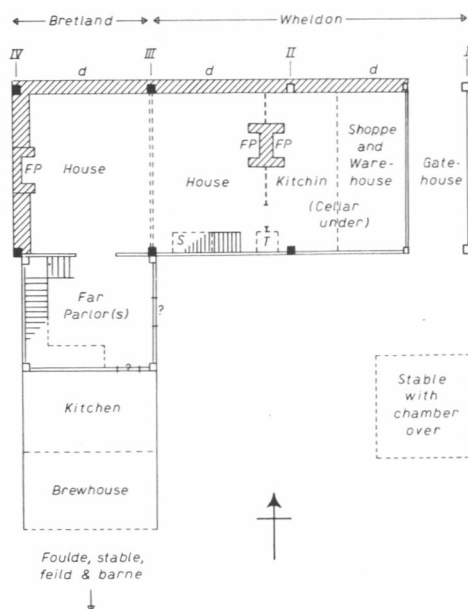
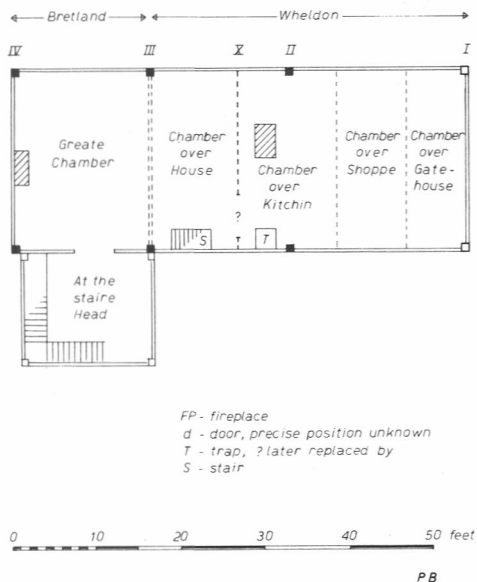
Fig. 16 The Peacock Inn: possible room arrangement, 1680-91

The decline in status of the building to multiple occupation resulted in much alteration—and damage—to its fabric. The alterations were not all carried out as a single operation but constituted a series of modifications, of which none is individually datable, though certain relative sequences can be discerned. Some insertions, however, such as those of the chimney stacks, probably initially of stone, must date to the early stages of the conversion. The division into two dwellings necessitated the complete closure, if the inventories are correctly interpreted, of the formerly open Truss III, and, to supplement the two existing partitions, many more were added. We know from the 1687 conveyance that the tenants who preceded the Wheldons and Thomas Bretland were both named Webster, Nicholas and William. We do not know whether they were related, and their common name may be no more than a coincidence; but they may well have been brothers, sharing and subdividing a hitherto single dwelling. After the division the eastern tenement needed access to its first floor accommodation, and the cutting of the joists in Bay II suggests a progression, as shown in Fig. 16, from a simple trap door to a more convenient stair. The upper rooms, except the 'greate Chamber' in Bay III, are likely to have been ceiled over at an early stage, though it is not recorded that the areas above were used for storage at the time of the inventories. To this earlier period probably also belongs the replacement (or encasement) of the west and north ground floor framing with stone walls, and these are therefore included on the plan (Fig. 16).
