THE NORBURY MILL SURVEY, 1983-84: THE DEVELOPMENT OF AN EARLY SEVENTEENTH CENTURY WATER MILL

By CHRISTOPHER DRAGE

(Trent & Peak Archaeological Trust, University Park, Nottingham NG7 2RD)

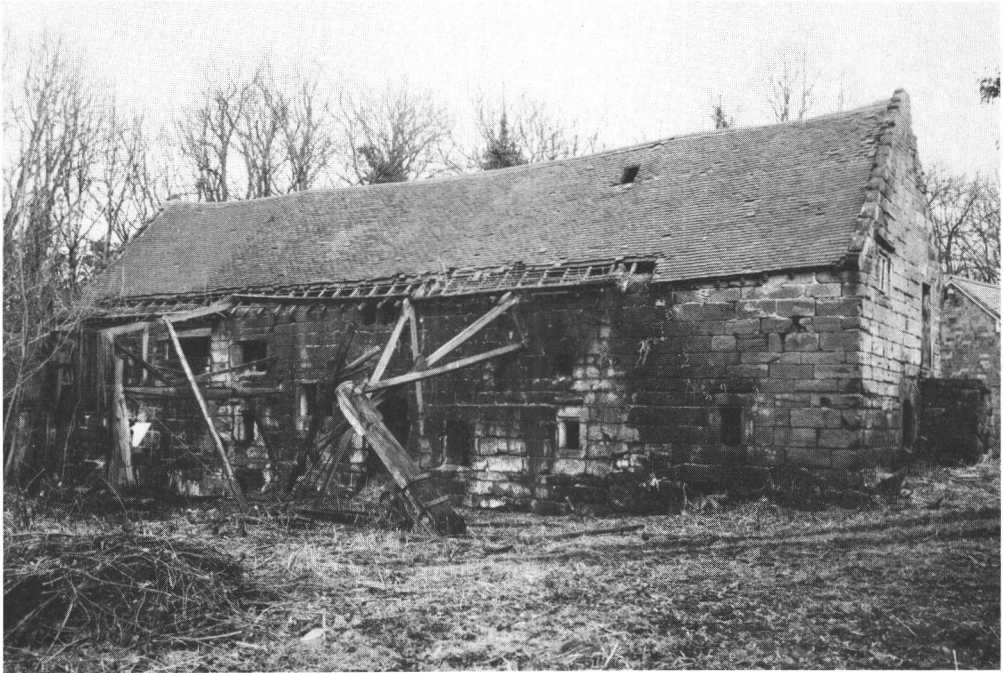
Plate 2 Norbury Mill: west elevation. (Note the collapsed crane and saw cradle.)

was led to the workshop. The tail races were covered with large timbers, probably railway sleepers. A timber cradle was constructed to support a saw, powered from the northern pit gear by a drive taken through the wall. A crane was driven off the southern pit gear, by a drive taken through the wall.

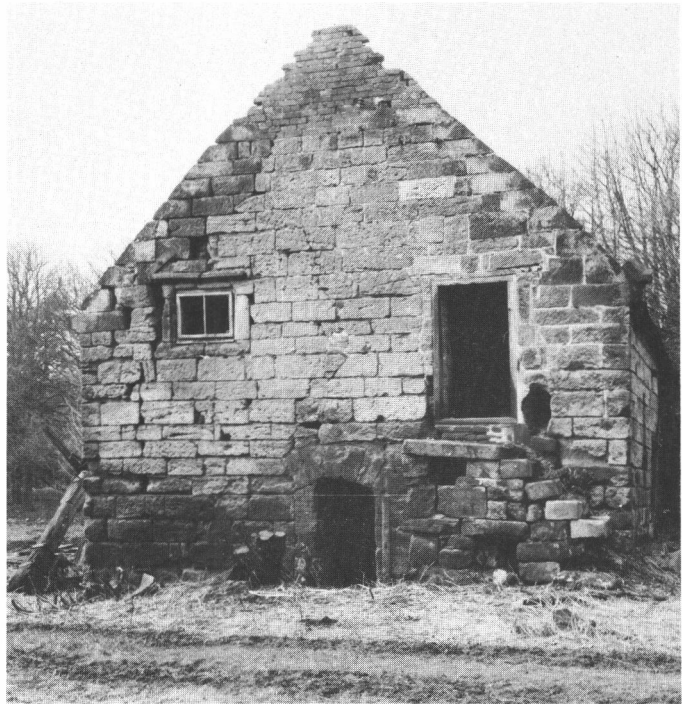
Plate 3 Norbury Mill:
south elevation.

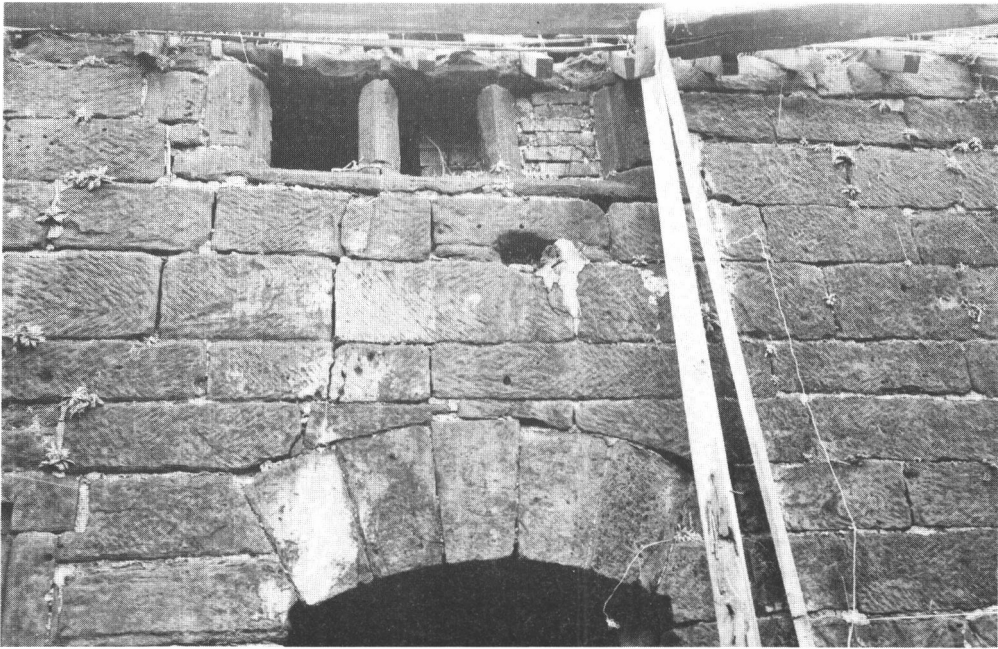
Plate 4 Norbury Mill: west elevation — detail. (Note the head of the west door and the common rafters trenched into the head of the wall and the first floor window.)

The thatch was replaced with irregular, staffordshire-blue tiles. To accommodate the new roofing material and to counter the effects of settlement, the tops of the walls were altered. In places brick was used to repair and raise the upper courses of the walls; elsewhere common rafters were trenched in to the ashlar of the wall top.

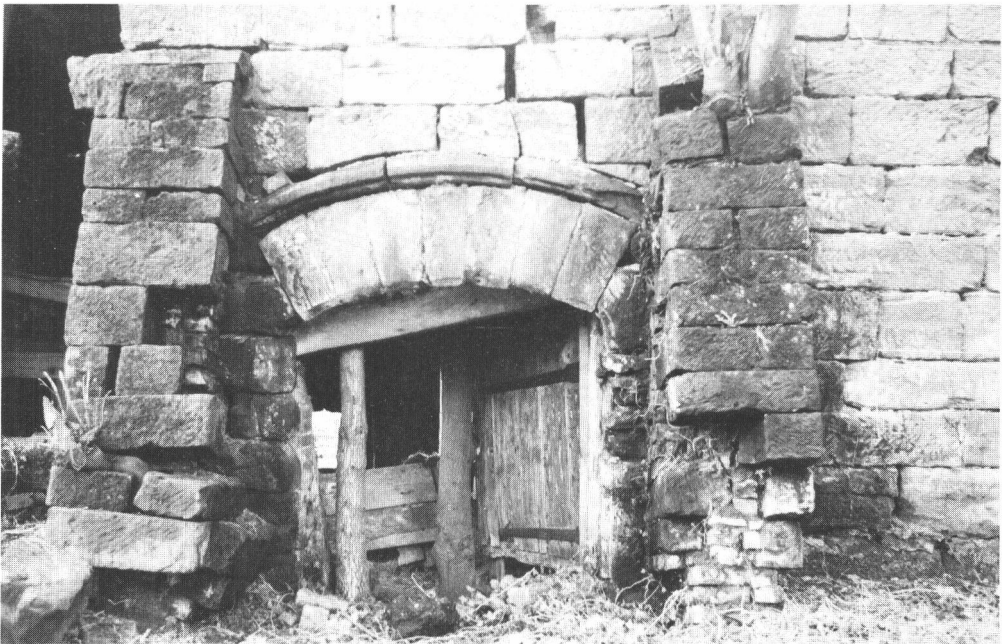
Plate 5 Norbury Mill: east door.

segmental-arched heads of plain voussoirs, with a flat timber lintel on the interior. The doorway on the east front of the building is wider and has a heavy projecting keel-shaped drip-mould. Such features clearly distinguish it as the 'main' doorway, but this may be an architectural conceit rather than a true indication of function, since it could be approached only by crossing the mill leat. The door, of oak planks studded with iron nails and hung from iron strap hinges, has eighteenth century inscriptions, and may be an original feature.

Evidence of mill wrights' work at Norbury, which may be connected with extensive reconstructions of the machinery, is provided by a series of inscriptions on the main east door and its lintel. 'WB 1736', and below it '1748', suggest two pieces of work by the same man. 'TO 1793' indicates further repair in the later eighteenth century. A phase of nineteenth century reconstruction is commemorated by 'SM 1833'. While it is probable that elements of early machinery remain at Norbury, it must be stressed that the surviving machinery is only part of that utilised in the relatively recent final phases of use. The present arrangement of the southern machinery replaces that employed in Phase 2, and is driven by a cast-iron shaft of probably nineteenth century date, inserted in Phase 4. The driving of the stones directly from the pit-wheel is a technologically primitive method, used since the Roman and Anglo-Saxon periods. However, in the final phases, 3 and 4, sawing, rather than milling, may have been the chief activity at the mill. Therefore, this comparatively primitive arrangement of the southern milling machinery probably arose from a reduced requirement, and need not represent an intact survival of early machinery.

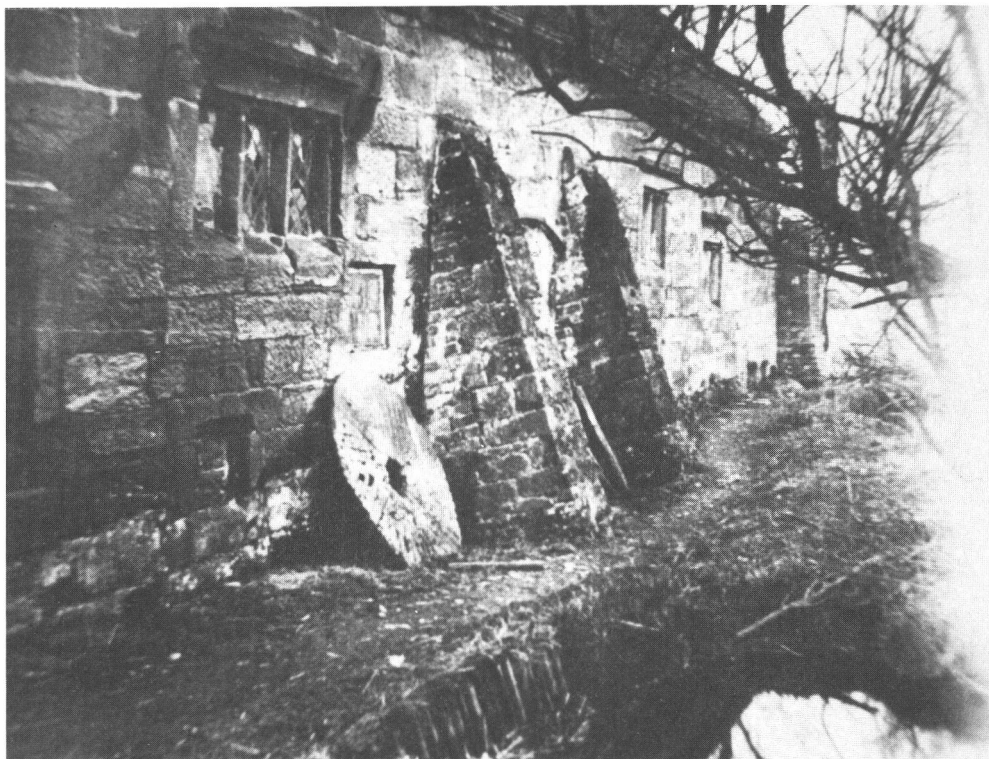
Plate 6 Norbury Mill: east elevation c. 1885.

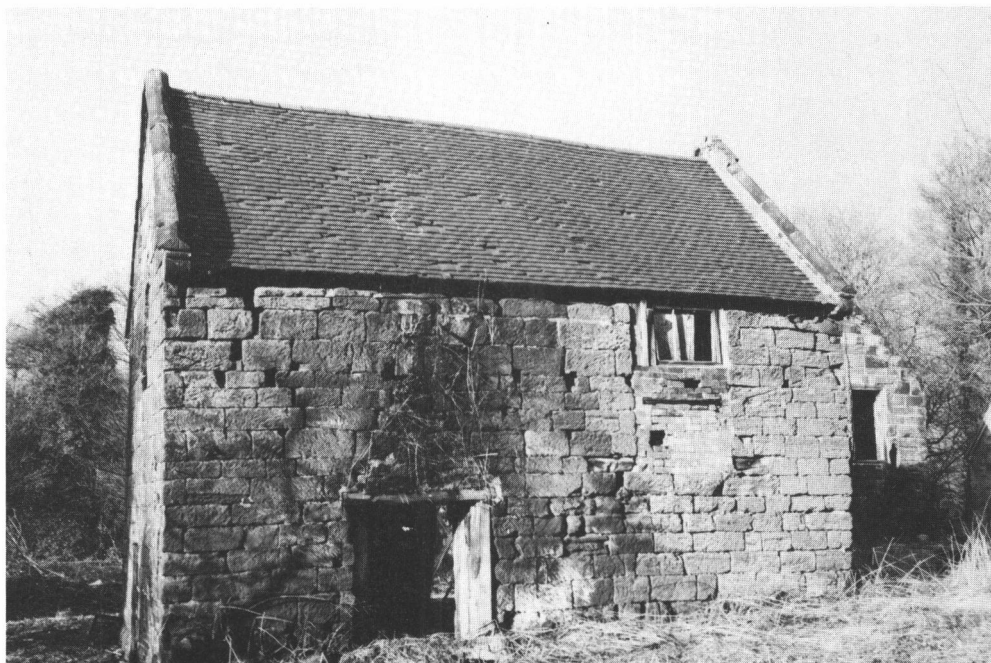
Plate 7 Norbury Mill: south elevation of the malt house.

The malt kiln comprises a rectangular, two-storey structure, aligned east-west and built of coursed rubble with ashlar dressings. The ground floor has flat lintled, opposed doorways in the centres of the long sides. The first floor chamber, originally with a timber floor resting on joists, is lit by two, two-light windows, with chamfered mullions and moulded surrounds. The roof has parapeted, coped gables, resting on stone kneelers, and is now covered with staffordshire-blue

tiles, but may originally have been thatched. The internal walls on the ground floor have been altered, but appear to have thickened and sloped to form a heating chamber at the west end, with a moveable screen or ‘hair’ at first floor level for drying the malt. The constructional details of the structure are similar to the mill and it is probably contemporary. Alterations to the kiln, using brick identical to that employed in Phase 2 work in the mill, suggest it was then converted to form an outhouse or barn. The malt kiln is not recorded in the estate valuation of 1809 (D/641/M/5), and may already have been disused. Until the development of large urban commercial maltings in the nineteenth century, malt kilns were a common feature of estates. In general they are simple functional structures, often inserted into redundant buildings. The quality of the Norbury malt kiln complements the adjacent mill.
