SOME FIELDWORK IN DERBYSHIRE BY TRENT & PEAK ARCHAEOLOGICAL UNIT IN 2000–2001

Compiled by GRAEME GUILBERT

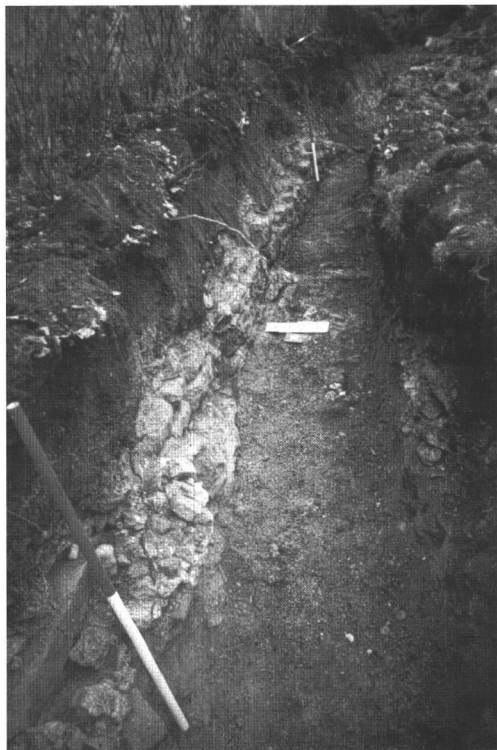
Plate 2: Bolsover Castle: rough limestone footings of possible medieval structure uncovered in side of service-trench within the Great Court. Scale 1m. *Photograph by R. Sheppard.*

The rubble footings of a structure, possibly that of a medieval fortification such as a tower, were found close to the east side of the Great Court (Pl. 2). Elsewhere, in three separate locations at or within sight of entrances, rough platform surfaces (two with steps) formed from a hard conglomerate of mortar and stone/brick rubble were found. One possible explanation may be that they were standing for cannon for the besieged and defending Royalist garrison during the Civil War. A small ?lead-smelting hearth, with a content that included human bone from a nearby burial, may also date from that period.

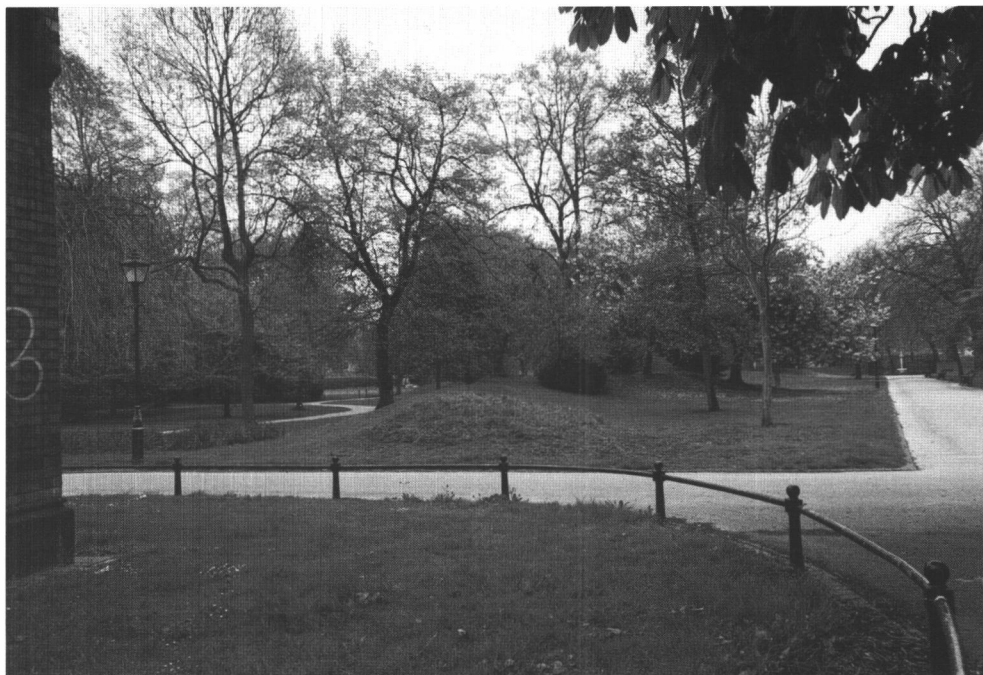
Plate 3: Derby Arboretum: viewed from the Grove Street Lodge in 2000. *Photograph by P. Beswick.*

Of the attendant buildings, the Grove Street Lodge on the west side of the Arboretum was described in 1840 as the Main Entrance to the site; another at the south-east was taken down in 1960. These buildings were designed by London architect E.B. Lamb, in Jacobean and Elizabethan revivalist styles respectively. The Grove Street Lodge had several entrances to allow visitor access to a ticket office, a heated rest-room and for the curator's office and upstairs lodgings. A single-storey extension may have housed a kitchen and teashop. Probably in the late 1860s, the building was extended, bays built and decorative slatework applied to the roof. Lamb used a similar revivalist design at the larger Rose Hill Lodge, built when the Arboretum was extended to the south in 1845/6. This had a tall open hall for public shelter, which, in the 1880s, was adapted for use as a public reading room. Finally, Lamb was responsible for two small 'James I style' pavilions, one at either end of the east-west cross-path; only the east one now remains.

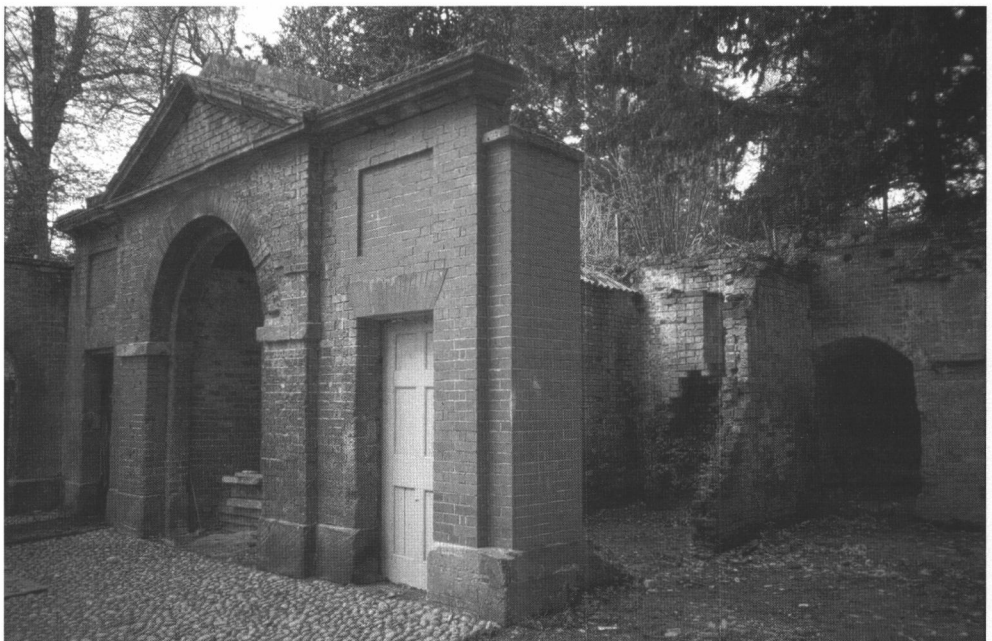
Plate 4: Kedleston Hall: pedimented front of Smithy Range, with some brickwork in foreground replaced following bomb-damage in 1940s. *Photograph by R. Sheppard.*

The structure runs north to south, measures about 24x5.7m, and is brick-built in Flemish and Flemish garden bond with an off-centre three-bay ornamental section topped with a dressed pediment and cornice; this part had a hipped roof, now lost. This section of frontage is the same width as the cobbled drive down which it looks, with the stables to one side and a series of dung-houses on the other. The latter extend back into made-up ground behind a ha-ha wall, and three of the walls of the Smithy Range abut the same material to their full height.

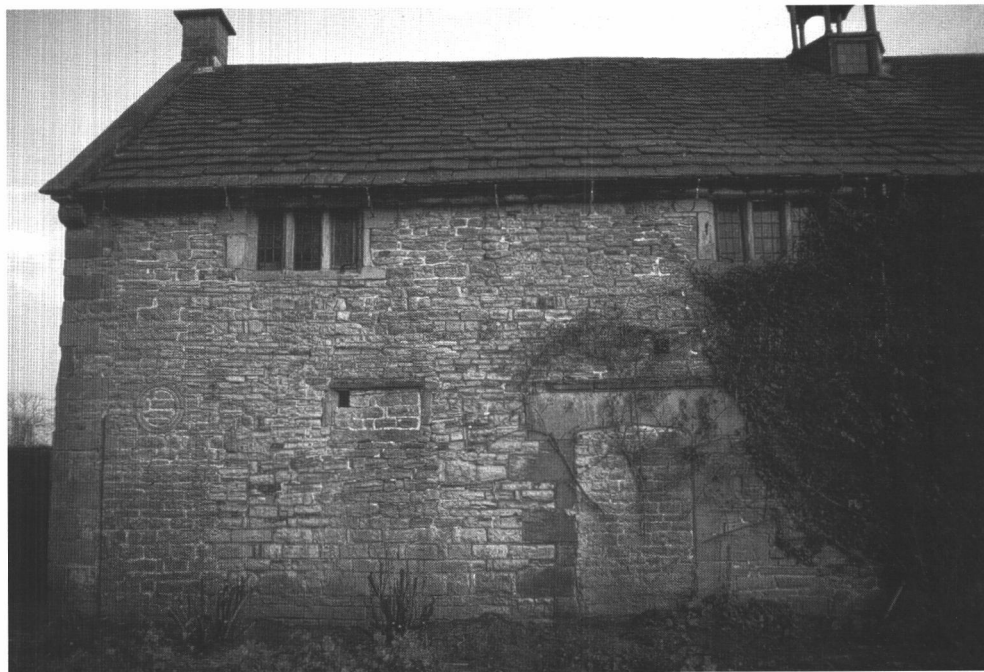
Plate 5: Tissington Hall: north end of west elevation of stables, with stonework infilling former window at centre of ground-floor (and later window at higher level), blocked oculi to left, and blocked 17th-century doorway to right. *Photograph by R. Sheppard.*

The irregular plan of the coach-house, its slight misalignment to the stable and an irregular junction of stonework between the two sections indicate that one had been added to the other. The quality of the thick north wall between the two sections bears more resemblance to the other walls of the coach-house, and observed differences in the nature of the respective foundations suggest the latter pre-dated the stable. Although the timberwork appears to be similar throughout the roof-space, small crescent-shaped carpenters' marks are found only in the coach-house part (observed by R. Howard); any relative dating differences might show up during any future dendrochronological dating
