SOME FIELDWORK IN DERBYSHIRE BY TRENT & PEAK ARCHAEOLOGICAL UNIT IN 2002–2003

Compiled by GRAEME GUILBERT

INTRODUCTION

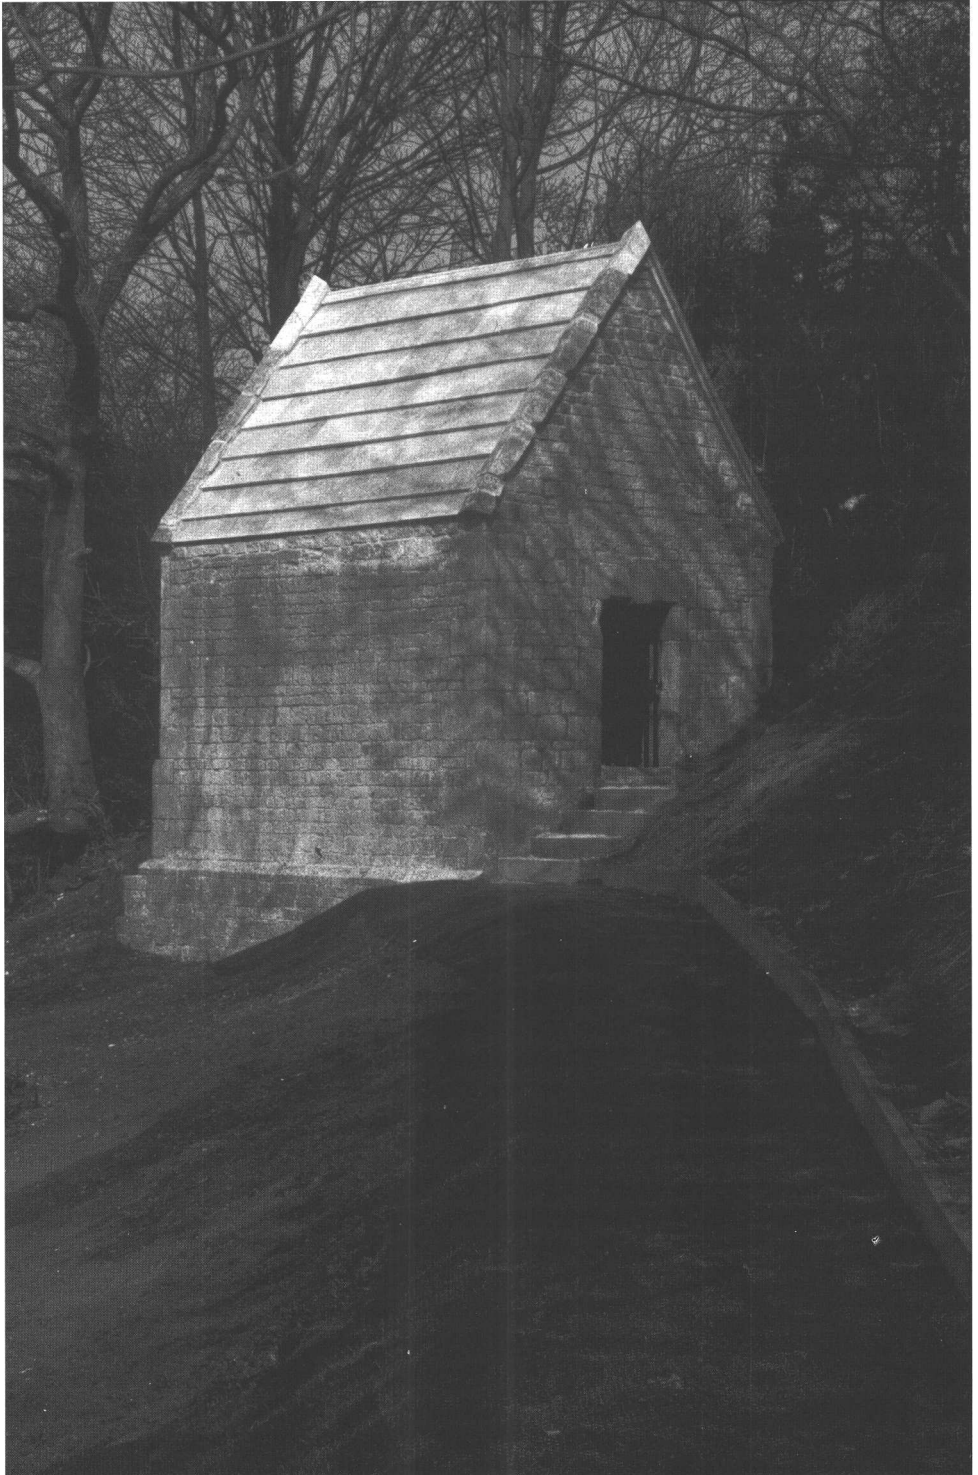
Plate 1: The 'Cundy House', Bolsover: viewed from south-east, as restored in 2003.

This rectangular stone-built structure, with internal dimensions of 3.65x2.65m and height of 3.7m from the present floor to the top of the roof, dates from early in the 17th century (Pl. 1); it is Grade II* listed. It is located 200m north of Bolsover Castle, below an escarpment and on a spring-line. From there, water flowed by underground pipe to the Cistern House at the Castle and thence to the Venus Fountain and the kitchens of the main residence, the Little Castle. At some time, its lead pipe was replaced by a cast-iron pipe, and only when this was damaged by a road-scheme early in the 20th century did the Cundy House cease to function. Survey by EDM has shown that, despite a drop in level of about 16m to cross a valley between them, the Cundy House and Cistern House stand at almost identical levels. The conduit had worked on the U-bend principle, without recourse to pump-action.

Until the 1970s, the timber rafter roof was intact, but this was subsequently destroyed by vandals. Research by English Heritage suggests that the roof may originally have been stone-vaulted, semi-circular on the underside but gabled on the top. This would be in keeping with the partially surviving roofs of two other small conduit-houses lying to the south of the Castle. Re-set coping-stones on the Cundy House have undercuts where former roof-slates were fitted, and intact gable-kneelers indicate that the roof was formerly more steeply pitched than the most recent version. Recording of the stonework and mortar of the inner faces of the gable-walls has shown re-set stonework generally corresponding with the projected line of the supposed vault. All the original walling beneath the copings on the outer faces of the gable-ends remains intact. The former vaulting seems to have been removed carefully, possibly following deterioration, perhaps after deliberate damage, or perhaps to facilitate removal of the lead cistern when it was transferred to Welbeck late in the 19th century. The present whereabouts of that cistern cannot be traced, and it may well have been melted down for re-use of the lead. Its brick-built replacement at Bolsover had a capacity of about one cubic metre.

A path has been laid for public access to the building, and a display-board explains how it functioned. With a metal gate barring entry and a solid stone roof, restored with

locally-derived limestone which is weathering successfully to blend with the tone of the original stonework, the building should now be far more vandal-proof than before.

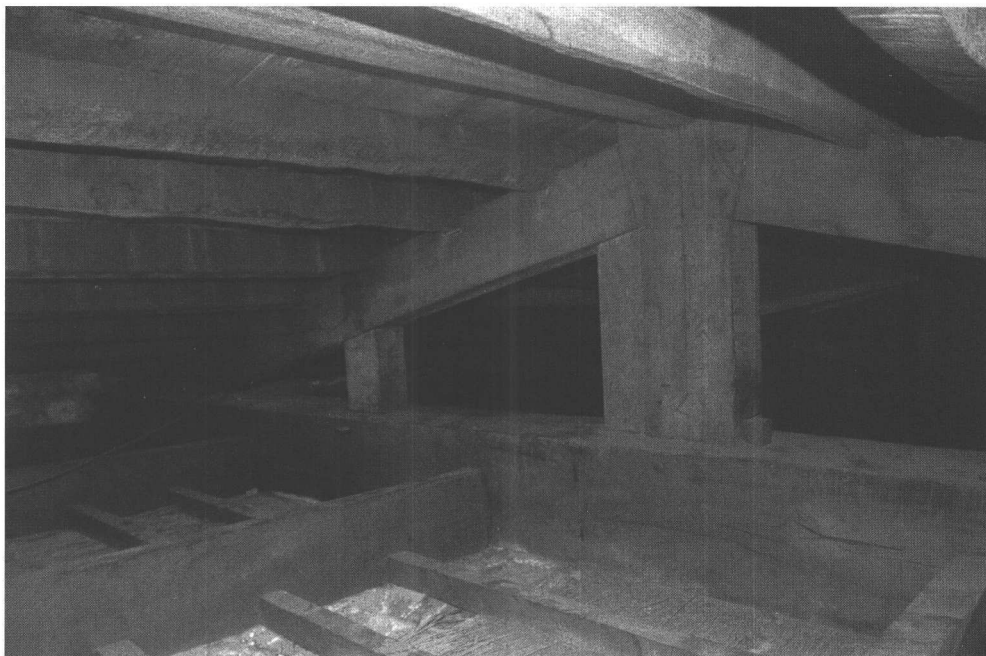
Plate 2: Bolsover Castle: one of shallow trusses of roof of 'Little Castle'; king-post is 0.82m in height.

The three-section roof reflects the tripartite plan of the building which, at each floor-level, features a narrow central axis with wider bay to each side. The central section of the roof is inaccessible, but the west and east sections were both found to have four main trusses with foot-square tie-beams and short king-posts with splayed heads abutted by principal rafters, each supported by a single short strut (Pl. 2). The roof covering of lead over boards is supported on longitudinal planks or battens, seated into the rafters. The hipped ends of the roofs consist of half-trusses with smaller beams. Most of the roof timbers are jointed by simple mortice and tenon. The height of each roof from ceiling to apex is 1.2m (4ft). The span of the west roof is about 6.9m (23ft) from gutter to gutter, and the slope of the roof is about 11°. The east roof is slightly narrower and thus slightly steeper. The shallowness of the roof-space was a handicap to recording of the sides of the respective roofs, and measurements had to be made from a distance by a device with laser-beam.

Although the roof-timbers lack decorative details their overall appearance is indicative of a single phase of construction. This is supported by the widespread occurrence of positioning scratch-lines and carpenters' marks, which were found on all the major timbers examined. The timbers were regularly cut and tightly assembled, suggesting a date later than the 17th century; and dendrochronology has proved that this is not the original roof, for it dates from 1749. The structural analysis of the portions examined

suggests that the total roof had been completely replaced at that time, with no original timbers re-used.

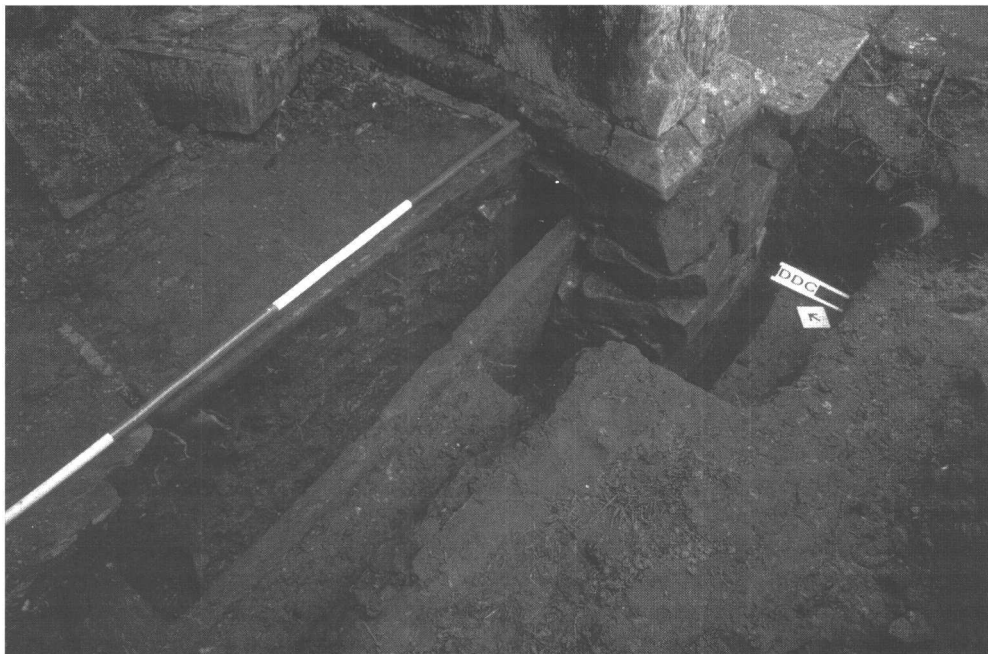
Plate 3: St Helen, Darley Dale: stone coffin built into foundation of 14th-century buttress of chancel; looking north-east; scale above coffin has divisions of 0.5m.

Two connecting rectangular trenches, *c.* 1.8x0.55m and 1.4x0.6m, were opened against the south and west faces of the buttress. Excavated to a maximum depth of 1.0m, this exposed several deposits and features. The lowest layer comprised a brownish-yellow sandy clay-loam with flecks of iron-pan, which had suffered some disturbance from a partially exposed, articulated burial. The shallowness of the burial, along with its possible truncation by the buttress, suggests that it is medieval. Above this, a 0.58m thickness of yellowish-brown sandy clay-loam with dark brown mottles contained fragments of disarticulated human bone and is interpreted as grave-earth. A medieval stone coffin, lacking the cover-stone, was revealed in the south-facing section of the trench, its east end partly incorporated into the buttress-foundation (Pl. 3). Despite later disturbance, the presence of a poorly-preserved adult skeleton confirmed that the coffin is *in situ*. No artefacts accompanied the burial, though two small fragments of green-glazed pottery were found within the fill of the coffin, which itself comprised a single hollowed-out block of Ashover Grit with straight sides and without head-rest, thus differing from three examples previously found within the church and now displayed along its south side. The exposed buttress-foundation comprised a 0.8m depth of random rubble of Ashover Grit, possibly from nearby quarries at Darley Dale. Also exposed was the north-east corner of a brick burial-shaft of the late-18th or 19th century, without surviving grave-marker. It was ensured that subsequent repair-work avoided damage to the more substantial features, including the coffin and burial-shaft.

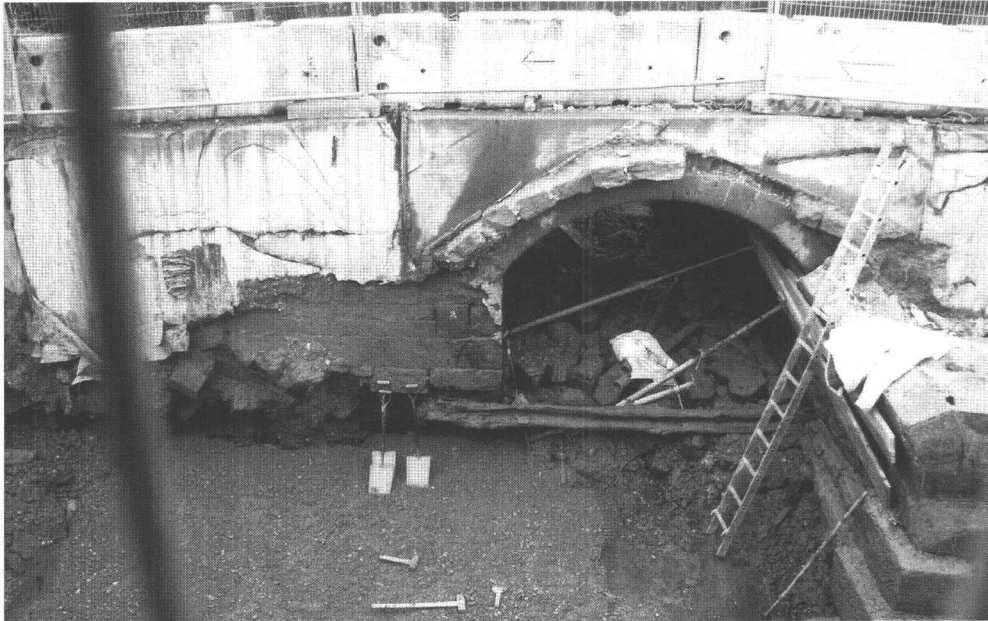
Plate 4: Monk's Flood North Bridge, Egginton: with most of Phase II widening removed before reassembly, west side of Phase I arch revealed together with added stone-collar and, beyond foot of ladder, one of horizontal timbers retaining stone infill; looking south-east; for scale, compare Fig. 1.

With the dismantling of the Phase II flanking wall and the soils behind it, some other Phase I stonework was revealed near the base of the cleared area south of the dismantled arch. Only one or two courses remained, with a series of nine oak piles below them, set out in two lines about 0.40m apart; one pile was removed and found to be *c.* 1.5m long. Other piles had been observed beneath the Phase I walling in three other locations, and had probably been driven in to support the stonework over the alluvial clay on its more vulnerable western flank. The position of the piles also suggests that water may have backed up behind the bridge at this time. Both the form of the arch and masons' marks on its underside suggest a construction-date for the Phase I bridge somewhere in the 17th century. During that time, Britain experienced cooler temperatures and higher rainfall than for some centuries previously, and there are records of heavy rainfall and flooding

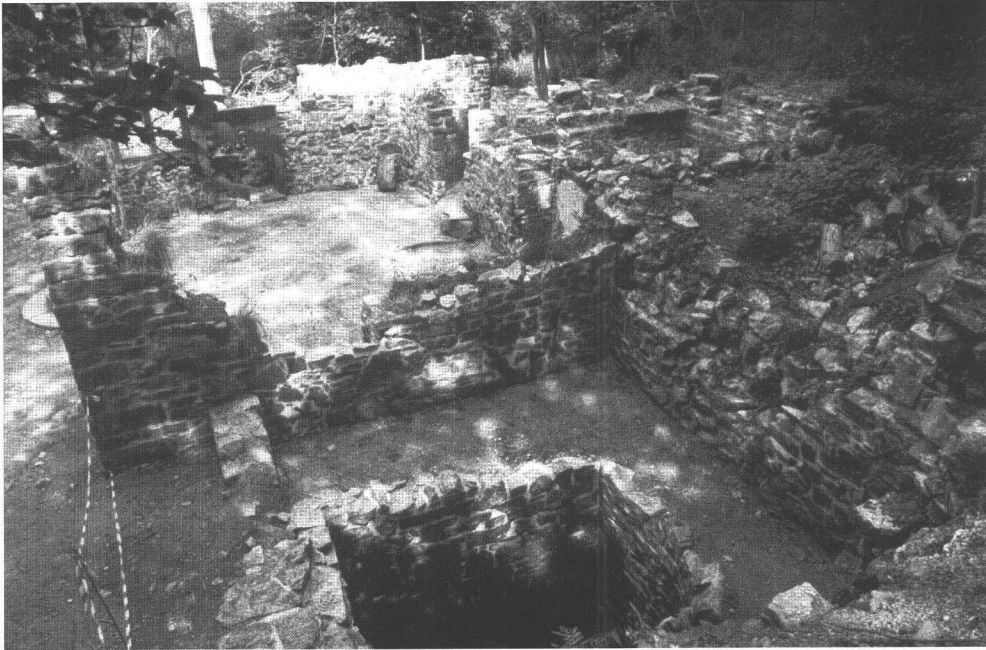
Plate 5: Bateman's House, Lathkill Dale: ruinous building during consolidation-works of 2003, with open top of shallower of two shafts in foreground; looking north; for scale, compare Fig. 2.

Following a pilot study in 2001, a scheme to consolidate the ruin of Bateman's House was completed in 2003 by the present owners, English Nature, with advice from English Heritage. The ruin, once the home of the mining-agent after whom it is named, was built early in the 19th century and abandoned scarcely 50 years later following the demise of lead-mining in the valley. Prior to consolidation of the remaining walls, a quantity of rubble was removed by the contractors, Historic Property Restoration Ltd. This was monitored archaeologically, so that architectural fragments from former windows, doors, etc could be recorded by both photography and basic measurement. As parts of the structure were being revealed from beneath obscuring rubble and vegetation, recording was extended to the standing structure (Fig. 2; Pl. 5).

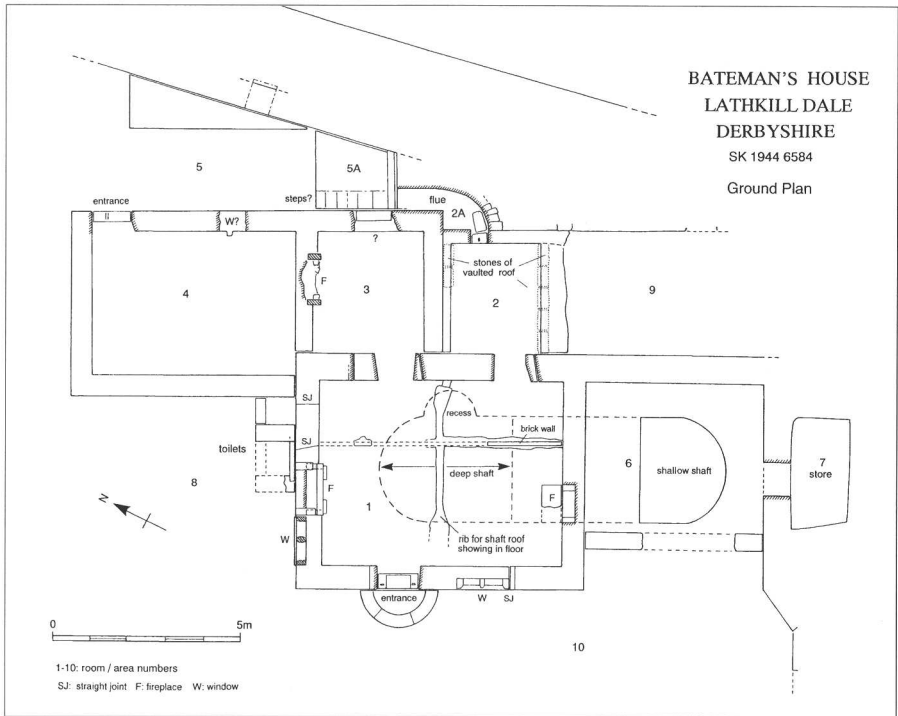
Fig. 2: Bateman's House, Lathkill Dale: plan of building and shafts; scale 1:200.

The original part of Bateman's House (rooms 1 and 6 in Fig. 2) is curiously sited immediately above a deep vaulted shaft, thought to have been dug in c.1830 to house an experimental water-pressure or disc engine for draining the sough below (Rieuwerts 2000, 55). It may have been preceded by an adjacent shaft of similar plan and depth, which was partly infilled at some stage. Now open to the sky, the latter provides access to a short underground passage connecting the two shafts. Early views of the building and remaining structural features reveal that the south elevation once featured a large opening of a size equal to the width of the shaft behind it. Together with the presence of the shafts and a nearby water-lead, this points to an industrial use of the building originally.

A third phase of building is represented by the addition of a small room (2) with barrel-vaulted roof (now surviving only at its lowest course). In the north wall of this room, a small opening led to a channel or flue-like feature set into the top of a raised area and running to another opening in the east wall of area 5 (Fig. 2); this could be reached by another stone platform with roughly-hewn steps (5A). The usage of room 2 and the platform is unknown, but the channel was found to contain crushed stone – a shale or toadstone with sulphite minerals – which had become blackened by the burning of fuel.
