NINE LADIES, STANTON MOOR: SURFACE SURVEY AND EXPLORATORY EXCAVATIONS IN RESPONSE TO EROSION, 1988–2000

By GRAEME GUILBERT and DARYL GARTON
(of 'PastWorks', on behalf of Trent & Peak Archaeology, University of Nottingham)

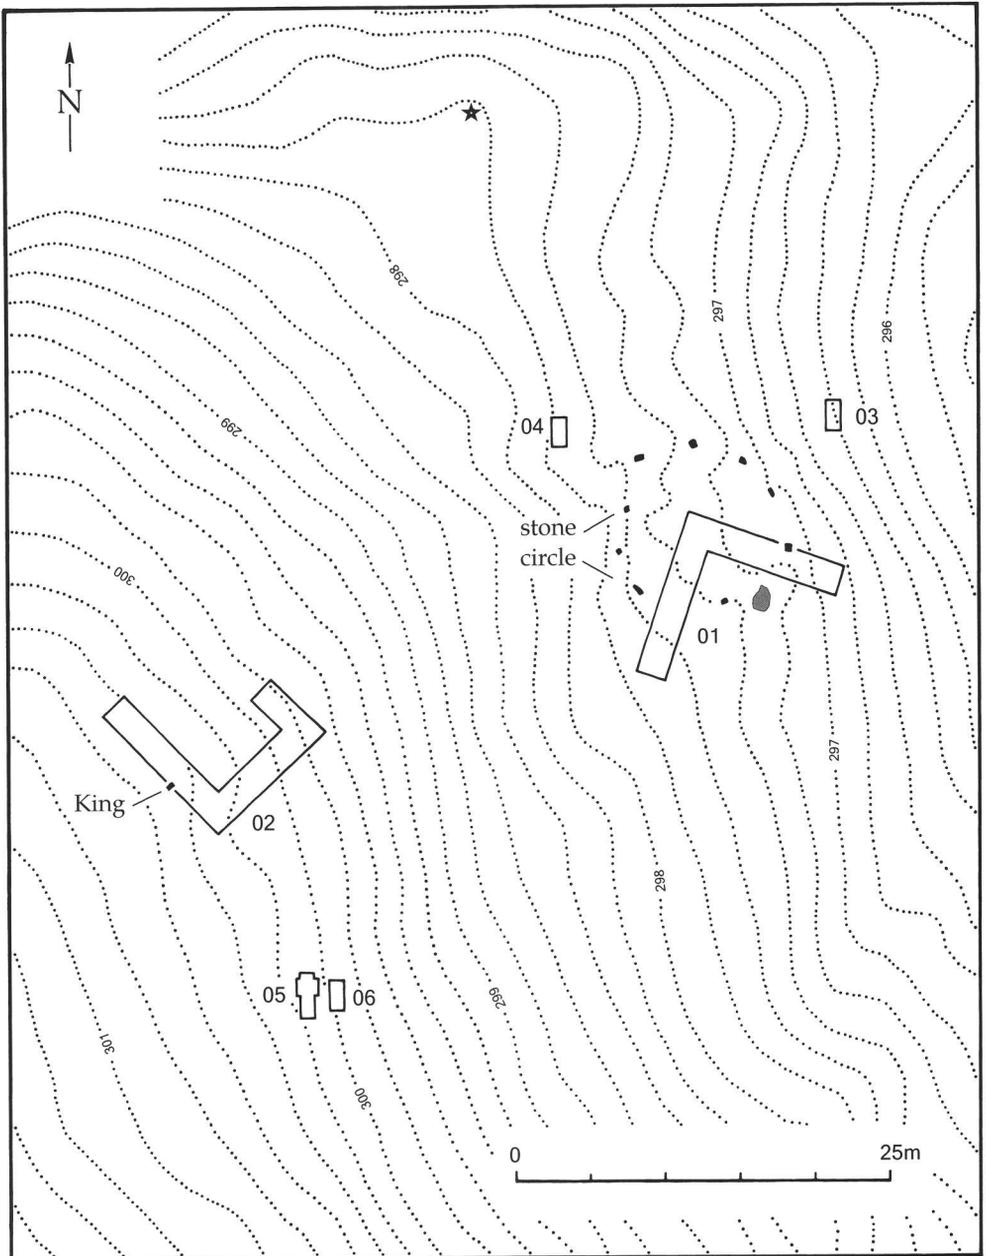
Fig. 1: Nine Ladies: simplified surface contours at 0.20m vertical interval (numbered in metres above Ordnance Datum), as recorded in November 2000 and, for areas at greatest distance from stones, in 2002; showing location of trenches 01–06 in relation to stone-circle (orthostats solid, recumbent slab shaded) and outlying King Stone, and with location of only other monument known to lie within this 83 × 65m area, a small cairn, marked by a star; scale 1:500.

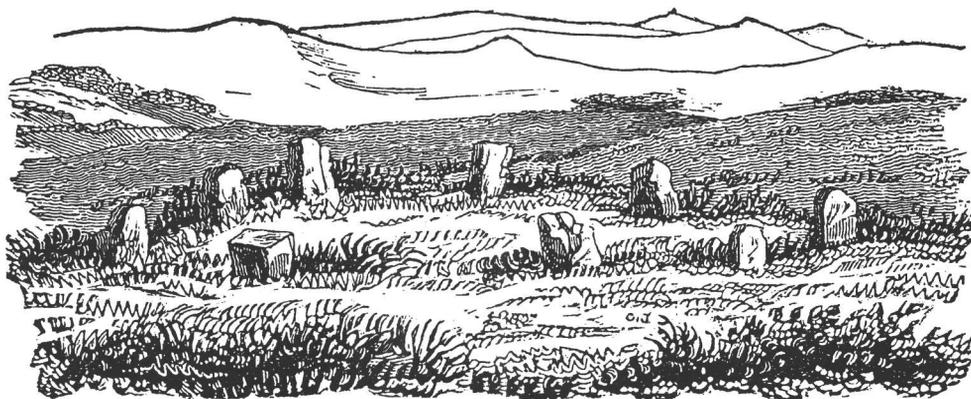
Fig. 3: Nine Ladies: view published in Glover 1829, looking east-south-east towards stone 4 from between stones 8 and 9.

One possibility, unprovable but anyway deserving of consideration, would be to suppose stone 4a to have been a relatively recent addition to the circle, conceivably dragged to its present location from some point within the precinct. For speculation of this sort to be regarded as any better than guesswork, it is necessary to review the antiquarian evidence in search of possible clues. At least it seems safe to assert that such an action is unlikely to have occurred since the days of Pitt-Rivers, whose 1883 notebook records merely that the circle 'has been opened in the centre', or Jewitt, who was unequivocal in his observation that 'in the centre are the remains of a rifled sepulchral mound' (1870, 74; 1884, 26 — though this is not evident from either his plan or his view — Fig. 6), while Glover had earlier made no reference to, nor depiction of, anything within the circle, his view making the central area appear more-or-less flat and featureless (Fig. 3).

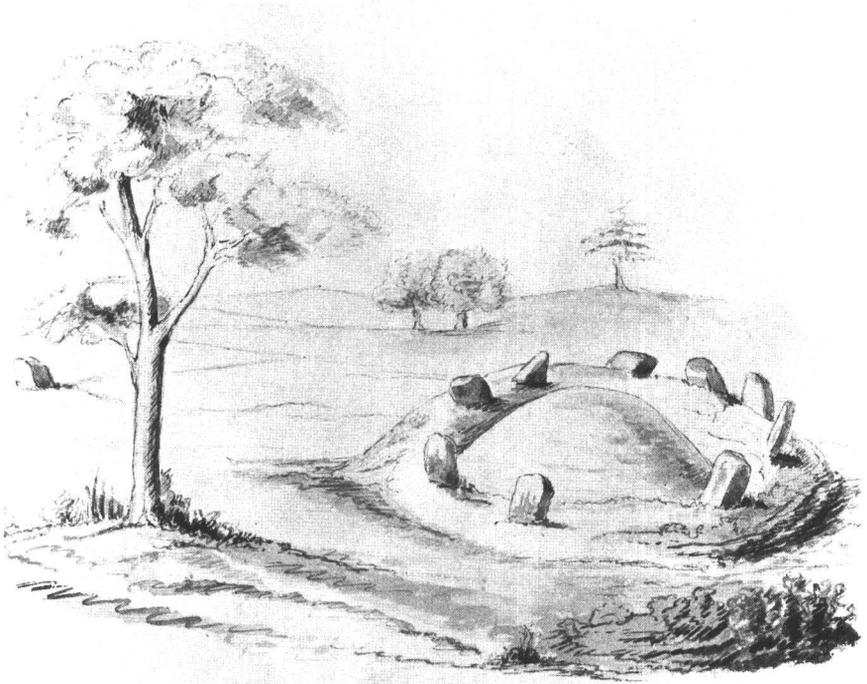
Fig. 4: Nine Ladies: watercolour of 'The Nine Ladies upon Stanton Moor 1847', taken from *Illustrations of Antiquity* (a bound volume of sketches of various monuments in the 'Bateman Collection' at Sheffield City Museum), being a companion to the view published by Bateman in 1848 (Fig. 5), looking north-west towards stone 9 from between stones 4 and 5, with King Stone situated to left of tree; at half size of original, which has only pale blue-grey wash except that each of the orthostats is given emphasis by yellow colouring on its right-hand, *i.e.* north-eastern, side. *Print supplied by National Monuments Record, and reproduced by permission of Museums Sheffield.*

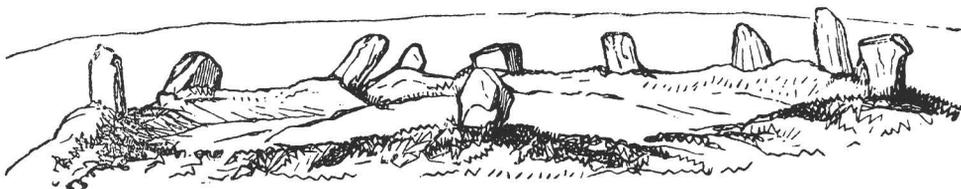
Fig. 6: Nine Ladies: view published in Jewitt 1870, looking north-north-west towards stone 9 from behind stone 5.

Perhaps more promising in the present context is Llewellynn Jewitt’s view of the stone-circle (1870, fig. 68; repeated in 1884, fig. 12; and reproduced here as Fig. 6), and it is of some interest that this incorporates an element which *may* show the monument to have once been more complex than has generally been appreciated — *viz.* Jewitt’s view has the distinction of depicting ten orthostats, despite the nine that he outlined, and disposed rather inaccurately, in the plain and simple plan of the circle published in the same places.⁹ The mysterious extra stone, situated between 8 and 9, is the

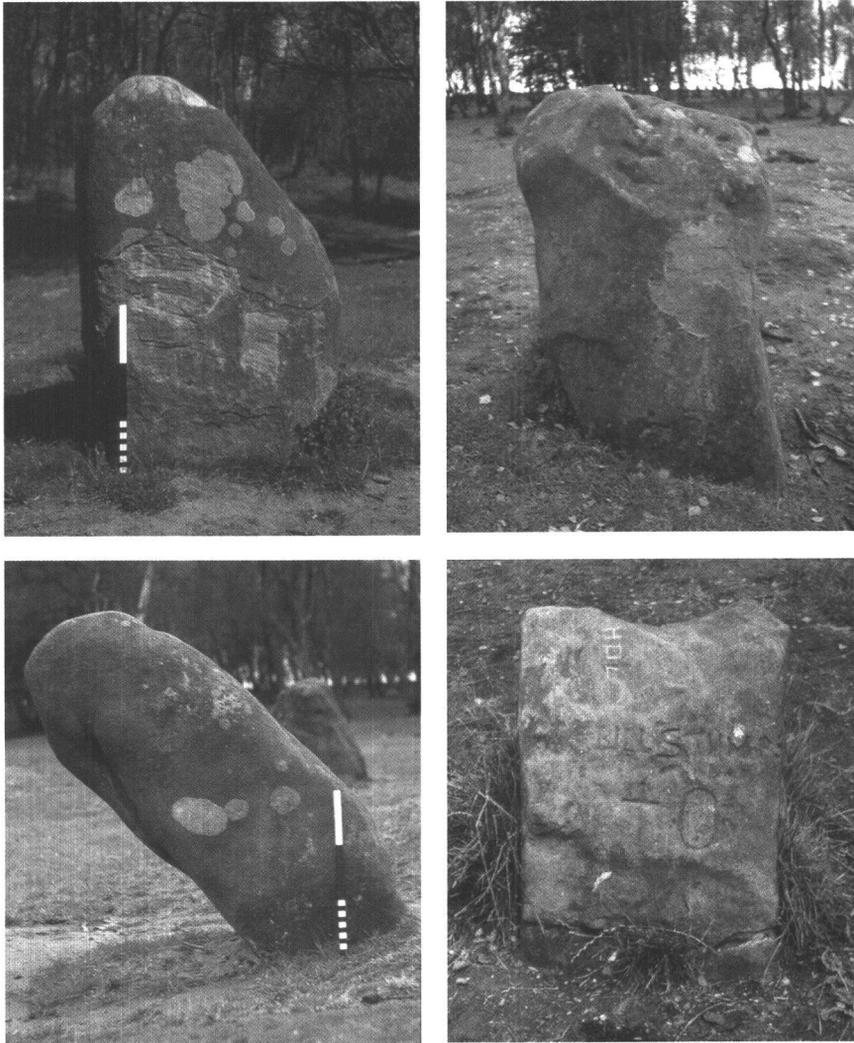
of those three stones in 2009 has shown that the damage to 2 and 4 remains obvious, though contrasting less with the remainder of the stone’s surface than it did two decades ago, while that to 5 is now scarcely detectable, even with the benefit of hindsight. Of course, it is bound to be unclear whether similar acts of vandalism have been perpetrated upon these or other circle-stones in the more distant past, its effects eventually becoming nullified by those of natural weathering but nevertheless meaning that original surfaces would have been lost forever. Another photograph (Pl. 1, lower left)

Plate 1: Nine Ladies: four orthostats, damaged in various ways at various times: upper left is south-west face of stone 2 in May 1988, showing deliberate and recent scratching away of much of its surface (scale 30cm); upper right is north face of stone 4 in November 1992, showing recent damage to surface much like that to stone 2, and with \ddagger carving on older scar atop stone, as noted by Pitt-Rivers in 1883 (middle cross-bar of \ddagger measures c.87mm); lower left is north face of stone 8 in May 1988, with loose soil at foot of stone, beneath overhang, where subsoil has been brought to surface through deliberate disturbance (scale 30cm); lower right is north-west face of King Stone in September 1994, showing recent graffiti, HOL, above and at right-angles to 19th-century BILL STUMPS above \dagger 0 (Guilbert 2001), and with fracture close to foot of stone, resulting from wilful damage in June 1990 when an existing crack was opened up (cross-bar of \dagger measures c.75mm).

exemplifies a different form of damage, just as irrevocable, caused by somebody digging into the ground immediately alongside the foot of an orthostat, for reasons that can only be guessed. Such disturbance has doubtless occurred from time to time on other parts of this site, but who can say exactly where or how often?

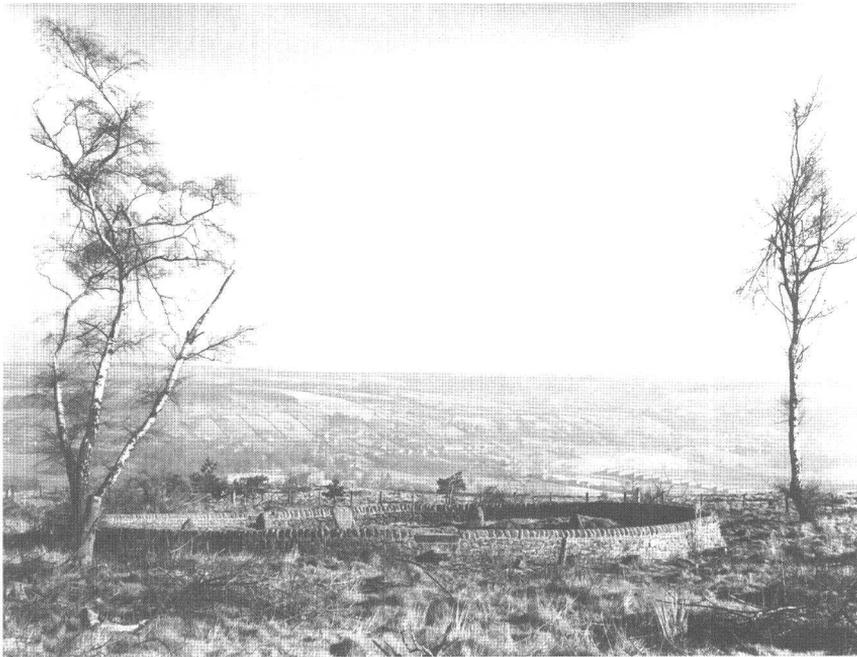
Plate 2: Nine Ladies: J.J. Parker's view of stone-circle, looking east towards gap between stones 3 and 4 from outside stile over 19th-century encircling wall, *i.e.* situated between stones 7 and 8; photograph taken on 20 January 1949. *Copyright J. Eccles.*

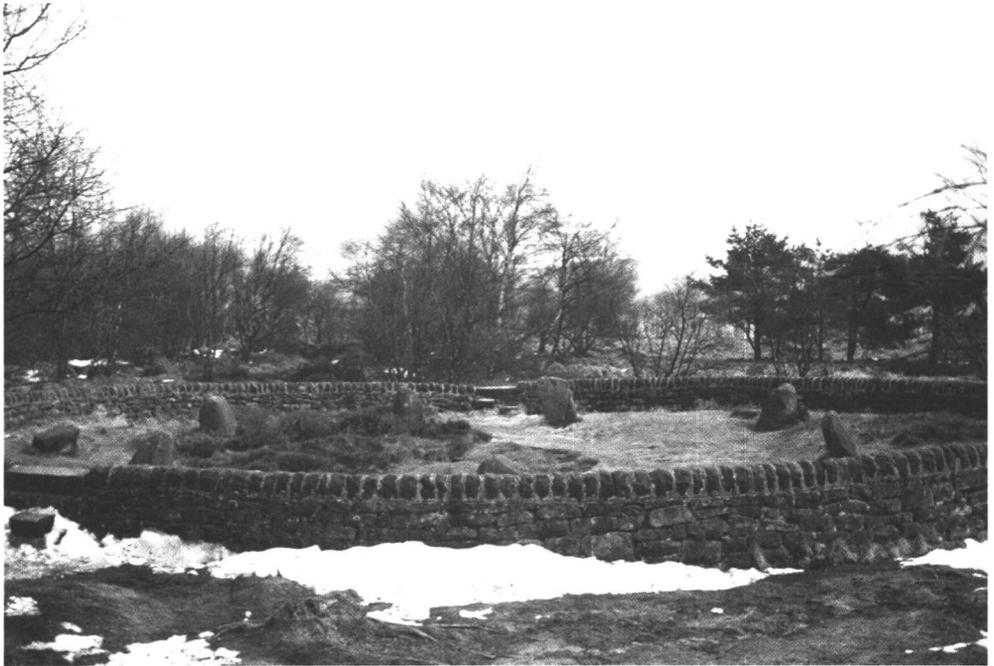
Plate 3: Nine Ladies: Aubrey Burl's view of stone-circle, looking north-east towards gap between stones 2 and 3 from behind stone 6; photograph probably taken in March 1969. *Copyright A. Burl.*

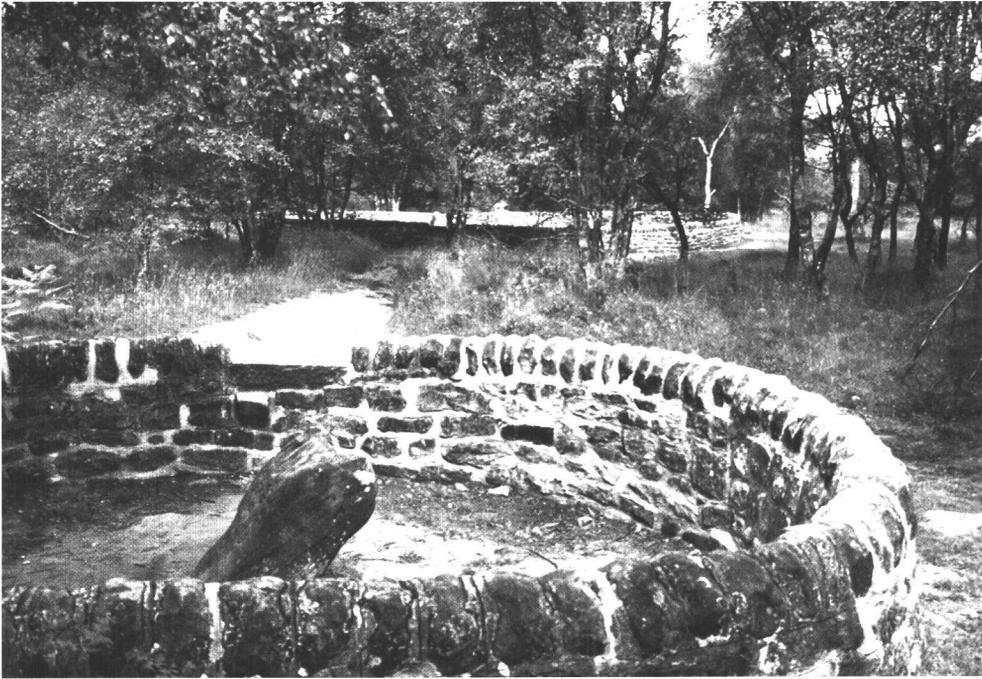
Plate 4: Nine Ladies: Aubrey Burl's view of King Stone, looking north-east towards stone-circle and its encompassing wall; photograph probably taken in August 1973. *Copyright A. Burl.*

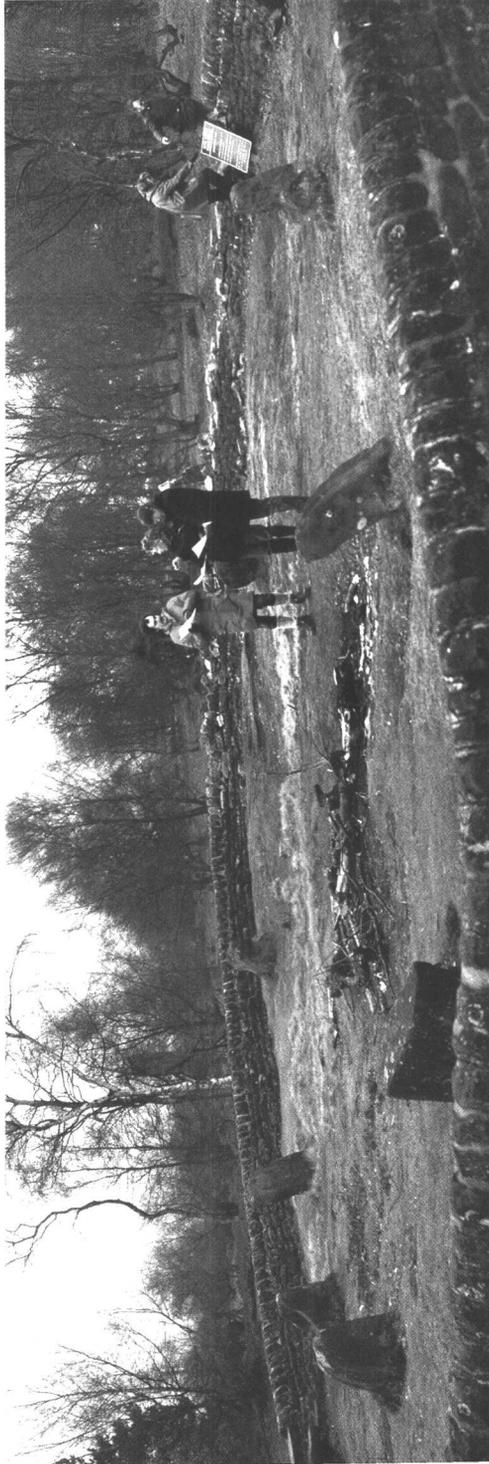
Plate 5: Nine Ladies: Sean Karley's view of stone-circle, looking south-east towards recumbent 4a from between stones 8 and 9, with remains of recent fireplace alongside hollow at centre of circle, and vandalized stretch of wall beyond figures; photograph taken in March 1983. *Copyright S. Karley.*

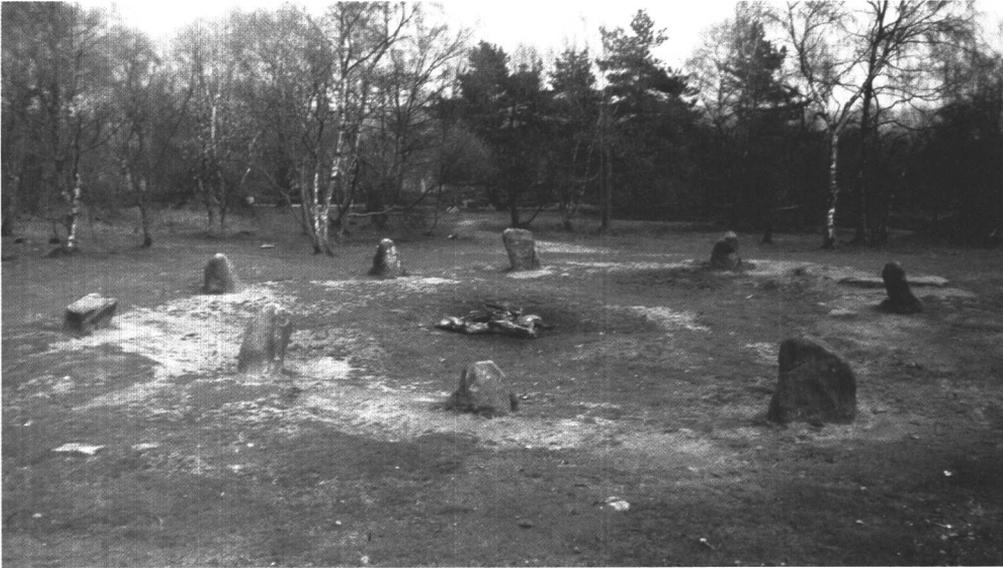
Plate 6: Nine Ladies: view of stone-circle, looking north-east towards stone 3 from behind stone 7, with remains of recent fireplace within hollow at centre of circle, and with areas of ground bare of vegetation showing pale; photograph taken in April 1988. Copyright G. Guilbert.

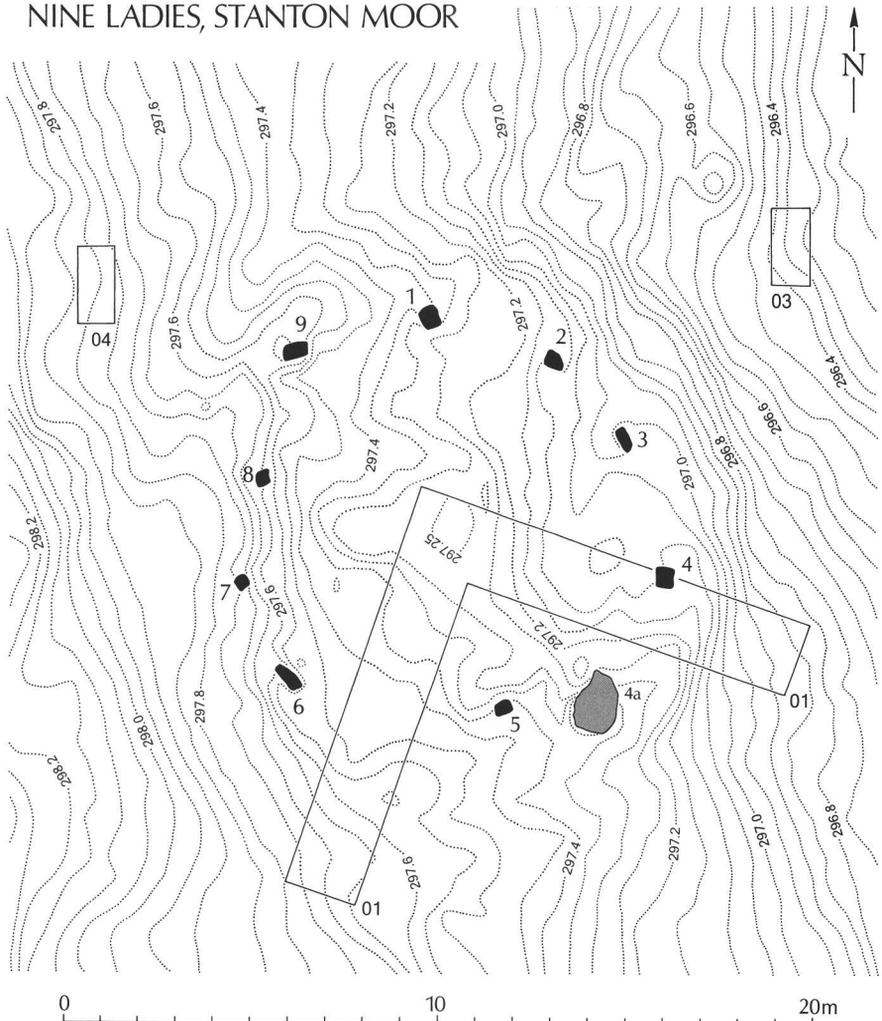
Fig. 8: Nine Ladies: surface contours at 0.05m vertical interval (numbered in metres above Ordnance Datum) in relation to ground-plan of stones of circle (uprights 1–9 solid, recumbent slab 4a shaded), as recorded in November 2000, immediately before opening of trenches 01, 03 and 04 (outlined); scale 1:200.

extensively masked by the debris dumped in 1987 (explained above), so becoming relatively flat and apparently lacking in archaeological interest, at least superficially.³⁰ The lengthy time-lag separating the sixth and seventh surveys of the circle occurred because EH's intention to take stock of the results in the autumn of 1994 became deferred until 1997, at which time it was decided to commission a further survey in order to ensure that the data to be assessed was up-to-date and therefore able to provide a sound basis for a review of practical options for additional action in the cause of conservation. As reported below, that assessment eventually led to a decision to

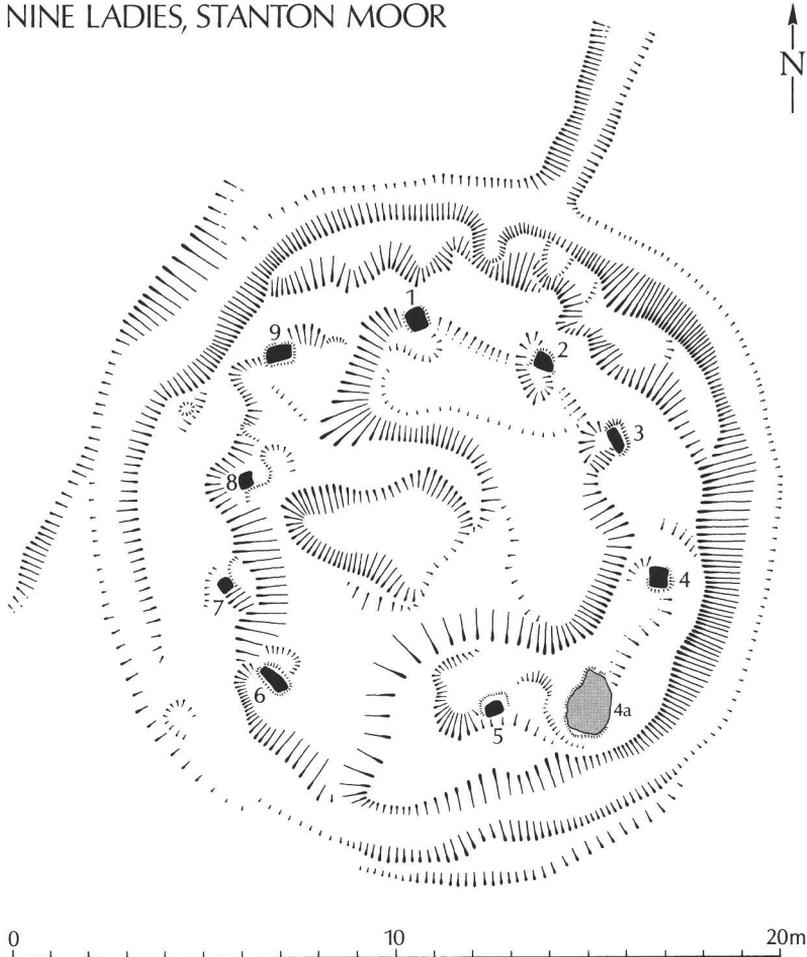
Fig. 9: Nine Ladies: hachured undulations within and around stones of circle (shown as in Fig. 8), as recorded in November 2000, before opening of trench 01 (outlined in Fig. 8); scale 1:200.

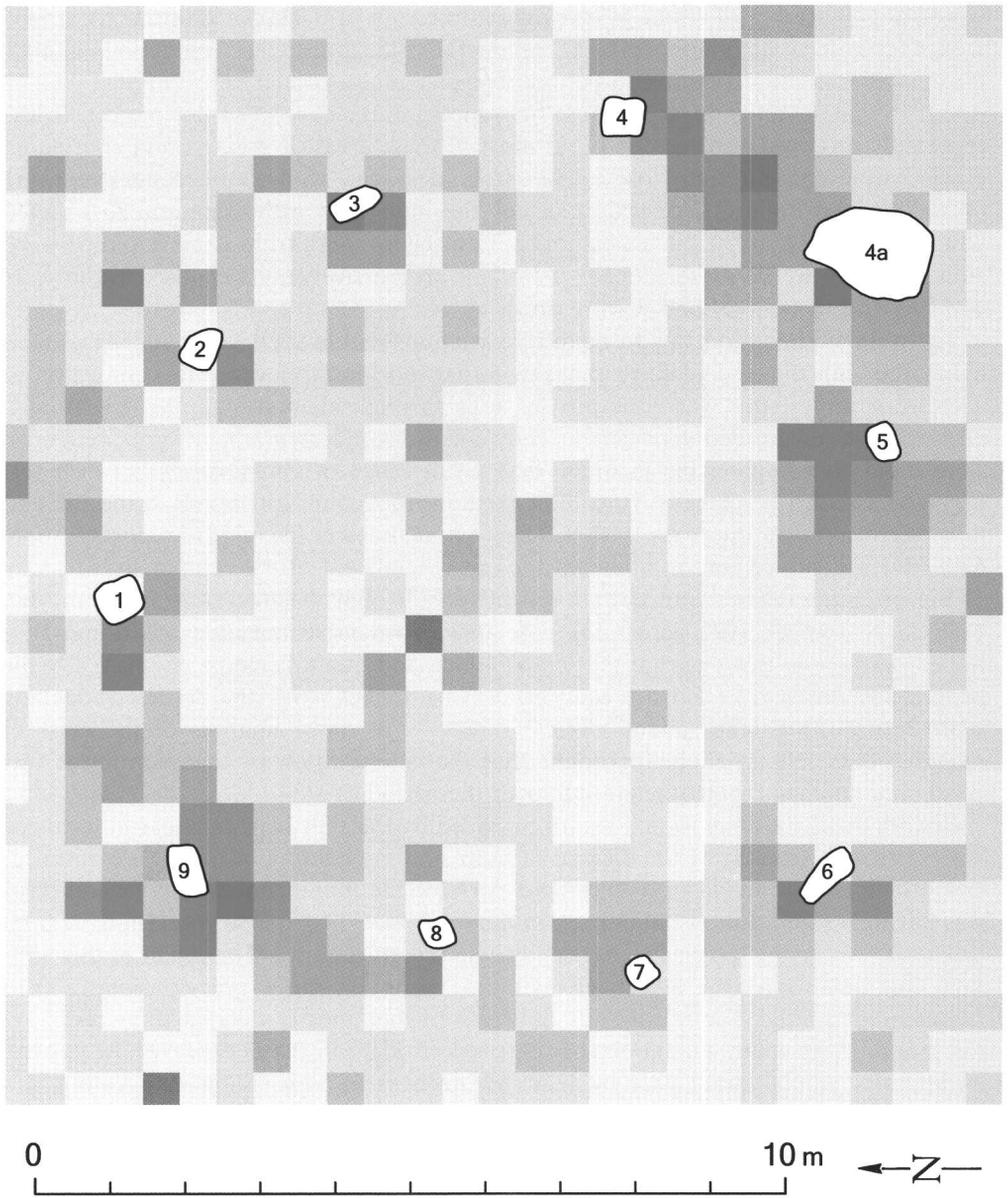
it was any clustering of readings revealing a lowering of 0.03m or more as compared with their immediate predecessors, as well as those locations where reductions of even greater order accumulated over a period of years (some as much as 0.12m over the 114 months), that gave the principal cause for concern in the context of this project. It was repeatedly observed and recorded that most of these areas of greatest and continuing erosion were concentrated close to the circle of stones, with a noticeable deepening of well-defined hollows alongside most of the individual orthostats and distributed patchily along the top of the 'embankment', especially south from stone 9 and between stones 4 and 5, where the recumbent 4a became progressively more exposed as the years wore on and the soil around it wore down.

Fig. 10: Nine Ladies: progressive erosion during 1988–97 within a $14.5 \times 13.3\text{m}$ area over and around stone-circle, with each 0.5m square coloured according to gradations of net loss (red) or gain (blue) over period of 114 months, each grade being equivalent to 0.02m , with patches of ground that had suffered greatest reduction, 0.12m , represented by most intense red (while greatest heightening, 0.08m , is most intense blue, partly due to introduction of topsoil over damaged patches); scale 1:100. (NB, for practical reasons, north is here aligned perpendicular to all other plans in this paper.)

Much of the recorded deterioration was clearly an unintended consequence of the plentiful visitors, whose observed tendency is to walk around the perimeter of the circle, casually touching the stones and often sitting upon certain of them (favourites for this being 8 and 9), there to contemplate the place, usually facing the centre of the circle when so doing, and frequently scuffing their feet in those already well-worn hollows. As observed on pages 8–12, however, some of the erosion obviously resulted from needless damage, especially through repeated fire-lighting, evidence for which was often to be seen scattered about the circle, particularly within the hollow at its centre (see below), but also immediately around the hapless King Stone. In fact, the King Stone suffered disproportionately over the period under review. This was due partly to fires, as when, in June 1988, the lower half of its south-eastern face became reddened and flaky through scorching, an event witnessed by GG when visiting the site shortly after the extinguishing of a fire situated directly beneath its overhang, leaving the stone still exuding heat. But its indignities also involved outright vandalism, as when, during revelries at midsummer in 1990, the King Stone was broken off close to ground-level (opening an old crack — Pl. 1, lower right), reputedly when a vehicle was driven into it (though no impact-scar was to be seen at any higher point on the stone), and it remained propped in place by other stones over the ensuing decade (until a permanent repair was effected at the time of the excavations in 2000 — page 47).

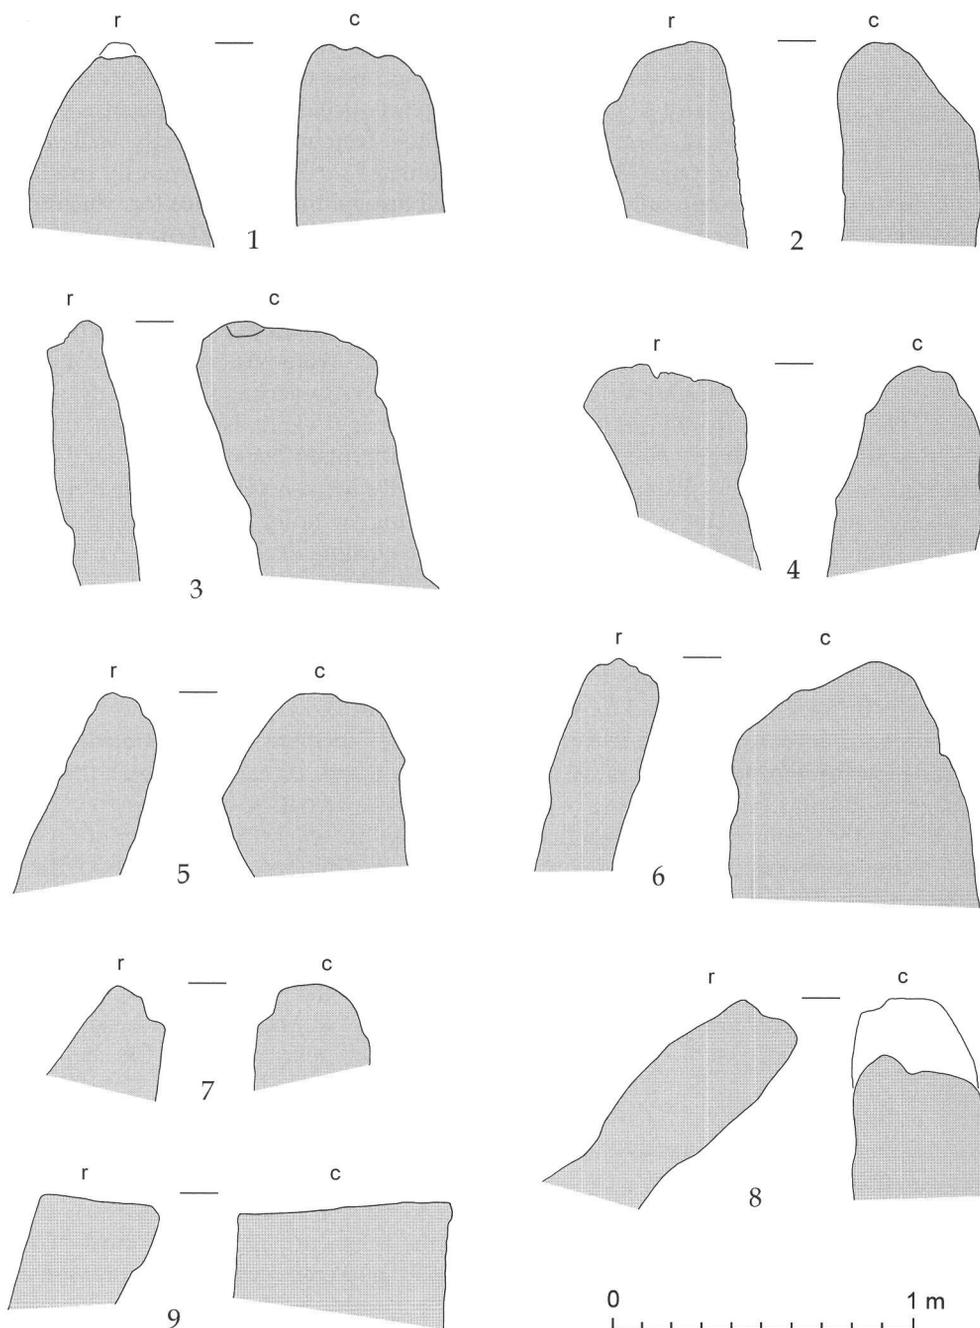
Fig. 11: Nine Ladies: profiles of the nine orthostats of the circle, as recorded at 1:10 in 1988; for each stone, left-hand profile is on approximate radius (r) of stone-circle, each with outer side to left, as viewed progressing clockwise around circle, while right-hand profile is on approximate circumference (c), as viewed from within circle; scale 1:25.

In addition, although erosion of the ground-surface was seen as the most important issue, at least in the short term, it was evident in 1988 that the stones which give this monument its most obvious and enduring identity had themselves been subject to abuse by some who have frequented the site over recent years. Accordingly, a record was made of the condition, form and current disposition of each of the orthostats, comprising photographs (two of which are reproduced here in illustration of damage — Pl. 1; and see page 8) as well as the cross profiles to which reference has already been made (Figs 11–12).³²

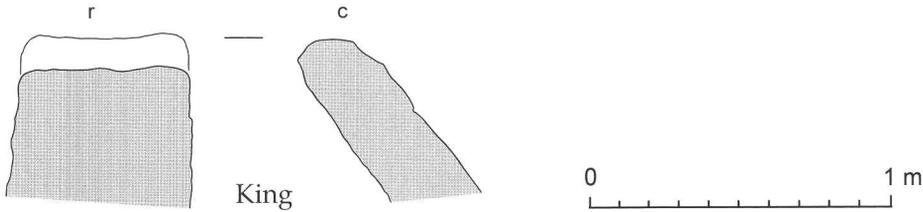
Fig. 12: Nine Ladies: profiles of King Stone, as recorded at 1:10 in 1988; radial (r) and circumferential (c) by reference to nearby stone-circle, as viewed from south-east and north-east respectively; scale 1:25.

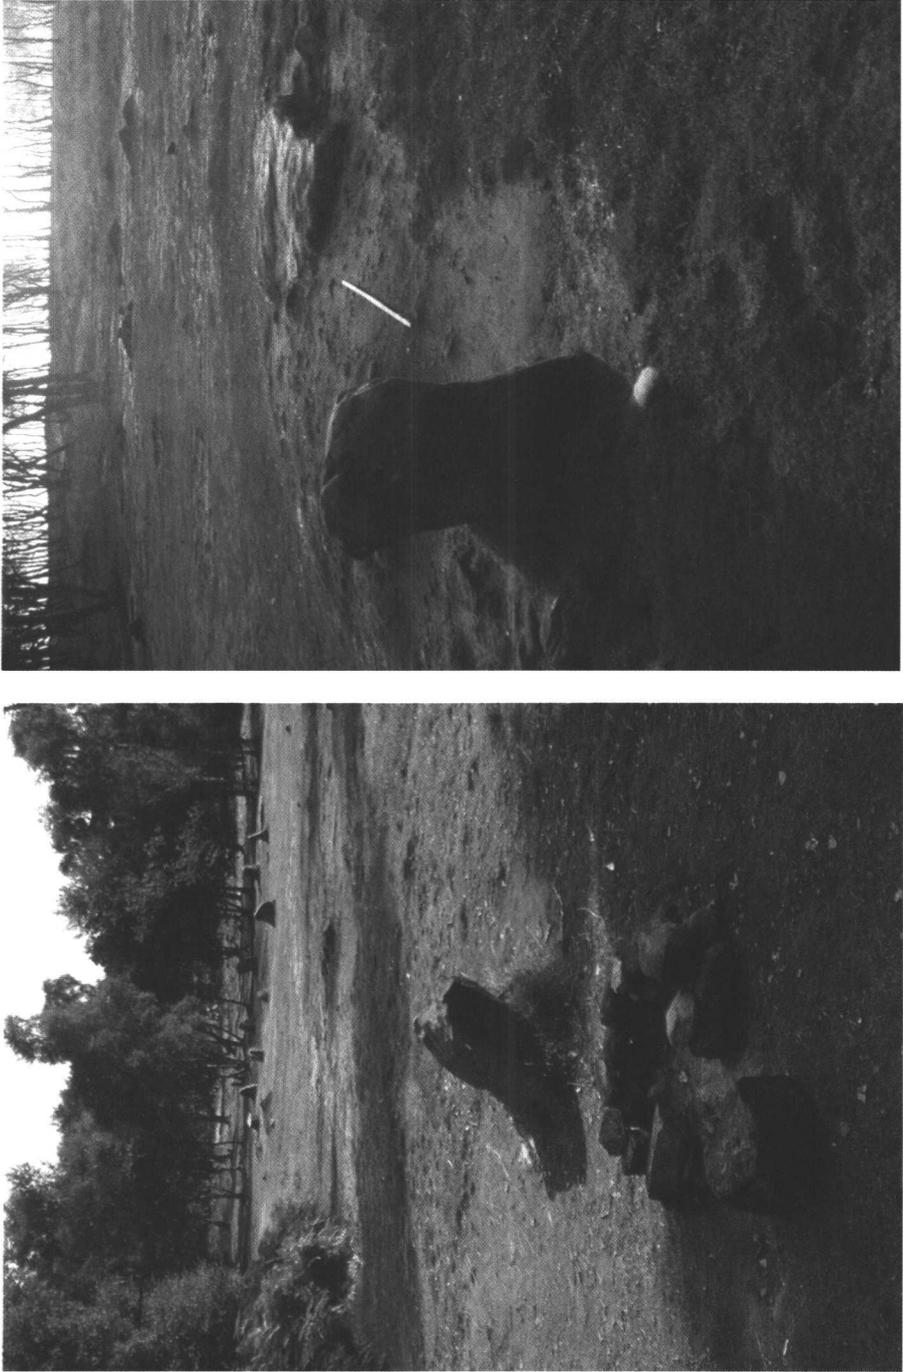
Plate 7: Nine Ladies: examples of abuse and misuse — left is view looking north-east from King Stone to stone-circle in August 1994, with hearth/fireplace built of loose stones in foreground; right shows orthostat 4 with recumbent stone 4a beyond, and eroding ground between and around them both, in December 1997.

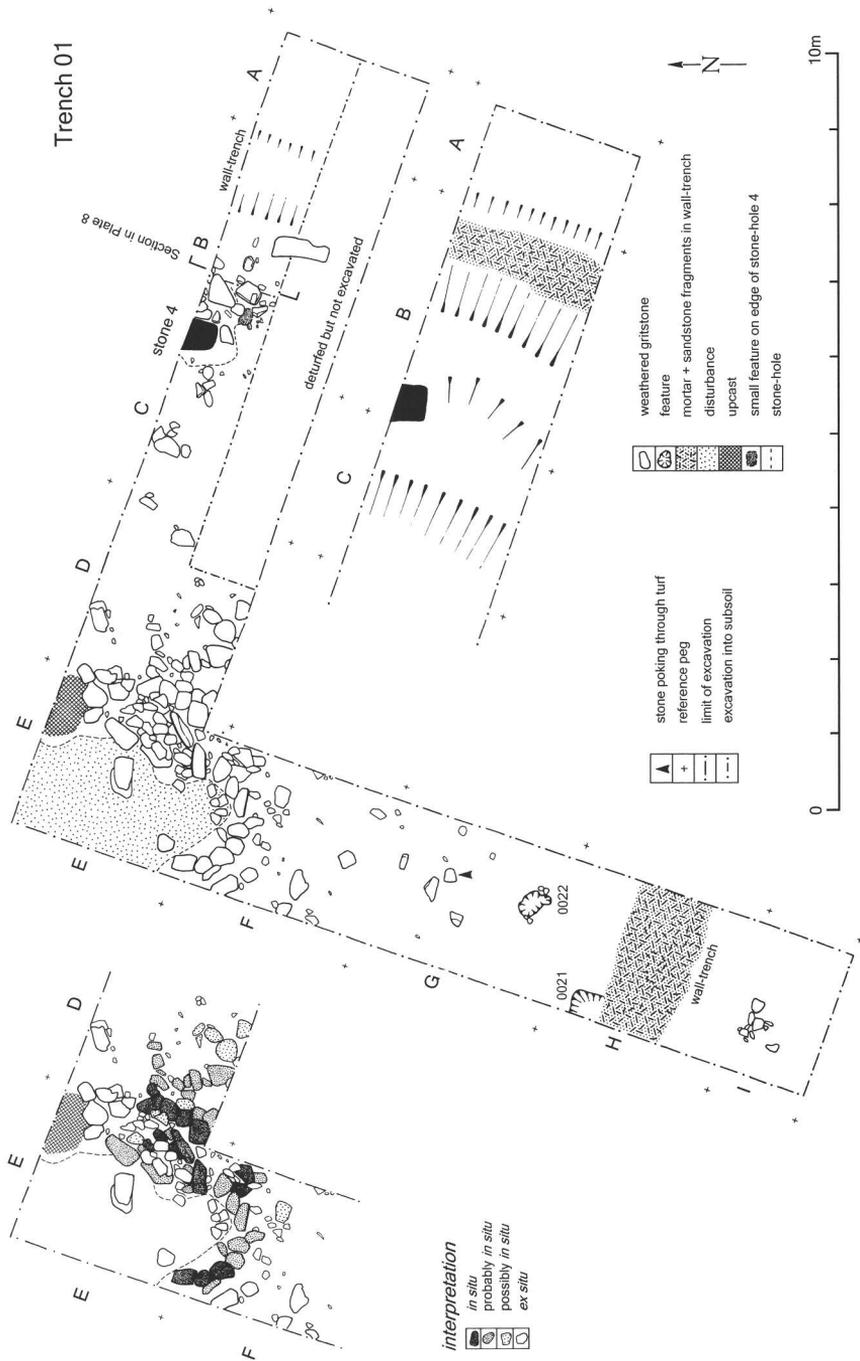
Fig. 13: Nine Ladies: trench 01, with overall plan incorporating detail recorded at various levels, left plan giving interpretation of stones around disturbance at centre of circle, and lower right plan showing superficial slopes of bank and wall-trench adjacent to stone 4 (cf. Fig. 9); scale 1:100.

One detail of the northern arm which remains hard to explain is an elongated block of stone sitting just below the turf, on the lower, yellow, subsoil, close to the eastern edge of the bank (outlined in Fig. 13, and protruding into left foreground of Pl. 8). The size and surface condition of this stone (weathered smooth, but not friable) distinguished it from fragments of sandstone embedded in the subsoil, while its location was suggestive of some form of kerb to the bank. However, there was no other sign of such a feature at any point in trench 01.

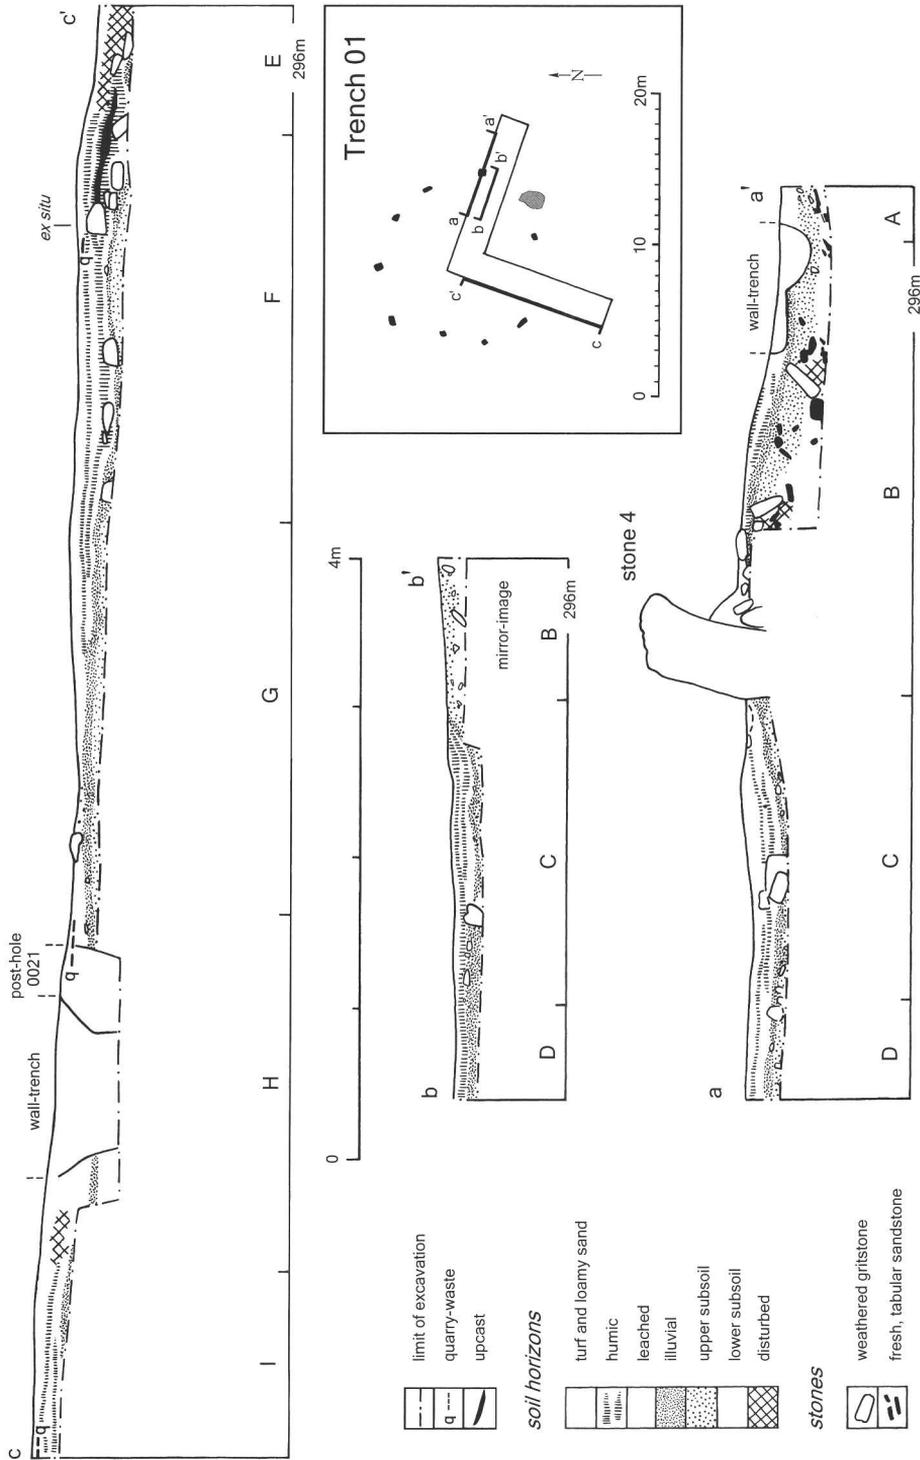
Fig. 14: Nine Ladies: trench 01 sections, including stone 4; scale 1:50. Inset plan, at 1:500, shows location of sections.

- ³⁵ These duplicated soil-horizons were most clearly seen in unit F of section c-c', but were also present in units I, C and B (Fig. 14).
- ³⁶ We are conscious of entering hypothetical waters, but it deserves to be noted that any significant heightening of the bank in former times would have the side-effect of making the standing-stones less prominent than as seen in recent centuries. Thus, even an additional

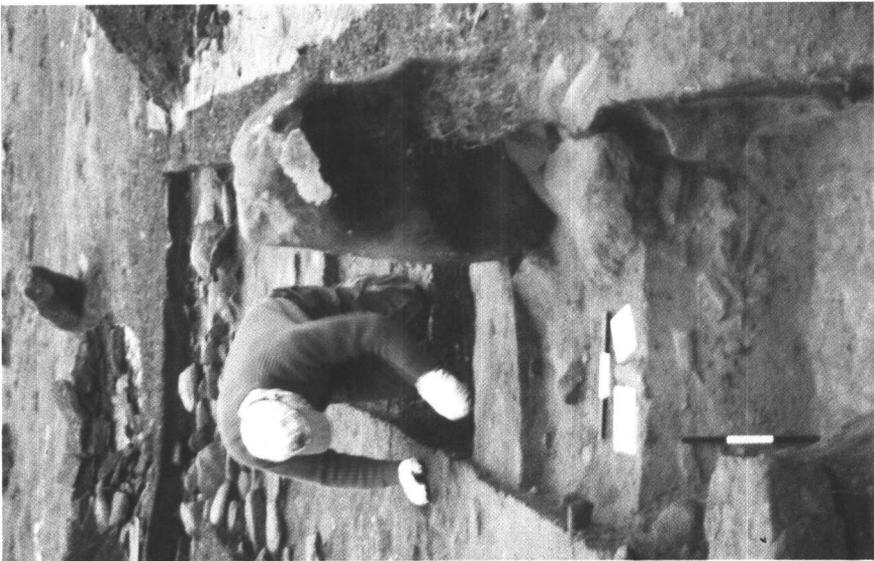
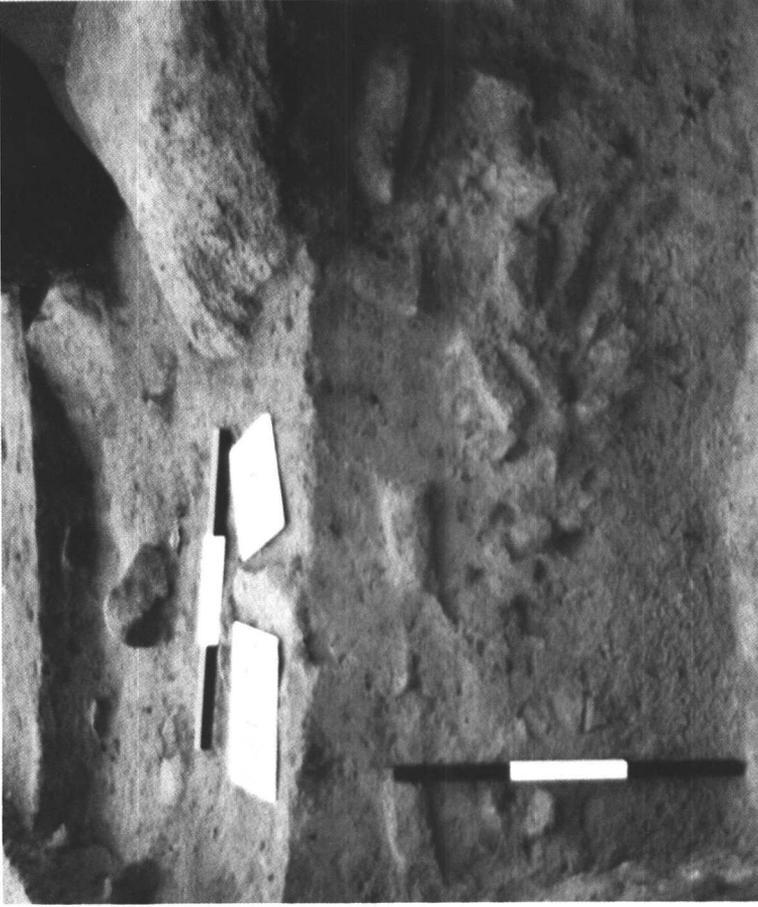
Plate 8: Nine Ladies: left shows excavation in progress within northern arm of trench 01, looking west-north-west, in November 2000; vertical scale rests against section through subsoil at 0.6m east of circle-stone 4, as seen in close-up in right-hand photograph; scale-divisions of 0.10m.

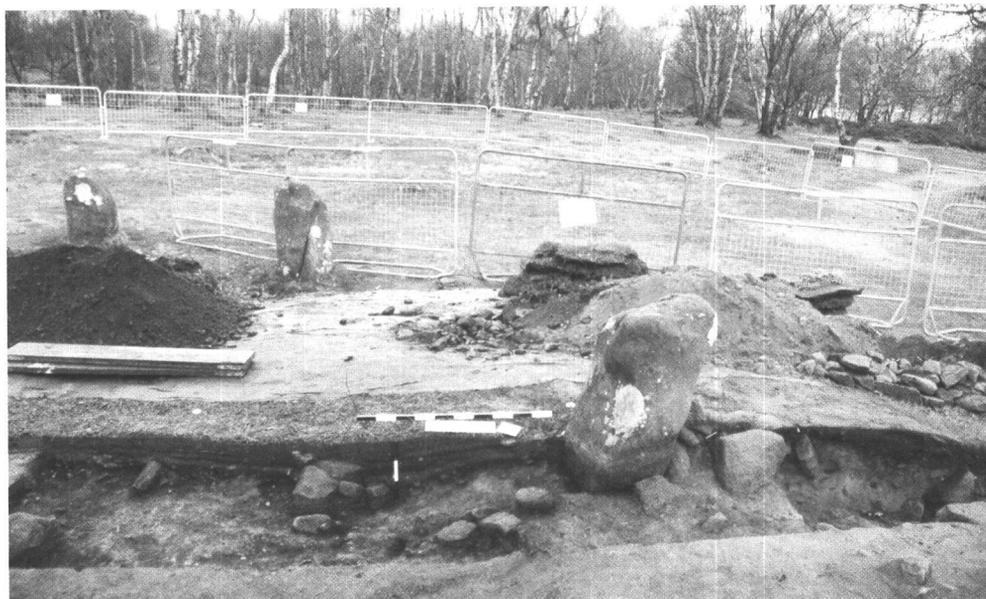
The packing-stones around stone 4 were clearly distinguishable, especially to its east (Pl. 9). With careful cleaning at the basal limit of excavation, it was possible tentatively to discern the outline of the ‘stone-hole’ that contains them, extending up to 1.2m west/east and 0.7m southwards into trench 01 (dashed in Fig. 13), and recognizable only by the mottling of its sandy-loam fill, slightly darker brown than the surrounding

Plate 9: Nine Ladies: circle-stone 4 within northern arm of trench 01, looking north-north-east, in November 2000, with stones 3 and 2 beyond; scale-divisions of 0.10m.

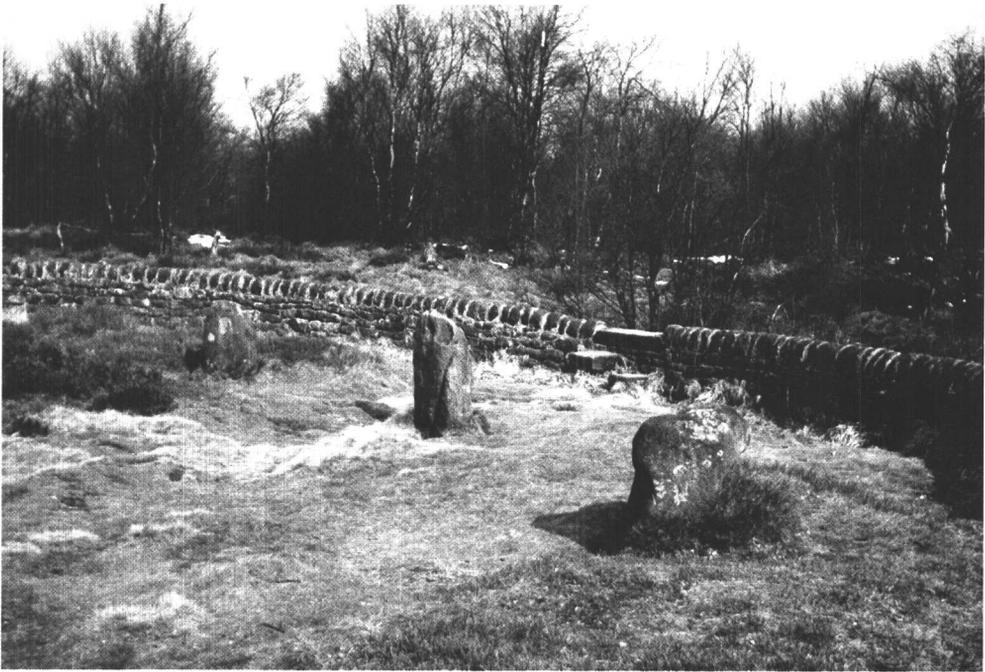
Plate 10: Nine Ladies: stones 4, 3 and 2, looking north, probably taken in March 1969. Copyright A. Burl.

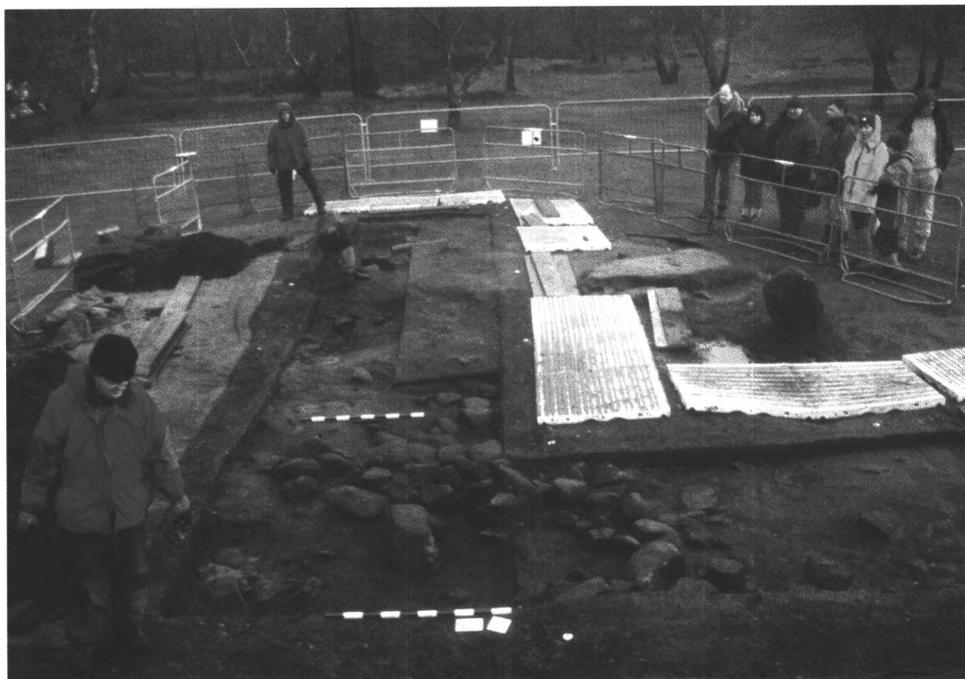
maximum dimension, formed a rough arc, 0.6–1.6m wide, around a hollow, or disturbance, central to the stone-circle (Plates 11 and 12). There were two distinct fills within the central hollow: the upper was sandy and very dark, with abundant charcoal and numerous recent artefacts (crystals, polished pebbles, plastic comb, cigarette-packet, metal pegs); the lower (yielding no artefacts, but only exposed, not excavated) comprised mid-brown sandy loam with many fragments of angular, fractured, tabular sandstone (some clustered with little soil matrix), quite different in character from the weathered stones which lay around the hollow, suggesting that the angular pieces may have come from penetrating bedrock or from breaking up a larger piece of rock. The possibility of a relatively recent delve of greater depth was also evident from occasional small patches of orange-brown sand at a high level close to the hollow, including a prominent lump at the northern edge of unit E ('upcast' in Fig. 13; cf. Plates 11 and 12), and a thin spread overlying the lower humic horizon in unit F (section c-c', Fig. 14). Some of the weathered gritstones forming the arc appeared to be *in situ* (because tightly packed together), while others appeared displaced (as interpreted in left plan of Fig. 13). The northernmost three stones were the most obviously *ex situ* because they overlay the upcast lump of orange sand noted above. It was clear that the best chance of understanding the structure(s) represented by these stones would be in wider area-excavation, so the best-preserved parts, in units E/D and in the eastern part of F, were not excavated beyond the stage seen in Pl. 12, though stones in the central and western part of unit F were removed to ascertain their

Plate 11: Nine Ladies: trench 01 within stone-circle, looking east-south-east, in November 2000; farther figure stands beyond stone 4, with 4a and 5 visible to right of trench (and party of visitors looking on); scale-divisions of 0.10m.
