NINE LADIES, STANTON MOOR: SURFACE SURVEY AND EXPLORATORY EXCAVATIONS IN RESPONSE TO EROSION, 1988–2000

By GRAEME GUILBERT and DARYL GARTON
(of 'PastWorks', on behalf of Trent & Peak Archaeology, University of Nottingham)

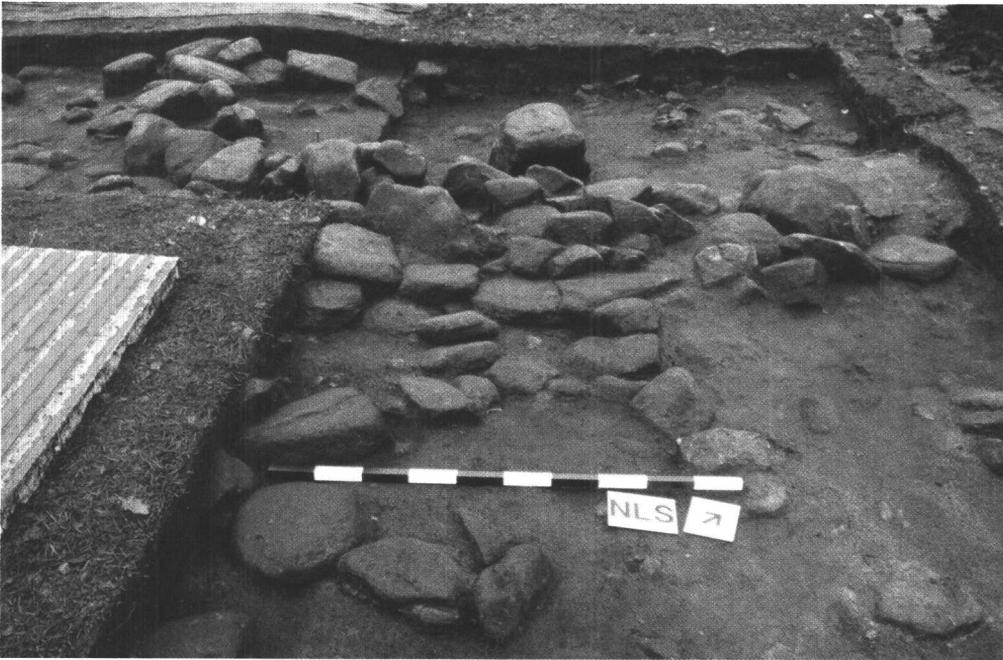
Plate 12: Nine Ladies: detail of stones around disturbance at centre of stone-circle, in trench 01, looking west-north-west, in November 2000; scale-divisions of 0.10m.

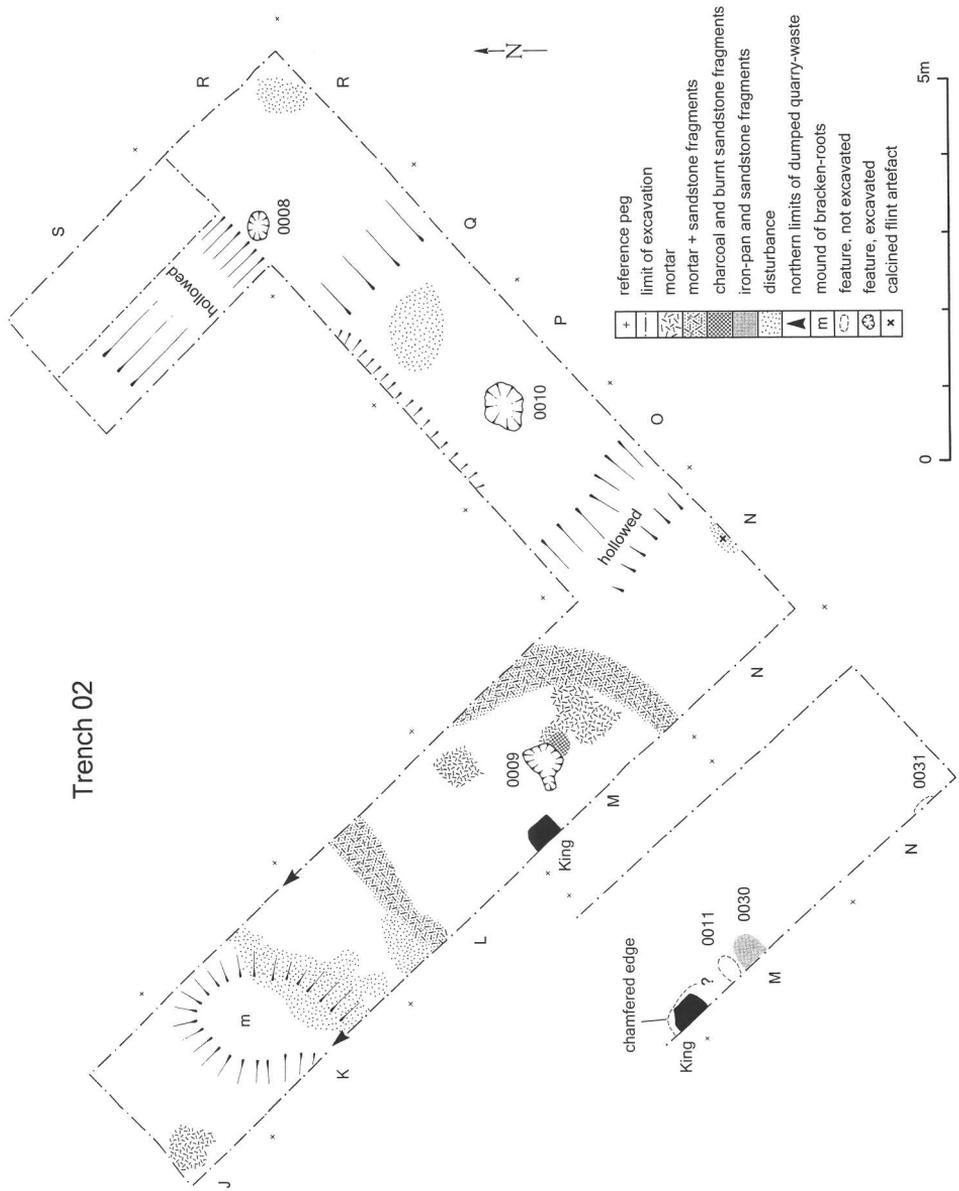
Fig. 15: Nine Ladies: trench 02, with overall plan including detail recorded at various levels, and lower plan showing features revealed adjacent to King Stone; scale 1:100.

The extent of modern features/disturbance in the western arm of 02 (units J-N) meant that it was decided to excavate only its western half, containing the King Stone, into the lower subsoil. Once the quarry-waste had been removed, the line of the Victorian enclosure-wall was immediately evident, marked by two bands of mortar and crushed sandstone, but, unlike its equivalent in trench 01, apparently without evidence of a foundation-trench. The northern band overlay the edge of a disturbance, dug at least 0.34m into the lower subsoil/bedrock and partly overlain by a mound of bracken-roots (hachured in Fig. 15, unit K), which itself overlay a crushed aluminium-can. A small, bottle-shaped pit (0009), situated close to the eastern corner of the King Stone, was filled with charcoal-rich humus and degraded sandstone flecks, like a patch of similar materials at the surface of subsoil to its south; this pit contained fragments of modern glass at the base, at *c.*0.10m depth. Numerous modern artefacts (including coins, crystals, polished semi-precious jasper, other types of non-local stone, and glass-fragments) were found within and below the patchy turf adjacent to the King Stone. Thereafter, the King Stone and three small features, each lying partly beyond the south-western limit of excavation, were all that remained for investigation in the western arm (lower plan in Fig. 15).

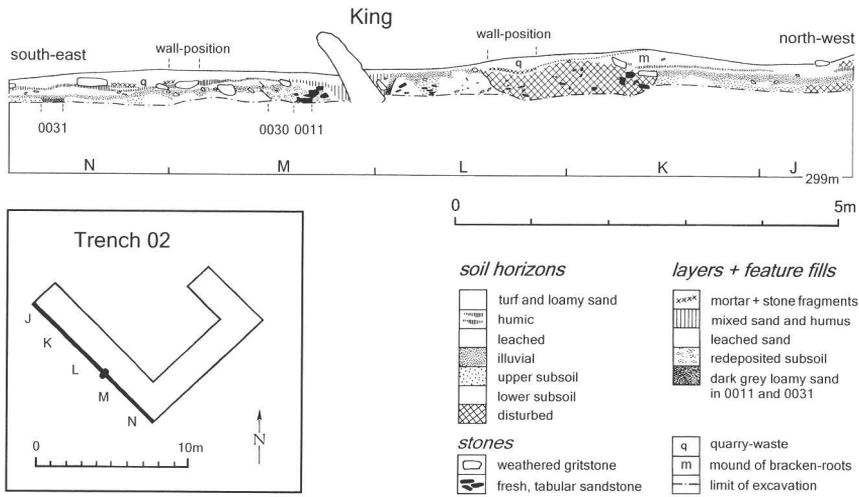
Fig. 16: Nine Ladies: trench 02 section, through King Stone; scale 1:100. Inset plan, at 1:500, shows location of section.

To north-west of the King Stone, the soils had been worn down to the top of the illuvial horizon, where this stood higher than to its south-east (Fig. 16). The orthostat was found to be set into an elongated hole (dashed in Fig. 15; *cf.* Pl. 13), its variably layered fill of fresh, leached and humic sands becoming clearly distinguishable only after the patchy illuvial horizon had been removed to reveal the surrounding soft orange sand containing horizontal, tabular fragments of sandstone, judged to be an *in-situ* lower subsoil. A relatively deep pocket of upper subsoil, seen in unit L of the Fig. 16 section, appeared to be part of a naturally undulating surface. The edge of the stone-hole was less clearly defined at the south than to east and north, where its almost-vertical edge was marked by a dark grey sand (containing an Edward VII penny), merging at its top into the adjacent illuvial horizon. Other modern artefacts found as much as 0.32m deep into the fill of the stone-hole included pieces of foil and glass, evidently attesting to recent delvings and/or bioturbation (rather than any disturbance due to tilting of the stone, because it is believed to have leaned to a similar degree since at least 1883 [page 22], while the 'Bateman view' also suggests a significant lean some 35 years earlier — Figs 4 and 5). South-east of the King Stone, a group of fragments of 'fresh, tabular sandstone' in unit M in Fig. 16, probably derived from bedrock, *may* have been included in the stone-hole; they overrode a patch of compact, dark grey, gritty, loamy sand with abundant charcoal flecks and small pieces of rotted sandstone,

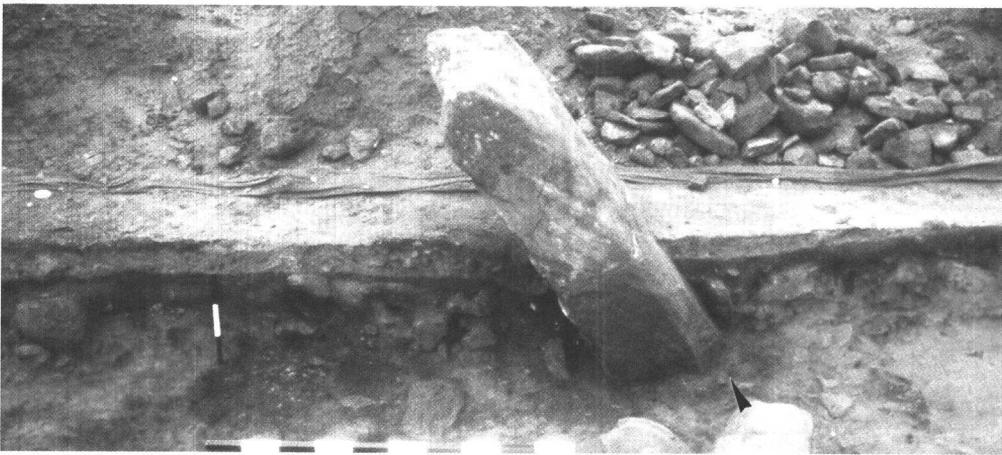
Plate 13: Nine Ladies: King Stone within western arm of trench 02, looking south-west, in November 2000; northern chamfered angle of stone arrowed from below; scale-divisions of 0.10m.
