# THREE NORMAN CHURCHES IN NORFOLK

East Anglian Archaeology 32

Norfolk Archaeological Unit, Norfolk Museums Service, 1987

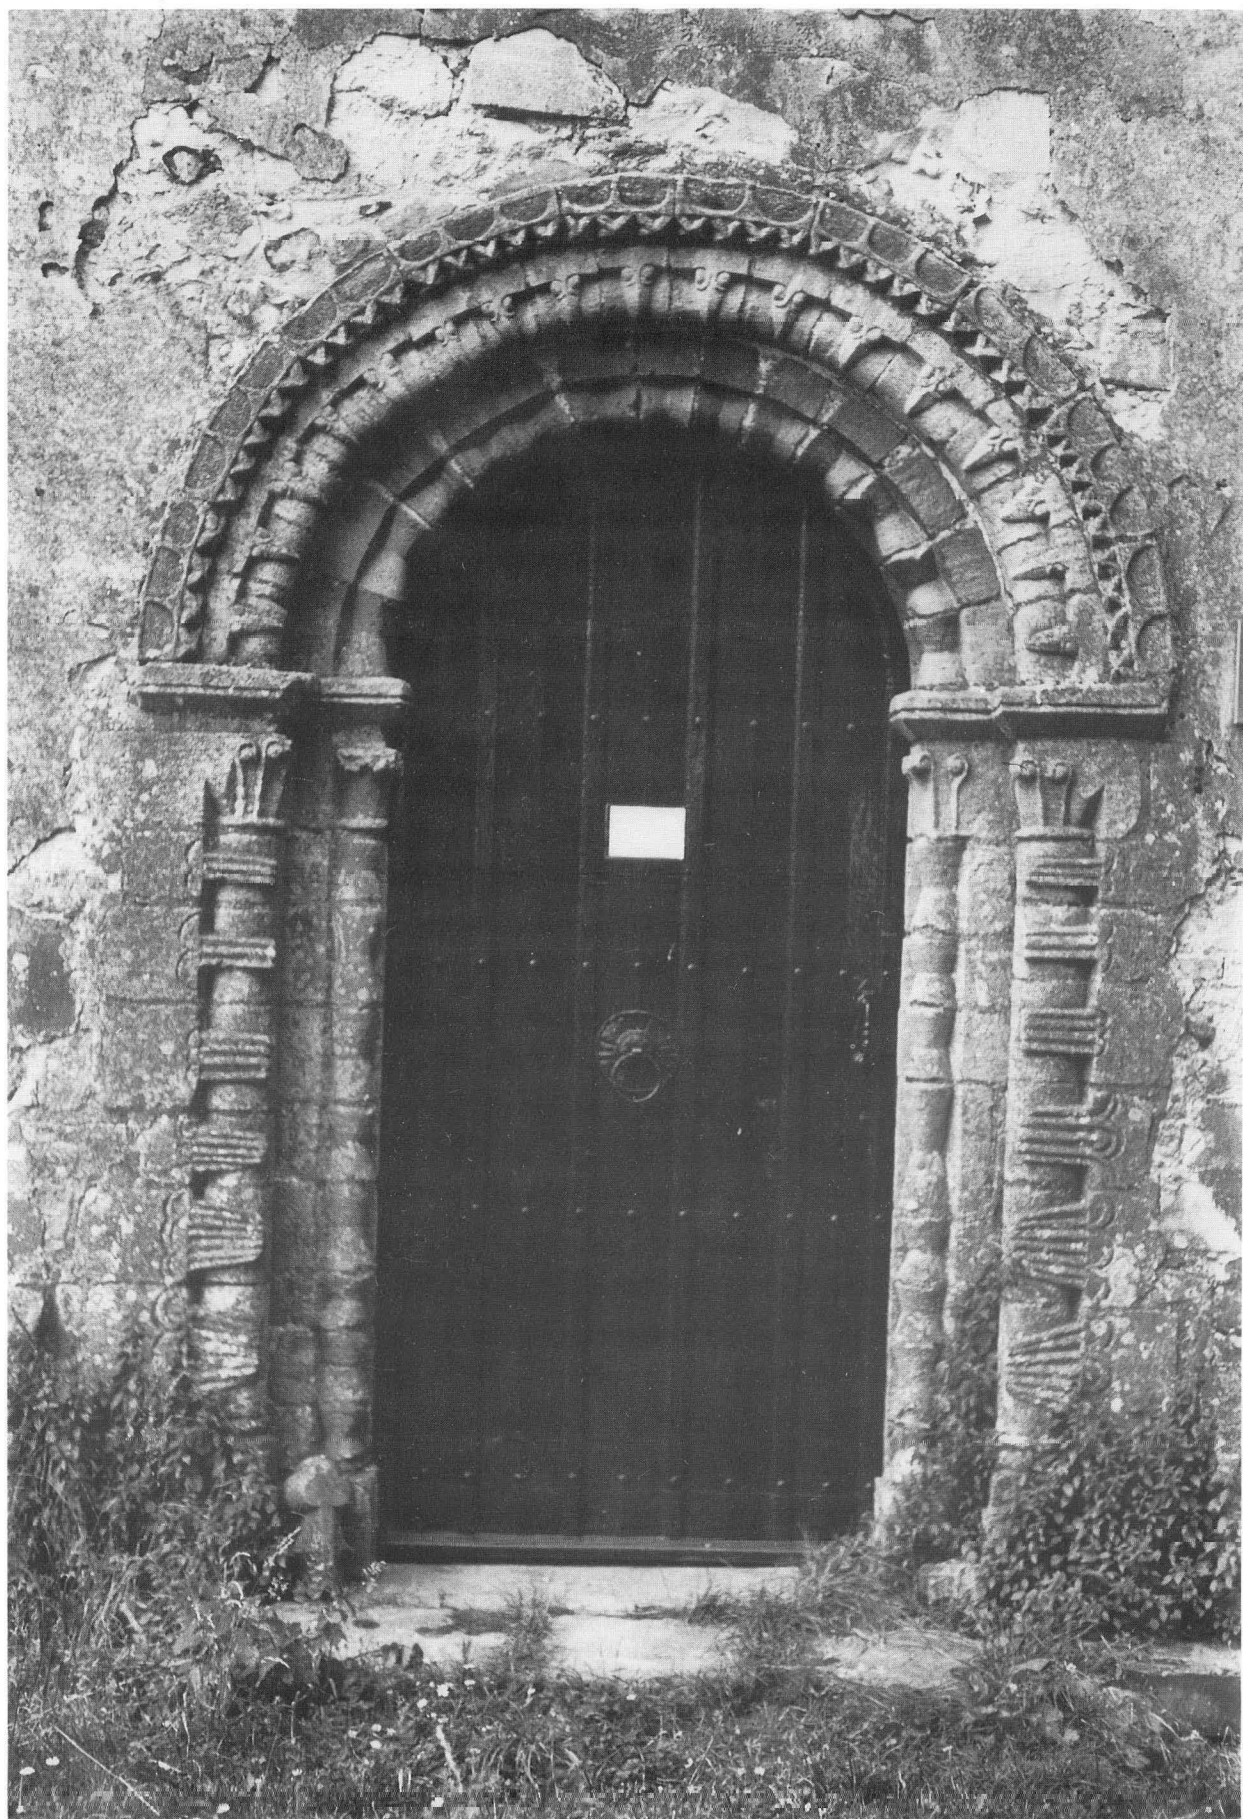
Frontispiece: The west doorway of St.Mary's church, Barton Bendish, formerly the north doorway of All Saints'.  
Ref.BYC 15

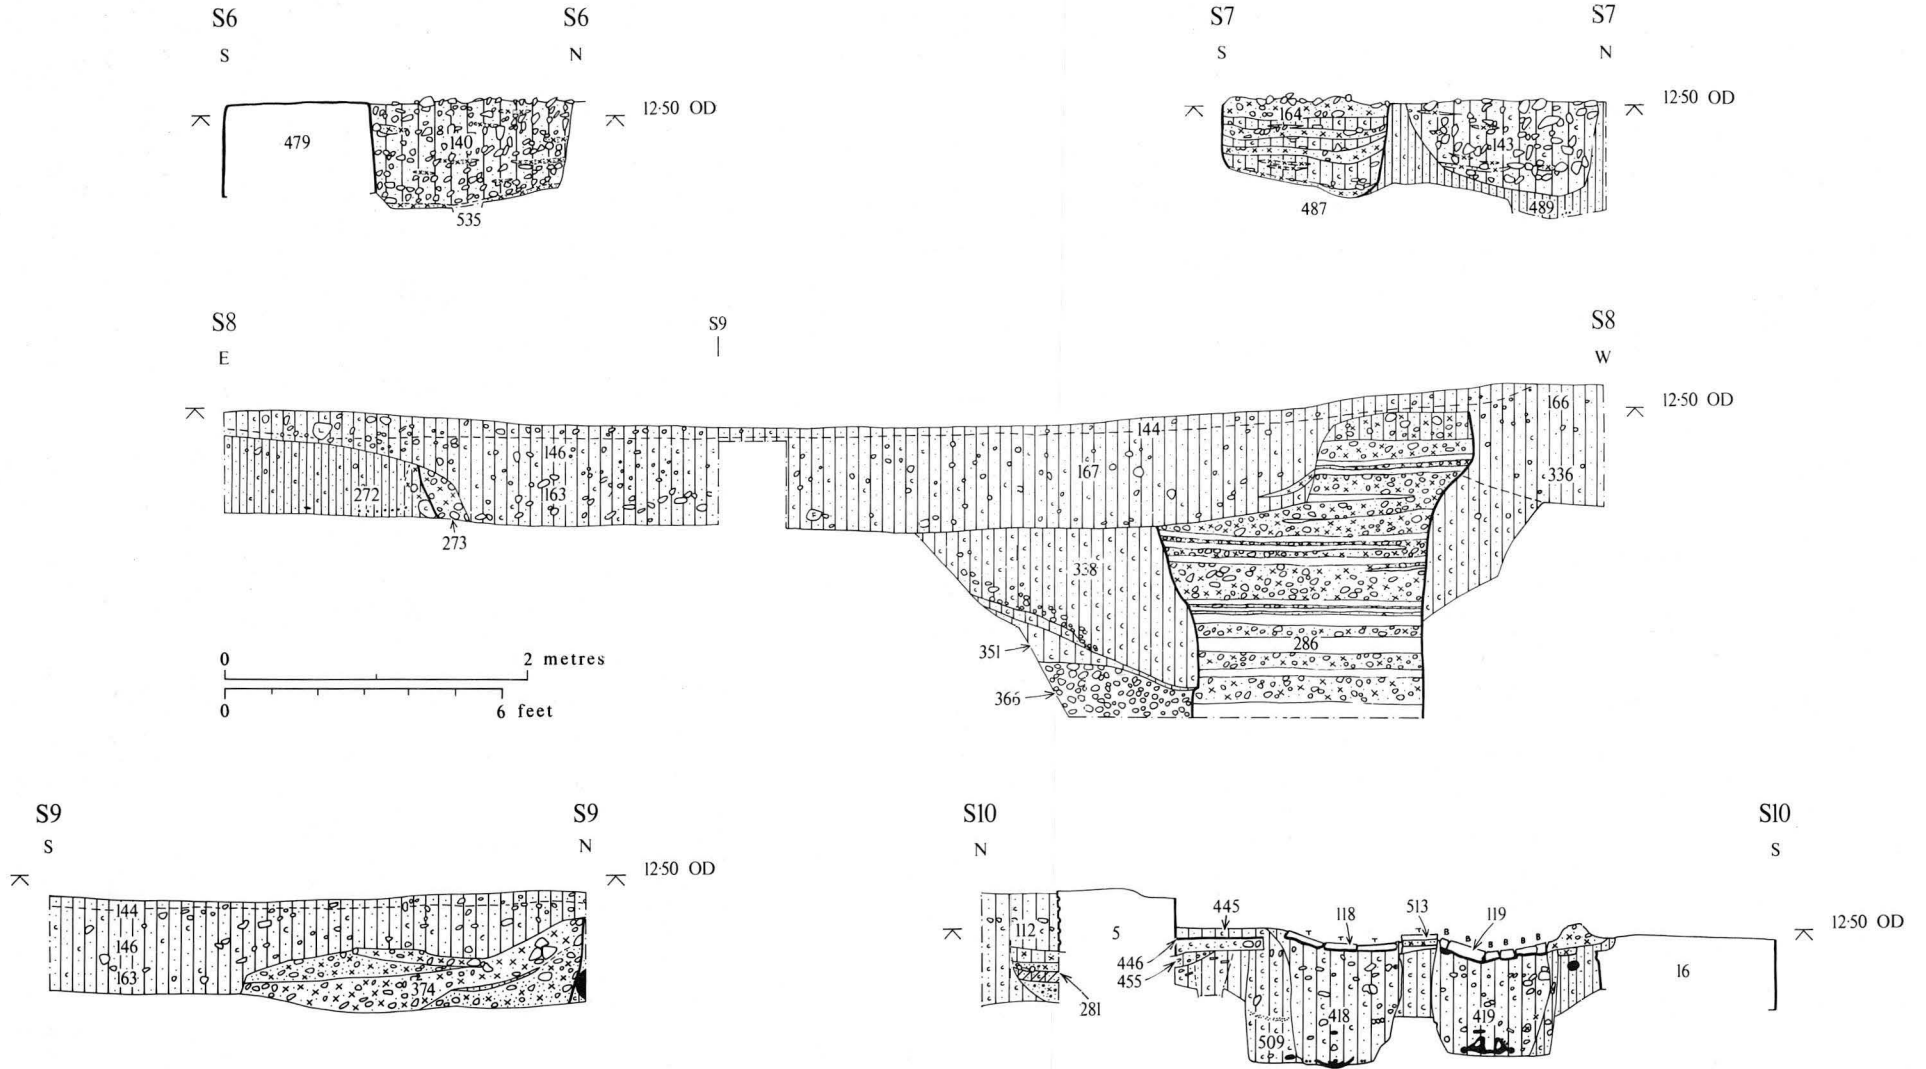
Figure 11 Sections S6-S10. Scale 1:50

The nave was extended westwards by 4.5 m, the north and south wall foundations (164 and 156) being cut into Phase 2 buttress foundations 520 and 521. The new west wall foundation (273 Sect.S8, Fig.11) was of one build with 164 and 156 but was mostly cut away by the west tower robbing pit (p.14). The foundation trenches (Sect.S7, Fig.11) were filled with alternating layers of yellowish-brown mortar and grey brown soil. The thickness of the soil layers and the manner in which soil and mortar layers rose upwards to the trench edges indicates a separate phase of building to that of the Phase 3 east wall 211. That this is a succeeding phase to 211 is suggested by the frequency of peg roof-tiles in trenches of Phase 4 and their absence from 211.

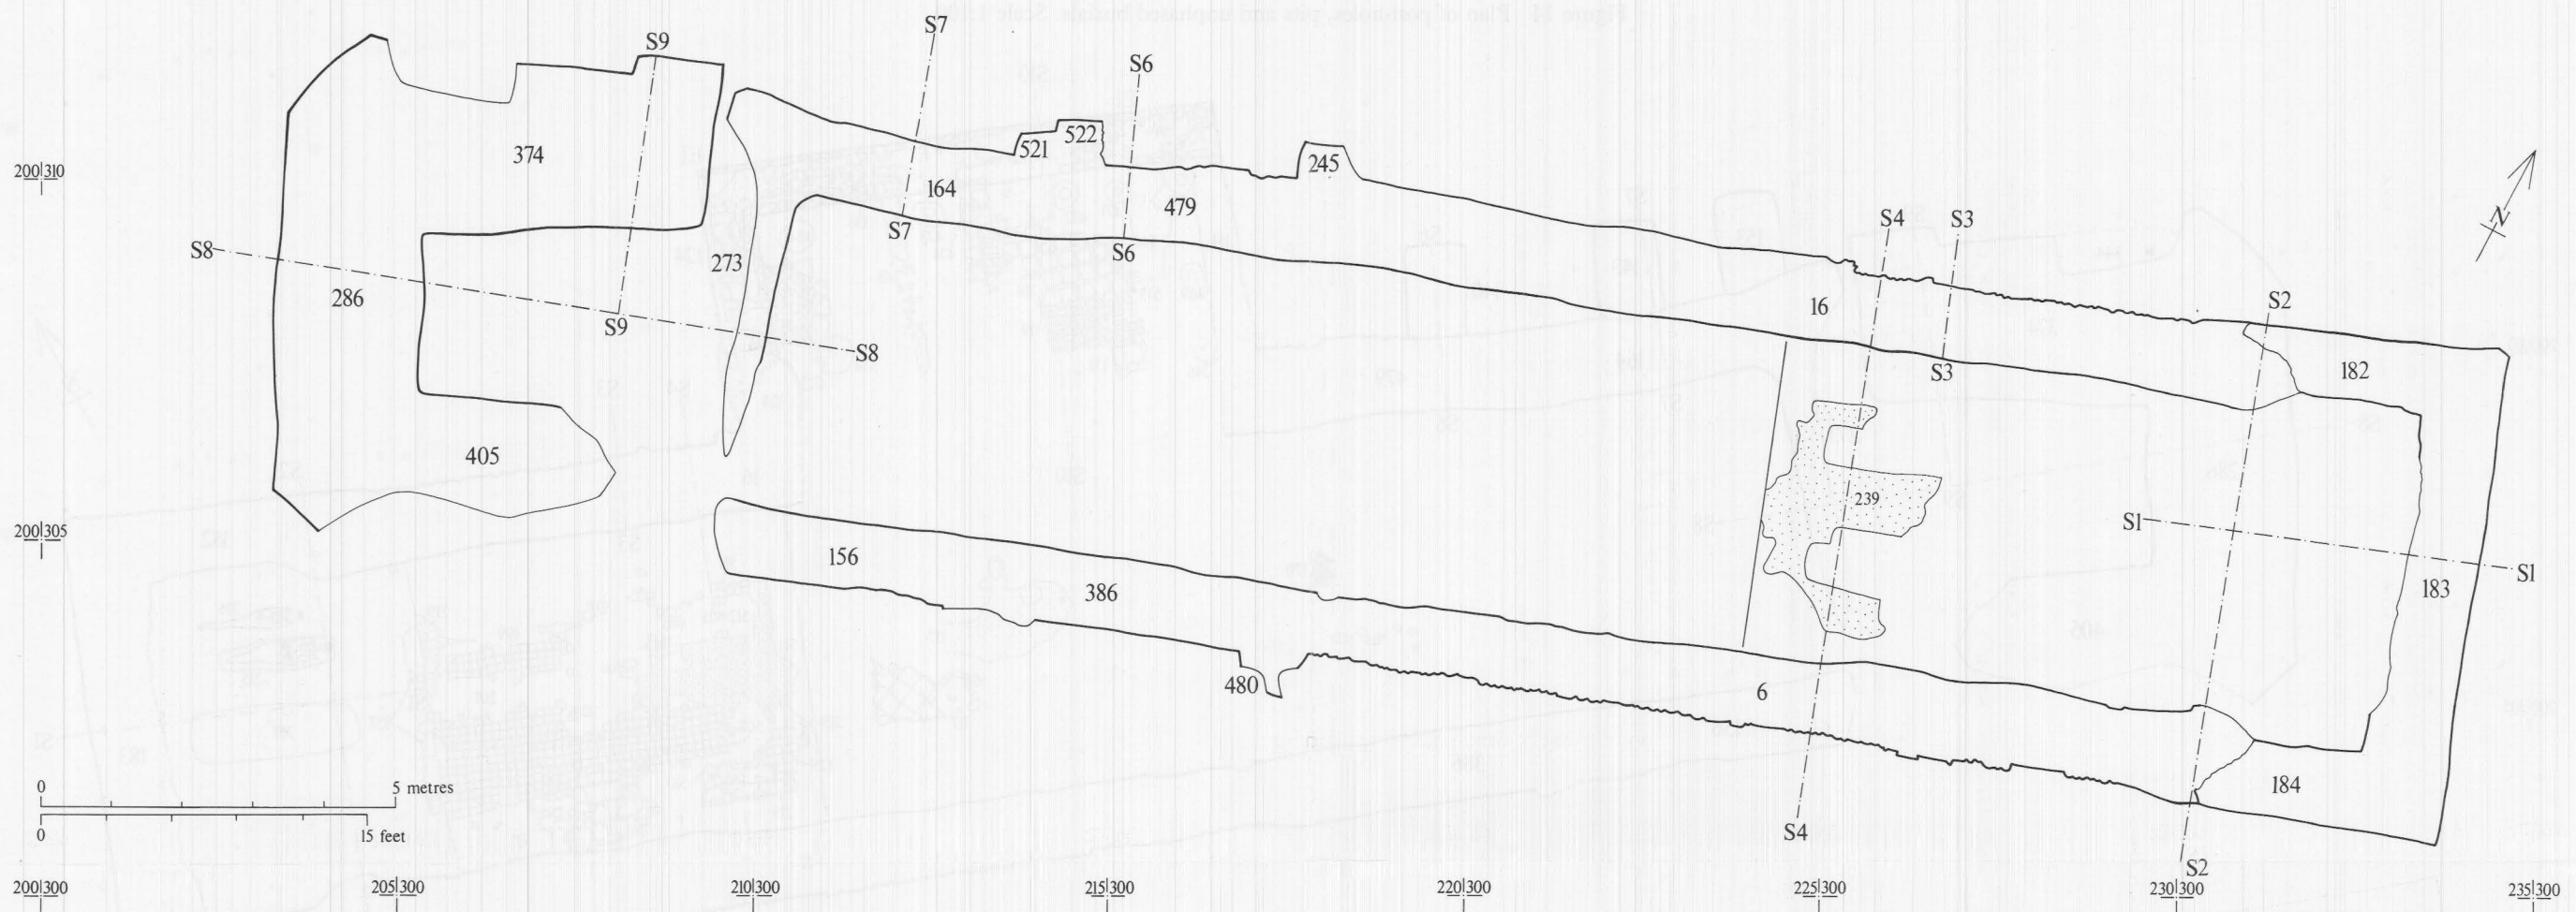
Figure 13 Plan: Phase 5. Scale 1:100

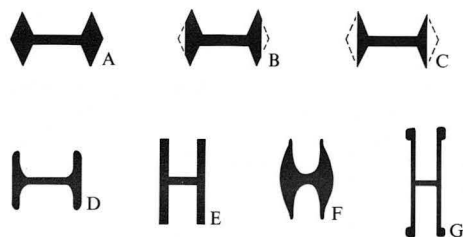
Figure 35 Diagram of lead window came typology

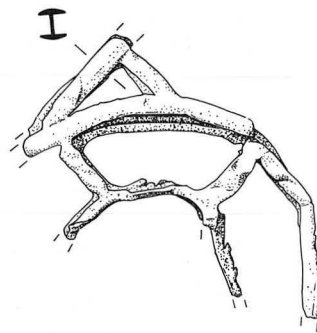
Figure 36 Window leading: demolition in north chapel and east end of nave (13). Scale 1:2

*Type C:* Most of the medieval window leads from this site was of type C, of which 327.5 g were found. Here, the hearts varied from 2 mm to 4 mm and the flange from 2.5 mm to 6 mm. This reflects the range of sizes that would have been used from the fourteenth century painted glass found at Barton Bendish All Saints, the smallest size heart in this group still being larger than all but two of the post-medieval lead comes. Whether the type A leads are actually older than those of this group or representative of an older kind still in use at the same time is not possible to establish, but no definite remains of glass-painting earlier than c.1350-60 date given to the medieval glass found here were discovered. One small section of leading of this type survives intact and is illustrated (Fig.36).

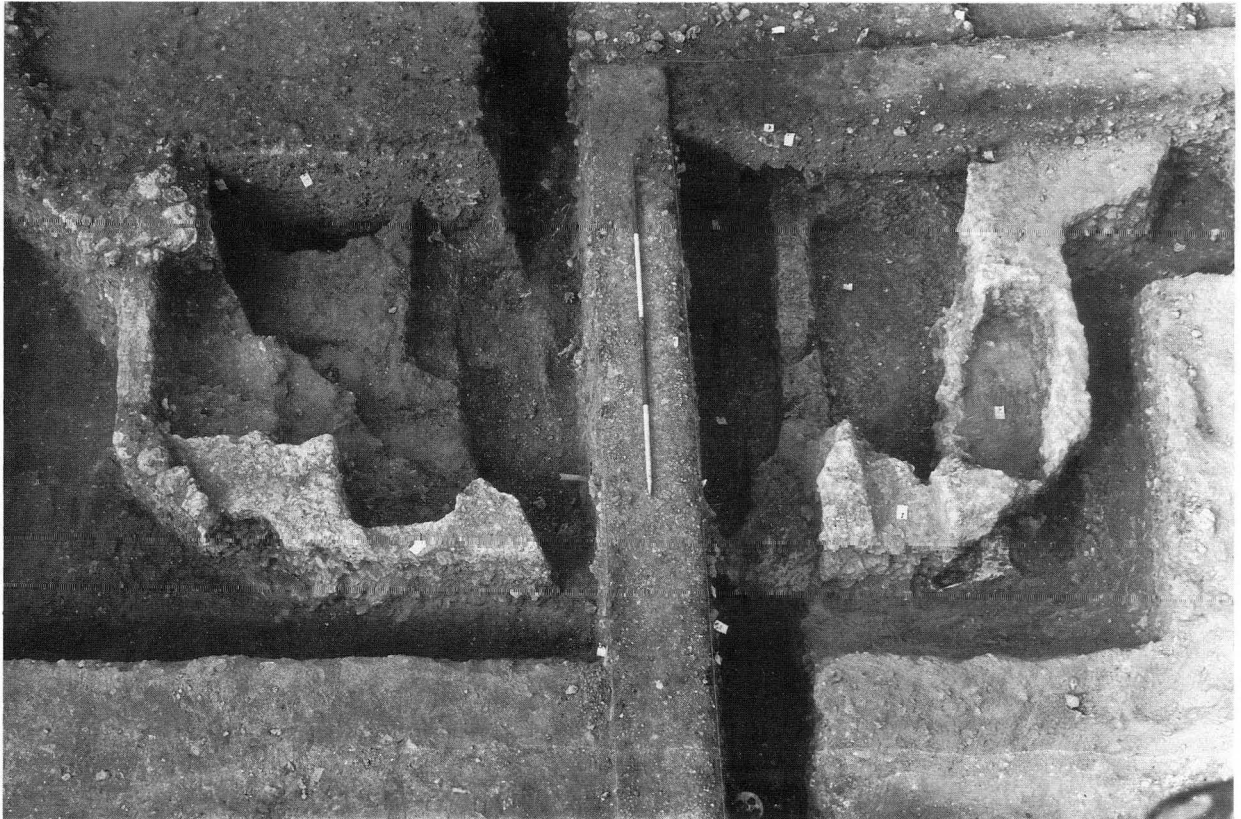
Plate V Barton Bendish All Saints': Phase 1 apse foundation 177, with the inner parts of Phase 5 chancel wall foundations removed. Ref.BYY 2

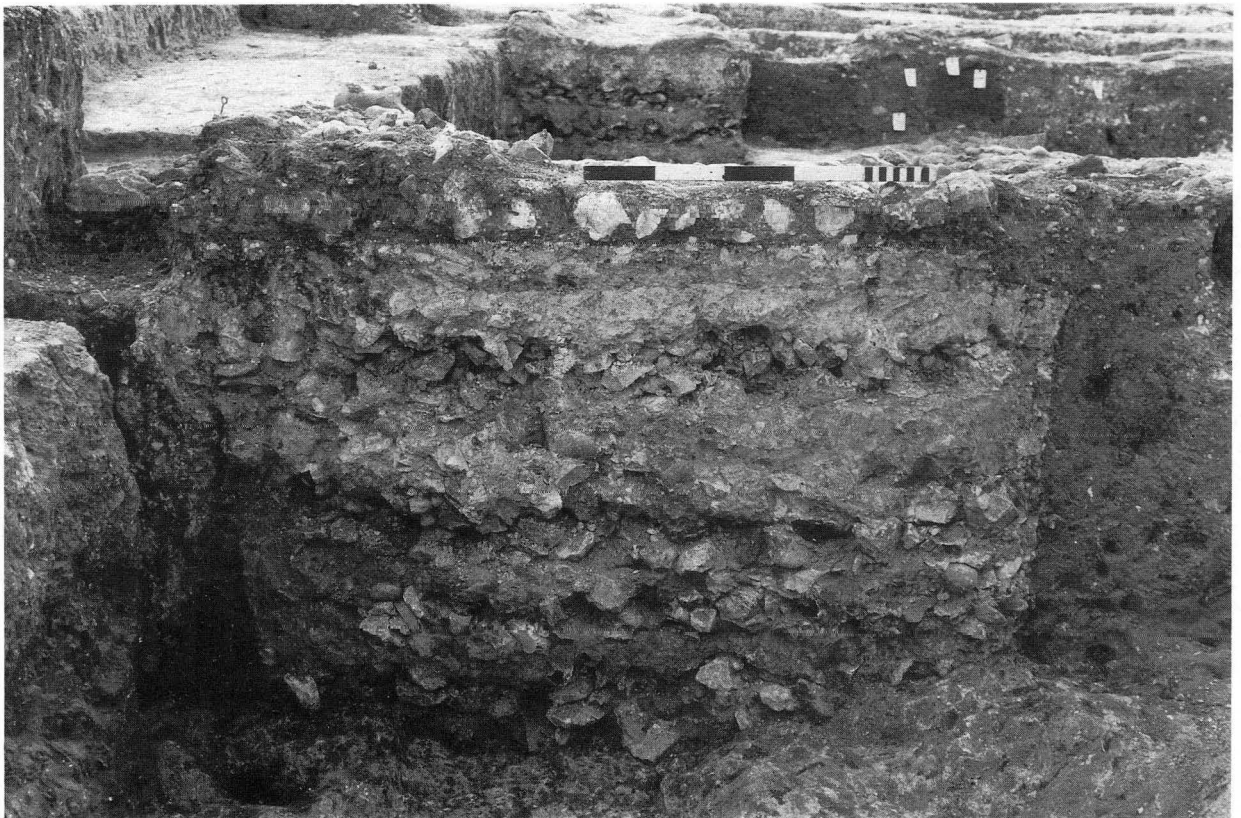
Plate VI Barton Bendish All Saints': section through Phase 1 apse foundation 177 and buttress foundation 478 to left. See Sect.S2, Fig.10. Ref.BYY 24

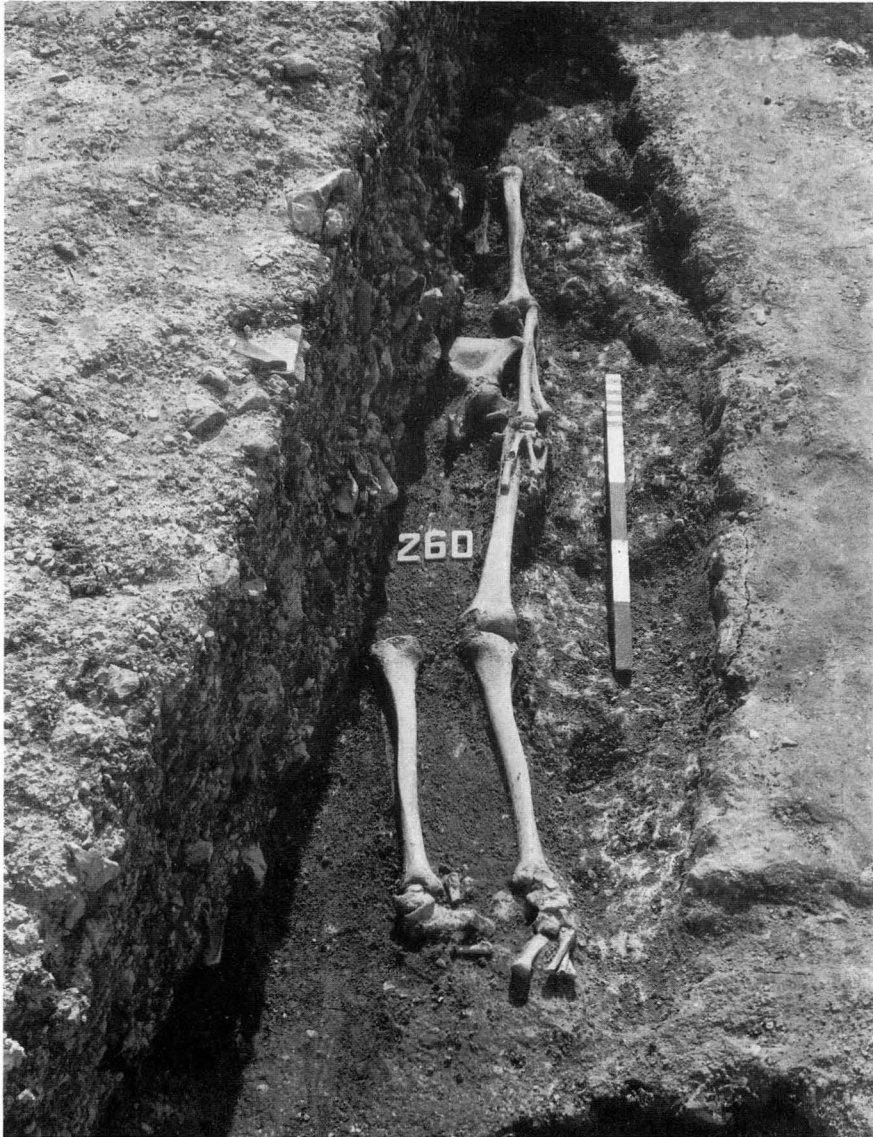
Plate IX Barton Bendish All Saints': pre-Phase 1 burial 260 cut by Phase 2 south wall foundation 386. Ref.BYU 10

To the west, within the Phase 2 extension, burial 260 (Pl.IX) was cut by pre-Phase 1 burial 355. Four others (242, 244, 276 and 288), stretching in a row to the north, were probably contemporary with 260 (Pl.VIII). A post-hole (357) cut the west end of 305 and was cut by the Phase 1 west wall. A ?grave pit (358) was cut by 242 and by Phase 2 wall foundations. Grave pits 394 and 528 were cut by Phase 2 and probably belong to the pre-Phase 1 cemetery, as may also burials 271 and 272, cut by the Phase 4 west wall (Fig.15; Sect.S8, Fig.11).

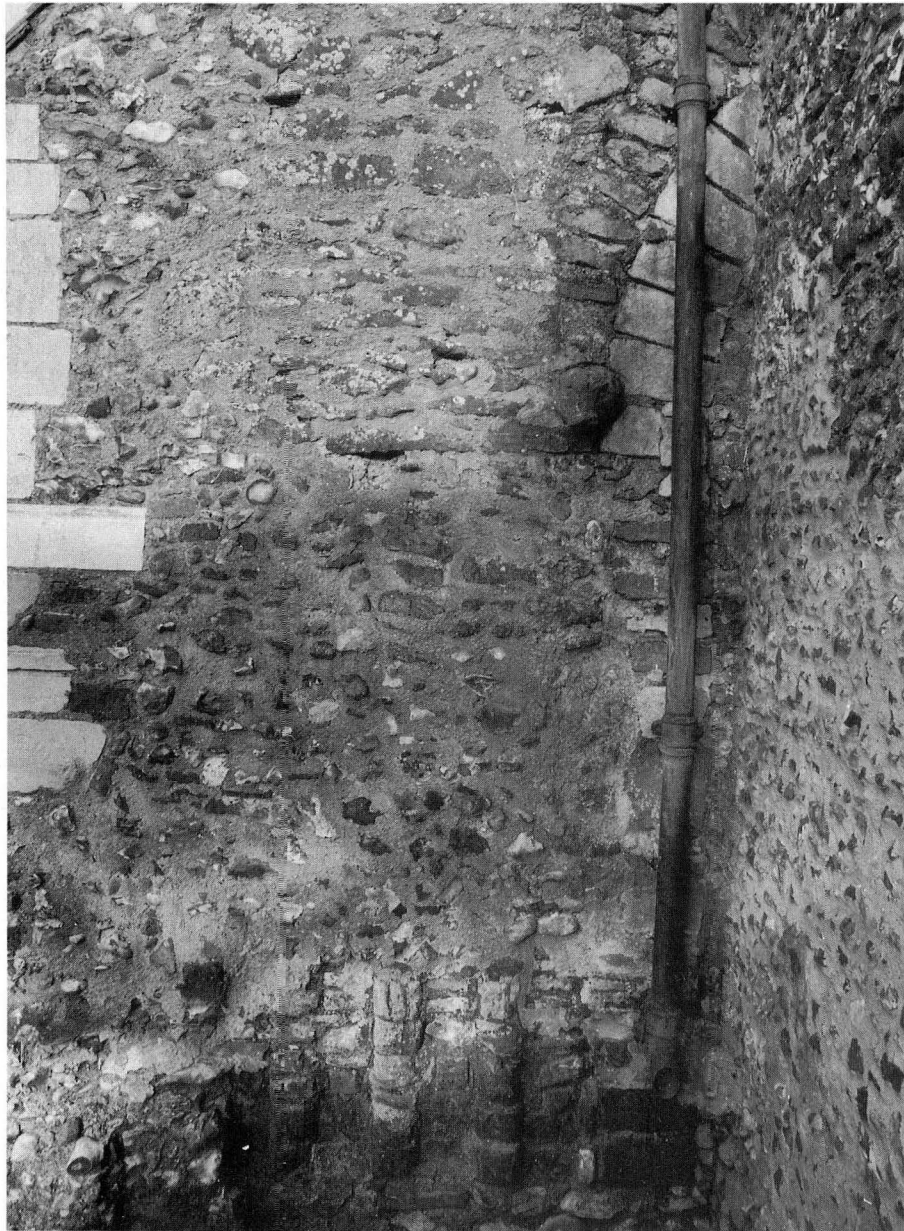
Plate XX. Guestwick: the lower part of the tower west face showing voussoirs of nave arch and recessed half-round mouldings. Ref.CLN 27

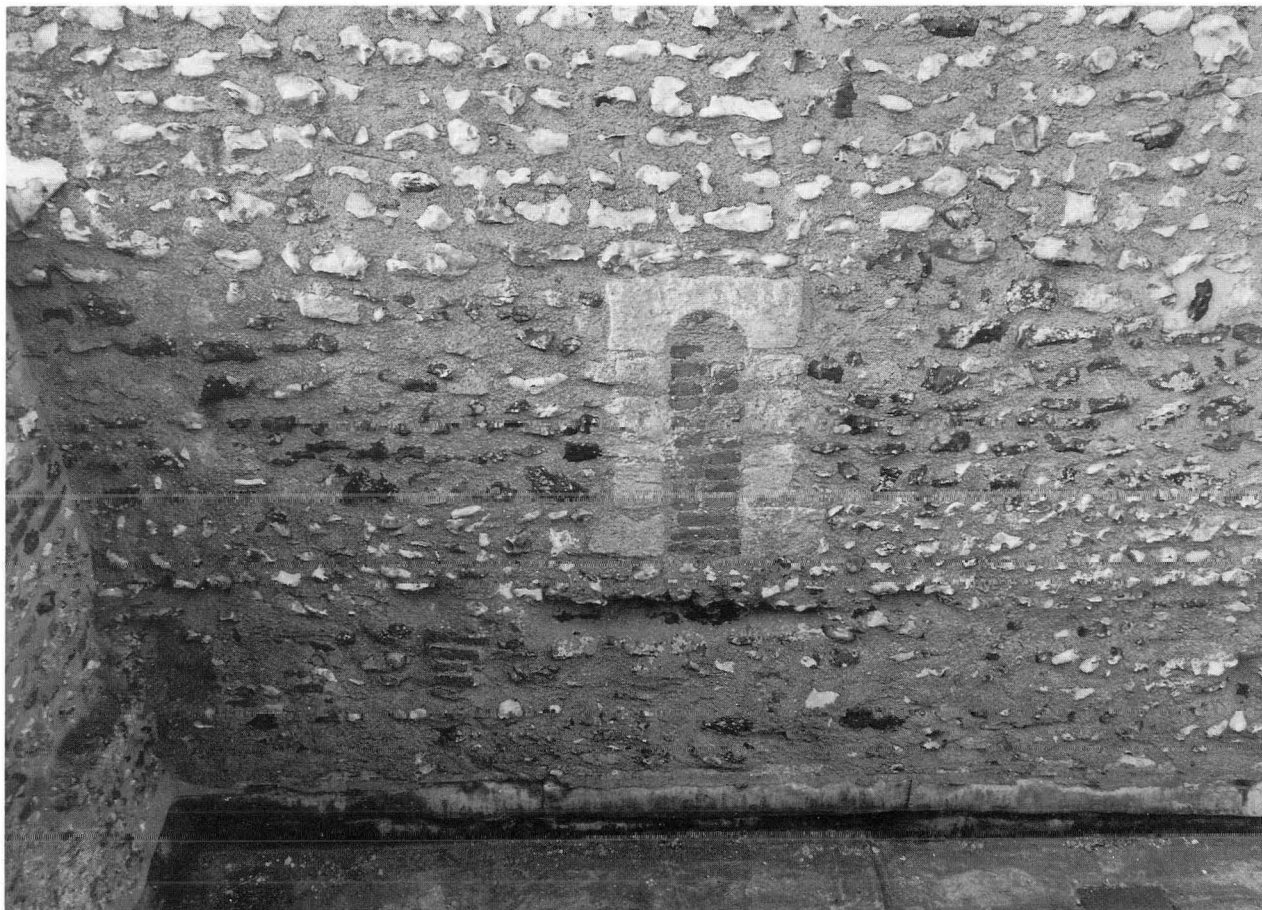
Plate XXII Guestwick: south face of tower showing blocked window above horizontal recess. Ref.CLN 10

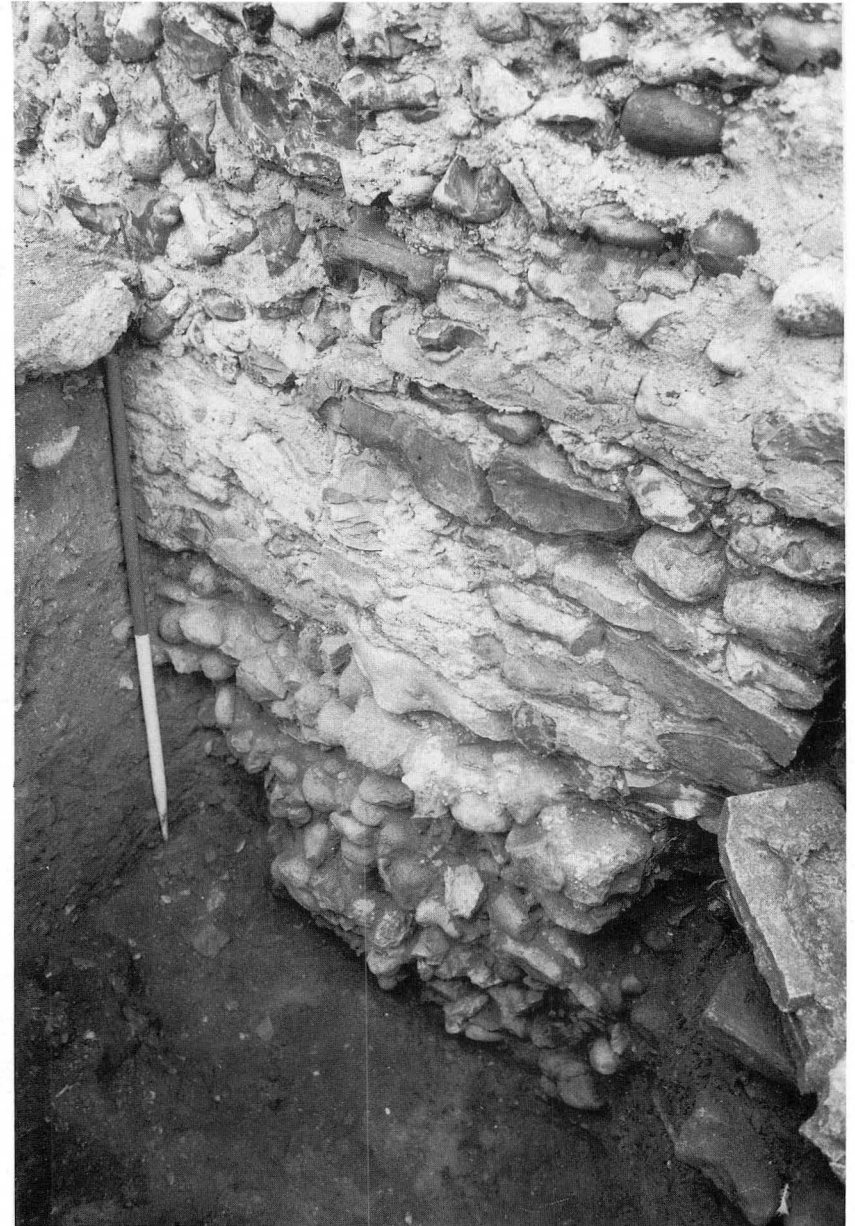
Plate XXVI Framingham Earl: Context 44, foundations of chancel and pilaster. Phase I (Photo: Andrew Harris)

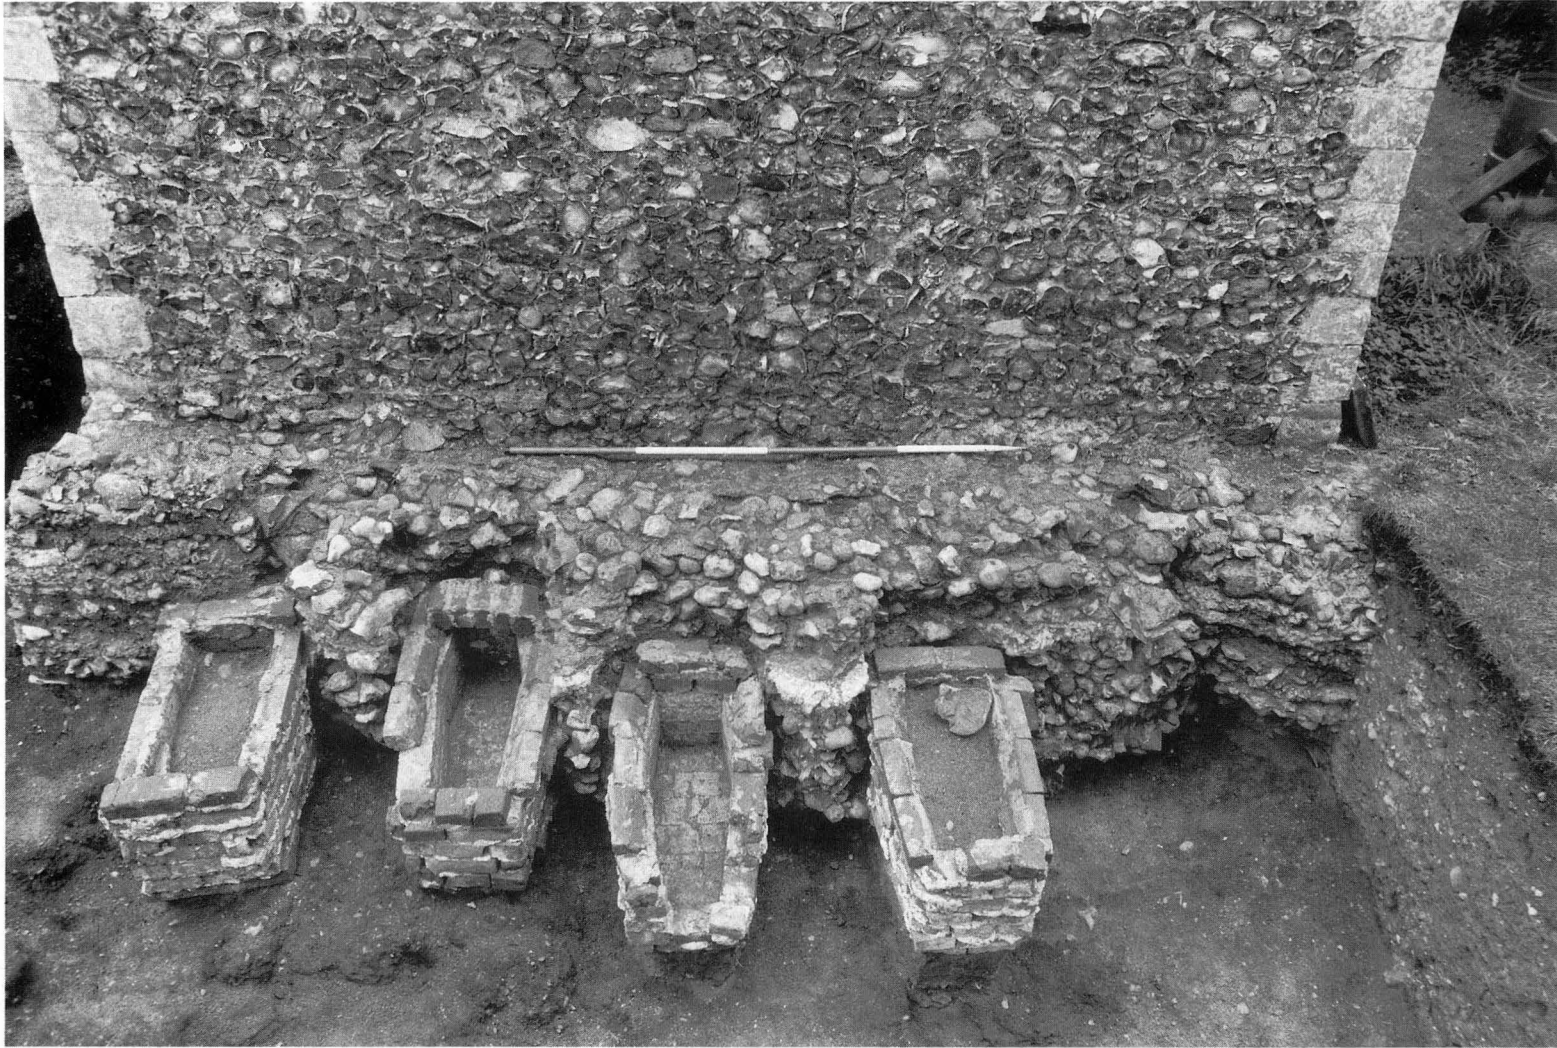
Plate XXVII Framingham Earl: view of apse showing contexts 20, 44, 45 and 77 (Photo: Andrew Harris)

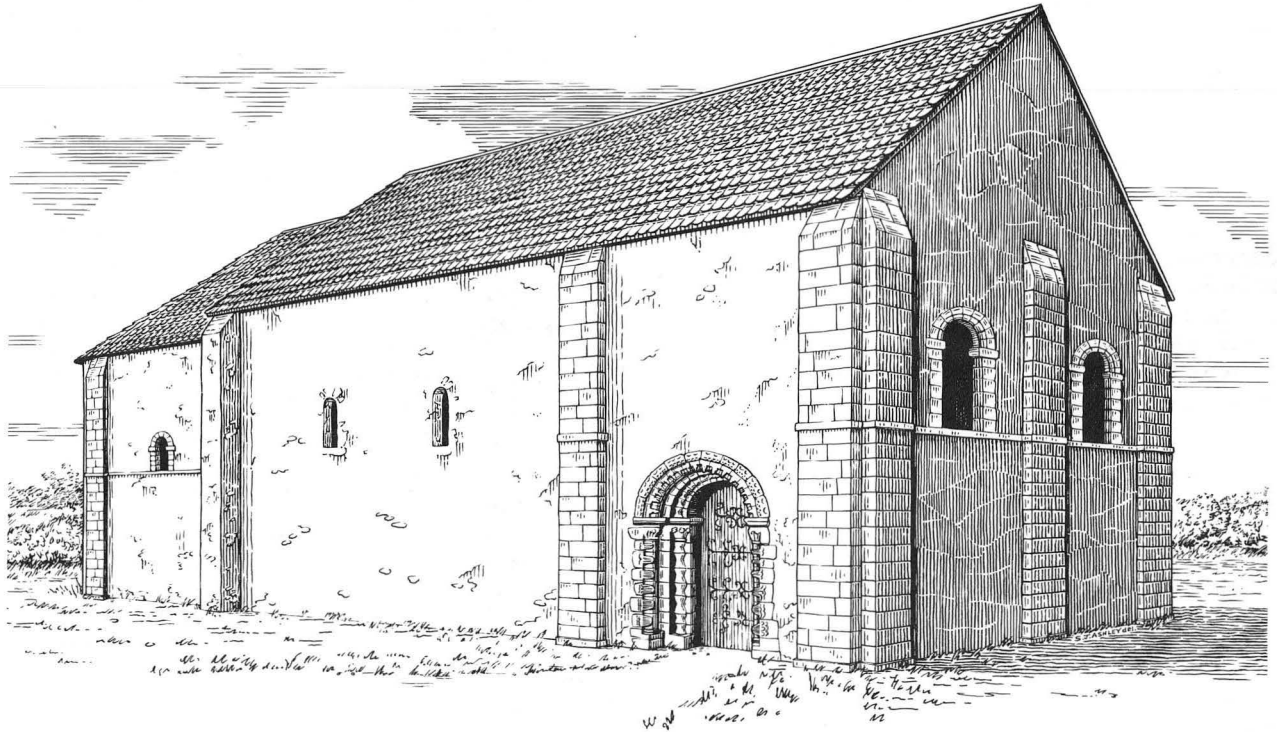
Figure 39 Reconstruction of All Saints in Phase 2, viewed from the north-west

There is no certain evidence concerning the fate of the Phase 1 west wall (133) in this phase. Either 133 was demolished and the nave extended to an internal length of 11.2 m, or 133 was retained as the east wall of a rectangular chamber, perhaps a tower, measuring 2.5m by 4.5m internally. The buttresses lend credence to the latter alternative, although there was no thickening of foundations as might be expected beneath a tower. These problems of interpretation are further discussed below (p. 53). The tower alternative is chosen on the phase plans (Figs 4, 8 and 9), but the extended nave version is shown on the reconstruction drawing (Fig.39).

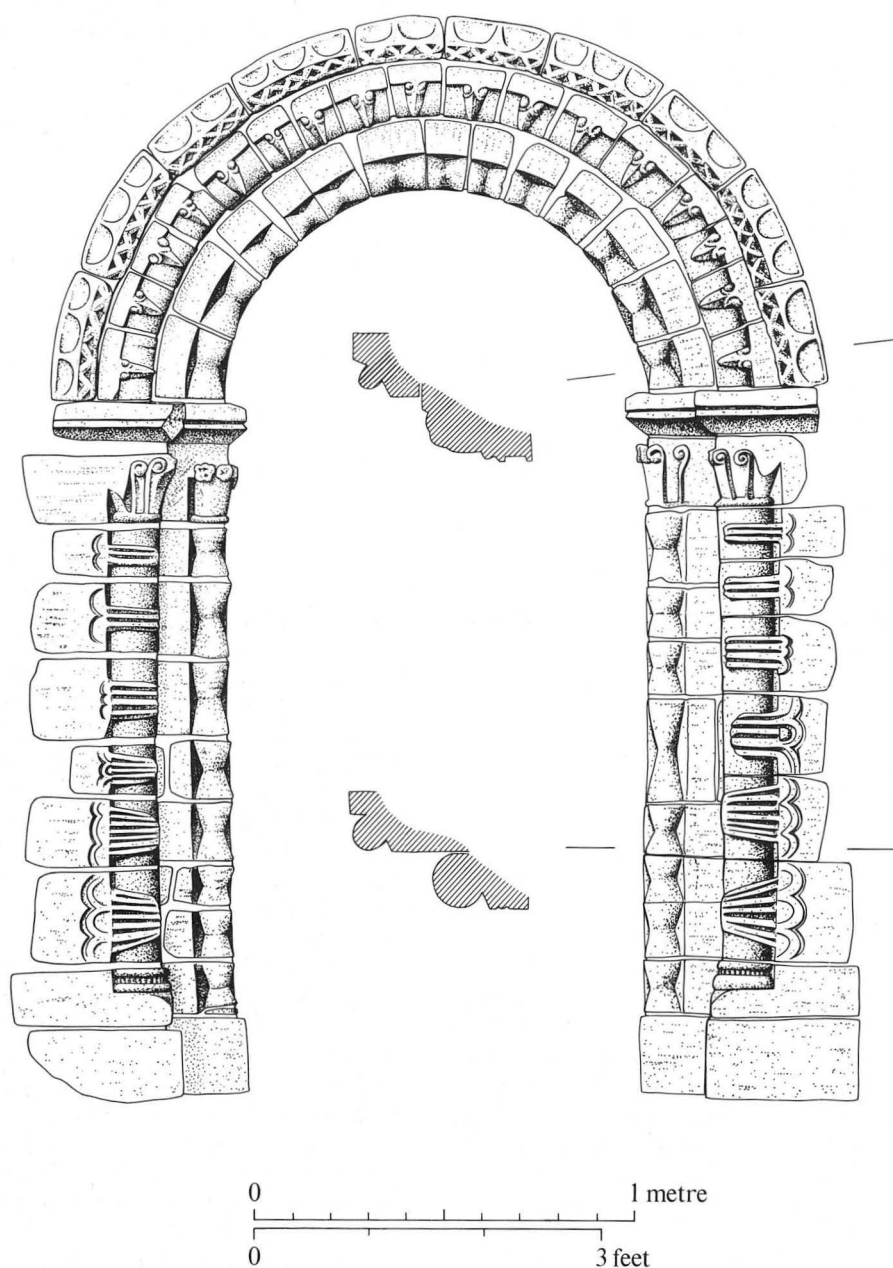
Figure 42 Elevation west door of St.Mary's, former north door of All Saints', with profiles of mouldings. Scale 1:20

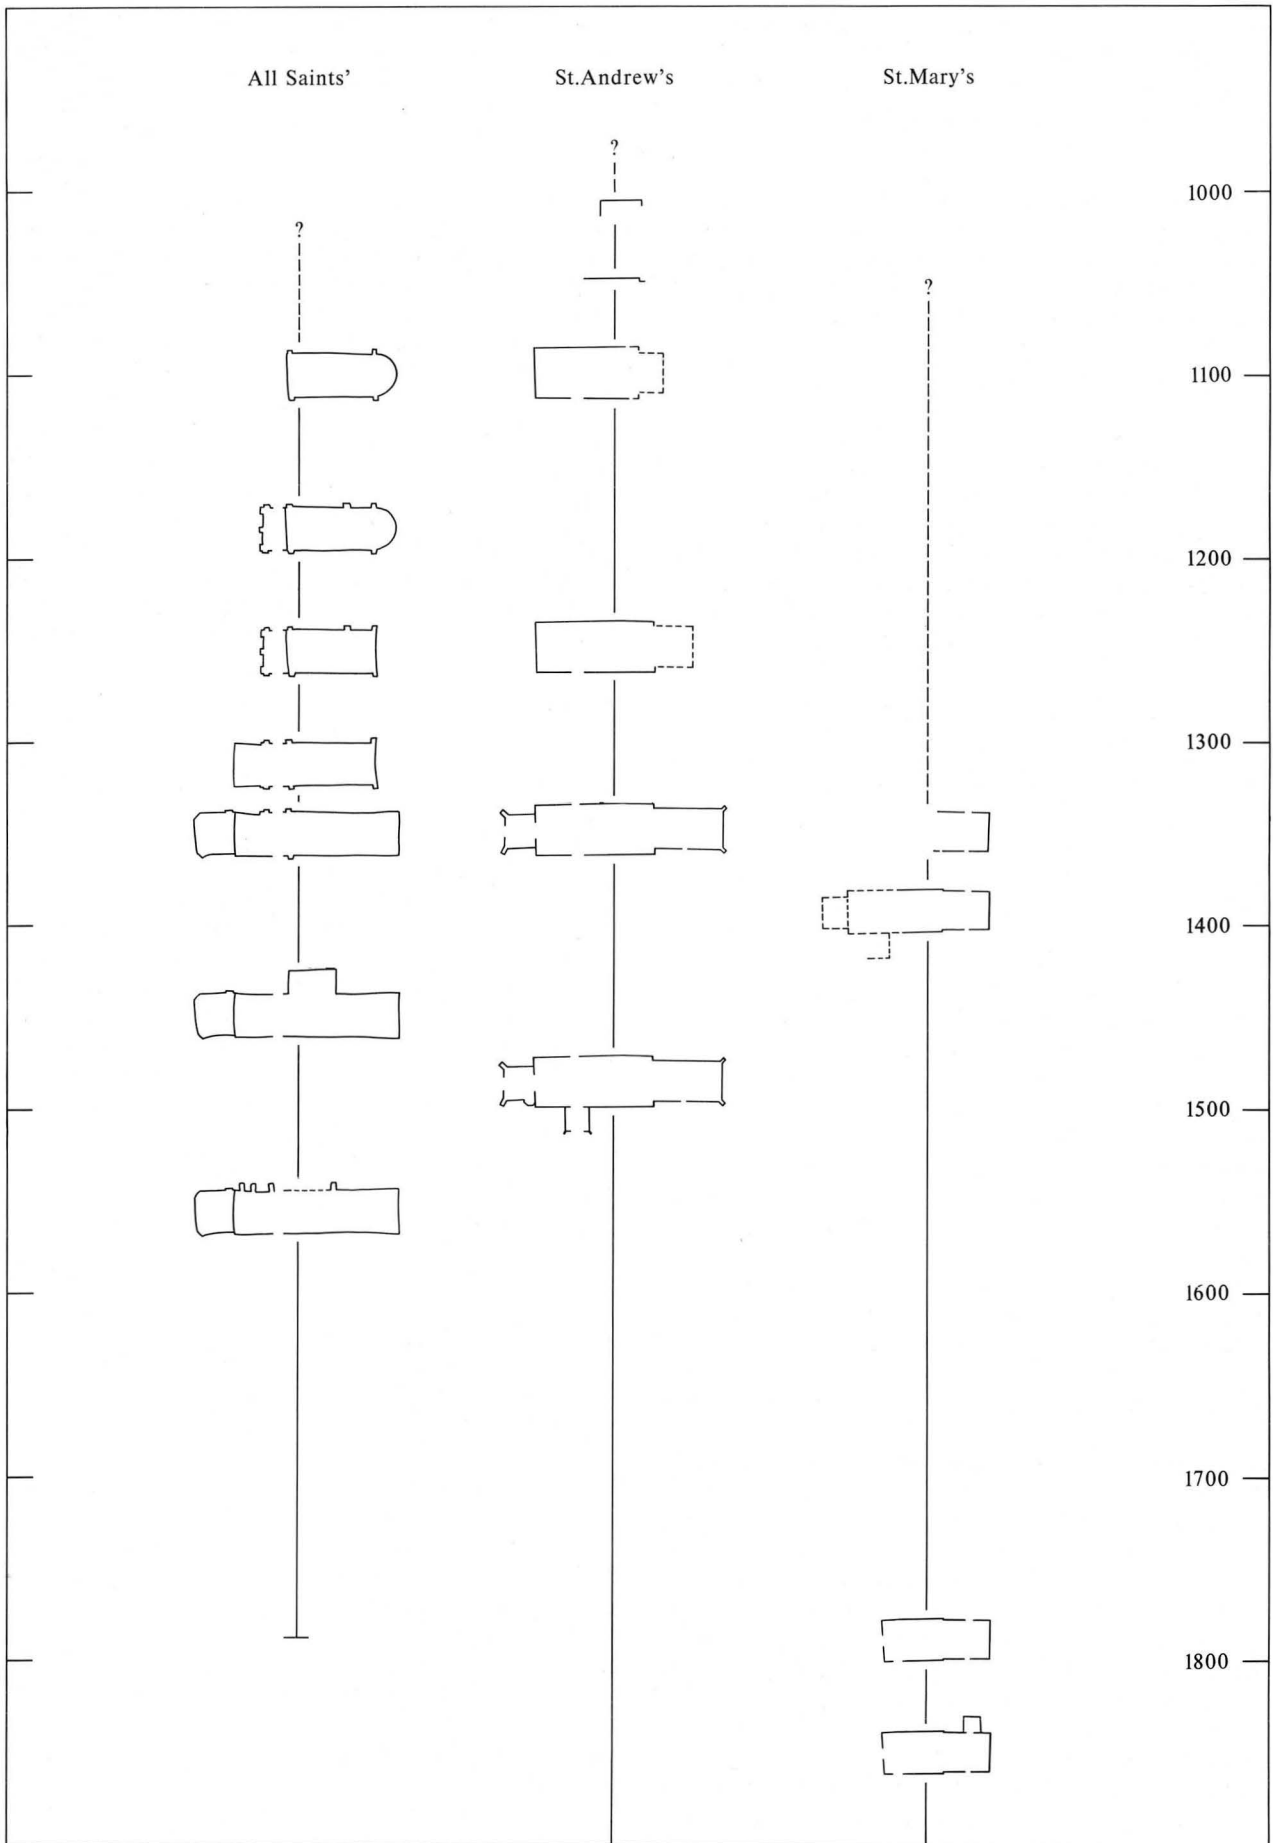
Figure 43 Comparative diagrams illustrating the architectural development of the three churches
