# THREE NORMAN CHURCHES IN NORFOLK

East Anglian Archaeology 32

Norfolk Archaeological Unit, Norfolk Museums Service, 1987

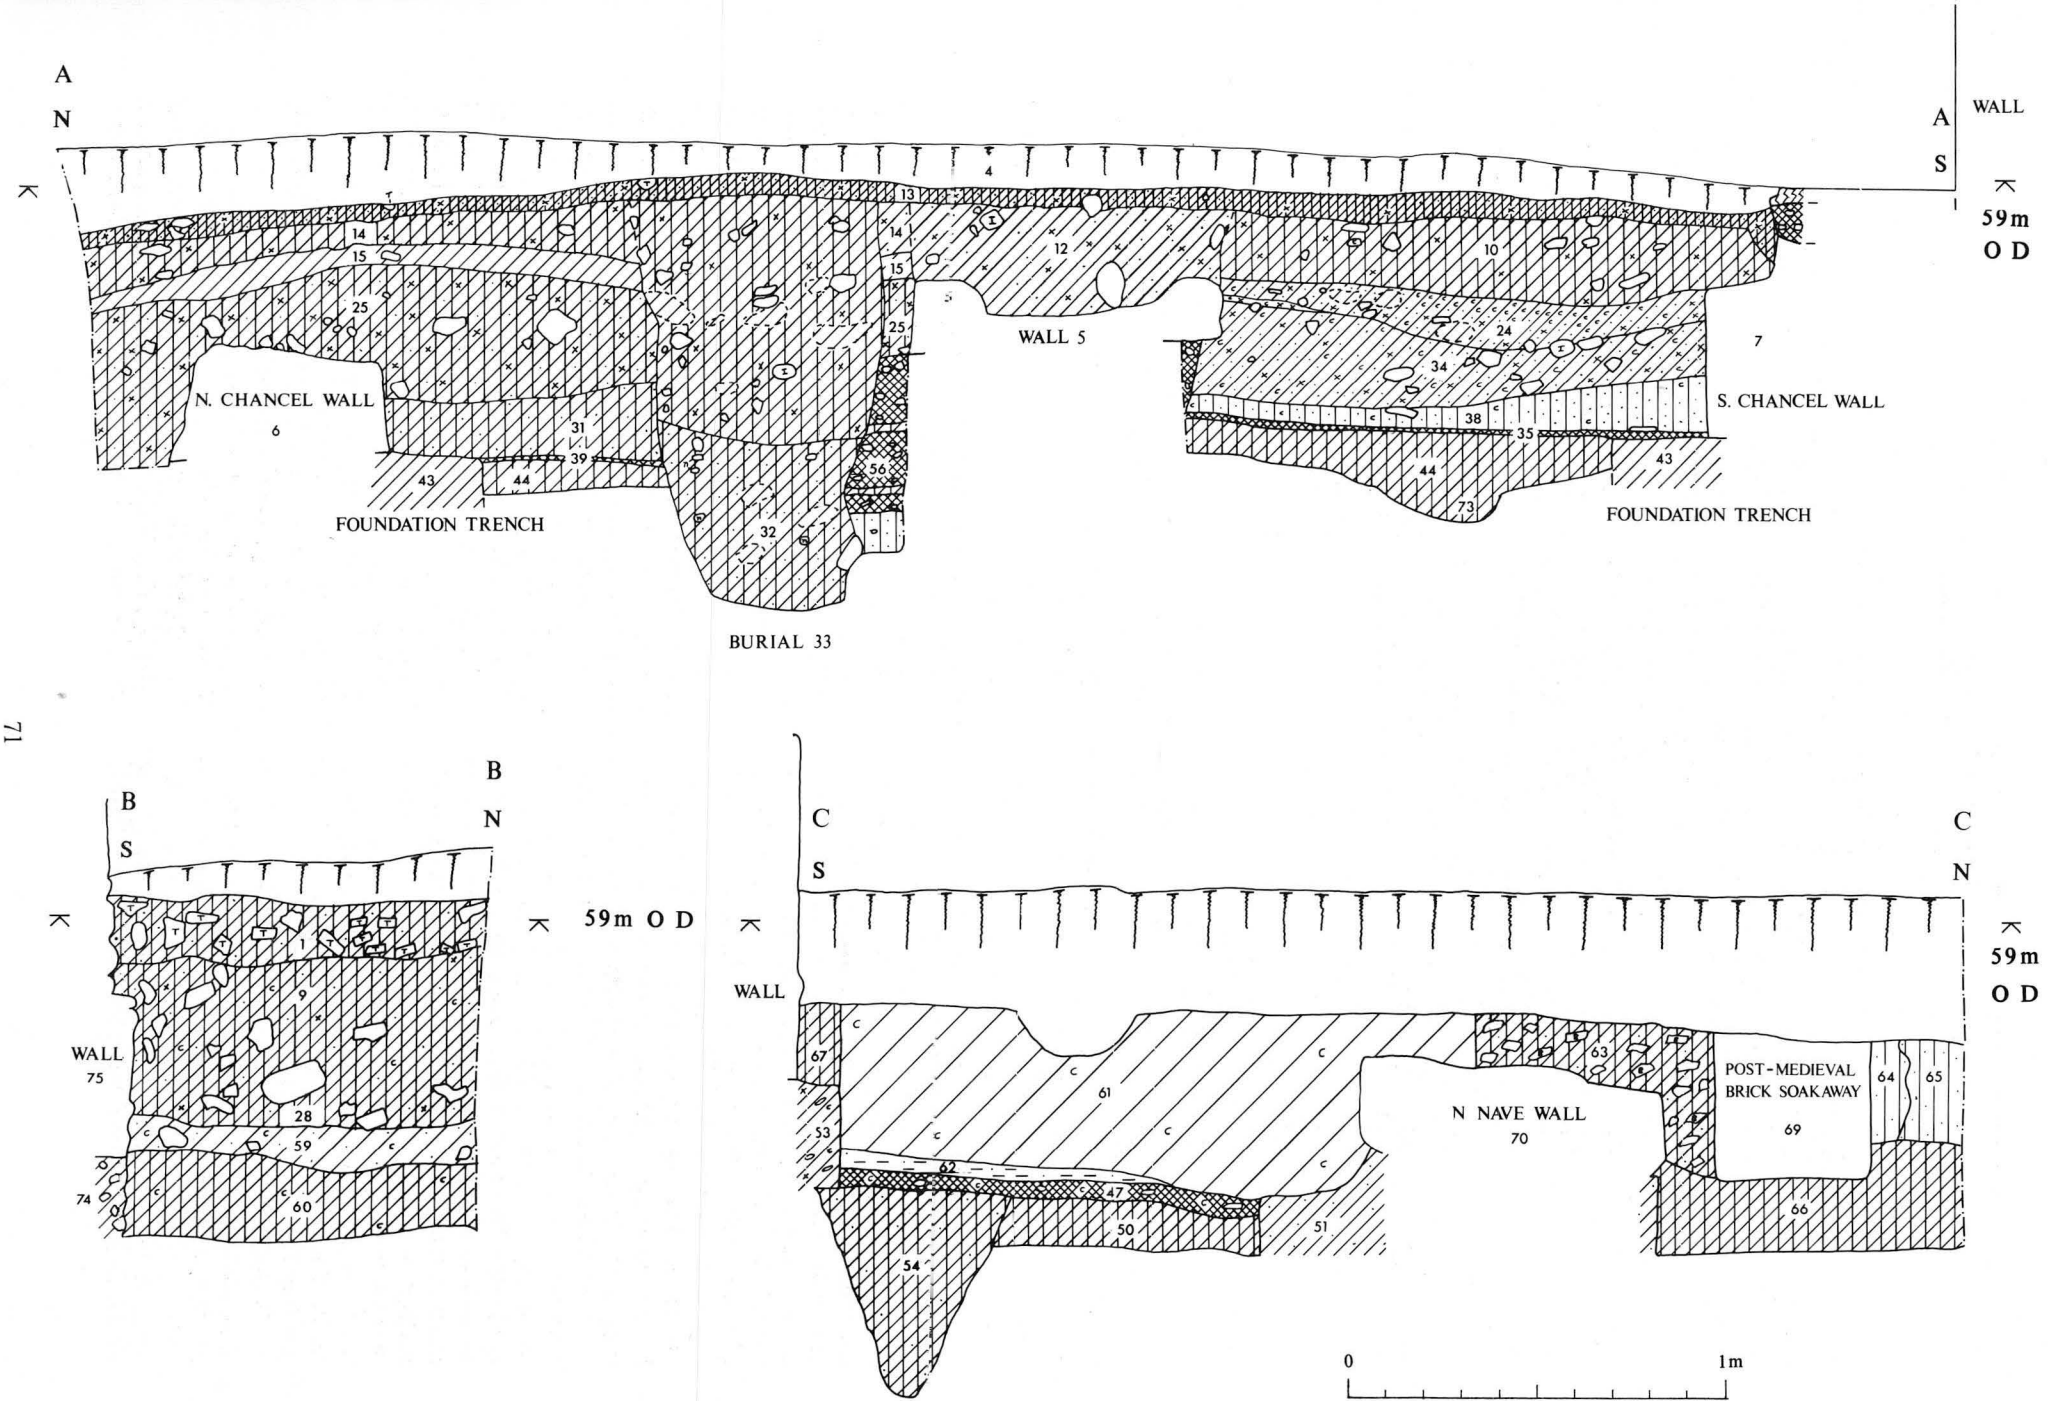
Figure 48 Sections A-A, B-B, and C-C. Scale 1:20

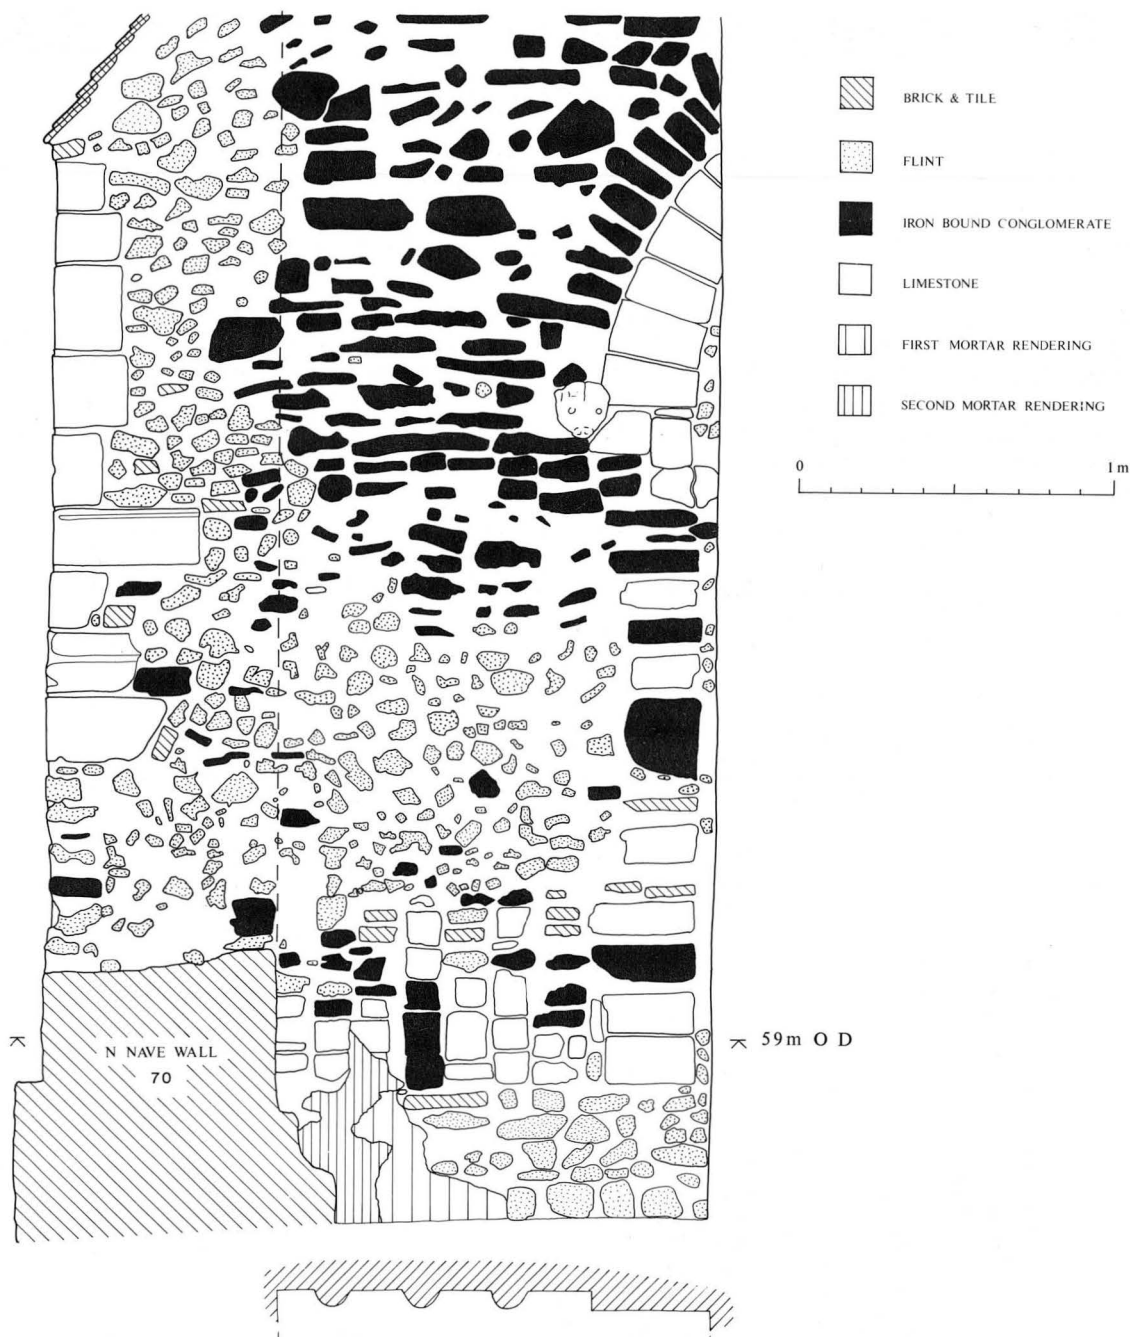
Figure 56 West elevation of nave arch, with profile of stripwork. Scale 1:25

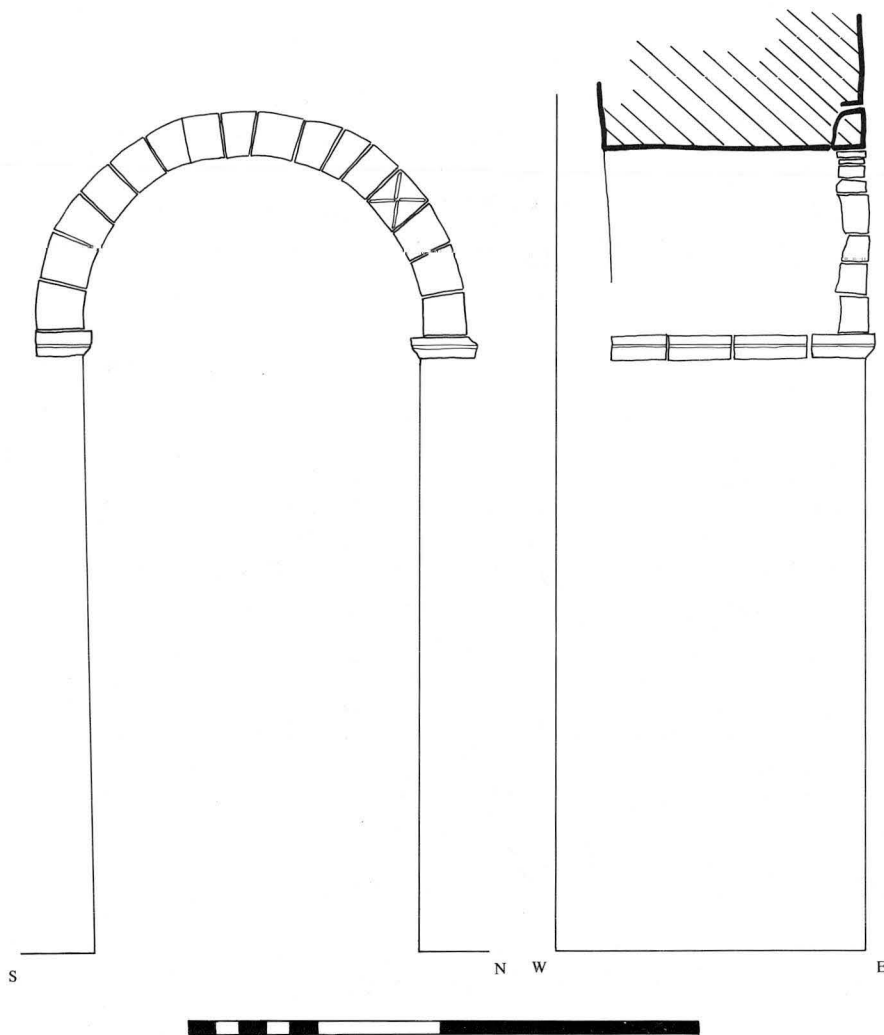
Figure 59 The tower arch, nave face and north section. Scale 1:30

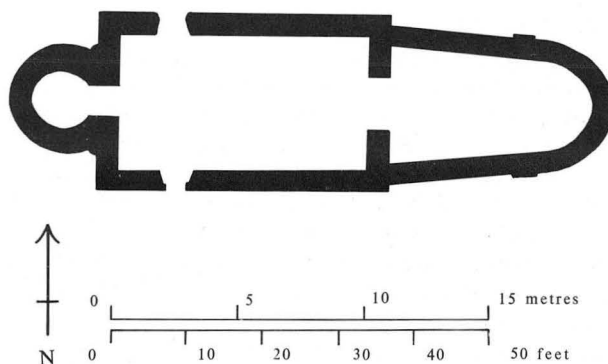
Figure 62 Reconstruction of plan as at end of twelfth century. Scale 1:300

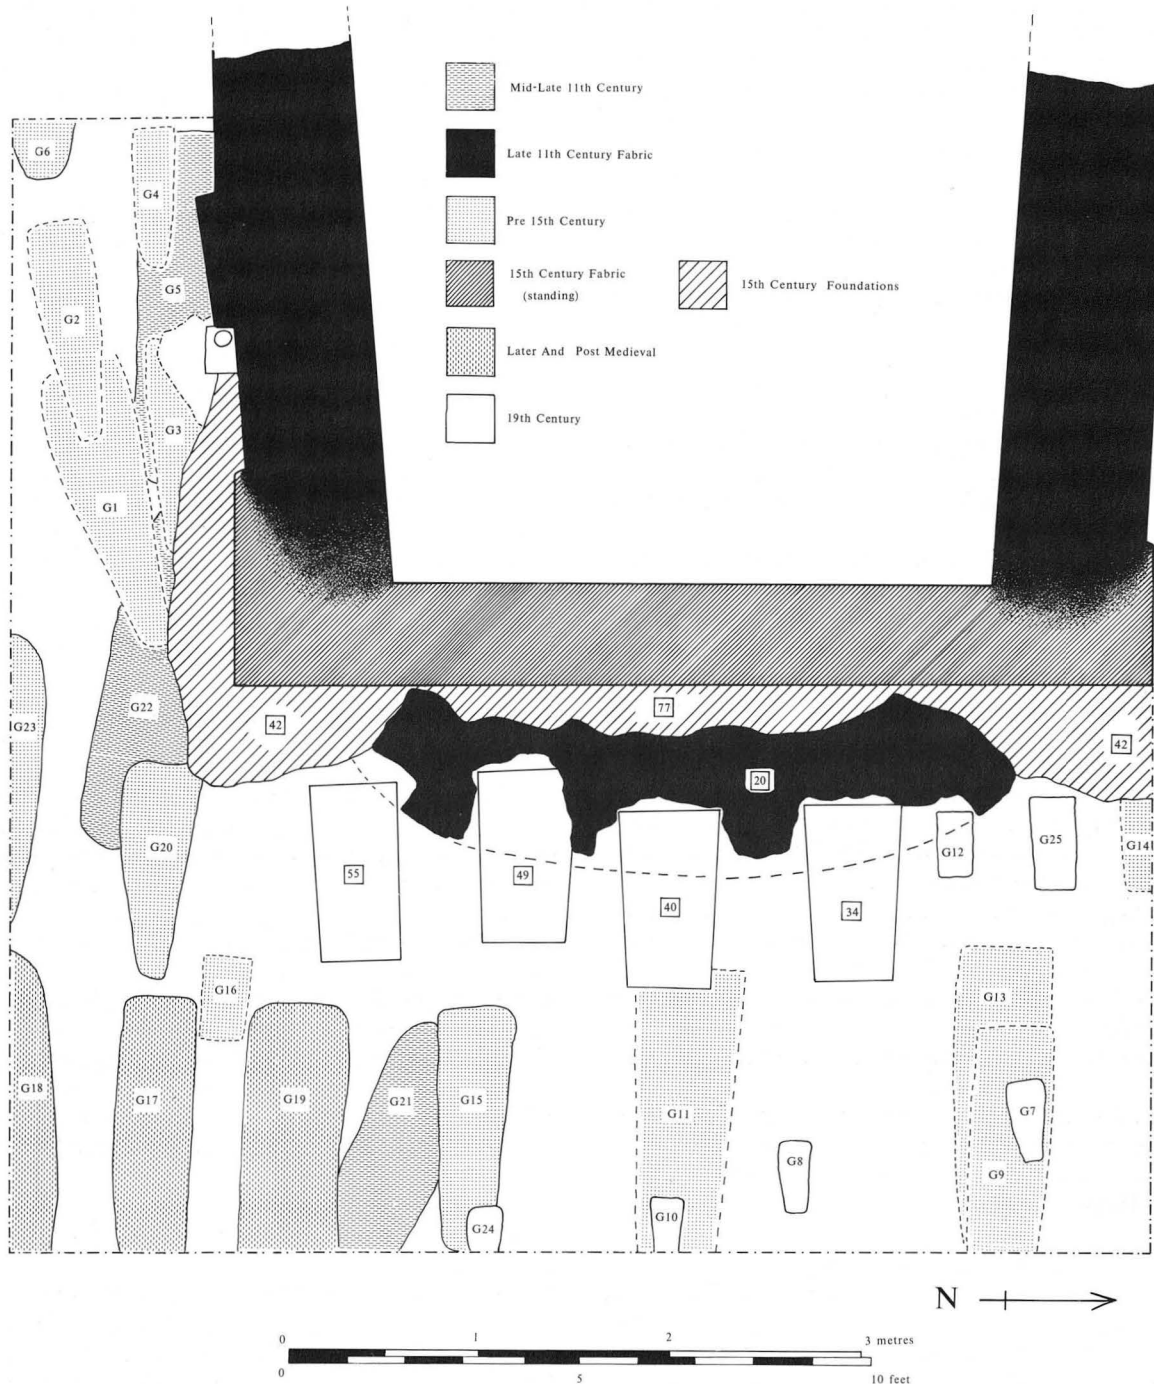
Figure 63 Interpretative plan of excavated features. Scale 1:40
