**The Ruined
and Disused
Churches
of Norfolk**

by Neil Batcock

**East Anglian Archaeology
Report No. 51, 1990**

**Norfolk Archaeological Unit
Norfolk Museums Service**

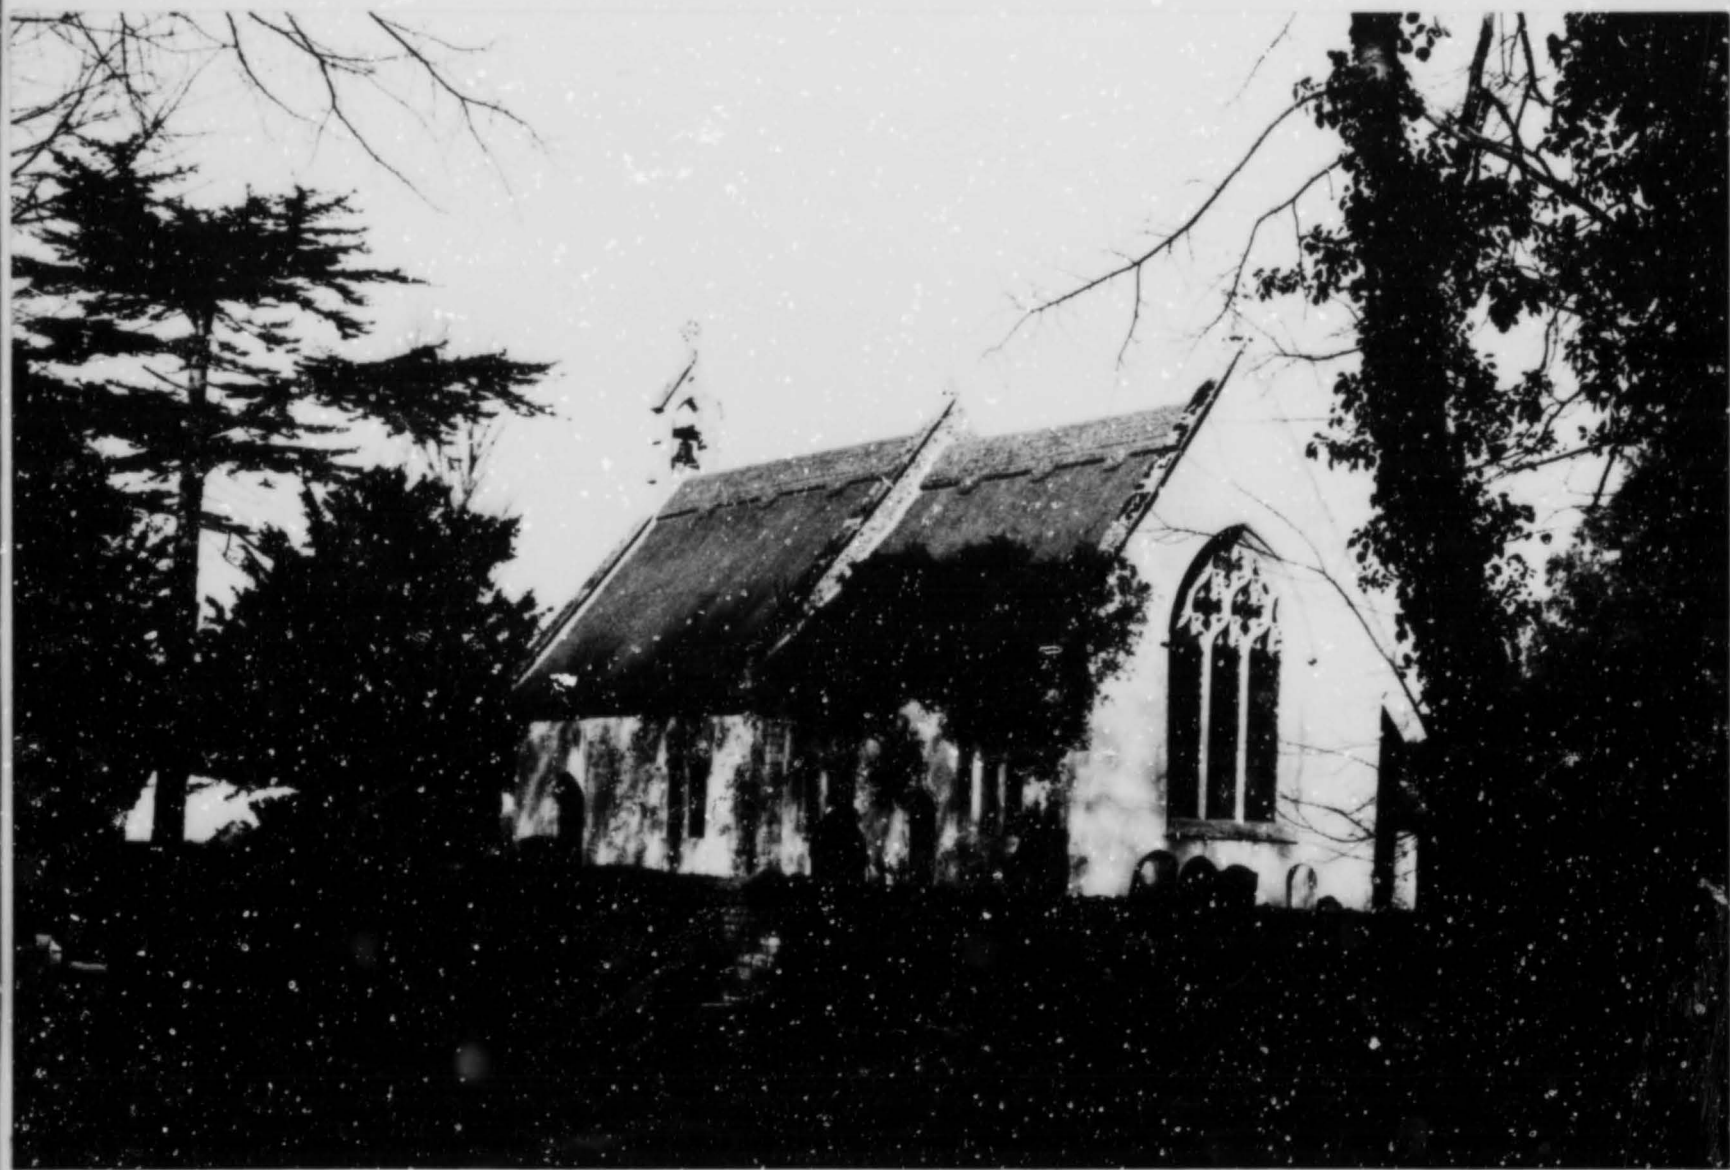
Plate CXLV. Barton Bendish, St Mary, from south-east

This report differs in some important details from that found in *East Anglian Archaeology* 32 (Rogerson, 1987, 59-63), since more details of the masonry fabric were brought to light after the stripping of the external rendering in February 1989. The church consists of chancel, north vestry and nave. The principal material is coursed flint, except the western part of the nave which consists largely of re-used limestone blocks. All roofs are thatched (Pl. CXLV).

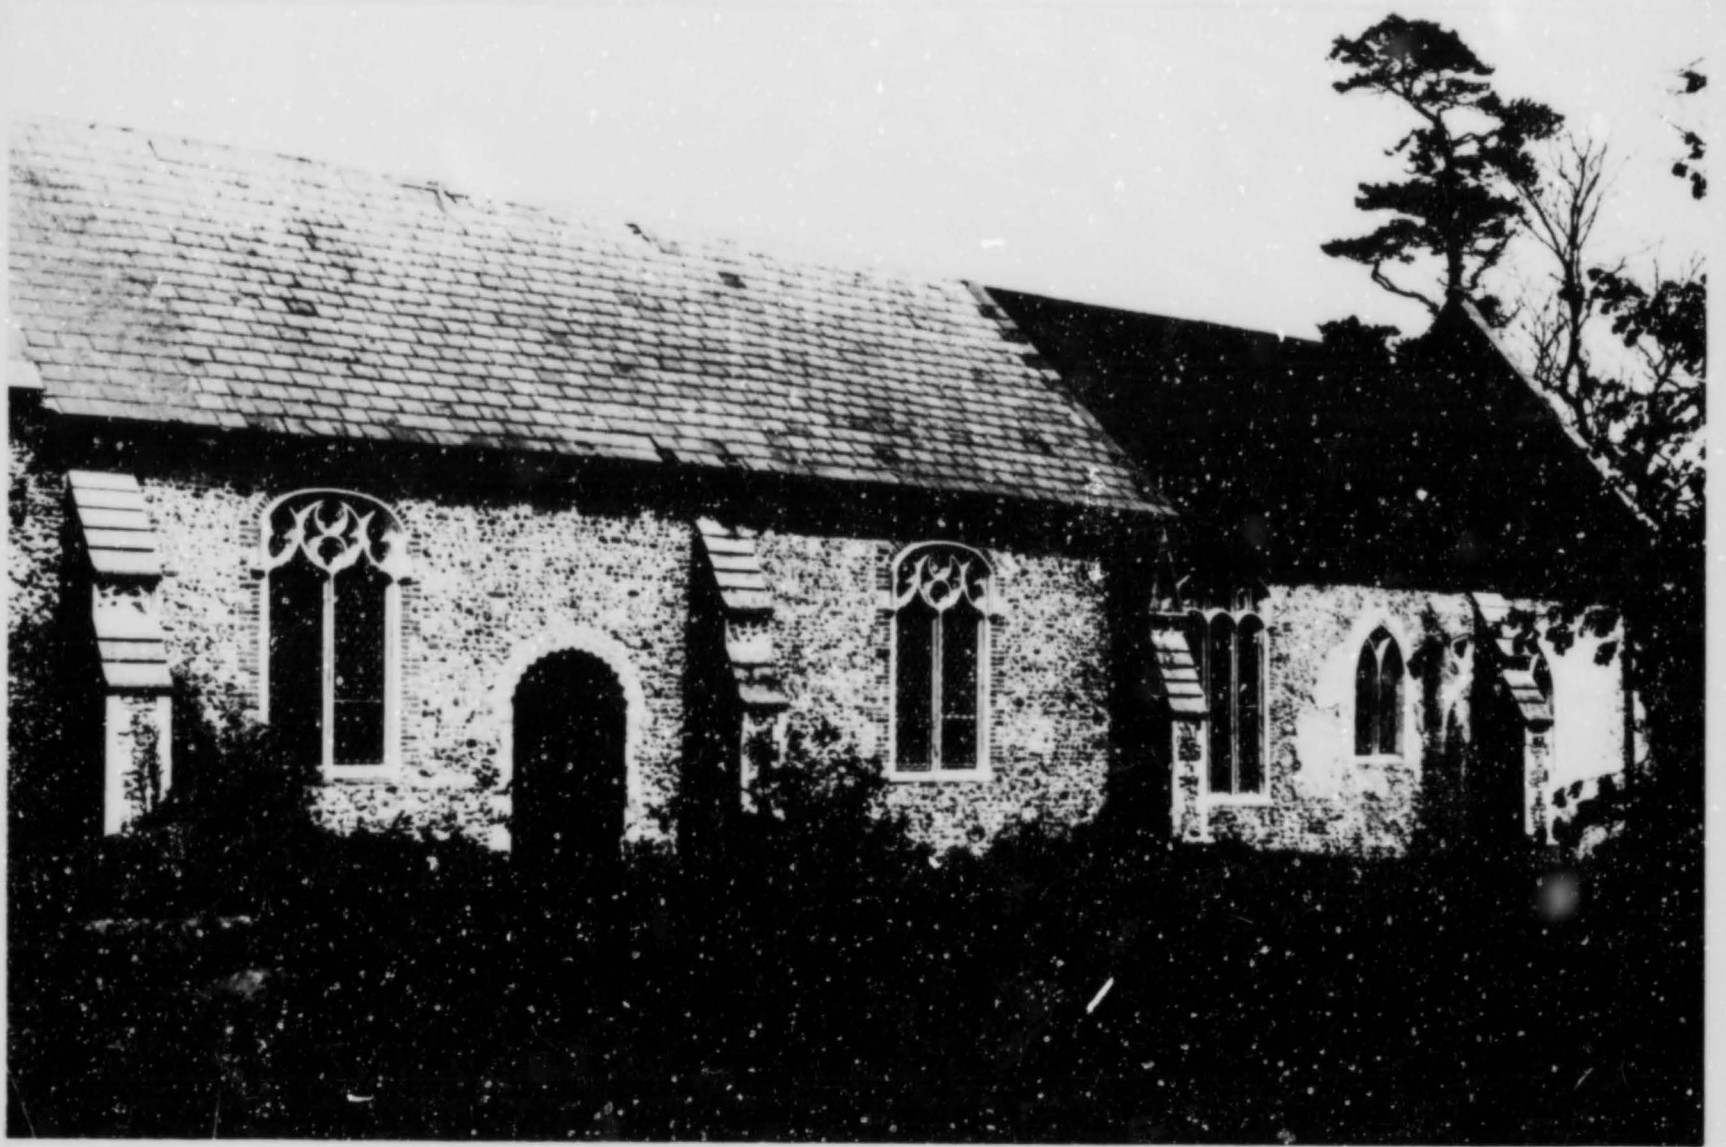
Plate CLVII. Buckenham Ferry, St Nicholas, south wall of nave and chancel

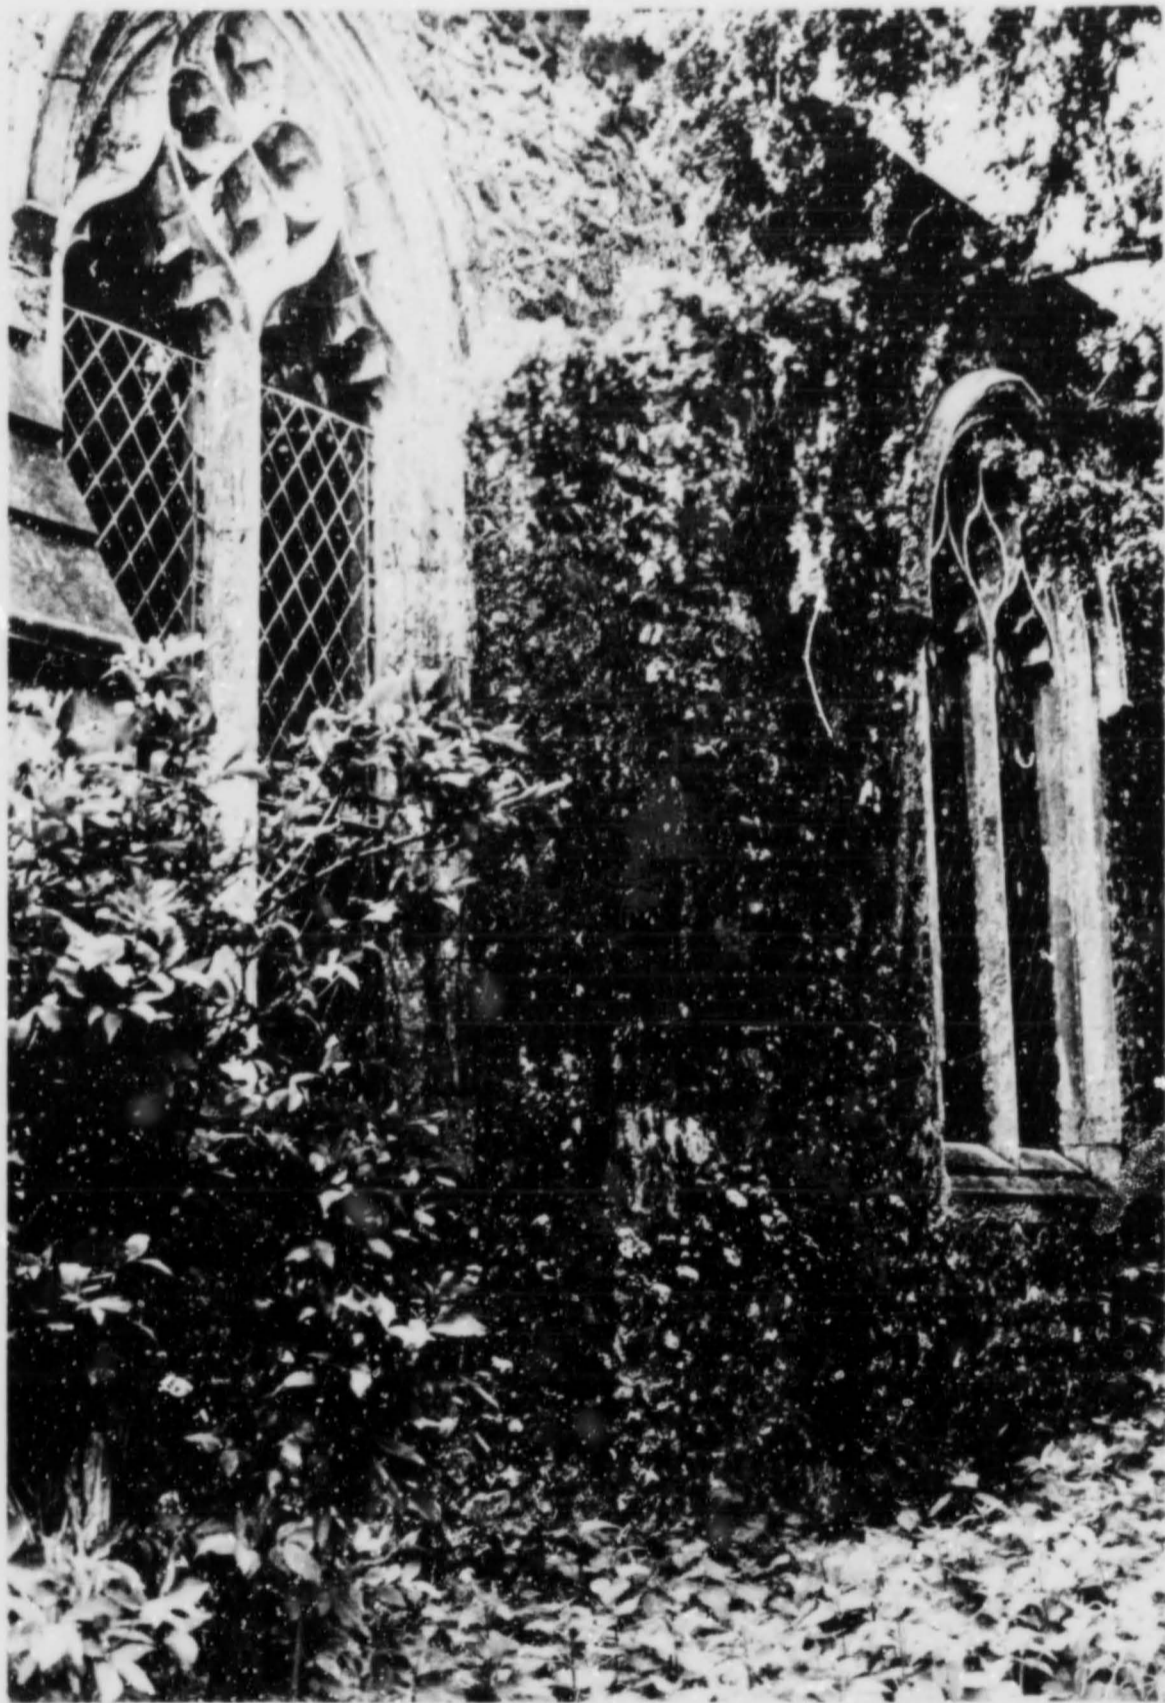
Plate CLVIII. Buckenham Ferry, St Nicholas, nave north wall

The north wall of the nave has not had such a thorough-going restoration. East of the projecting vestry are two two-light windows, nineteenth century in date. Between the windows is a mass of masonry 1m wide and projecting 6 or 7cm, rising to a height of 1.5m; above this there is some repair work with freestone and much brick; above 2m from the ground there are marks of gable-shaped bricks capping this projection, which must have been some sort of chapel (Pl. CLVIII). There is a straight vertical joint between this masonry and the walling east of it. Perhaps this work relates to the 'new aisle' for which John Dik, priest in 1509, left £20 for stonework and £16 for timber in his will (Blomefield 1807, VII, 215).

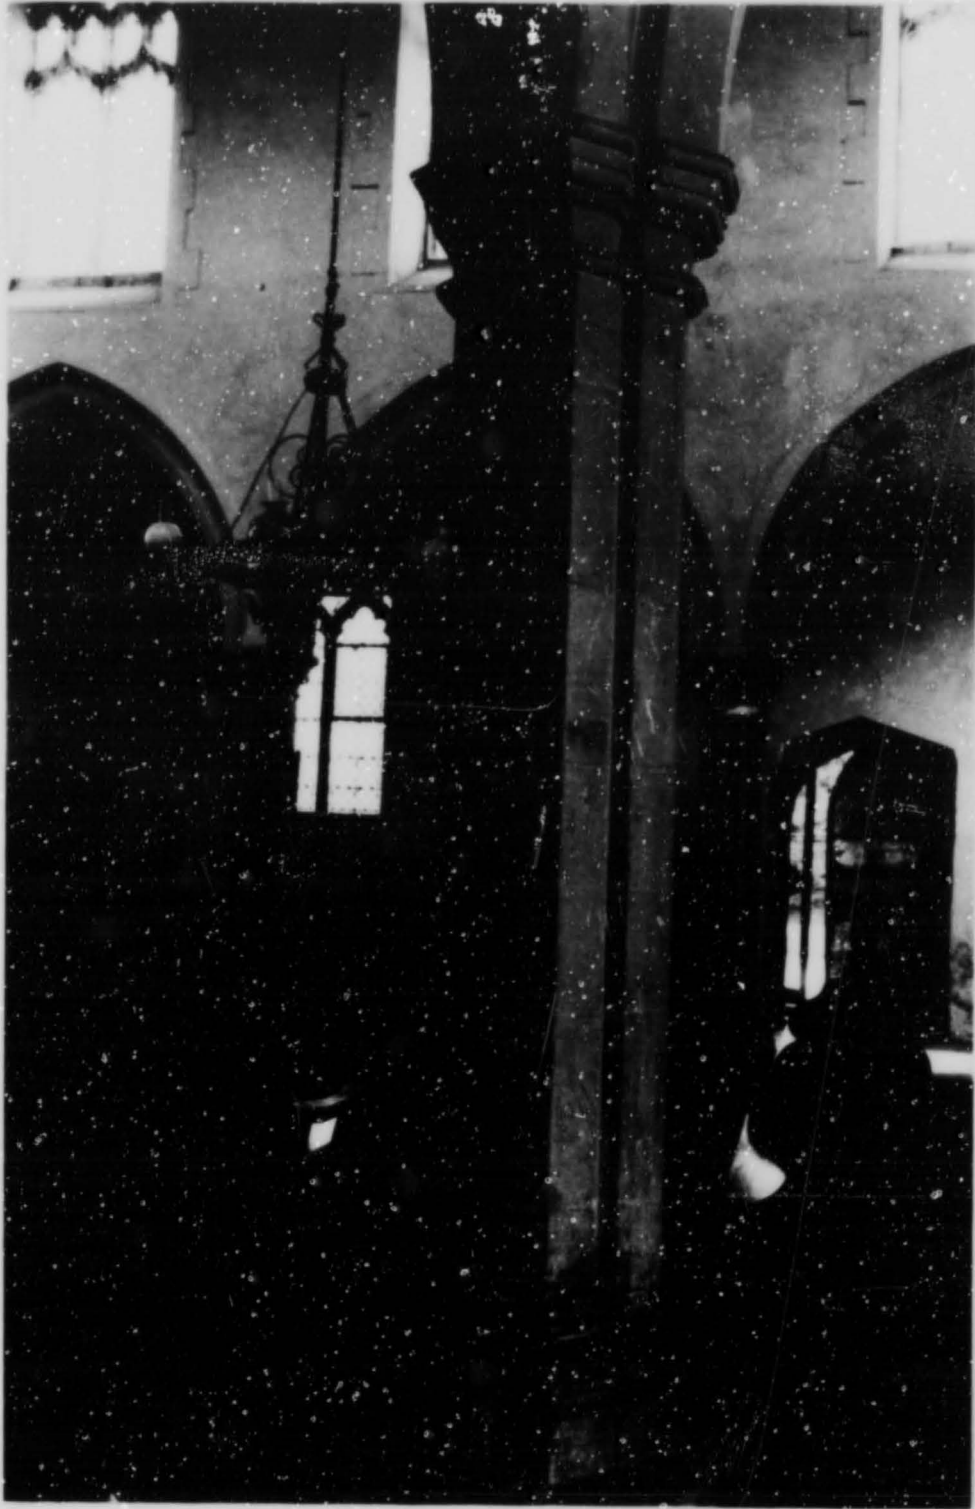
Plate CLXXXIX. Feltwell, St Nicholas, pier, north arcade

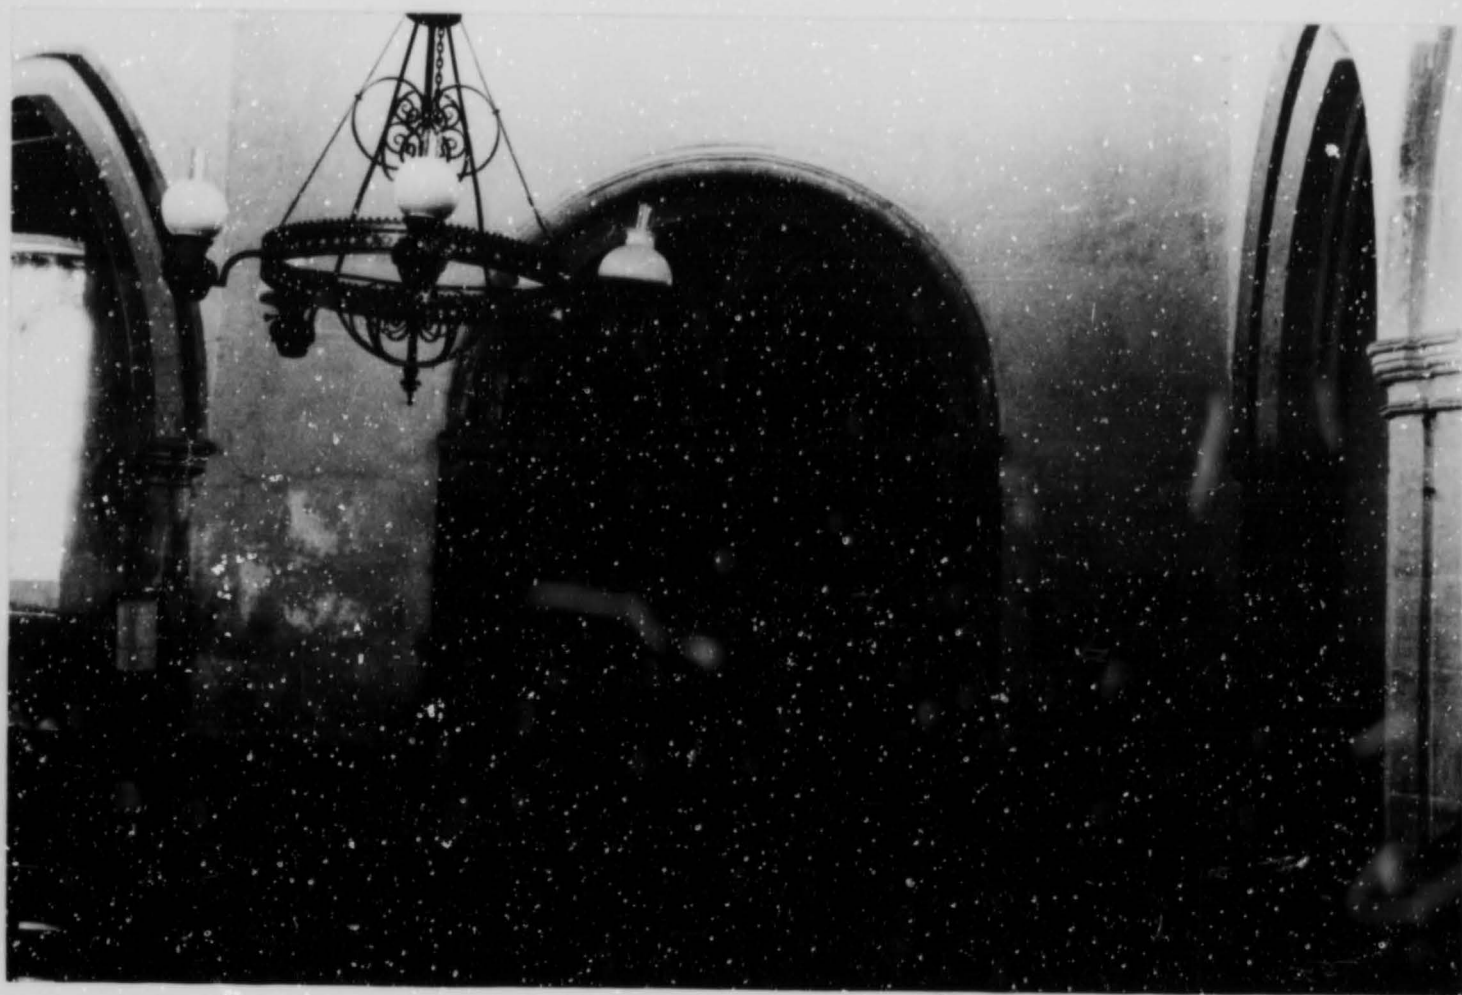
Plate CXCIII. Feltwell, St Nicholas, tower arch, looking west
